SUBJECT: I 64, Boyd County; MP 188; SP-10-115-29-L; Repair of Unstable Embankment

Research Report
363

STABILITY OF A SIDE-HILL EMBANKMENT

I 64, LEXINGTON-CATLETTSBURG ROAD
Milepost 188, Stations 282+38 to 284+20
Project SP-10-115-29L

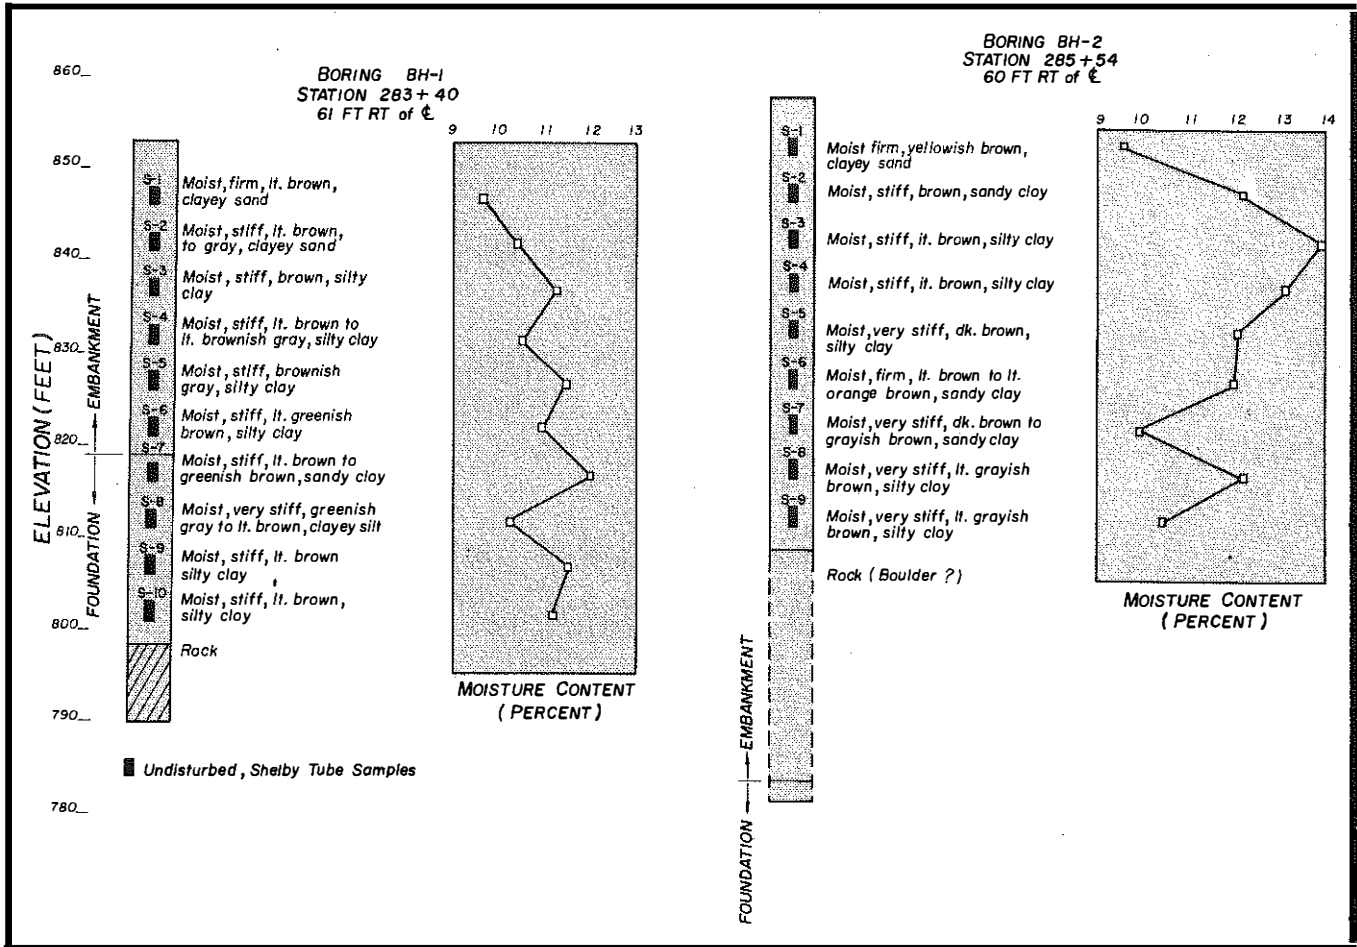
Figure 6. Boring Logs, BH-1 and BH-2.

Sample Preparation. Soil samples were extruded from the Shelby tubes, cut into 4-inch lengths, identified according to the visual-manual procedure (ASTM Designation: D 2488 T), waxed and stored until ready for testing. Water content determinations were performed on each of the extruded samples (see Figure 6 and Table 1).

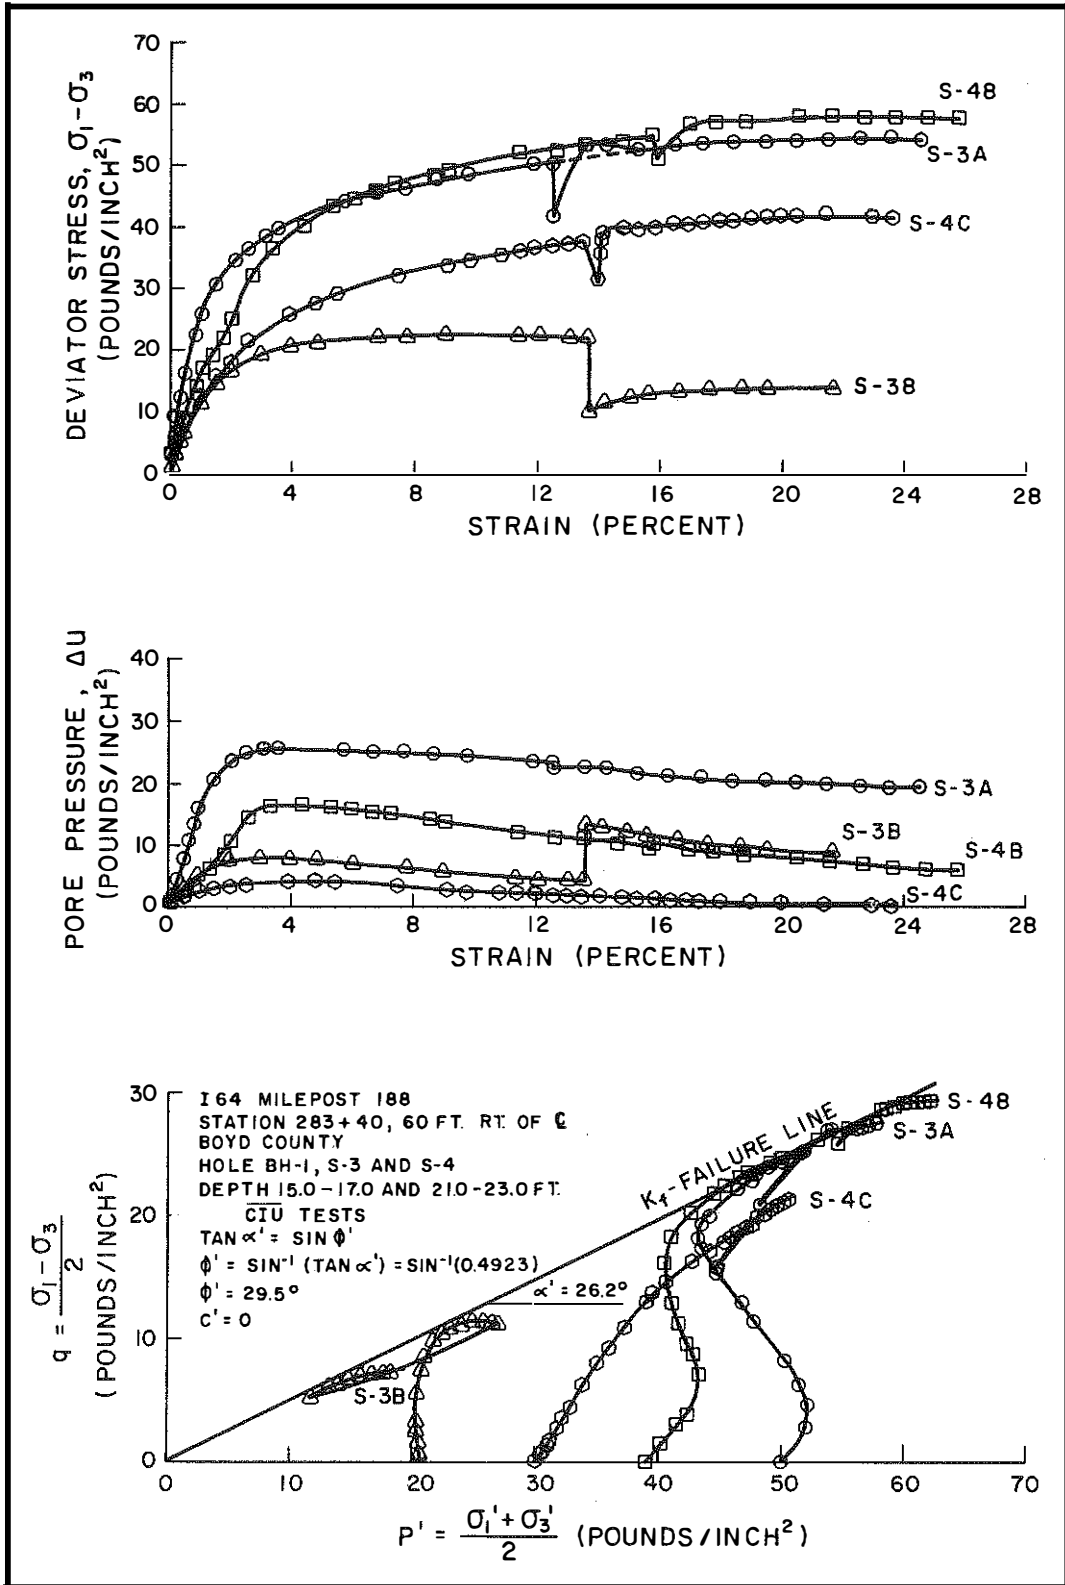
Figure 11. CIU Test Results, Boring BH-1, Samples 3 and 4.

Shear strength parameters obtained from the CIU and CDS tests are tabulated in the left portion of Table 1. Results of the CIU, that is, effective stress paths and change in pore pressure and deviator stress as a function of strain, are presented in Figures 11 through 16. CDS test results are shown in Figure 17. All stress paths in Figures 11 through 16 generally are either vertical or curved to the right on the p-q diagram. This indicates the embankment and foundation soils of the slide are over-consolidated. Except for results shown in Figure 16, stress paths at failure generally follow the K_f -failure envelope. Results shown in Figure 16 indicate the foundation specimens obtained from Boring RH-4 were highly over-consolidated. As shown in Figure 7 (Boring RH-4, Sample 2), these test specimens were an underclay or clay shale. The unusual stress paths obtained for these samples were a result of the highly preconsolidated nature of the clay shale specimens; consequently, confining pressures used in testing the clay shales apparently did not influence their failure strengths.

The angle of shearing resistance, ϕ' , of the unstable embankment soils was generally about 29°; it ranged from 27° to 33° (see Table 1). The shear parameter, c' (cohesion), was zero as determined from the CIU tests. Based on the CDS tests, c' was 476 pounds per foot square. The shear strength parameter, ϕ' , of the foundation located in the vicinity of the centerline of roadway ranged from about 27° to 29°. In the lower region of the slide, the angle of shearing resistance, ϕ' , of the foundation soil was 23° or 24°; cohesion was assumed to be zero.

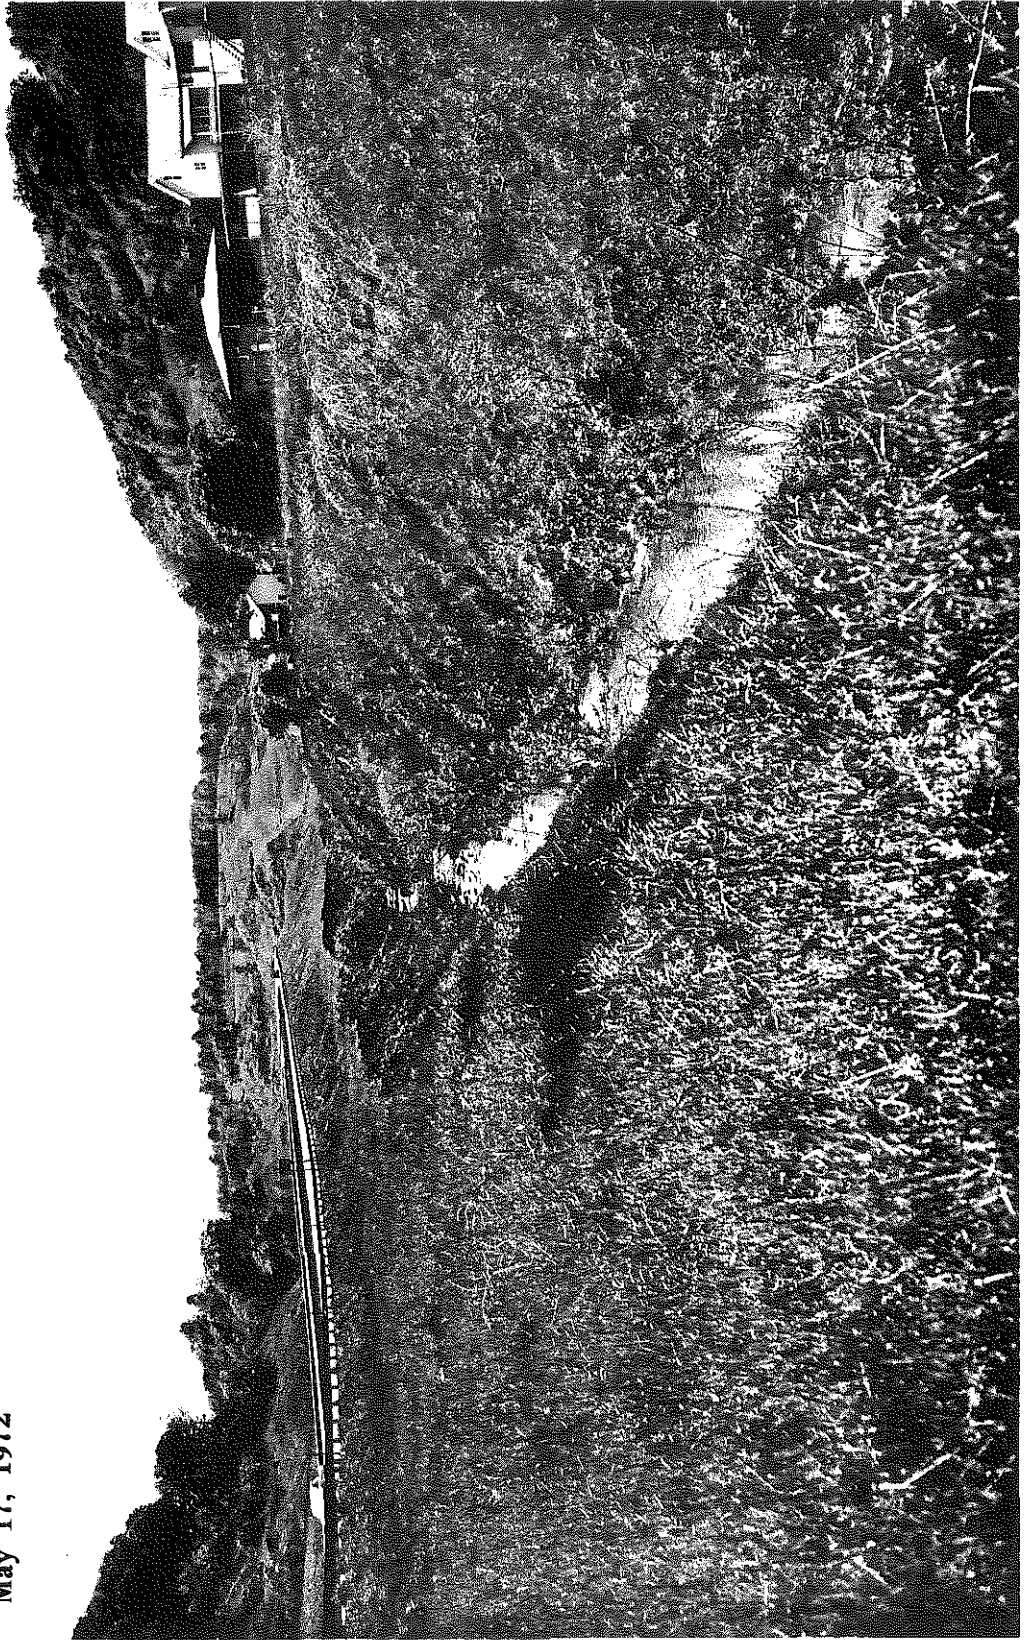
Figure 5.

A channel change constructed on the north side of I 64 from Station 390+00 to 420+00 has been eroding since the time of construction. Soil conditions in this area are such that velocities of 2-3 fps cause constant erosion. Down-cutting of the stream bed (Figure 4) has caused loss of sod and severe sluffing of the banks. This erosion has now lowered the flow line of the stream some 6 feet (according to District 9 officials). The channel is typically V-shaped. An inspection of the site on April 11, 1972, indicated that erosion had progressed to the point of endangering both private property and the road. An earlier attempt to control the situation by dumping large stone (quarry run) in the channel at some locations was not successful; high velocities during peak discharge dilapidated those fill-ups.

I 64 - 8(6) 180, M.P. 190-191
CONCEPTIONAL REMEDY FOR CHANNEL EROSION
Ditch - Checks, 2 to 3 Ft. High
23 - Ft. Drop in 1900 Ft.
May 17, 1972
