MEMORANDUM TO: J. R. Harbison
State Highway Engineer
Chairman, Research Committee**SUBJECT:** Research Report No. 359; "Experimental Installations of Impact-Attenuating Devices;" Final Report on Study KYHPR-70-64; HPR-1(8), Part II.

March 1973

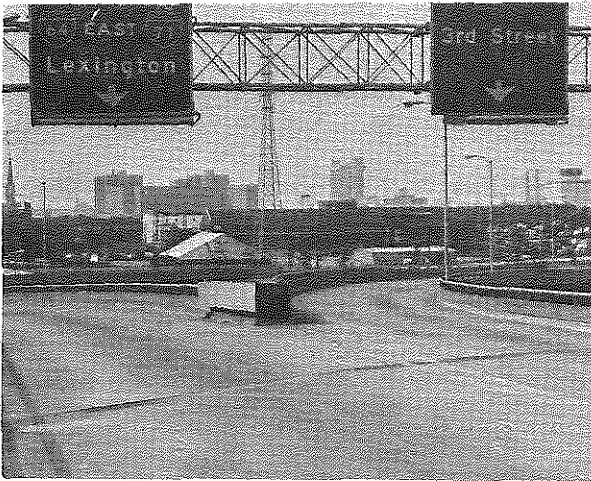
Figure 5. HI-DRO Cushion Installation at Location 3(a).

Since installation, there have been four known hits. All were rather insignificant, and none was reported to the police. Apparently no injuries were sustained. Three of the four impacts were recorded on film by a camera monitoring system. Circumstances contributing to the first hit, which was of least significance and probably involved contact with only a restraining cable, are unknown. The most severe damage was obvious vandalism; a late model car slowly but intently approached the front of the barrier; the driver then applied power and pushed the barrier back some three feet. Another filmed hit revealed snowy roadway conditions and an out-of-control vehicle sliding sideways into the front of the barrier system. These first two hits were recorded by the camera system under nighttime conditions. The most recent hit occurred during wet daytime conditions and involved a

All four impacts involved very minor damage to the barrier system. Following the vandalism hit, which was the only hit to involve significant barrier displacement, the barrier was repositioned without difficulty. The repair cost, including labor, materials and equipment usage, was estimated at \$60 for each of the first three hits. Table 3 summarizes the available information pertaining to these four impacts.

On several inspections of the system during winter months, alarming amounts of frozen liquid in the cells were observed. This appeared to be the case during the impact recorded on film during snowy conditions. Obviously, this condition significantly reduces the effectiveness of the barrier. District 5 engineers attributed the freezing to the inability to obtain proper solution of calcium chloride in the water in individual cells.

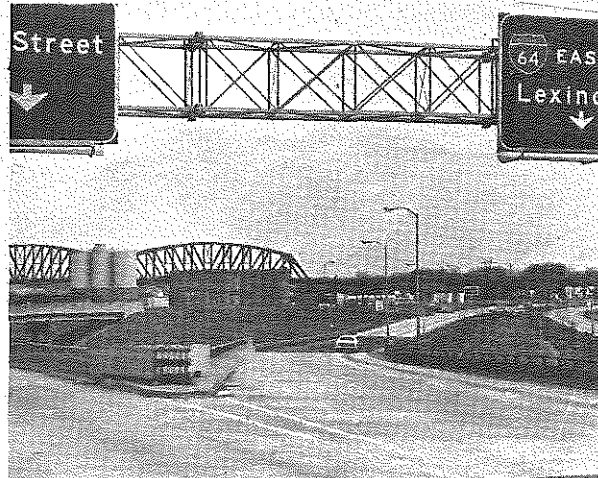
Figure 6. HI-DRO Cushion Installation at Location 3(b).

A HI-DRO Cushion system was designed by the manufacturer, and materials and costs were \$6275. It was installed in early September 1970 and is pictured in Figure 6.

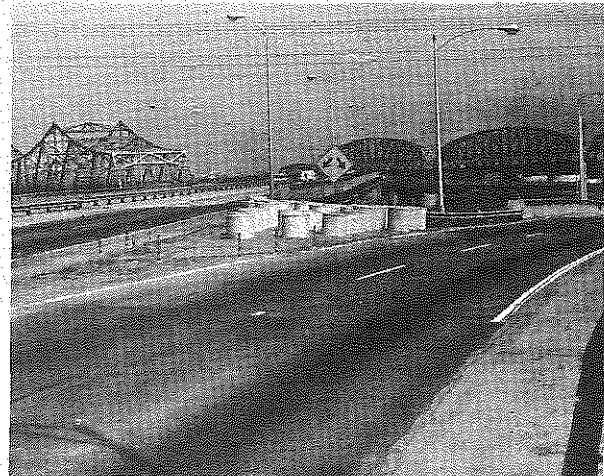
Figure 7. Fitch Inertial Barrier Installation at Location 3(c).

The Fitch Inertial Barrier system, containing 43 modules, was installed on August 13-14, 1970. The system is schematically depicted in Figure 32; the barrier installation was previously shown in Figure 7. At the time of installation, modules cost \$120 each, making the cost of materials for the initial installation approximately \$5500.

One problem encountered at this location was the cross slope of the gore area. It is believed to have caused several, lighter, top-heavy, modules to tip over under their own weight as a result of the strong axes of the inserts being placed along the slope. Another problem is the rather unpleasing appearance the barrier has developed with time. Specifically, the barrier is dirty, due to vehicle spray and dust.

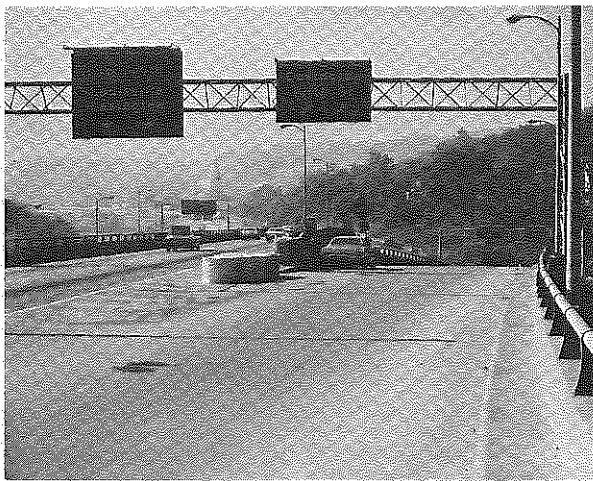
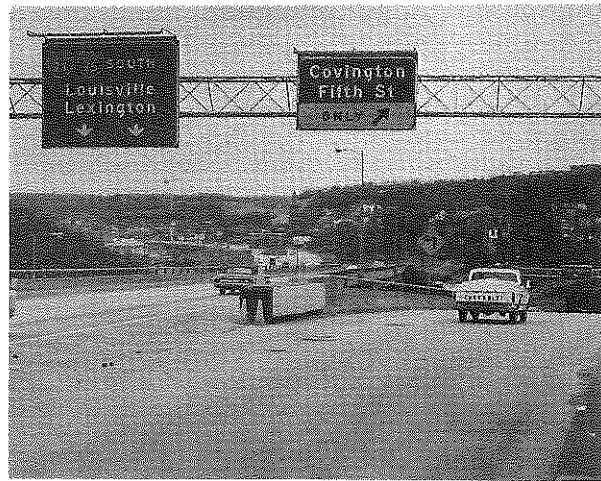
Figure 13. Former Fitch Barrier and Present HI-DRO Installation at Location 7.

A Fitch barrier was installed November 5, 1970. The Fitch-type barrier was replaced with a HI-DRO Cushion barrier on October 10, 1972. This site will be discussed in depth in the next section of the report. The former Fitch installation and the present HI-DRO barrier are shown side-by-side in Figure 13.

Other problems were observed at this location. Apparently, bridge vibrations caused at least two modules to split along a riveted seam. No other explanation could be offered. Also, the camera monitoring system, when actuated by maintenance personnel removing debris and reinstalling modules after impacts, showed wet sand being shoveled from the roadway and put into replacement modules. This practice seemed to invite adverse performance of the barrier during freezing weather.

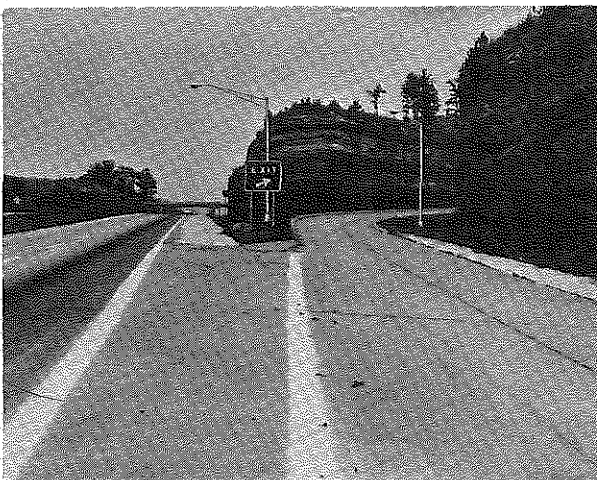
Figure 23. Location 12 (Existing Condition) before Planned Installation of a Steel Crash Cushion.

A Steel Crash Cushion is planned for this location as part of a future safety improvement project. The existing gore area is shown in Figure 23.

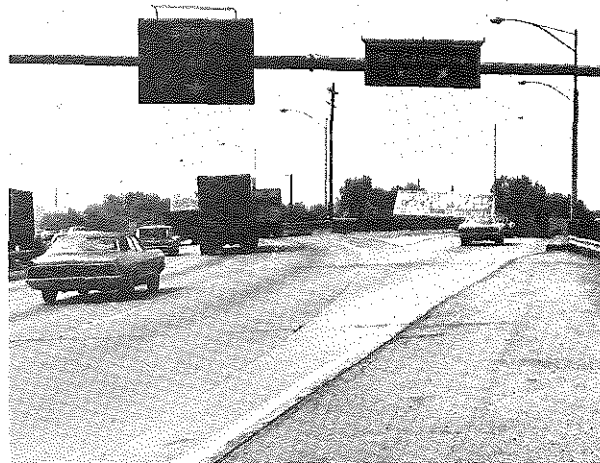
Figure 25. Fitch Inertial Barrier Installation at Location 14.

A Fitch Inertial Barrier, shown in Figure 25, was installed on July 2, 1971. Further discussion of this installation can be found in the next section of this report.

There have been two impacts with this barrier -- both were major. The first hit occurred on November 7, 1971; 18 modules were destroyed. Figure 43 shows the aftermath of this first impact. The second hit, in which 19 modules were destroyed, occurred on January 29, 1972. There were no police reports of these apparent drive-away situations. Considering the apparent magnitude of these impacts, the Fitch system was extremely effective. Costs of replacement modules, including 10 which were vandalized, are shown in Table 5.

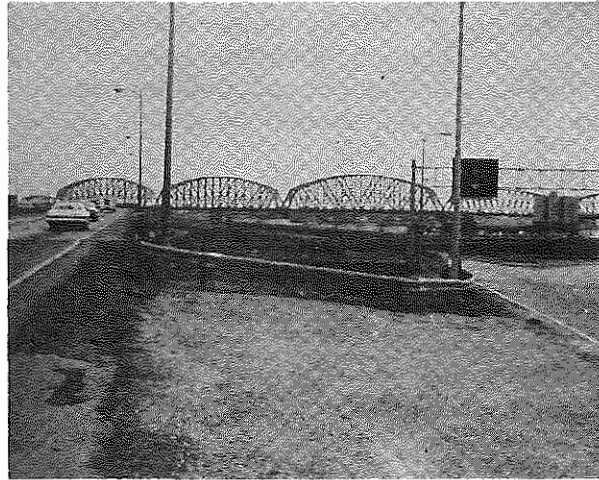
Figure 31. Location 3(c) after Guardrail Removal and Leveling.

To decrease the severity of accidents in this gore area, plans were made to increase the recovery area between the bifurcating roadways by filling back to the bridge structure, turning the guardrail on a longer radius, and installing a Fitch barrier. This procedure would provide a crash cushion and also increase the recovery area by some 100 feet. Figure 31 shows this gore area after guardrail removal and leveling.

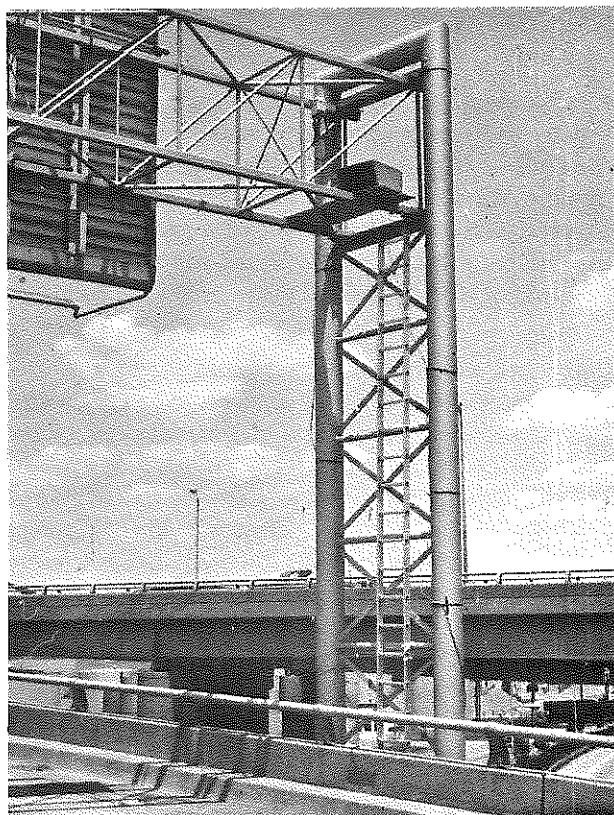
The third camera system was installed at a HI-DRO Cushion in Louisville (Location 3(a): Jefferson County; Kennedy Interchange (I 71 - I 64 - I 65), southbound secondary gore between Ramps 4 and 8) on May 14, 1971. Figure 47 is a photograph of this camera monitoring system. Three hits occurred at this location after the camera system was installed. All three were recorded on film - two by the night camera and one by the day camera. None of these hits was of the high-speed, high-damage type.

Figure 47. Camera Monitoring System at Location 3(c).
