THE BUMP AT THE END OF THE BRIDGE

KYHPR-64-17; HPR-1-(4), Part II

Division of Research
DEPARTMENT OF HIGHWAYS
Commonwealth of Kentucky

June 1969

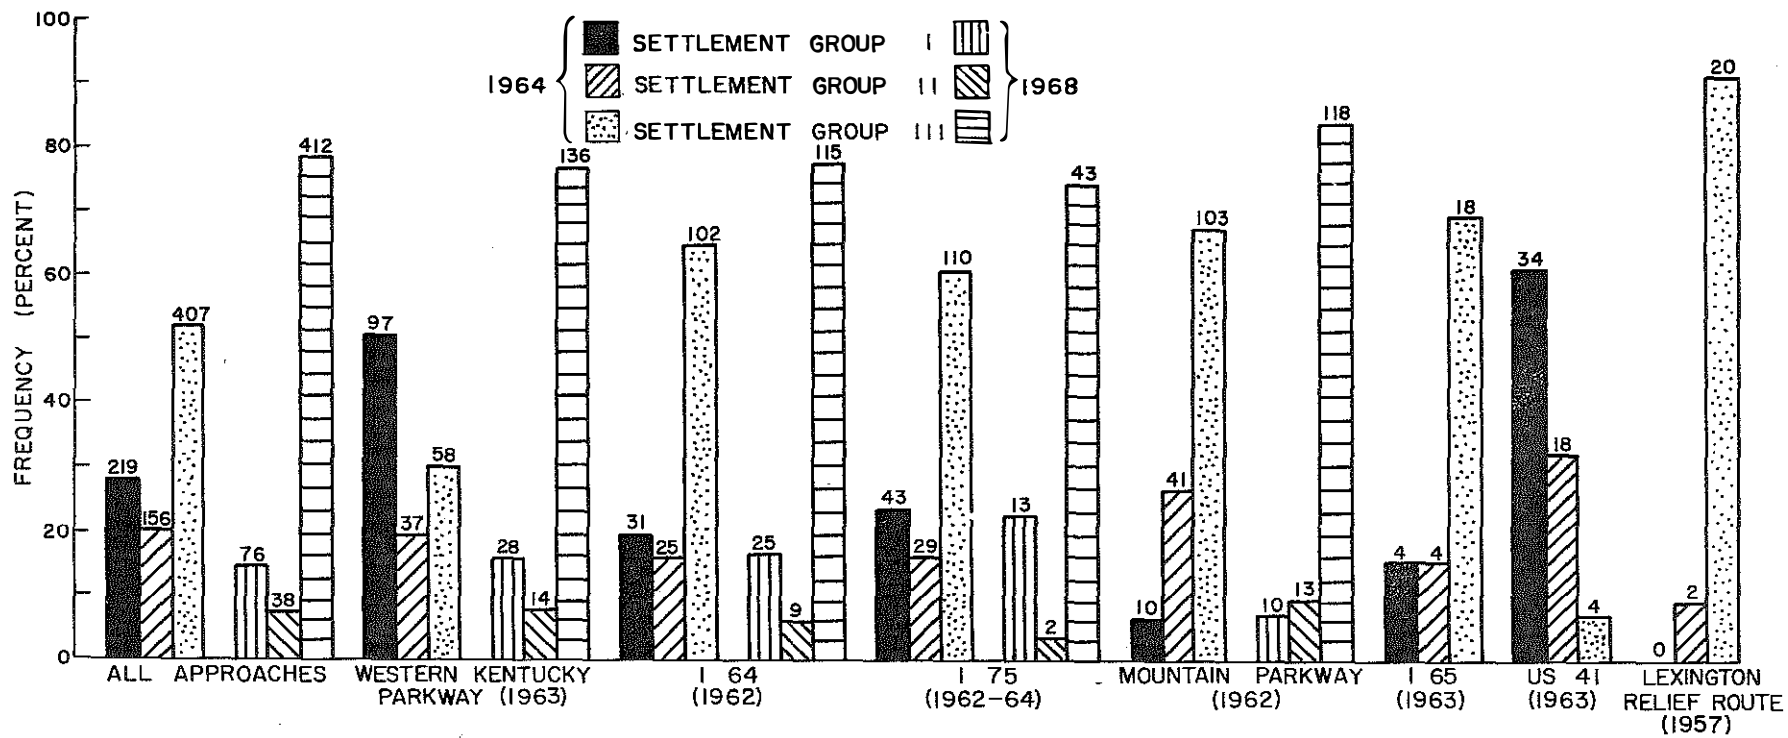
FIGURE 3. COMPARISON OF BRIDGE APPROACHES BY ROUTES

The criterion used to distinguish between Groups I and II was whether or not a 'bump' was evident when an automobile passed onto or off the bridge deck. Additional information was obtained by visually inspecting each approach. Figure 3 summarizes the 1964 and 1968 data, showing the total number and percentages of approaches classified in accordance with each settlement group. In addition, the ages (approximate dates opened to traffic) of the approaches are shown. The majority of approaches were at least two years old in the 1964 survey. From these data, it is evident that present design and construction procedures are not sufficient to obtain smooth bridge approaches.

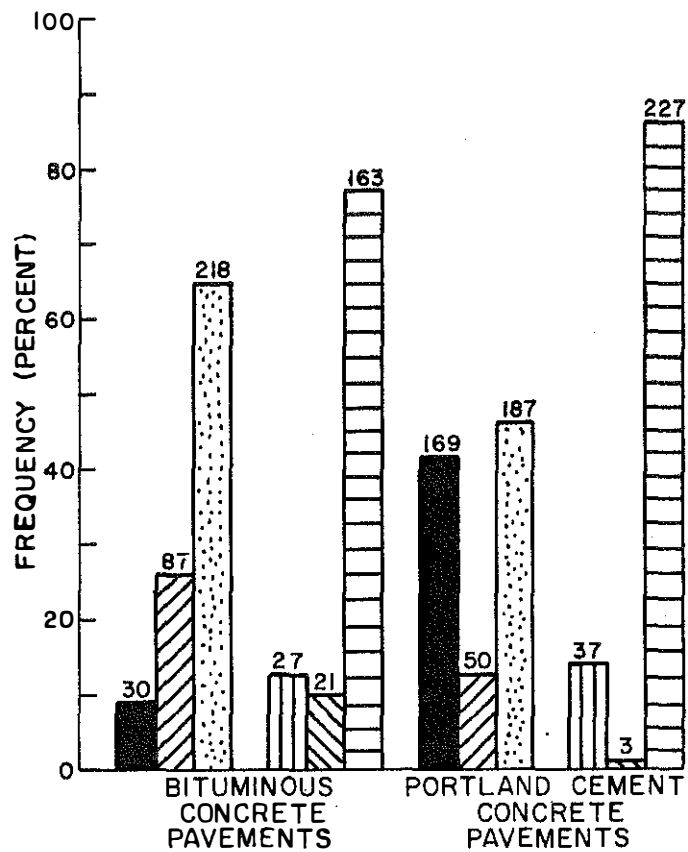
FIGURE 4. COMPARISON OF BRIDGE APPROACHES BY PAVEMENT TYPE

A comparison of portland cement concrete and bituminous concrete approaches, Figure 4, shows a markedly higher percentage of bituminous concrete approaches with patching than rigid approach pavements with mudjacking in 1964. In addition, there was a much greater percent of smooth approaches (Group I) for concrete approaches than for bituminous approaches. However, in 1968, the difference in percentage of mudjacked and patched approaches, as well as smooth approaches, was almost insignificant. Furthermore, the 1968 data, when compared to 1964 data, showed that there was an appreciable percentage decrease in smooth approaches and an increase in maintained approaches for both types of pavements. Apparently, at least for a short period of time, the rigidity of portland cement concrete pavement reduced the occurrence of the approach fault by bridging the presumed depression behind the abutment. Generally, the approach settlement appeared to be confined within 100 feet of the end of the

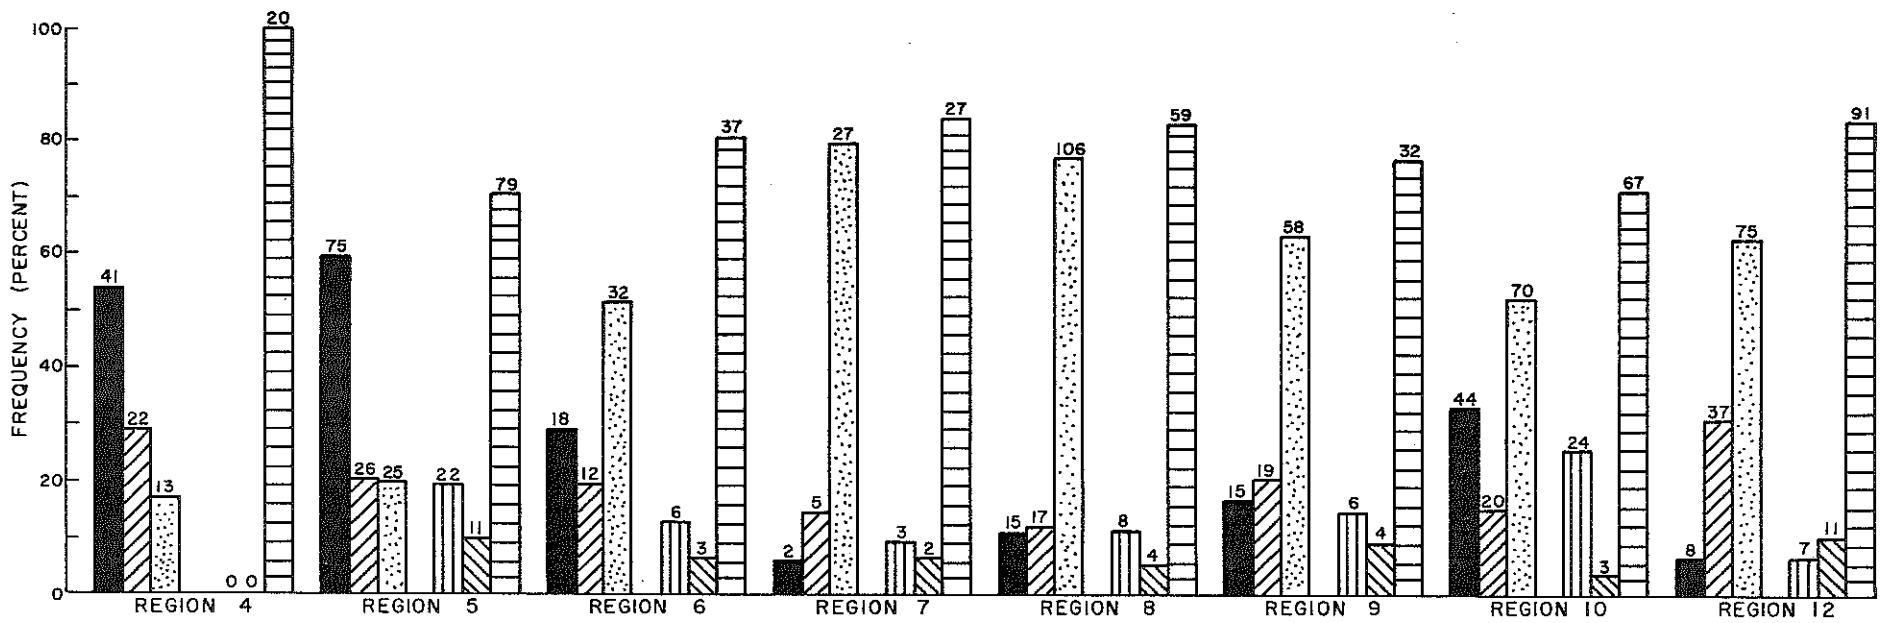
FIGURE 5. COMPARISON OF BRIDGE APPROACHES BY PHYSIOGRAPHIC REGIONS

Figure 5 shows the distribution of bridge approaches with respect to the three settlement groups in each of eight physiographic regions of Kentucky in which the observed bridges were located. 1964 data show that the best approaches, or the lowest percentages of defective approaches, occurred in Regions 4 and 5 (the Western Coal Field). But by 1968 there was a large increase in defective approaches in both regions. This area is a topographic as well as a structural basin; it is a dissected plateau with rolling hills and moderately wide valleys. An outstanding feature of this area is the broad alluvial bottoms of larger rivers. A large number of approaches studied lie within these recent alluvial deposits. Soils of this area have been formed by weathering of sandstone and shales, and large quantities of silts are present.

The highest percentage of approaches in Settlement Group III in 1964 occurred in Region 7, referred to as the Knobs, and Region 8, commonly called the Outer Blue Grass. The Knobs Region, characterized by conical knobs, erosional remnants of former uplands, is a narrow belt of land surrounding the Blue Grass limestone country. Consequently, a rough topography has emerged with the major stream beds flat and wide. This area contains large amounts of shale and plastic clays. The comparatively impervious and easily eroded shale of the Outer Blue Grass has produced a rough, hilly terrain. This region also contains large amounts of plastic clays derived from limestone and shales. For both 1964 and 1968, the proportion of smooth and defective approaches was about the same.

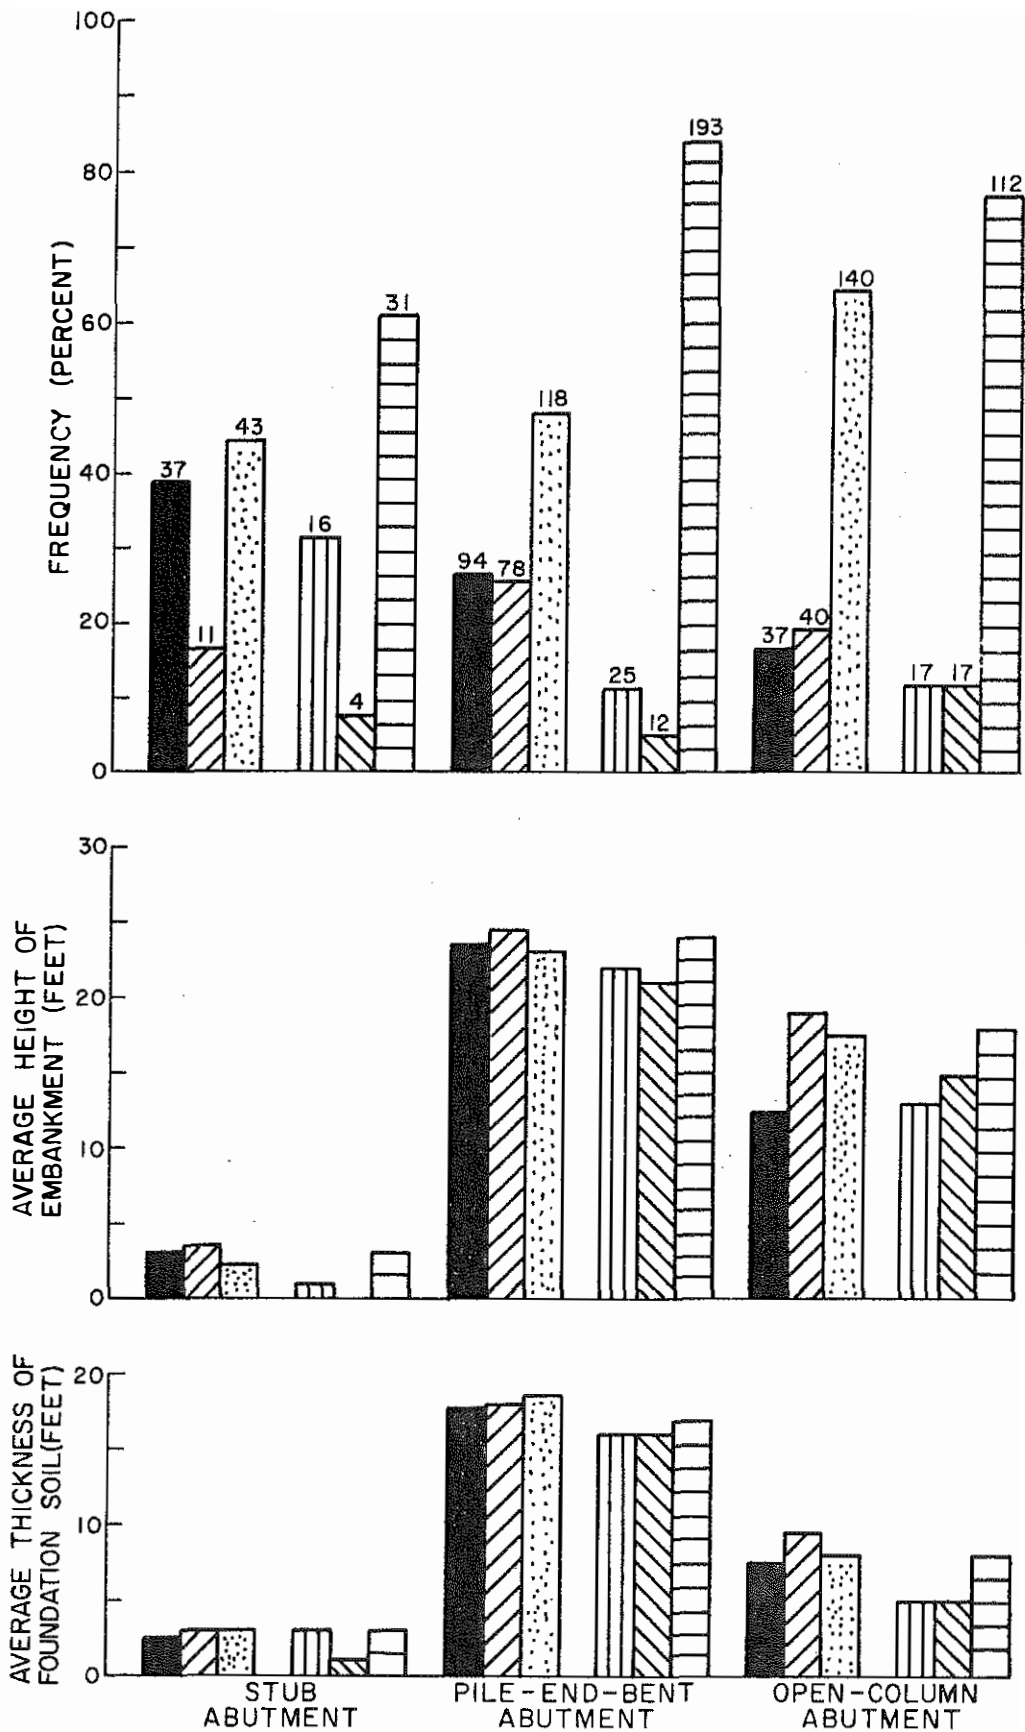
FIGURE 7. COMPARISON OF BRIDGE APPROACHES BY ABUTMENT TYPE

A comparison of the most commonly used types of abutments (see Figure 6), with respect to the three settlement groups, Figure 7a, revealed that the open-column type (open-end) was more commonly

associated with Settlement Group III than either the pile-end-bent (open-end) type or stub type (closed-end) in 1964. The relationship between average height of embankment, average thickness of foundation soil and type of abutment with respect to settlement groups is shown in Figures 7b and c. Notice that stub abutments are associated with smoother bridge approaches, smaller average heights of embankment and thinner foundation soils. The pile-end-bent abutments had greater average heights of embankment and thicknesses of foundation soils than the open-column abutment, but the pile-end-bent abutments had better bridge approaches. The better performance of approaches located behind stub abutments may be attributed to smaller settlements associated with shallower embankments and foundation soils. The comparatively larger time for consolidation before construction of the pavement and the need for less hand compaction near the abutment may account for better performance of approaches associated with pile-end-bent abutments than those approaches at open-column abutments. However, in 1968 there was an increase in percentage of faulted approaches for all types of abutments with the percentage for pile-end-bents increasing the most. There were small differences in percentages between the pile-end-bent and open-column abutments. Although the percentage of faulted approaches increased, stub abutments still had a comparatively high percentage of smooth approaches in 1968. For both surveys, there was a large number of defective bridge approaches associated with all types of abutments.

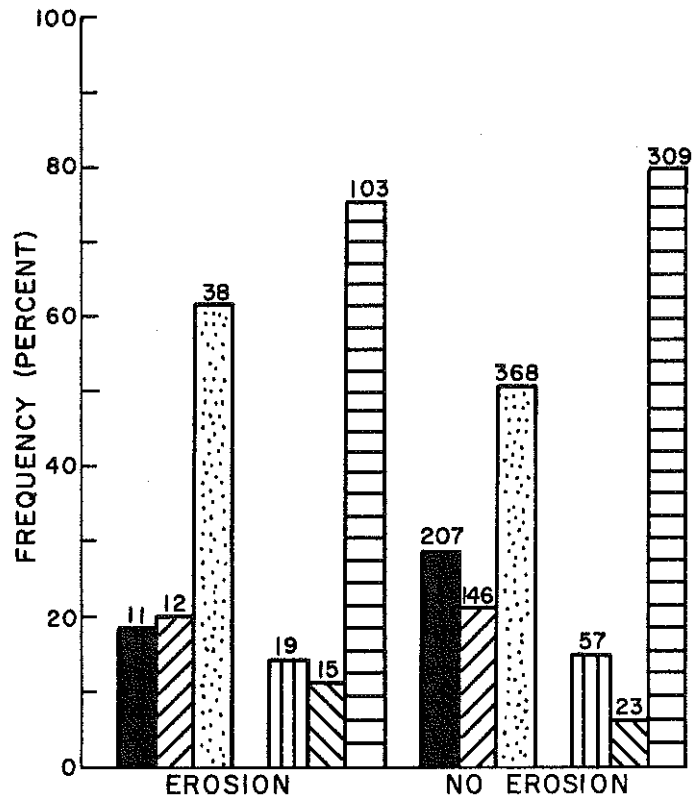
FIGURE 9. COMPARISON OF BRIDGE APPROACHES BY EXTENT OF EROSION AT FACE OF ABUTMENT

In a few cases, the 1964 study indicated that erosion of soil adjacent to the abutment (Figure 8) contributed to the development of the approach fault. In one observed case, grouting material from the mudjacking operation had effused from underneath the face of the abutment. As shown in Figure 9, there was an increase in the percentage of repaired approaches when such erosion occurred. This type of erosion appears to be a result of ground water seepage (including runoff from the pavement) as shown diagrammatically in Figure 10.

Loss of material around the abutment could result in a loss of subgrade material and, consequently, cause the approach to settle. By 1968 the percentage of defective approaches had increased noticeably, and there were no significant differences in percentages of smooth approaches as well as faulted approaches for approaches with erosion and without erosion. However, the number of faulted approaches with erosion at the face of the abutment increased considerably.

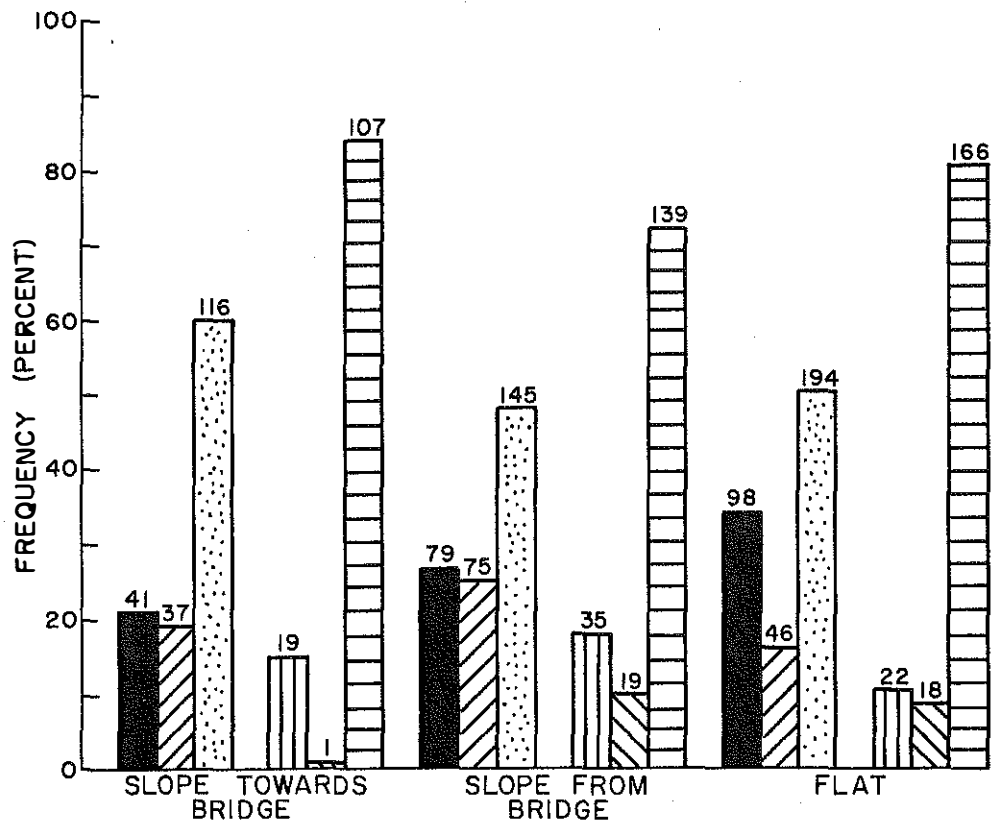
FIGURE 11. COMPARISON OF BRIDGE APPROACHES BY SLOPE OF APPROACH PAVEMENT

Other supporting evidence that seepage may, in some cases, result in settlement of the approach is presented in Figure 11. A comparison was made among those approaches which sloped toward the abutment, those which sloped away and those which were relatively level with respect to the three settlement groups. Those which sloped toward the abutment had a higher percentage of Group III approaches than the other two categories.

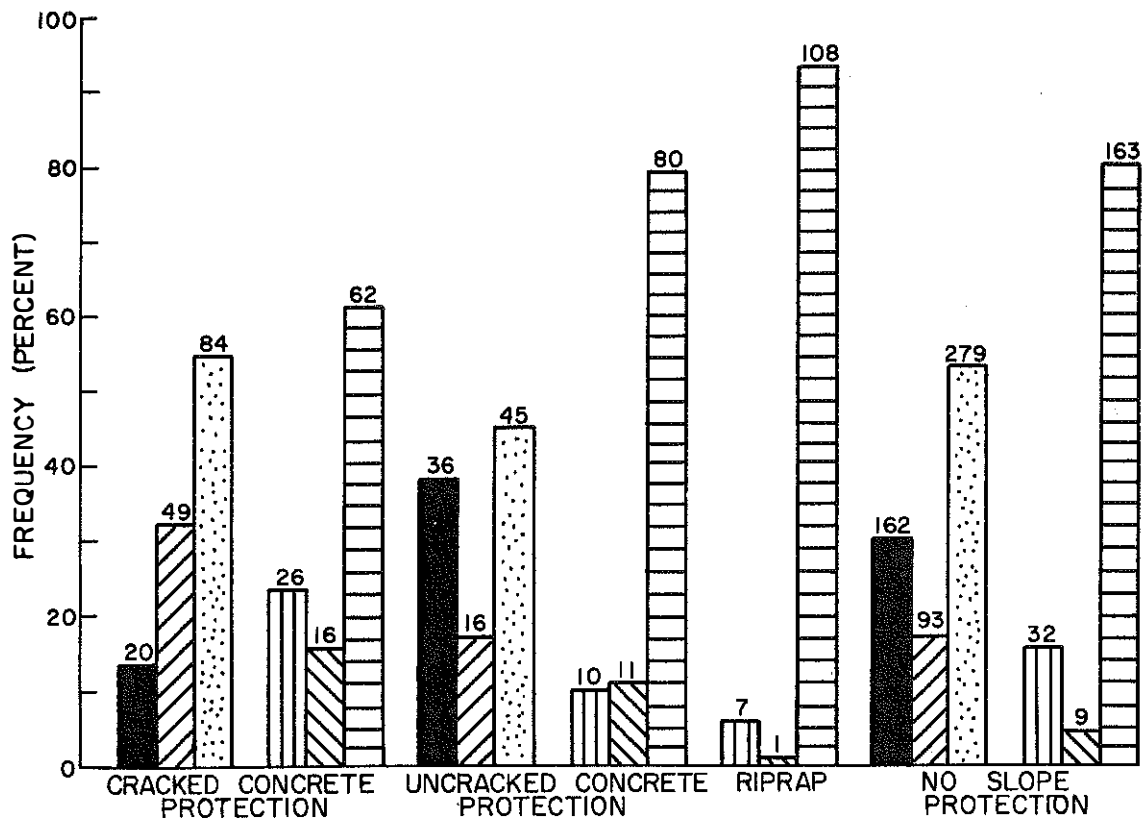
FIGURE 12. COMPARISON OF BRIDGE APPROACHES BY TYPE OF SLOPE PROTECTION

There was suggestive evidence that progressive failure, or creep, of the approach embankment may, in some cases, contribute to development of the approach fault. Figure 12 is a comparison of approach embankments with cracked concrete slope protections, embankments with uncracked concrete slope protections, and embankments with no slope protection, suggesting a relationship between cracked slope protections and bridge approach settlement. One possible explanation for the cracked slope protections could be progressive failure of the embankment, as shown in Figure 13, resulting in a loss of subgrade support. In some cases, slope protections did appear to be bulging outward.

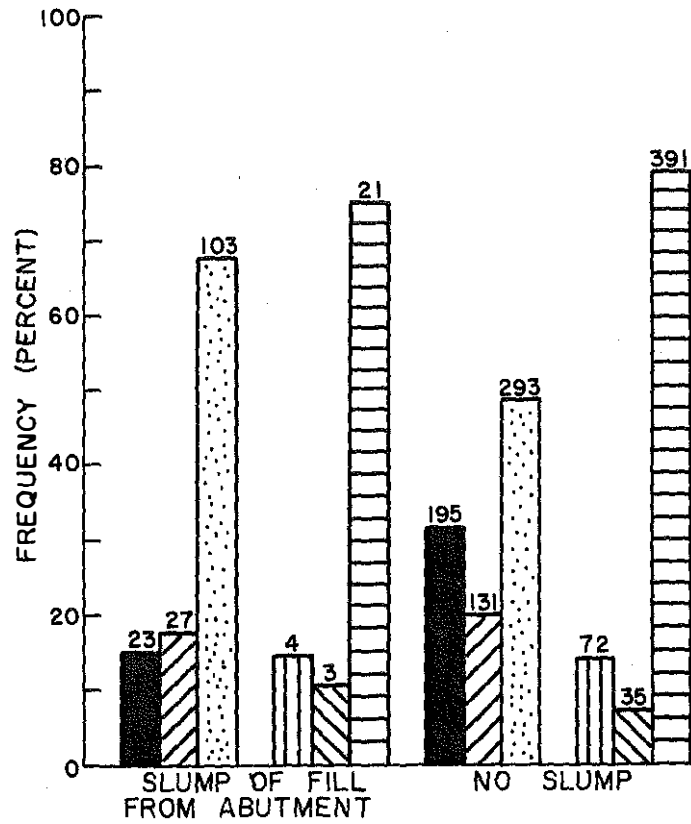
FIGURE 15. COMPARISON OF BRIDGE APPROACHES BY EXTENT OF SLUMP OF FILL FROM FACE OF ABUTMENT

A comparison of those approaches with embankments that appeared to have settled from the face of the abutment and those which had not (see Figure 14) revealed that there was a greater percentage of

Group III approaches for the former category in 1964. These data are shown in Figure 15. By 1968 the percentage of defective approaches had increased significantly, and both categories exhibited little difference.

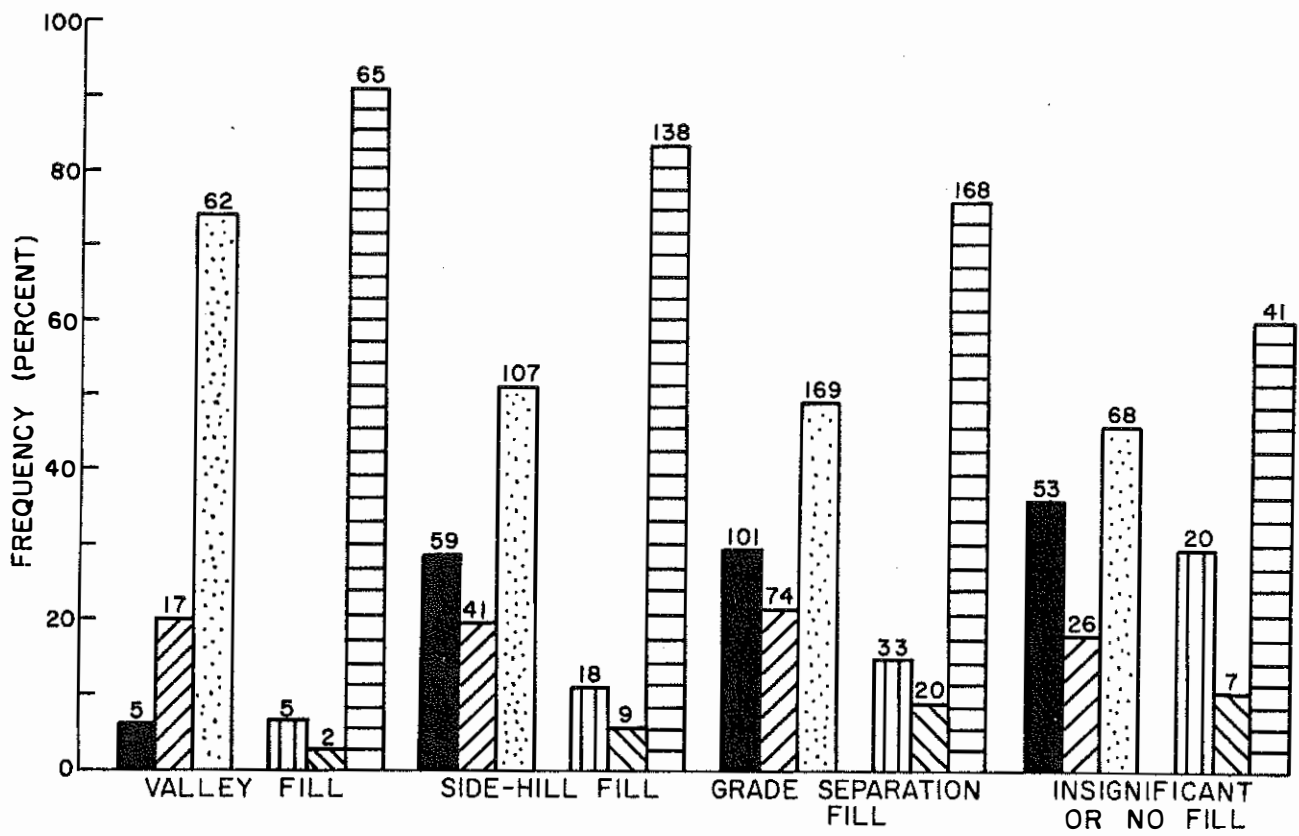
FIGURE 16. COMPARISON OF BRIDGE APPROACHES BY TYPE OF EMBANKMENT

Different types of embankments were studied with respect to the settlement groups. These data, Figure 16, show that embankments located in valleys of major streams had a much greater percentage of Settlement Group III approaches than embankments at other locations. Side-hill fills were considered to be those embankments which were generally part fill and part cut. Grade separation embankments were those considered to be built-up on a relatively flat plain. It is reasonable to assume that valley fills were located on foundations which were thicker than the other types of fills. Hence, these data probably reflect the importance of the foundation as a variable in bridge approach settlement. Those faulted approaches with embankments three feet or less in height may reflect improper backfill placement and compaction and such other causative factors as erosion or swelling and shrinkage.

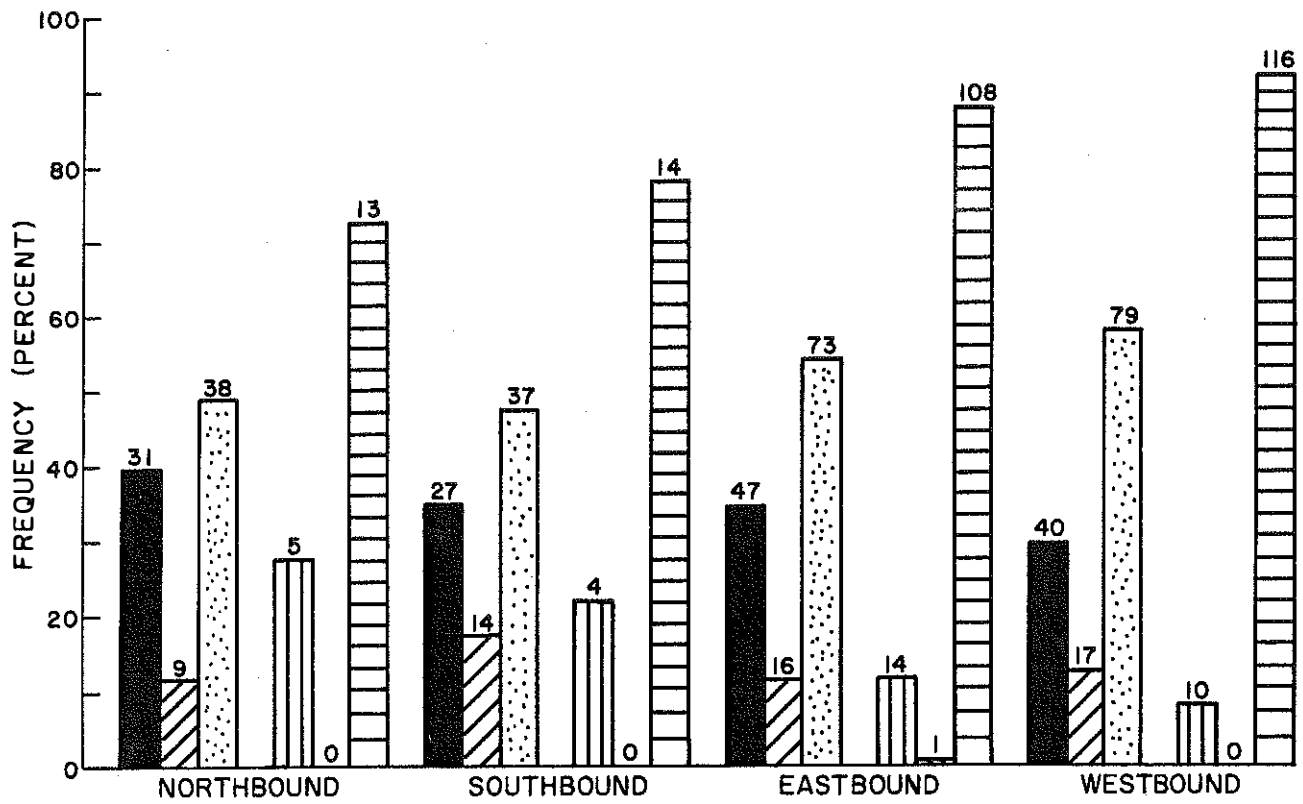
FIGURE 17. COMPARISON OF BRIDGE APPROACHES BY DIRECTION OF TRAVEL

A comparison of bridge approaches (four traffic lanes – two bridges), Figure 17, with regard to direction of travel revealed only a slight difference in settlement between northbound and southbound traffic approaches, and between eastbound and westbound approaches. Furthermore, a comparison between entry and exit bridge approaches, Figure 18, also showed little difference. Also shown in Figure 18, for the purpose of comparison, is the distribution of bridge approaches, located at sites involving only one bridge, with respect to the different settlement groups.

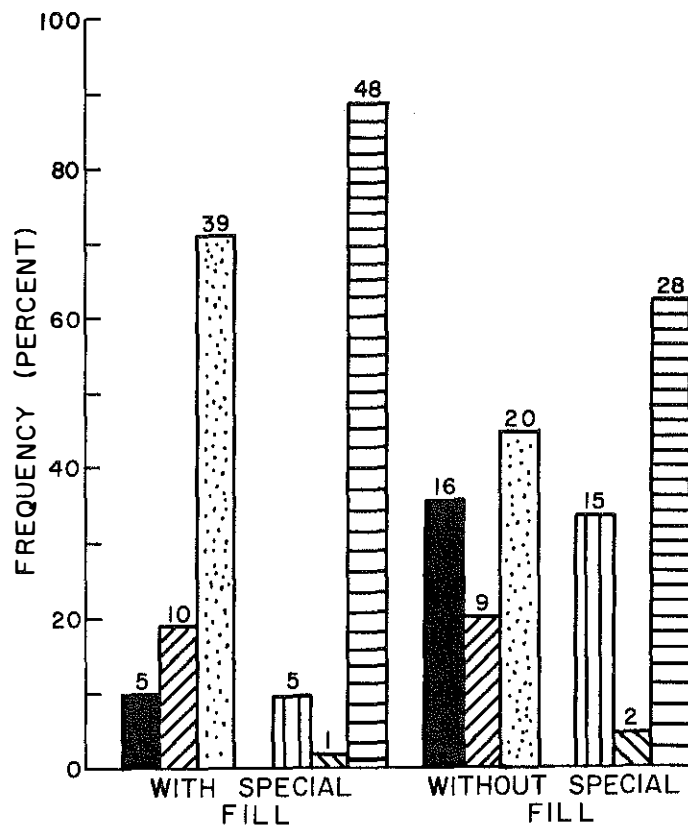
The performance of bridge approaches associated with the special granular backfill is shown in Figure 20 and compared with bridge approaches not associated with the special backfill on the same route. The data show that backfilling behind abutments in a manner specified by Kentucky Standard SF-1 did not check the development of faulted approaches. Moreover, for cases involving the special backfill when compared to cases without the special fill, there was an increase in frequency of faulted approaches.

FIGURE 20. COMPARISON OF BRIDGE APPROACHES BY USE OF SPECIAL BACKFILL MATERIAL
