COMMONWEALTH OF KENTUCKY
DEPARTMENT OF HIGHWAYS
FRANKFORT, KENTUCKY 40601

August 23, 1968

SUBJECT: Final Performance Reports on:
1) A Concrete Pavement without
Transverse Joints
2) Wire Mesh Reinforcement in Bituminous
Concrete Overlays
3) Limestone Sand Blankets to Control
Reflection Cracking in Bituminous Overlays
4) Experimental Joint Installations for Concrete
Pavements

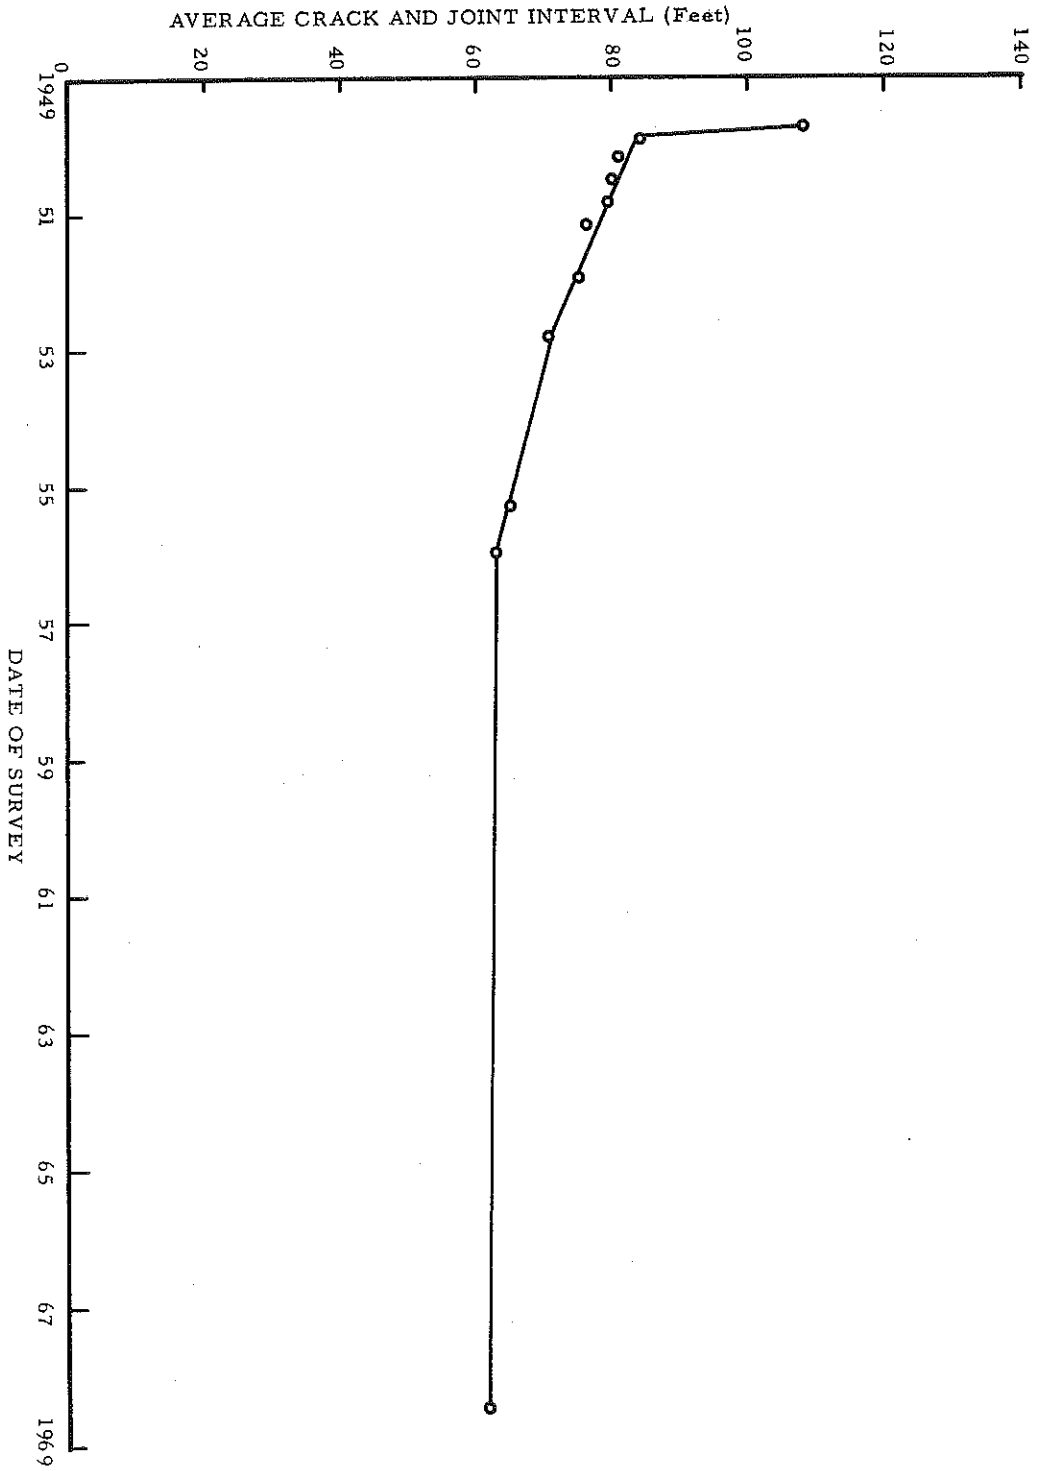
Figure 1. Trend of Average Crack and Joint Interval

Survey Date	Cracks	Cracks and Joints**	Average Interval (Feet)	
			Cracks	Cracks and Joints
6-23-49*	77		247.9	
9- 7-49	283	279	127.0	108.3
11-18-49	318	359	95.1	84.2
2-16-50	327	368	92.4	82.1
6- 5-50	337	378	89.7	80.0
10-19-50	341	382	88.6	79.1
2-13-51	354	395	85.4	76.5
11-15-51	361	402	83.7	75.2
10-24-52	386	427	78.3	70.8
4- -55	424	465	71.3	65.0
12- -55	440	481	68.7	62.8
6- 6-68	458	499	66.0	60.6

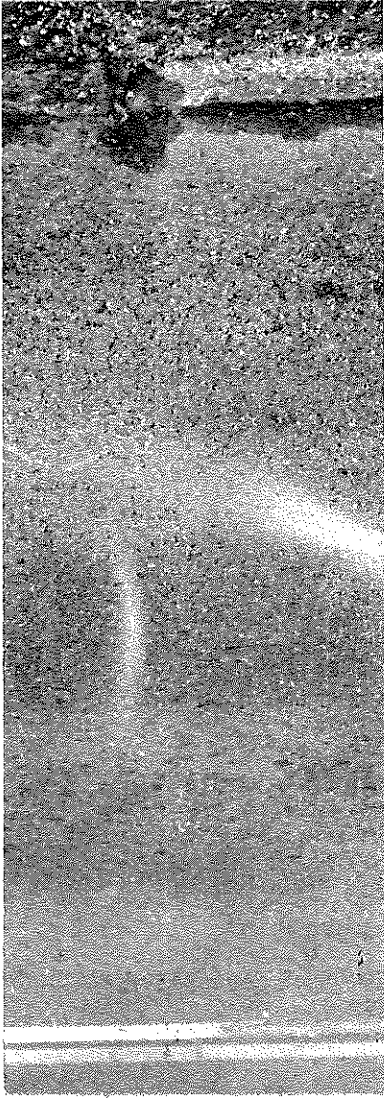
JOINT NUMBER 6

NBL- Joint shows excellent qualities of smoothness and tightness.
