COMMONWEALTH OF KENTUCKY
DEPARTMENT OF HIGHWAYS
FRANKFORT

September 19, 1966

SUBJECT: Research Report; "Interim Performance Report,
Experimental Use of Thermoplastic Pavement-
Striping Materials;" KYHPR-64-18, HPR 1(1),
Part II.

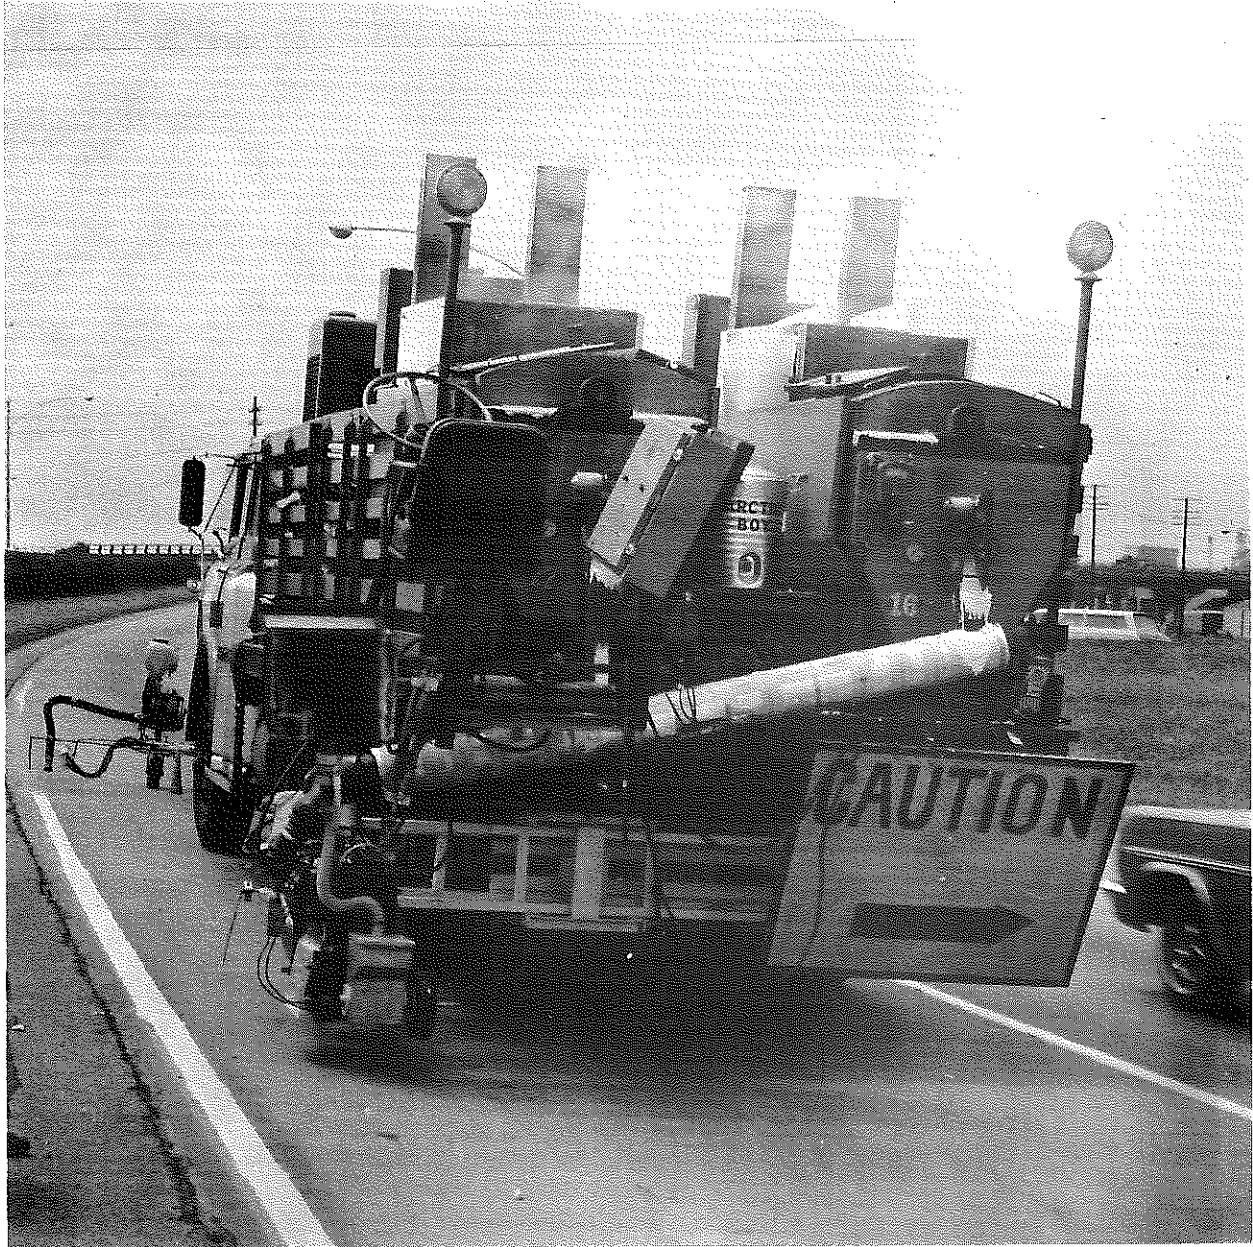
Figure 1. Perma-Line's Automatic Striping Equipment.

The major portion of Perma-Line's thermoplastic was applied by one crew operating an automatic, truck-mounted applicator (see Figure 1, Attachment 4). In front of and attached to this unit was a strong, air blower that was capable of removing dust, small rocks, and light debris from the surface prior to priming and striping. Directly behind the blower was a spray nozzle which applied epoxy primer to the pavement. The two-component epoxy system which consisted of two parts liquid epoxy and one part liquid catalyst was made by the Adhesive Products Corporation of New York. The system contained a large amount of retarder (methyl ethyl ketone or a similar solvent) which prolonged the pot life to 16 hours. The application rate was such that good coverage of the pavement was obtained; and the width of the primer coat ranged from 9 to 10 inches (see Figure 2, Attachment 5). Just prior to the overlaying of the stripe, the primer was very tacky; and between the time the primer was applied and the overlaying thermoplastic stripe was placed, a period of approximately 20 seconds elapsed. Heat from the newly applied thermoplastic line greatly accelerated the time-of-set of the primer. Laboratory tests indicated that when the primer was heated to 315°F, the time-of-set was reduced to 15-20 minutes.
