SUBJECT: Research Report: "Fifth Annual Performance Survey of  
Reinforced Concrete Pipe Culverts;" KYHPR-64-22,  
Part II, HPS-HPR-1(26)

FIFTH ANNUAL  
PERFORMANCE SURVEY OF REINFORCED  
CONCRETE PIPE CULVERTS  
KYHPR-64-22; HPS-HPR-1(26)

R. D. Hughes  
Research Engineer  
Research Division  
DEPARTMENT OF HIGHWAYS  
Commonwealth of Kentucky

June, 1965

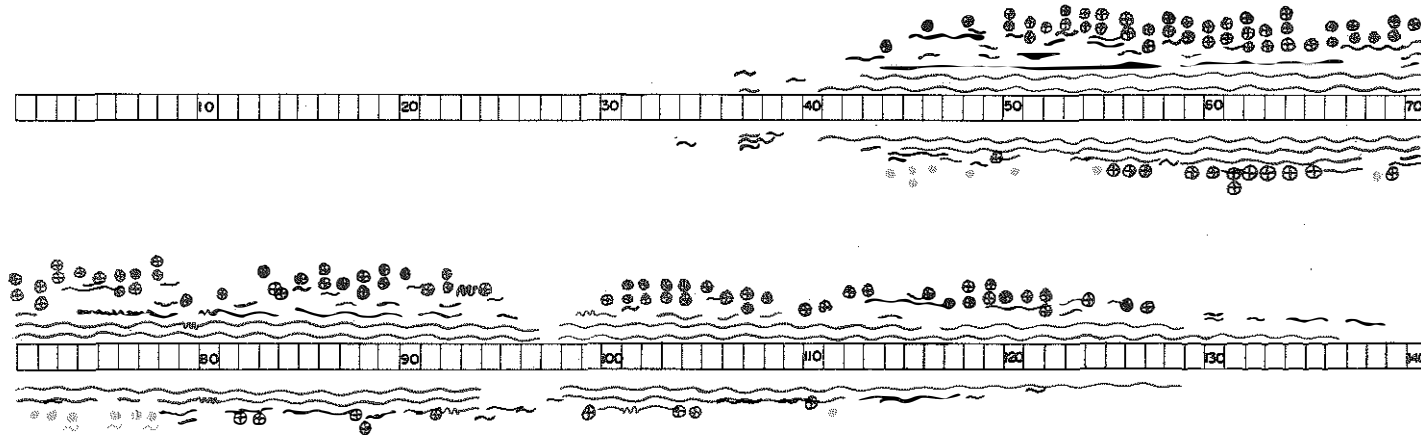
Station Number	Diameter (in.)	Design Length (ft.)	Actual Length (ft.)	Class	Bedding	Projection	Design Grade (%)	Actual Grade (%)	Embankment Height		Skaw (°)	Embankment Material	Factor of Safety as Constructed	Location of Inlet
									West (ft.)	East (ft.)				
37 + 50 US 460 SW Ramp	48	560	560	III	B & B <sub>1</sub>	Positive	1.23	1.22	36.0	34.0	51 E	Soil & Rock	0.78 for B 1.60 for B <sub>1</sub>	East
