SUBJECT: Interim Report on Rural Secondary, Base-  
Stabilization Projects; July, 1963.

INTERIM REPORT

RURAL SECONDARY, BASE  
STABILIZATION PROJECTS

July, 1963

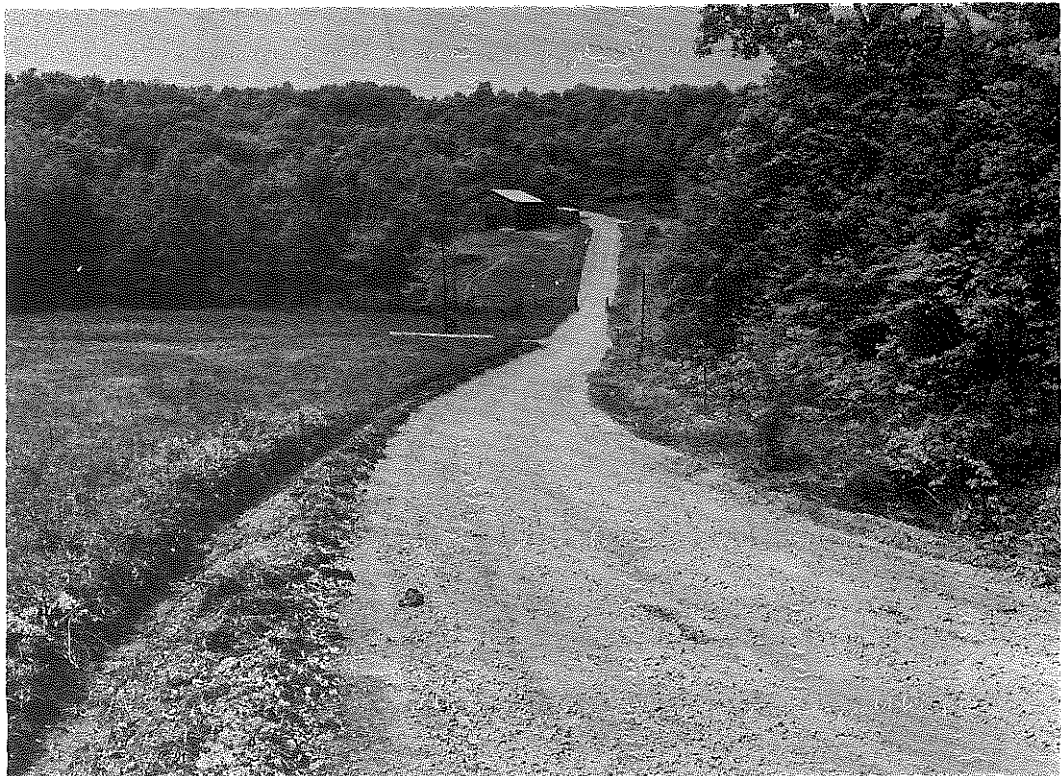
Initial Condition Survey: May 9, 1962: Several areas were noted where the metal appeared to be thin and the roadway soft due to poor drainage conditions. A few areas of rock outcropping were also observed. The metal on the eastern most mile of the project was very thin with excessive amounts of clay inter-mixed, as shown in Fig. 1. The remainder of the project was in much better condition, as shown by Fig. 2.

Fig. 2. RS 24-655-1. Condition of Western Portion of Project on May 9, 1962.

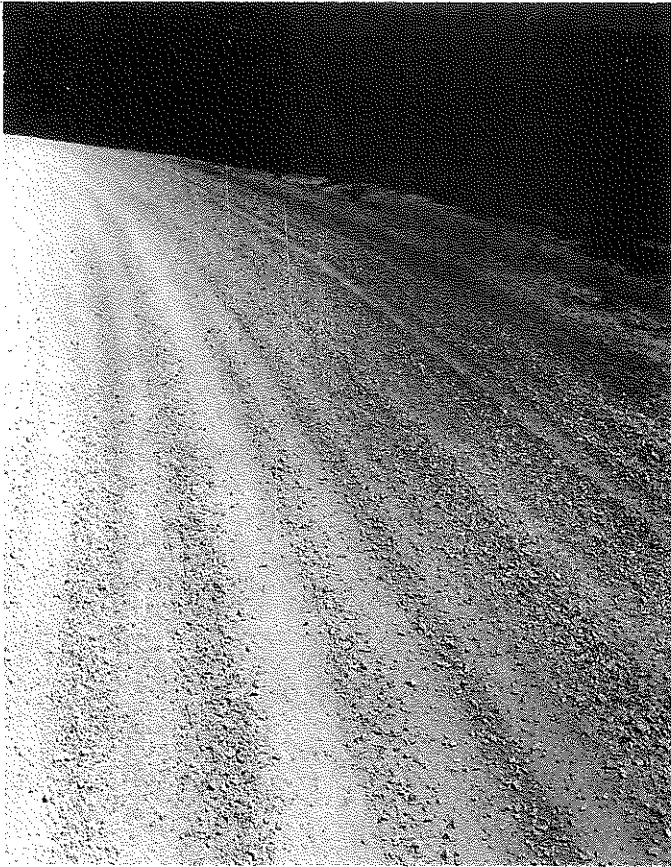
Fig. 7.

Performance Surveys: July 30, 1962: Much and wide-spread raveling was observed on the eastern portion of the project (low sodium chloride content)(Fig. 7). The western portion was retaining the aggregate significantly better, but some minor raveling had developed (Fig. 8).

RS 24-655-1. Raveling of Aggregate on Eastern Portion (Low Sodium Chloride Content) of Project, July 30, 1962.

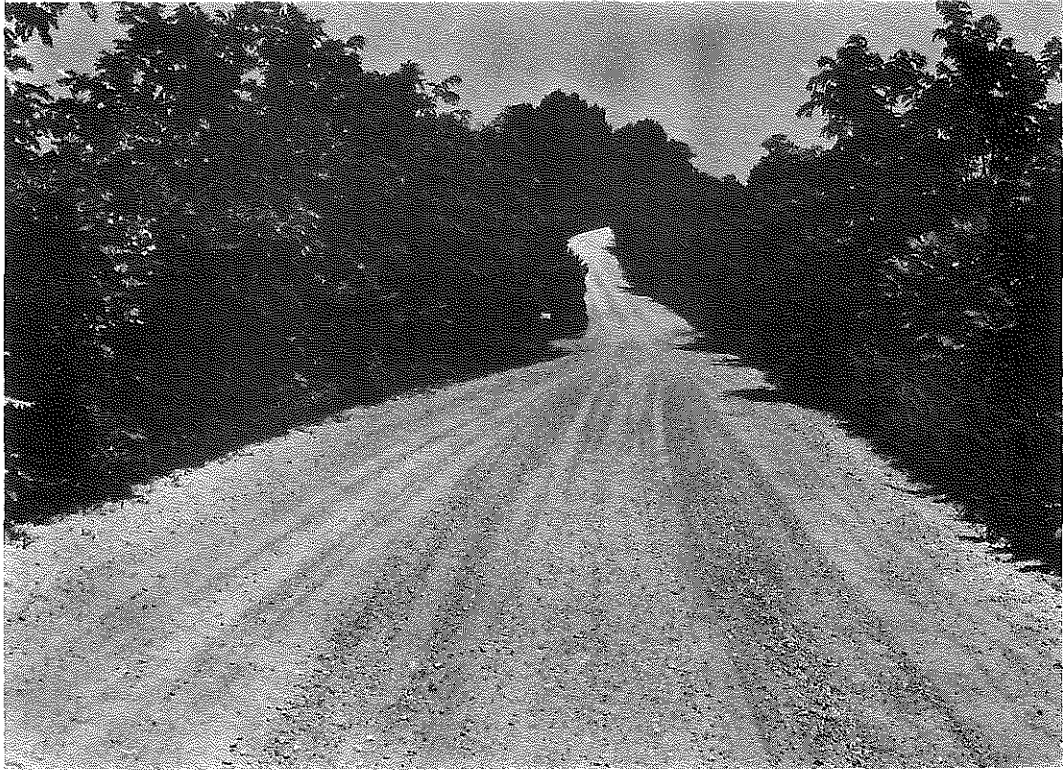
Initial Condition Survey: July 10, 1962: The metal on the entire road was moderately thick (Fig. 1). Most curves had thin metal on the inside edge and an accumulation of sandy material. Two areas of extremely thin base near the middle of the project were noted.

Fig. 1. RS 32-189. Condition of Roadway on July 10, 1962.

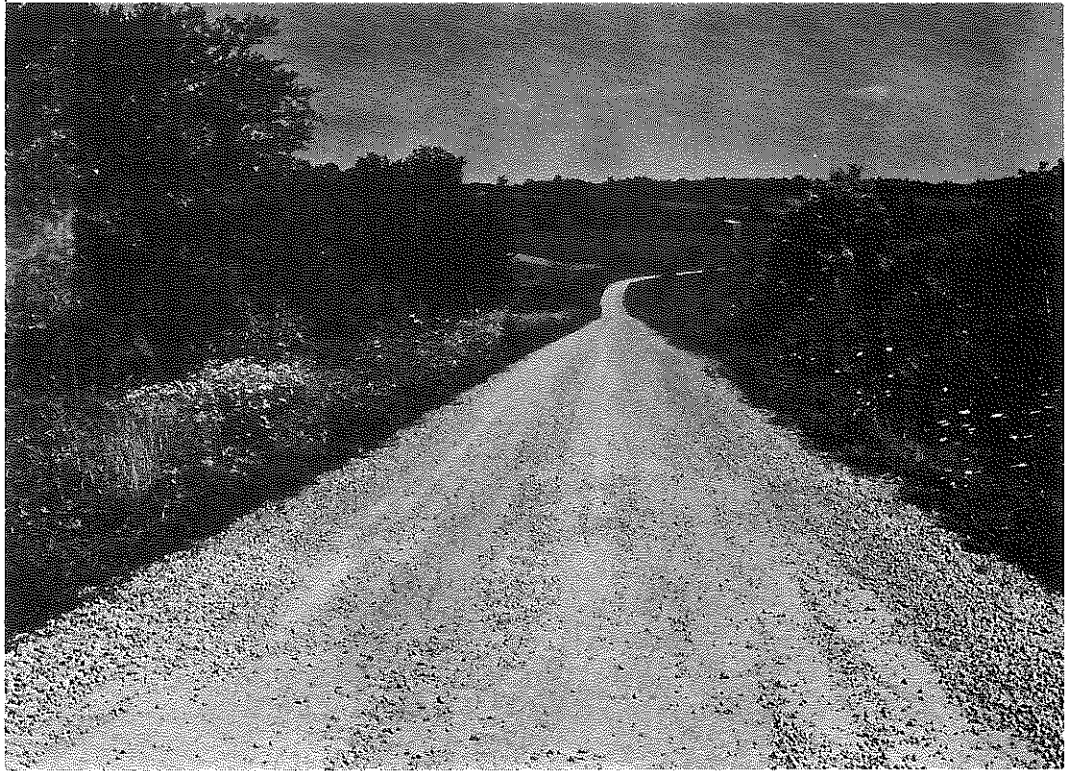
Initial Condition Survey: July 10, 1962: The roadway was narrow throughout the entire length. Numerous rock outcrops and potholes were noted. Metal appeared to be thick, uniform and in good condition over entire length (Fig. 1).

Fig. 1. RS 35-750. Condition of Roadway on July 10, 1962.

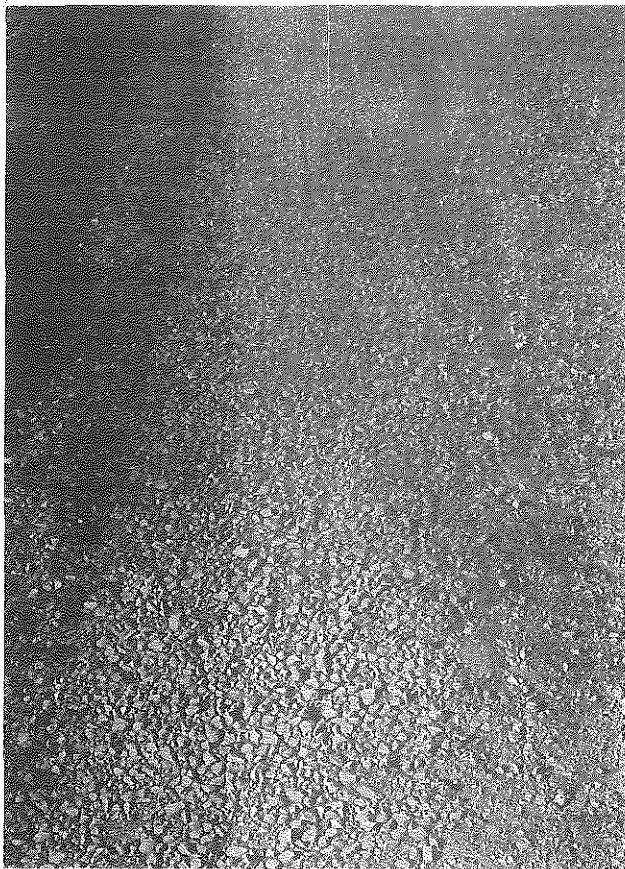
Fig. 5.

RS 35-750. Segregation Resulting from Overblading the Aggregate.

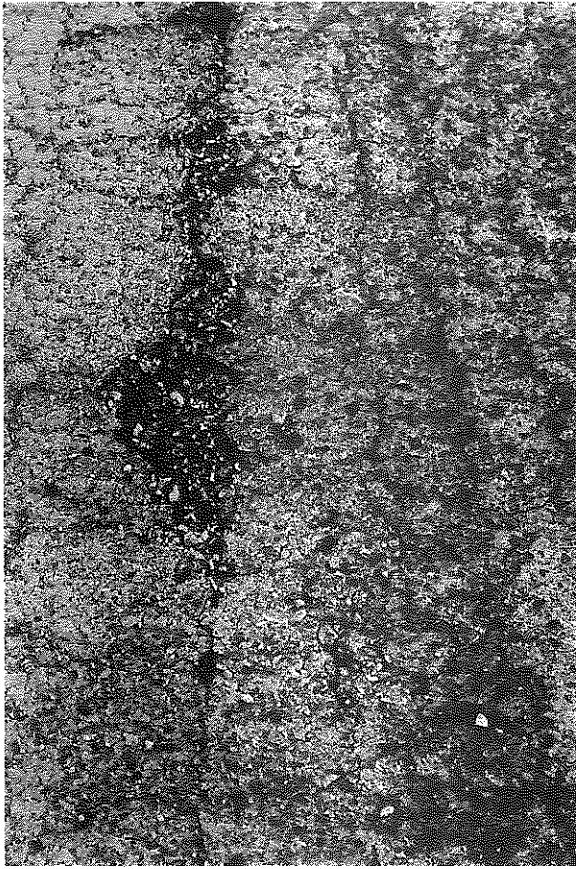
Fig. 7.

April 23, 1963: Loose metal was noted over the entire length of the project. Rutting was occurring in several areas, mostly in the outside wheel track of the southbound lane. Map cracks were observed over the length of the roadway. In some areas this cracking was quite severe (Fig. 7). Scattered potholes were present and several large chip seal patches had been made. Figure 8 shows the general condition of the roadway.

RS 35-750. Distressed Area of Roadway, April 23, 1963.

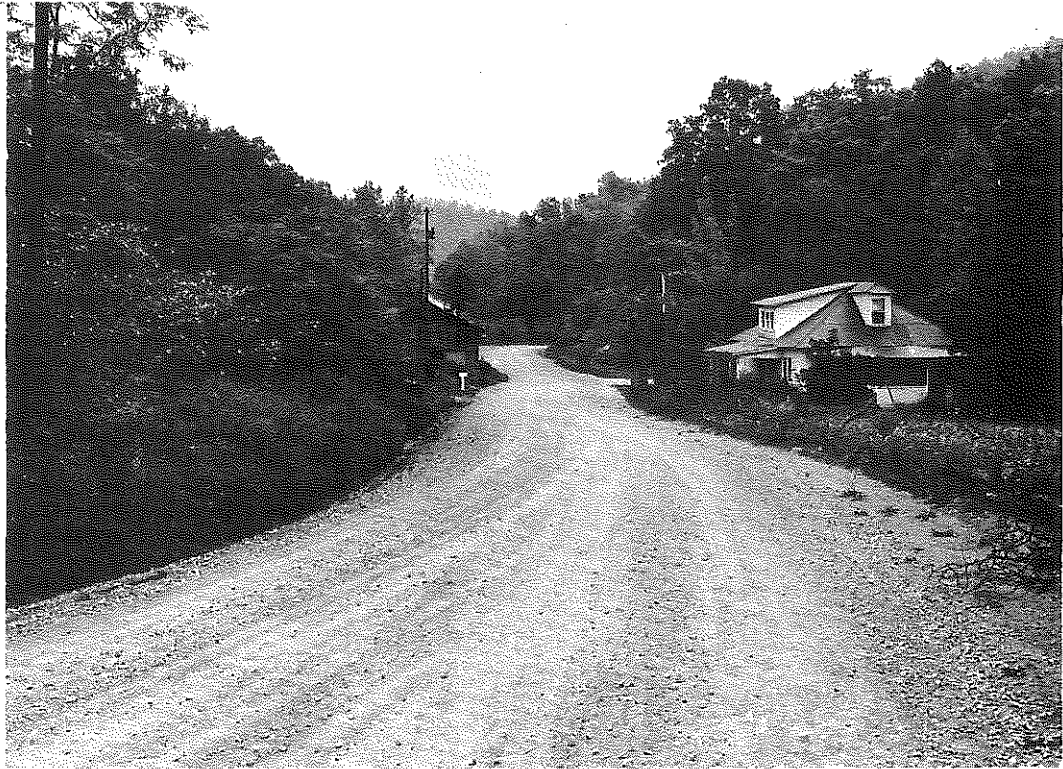
Fig. 1. RS 65-289. Condition of Roadway on May 23, 1962.

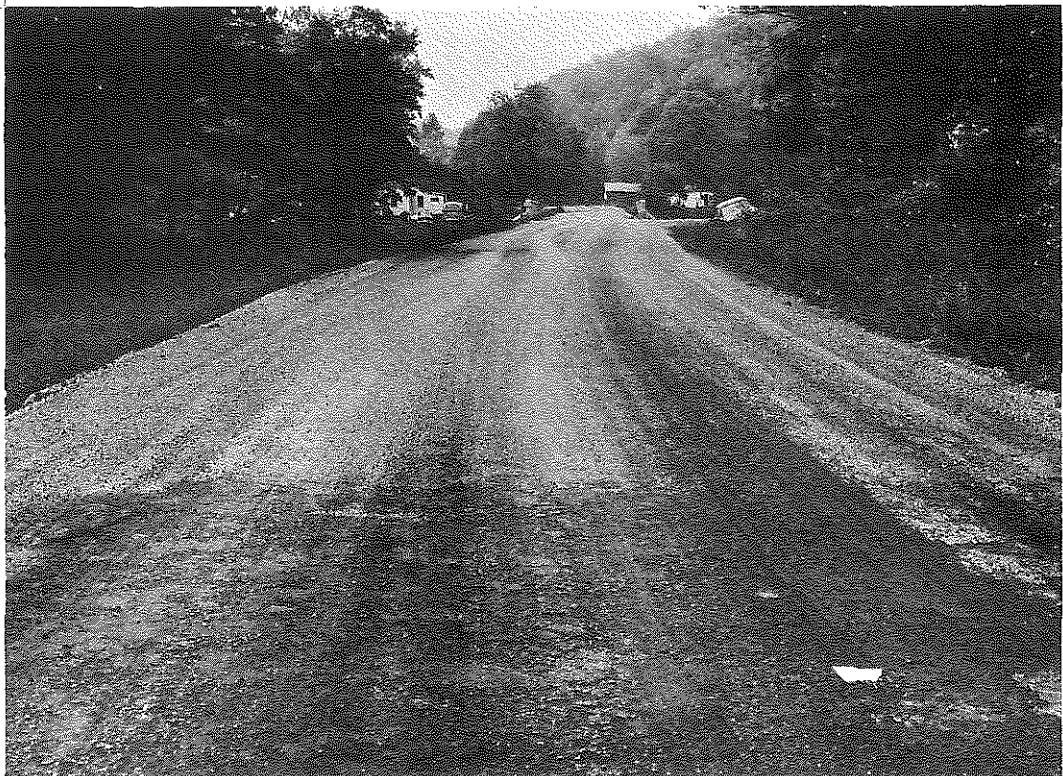
Fig. 2. RS 65-549. Condition of Roadway on May 23, 1962.

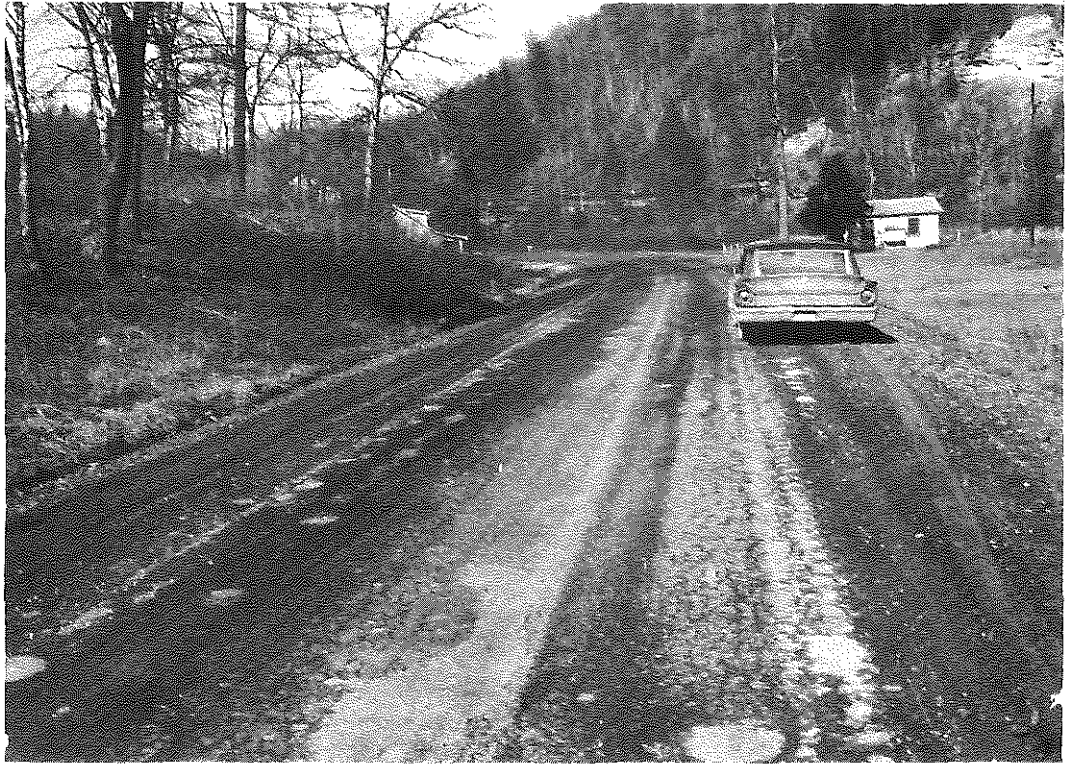
Performance Surveys: February 6, 1963: Both projects had received an application of light road oil over most of the length since the time of construction. Numerous patched and open potholes (Figs. 3 and 4) were observed. Map cracking had also developed. Drains had been installed in an attempt to alleviate wet conditions existing. Drainage ditches were not functioning to carry off free water. Very little loose metal was noted.

Fig. 3. RS 65-289. Condition of Roadway on February 6, 1963.

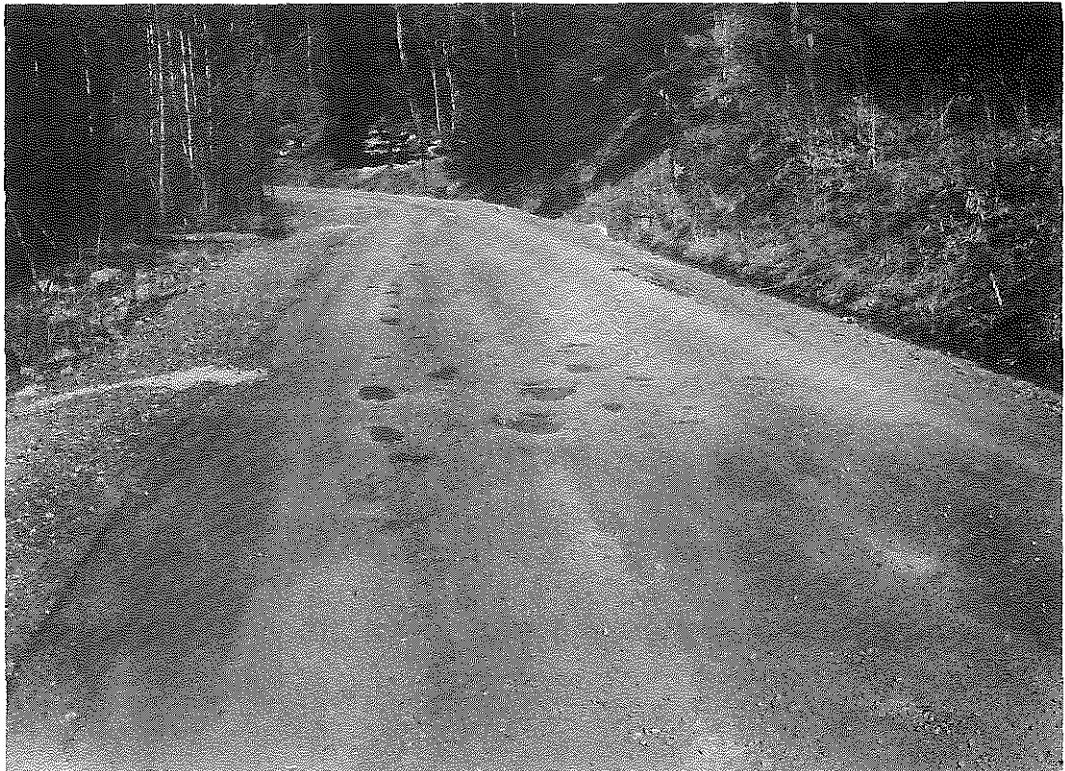
Fig. 4. RS 65-549. Condition of Roadway on February 6, 1963.

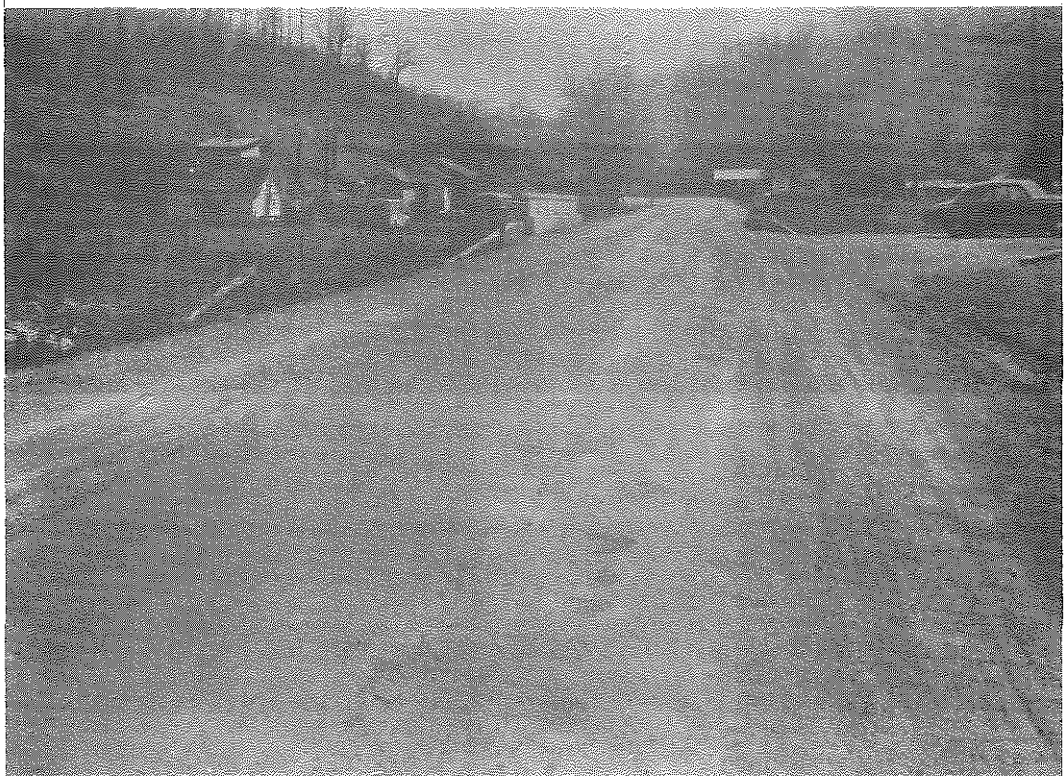
April 15, 1963: Considerable raveling and loss of fines was occurring on RS 65-549 (Fig. 5), the light oil application not being too effective. Only a small number of open potholes were observed on this project. On project RS 65-289 numerous potholes were noted but raveling was not as severe (Fig. 6). It appeared that an application of some type of asphalt surface treatment had been placed on this project.

Fig. 6. RS 65-289. Condition of Roadway on April 15, 1963.

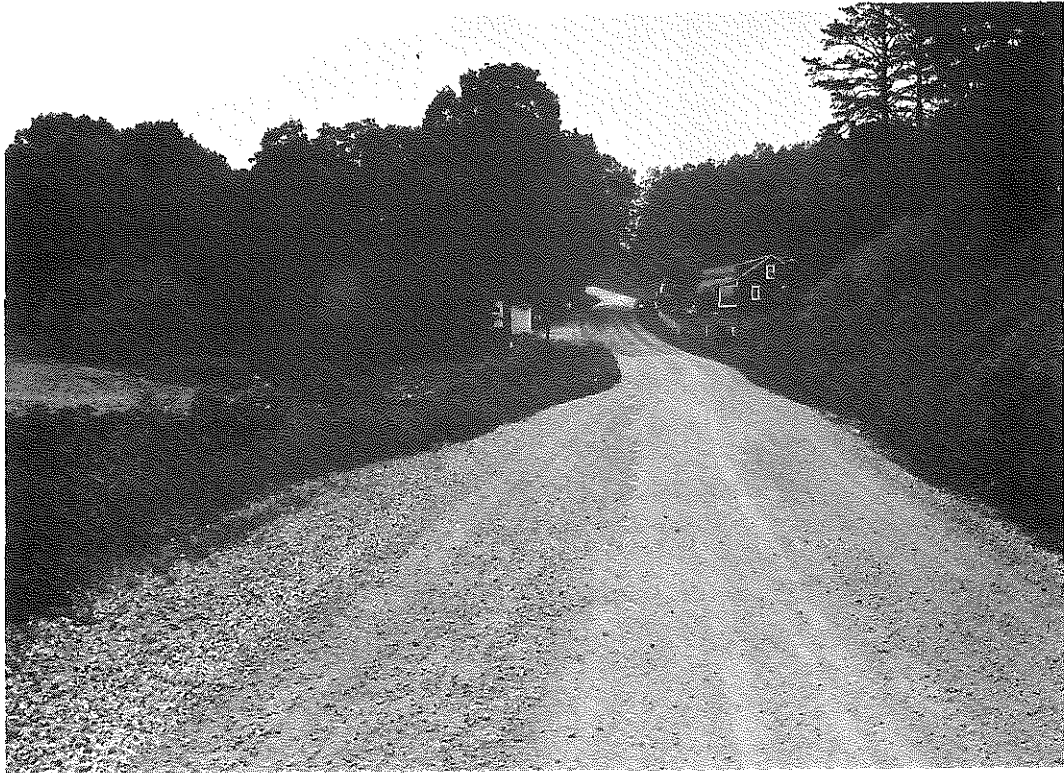
Fig. 1. RS 95-376. Condition of Roadway on May 23, 1962.

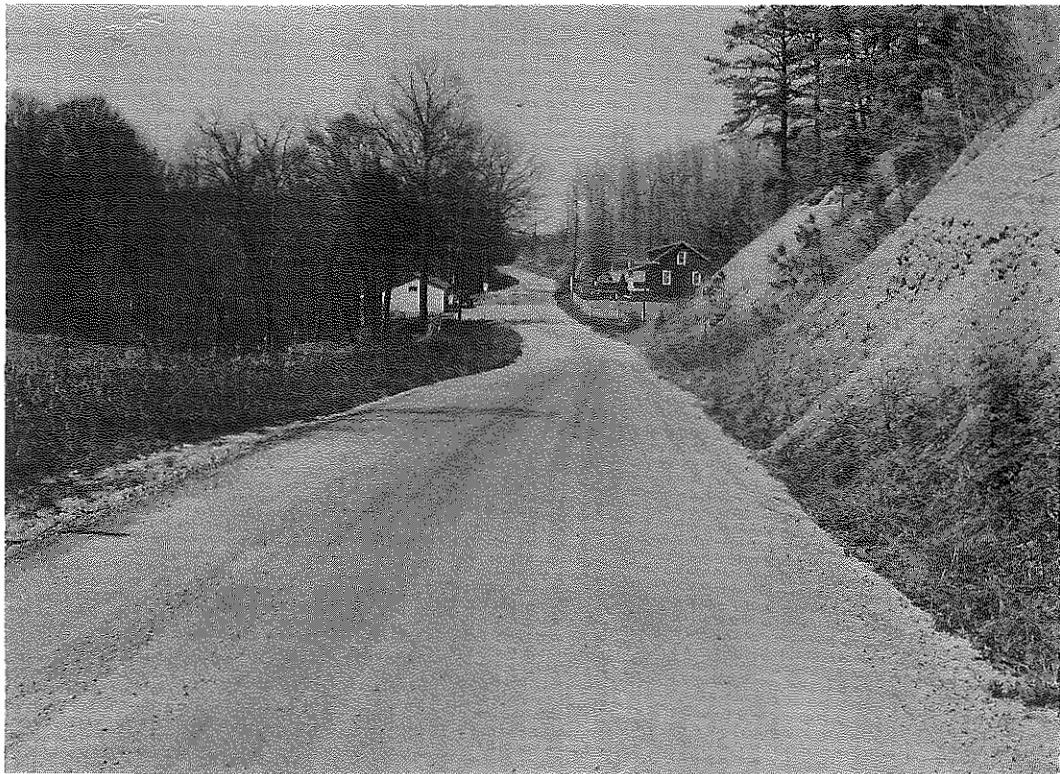
April 15, 1963: Many potholes, both patched and open, were present over the entire project (Fig. 10). Figure 11 shows the amount of raveling occurring over the project. Several soft areas were noted. In the foreground of Fig. 12 is the best section of the roadway.

Fig. 12. RS 95-376. Photograph Showing Best Section on April 15, 1963.

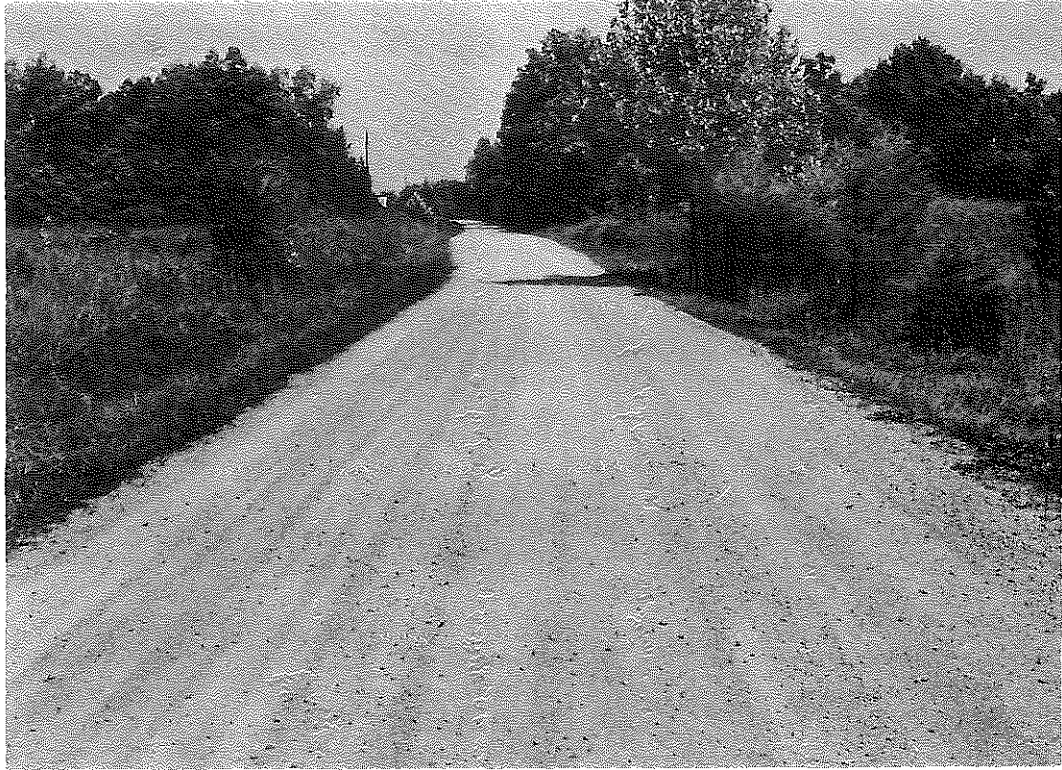
RS 100-635 & RS 100-655: There were scattered areas of potholes over both projects. Thin areas with soil showing were noted. The roadways were generally in good condition (Fig. 1 ).

Fig. 1. RS 100-635. Condition of Roadway on August 16, 1962.

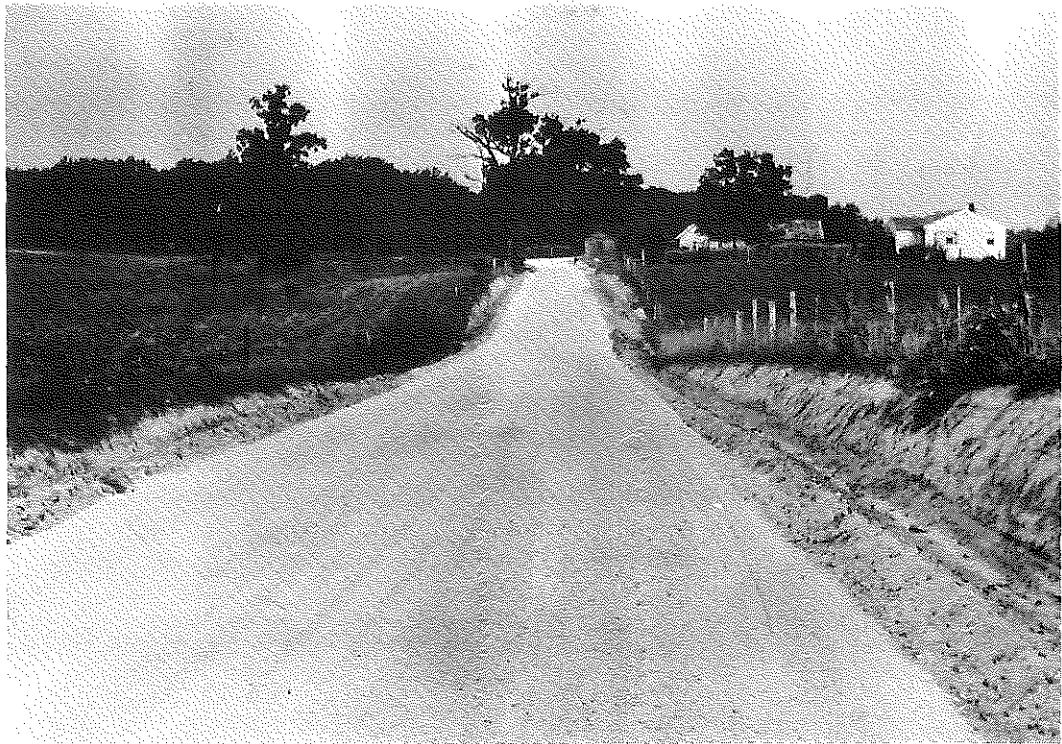
Fig. 2. RS 100-615. Shaped Roadway Prepared for Application of Aggregate, August, 1962.

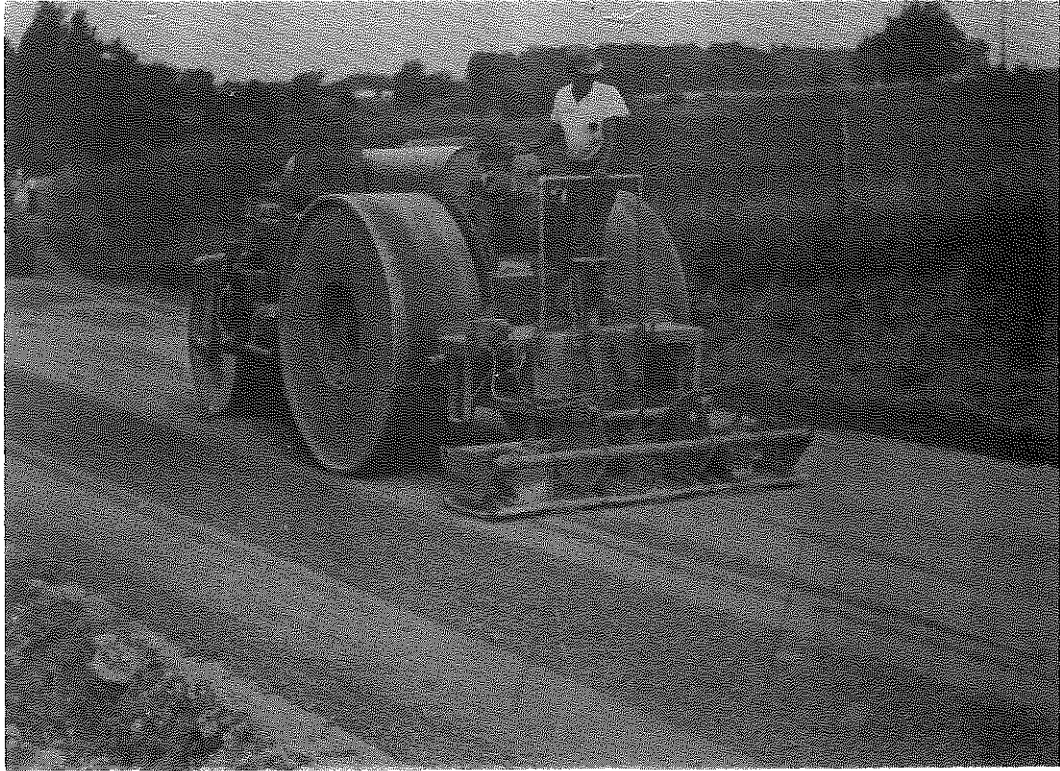
Fig. 3. RS 100-615. Compaction with a Vibratory Compactor, August, 1962.

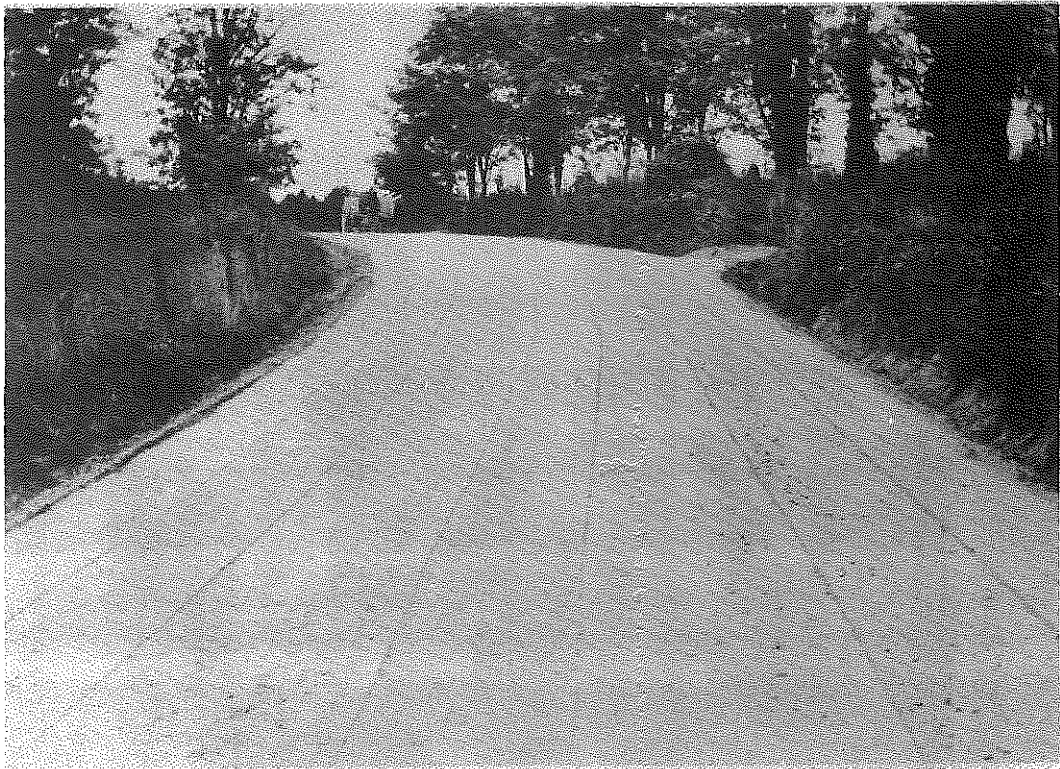
Fig. 4. RS 100-615. Compacted Granular Base, August, 1962.

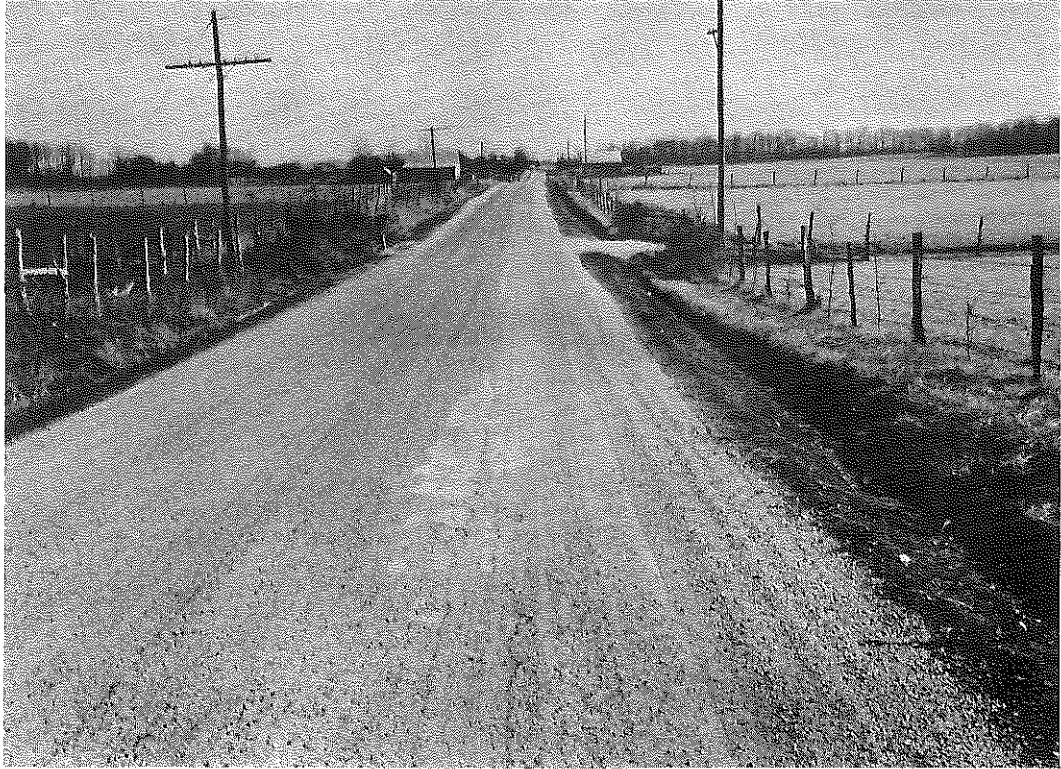
January 22, 1963: The seal did not bond to the base in some areas (Fig. 5), however, it was generally in very good condition (Fig. 6). Figure 7 shows a low wet area on RS 100-635 where the only failure on these projects has occurred to date. Several wet areas were noted on project RS 100-615 (Fig. 8).

Fig. 5. RS 100-655. Area Showing Poor Bond of Double A-2 Seal to Base Course, January 22, 1963.

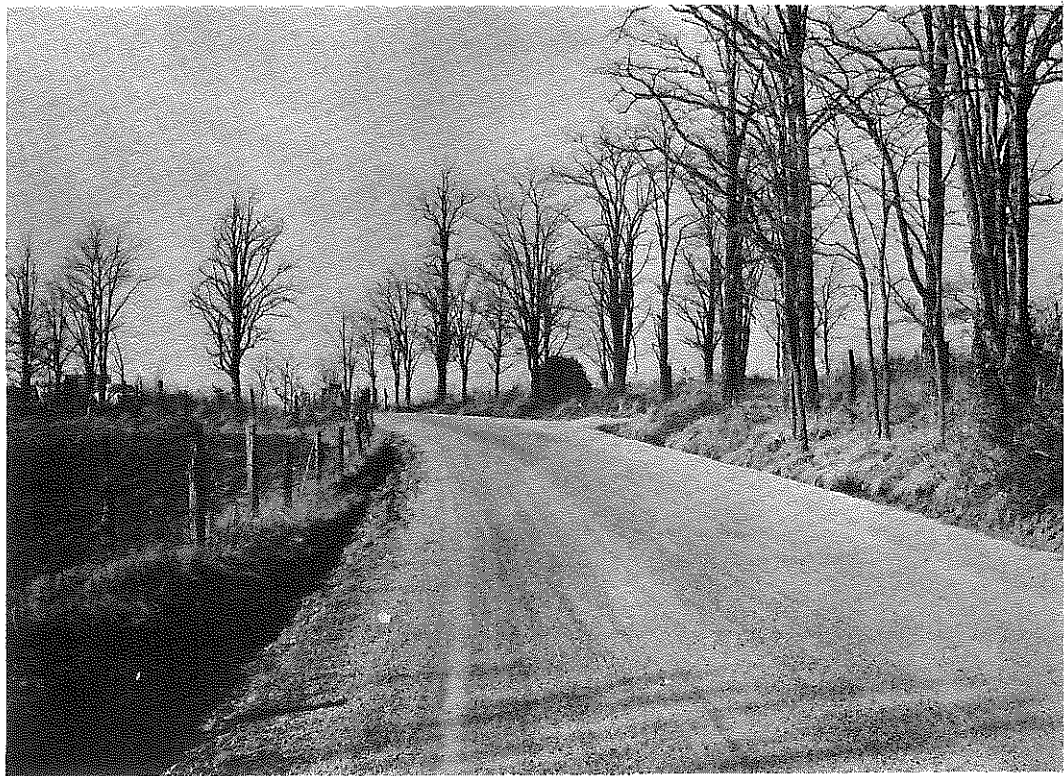
Fig. 6. RS 100-615. Condition of Roadway on January 22, 1963.
