Commonwealth of Kentucky
Department of Highways

TEN RURAL HIGHWAY BASE STABILIZATION PROJECTS

James H. Havens
Senior Research Engineer

August , 1957

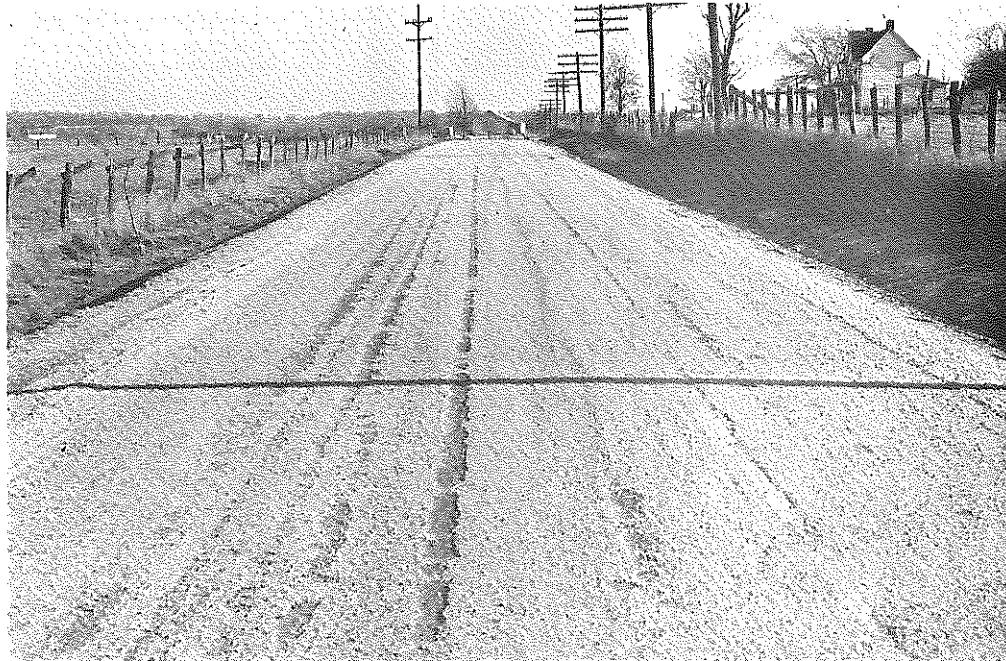
1. Breckinridge County - From the series of pictures, it is quite obvious that there has been a considerable loss of seal from the road. Further, it is a well recognized fact that soil-cement bases, unless adequately protected and sealed, are not in themselves sufficiently resistant to wear and weather. Loss of seal here is not considered as a failure of the base or of the seal material, but as evidence of the need for intermediate treatment and preparation of these bases for application of the seal -- that is: treatment to bond the seal properly to the base. The road was quite dry and dusty when the seal asphalt was applied, and the emulsion apparently broke before it had thoroughly penetrated the dust layer. Therefore, sufficient bond was not made with the base. If the asphalt bleeds to the surface, it sticks to tires and seal is peeled off. As a precautionary measure against recurrence of this condition, it is suggested either that the finished base be sprinkled to promote penetration of the seal asphalt (RS-2) or that the

Fig. 9: Breckinridge Co.: General Condition of Road after about 2-1/2 Months. Failure of seal coat to stick is attributed to absence of prime. (1-3-57)

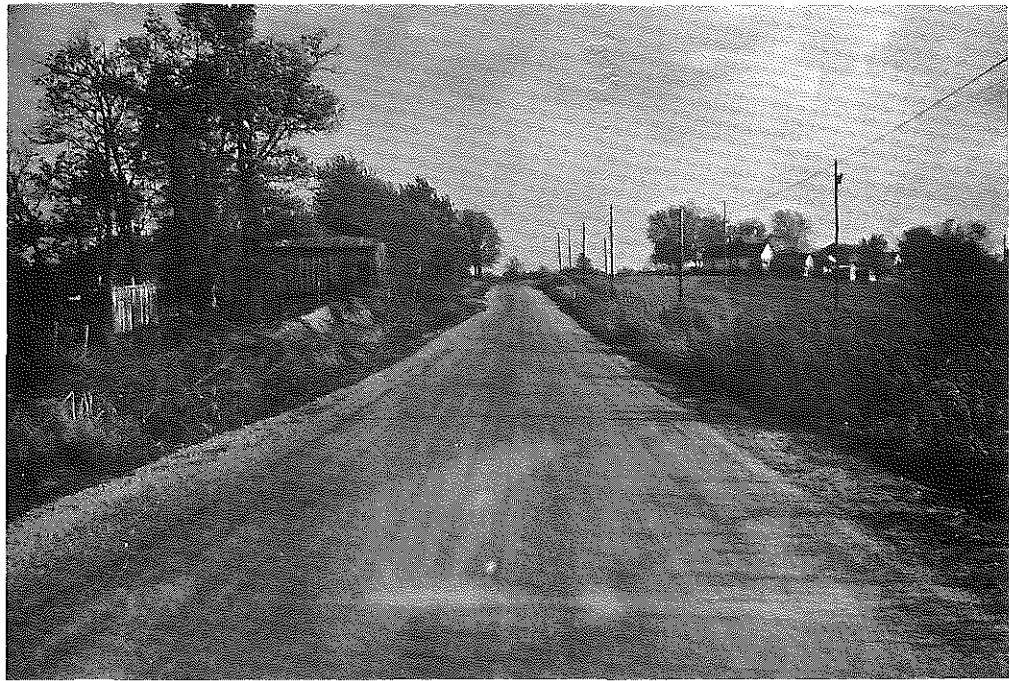
2. Webster County - Only 0.3 mi. of soil-cement base was completed on this job. The remaining 0.7 mi. was worked with a grader, given a treatment of CaCl_2 , compacted, and sealed. MC-4 asphalt was used for the seal. Both sections are giving satisfactory performance and can hardly be differentiated by appearance. On close inspection the section treated with CaCl_2 can be seen to have a slightly darker appearance because of retained surface moisture.

Fig. 14: Webster Co. : Portion of 0.3 mi. Section of Project Where Soil-Cement was Used. The remaining 0.7 mi. was not completed in the time scheduled. (4-24-57)

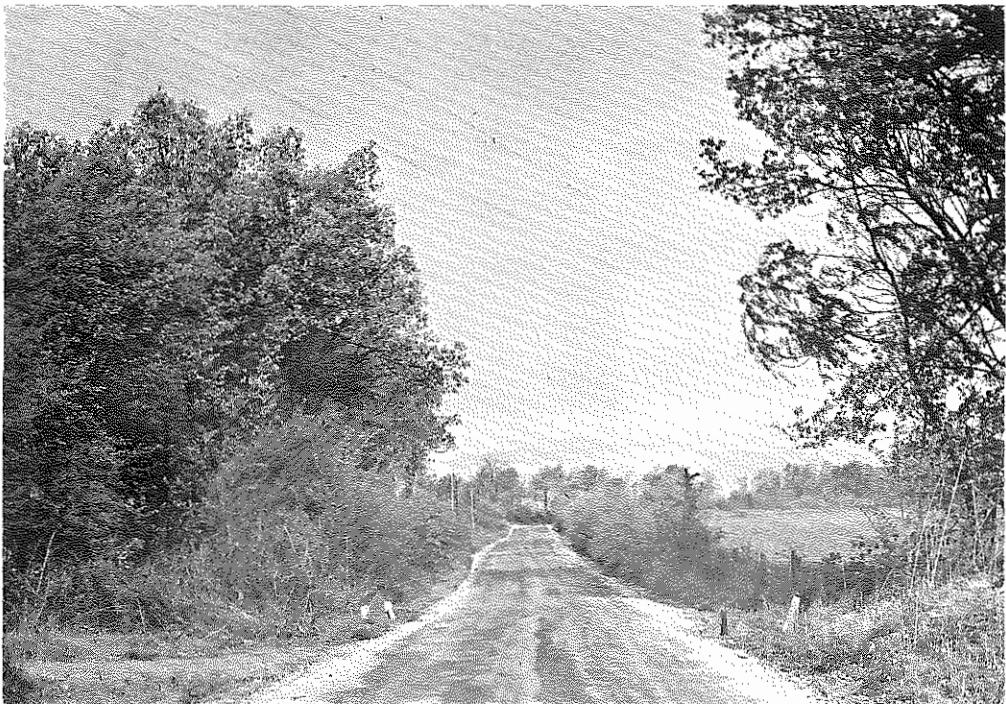
Fig. 25: Ballard Co.: General Appearance after about 7 Months. Dark spots in road are due to early morning dew. (4-24-57)

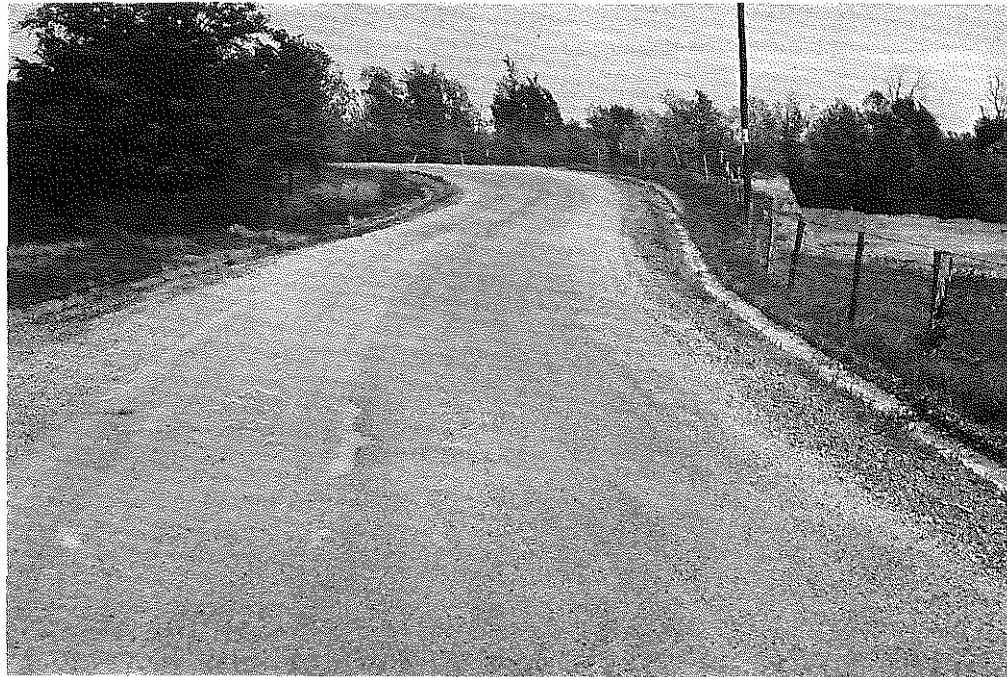
Fig. 33: Marshall Co.: Seven Months after Stabilization. General performance and appearance have been good. Note gravel pit immediately to the right of roadway. (4-24-57)

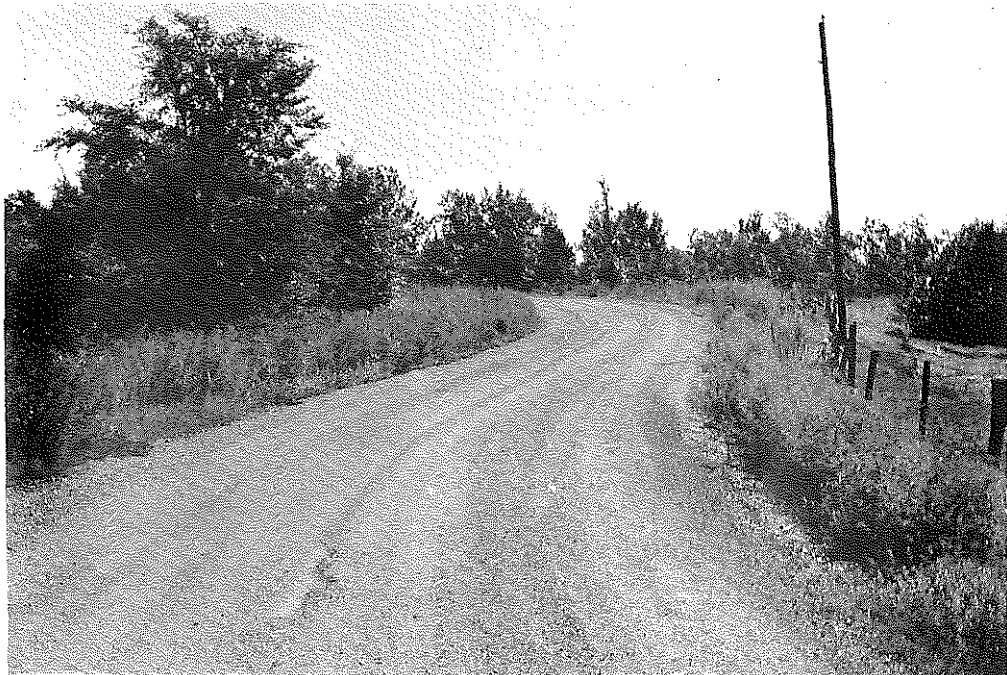
Fig. 34: Marshall Co.: Same View as Above, after 10 Months. (8-4-57)

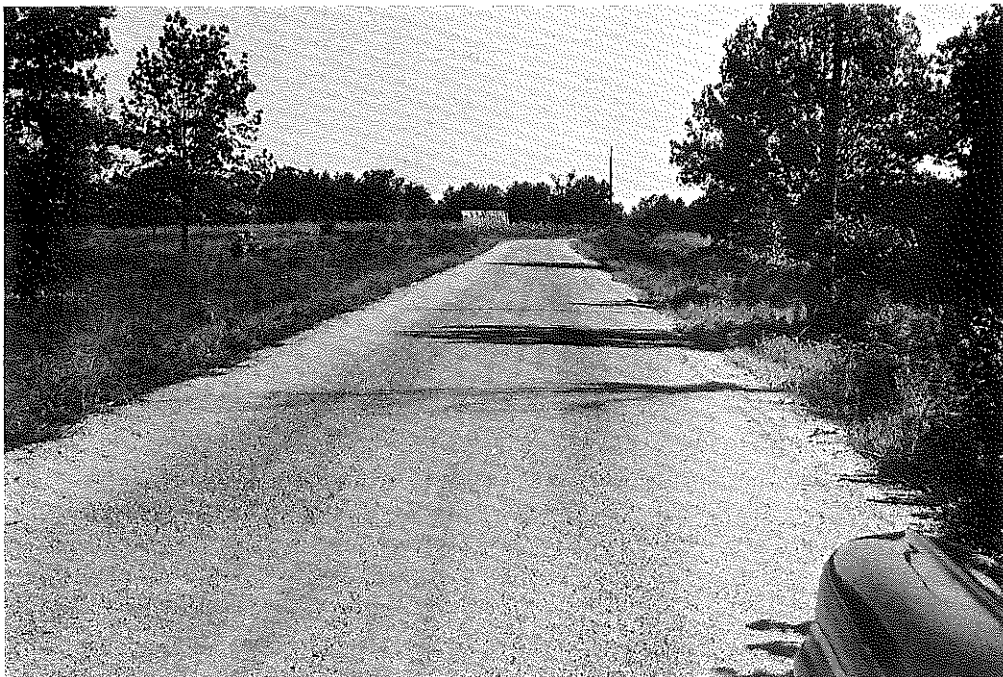
Fig. 36: Marshall Co.: Middle Section of Project after 10 Months. (8-4-57)

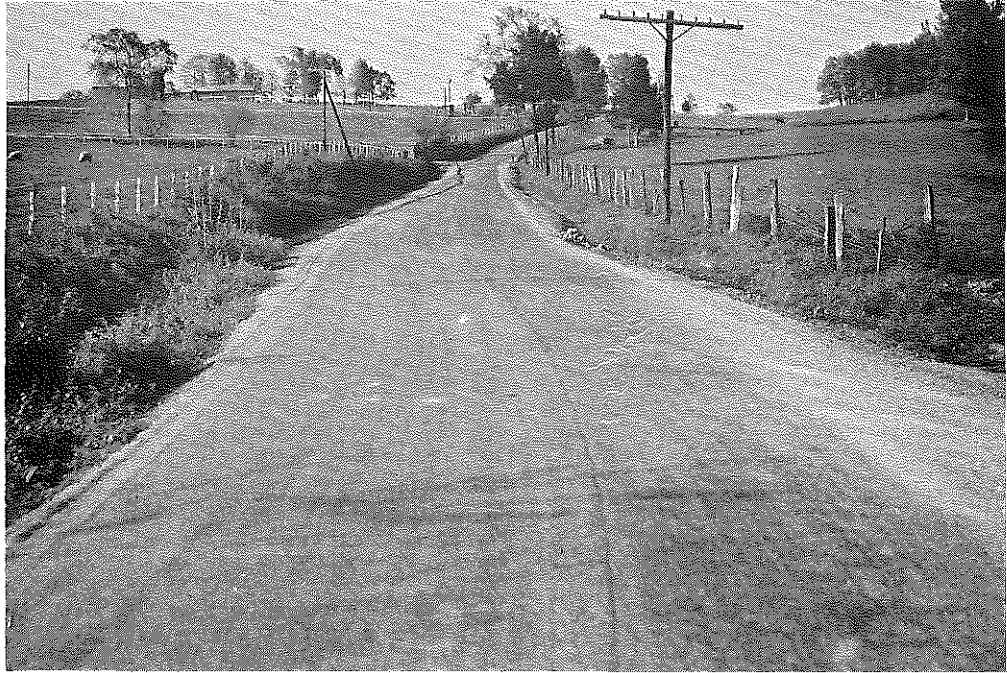
Fig. 39: Barren Co.: Similar Section after 2-1/2 Months. (1-3-57)

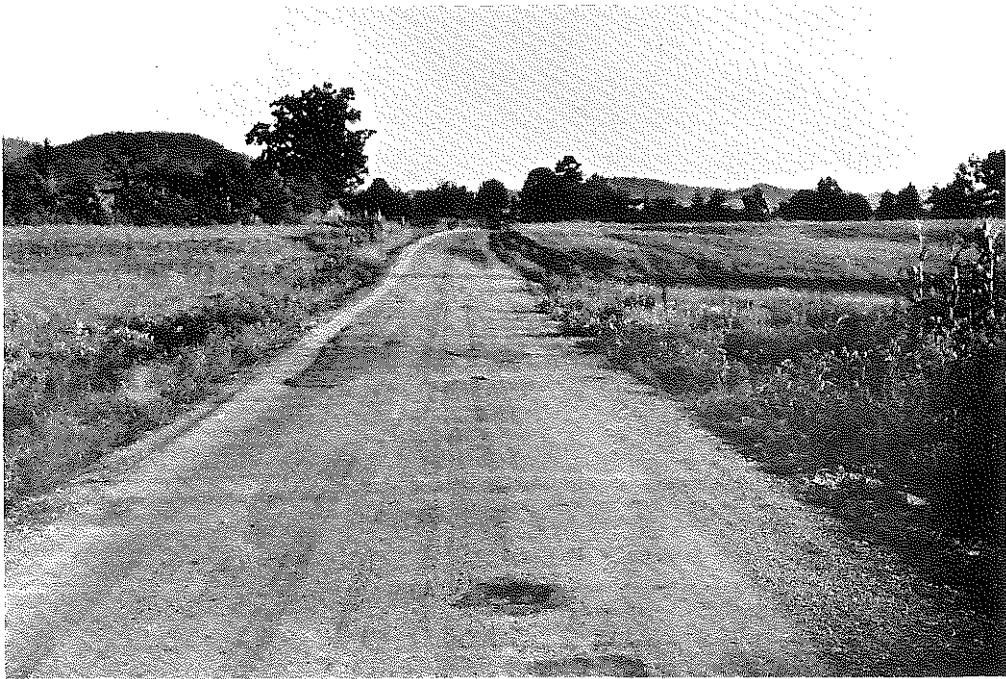
7. Madison County - General performance here has not been quite as good as it has in Barren County. There has been some consolidation or deformation in the wheel tracks, several small pot-holes have developed, and in one sharp curve most of the seal and base have been raveled away. At two locations where culverts were installed, water has overrun the fills and caused some damage. Some repairs have been made there and a few of the pot-holes have been patched (see recent photographs). Logging trucks are known to have used the road, and this may account for most of the deformation, since the road was not designed for very heavy wheel loads.

Fig. 52: Madison Co.: View of Curve Shown in Fig. 50, after 10 Months. (8-5-57)

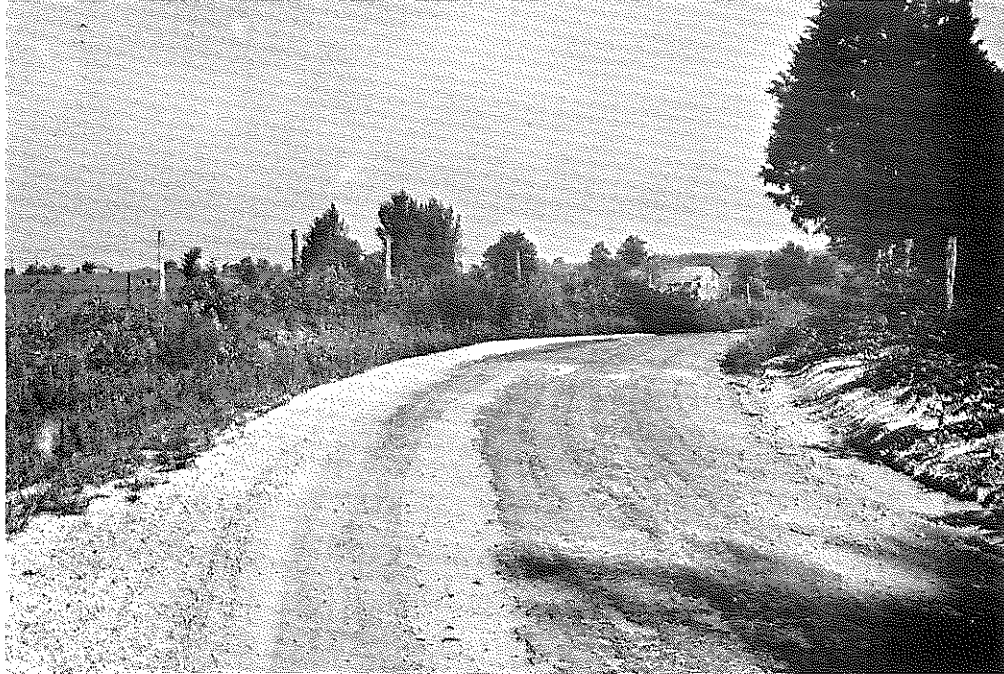
8. Montgomery County - Several prominent failures have developed here; but, as mentioned earlier, the cause is attributable to sub-base conditions rather than to the base itself. Shale outcroppings at several places along the sloping grades not only prevent subsurface drainage of the base but concentrate subsurface water at these points.

Saturation has therefore weakened the base and caused failure. Sections of the road both above and below the outcroppings have shown fair to good performance.

Fig. 59: Montgomery Co.: Section Similar to that Shown Above. (5-27-57)

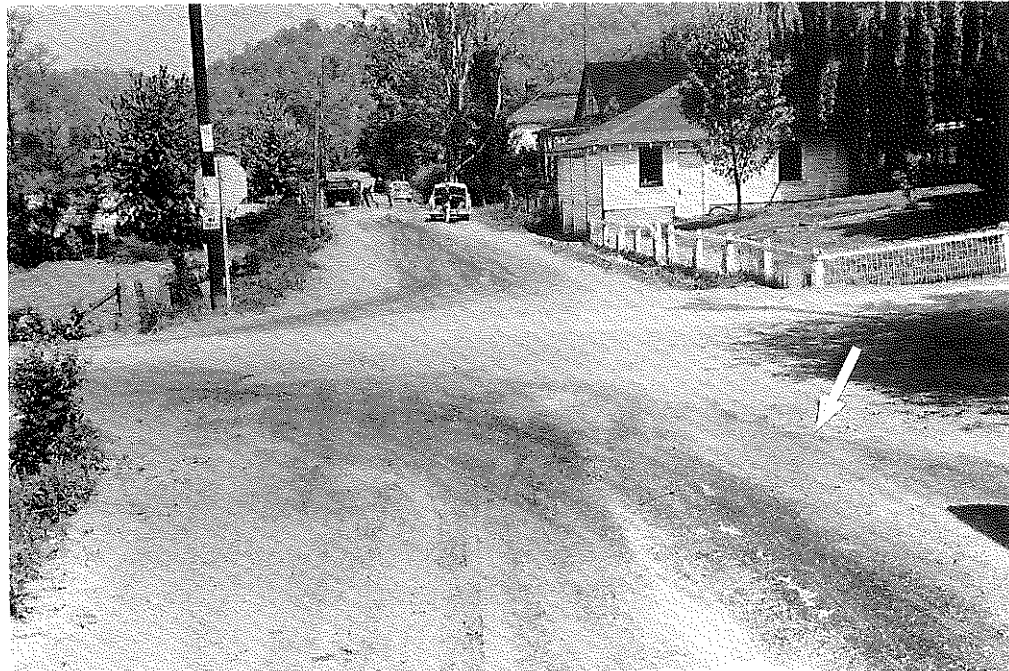
Fig. 82: Johnson Co.: Cross-Street, W. Van Lear. Seal asphalt bleeding through tended to stick to tires and to peel off the base. (5-2-57)

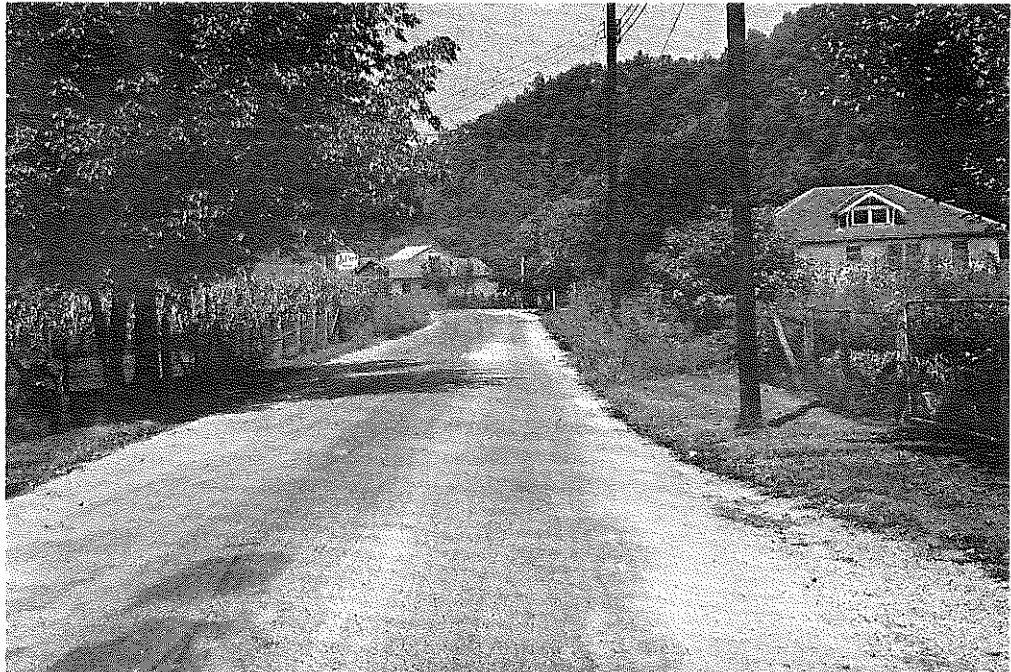
Fig. 86: Johnson Co.: Short Cross-Street in W. Van Lear. Several streets such as this were stabilized but none of them carries much traffic. (8-20-57)
