COMMONWEALTH OF KENTUCKY
DEPARTMENT OF HIGHWAYS
FRANKFORT

On the basis of these limited studies, the attached "Preliminary Report on the Performance of Kentucky Rock Asphalt" has been prepared by J. H. Havens and E. G. Williams. The intent of this report is to show what has been found with regard to the underlying cause of the pavement distress, to record a few ideas on the manner in which the cause might have developed, and to make recommendations concerning research that should be carried out to determine whether and how rock asphalt can be used and controlled satisfactorily in the future.

SUBJECT: Performance of Kentucky (Natural Sandstone)
Rock Asphalt

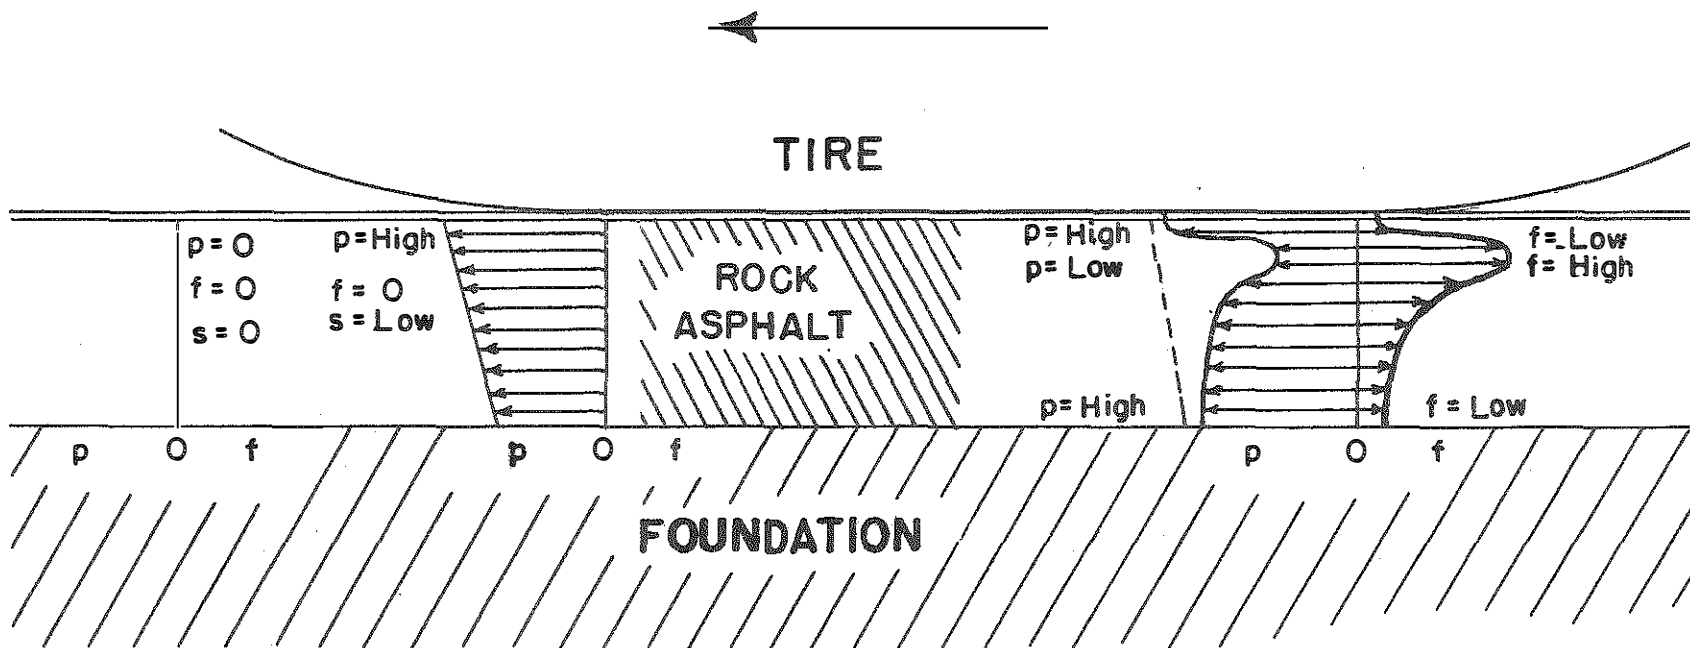
A logical concept of the scaling process is reconstructed and portrayed diagrammatically on the following page. In a saturated or inundated surface, highly porous; under traffic there would be high velocity currents and possibly very high hydrodynamic pressures under the wheels. Pressures in front of the wheels might even be considered as positive pressures and those behind be negative. Assuming that such a hydraulic gradient does exist and that the plane of high velocity current is parallel to the surface, the layer above is confined under the wheel and the layer below is confined from below on all sides; water in the lower layer is made more static by these restrictions; and the

P - Hydrostatic Pressure
f - Flow of Water (Quantity)
s - Stress in Rock Asphalt

resultant or summation of these vectorial forces is near the surface and parallel to it. If the binding forces holding the bitumen onto the sand particles were strong enough to resist these hydro-dynamic forces, stripping could not occur.

Material that has not achieved a high degree of consolidation (high density) may have a tendency to be spongy under wheel loads and actually pump or squeeze water laterally through the pores. A material that is both damp and spongy could "shove" slightly in front of the wheel and produce a sheared plane which might not re-heal because of the moisture. An un-bonded surface layer would be free to flush water along in front of the wheel as portrayed in the second diagram.
