COMMONWEALTH OF KENTUCKY
DEPARTMENT OF HIGHWAYS
FRANKFORT

December 13, 1954

(Rural Secondary Projects 1949-1951)

November, 1954

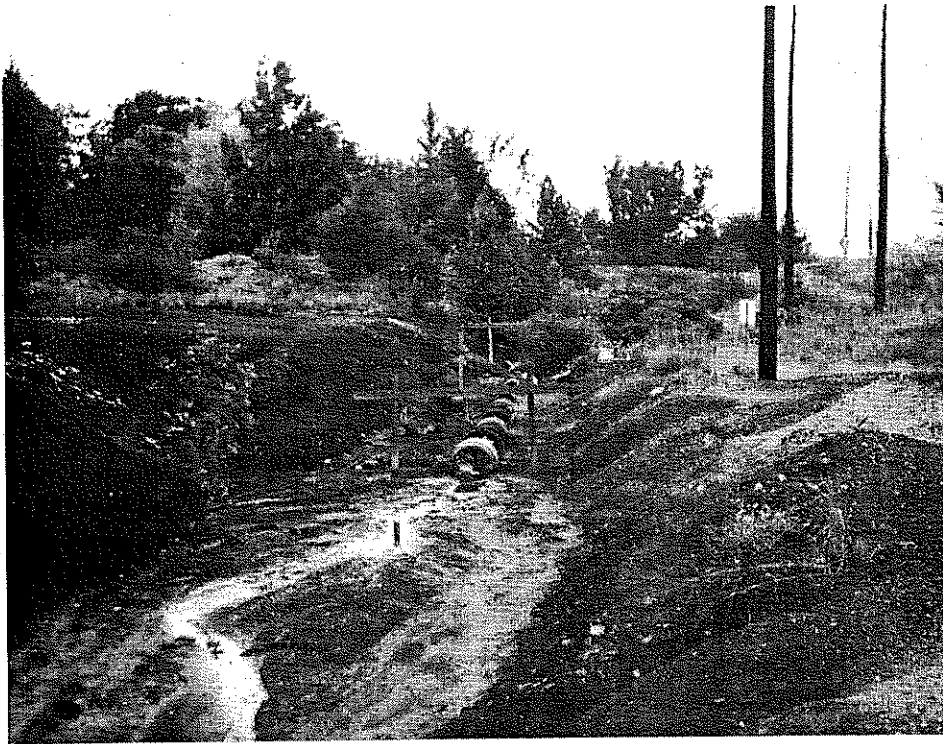
Fig. 13 - Test installation at Mortons Gap

The test installation originally consisted of 16 sections of 24-in. pipe. Two sections of each of the different types were installed in the following order, beginning at either end (See Fig. 13).
