Report No. 1

A BANK GRAVEL BASE CONTAINING CALCIUM CHLORIDE

(U.S. 62, Paducah-Eddyville Road)

W. B. Drake  
Research Engineer

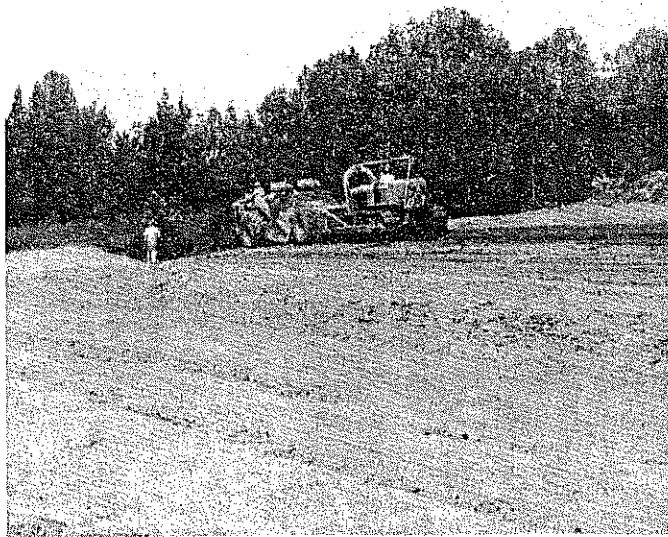
Fig. 5. Cutting binder soil into the pan of the earth moving equipment. This process partially pulverized the silty borrow material. Several passes of the pan over the exposed surface was required to accumulate a load.

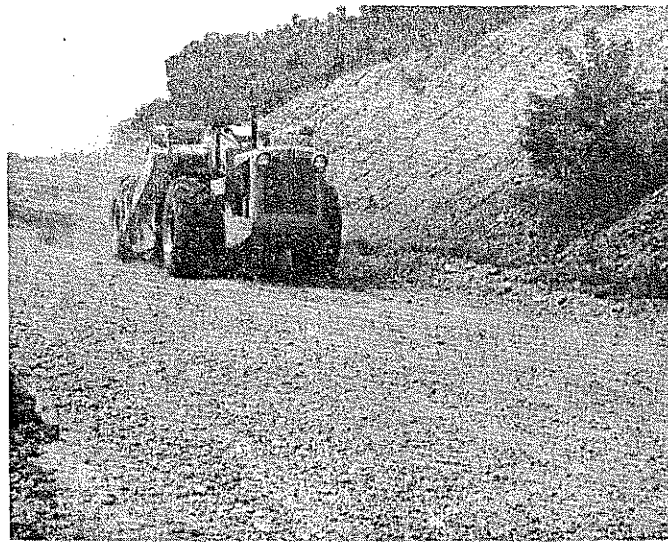
Fig. 6. Spreading binder soil at the rate of 52 pounds per lineal foot.

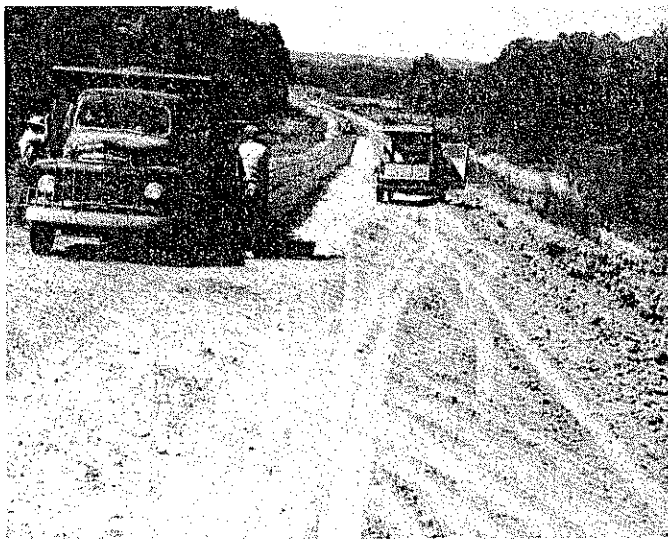
The stabilized calcium chloride-treated courses were started on August 22, at the Cumberland River Bridge, and work proceeded toward Kuttawa. Gravel in sufficient quantity to give a 2-inch compacted depth was laid along the south lane of the road ( Fig. 7) shortly after the binder soil was spread in the north lane. The rate of placement for the binder soil was 52 pounds per lineal foot. An Apsco Self-propelled Spreader was used in placing the gravel, and an earth-moving pan, as shown in Figs. 5 and 6, shaved the binder soil and placed it on the road. Both operations were carried out very efficiently. The pan was loaded by means of shallow cuts in order to pulverize the silty soil; gravel trucks passing over the soil after it was spread on the road were also effective in pulverizing the soil so long as it remained dry.

Fig. 7. Placing selected bank-run gravel uniformly with a mechanical spreader. Binder soil to be mixed with the gravel was spread in the right lane prior to the placing of the gravel.

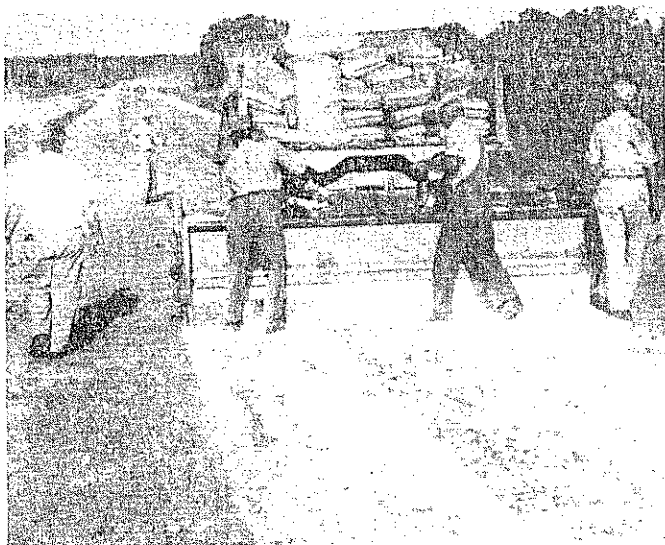
After the soil and gravel had been thoroughly mixed the windrow was brought to the center of the road and struck off square with the blade. An application of water was given at this time unless the materials were quite damp. Calcium chloride at the rate of one pound per square yard was then spread with a mechanical spreader box. (See Fig.9)

Fig. 9. Application of calcium chloride. A rolling mechanical type spreader box was used to control the rate of application which was one pound per square yard per 2-inch depth, except for two 1000-foot sections where the rate of application was doubled.

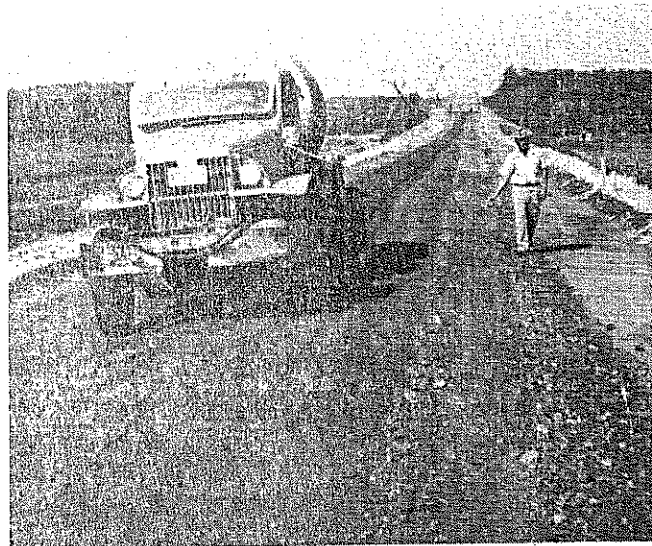
Fig. 10. Applying water to the stabilized mix. Invariably water was applied shortly after the calcium chloride was spread, and when the materials were exceptionally dry water was added in advance of the calcium chloride also.

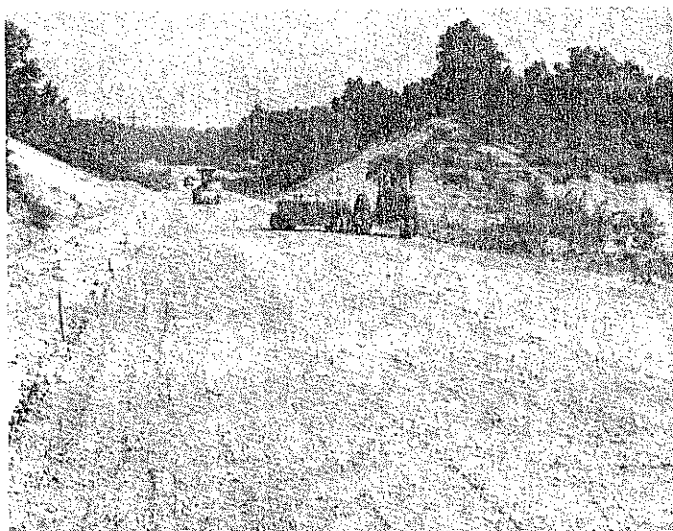
Fig. 11. A pneumatic roller in the foreground and a three-wheel, 10-ton roller in the distance were used throughout the job. On the non-stabilized layers of base three or four passes with the flat-wheel roller were made in advance of the pneumatic roller operation. On the courses containing calcium chloride, all except the final finished rolling was accomplished with the pneumatic roller.

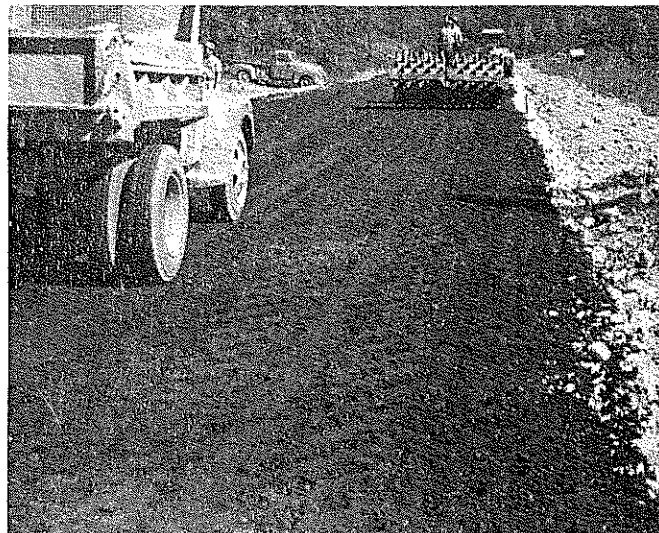
Following the conference of October 9, the contractor was requested to move to the Bohannon Pit in Marshall County where the qualities of the gravel were better suited to the construction. From that point on, the sheepsfoot roller (See Fig. 25) was introduced with a view toward "setting" the gravel before it was subjected to the pneumatic roller. Actually, the sheepsfoot roller seemed to be of little value, and most of the compaction was accomplished with the pneumatic roller followed by the three-wheel for final finish. Even though there was no mixing involved, the blade graders were used for shaping the top course of base before and during the pneumatic roller operations.

Fig. 25. The sheepfoot roller being used on the top course of base gravel in Livingston County. The gravel was from the Max Bohannon pit in Marshall County.
