Commonwealth of Kentucky
Department of Highways

Progress Report

EXPERIMENTAL JOINTING INSTALLATIONS
FOR CONCRETE PAVEMENTS

Project F 367 (10) - U.S. 27 Campbell County
 Prefabricated Neoprene Seal

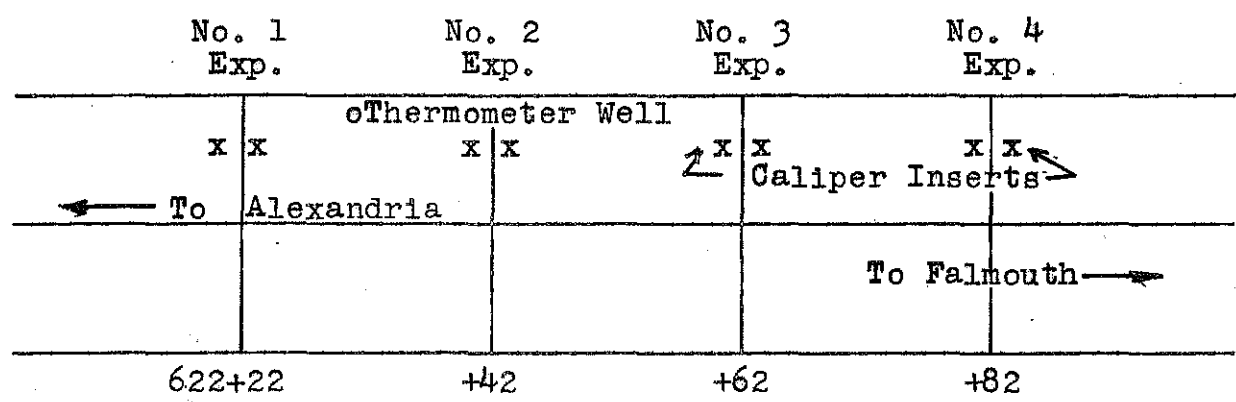
Fig. 1 - Layout of Campbell County installation showing location and identification of the joints investigated and positions of Caliper Inserts.

Brass caliper inserts were set in the north bound lane on each side of the three experimental joints and one standard joint for the purpose of observing joint measurements as influenced by time and temperature variations (See Fig. 1). A thermometer well was also provided for measuring the internal temperature of the concrete at the same time. The results of these measurements are listed in Table I and plotted in Fig. 10. No great amount of closure was observed in the three special joints even with an appreciable temperature increase, while in the standard reference joint there was a slight amount of opening despite the temperature increase. Measurements made in December, 1949, and February, 1951, when temperatures were comparable with that at time of the original measurements, indicate a progressive opening of all joints. This condition was more pronounced in the standard reference joint than in the special joints with neoprene sealers.

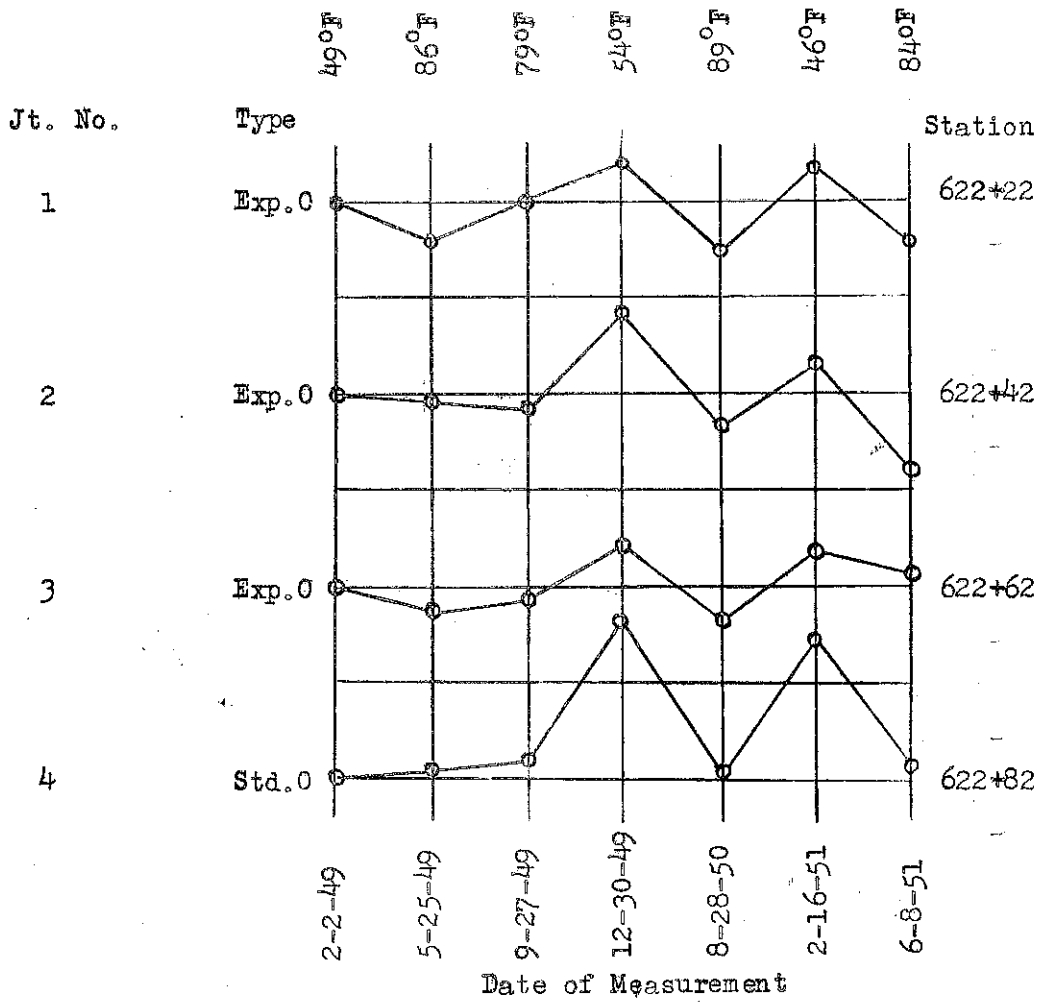
Fig. 10 - Joint Width Variations

Note: - Original measurements taken as zero. Points above the zero line indicate the amount of opening and points below indicate the amount of closure, with relation to the joint widths at the time of the first measurement.

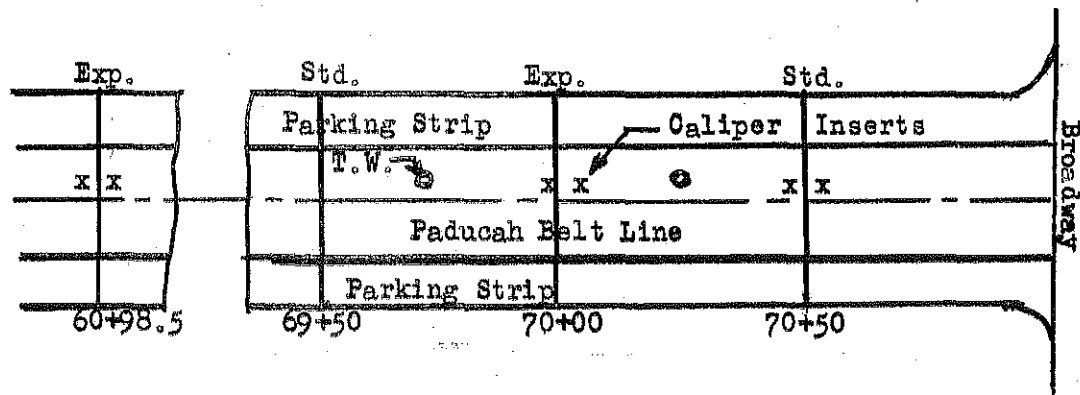
Fig. 10A- Layout sketch of pavement section showing locations of joints under investigation and the positions of Caliper Inserts and Thermometer Wells (T.W.).

Brass caliper inserts were grouted on each side of the two special joints and one standard joint at Station 70+50 (Fig. 104), for the purpose of measuring the amount of movement as effected by time and temperature changes. Thermometer wells were also provided for measuring the internal temperature of the concrete.

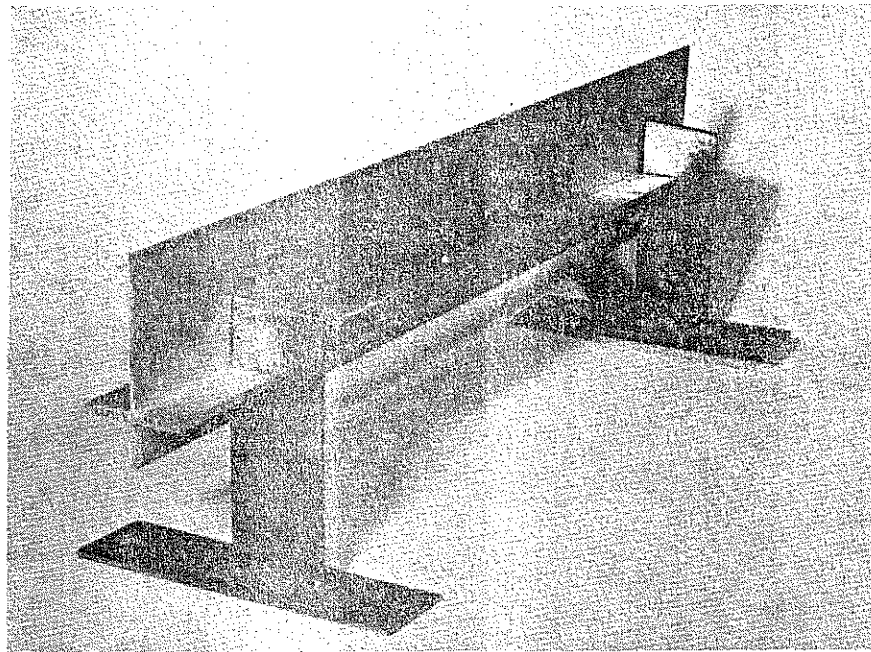
Fig. 11. Closeup view of a section of the aluminum load transfer device. The chairs shown are the type used at Station 60/98.5 .

The two first mentioned features are true; however, there is a definite lack of stability in the assembled device and it is easily dislocated during placement of concrete about the joint. There are, also, some doubts as to the permanence of aluminum when exposed to concrete; that is, the corrosive reaction of concrete on aluminum may be equally as serious or more so, than rusting of ferrous metals.

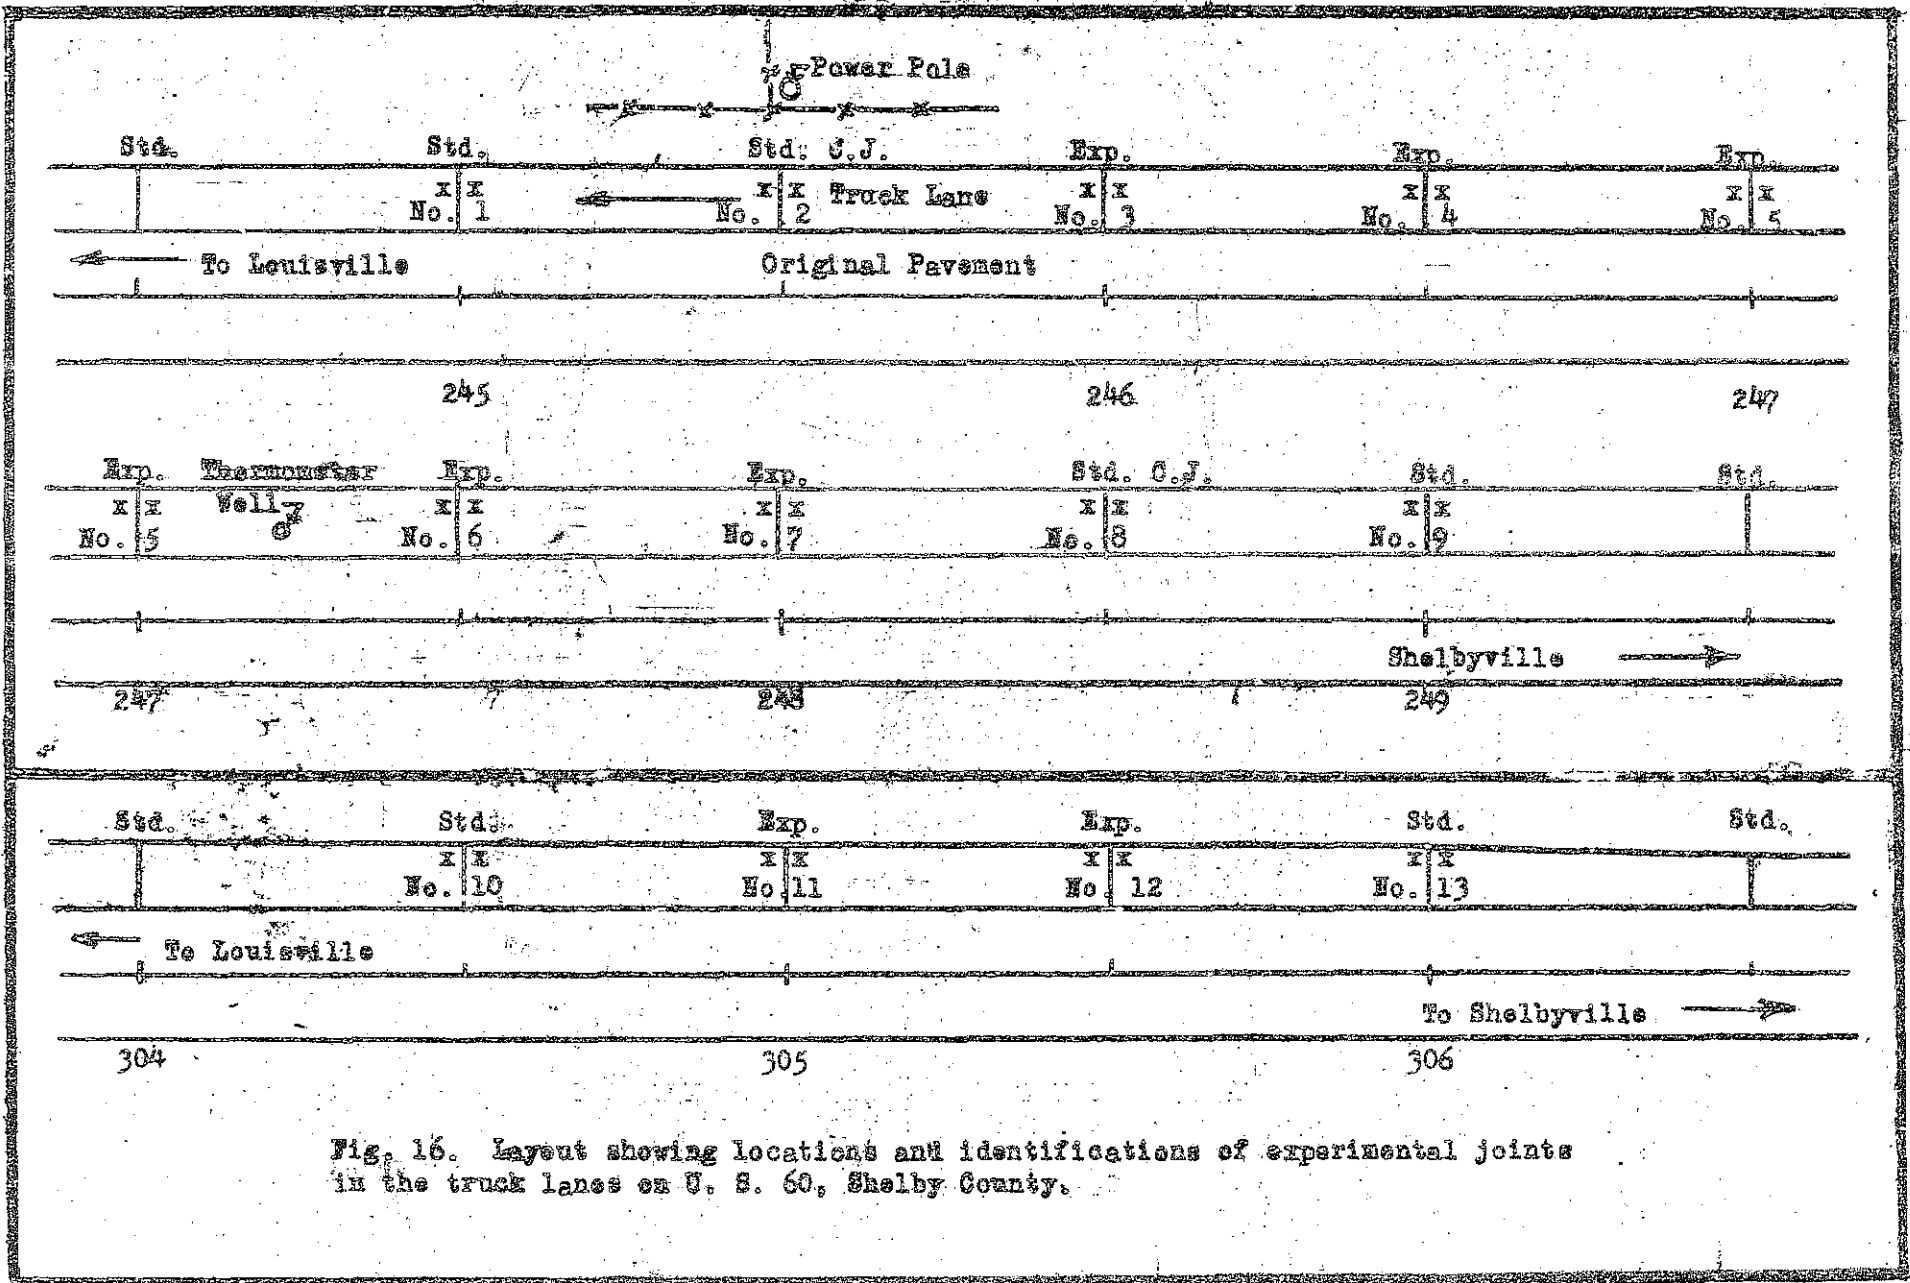
Fig. 16. Layout showing locations and identifications of experimental joints in the truck lanes on U. S. 60, Shelby County.

The first aluminum joints (identified as experimental Joints No. 11 and 12) were placed September 30 in Lane Four, at the second and third full-width (11 feet) joints nearest the Shelbyville end (Fig. 16). Joint No. 12 was tilted to the rear (See Fig. 25), and was tilted slightly ahead with respect to the direction of paving. Due to these unsatisfactory results, further installations were postponed until adjustment could be made in the "joint-holding" apparatus.

Caliper inserts were set at 13 joints identified as standard joints No. 1, 2, 8 and 9; experimental joints No. 3, 4, 5, 6 and 7 in Lane Three; and standard joints No. 10 and 13, and experimental joints No. 11 and 12 in Lane Four. No inserts were set for the joint at Station 294+08.5.

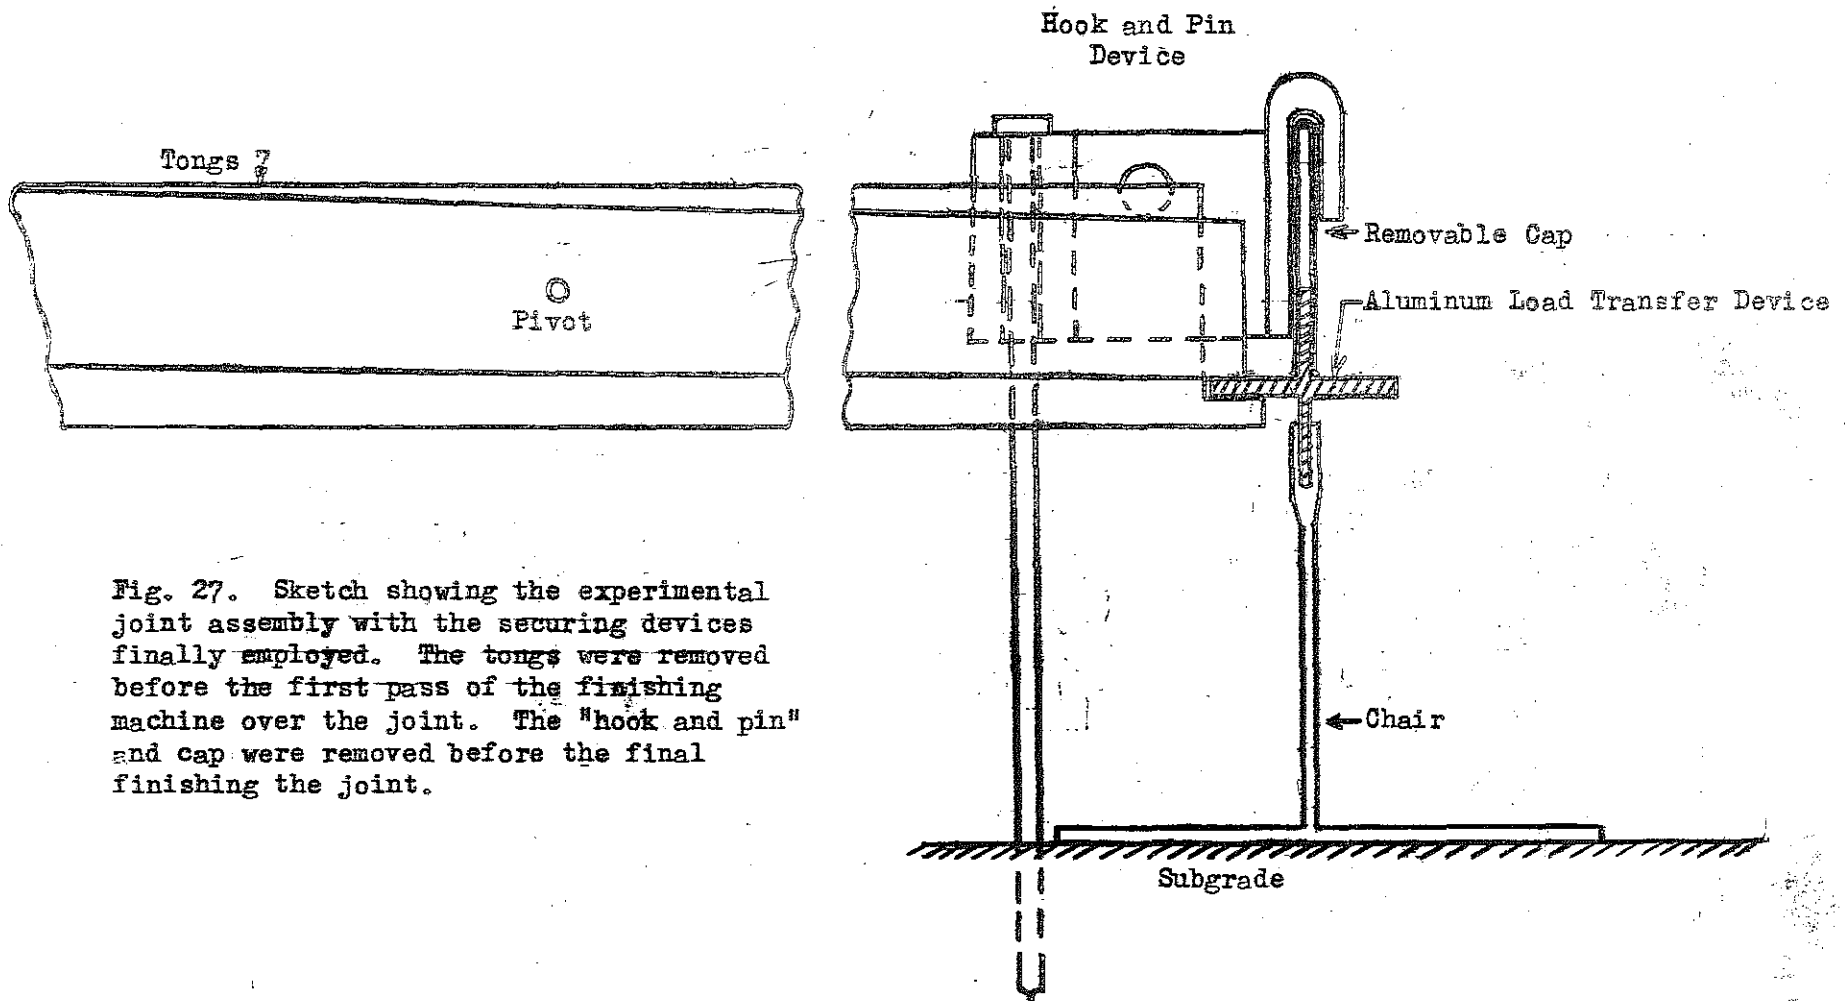
Fig. 27. Sketch showing the experimental joint assembly with the securing devices finally employed. The tongs were removed before the first pass of the finishing machine over the joint. The "hook and pin" and cap were removed before the final finishing the joint.

To further improve the stability of the joint assembly, the company representative decided to prepare devices to hook over the cap and to be secured with a pin driven into the subgrade - similar to those employed with the dowel bar assembly (See sketch in Fig. 26). These hook and pin devices were used in conjunction with the "tong" apparatus and were removed prior to the final finishing of the joints. Five special joints Nos. 7 through 3, (Station 248+00 to Station 246+00) were installed in Lane Three on October 10, employing this combination of securing devices with satisfactory results.
