Commonwealth of Kentucky
Department of Highways

OBSERVATION ON SEAL COATS, TACK COATS, PENETRATION
MACADAM, AND BLADE SPREAD HOT MIX IN 1951

December 7, 1951

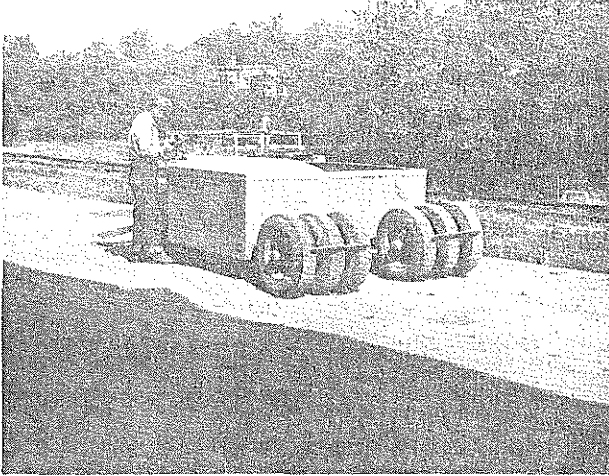
(a)
Rubber-tired roller used on all sections of Experimental Seal Project (weight 5 to 6 tons).

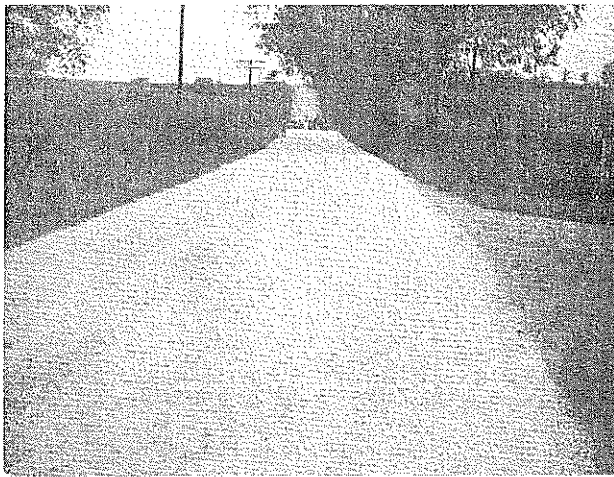
(a)
Dry stone after spreading on RT-10 Section of Experimental Seal Project.

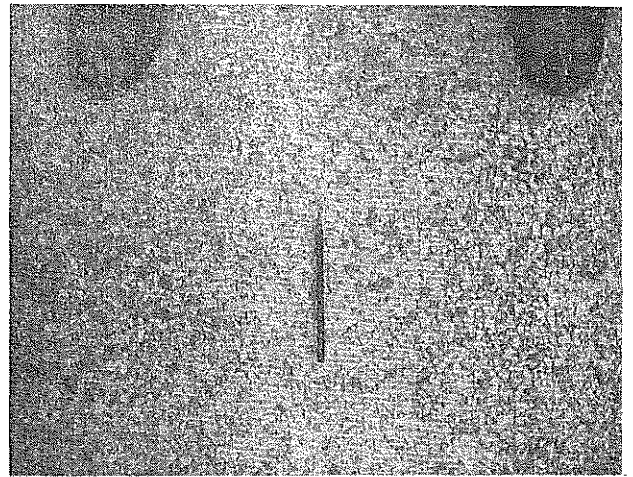
(b)
Surface texture of dry stone after dragging and rolling operations.

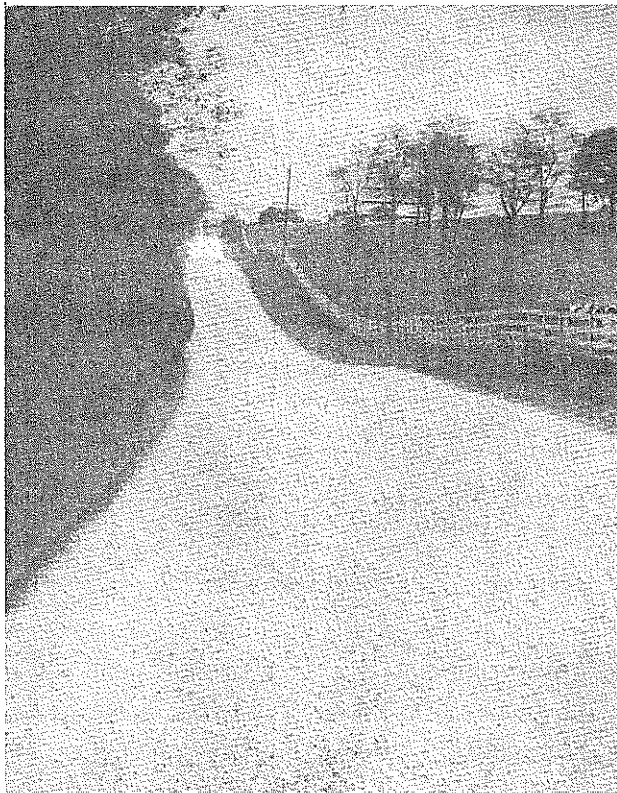
(c)
Finished surface NAC-8 Section of Experimental Seal Project.

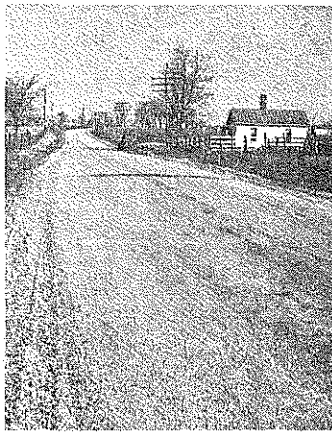
NAC-8 (a) Section

Looking eastward from Springfield toward Harrodsburg into each successive section as indicated. November 29, 1951

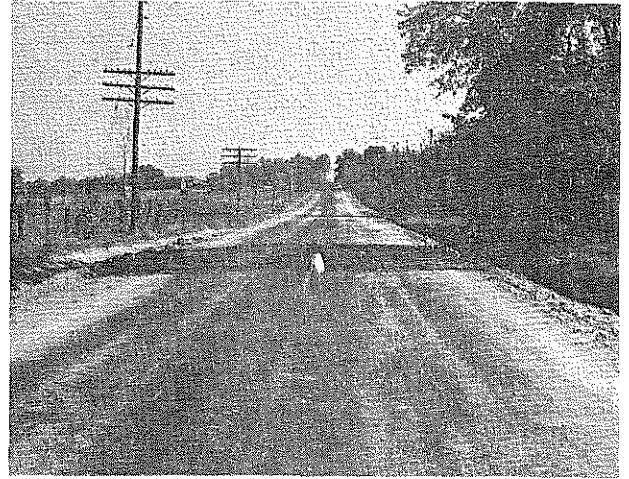
Fig. 12. Finished surface, looking north from Station 47+00. Shoulder construction had not been completed.

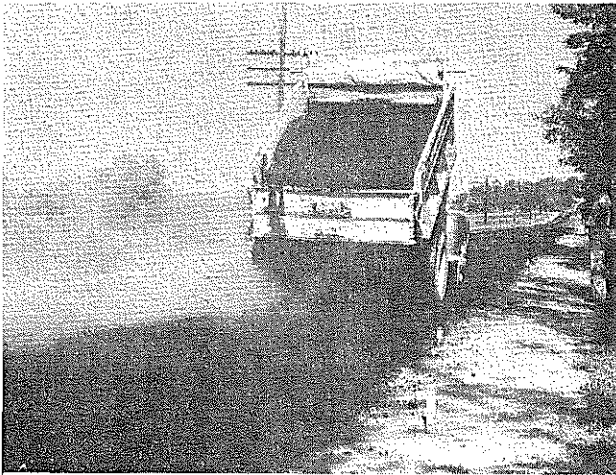
Two men supervised the general distribution of the mix which was "tailgated" from the trucks. One dumper proceeded with the distribution of the material in "spot" applications over portions of the old surface requiring more than the average quantities for eliminating the irregularities. In accomplishing this, the low spots were not marked on the pavement but rather the man supervising this spread rode with each truck and specifically located the points where material was to be dumped. Sometimes an entire truck load was required in a single low spot, but in many instances a portion of a load was dumped, the bed lowered, and the truck passed forward or backward to one or more other low spots before dumping the remainder of the load. This was then spread by the grader. These operations are illustrated in Figs. 13 and 14.

Fig. 13. Distributing by "tailgating", Class I Binder Material on half-width construction.

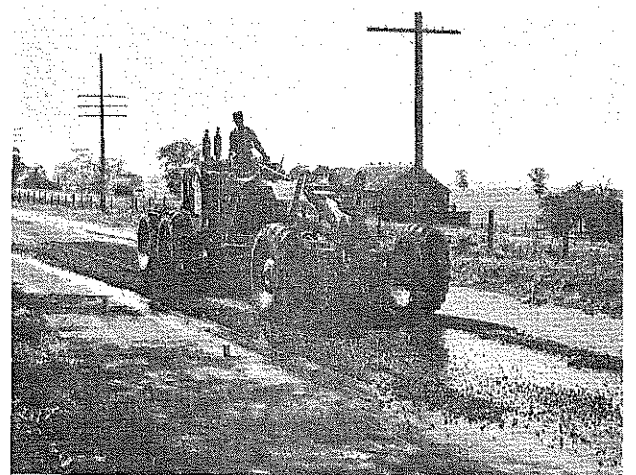
Fig. 14. Blade spreading a "spot" application of the "hot-mix" material over a portion of the old surface requiring more than a normal amount of the material to eliminate the irregularities.

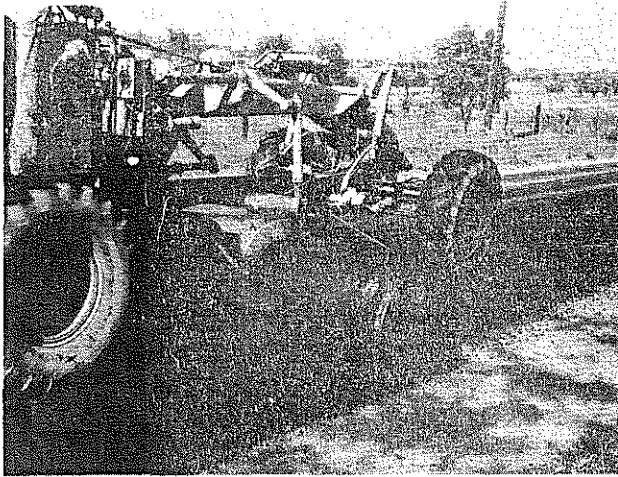
The courses were not laid in any well defined sections, such as by jointing, but were joined by long wedge-like overlaps. The length of the paving operations varied, but were such as to provide more or less continuous operations by the rollers and to maintain a convenient traveling distance of the grader. Attached to the grader blade was a device for aligning the edges (Fig. 15).

Fig. 15. Shaping and aligning the edge of the binder course prior to rolling.

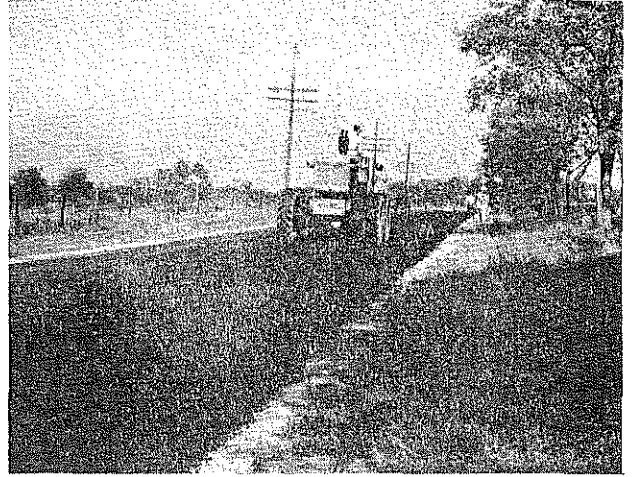
Fig. 16. Spreading and shaping a second run of binder material to improve the finished section.

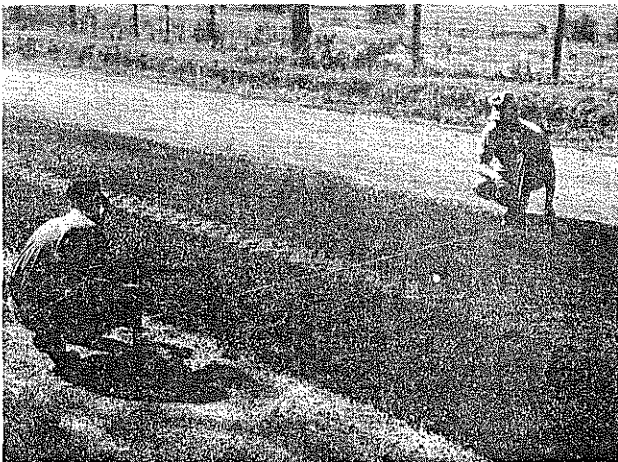
As a means of control, elevation markings were set on offset-line stakes for checking the crown section at each hundred-foot station (Fig. 17). This was done by stretching a line between the centerline and the elevation marking. Although, such control was effective only at the given locations, and even though the effectiveness was reduced by centerline grade irregularities, it appeared to be a worthwhile effort. To obtain the greatest improvement in grade and cross-section, the prime requisite was careful visual inspection by all personnel concerned.

Fig. 17. Checking the crown section. A line was stretched between center-line and elevation mark on the offset line stake.

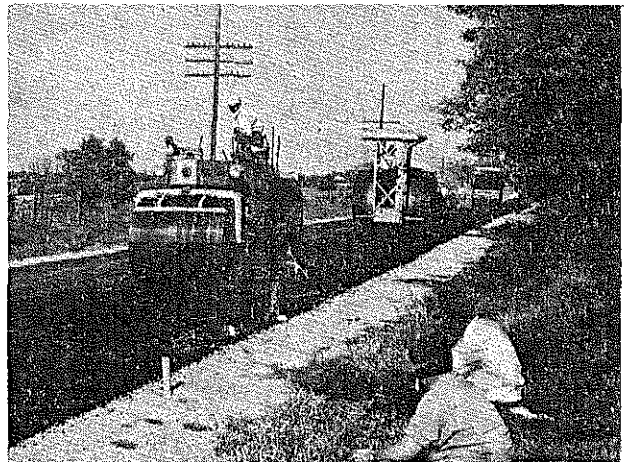
Fig. 18. Rolling the Class I Binder. The three wheeled roller was followed by the tandem roller, for both the binder and surface courses.
