Phase I Inspection of the Stay Cable System on the US 231 William H. Natcher Bridge over the Ohio River

Kentucky Transportation Center Research Report — KTC16-01/KHIT77-1F

Research Report
KTC-16-01/KHIT77-1F

January 2016

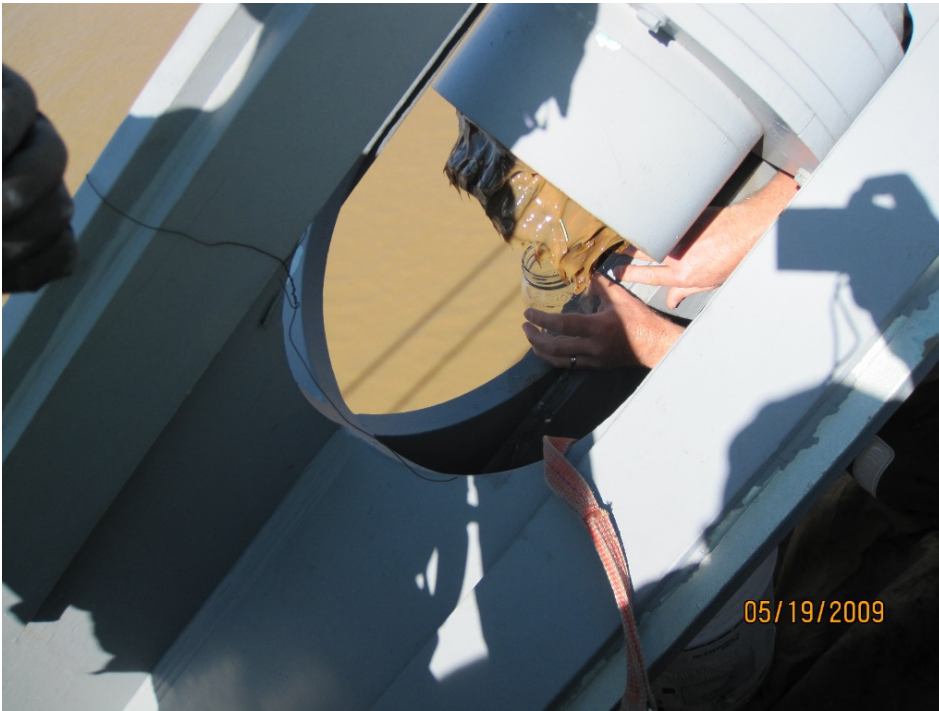
Figure 10. Deck Anchorage Showing Heavy Grease Coating on Strands/Wedges/Anchor Head. Note Water inside Anchorage Piping being Collected

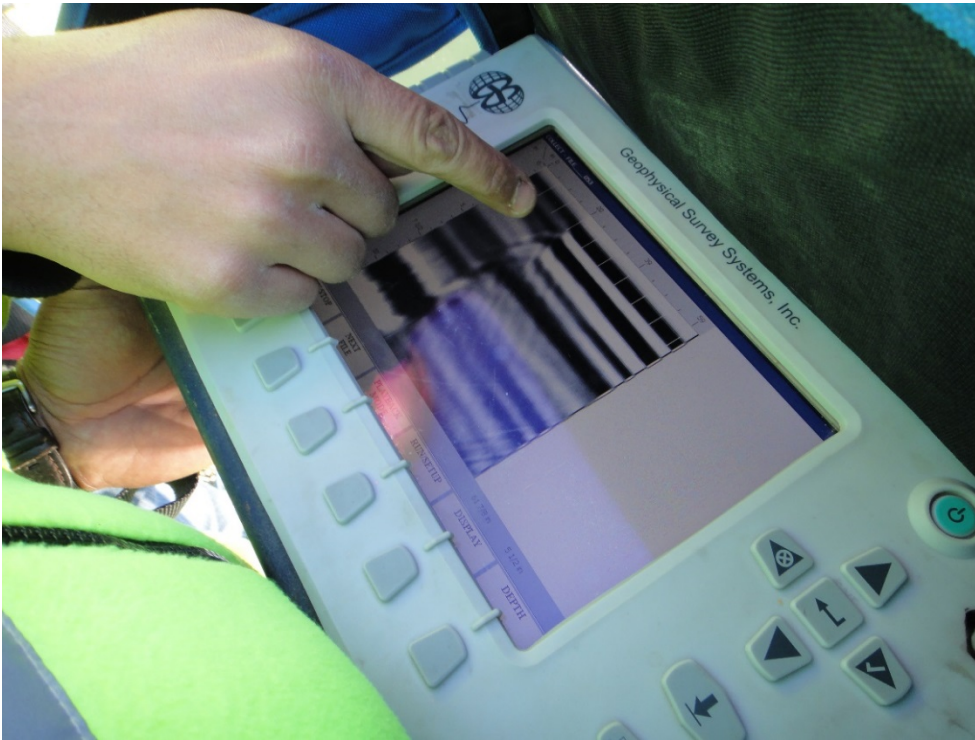
Figure 20. Grout Void Indication on GPR Monitor Screen.

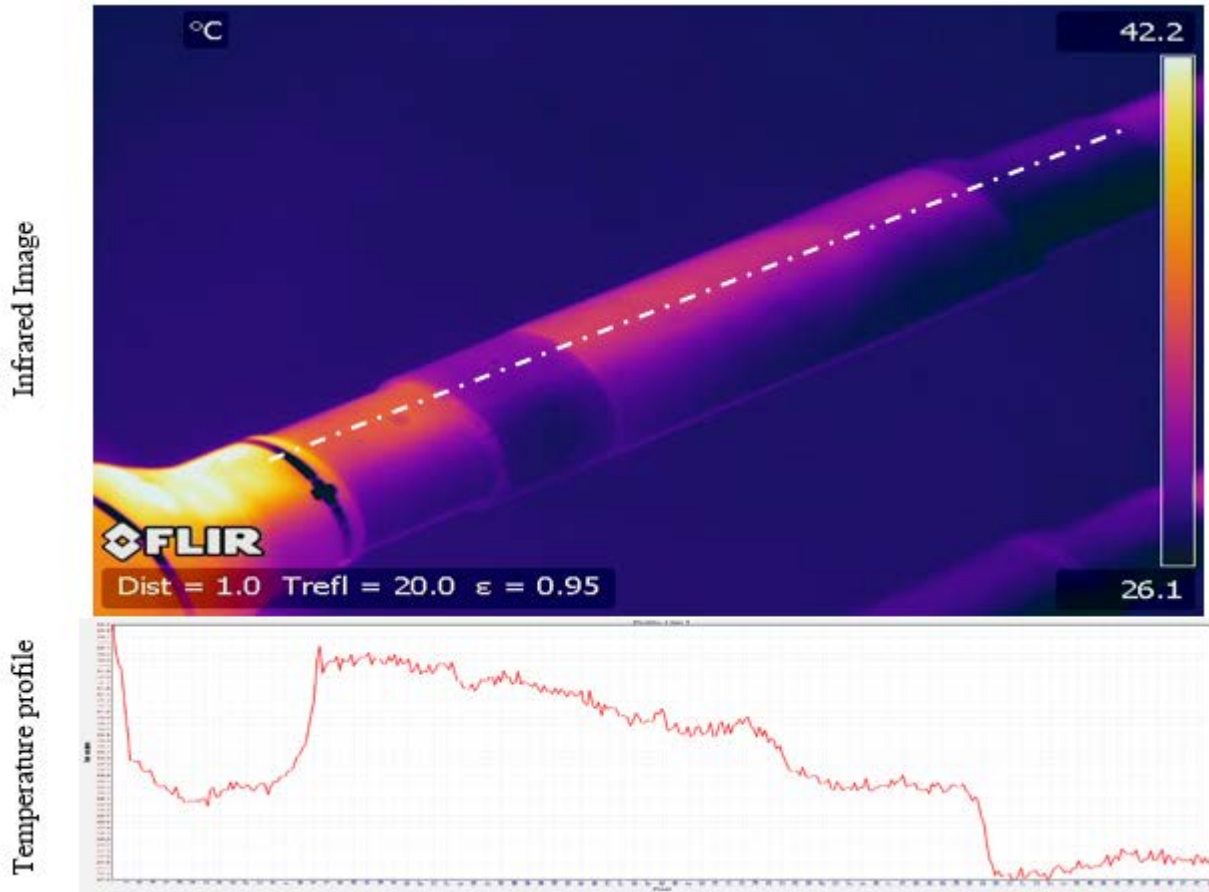
Thermal images taken of the connection sleeve pipe sections at the tower anchorages were taken on June 20 and 21, 2013 at about 10:00 am CDT. They produced similar results, detecting grout voids in numerous cables (Figure 31). Researchers encountered problems in imaging all of the anchorages due to poor visual access to some cables hampering thermal imaging from the tower platforms. Another problem related to solar reflections which obscured the thermal images from some cables (Figure 32).

Figure 31. Infrared Image of the Tower Anchorage Connection Sleeve Pipe Section for Cable B3D and Thermal Profile for the Dashed Line Shown in the Infrared Image (Op. Cit. 10, p. 24).

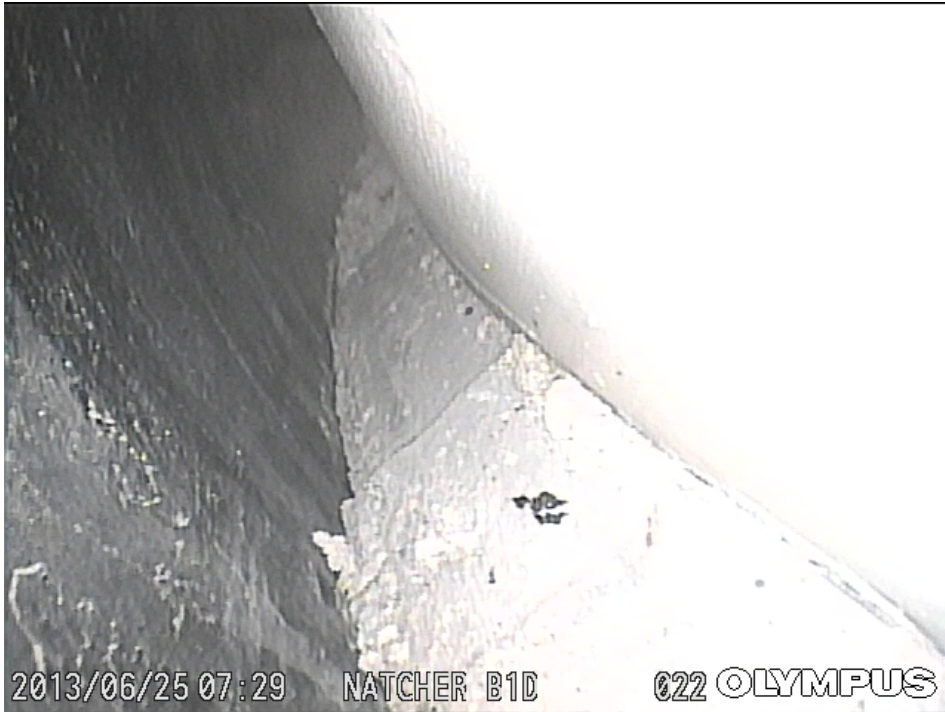
Figure 36. Grout Interface between the Inner Wall of the Connection Sleeve Pipe and the Stay Pipe.

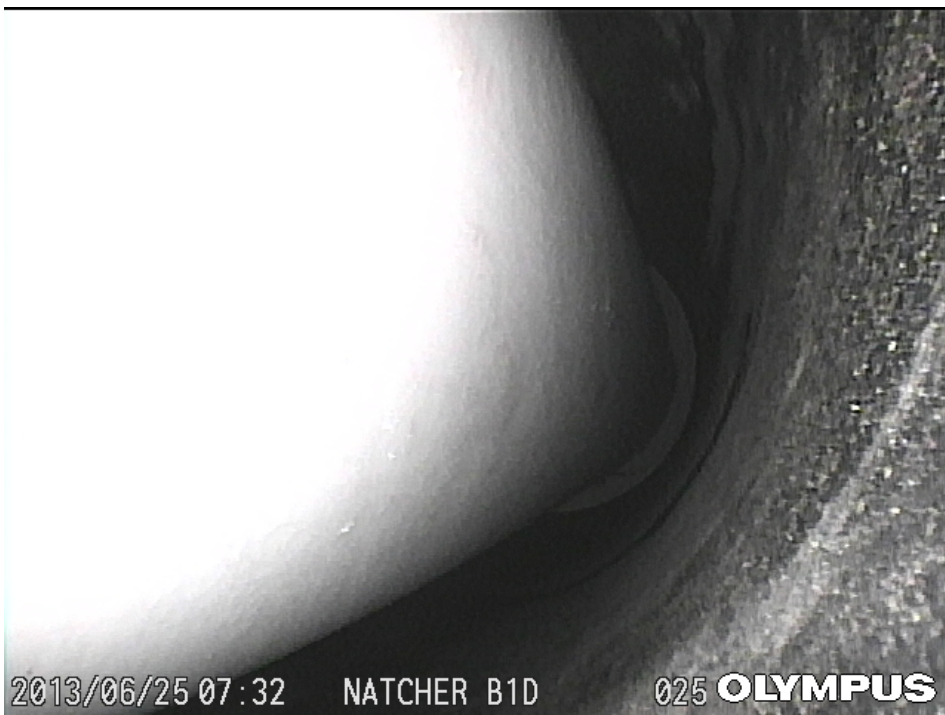
Figure 37. Picture Taken by Videoscope inside a Grout Void Looking Upward Where the Stay Pipe Passes Through the Reducer.

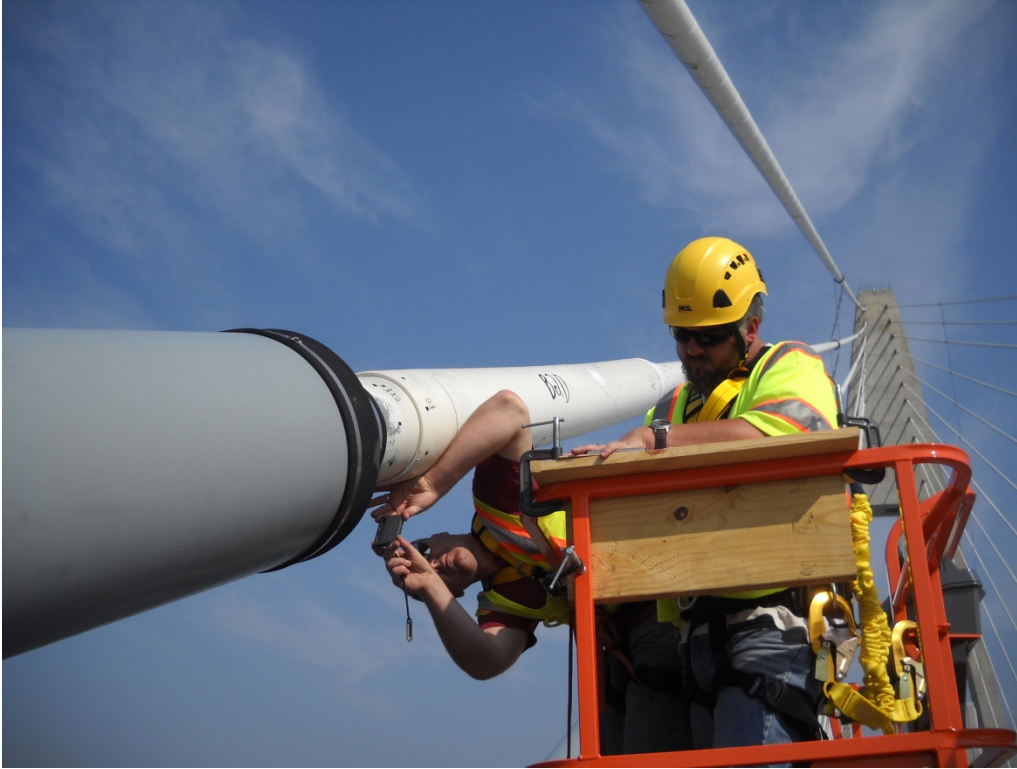
Figure 44. Arm's Length Crack Inspection of the HDPE Piping at the Deck Anchorages.

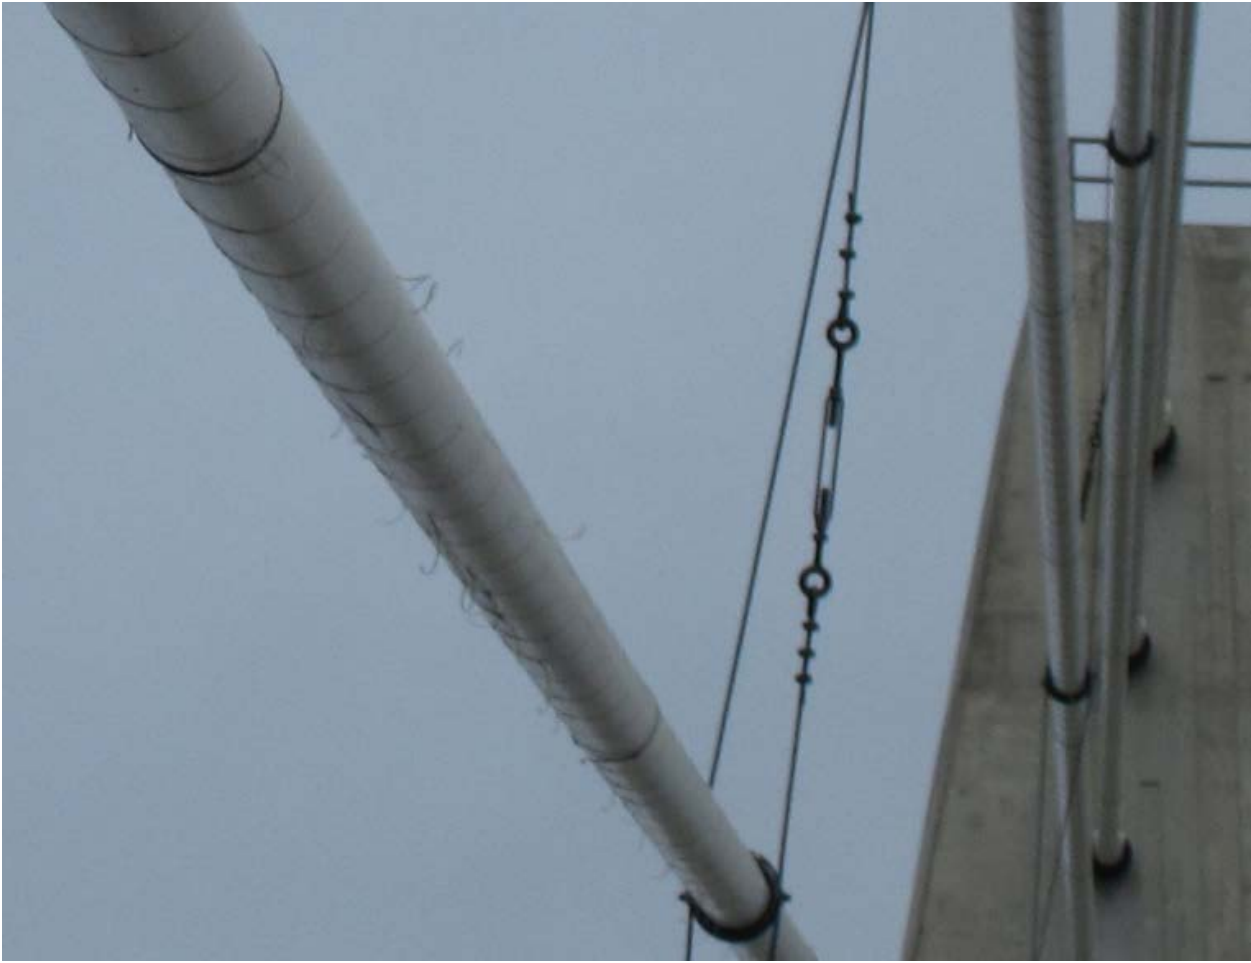
Figure 62. Severe Disbonding of Ribbing from Stay Pipe Segment (2009).

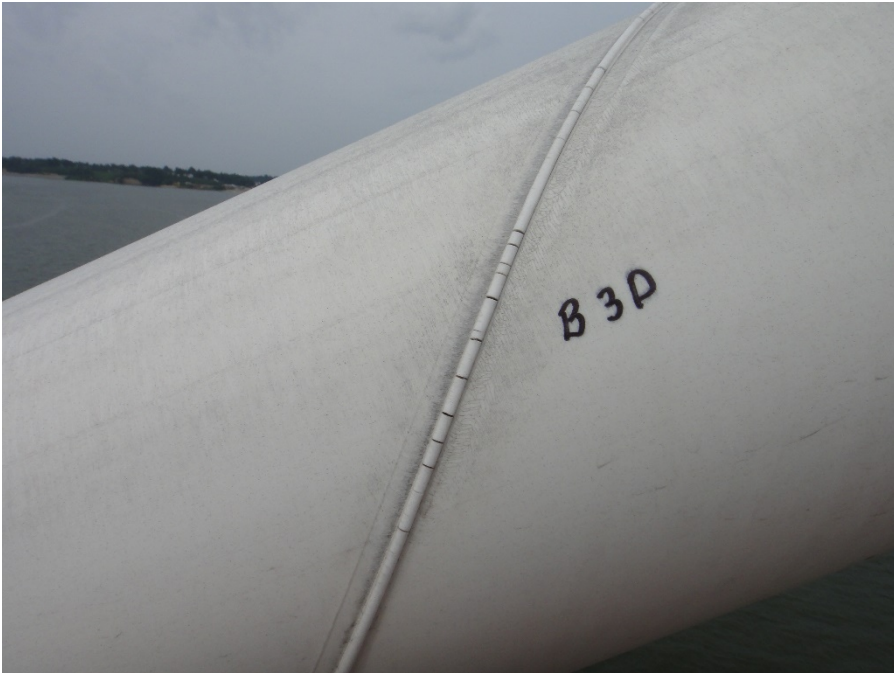
Figure 63. Cracking of Ribbing Still Bonded to Stay Pipe (2013).

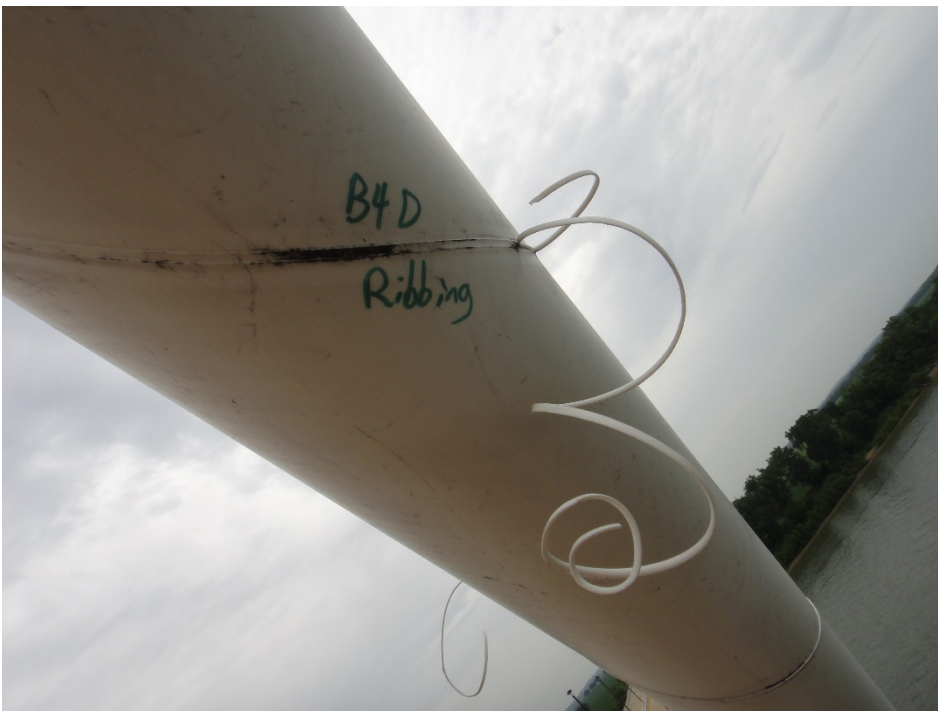
Figure 64. Ribbing Detaching from Stay Pipe near Deck Anchorage

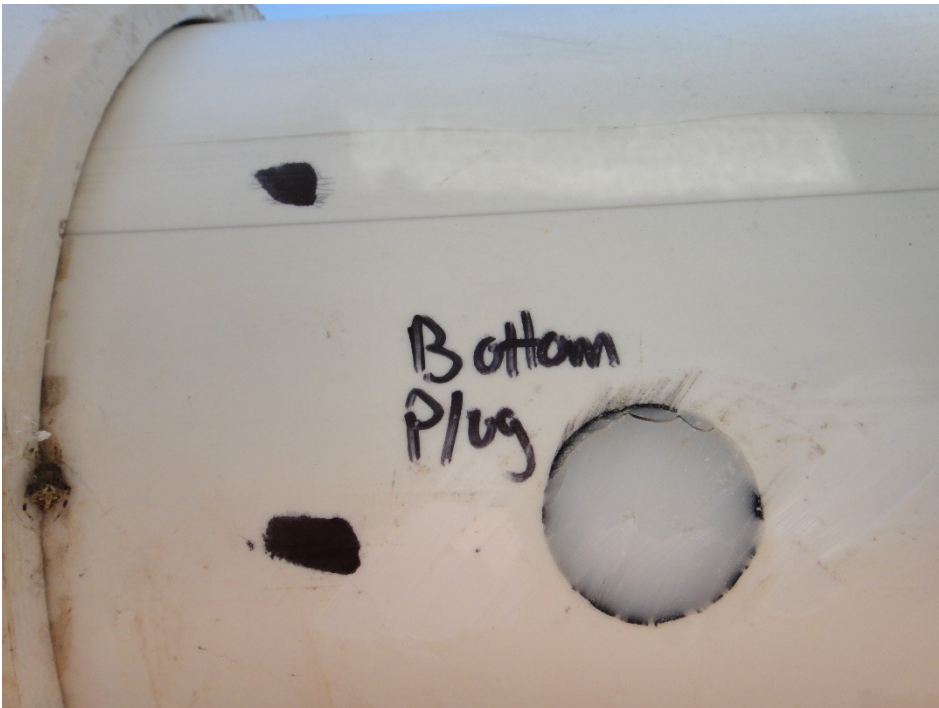
Figure 66. Grout Plug with Minor Cracking.

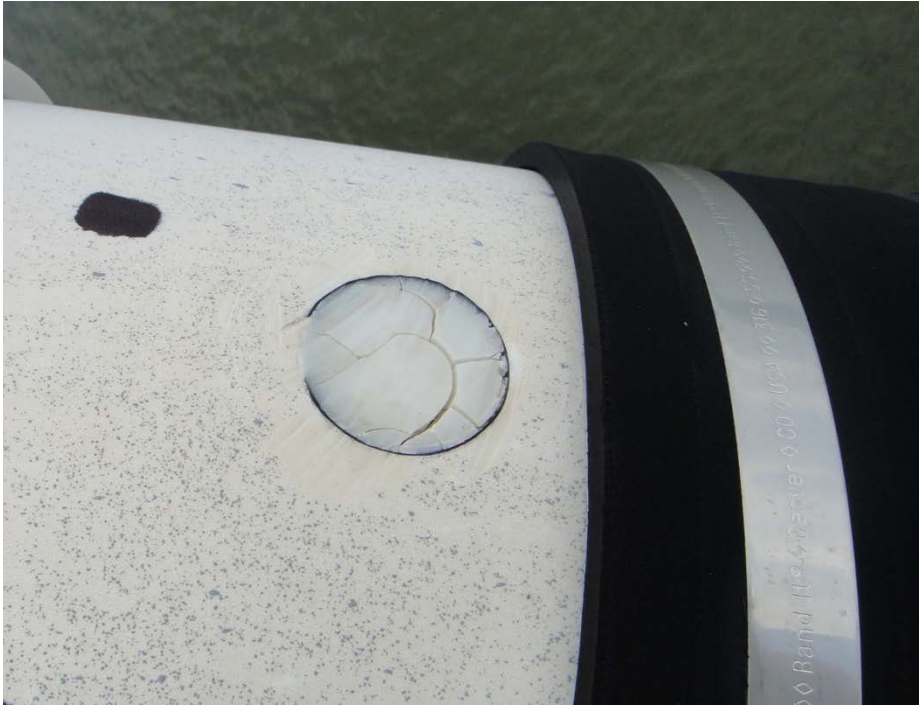
Figure 67. Grout Plug in Transition Pipe Having Extensive Cracking.

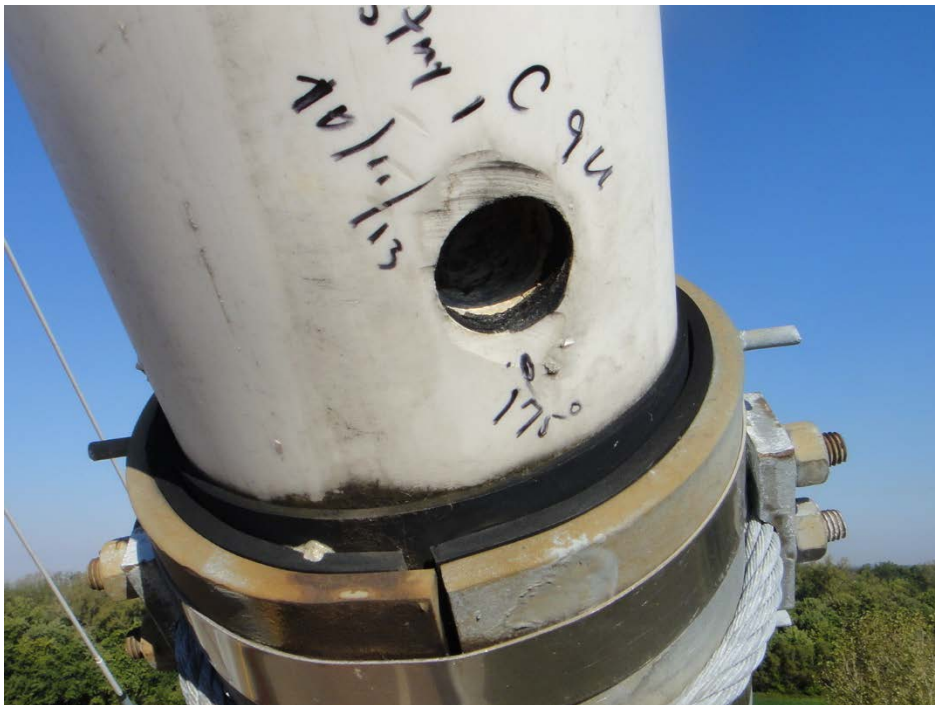
Figure 68. Missing Grout Plug.

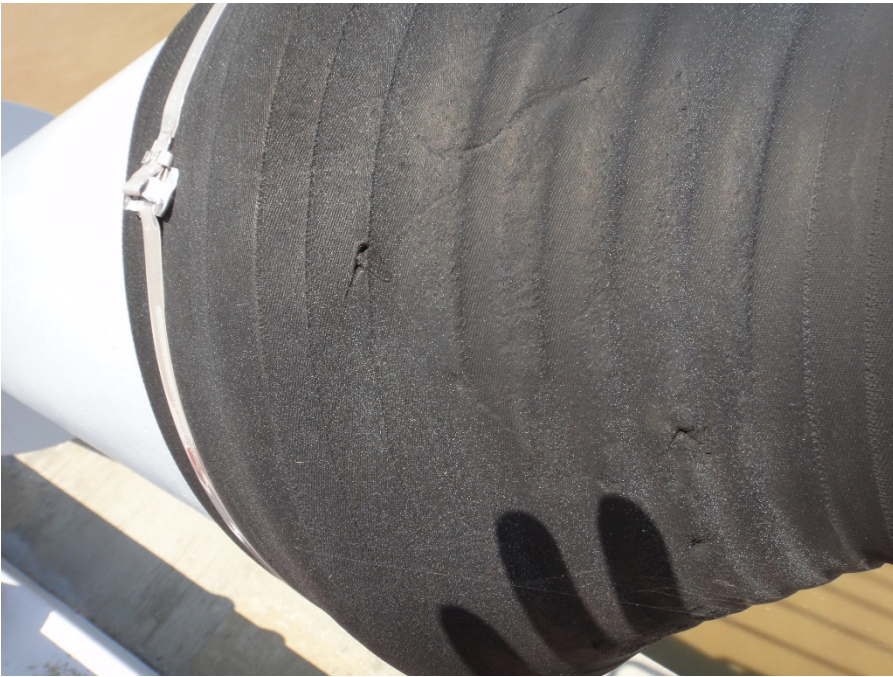
Figure 69. Neoprene Boot at Deck Anchorage with Superficial Damage.

The condition of neoprene boots at both the deck and tower anchorages requires further study. Some had physical damage (cuts, gouges) or were improperly mounted. The cause of moisture in the boots at the tower anchorages may relate to leakage at the boot seams, loss of material water resistance or water entering the boot from the gap between the transition and guide pipes. Internal inspection of the tower anchorages at the anchor heads may provide insight into the latter possibility. The water-tightness of the deck anchorage boots needs to be evaluated by internal inspections in the space between the transition and guide pipes as well. The implications/consequences of water in the boots has not been assessed. One piece zip-up neoprene sleeves are available to replace boots that are damaged or leaking (Figure 106). The existing neoprene boots can also be painted with a protective coating (e.g., hypalon) to seal them from water and reduce weathering.

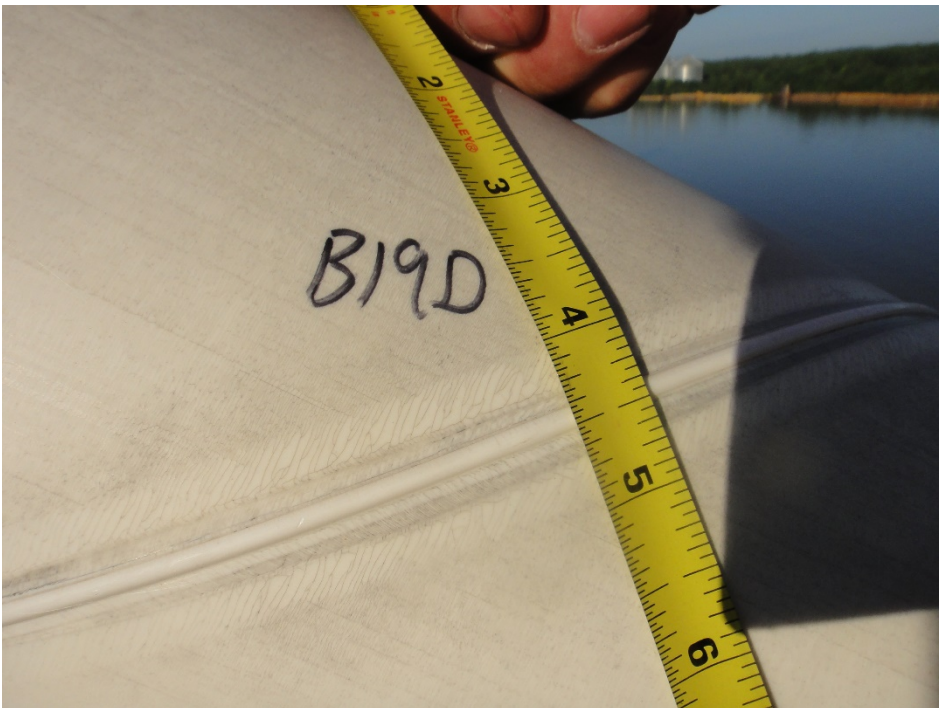
Figure 77. Ink Mark on Coupler Showing the Absence of In Bleeding/Micro-cracking.

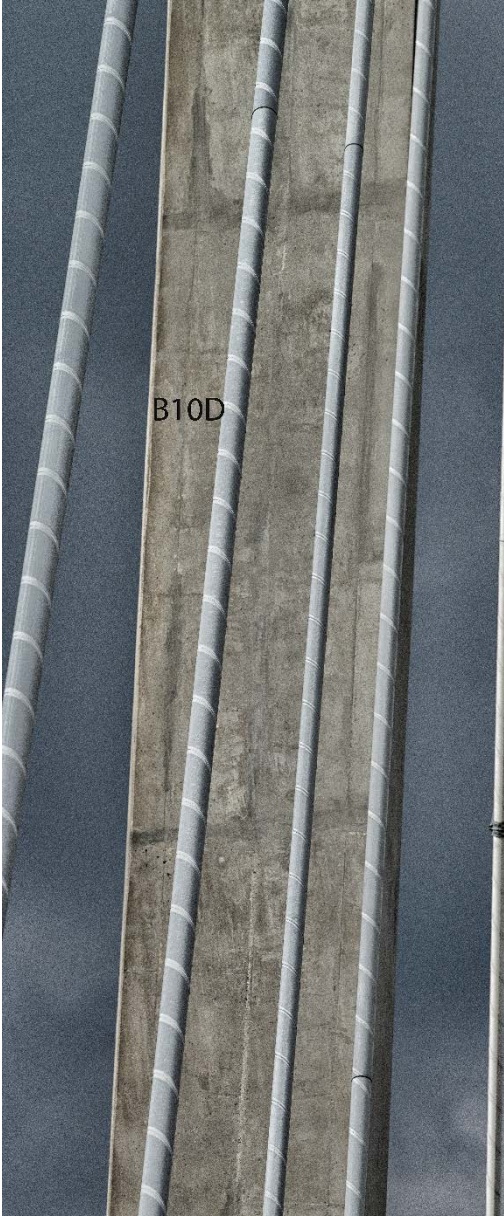
Figure 78. Differences in Micro-cracking in a Stay Pipe Adjacent to the Ribbing.

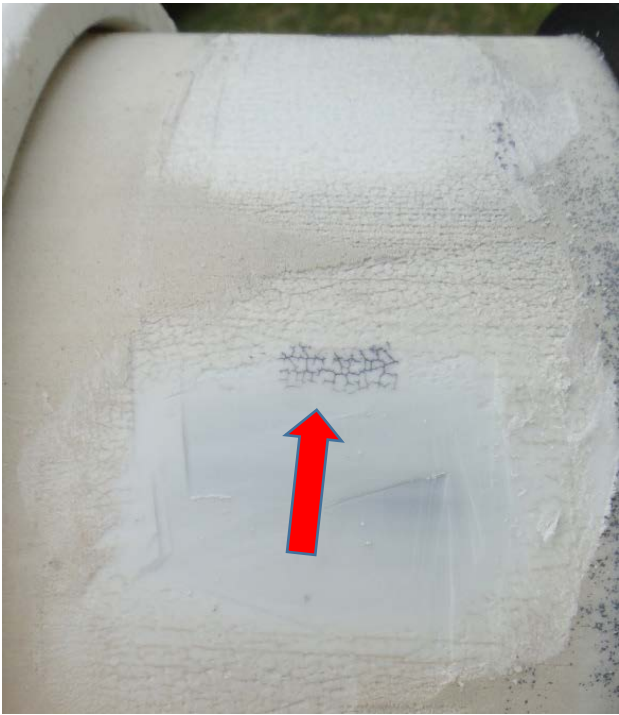
penetrated down to the black base HDPE (Figure 85). In several locations, the white coextruded HDPE exhibited spalling (Figure 86).

Insight into the performance of the white co-extruded HDPE material can be gained in reviewing a certificate of performance from the material supplier (22). The supplier subjected samples of the co-extruded piping to an accelerated weathering test (Xenotest 1200) for 10,000 hours. The supplier noted that this was equivalent to 10 years of service. That testing produced “micro-fissures” (e.g., micro-cracks) that were at a maximum of 10 percent of the co-extruded material thickness (2 mm). As of 2013, the Natcher Bridge had been in service for 12 years. The micro-cracks in the co-extruded material exceeded the amount predicted by the supplier. At one scrape test location KTC researchers observed that the micro-cracking had penetrated down to the black base material of a transition pipe (Ref. Figure 84).

Figure 84. Magnified Picture of the Surface of a Coextruded HDPE Pipe Adjacent to A Scrape Showing the Interwoven Pattern of the Micro-cracking with Depth into Surface down to Sound HDPE.

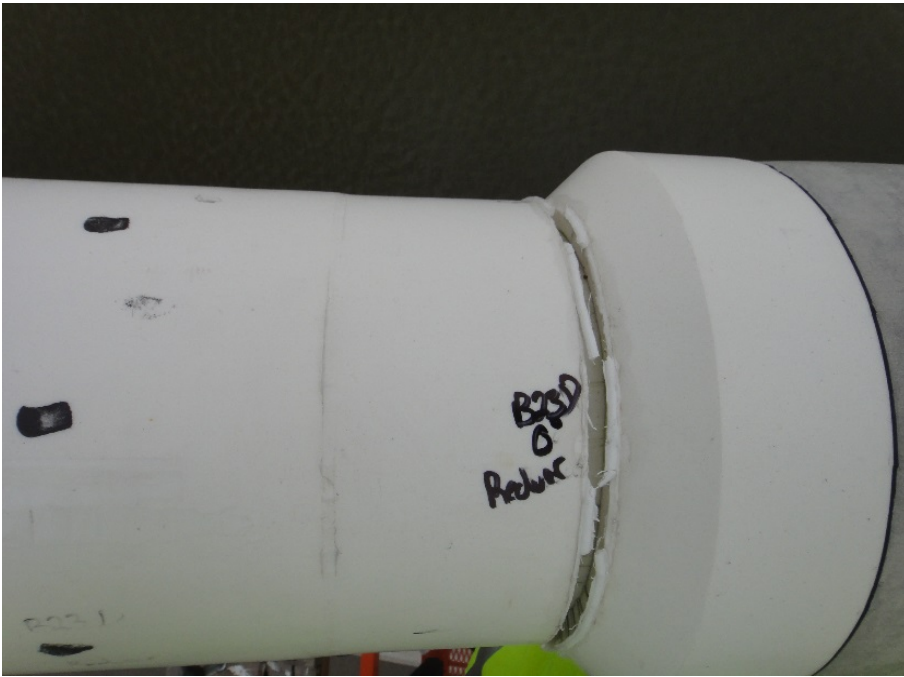
Figure 93. Completed Weld Repair in a Previously Cracked Reducer.

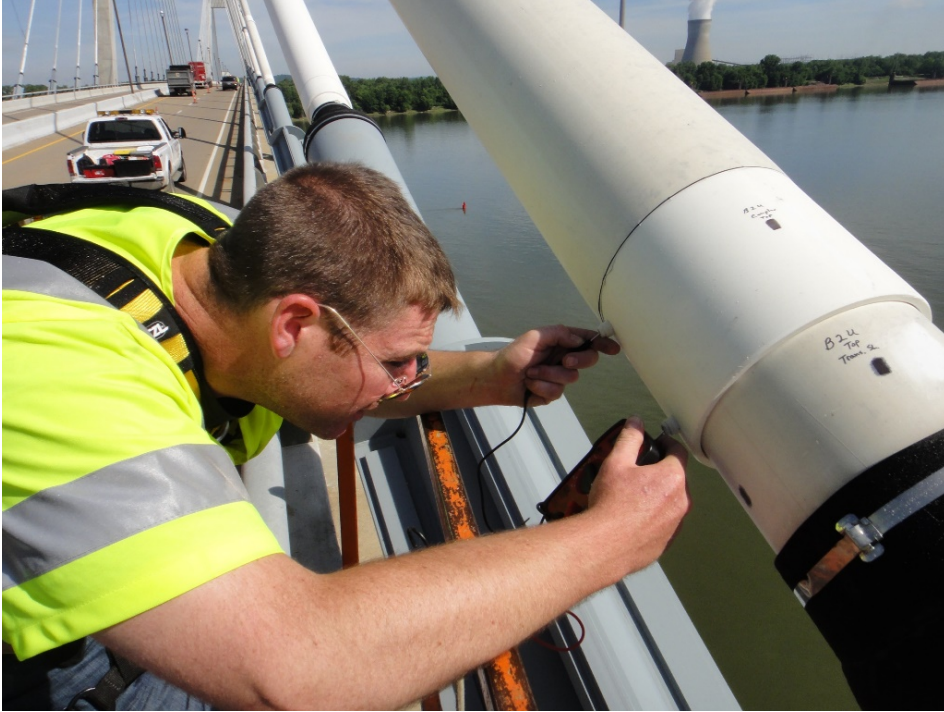
Using a voltmeter, KTC researchers performed resistance measurements on the weld nipples of electrofusion welds on the deck anchorage couplers and reducers (Figure 100). The tests were used to determine if continuity still existed between the weld nipples. That would indicate the condition of the weld wiring and indicate if it was damaged. In some cases, broken weld wires were observed at gaps in cracks at the electrofusion welds – usually along with missing weld nipples (Figure 101). KTC researchers performed measurements with the potential for future repairs at the electrofusion welds by re-applying at current and re-melting the HDPE piping. This would be done to repair those welds showing lack of fusion (e.g., at the reducer-stay pipe gaps) and to re-weld connections showing signs of electrofusion weld shear failures and modest (< 1 inch) slippage (Ref. Appendix 2 Condition Category 8). The former task would require using straight-beam ultrasound to identify lack of fusion areas in the existing welds, which may be possible if KTC can obtain suitable exemplary welds for laboratory testing. Intact electrofusion welds had resistance reading on the order of a few ohms. Potentially failed electrofusion welds typically under tight cracks (Ref. Appendix 2 Condition Categories 3 & 6) had resistance readings in the hundreds to thousands of ohms. Completely failed electrofusion welds showed no continuity between the weld nipples.

Figure 99. The Application of STOPAQ® Tape to Seal the Reducer-Stay Pipe Gap and Prevent Water Intrusion into the Grout Void.

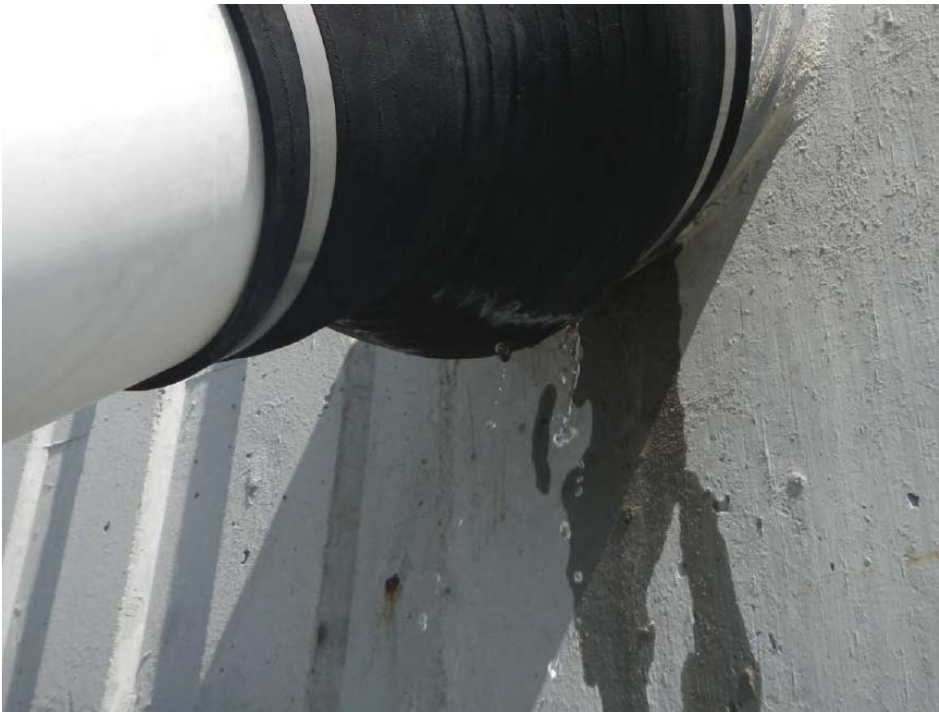
The 2013 consultant inspection report noted the presence of water in the neoprene boots at the tower anchorages at 14 locations (Figure 103). A recent 2015 consultant inspection found that the number of boots with water had increased to 29 (18). SCS personnel have observed a similar problem on a cable-stayed bridge in another state (19). It is likely due to either leakage where the boot laps the guide pipe or to porosity in the boot material. The large gaps in some HDPE piping at the tower anchorages lead to water vapor entering the upper portions of anchorages inside the connection sleeves and condensing. The SCS report noted that some deck anchorage anchor heads had open holes that, according to the plans, should have been stopped by rubber plugs. They may also be missing from the tower anchor heads. Moisture from condensation could cause corrosion at the anchor heads.

Figure 102. Re-welding HDPE Plug Cut from a Connection Sleeve at a Void Access Hole.

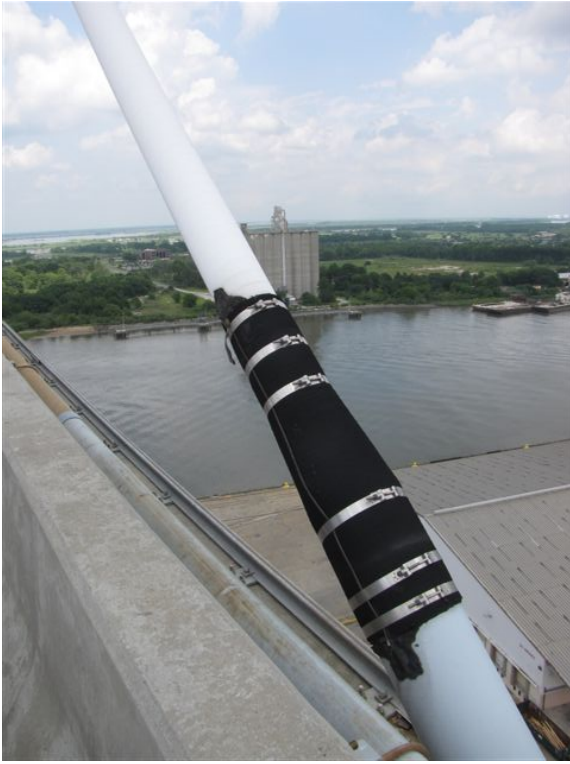
Figure 105. Commercial Cable Wrap Used as a Spot Repair on Stay Cable B22D (Arrow).

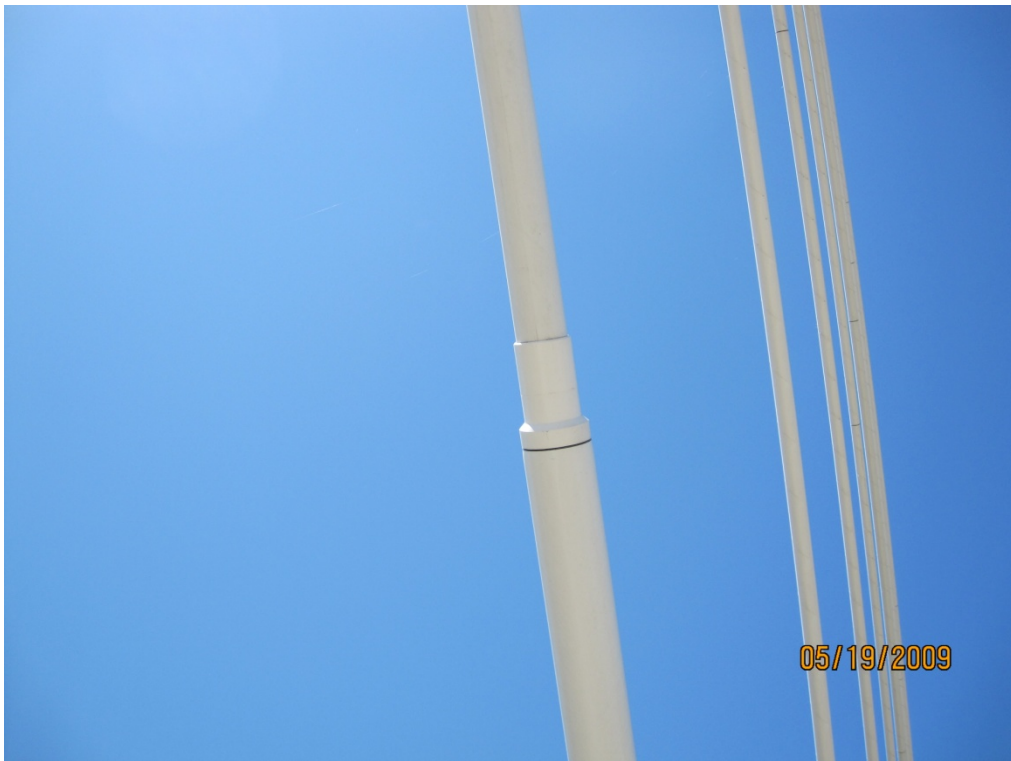
Condition Category 0:- No Cracking (Applies to Both Connection Sleeve Couplers and Reducers).

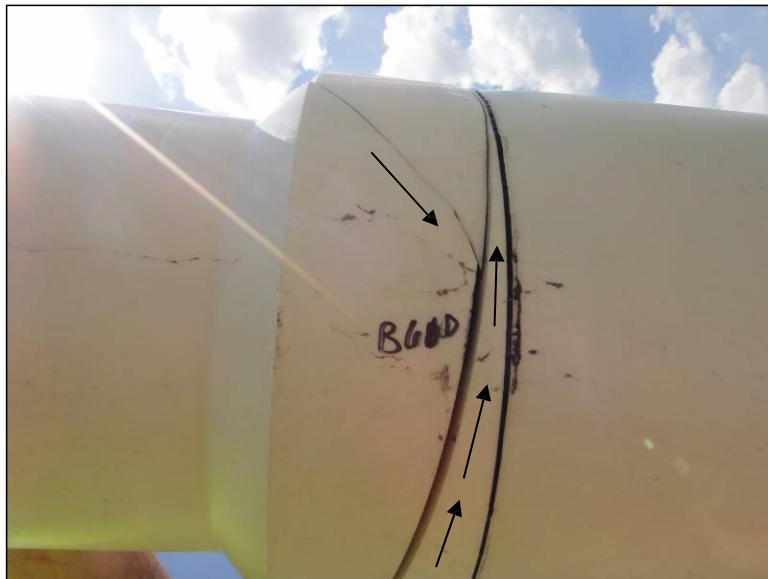
Figure 8: B6D: Reducer Crack at Notch Located at Diameter Transition

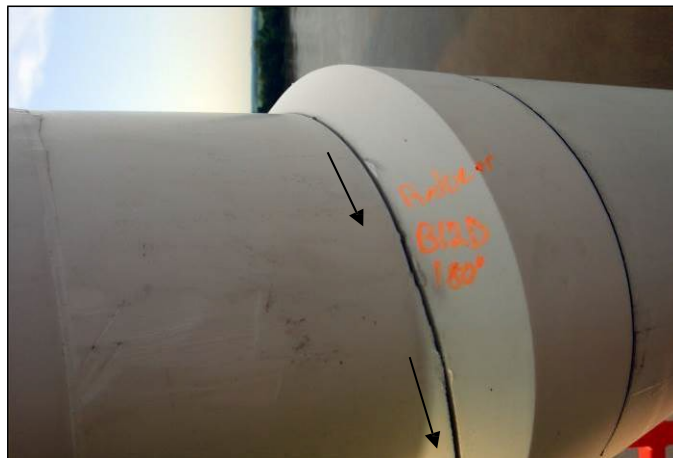
Figure 13: B11D: Reducer Crack at Coupler Hole Used For Electro-Fusion Weld

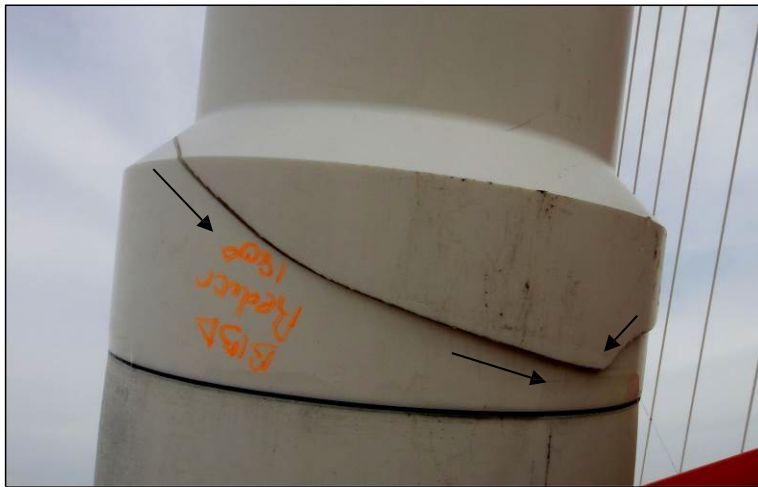
Figure 14: B12D: Reducer Crack at Notch Located at Diameter Transition

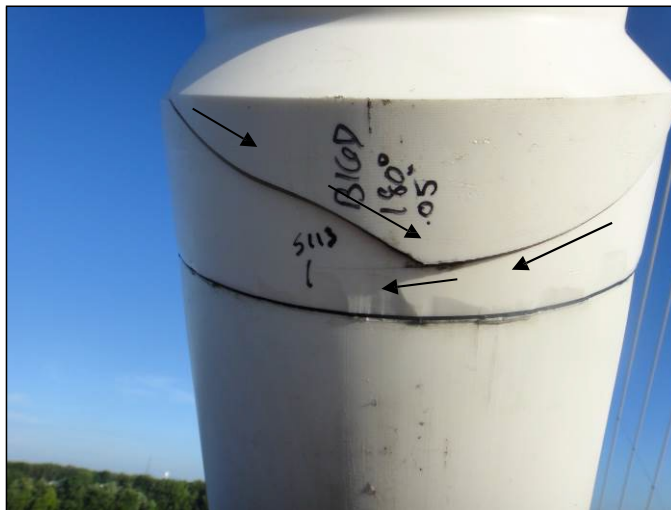
Figure 17: B15D: Reducer Crack at Notch Located at Diameter Transition

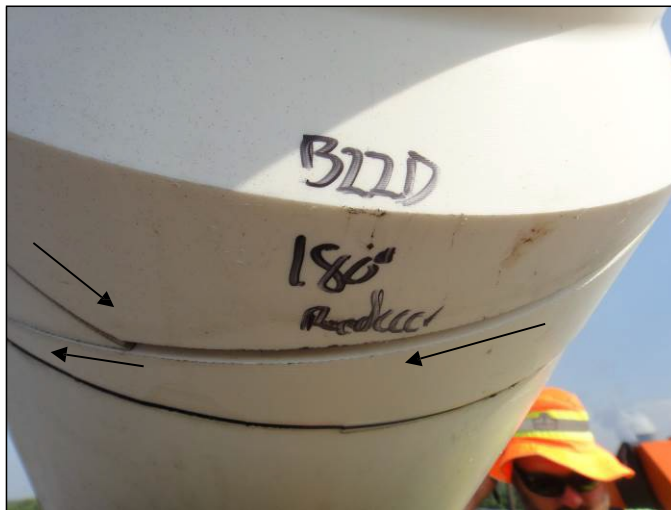
Figure 24: B22D: Reducer Crack at Notch Located at Diameter Transition
