Re: Concrete Pavement without Transverse Joints,  
U. S. 31-W, Franklin-Tennessee State Line Road

Report No. 2

A CONCRETE PAVEMENT WITHOUT  
TRANSVERSE JOINTS

W. B. Drake  
Research Engineer

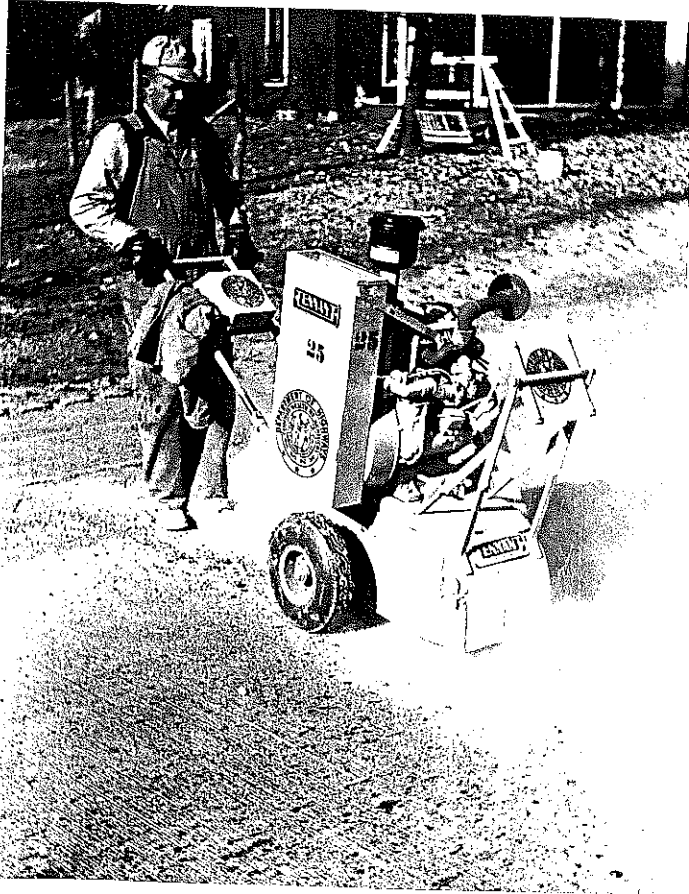
Fig. 7. A photograph of the cutting machine in operation. The mirror mounted on the front of the equipment allows the operator to see the crack and the painter just above the cutting wheel. The flexibility of the bits on the cutting wheel allowed the machine to cut a fairly irregular crack without excessive spalling.

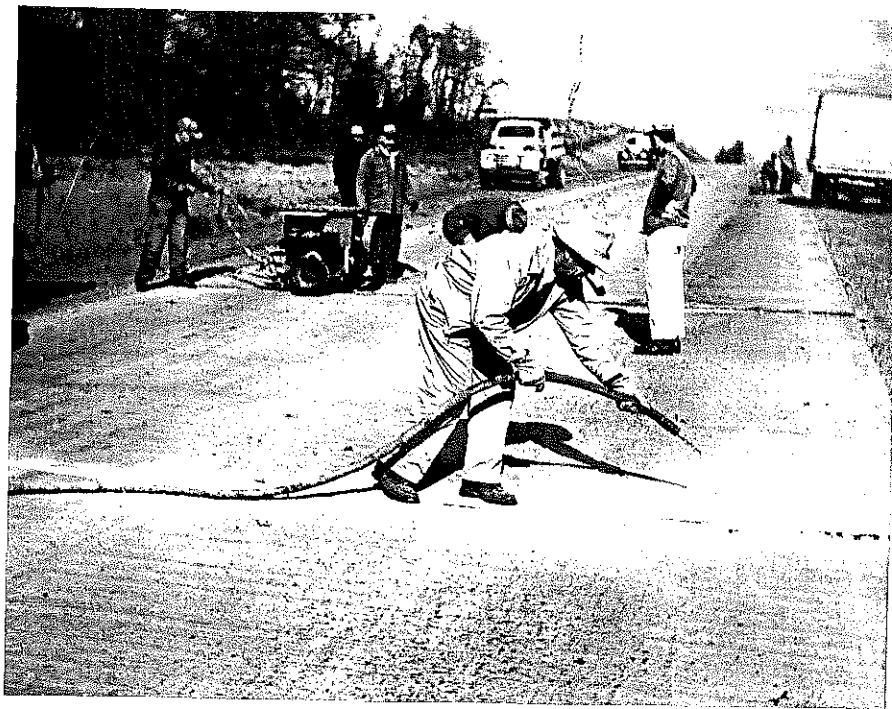
Upon completion of the cutting, each crack was blown out with compressed air. Fig. 9 is a photo of this phase of the job. Cleaning with an air jet along<sup>e</sup> did not conform with the procedure used on other maintenance projects where a power driven wire brush was used to remove most of the coarser matter. The crack was then washed out with water to remove the dust film and allow the filler to bond with the newly cut concrete.

Fig. 9. This illustrates process of blowing out the foreign material with compressed air. In the background is the special mixing and extruding machine for filling cracks.

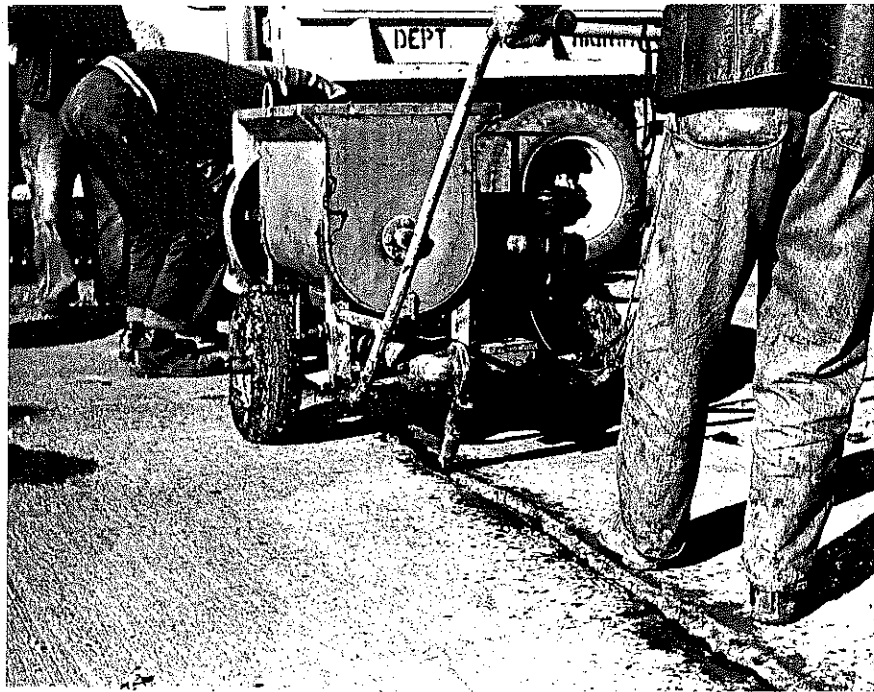
The clutch was then engaged for extrusion of the filler into the cracks. This process is shown in Fig. 11. The rate of extrusion was controlled by a hand throttle on the machine, but the amount of filler in each crack was governed mainly by the rate of movement of the machine across the pavement.

Fig. 11. Rear view of the mixing and extruding machine, showing the relation between nozzle, pavement surface, and crack. An average of 2 to 3 minutes was required for filling a crack. The machine was operated by a  $3/4$  horse power gasoline engine but was not self propelled.

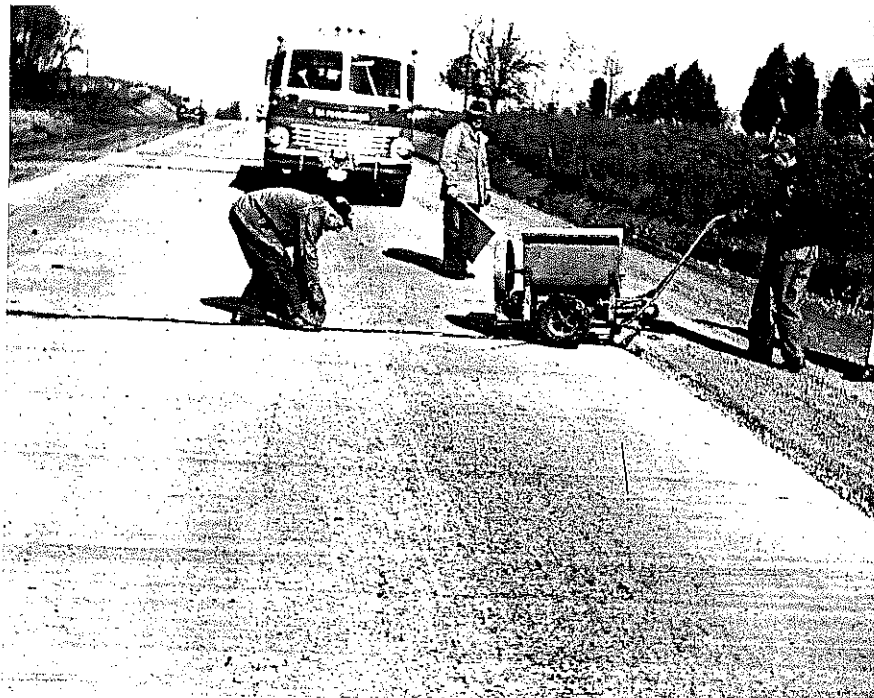
As rapidly as a crack was filled it was covered with a strip of wrapping paper in order to prevent tracking of the filler by traffic. This operation is shown in Fig. 13.

Fig. 13. The operation of covering the freshly filled crack with a strip of wrapping paper. This prevented the traffic from tracking out the filler which was very sticky at this time.
