**Research Report**  
**KTC-03-14/SPR193-98-1F**

**ASSESSMENT AND MODELING OF  
STREAM MITIGATION PROCEDURES**

May 2003

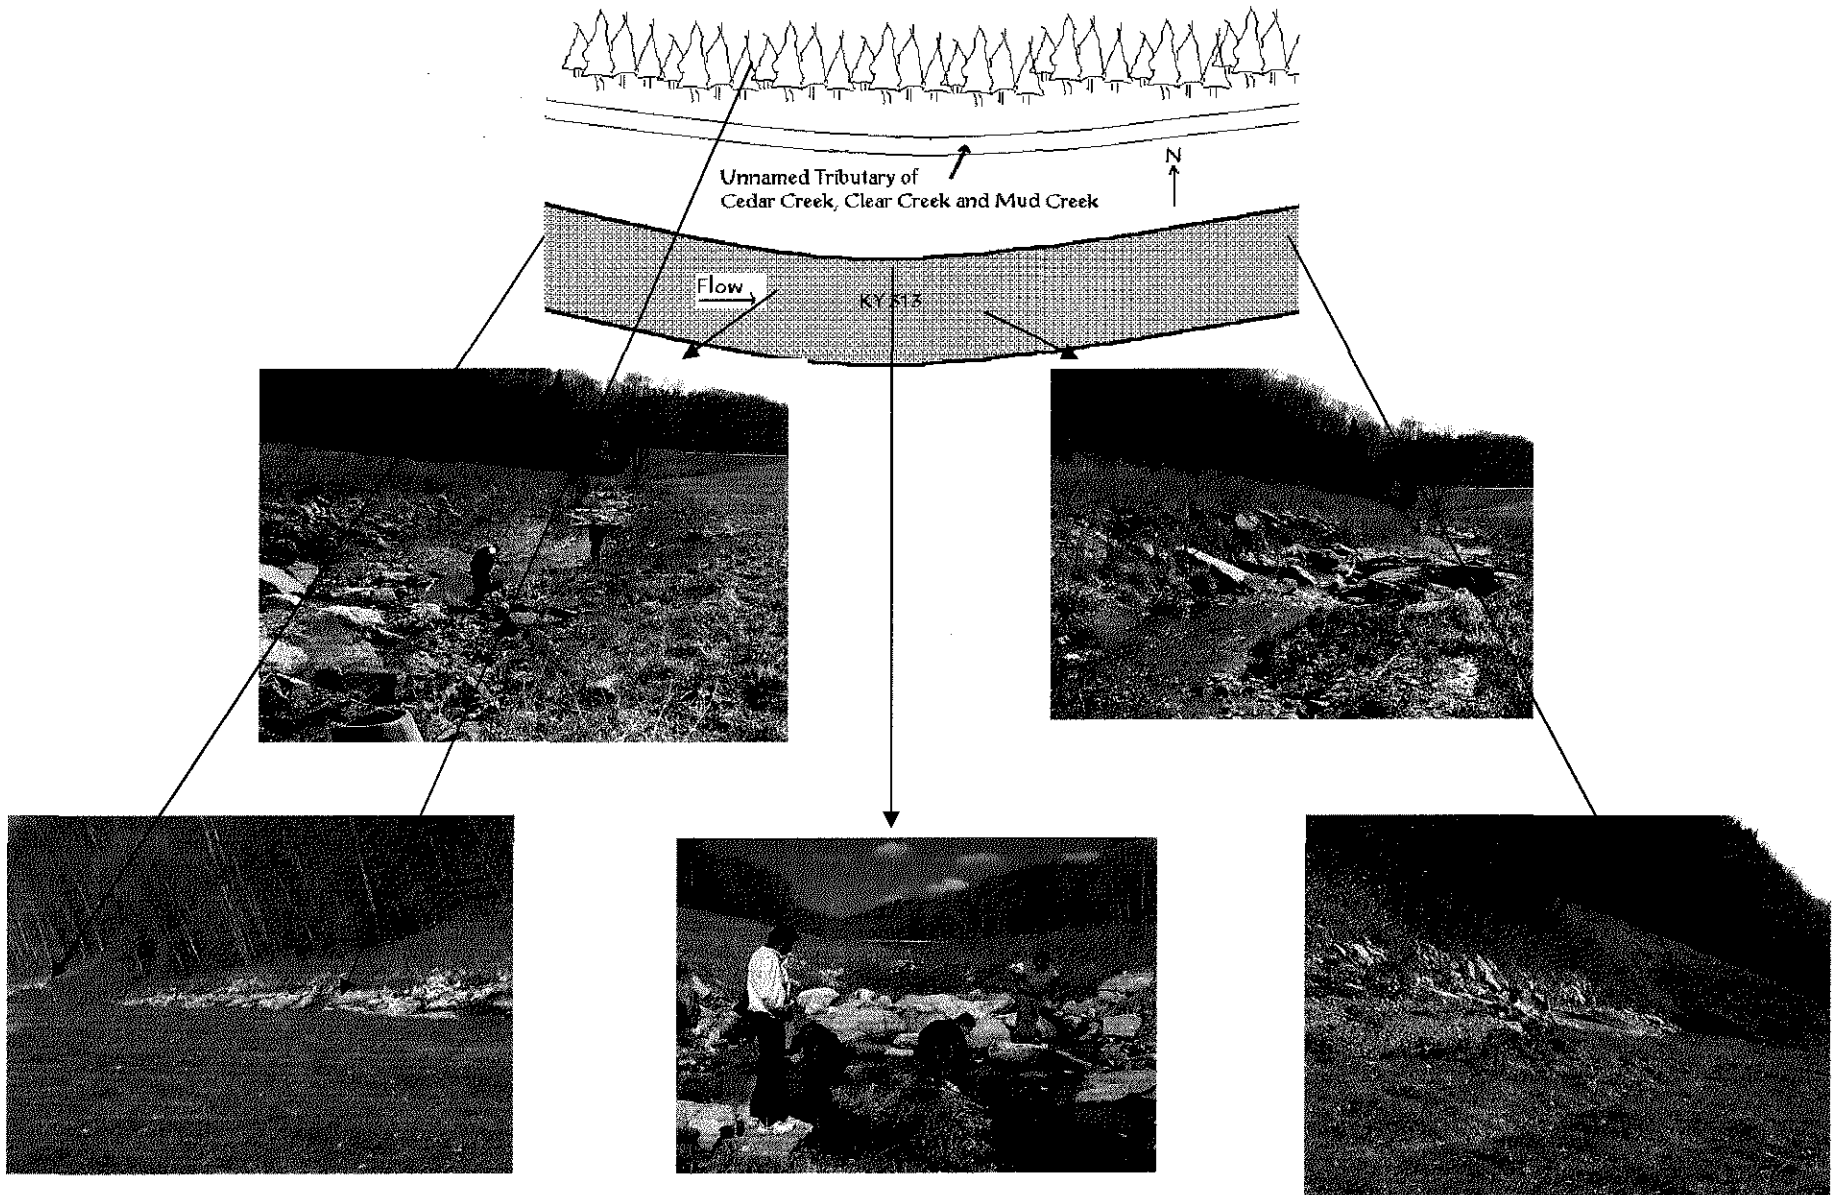
Figure 15 Conceptual drawing and photographs of: KY 313, Cedar Creek1, Hardin County.

This mitigation project was very basic and included two pipes, two box culverts, and approximately 10,000 feet of channel change varying in width from two to twelve feet. The channel runs from Station 535+11 to Station 763+00 and is generally parallel to, and north of, KY 313. Stone riffles and energy dissipaters were constructed as part of the mitigation plan. The channel flows at a depth of about 6 inches at its deepest spot during the spring and is probably an intermittent stream (Figure 15).

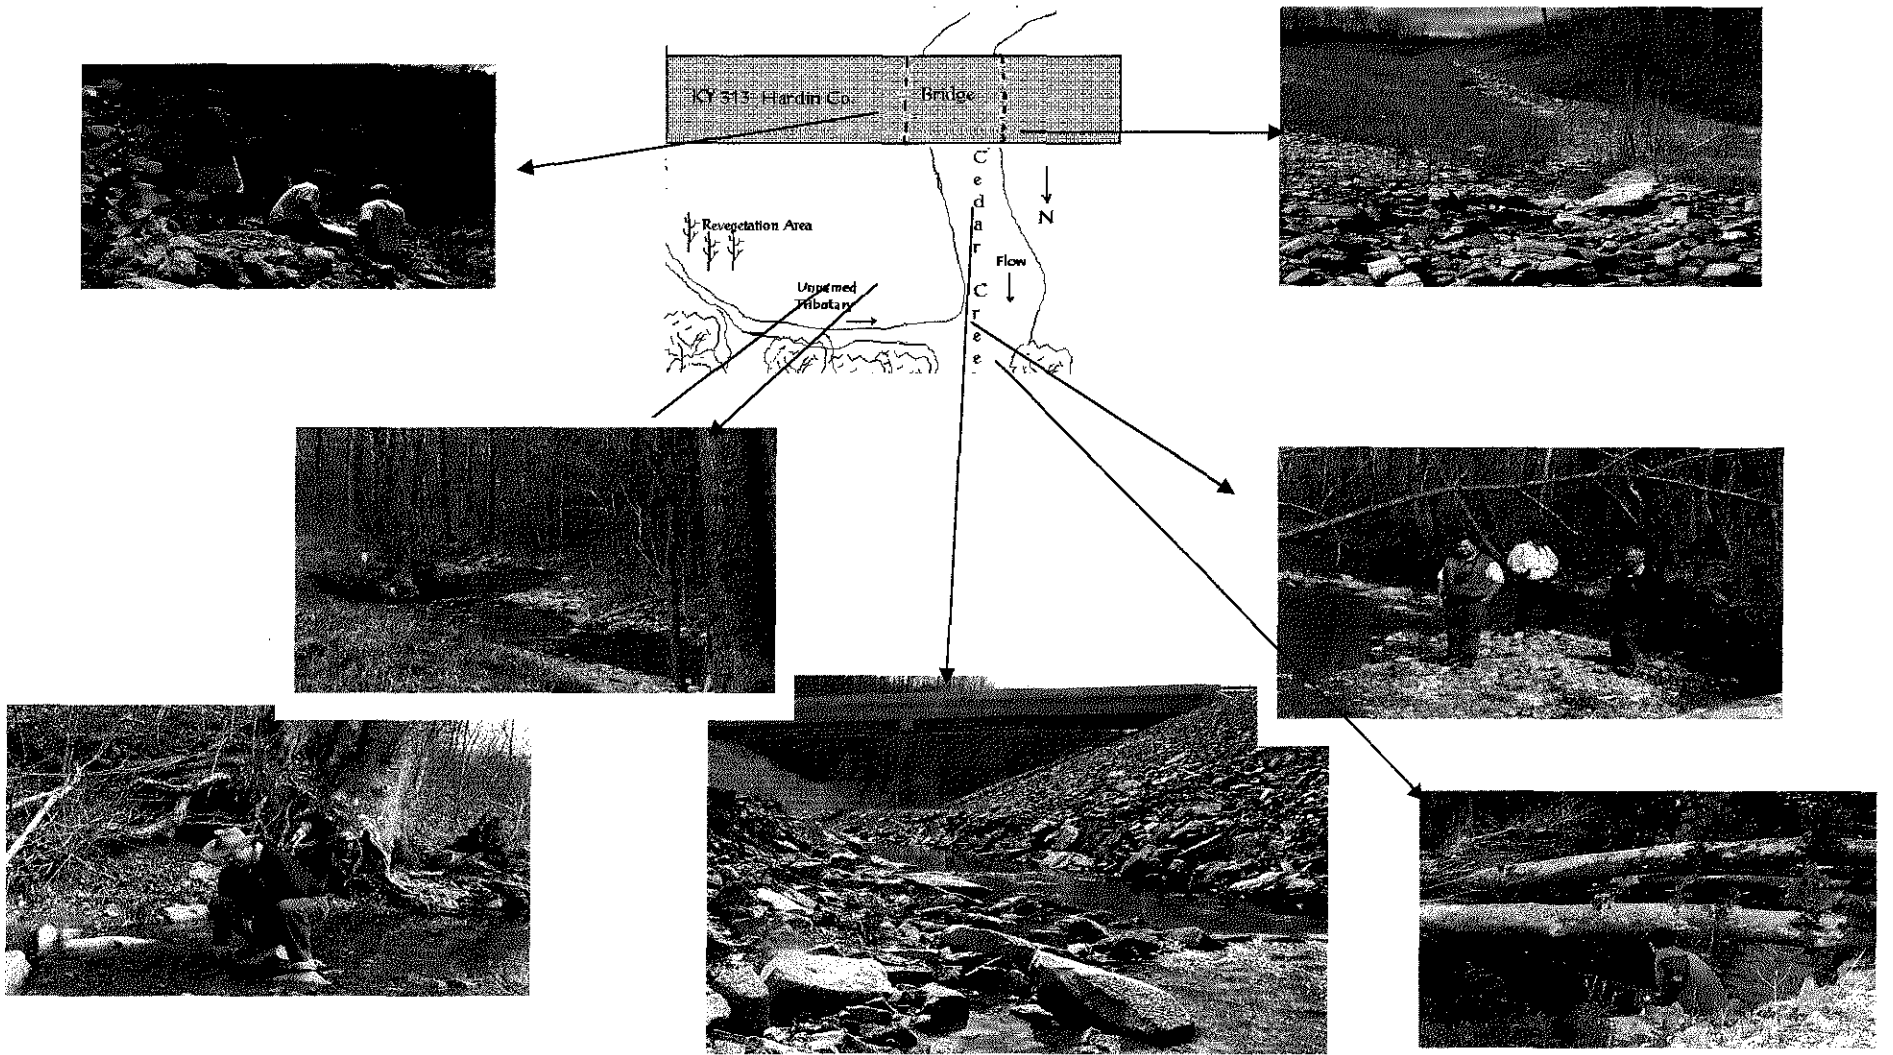
Figure 18 Conceptual drawing and photographs of KY 313, Cedar Creek2, Hardin County.

Although the remediated stream sector scored lowest for habitat quality due to less vegetative protection and less developed riparian zones( Table 2, Appendix B), the IBI scores reveals no significant difference with respect to fish metrics and the scores ranges from 50 to 54 (Table 2, Appendix B).

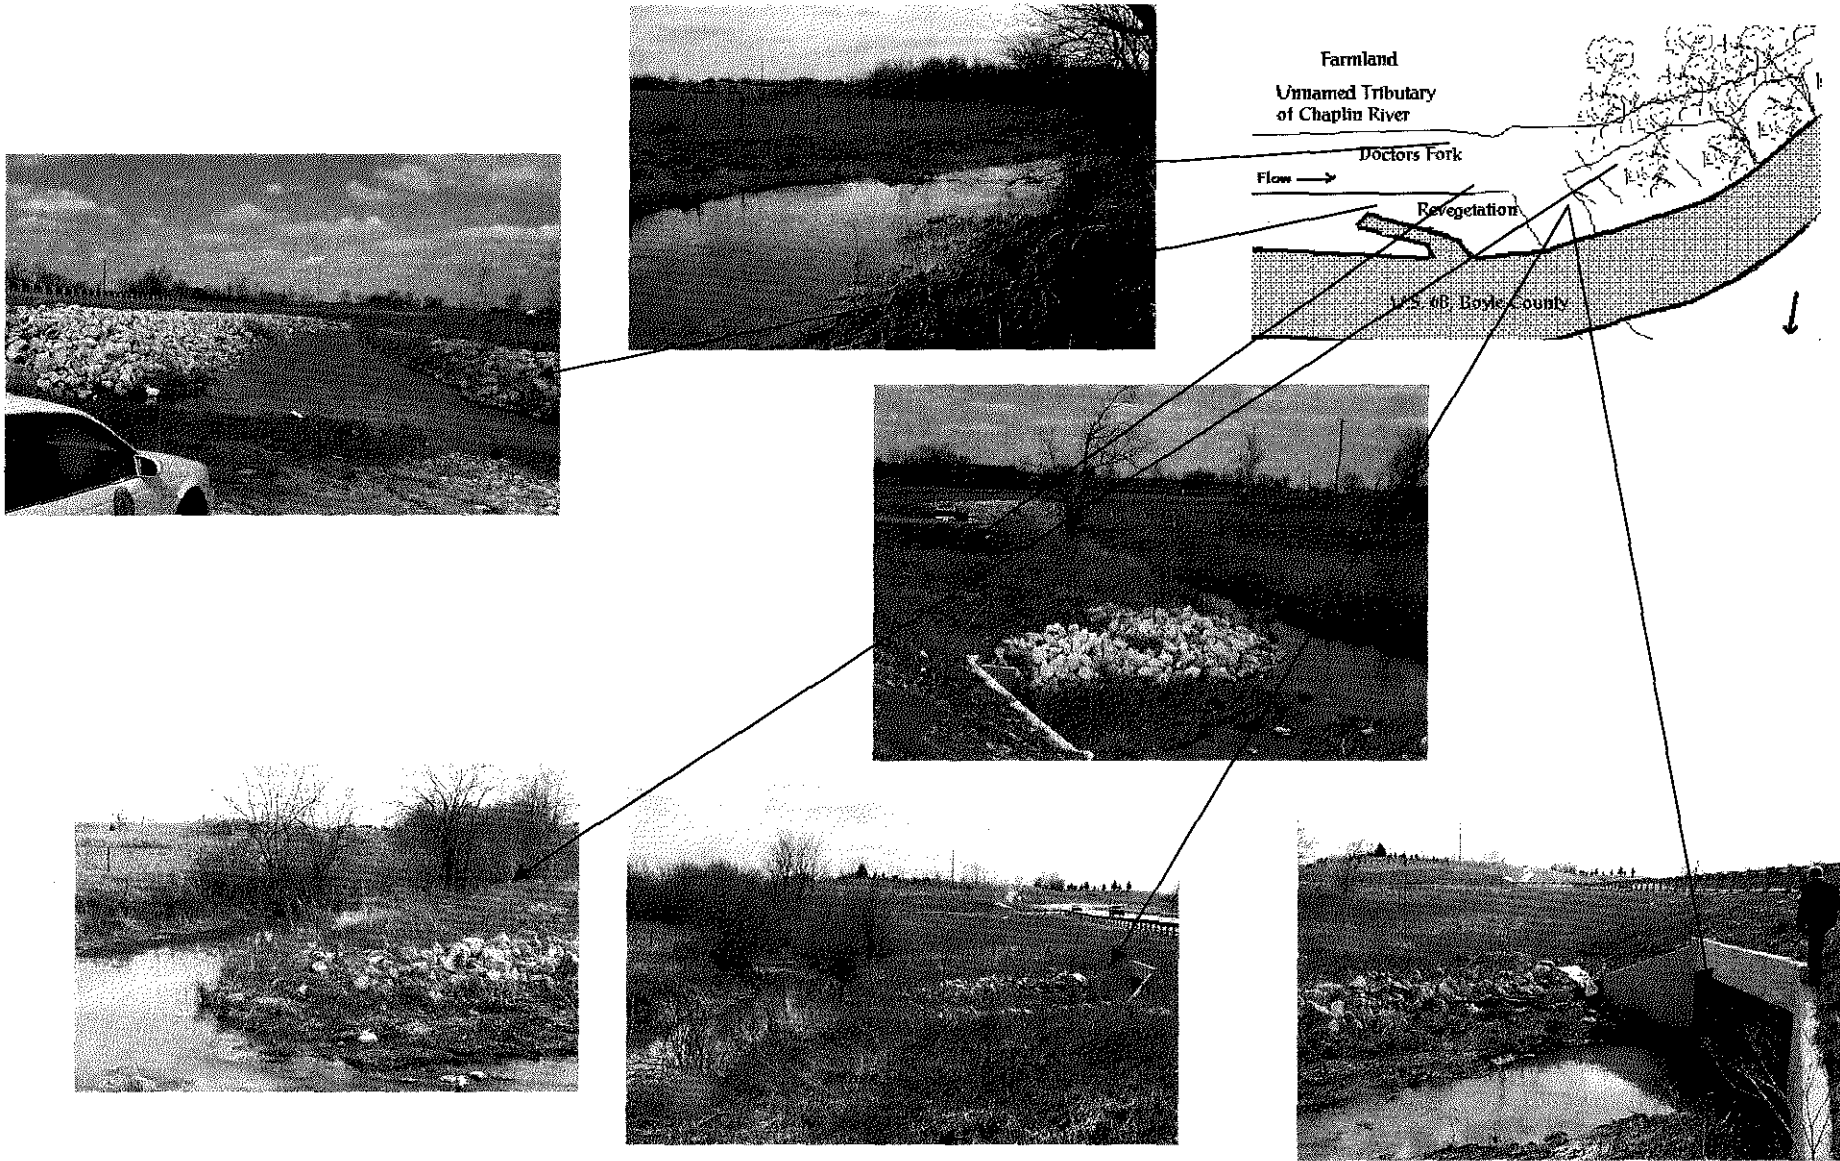
Figure 21 Conceptual drawing and photographs of US 68, Doctors Fork, Boyle County.

This project required channel modification of Doctors Fork and unnamed tributaries to Doctors Fork for the realignment of US 68 approximately two miles west of Perryville in Boyle County (Figure 21). The mitigation plan includes four box culverts and approximately 1,000 feet of channel change from Station 23+00 to 231+00. A

significant part of the mitigation is 350 feet of 30-foot wide channel change south of relocated US 68 beginning at Station 190+50 (Figure 22). The project is bordered by farmland on the southeast side. Runoff from the farmland is deposited in the stream.

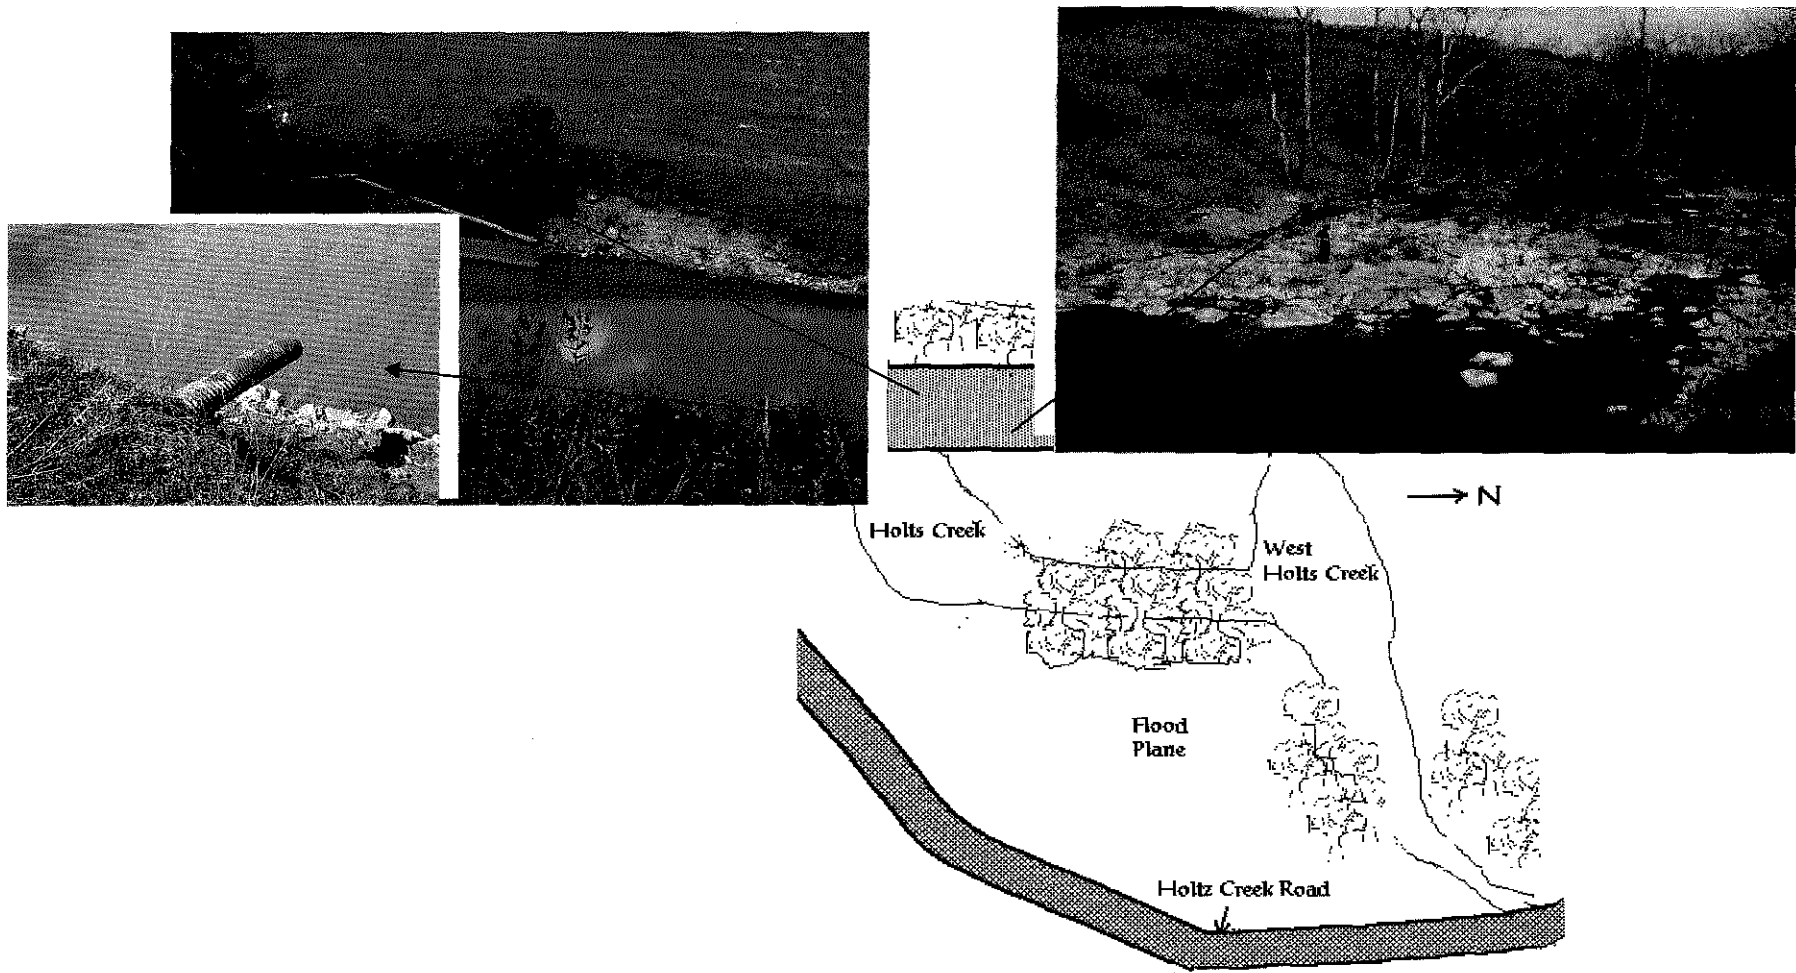
Figure 26 Conceptual drawing and photographs of AA, Holts Creek, Bracken County.

Two streams, West Holt's Creek and Holt's Creek combine to form a single stream that goes underground where the riprap and gravel have been deposited, about 350 feet from the confluence of the two creeks (Figure 26 & 27). After the two streams connect they become significantly more shallow.

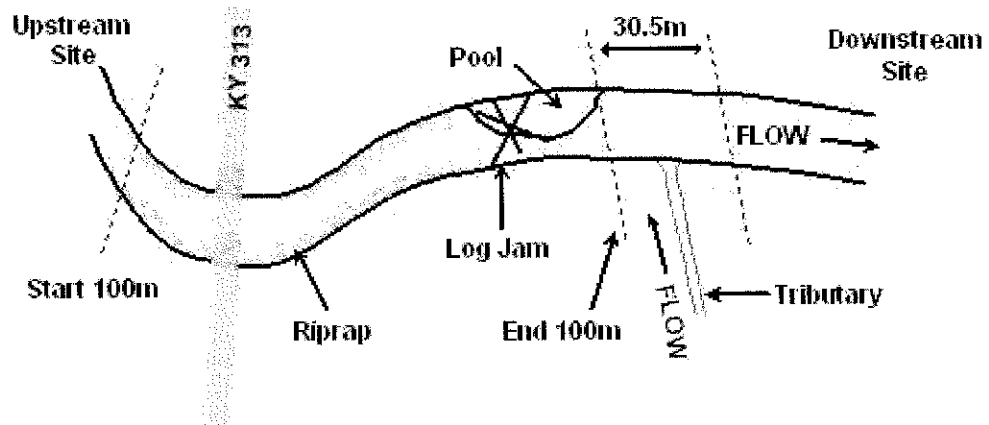
Figure 6. Remediated Sited in Cedar Creek, Hardin County, KY.

Habitat assessment scores for Cedar Creek are presented in Table 2. A decrease in total IBI habitat score was observed at the remediated site, followed by recovery at the downstream site. The remediated station at Cedar Creek had a lower assessment value primarily due to reduced vegetative protection along both banks (Metrics 9a, 9b) and poor riparian vegetative zones. The presence of riprap along the banks (Figure 6) also reduced the score for channel alteration (Metrics 10a, 10b).

- The most apparent deficiencies in habitat restoration involved protective and riparian vegetation (e.g. Figure 6). This resulted in diminished bank stability (e.g. Figures 11-14) and increased prospects for bank erosion and downstream siltation.
