**Research Report
KTC-03-20/SPR107-01-1I**

THE USE AND PERFORMANCE OF GEOGRIDS IN KENTUCKY

August 2003

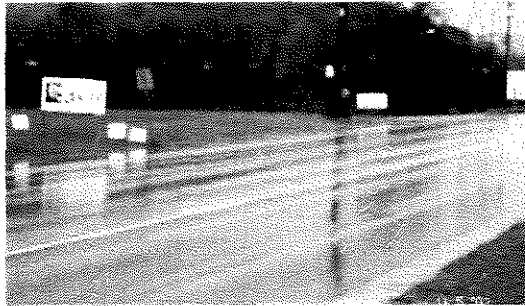
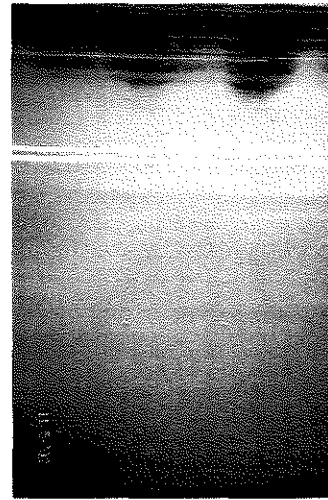
2. Description of Site – This road appears to be in good condition.

4. Conclusions About Site – This section of the road, with geogrids, is in good condition.

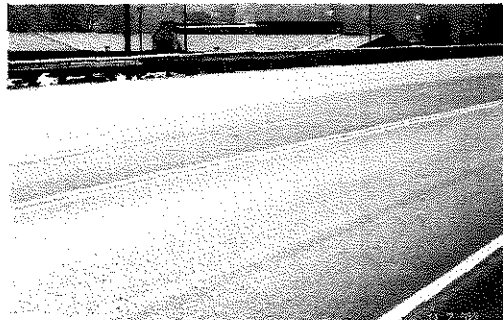
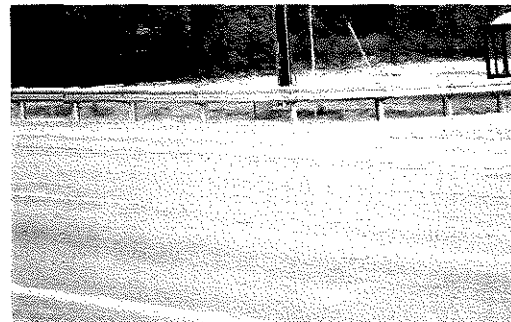
Project 11: US 60, Morehead, Rowan County, Kentucky

2. Description of Site – This section of the road under cut the subgrade by two feet, and then Type IV fabric was filled with two feet of #2 crushed limestone and was finally wrapped with fabric. There was also Type I fabric used under storm sewers. The trench was wrapped with fabric, the pipe was installed, and then covered with one foot of rock.

4. Conclusions About Site – This section of road, used with geogrid, is in good condition.
