Truck Route Access Evaluation: Paducah-McCraken County US 60 Business Route and Locust Drive Site # 14

KTC-99-18 Paducah - McCracken County US 60 Business Route and Locust Drive Site # 14

"Freight Movement and Intermodal Access in Kentucky" SPR 98-189

January 1999

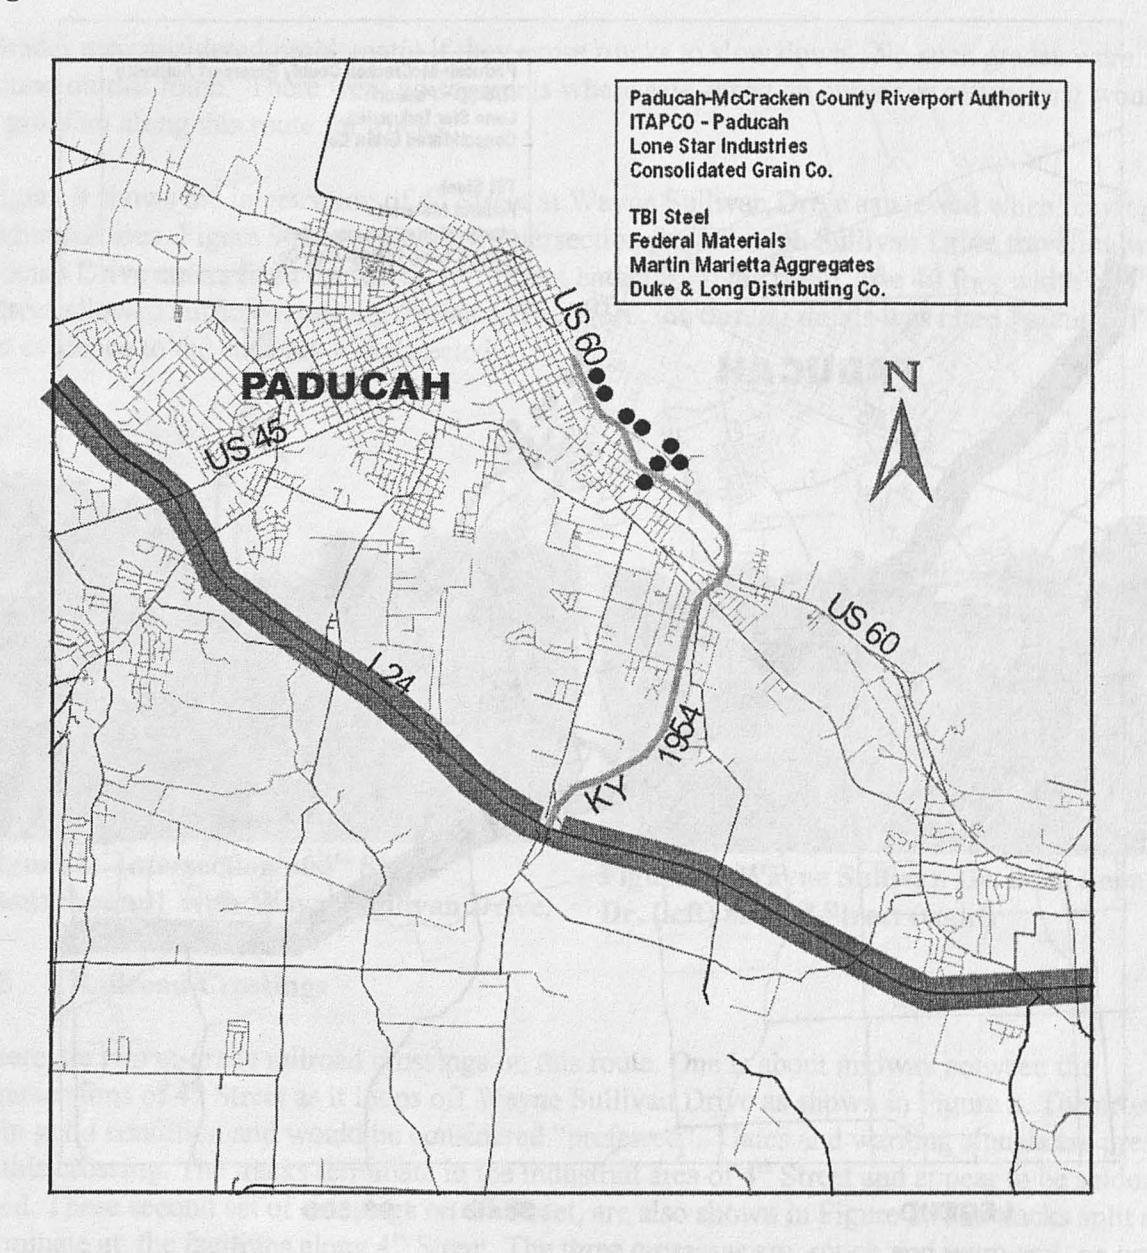
Figure 6: Lane Widths

Figures 6 and 7 illustrate the sections of the route having different widths of lanes and shoulders. KY 1954 has 12-foot lanes the entire length and connects with Wayne Sullivan Drive (US 60 Business) which also has 12 foot lanes to the site. KY 1954 has 9 foot shoulders, while Wayne Sullivan Drive has curbs.

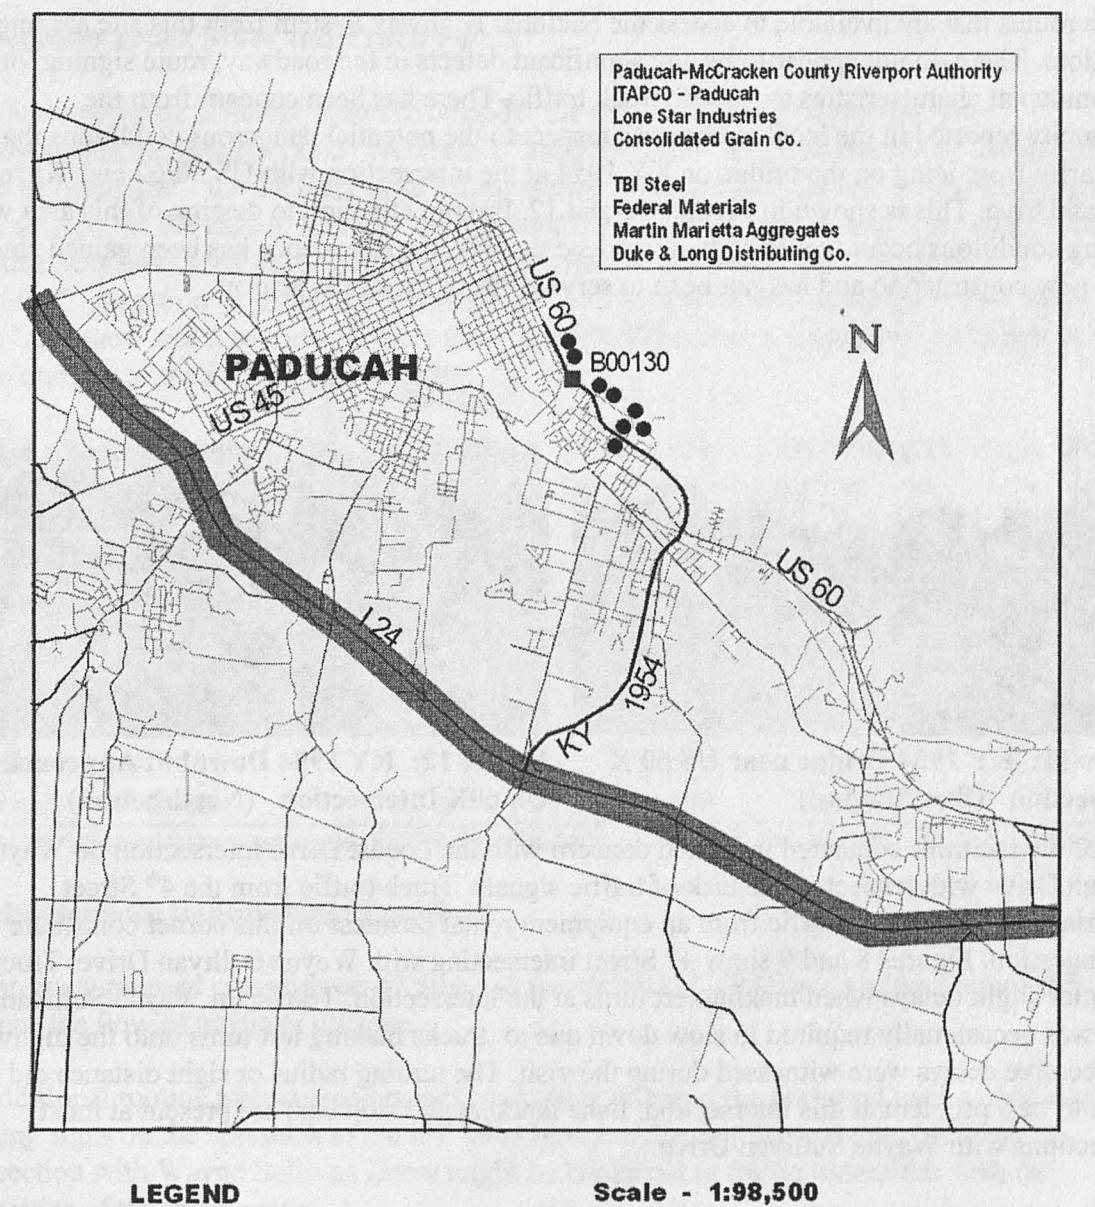
Figure 10: Bridge Locations

The location of bridges along the routes are shown in Figure 10. The bridge on KY 1954 near the intersection with US 60/62 and Wayne Sullivan Drive was opened to traffic in early 1998 and no information is yet available. It is a new bridge and can be assumed to have a "preferred" rating. The proximity of the downgrade of the bridge on KY 1954 to the intersection could present some difficulty during icing conditions. Since the bridge had not been opened to traffic during a winter season at the time of visit, no experience has been gained with regard to winter operations.
