Failure Mechanism of Woven Roving Fabric/Vinyl Ester Composites in Freeze–Thaw Saline Environment

Original Research Article

Failure Mechanism of Woven Roving Fabric/ Vinyl Ester Composites in Freeze-Thaw Saline Environment

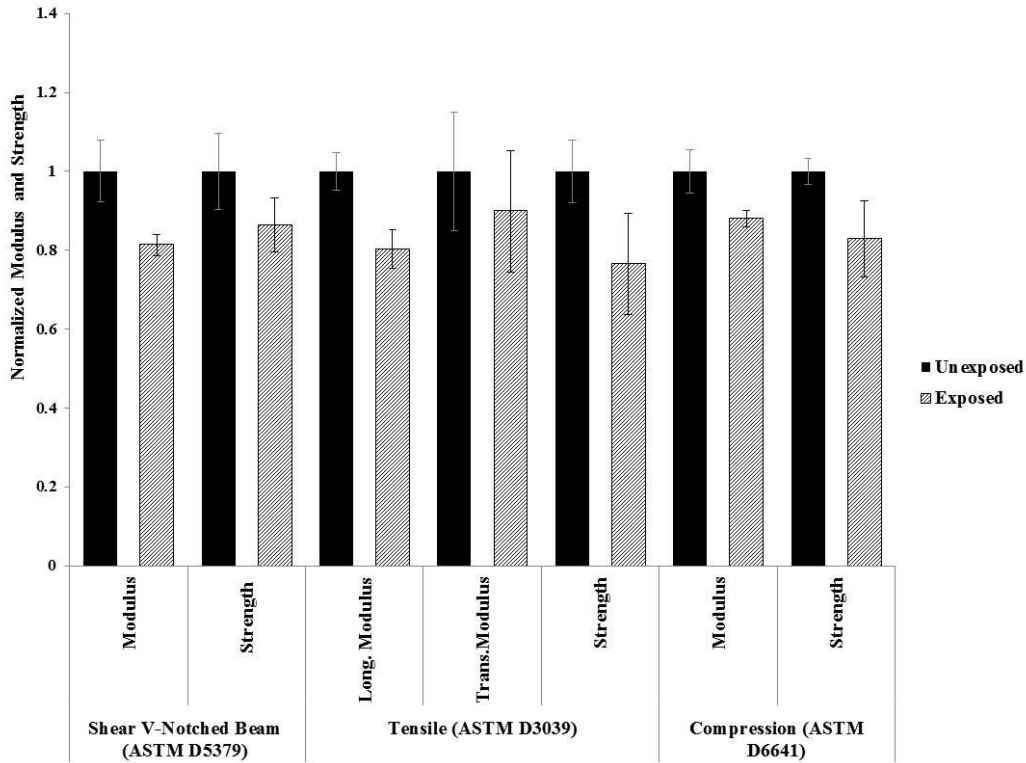
Normalized moduli and strengths for shear, tension, and compression are shown in Figure 2. Large reductions occurred in the tensile and compressive strengths of the GFRP material. The shear and tensile longitudinal moduli were also reduced after F/T exposure. In general, the compression strength in WR fabric is lower than the tensile strength; this is due to the already kinked fibers; however this is not the case after exposure (Table 3, row 6 and 8). The tensile test results are mainly dominated by the fiber properties and clearly indicate that the longitudinal fibers and the structural integrity of the WR have been endangered due to the environmental conditions. A mechanistic model, which describes the mechanism of deterioration of the exposed laminates, is described in the root cause failure analysis section.

Figure 2- Overall results of exposed (200 cycles) and unexposed (0 cycle) specimens

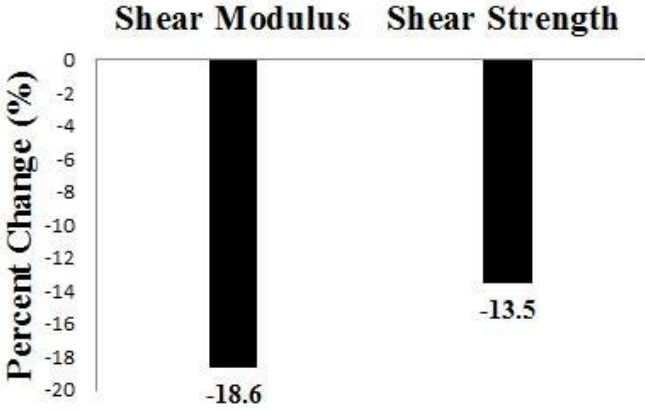
Effect of exposure on shear properties of the laminates was studied in accordance to the v-notched beam test (ASTM D5379-12) [13]. Figure 3 shows typical shear failure mode that occurred at the mid-span of the V-notched beam. The average reduction in shear modulus and strength after 100 days of exposure is 18.5% and 13.5 %, respectively (Figure 4).

Figure 4- Percent change in shear modulus and strength

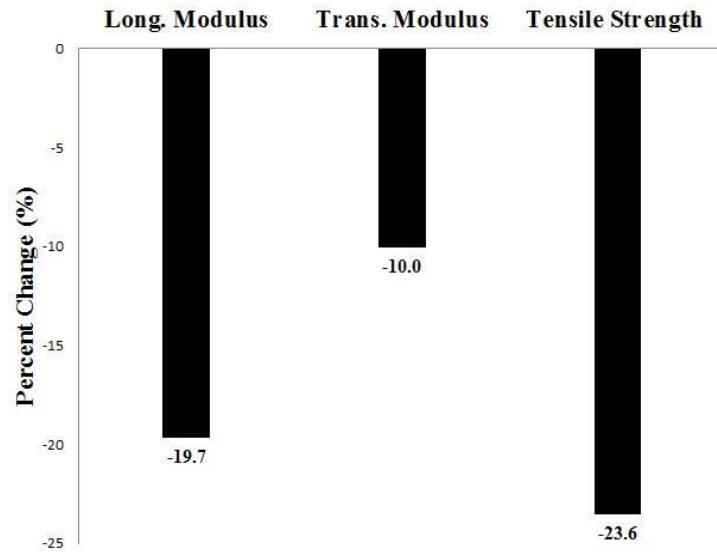
In this test a 23% reduction in the tensile strength and 19.7% in the longitudinal modulus occurred after exposure. These values are significantly higher than the COV listed in Table 3. Since the ASTM D3039 [14] test results are mainly dominated by the fibers, this presumably indicates that the fibers were damaged in the longitudinal and transverse directions of the WR construction. In general, when a delaminated composite material is subjected to tension, the residual strength is reduced by only 10 to 15 % [15]. Lateral strains (90 degree direction) were used to monitor and extract the stiffness of the laminate in the transverse direction. The transverse modulus decreased by 10 %. The failure modes are shown in Figure 7. It is interesting to note that Guzman and Brøndsted [12] reported similar reductions in transvers tensile modulus and strength (single glass fiber) after 8 years in salt water environment.

Figure 6– Percent change in tensile modulus and strength

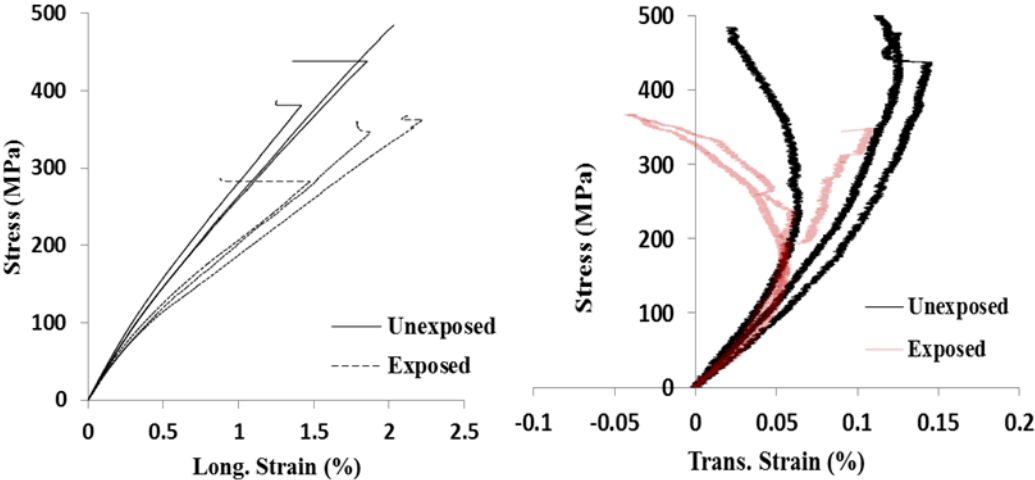
Figure 8 shows the tensile stress-strain curves in the longitudinal and transverse directions. For the exposed samples, the transverse strains are more pronounced than the unexposed samples. These highly deviated curves designate some sort of stiffness degradation due to loss in the structural integrity of the laminate, especially at the weave junctions (nodes) between the 0 and 90 degree fibers of the WR construction. This could be a direct result of a weakened matrix that binds the warp fiber to the fill fiber. More in-depth validation of this key failure mechanism is explained in the non-destructive testing section.

Figure 8- Longitudinal and transverse Stress-Strain curves for exposed and unexposed specimens

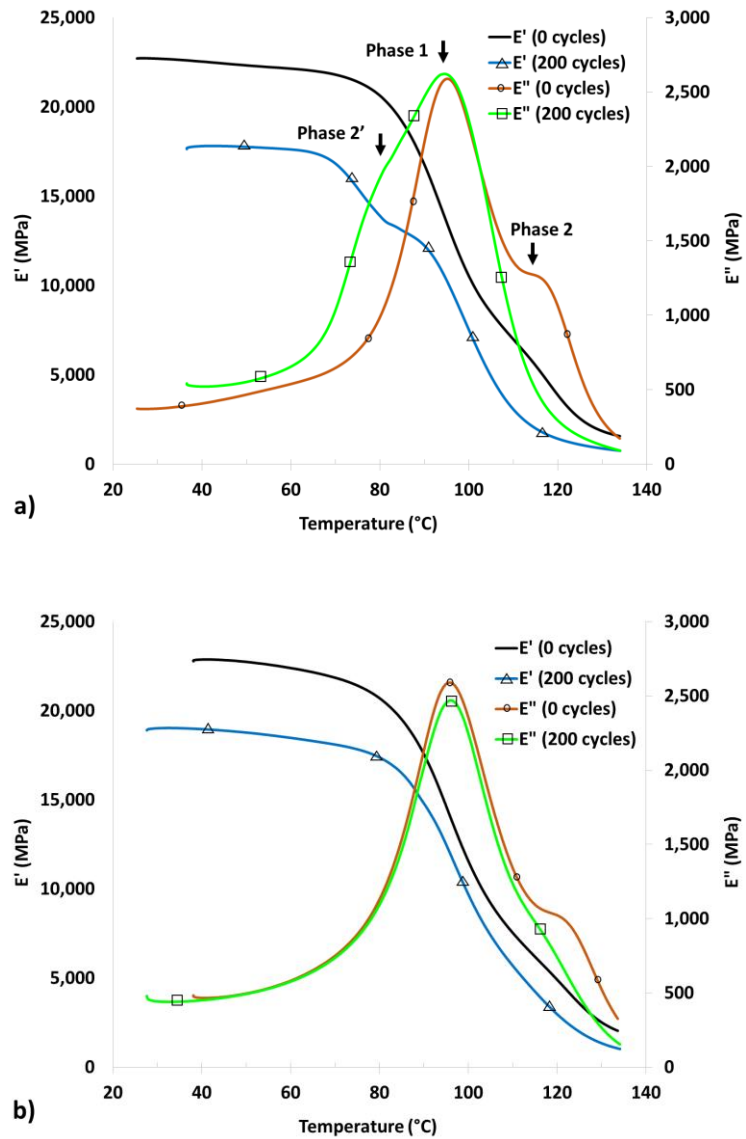
Referring to Figure 10a, the sample subjected to 200 freeze-thaw cycles exhibited a 20% decrease in E' near room temperature. This could be due to a variety of reasons, such as plasticization of the matrix, chemical decomposition of the matrix, physical degradation of the fiber-matrix interface, etc. Chemical decomposition of the matrix could be explained by hydrolysis of the ester linkage in the vinyl ester matrix, although hydrolysis reactions usually slow at the temperatures encountered. Therefore, the change may be due to physical degradation of the resin and/or fiber-matrix interface from the freeze-thaw exposure.

interesting that the 200-cycle sample does not exhibit the phase 2 transition in the same location. Most likely, the phase 2 transition was reduced to about 75°C (labeled as phase 2', which is the shoulder in the E'' curve, as well as the steep drop in E'). Absorbed water would be expected to plasticize the main network because it has some polarity (e.g. ester bonds), while water should have little or no impact on the highly nonpolar polystyrene phase. Indeed, the phase 1 peak is almost identical in both samples.

Figure 10B shows the results after post curing the samples. Any water in the matrix is expected to be removed in the 1st heating cycle. The value of E' for the 200-cycle sample remained lower (17.5%) than the control sample, which indicates that there was some nonreversible degradation caused by the freeze-thaw cycles. The E'' peak of the polystyrene phase (phase 1) was largely unaffected by the post curing process in both 0 and 200 cycle samples. In the 0 cycle sample, the E'' peak of the vinyl ester phase shifted to a slightly higher temperature (120°C), which can be attributed to residual curing from the 1st heating cycle. In the 200 cycle sample, the vinyl ester E'' peak is seen as a faint shoulder around the same temperature as the 0 cycle sample. This indicates that the vinyl ester network was no longer plasticized, but was not as prevalent as the 0 cycle sample. As with the E' result, this also indicates some difference in the network or fiber-matrix interface caused by the freeze-thaw cycle.

Figure 10: DMA results for composite, a) 1st DMA heating cycle, b) 2nd DMA heating cycle.
