# The San Francisco Earthquake and Fire April 18, 1906 and Their Effects on Structures and Structural Materials

US Department of the Interior

THE  
SAN FRANCISCO EARTHQUAKE AND FIRE  
OF  
APRIL 18, 1906  
AND THEIR EFFECTS ON STRUCTURES AND  
STRUCTURAL MATERIALS

REPORTS BY  
GROVE KARL GILBERT, RICHARD LEWIS HUMPHREY,  
JOHN STEPHEN SEWELL, AND FRANK SOULÉ

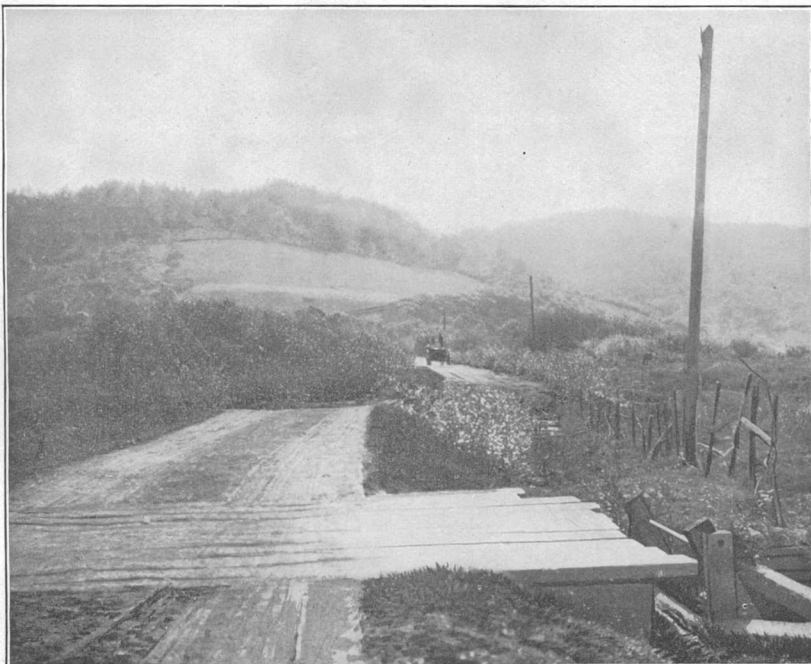
A. ROAD CROSSING FAULT TRACE NEAR POINT REYES STATION.  
Looking southwest. Offset, 20 feet. Photograph by G. K. Gilbert.

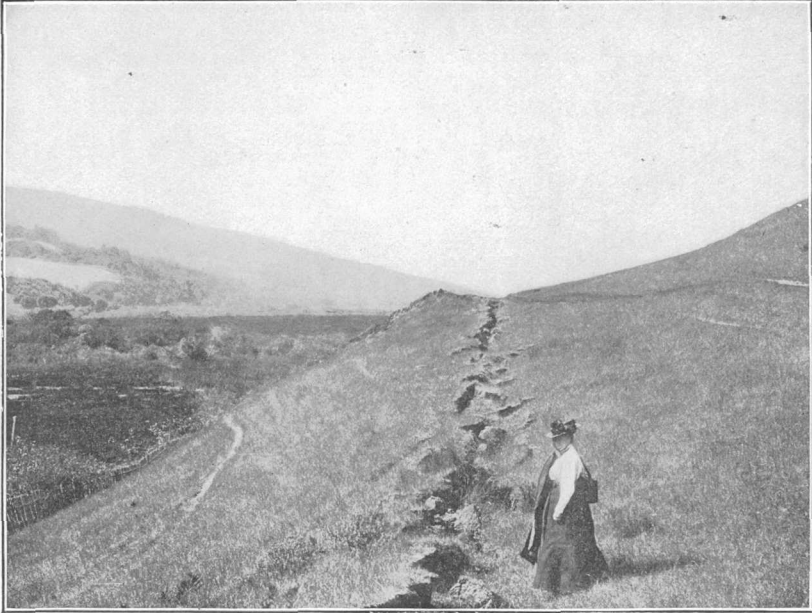
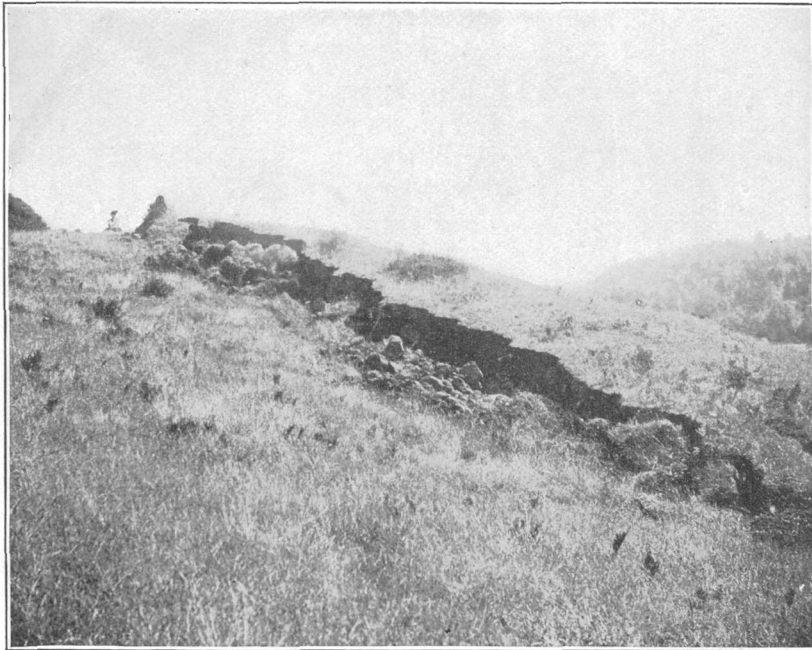
THE FAULT TRACE NEAR POINT REYES STATION.

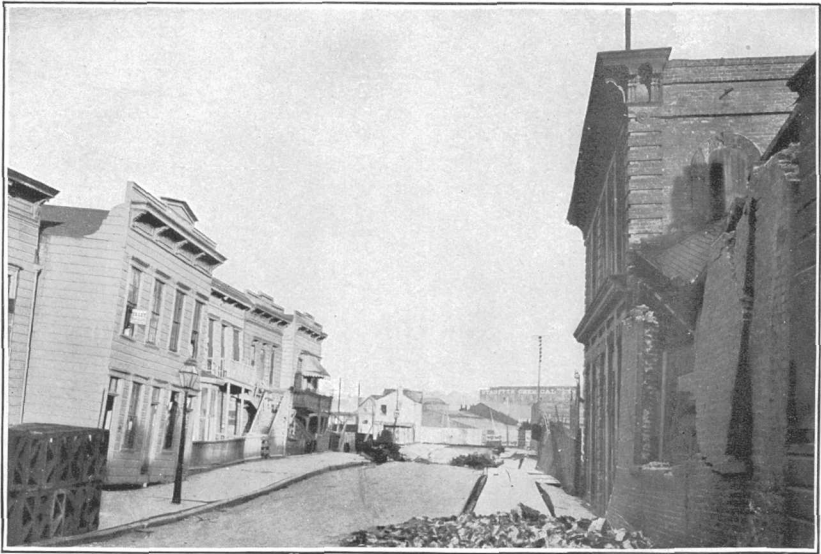
A. SETTLING (5 FEET) ON DORE STREET, BETWEEN BRYANT AND BRANNAN STREETS, SAN FRANCISCO.

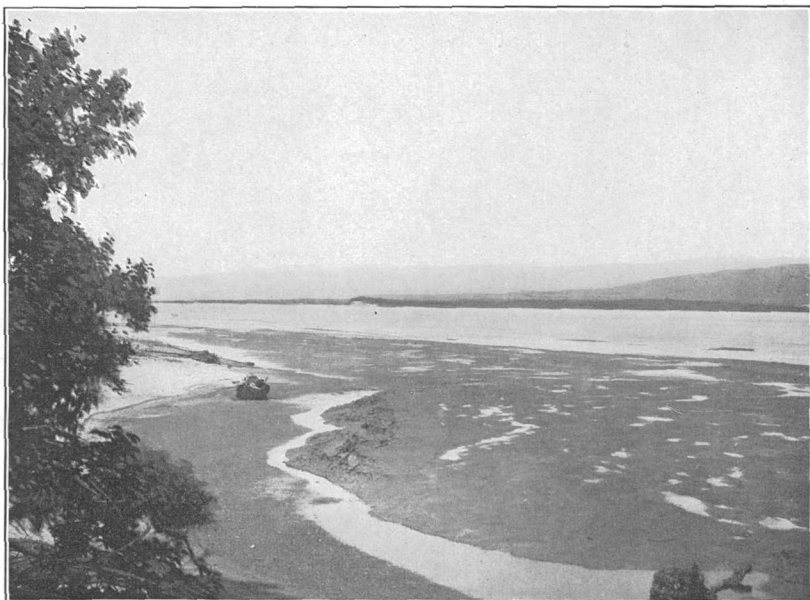
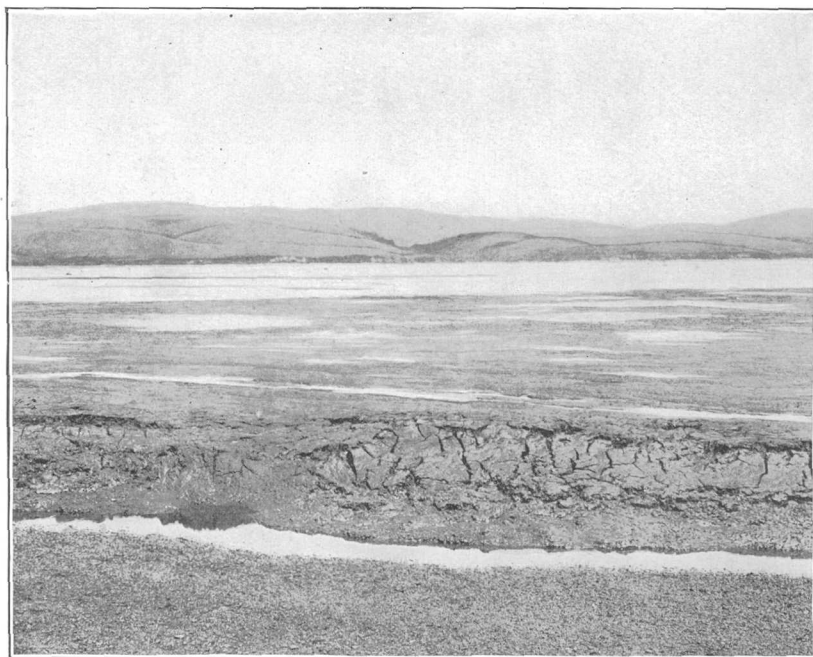
SHIFTED BOTTOM OF TOMALES BAY.

A, General view; B, Edge of new shoal. Photographs by G. K. Gilbert.

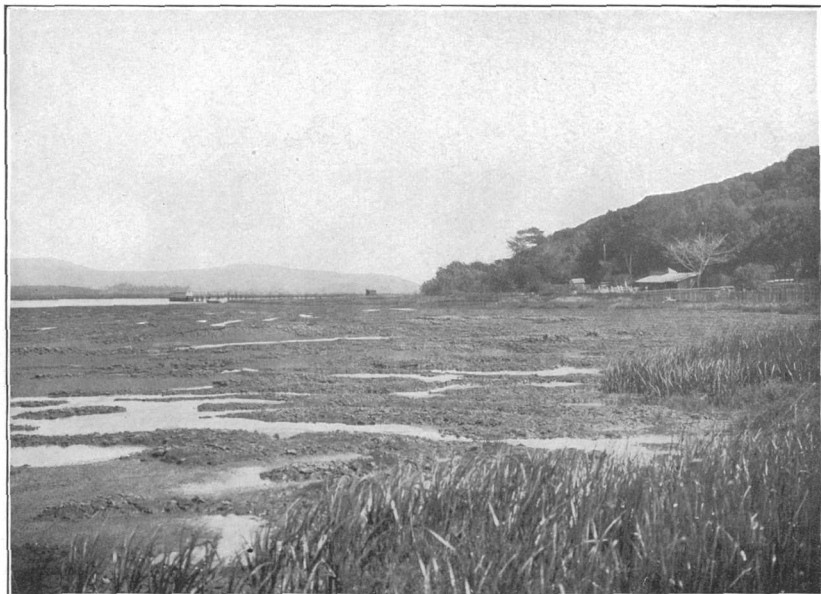
A. EARTHQUAKE RIDGES ON TIDAL FLAT, TOMALES BAY.

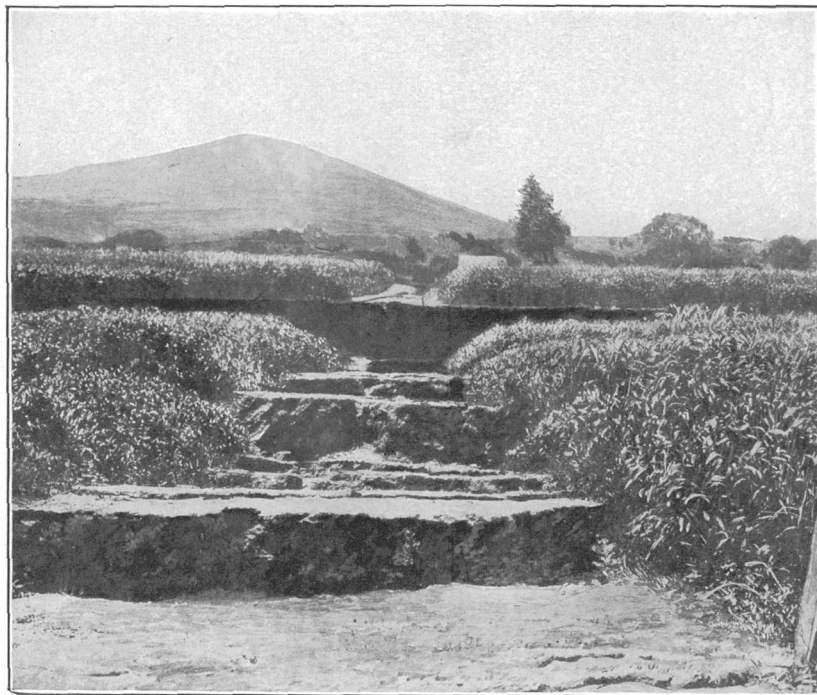
B. SLIPPING OF ALLUVIAL SOIL TOWARD SALINAS RIVER.

Grain field adjoining road along river between Spreckels's sugar mill and Salinas. Photograph by A. C. Lawson.

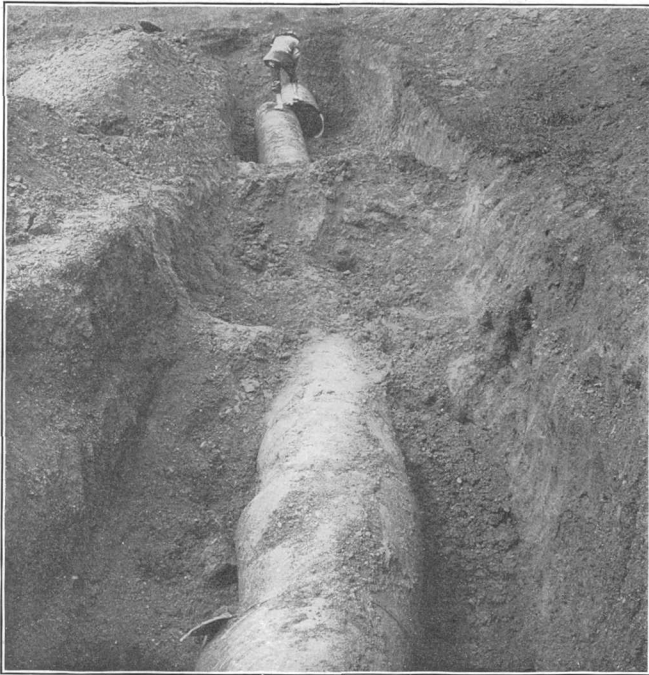
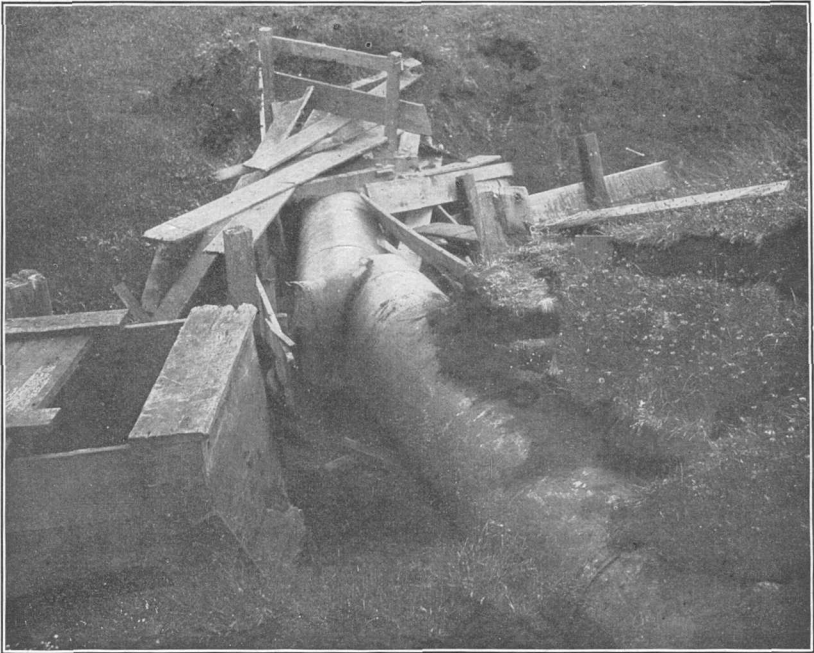
DAMAGE TO PILARCITOS 30-INCH PIPE LINE BY EARTHQUAKE.

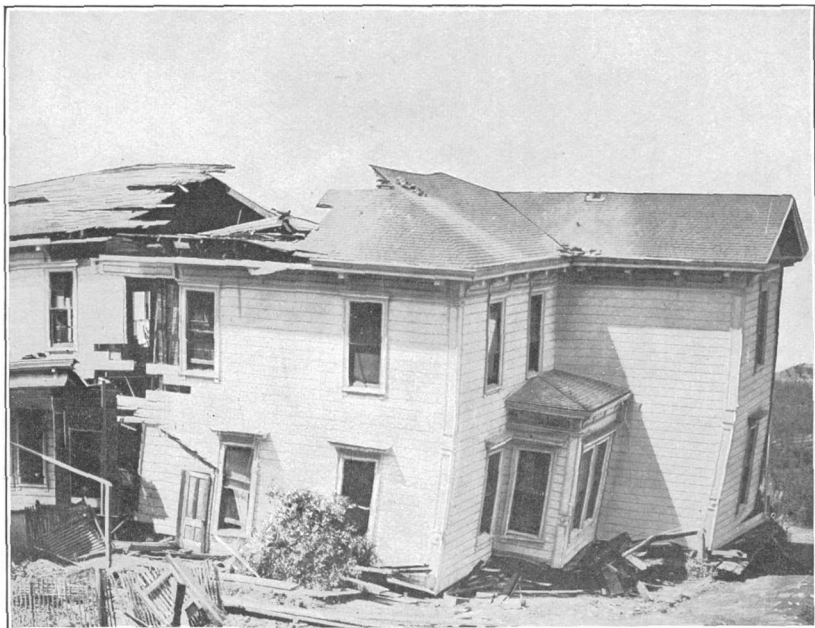
B. HOUSE ON LINE OF FAULT, TORN ASUNDER BY EARTHQUAKE.

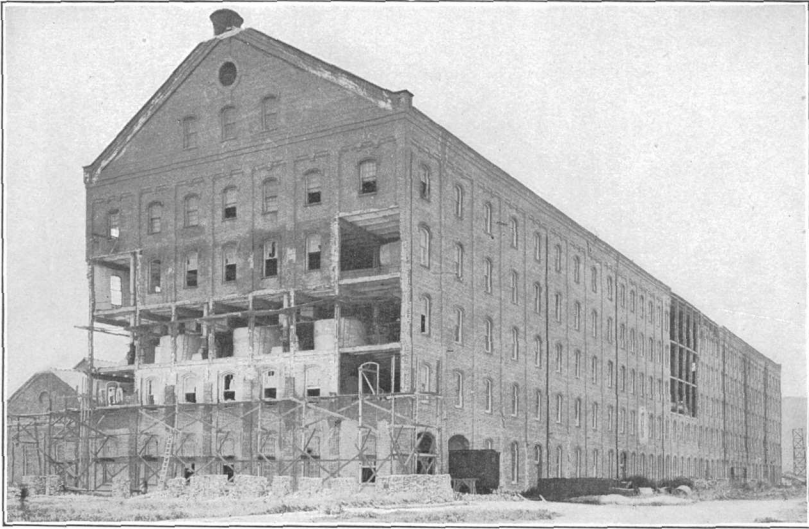
A. EFFECT OF EARTHQUAKE ON THE END AND THE INSUFFICIENTLY BRACED CENTRAL PORTION OF A BRICK BUILDING, SPRECKELS'S SUGAR MILL, ABOUT 4 MILES SOUTH OF SALINAS.

Note the stripping of brick pilasters from steel columns. Photograph by Richard L. Humphrey.

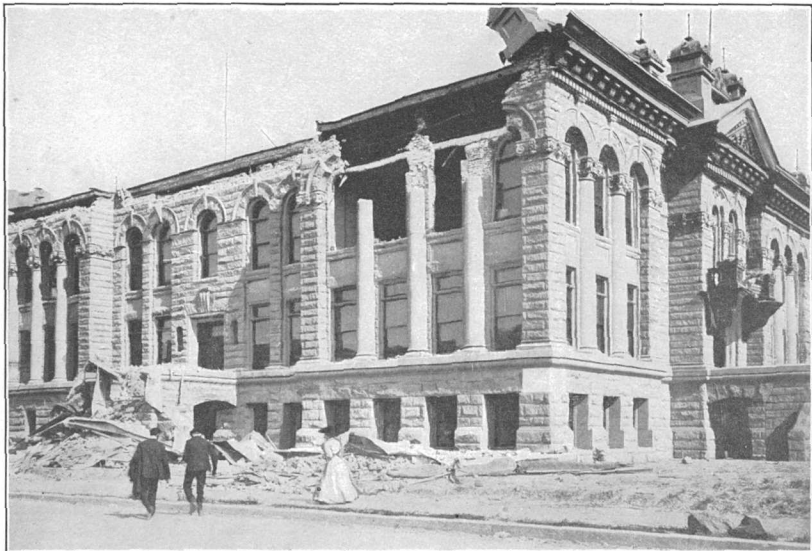
B. EARTHQUAKE WRECK OF NEW HALL OF JUSTICE, SAN JOSE, BUILT ON ALLUVIAL SOIL.

Wreck due to poor quality of stonework and unnecessarily massive construction. Photograph by Frank Soulié.

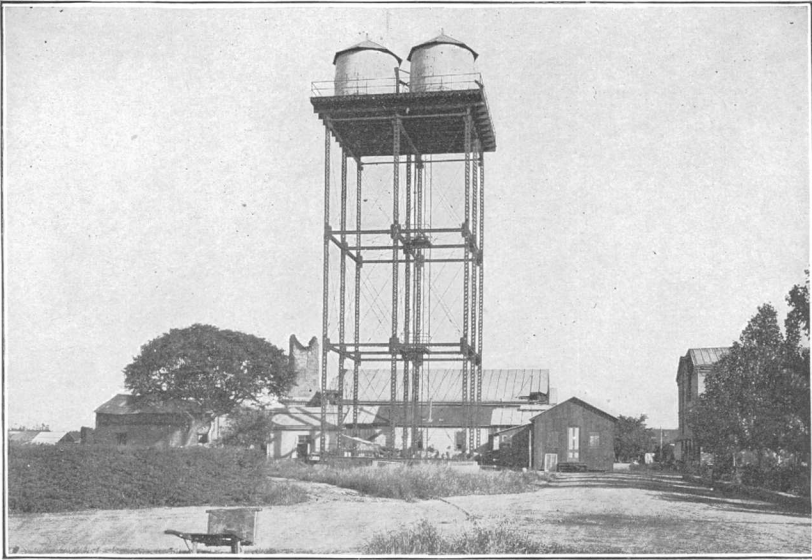
A. COMPARATIVE EARTHQUAKE ENDURANCE OF DISSIMILAR STRUCTURES, AGNEW INSANE ASYLUM, NEAR SAN JOSE.

Tanks on steel trestle, undamaged, and circular brick stack, collapsed. Photograph by Richard L. Humphrey.

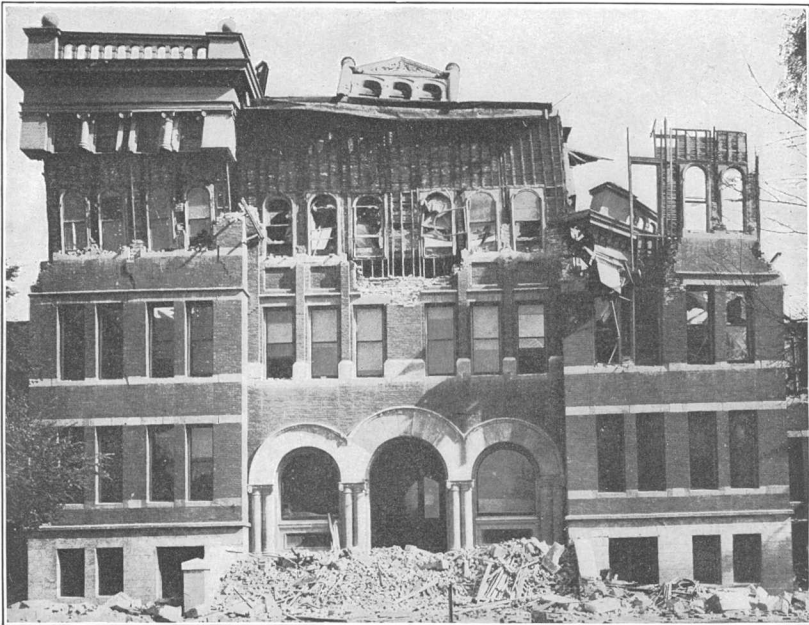
B. EARTHQUAKE EFFECT, HIGH SCHOOL BUILDING, SAN JOSE.

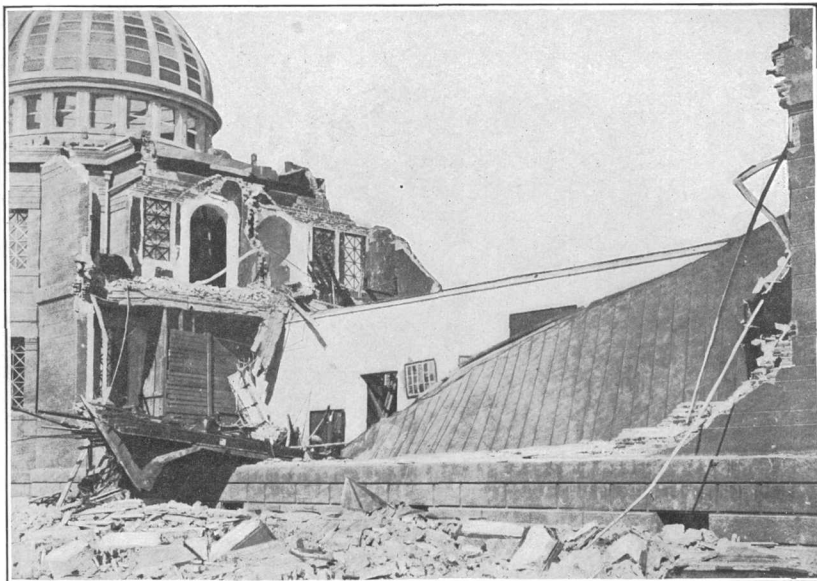
A. COMPARATIVE BEHAVIOR OF REINFORCED CONCRETE AND BRICKWORK UNDER EARTHQUAKE VIBRATION, MUSEUM, LELAND STANFORD JUNIOR UNIVERSITY.

The central portion, of reinforced concrete, was undamaged, but the brick wings collapsed. Photograph by Richard L. Humphrey.

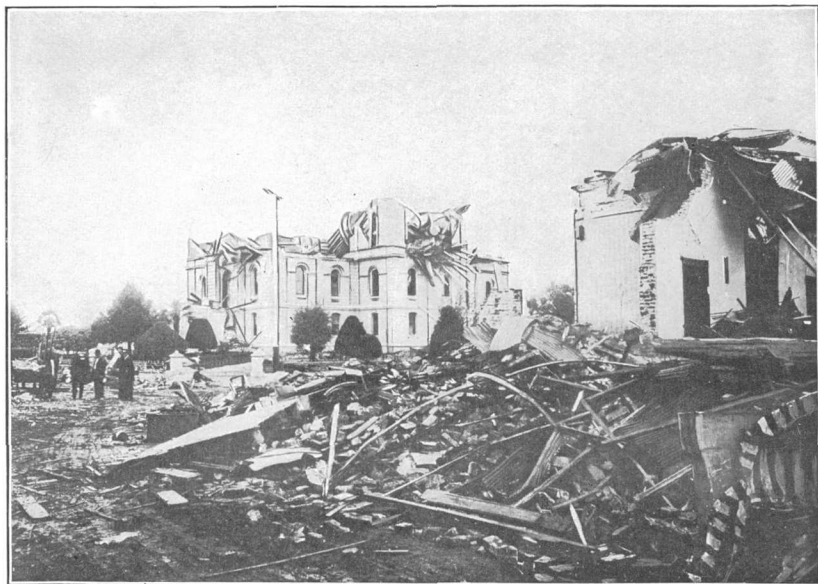
B. COMPLETE WRECK BY EARTHQUAKE, COURT-HOUSE AND HALL OF RECORDS, SANTA ROSA.

Wreck due to light wooden framing, insufficient bracing, and poor mortar. Photograph submitted by Richard L. Humphrey.

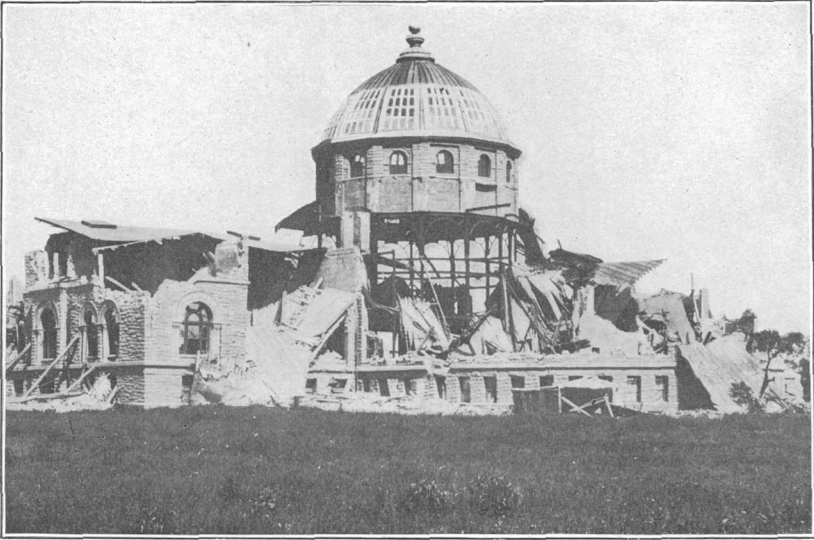
A. UNDAMAGED STEEL FRAMEWORK SUPPORTING DOME OF LIBRARY.

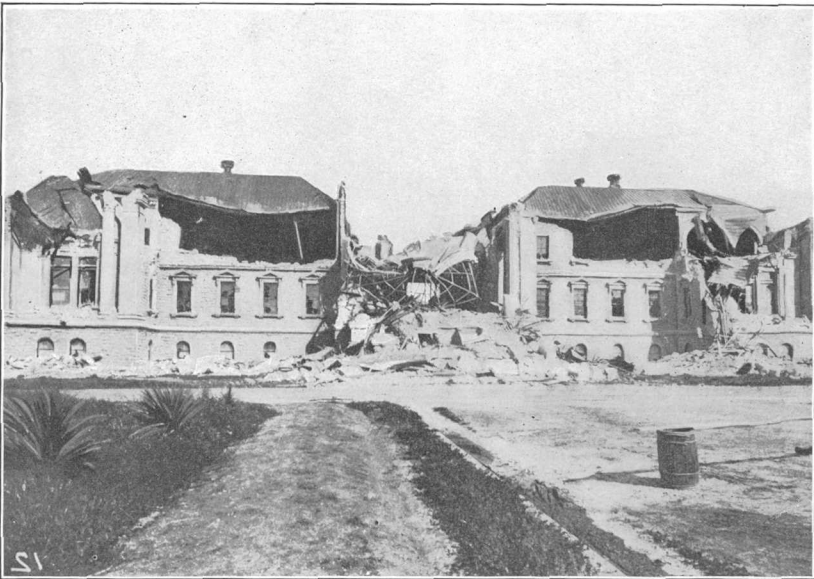
B. COLLAPSE OF BRICK WALLS, CAUSING DESTRUCTION OF STEEL SKELETON DOME OF GYMNASIUM.

ENDURANCE OF STEEL FRAMEWORK AS AFFECTED BY METHOD OF SUPPORT, LELAND STANFORD JUNIOR UNIVERSITY.

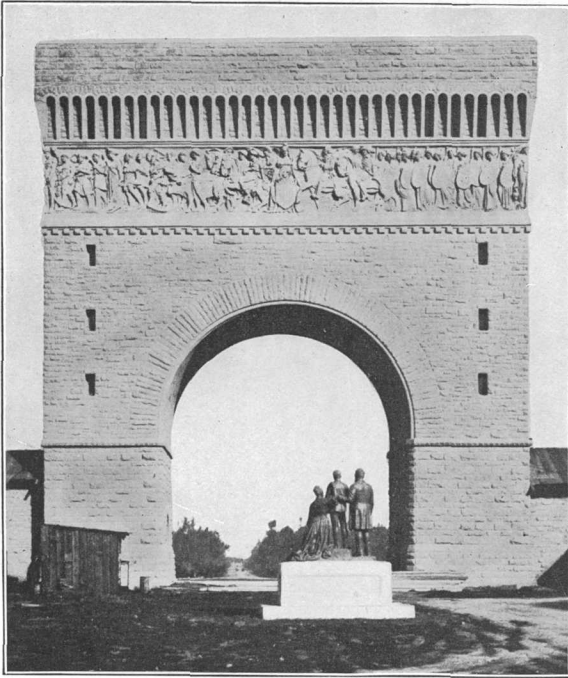
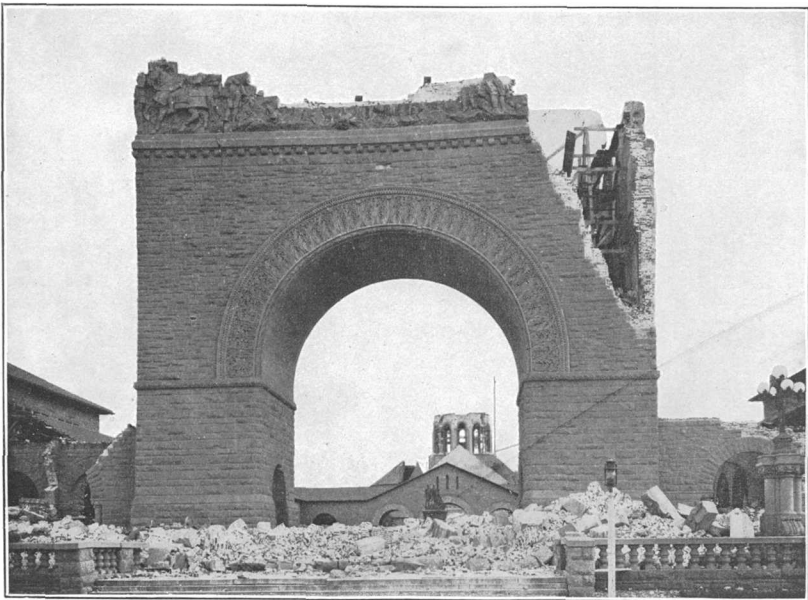
## MEMORIAL ARCH, LELAND STANFORD JUNIOR UNIVERSITY.

A, Before the earthquake (photograph submitted by Richard L. Humphrey); B, Earthquake effect (photograph by Richard L. Humphrey). The beams designed to stiffen the walls were not tied to them and helped to batter them down when the shock came.

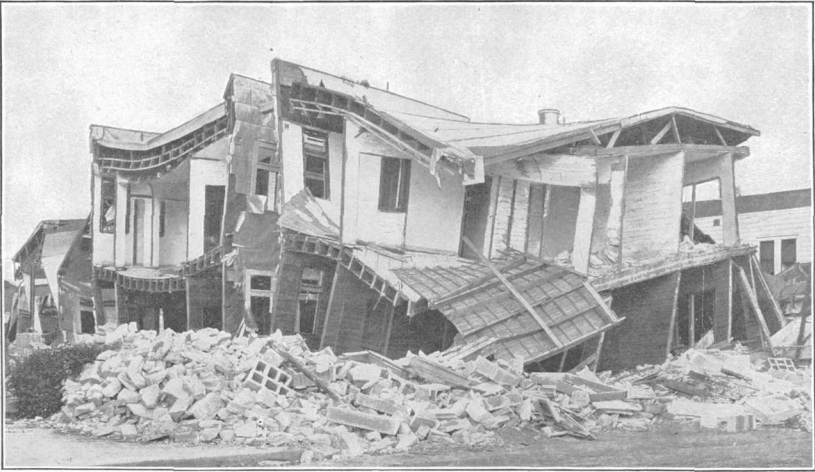
A. COLLAPSE DUE TO LACK OF TIE BETWEEN WALLS AND FRAME, THIELE BUILDING (CEMENT BLOCK), PALO ALTO.

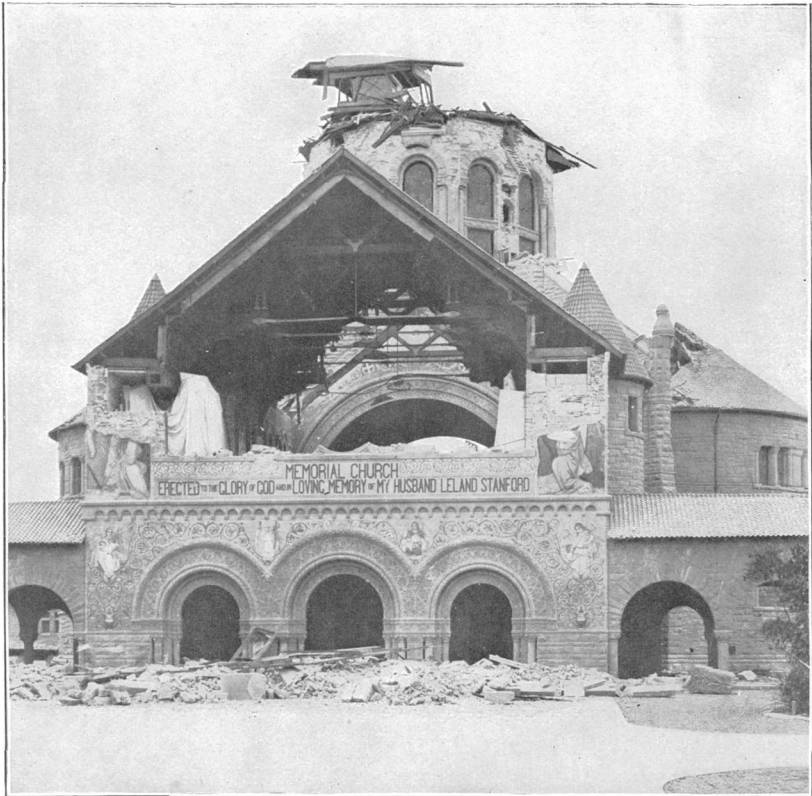
B. COLLAPSED TOWER AND GENERAL EARTHQUAKE WRECKAGE, MEMORIAL CHURCH, LELAND STANFORD JUNIOR UNIVERSITY.

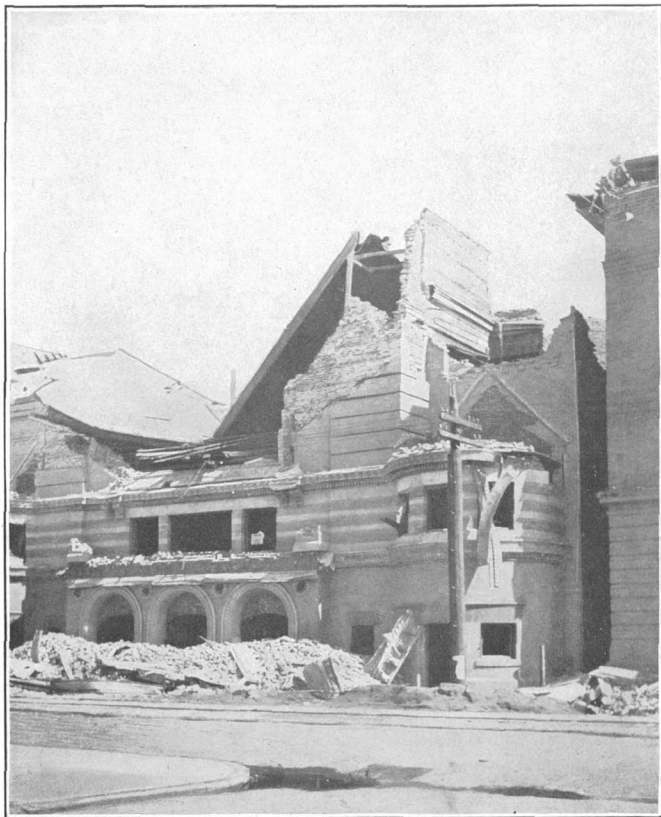
A. RACKING OF NEWLY CONSTRUCTED BUILDING, SYNAGOGUE, GEARY AND FILLMORE STREETS, SAN FRANCISCO.

Note the separation of the brick veneer from the backing; also the racking of the wall at the corner. Photograph by John Stephen Sewell.

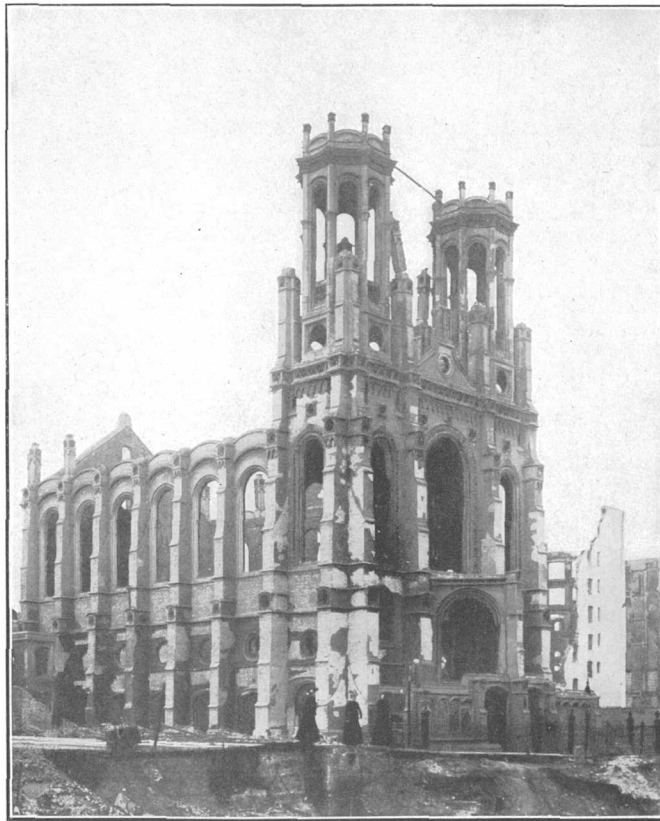
B. GOOD EARTHQUAKE ENDURANCE OF BUTTRESSED WALLS, SYNAGOGUE EMANUEL, SAN FRANCISCO.

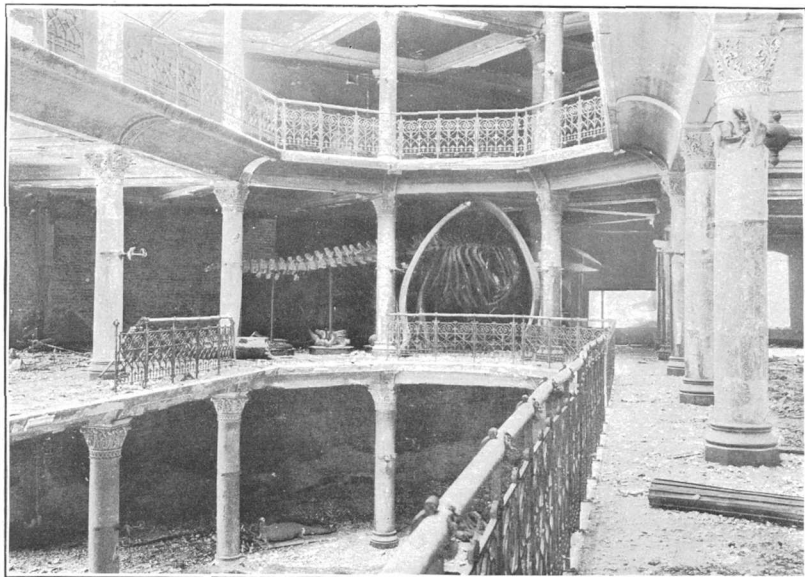
.2. FIRE ENDURANCE OF CONCRETE, ANNEX OF ACADEMY OF SCIENCES BUILDING, SAN FRANCISCO.

Reinforced-concrete floors and concrete-filled cast-iron columns with plaster covering. Photograph by Richard L. Humphrey.

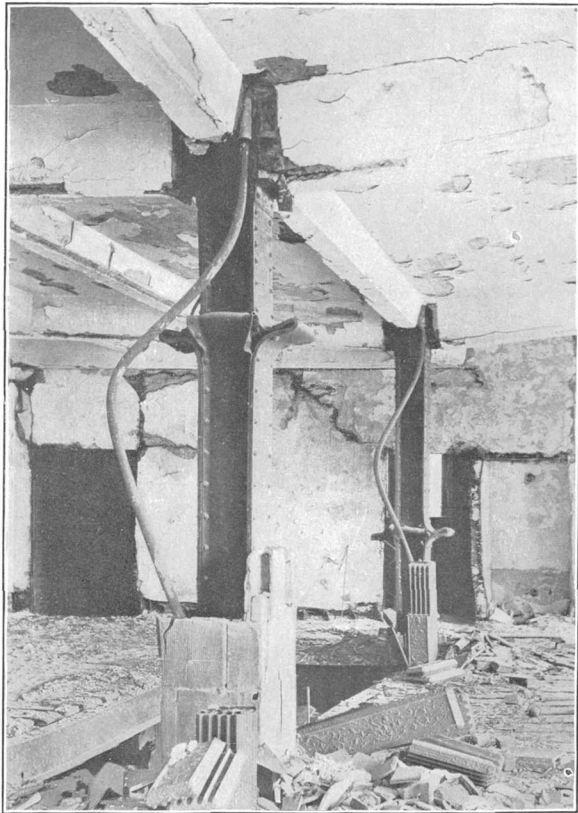
A. BUCKLED COLUMNS AND COLLAPSED FLOOR PANEL,  
BULLOCK & JONES BUILDING, SAN FRANCISCO.

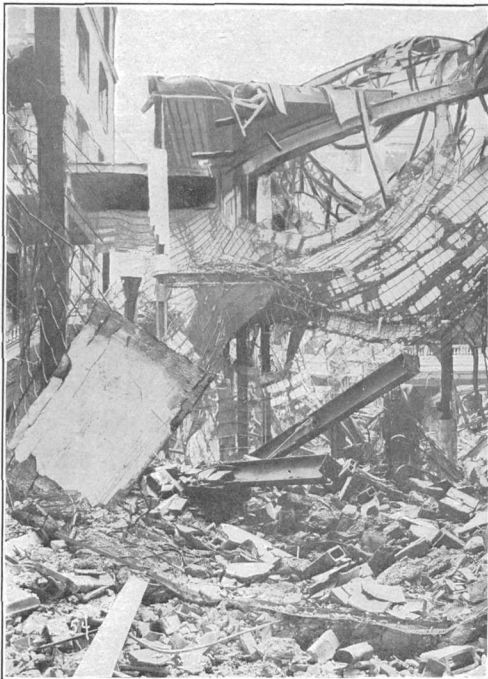
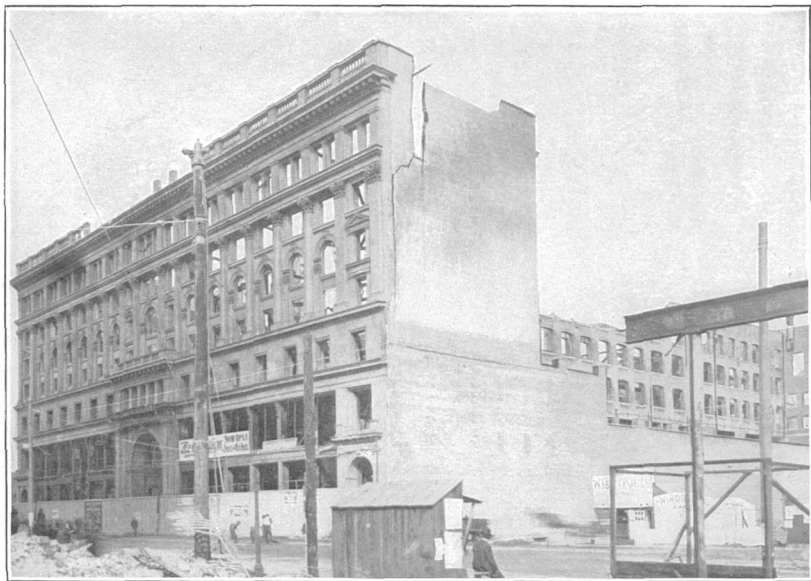
COMPLETE FAILURE OF SLOW-BURNING WOOD CONSTRUCTION,  
THE EMPORIUM, SAN FRANCISCO.

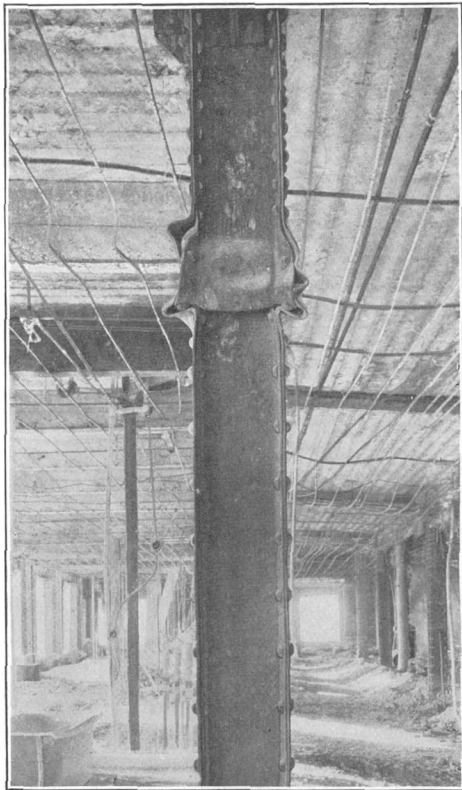
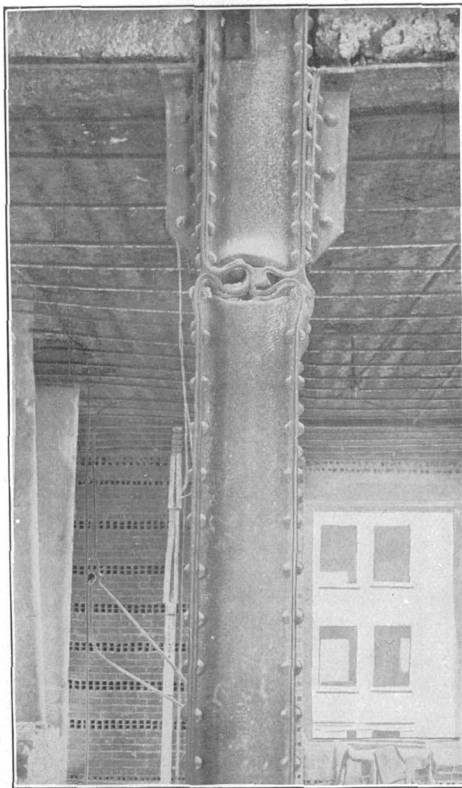
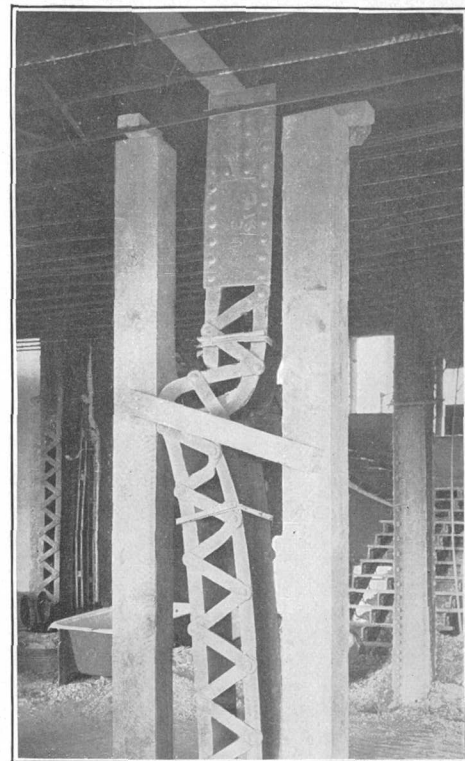
BUCKLING OF COLUMNS DUE TO FAILURE OF PLASTERED METAL-LATH FIREPROOFING, FAIRMOUNT HOTEL, SAN FRANCISCO.

The method of fireproofing was to inclose the column between the metal lath forming the partitions. Photographs by Richard L. Humphrey.

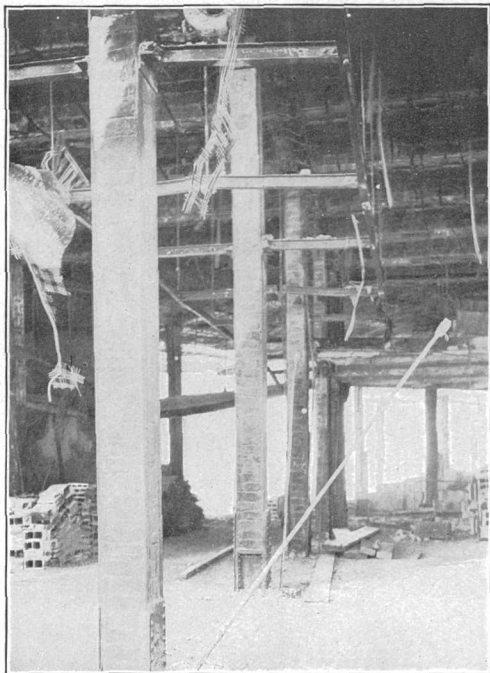
A. INCIPENT BUCKLING OF COLUMNS FROM HEAT, FIRST STORY, JAMES FLOOD BUILDING, SAN FRANCISCO.

The brick filling probably saved the columns from fatal buckling or collapse. Photograph by John Stephen Sewell.

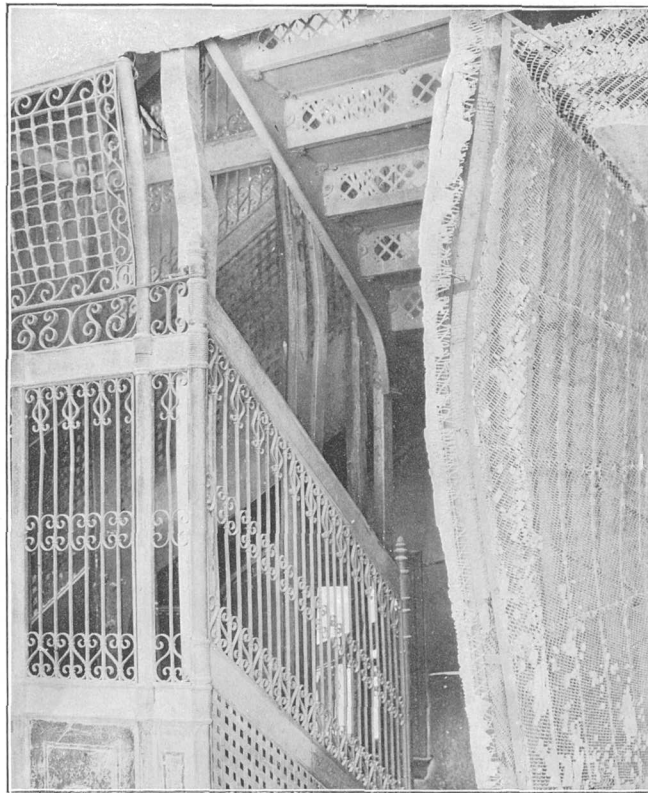
B. WARPING OF PLASTERED METAL-LATH COVERING BY FIRE, MURPHY BUILDING, SAN FRANCISCO.

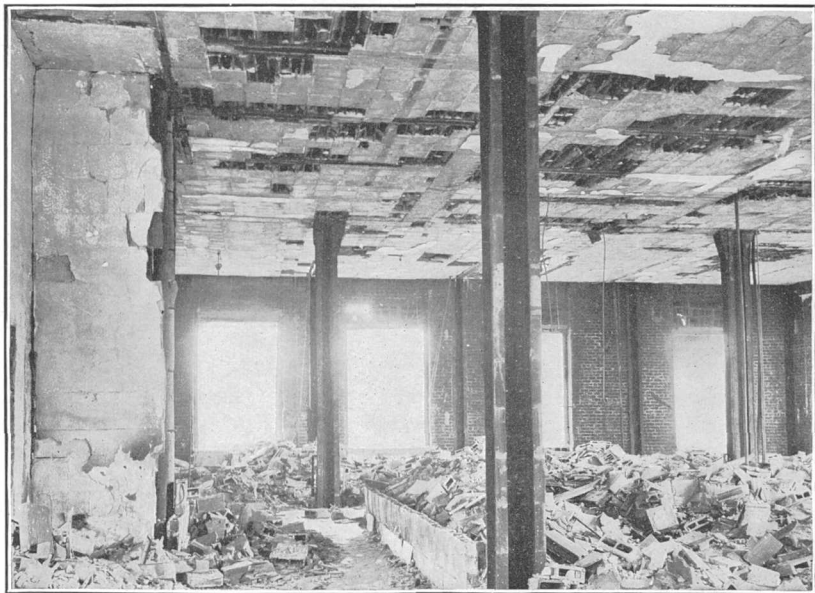
A

#### FAILURE OF HOLLOW TERRA-COTTA TILE FIREPROOFING.

A, First story of Spring Valley Water Company's Building, San Francisco (photograph by John Stephen Sewell);  
B, Mills Building, San Francisco (photograph by Richard L. Humphrey). The lower webs of the floor tiles  
were spalled or taken entirely off by the fire.

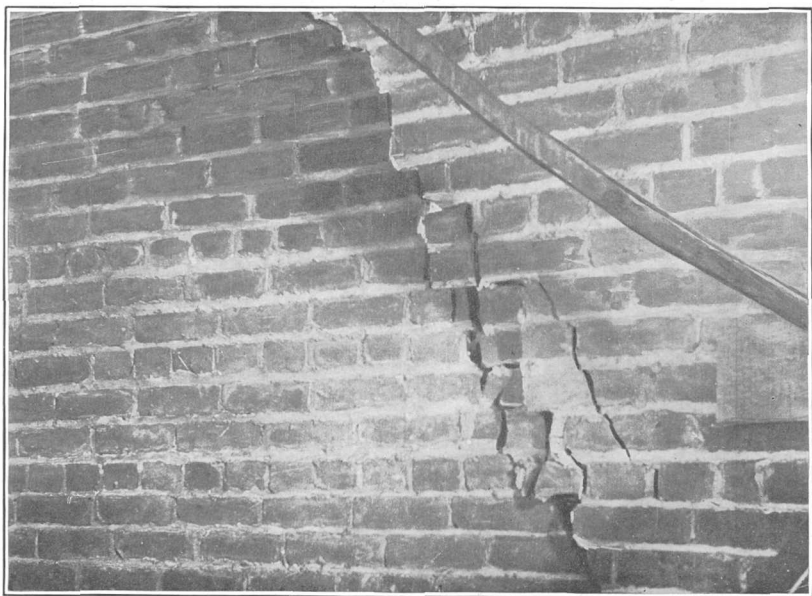
*B.* EFFECT OF SEVERE SHAKING ON WELL-BONDED BRICKWORK FILLED WITH GOOD MORTAR, TOWER OF UNION FERRY BUILDING.

Note sagged tie-rod, stretched by the racking of the structure. Photograph by John Stephen Sewell.

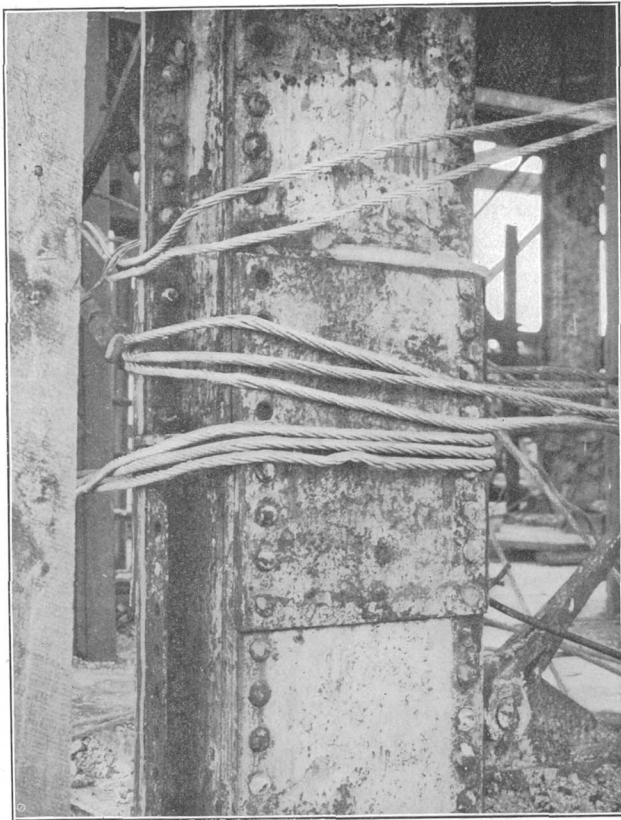
*A*

SHEARED RIVETS, TOWER OF UNION FERRY BUILDING, SAN FRANCISCO.

*A*, In column cover plate; *B*, In diagonal connection. Photographs by Richard L. Humphrey.

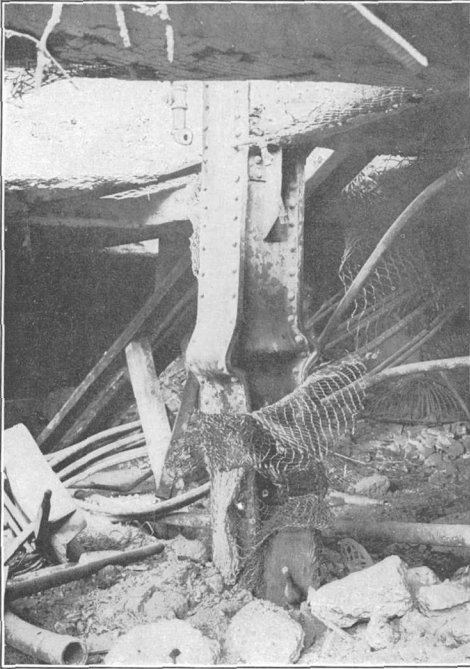
A. BUCKLING OF BASEMENT COLUMN DUE TO FAILURE OF PLASTERED METAL-LATH FIREPROOFING, RIALTO BUILDING, SAN FRANCISCO.

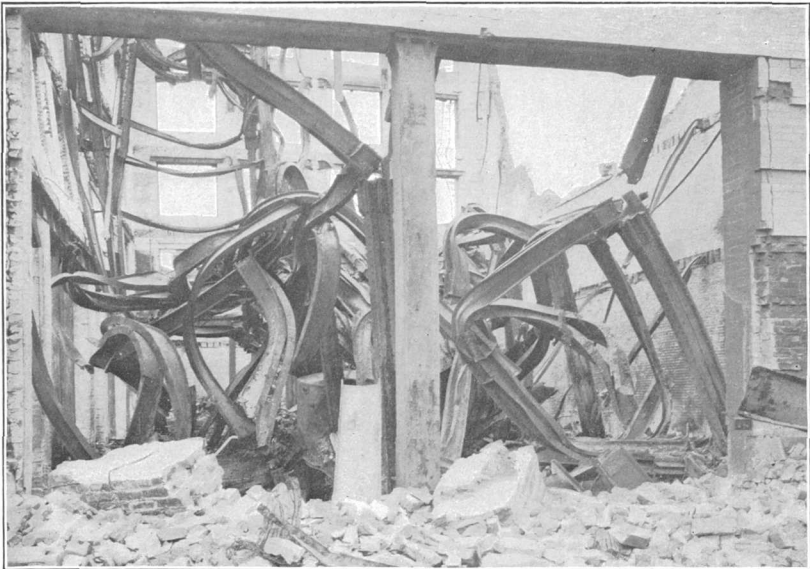
B. UNPROTECTED STEEL FRAME AND GENERAL FLIMSY CONSTRUCTION, COWELL BUILDING.

EFFECTS OF HEAT ON STEEL WORK, SAN FRANCISCO.

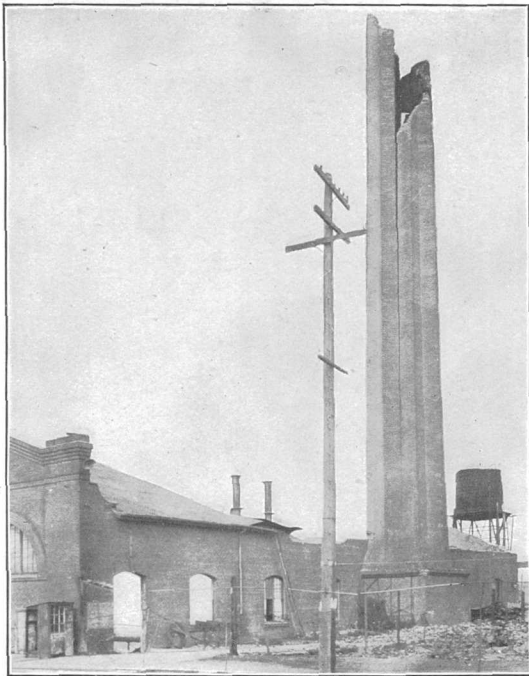
A. EARTHQUAKE DAMAGE TO BRICK STACK OF STAR SECTION, VALENCIA STREET POWER STATION, SAN FRANCISCO.

Showing peculiar crack in reentrant angle. Photograph by Richard L. Humphrey.

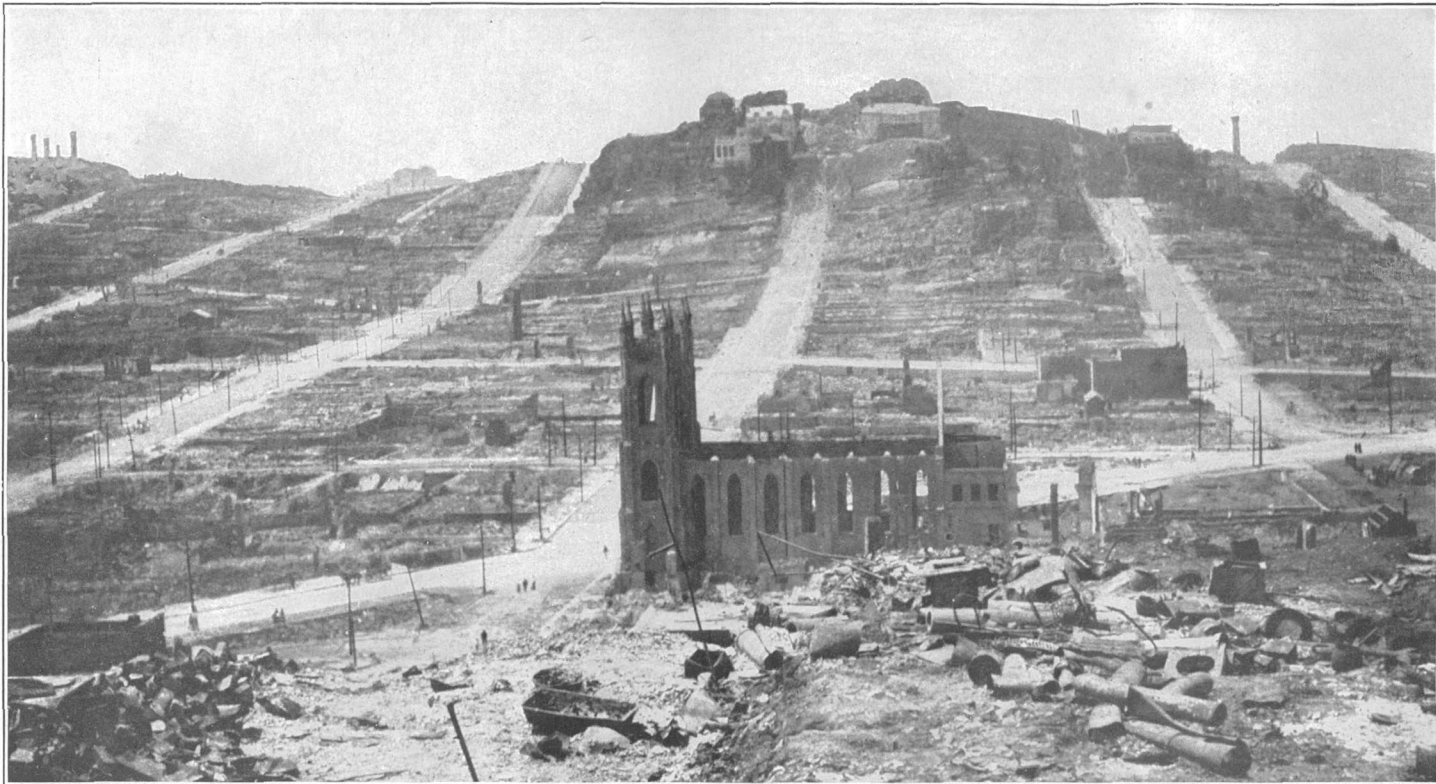
DESTRUCTION BY FIRE, SAN FRANCISCO.

View looking west from Telegraph Hill, showing unburned houses on summit of Russian Hill. St. Francis Roman Catholic Church, with its excellent brick walls, in the foreground. Photograph submitted by Frank Soule.

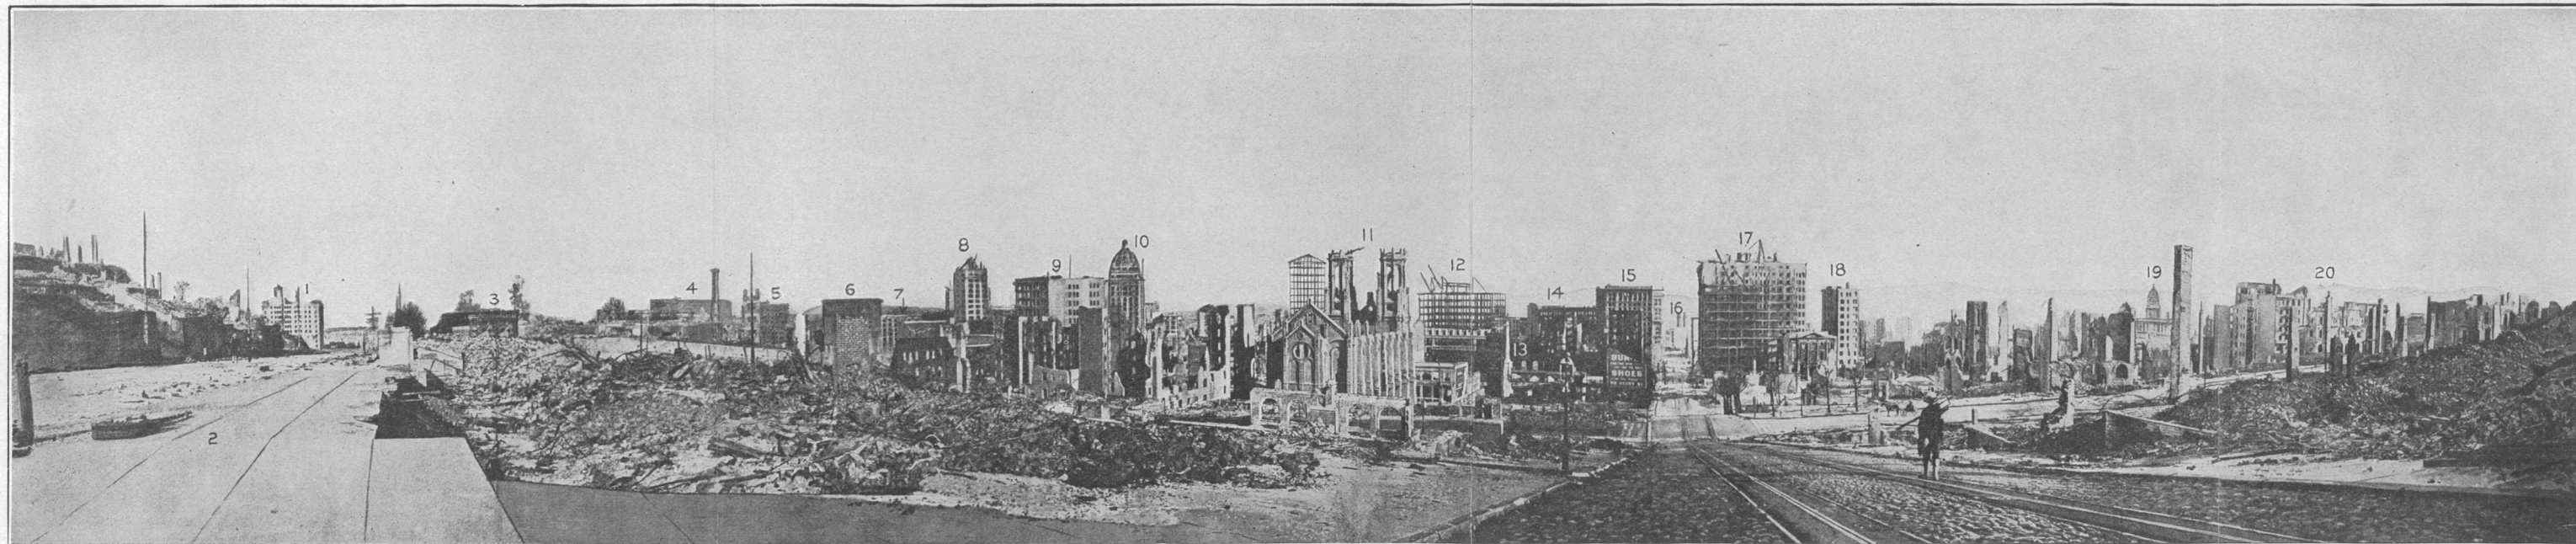
DESTRUCTION BY FIRE, SAN FRANCISCO.

Panorama taken at corner of Pine and Powell streets, showing location of principal buildings in the area south of Pine street. Photograph by John Stephen Sewell.
