Investigation of Environmental Factors Influencing the Deterioration of Nikka Stone in Koshien Hall

Tomoko Uno¹ and Kana Noguchi¹

¹ Department of Architecture, Mukogawa Women's University, Nishinomiya, Japan

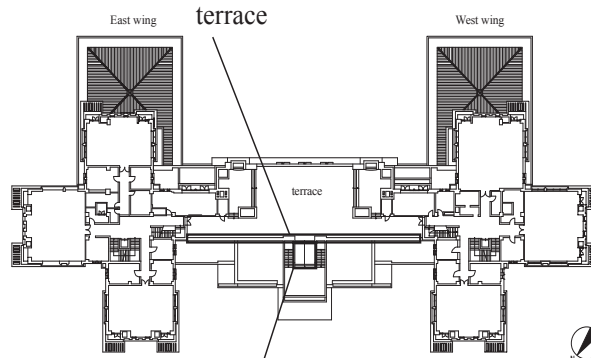
Point C: Crest table on the north side of the 3F roof terrace

Several types of detachment were observed. Large detachment tends to occur on horizontal surfaces, such as the stairs of the 2F roof terrace (point B, Table 1) and the crest table on the north side of the 3F roof terrace (point C, Table 1). Fine detachment, such as flaking, was observed on the surface of the outside floor on the east and west sides of the West Hall (Figure 3a), on the exterior steps at the front entrance, on the stairway of the terrace at the south side in front of the lobby in 1F (point A, Table 1 and Figure 3d), and in other locations. Algae were not observed on these flaking areas. Detachment with salt efflorescence was observed on the lower side of the pillars on the south side terrace of the 1F lobby (Figure 3a) and in other

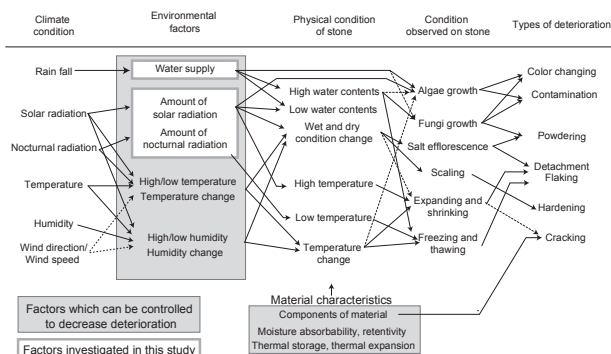
Figure 2. Relationship between environmental factors and type of stone deterioration

Most stone deterioration is caused by the presence of water (Figure 2) and materials with high water absorption capacities tend to maintain water to a greater degree. Water-related characteristics are thus important factors in this study.
