The Ozarks Environmental and Water Resources Institute (OEWRi)

PRE-CONSTRUCTION REPORT FOR THE WARD BRANCH STREAM RESTORATION PROJECT

November 14, 2007

OEWRi EDR-07-004

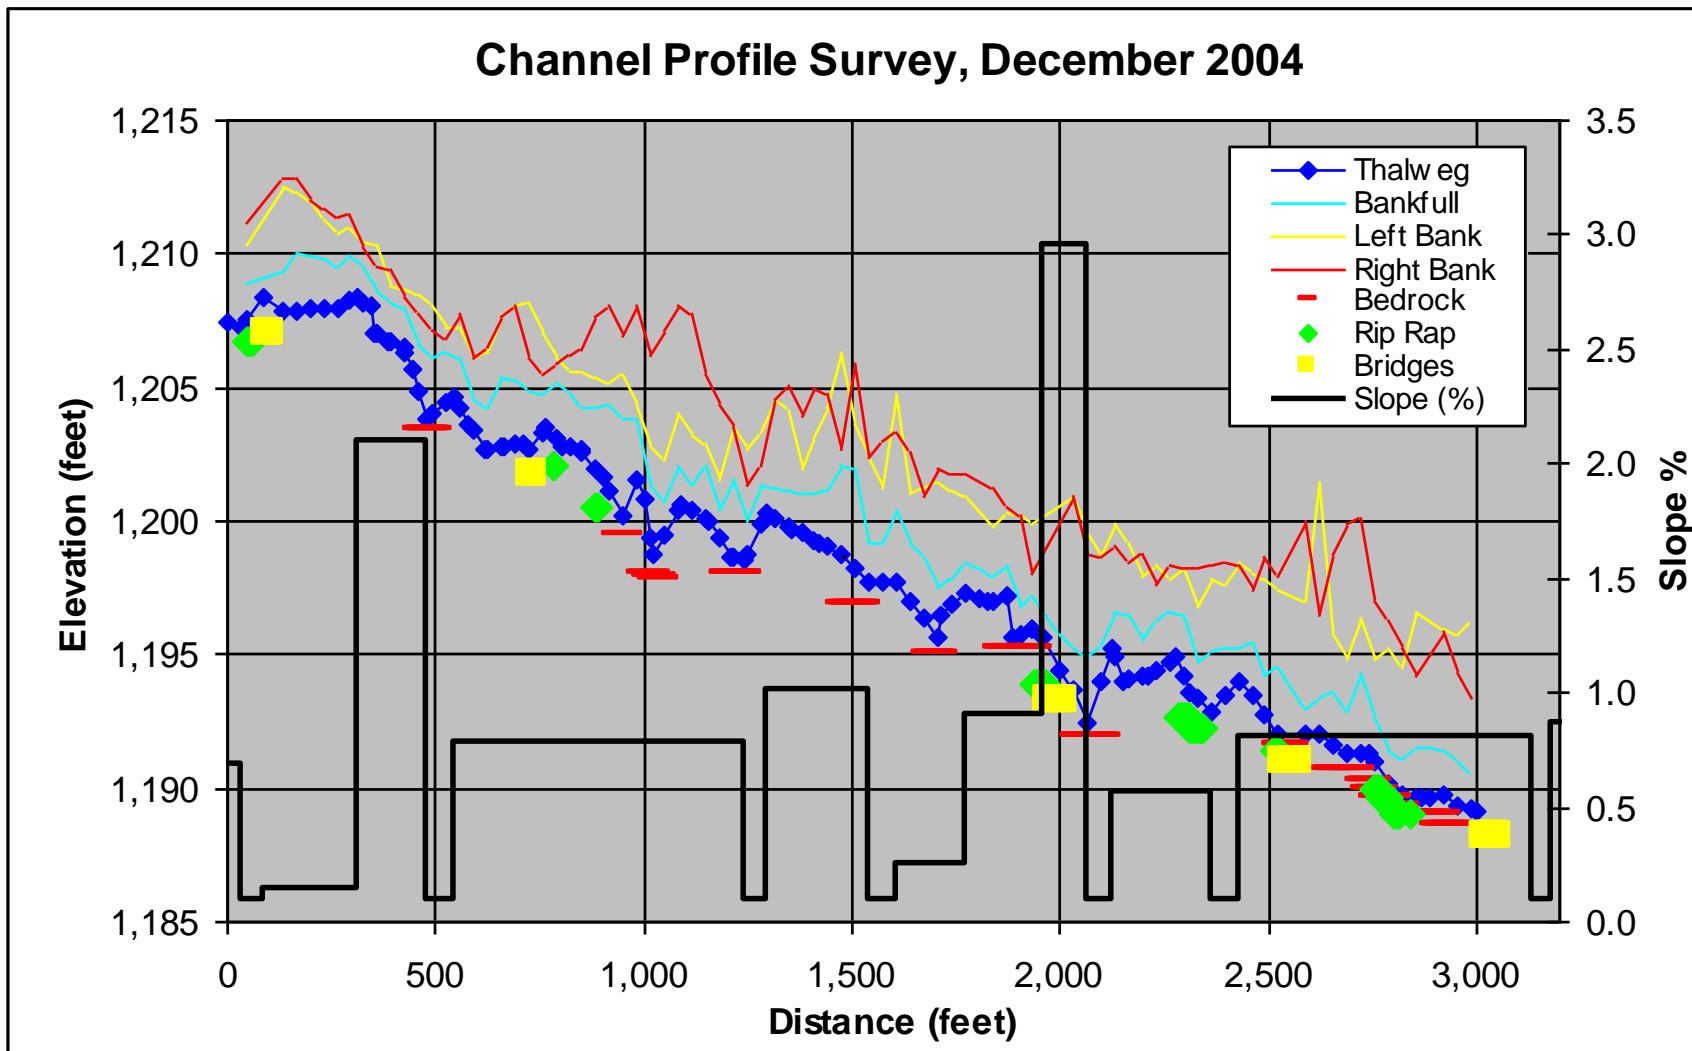
Figure 3. Longitudinal Profile

The channel survey begins (0 feet) at the downstream face of the Republic Road culvert at a pool. A riffle crest at approximately 300 feet marks the beginning of a relatively steep reach that extends to 500 feet (Figure 3 and Photos 1 and 2). The slope exceeds 2% through this section and bank heights are relatively low. Bedrock does begin to appear in the channel at 500 feet along the profile suggesting bedrock may be controlling the headcut elevation along this section. Downstream of 500 feet station, bank heights and pool depths begin to rise indicating either a headcut moved through this reach due to bedrock elevation change or the channel was able to cut through fill material or colluvium increasing the bank height due to increased flooding from urban runoff or historical land clearing and row cropping activities. Downstream bedrock appears at a lower elevation along the high right bank between 800 and 1,200 feet along the profile limiting further downcutting. This 400 foot long vertical right bank along the west side of the stream is approximately 6 foot in height (Photo 3).

A plane bed section with little contrast between pool and riffle topography occurs between 1,200 and 1,600 feet and has low to moderately high banks. This indicates excess bed sediment loading into the reach due to upstream bank erosion releasing gravel to the channel. Downstream of 1,600 feet the profile remains relatively consistent until 2,000 feet at the first subdivision bridge. Immediately downstream of the bridge a scour hole has formed and increased the slope locally (almost 3%) (Photo 4). The vertical adjustment of the stream below the bridge is also limited due to bedrock that is again visible along the bed at the scour hole location. A reality consistent riffle/pool sequence alternating from the right to left low terrace bank in the section between the bridges indicates a quasi equilibrium through this reach. Downstream of the second subdivision bridge the stream is pinned up against a high right bank that is eroding, but vertical adjustment is again controlled by bedrock that is visible along the bed throughout the remainder of the study reach. Appendix A shows the longitudinal profile data collected.

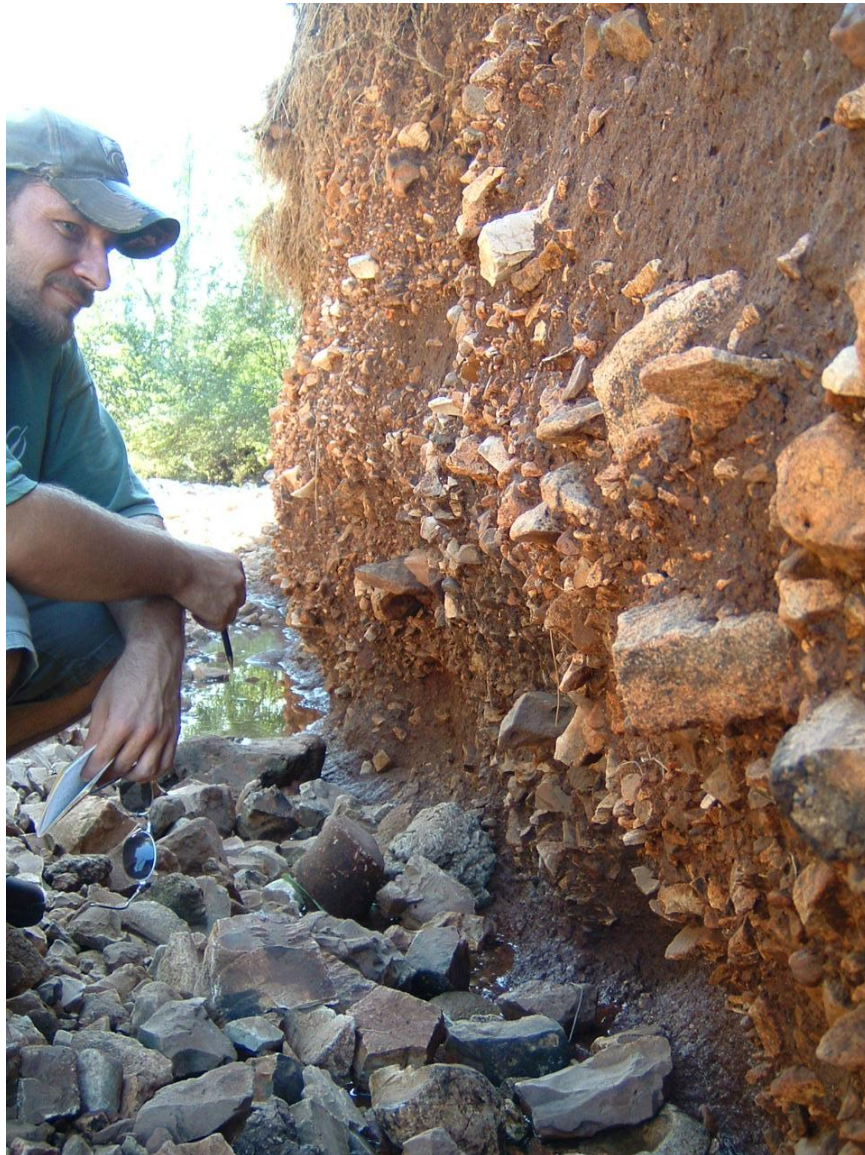
Graduate student Mark Gossard inspects erosion pins after a storm event in September 2005

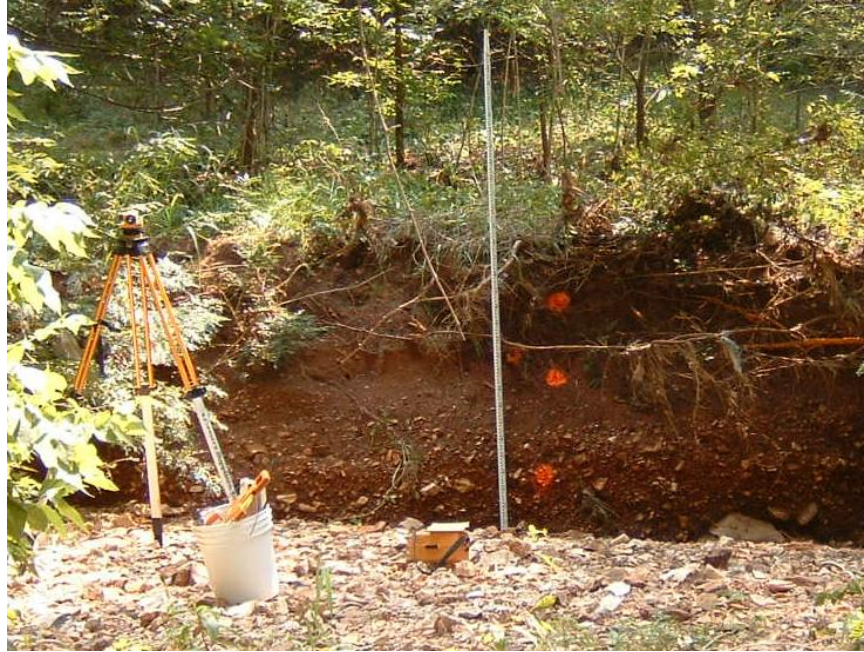
Photo 1. Erosion pin array

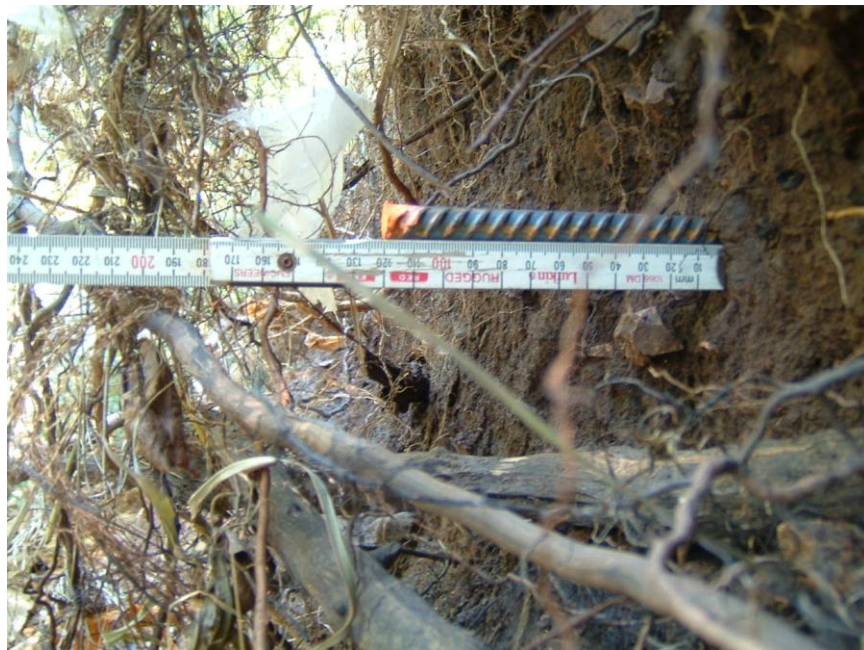
Photo 4. Measuring bank erosion at a pin
