**The Ozarks Environmental and Water Resources Institute (OEWRI)  
Missouri State University (MSU)**

**Channel Stability and Riparian Corridor Assessment  
to Identify Nonpoint Source Pollution, Wilson Creek,  
Springfield, Missouri**

*Field work completed July 20, 2012*

OEWRI EDR-12-003

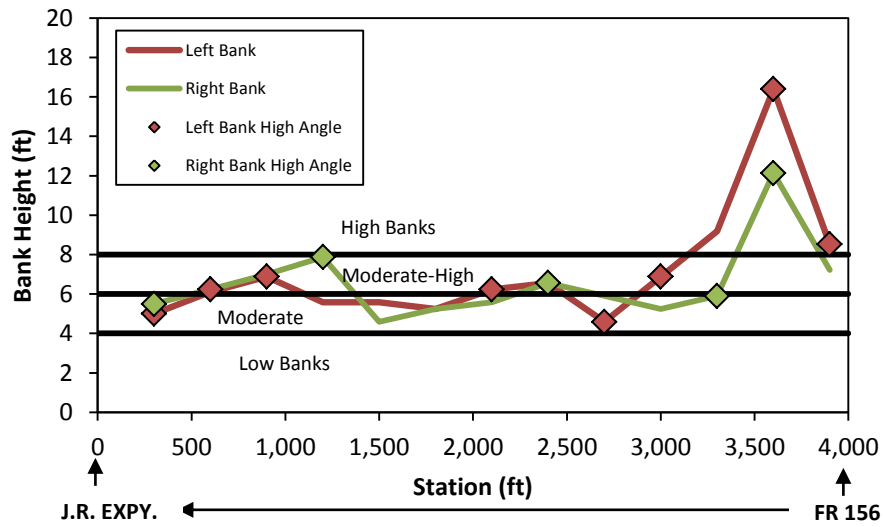
Figure 5. North Segment - Bank Height and Angle

Channel and bed width decreased downstream and bedrock was exposed along the bed throughout the majority of the reach (Figure 4). Bed width ranged from 20-38 ft and channel width ranged from 43-62 ft wide. While channel width should be expected to increase downstream, bedrock can control bed elevation and slope locally to disrupt that downstream pattern. The banks through this segment ranged from 4.6-16.4 ft high. The majority of the banks through this reach would be considered moderate to moderately high (4-8 ft) (Figure 5). Bank in the upper 500 ft and near station 1,200 ft would be considered high and susceptible to erosion (> 8ft). Bank heights were highest in the upper 500 ft of the site, with banks exceeding 12 ft near the knickpoint at 3,600 ft where the bed drops 8 ft . Bank angles that exceed 70° are common all along the north segment reach. High banks with steep angles should be considered an erosion risk.

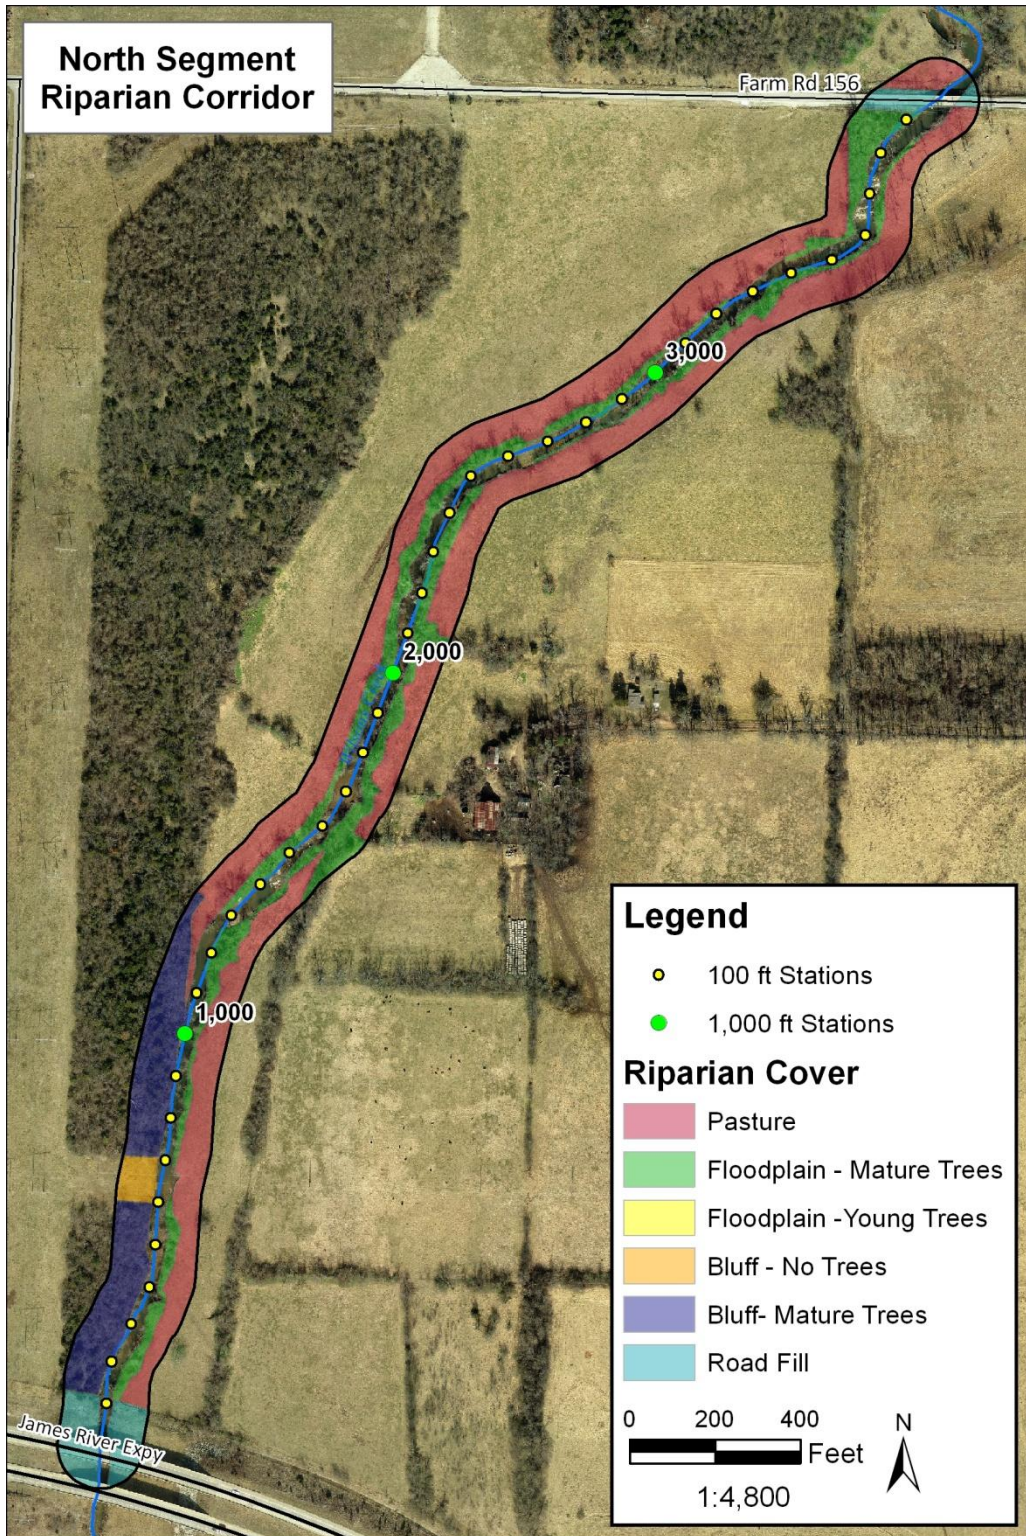
Figure 6. North Segment Riparian Corridor

The riparian corridor was assessed 100 ft on both sides of the centerline of the stream. The buffer through the north segment is mostly pasture with a thin line of mature trees along both banks (Figure 6). The entire buffer area is approximately 15.6 acres with around 8.7 acres of pasture (≈56%). Mature floodplain trees that make up the current thin corridor make up about 3.6 acres (23%) of the entire 100 buffer (Table 2). The vegetation along the bluffs is also mature, with the exception of the powerline easement between 700-600 ft. Also, the road fill along James River Expressway is grass and appears to be periodically maintained.

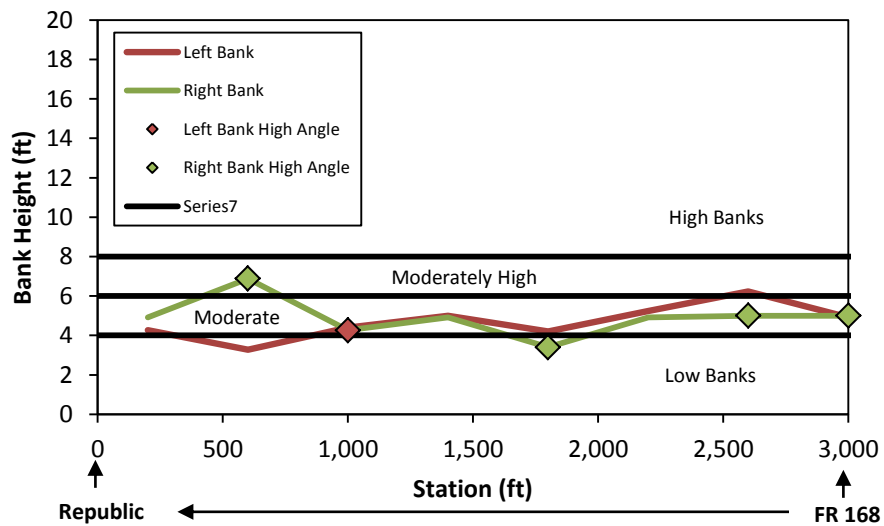
Figure 8. South Segment – Bank Height and Angle

Channel width and bed width increase slightly downstream and bedrock is exposed at the surface along most of the reach (Figure 7). Bed width ranged from 35-55.6 ft and channel width ranged from 45-74.1 ft. Bed and channel widths were higher in the areas of the channel where no bedrock was present in the channel (Stations 1,900-2,300 ft). Banks along the south segment range from 3.3-6.9 ft and appear to be relatively less susceptible to erosion than the north segment with lower bank heights and angles. Bank heights through the south segment would be classified moderate (<6 ft) with the exception of the moderately high bank at station 600 ft (Figure 8). High bank angles were mostly along the right bank though this reach. The highest erosion risk is along the right bank near 600 ft where the height is >6 ft with a steep angle.

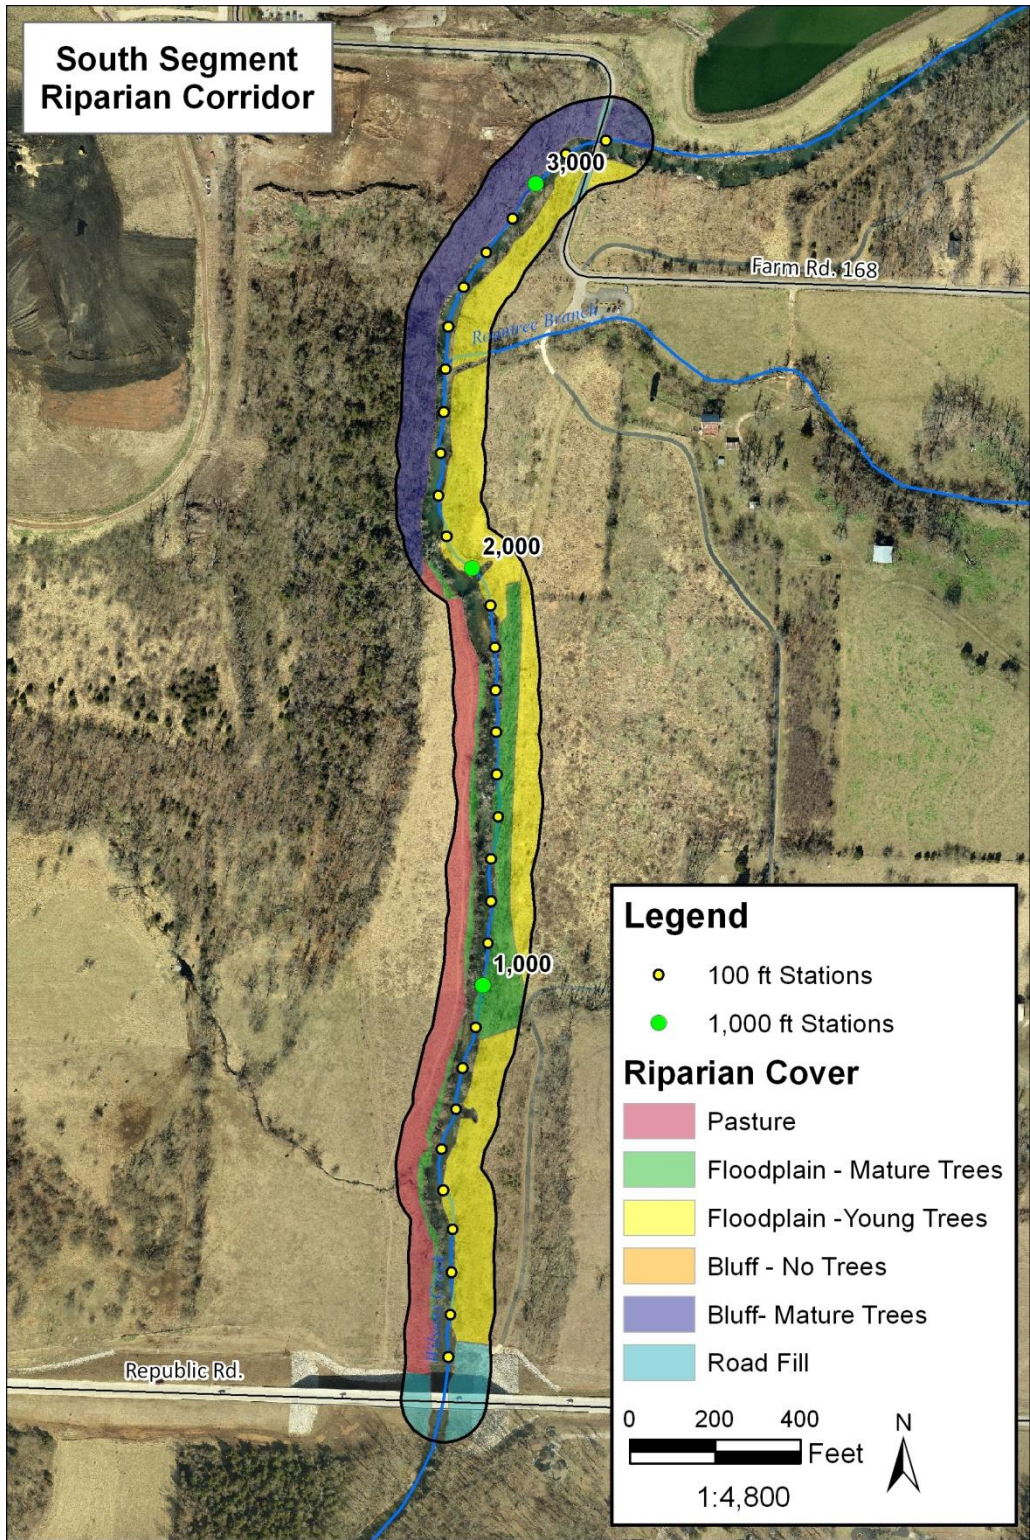
Figure 9. South Segment Riparian Corridor

The riparian corridor through the south segment is much healthier and more mature than the north segment. The east bank in particular is in good shape with a thin line of mature trees flanked by younger trees along the floodplain, likely allowed to grow when the Greenway was established (Figure 9). The upper 1,000 ft of the west side of the stream is bluff covered by mature trees. The remaining 2,000 ft has a thin line of mature trees and grass pasture beyond. The entire buffer area is 12 acres, with 4.8 acres (40.3%) covered by young trees on the floodplain (Table 3). The bluff is 2.5 acres (20.8%) of the buffer and the grass pasture makes up about 2.3 acres (19%) of the buffer. The remaining 0.7 acres (5.9%) is the road fill near Republic Road.
