Cracking of RC School Building Due to Soil Expansion

*Omer S. Mughieda*¹⁾ and *Khaldoon A. Bani-Hani*²⁾

ABSTRACT

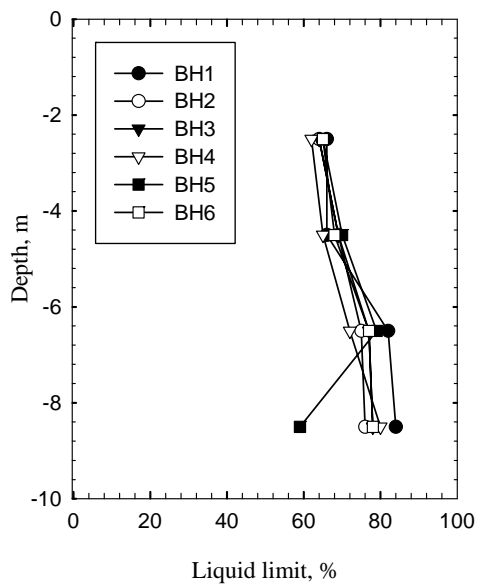
of the clay layer is very stiff. The results of the UU triaxial test showed that the cohesion is small compared with that obtained from the correlation with the SPT test results. Apart from the triaxial UU test and the unconfined compressive test, the reason for the discrepancy is attributed to the disturbance suffered by the triaxial soil samples during the extraction process. This disturbance caused the soil specimens to crack thus lowering the strength parameters of the tested soil specimens.

Figure 4: Liquid limit Versus depth for all soil specimen extracted from the six drilled bore holes

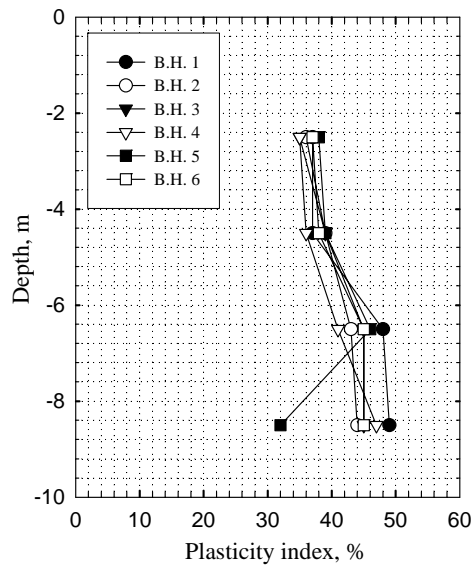
The foundation soil was classified as high plasticity clay (CH) with a high swelling potential according to the Unified Soil Classification System (USCS). The swelling pressure varies between 9.3 kPa and 21.3 kPa. The maximum value 21.3 kPa was measured at a water content of 28% and is much higher than the contact pressure, 15 kPa. The high value of the swelling pressure implies that soil expansiveness is the source of the problem that the superstructure of the school has been experiencing.

Figure 5: Plasticity index versus depth for all soil specimen extracted from the six drilled bore holes

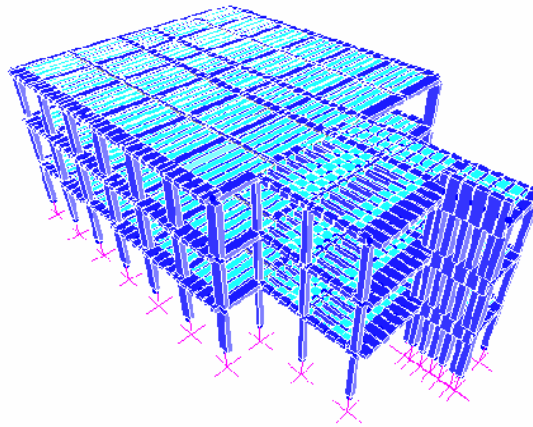
The building under study was modeled as a 3-D model with releases in the end joints of the columns to assure the simple beam action. The 3-D Finite Element Model is shown in Figure (10). SAP2000 code was used to analyze the finite element model. The analyses produced several cases including the most critical case, which was adopted for the design and repair measures. Figure (11) is presented as an example of the bending moment diagram for the **DLLSTL** case.

Figure (10): 3-D FEM model for analyzed part of the building.
