Post-seismic effectiveness of the strengthening work carried out with GFRP applied to historical masonry buildings: the case study of the Spoleto Cathedral

Post-seismic Effectiveness of the Strengthening Work Carried Out with GFRP Applied to Historical Masonry Buildings: The Case Study of the Spoleto Cathedral

Alessandro Grazzini¹ (*), Stefano Agnetti²

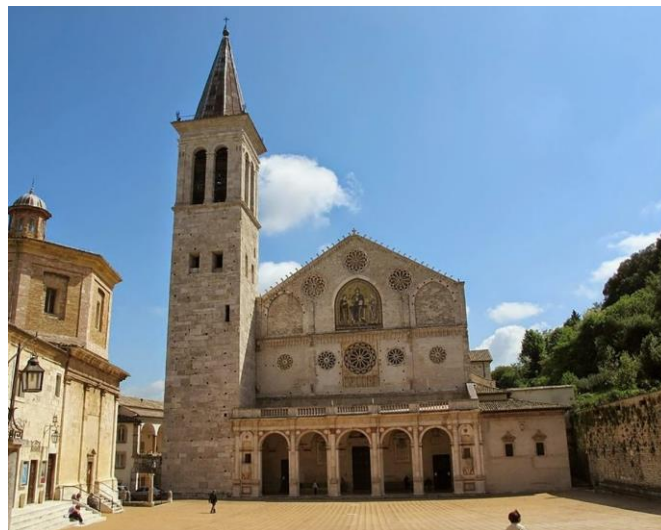
Figure 1. The Spoleto Cathedral.

After the 1997 Umbria-Marche earthquake, the Spoleto Cathedral was subjected to a detailed survey carried out in order to know the actual conditions of the monument about the structural and security aspects. The non-homogeneous distribution of the damages present in the various parts of the cathedral showed a different behaviour towards the seismic actions. So the seismic events have highlighted the structural weaknesses, also amplified by the absence of maintenance. The façade showed widespread degradation, mainly due to water infiltration. The main aisle instead suffered cracks on the barrel vault following the seismic action. In the left aisle there were diagonal cracks with respect to the axis of the church in correspondence with the cross-vault centreline. In the area of the high altar there were instead cracks in correspondence of the triumphal arch near the apse (**Figure 8**). In this arc there were produced deep cracks and tilted both in key and in the kidneys which produced a detachment of the central part of the arch up to the dome's turn. In the left transept there was a detachment between the barrel vault and the stiffening arches. The most serious damage occurred in the Chapel

of the Blessed Sacrament which suffered cracks on the vertical walls and in particular at the openings.

The analysis of the cracking state and of the structural behavior of the Cathedral have inspired the choice of the restoration and seismic improvement work of the structures. The strengthening work was carried out between 1997 to 2002 on the central nave, the dome, the façade and the side aisles. Between 2002 and 2009, specific work was carried out involving the sacristy and the convent, thanks to private funding. In 2009, the aim of a second phase of strengthening work was to consolidate the side chapels, the transept coverings and to restore the plasterwork of the chapels and the façades of the bell tower. Composite materials were used to strength the vaults of the chapels and of the main nave. The interventions therefore had the purpose of recovering the static integrity and improving the structural behavior towards seismic actions. This work has allowed the restoration of the structural continuity in the damaged walls, the improvement of the mechanical characteristics and the seismic behavior of the individual structural elements and of the entire Cathedral. In the upper area of the central aisle, the interventions carried out mainly aimed at effectively consolidating the attic masonry between the vault and the roof slab by means of injections and reinforced perforations.

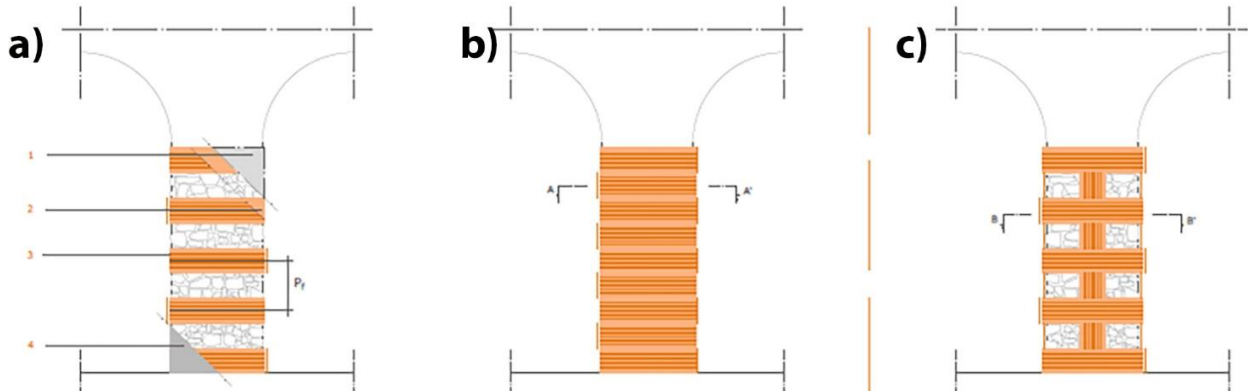
Figure 4. Different solutions for confinement of masonry columns by FRP wrap: a) discontinuous bandage; b) continuous bandage; c) discontinuous wrapping with the addition of longitudinal strips.

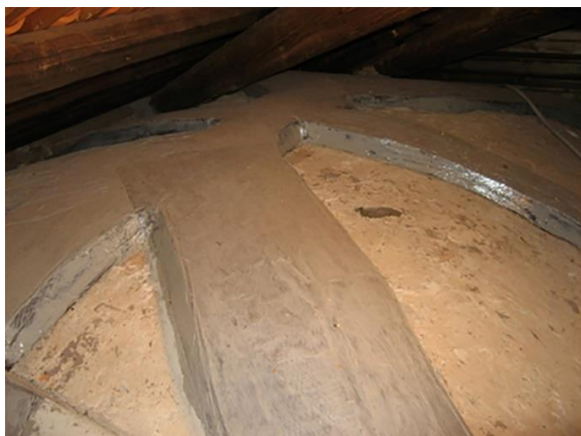
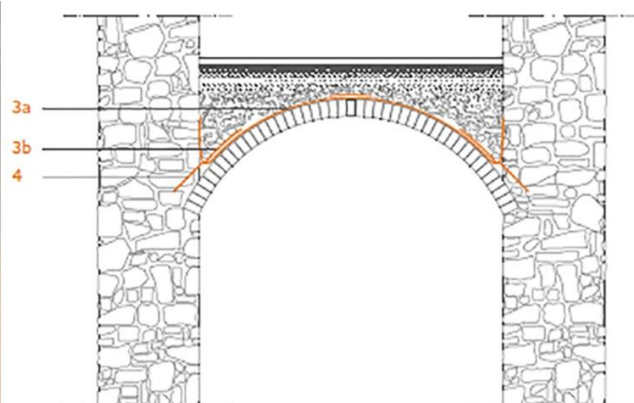
Figure 5. FRP Strengthening vault from the extrados.

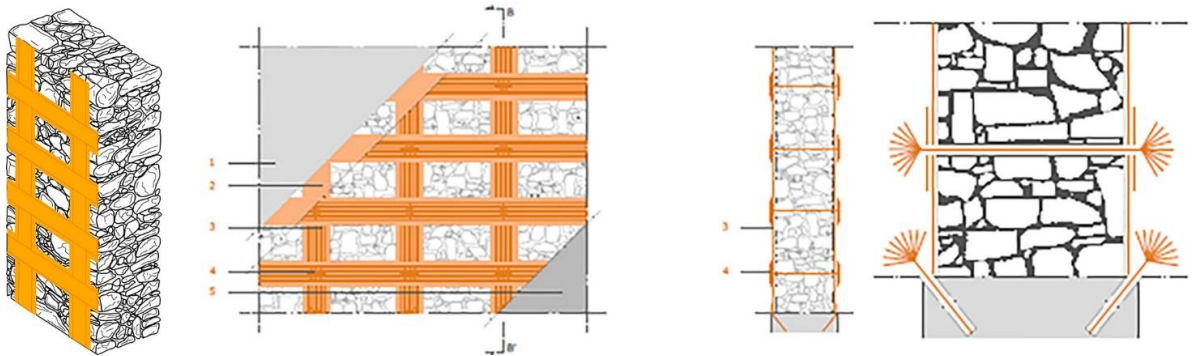
Figure 6. Reinforced (flexural and shear) masonry panel by FRP glued bands.

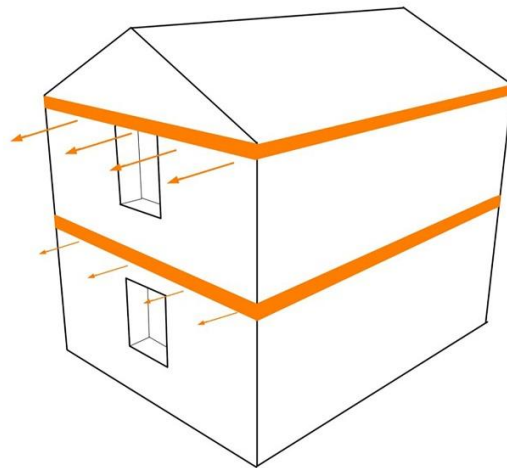
Figure 7. Reinforcement circle buildings made by FRP bands for the contrast of out of plane in masonry vulnerable to seismic action.
