Dune Monitoring Data Update Summary

Kevin P. O'Brien
Virginia Institute of Marine Science

March 2009

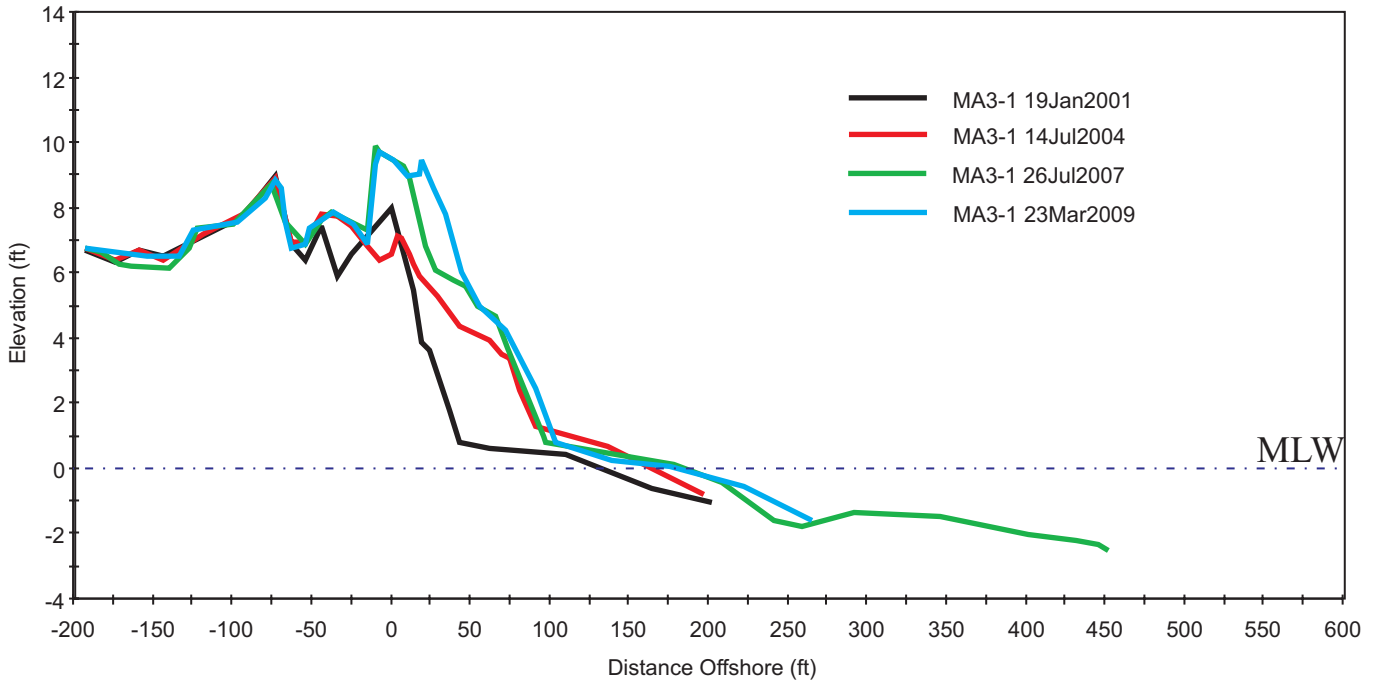
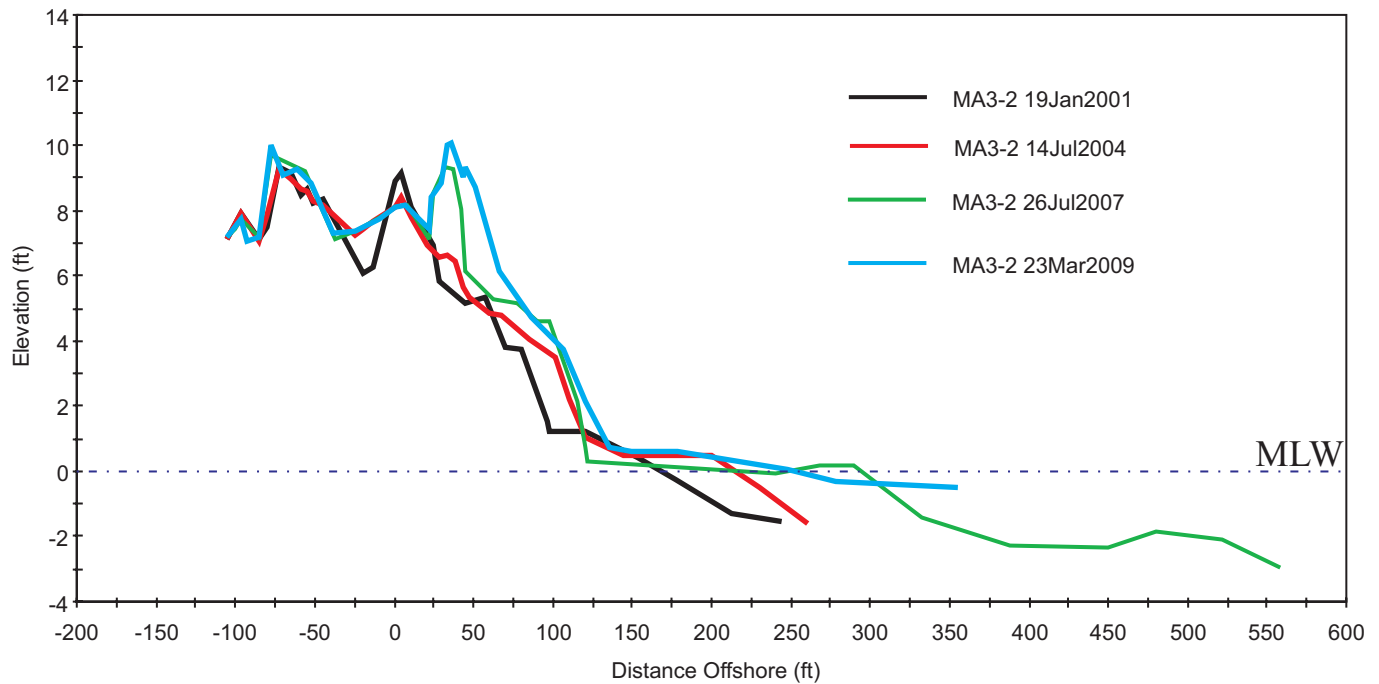
Figure 7A. Individual profile change through time.

MA3 is a secondary dune site with a low upland that is controlled by two marsh headlands and nearshore attached bars (Milligan *et al.*, 2005). The source of sand for dune development at this site is from these nearshore bars. This abundance of sand has elevated the toe of the beach such that sand is available for aeolian transport to the backshore and dune area. The residents of the local communities have enhanced this process by installing dune fencing and planting dune grasses. Dunes have existed at this site since at least 1973. When Hurricane Isabel impacted the shore in September 2003, a wide beach was left as sand was eroded from the dunes and deposited close by (Milligan *et al.*, 2005). The residents reinstalled dune fencing to help the dunes recover, and many of the dunes are rebuilding at the same location. Before the storm, most of the beach was accretionary as only the southern end was eroding, and the dunes were stable overall. Due to the storm, the dune crest heights decreased along the site, and the position of the crest moved towards the water in most cases. The only exception to this was at profile MA3-7 which was completely removed during the storm. Since the storm, the site has been surveyed twice more on July 26, 2007 and March 23, 2009 (Figure 7A-D), and these surveys reveal accretion for most of the primary dunes on the site. With the exceptions of MA3-6 and MA3-8, the profiles are showing growth and stability including the primary dune on MA3-7 (Figure 8) which is starting to grow back well, but is still not as large as it was before Isabel. MA3-1 to MA3-3 and MA3-5 has had growth to the primary dune and has advanced. MA3-4 has grown but has stayed at the same position. MA3-6 is eroding at the beach face and upper beach while MA3-8 is eroding along both the beach and dune.

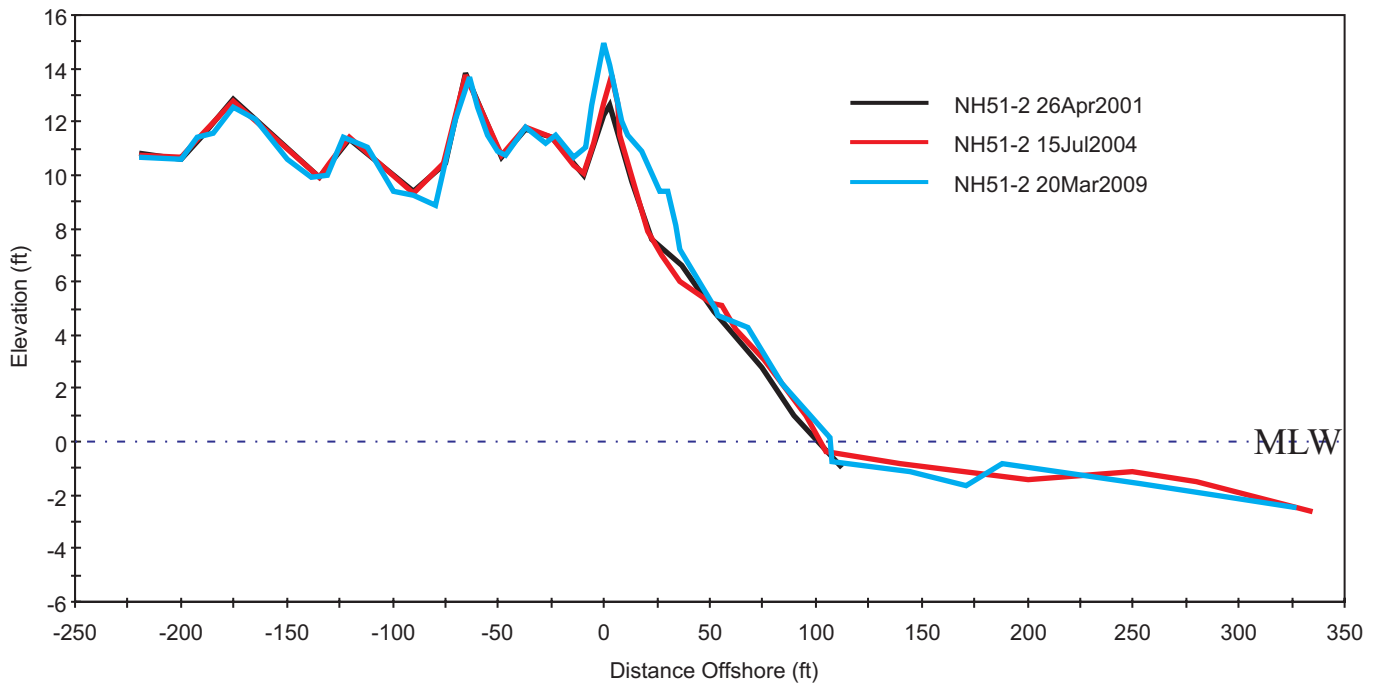
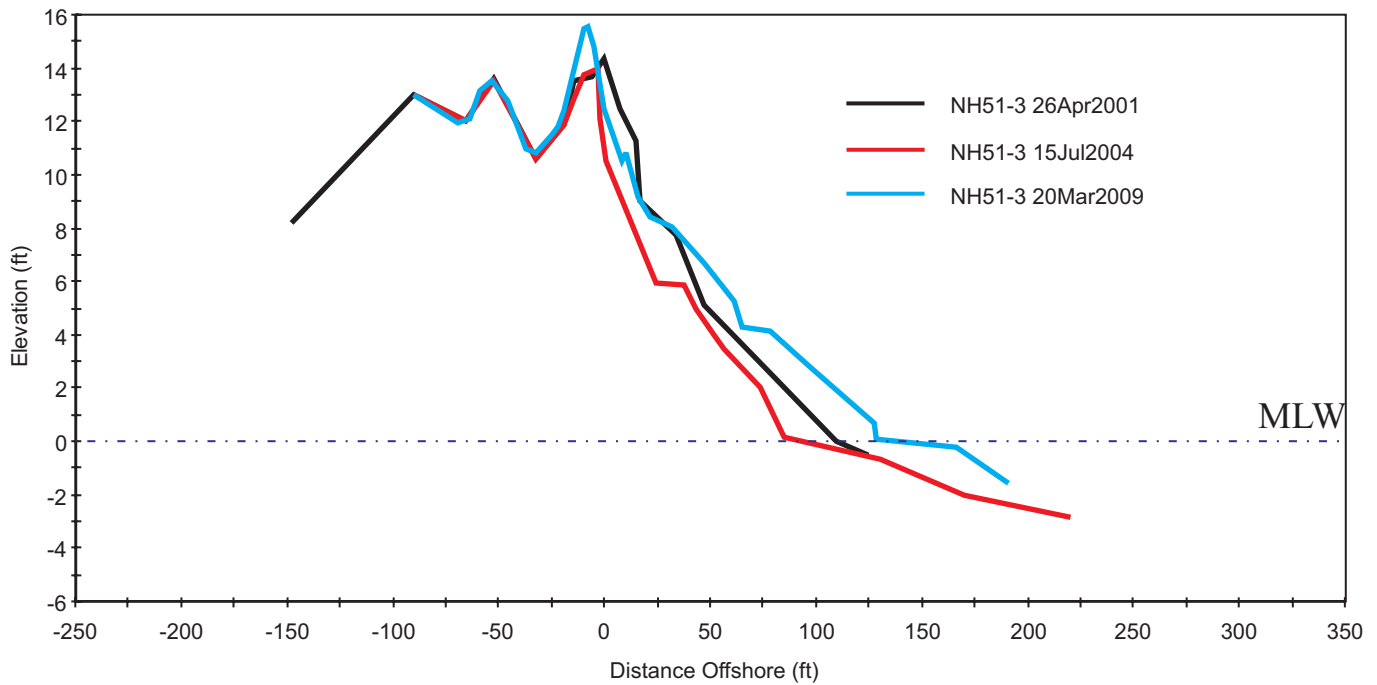
Figure 7I. Individual profile change through time.

Site NH51 is part of a larger dune system that has existed since 1807. Since that time, this system has been fragmenting. Yet, the same shore morphology has occurred at this site since 1863 and, the dunes at NH51 are shown in the 1937 aerial photography (Milligan *et al.*, 2005). This large headland morphology is controlled by geology, and the nearshore attached and offshore bars. The wave climate at the site is a blend of ocean and bay. The dune field sits against a high upland bank whose erosion updrift and downdrift have been a source of sand for the site. Part of the site was stable before Hurricane Isabel, but the most northern section was erosional (Milligan *et al.*, 2005). The southern section of the site is erosional both on the beachface and upper beach, but the dune has remained stable (Figure 10). The northern section of this site is relatively accretionary and while some growth to the dune crest has occurred, the crests themselves have retreated several feet (Figure 7H-I).

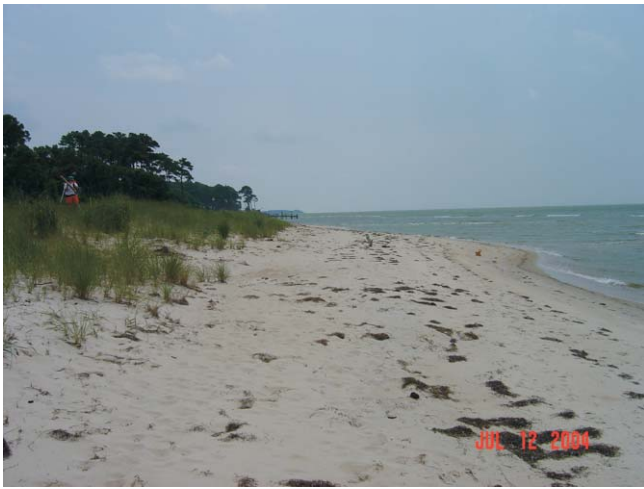
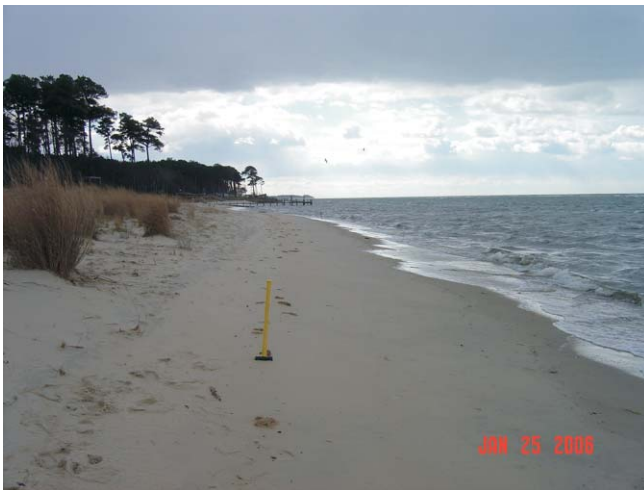
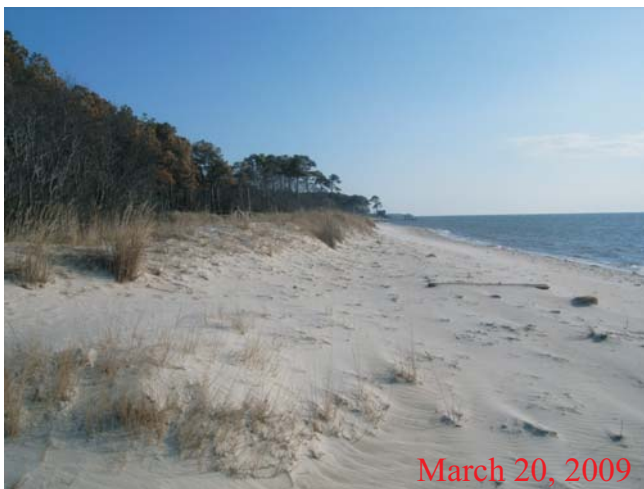
NH10-3

NH10 is a dune site backed by a fastland bank. Only the middle profile has a secondary dune while the other two profiles only have primary dunes. A great deal of sand exists in the nearshore attached bar system. This section of shore has the widest bar system leading to the most stable beach. Generally, this reach is a nodal point inside the larger reach that has had little change. Patchy dunes have existed at this site from 1949 through 1973, but by 1989, the dune field had matured (Milligan *et al.*, 2005). Over the course of the earlier monitoring period (2001-2004), the dune crest height has accreted about 0.5 ft. During the hurricane, significant southerly transport allowed the beach, backshore and dune to accrete (Milligan *et al.*, 2005). The storm created stable beaches that have become accretionary but now, six years later, the site is exhibiting signs of major erosion (Figure 7E-F). The beach particularly, has eroded back as much as 40 ft as was the case of the upper beach on the middle profile (Figure 9). The back of the primary dune is the only section of the site that is stable. The site is somewhat man-influenced due to the presence of a groin at the southern end of the site.

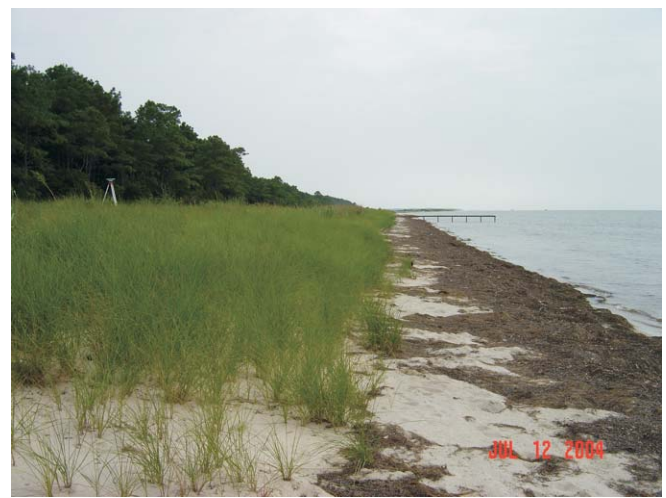
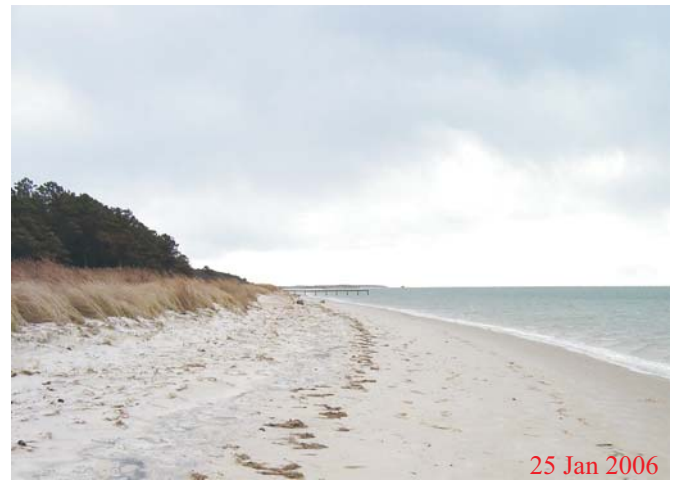
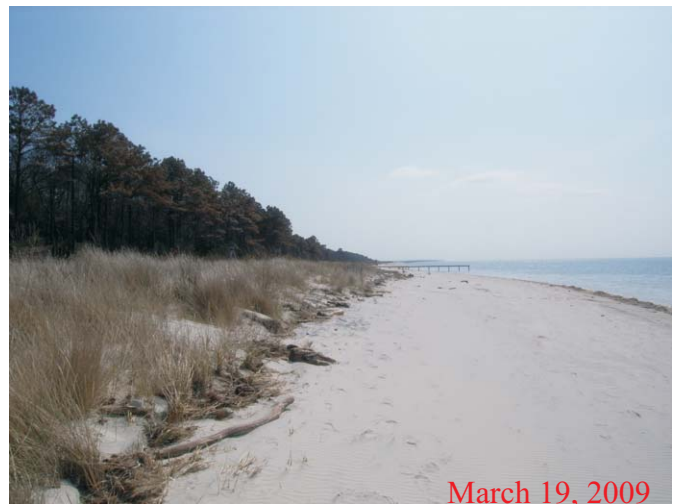
The present day dune at NH17 developed on a spit that formed in 1955. The dunes were established by 1972. This site also has nearshore attached bars which provide a large amount of sand for dune creation. NH17 is backed by a high upland bank which has been farmed for several generations. The entire reach is slightly erosional updrift and downdrift of the dune site, but the dune site itself has been accretionary even after Hurricane Isabel impacted the shore (Milligan *et al.*, 2005). Presently, the dune crest itself has remained in the same position while the beach has started to accrete on NH17-1 and NH17-2 (Figure 9). However, the shore at NH17-3 and NH17-4 has eroded and may soon impact the crest (Figure 7F-H). Significant foredune growth has occurred at the southern end of the site which decreased the width of the backshore.

Figure 9. Photographs of NH10 and NH17 during the course of surveying.

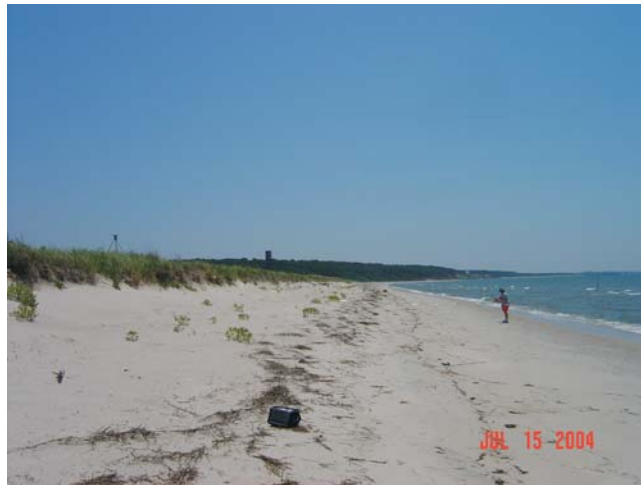
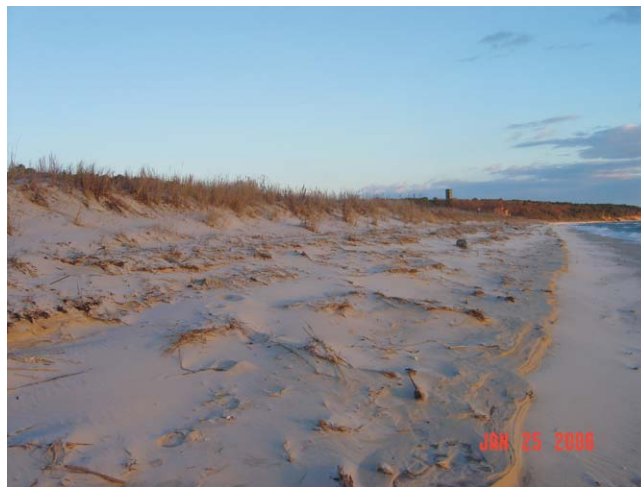
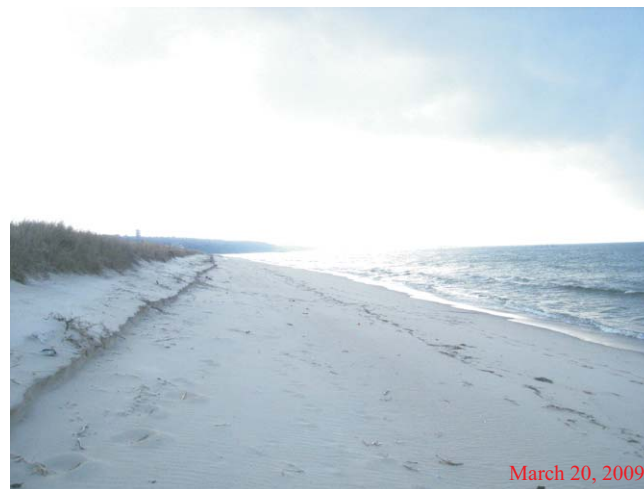
NH51-1

Figure 10. Photographs of NH51 during the course of surveying.
