## **New Point Comfort Lighthouse Mathews, Virginia Site Assessment Plan**

New Point  
Comfort  
Lighthouse  
Mathews, Virginia

Site Assessment Plan

**February 2008**

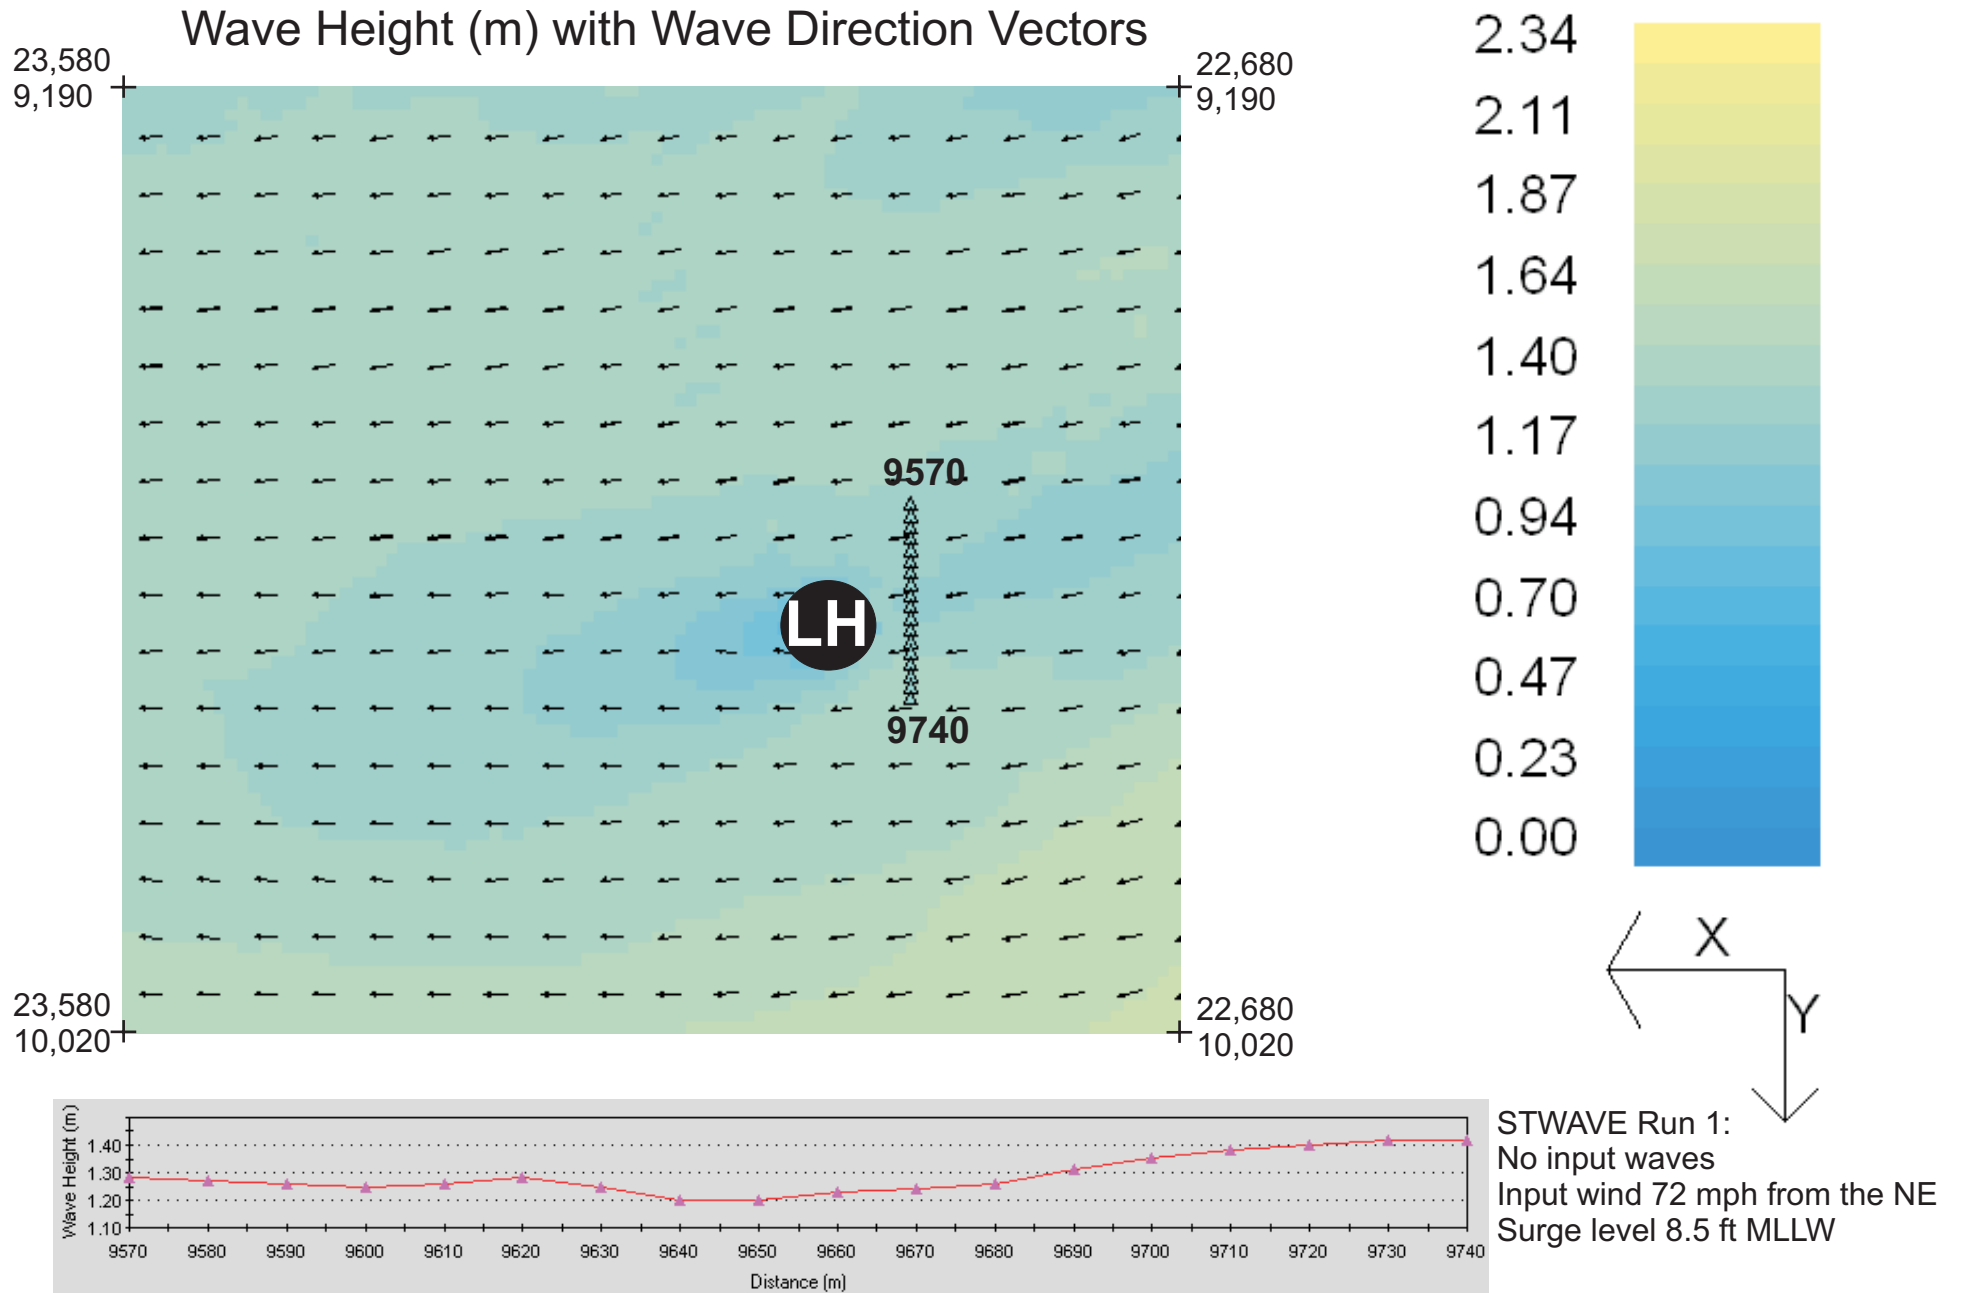
Figure 17. Results from STWAVE model run 1. Lighthouse position is approximate.

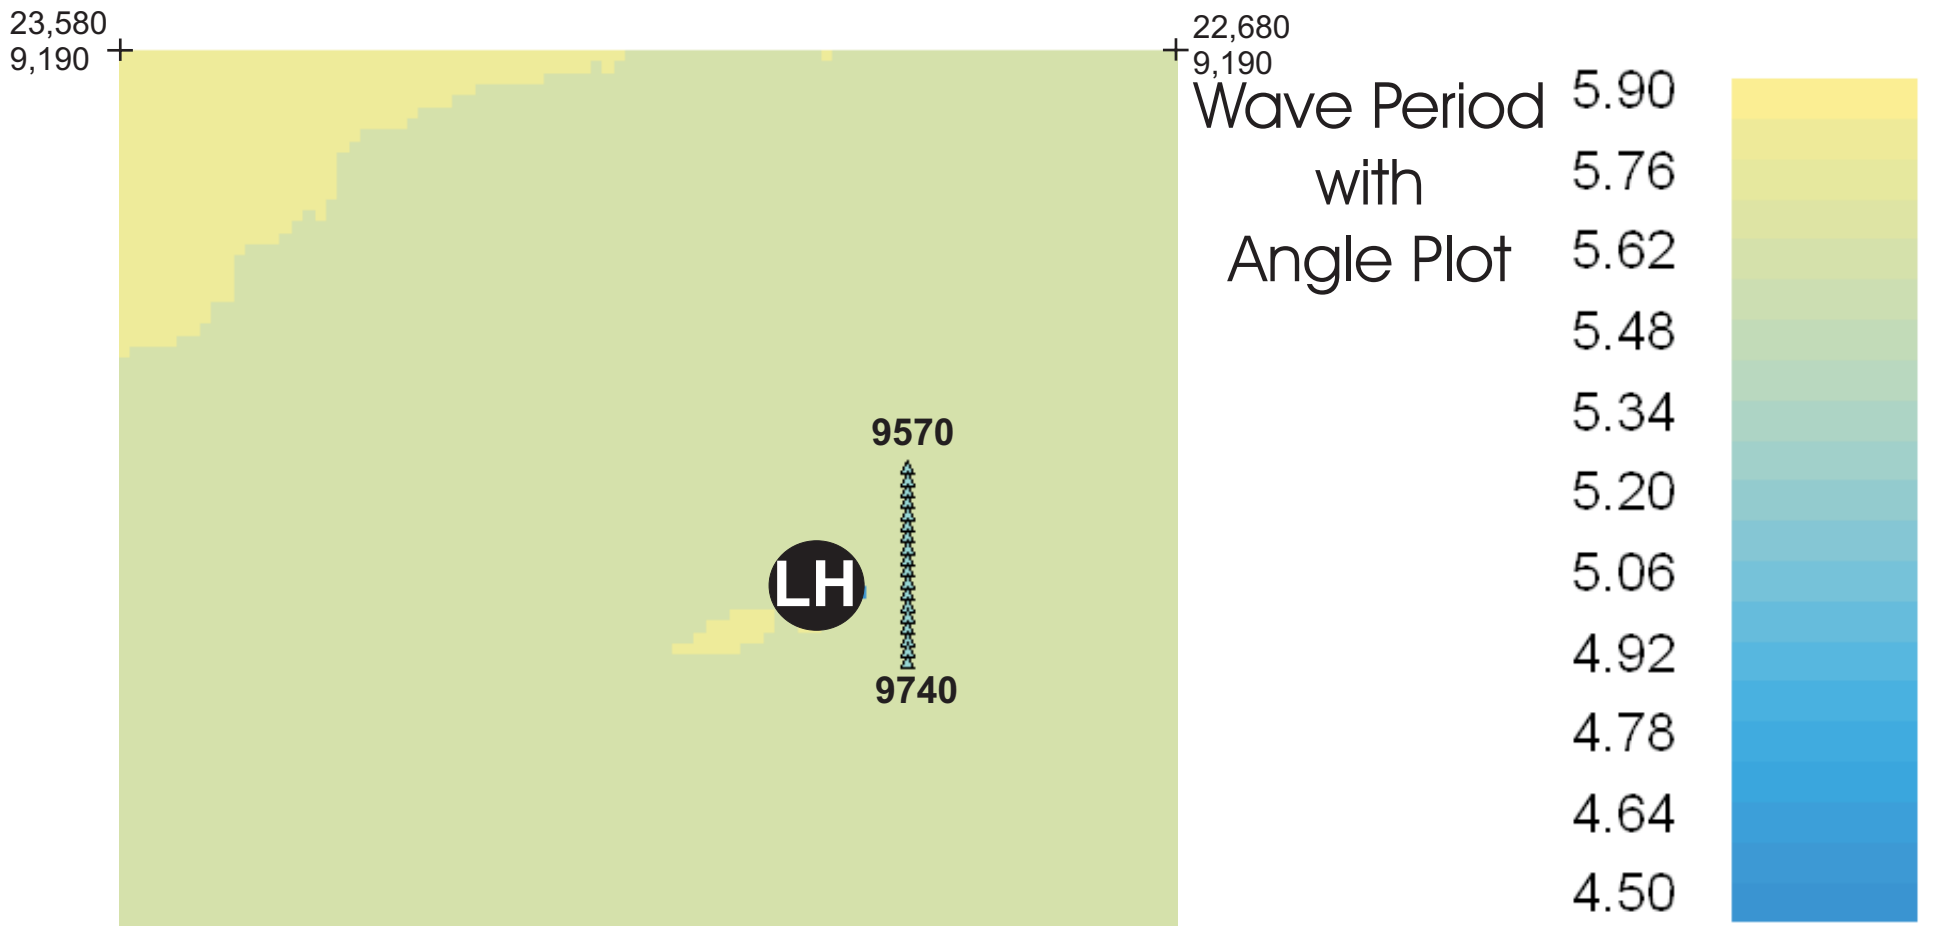
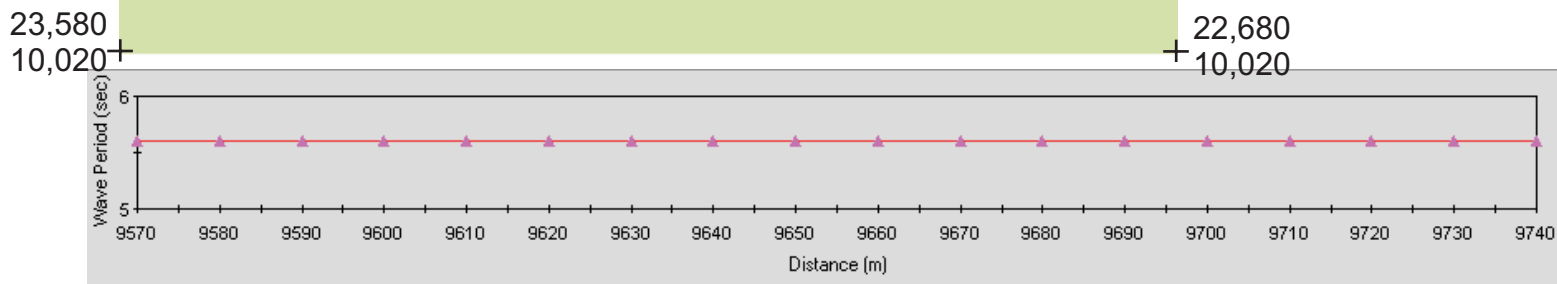
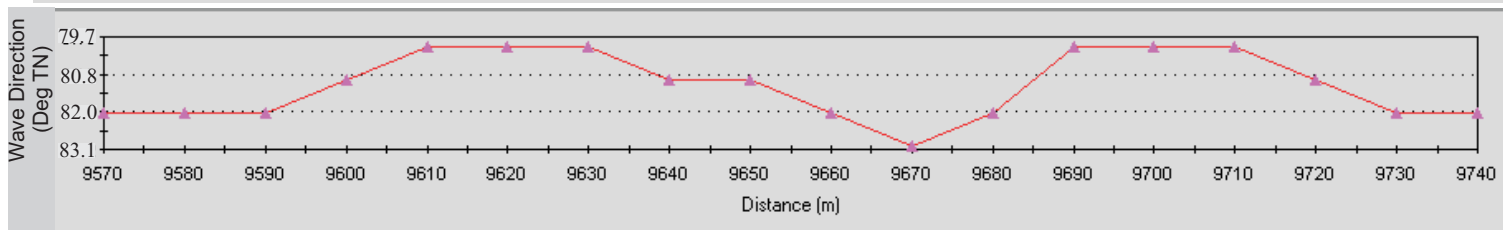
STWAVE Run 1:  
 No input waves  
 Input wind 72 mph from the NE  
 Surge level 8.5 ft MLLW

03 Figure 18. Results from STWAVE model run 1. Lighthouse position is approximate.

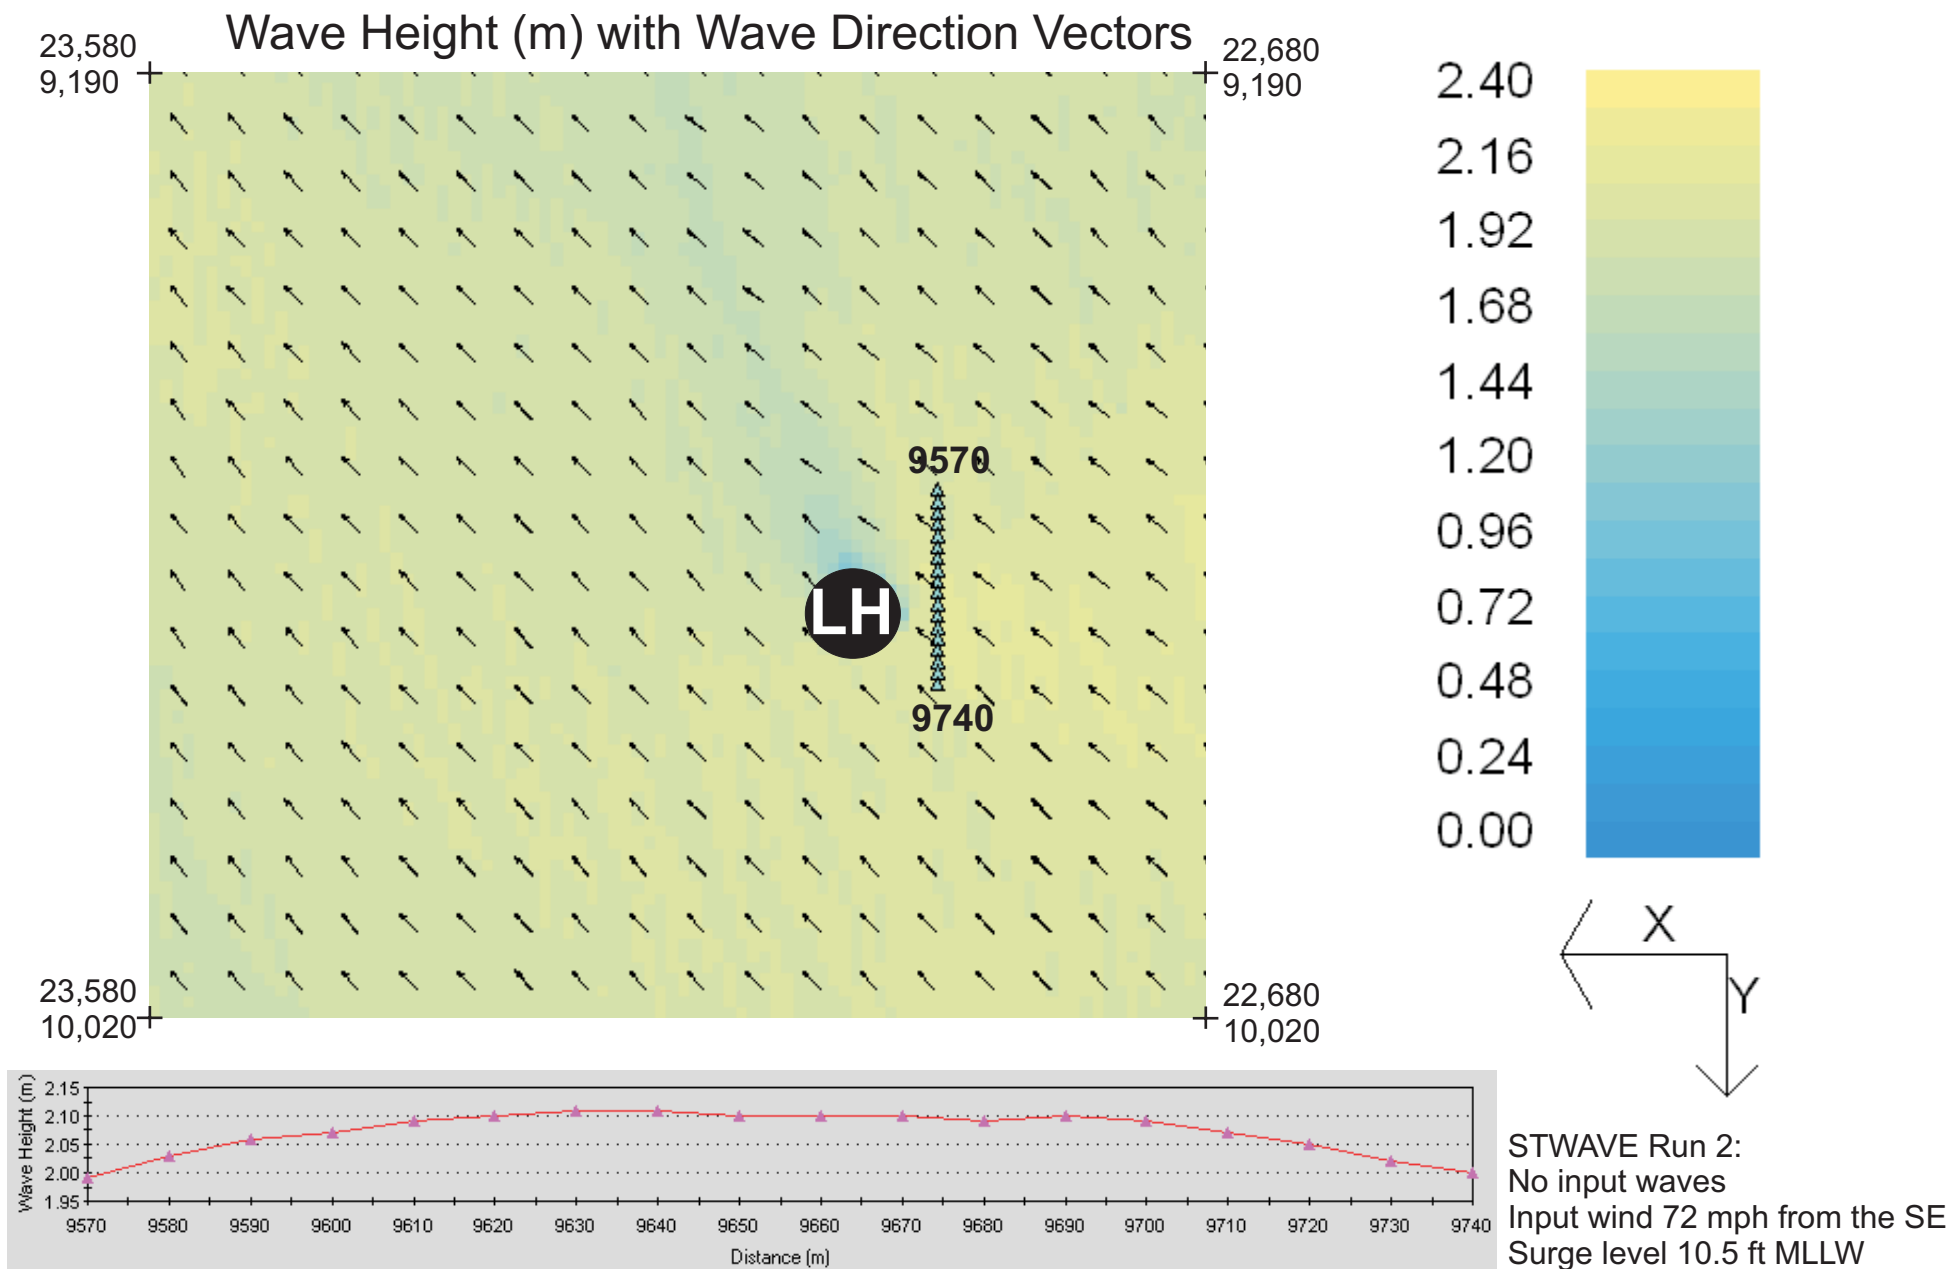
These factors were taken into consideration when determining the storm scenarios to model. The initial model run used 72 mph winds which was slightly higher than those experienced at VIMS to simulate a more open bay condition. Storm surge was 8.5 ft MLLW which was consistent with the surge experienced at Yorktown. [Figures 17 and 18](#) show the results of the first design model run. Northeast winds generated a maximum wave of 4.6 ft MLLW and 5.6 sec mostly coming from the east-northeast. Considering these conditions have already been experienced during Isabel, the second model run used a larger surge ([Figure 19 and 20](#)). Southeast winds generated a maximum wave of 6.9 ft MLLW and 6.1 sec from the southeast.

Figure 19. Results from STWAVE model run 2. Lighthouse position is approximate.

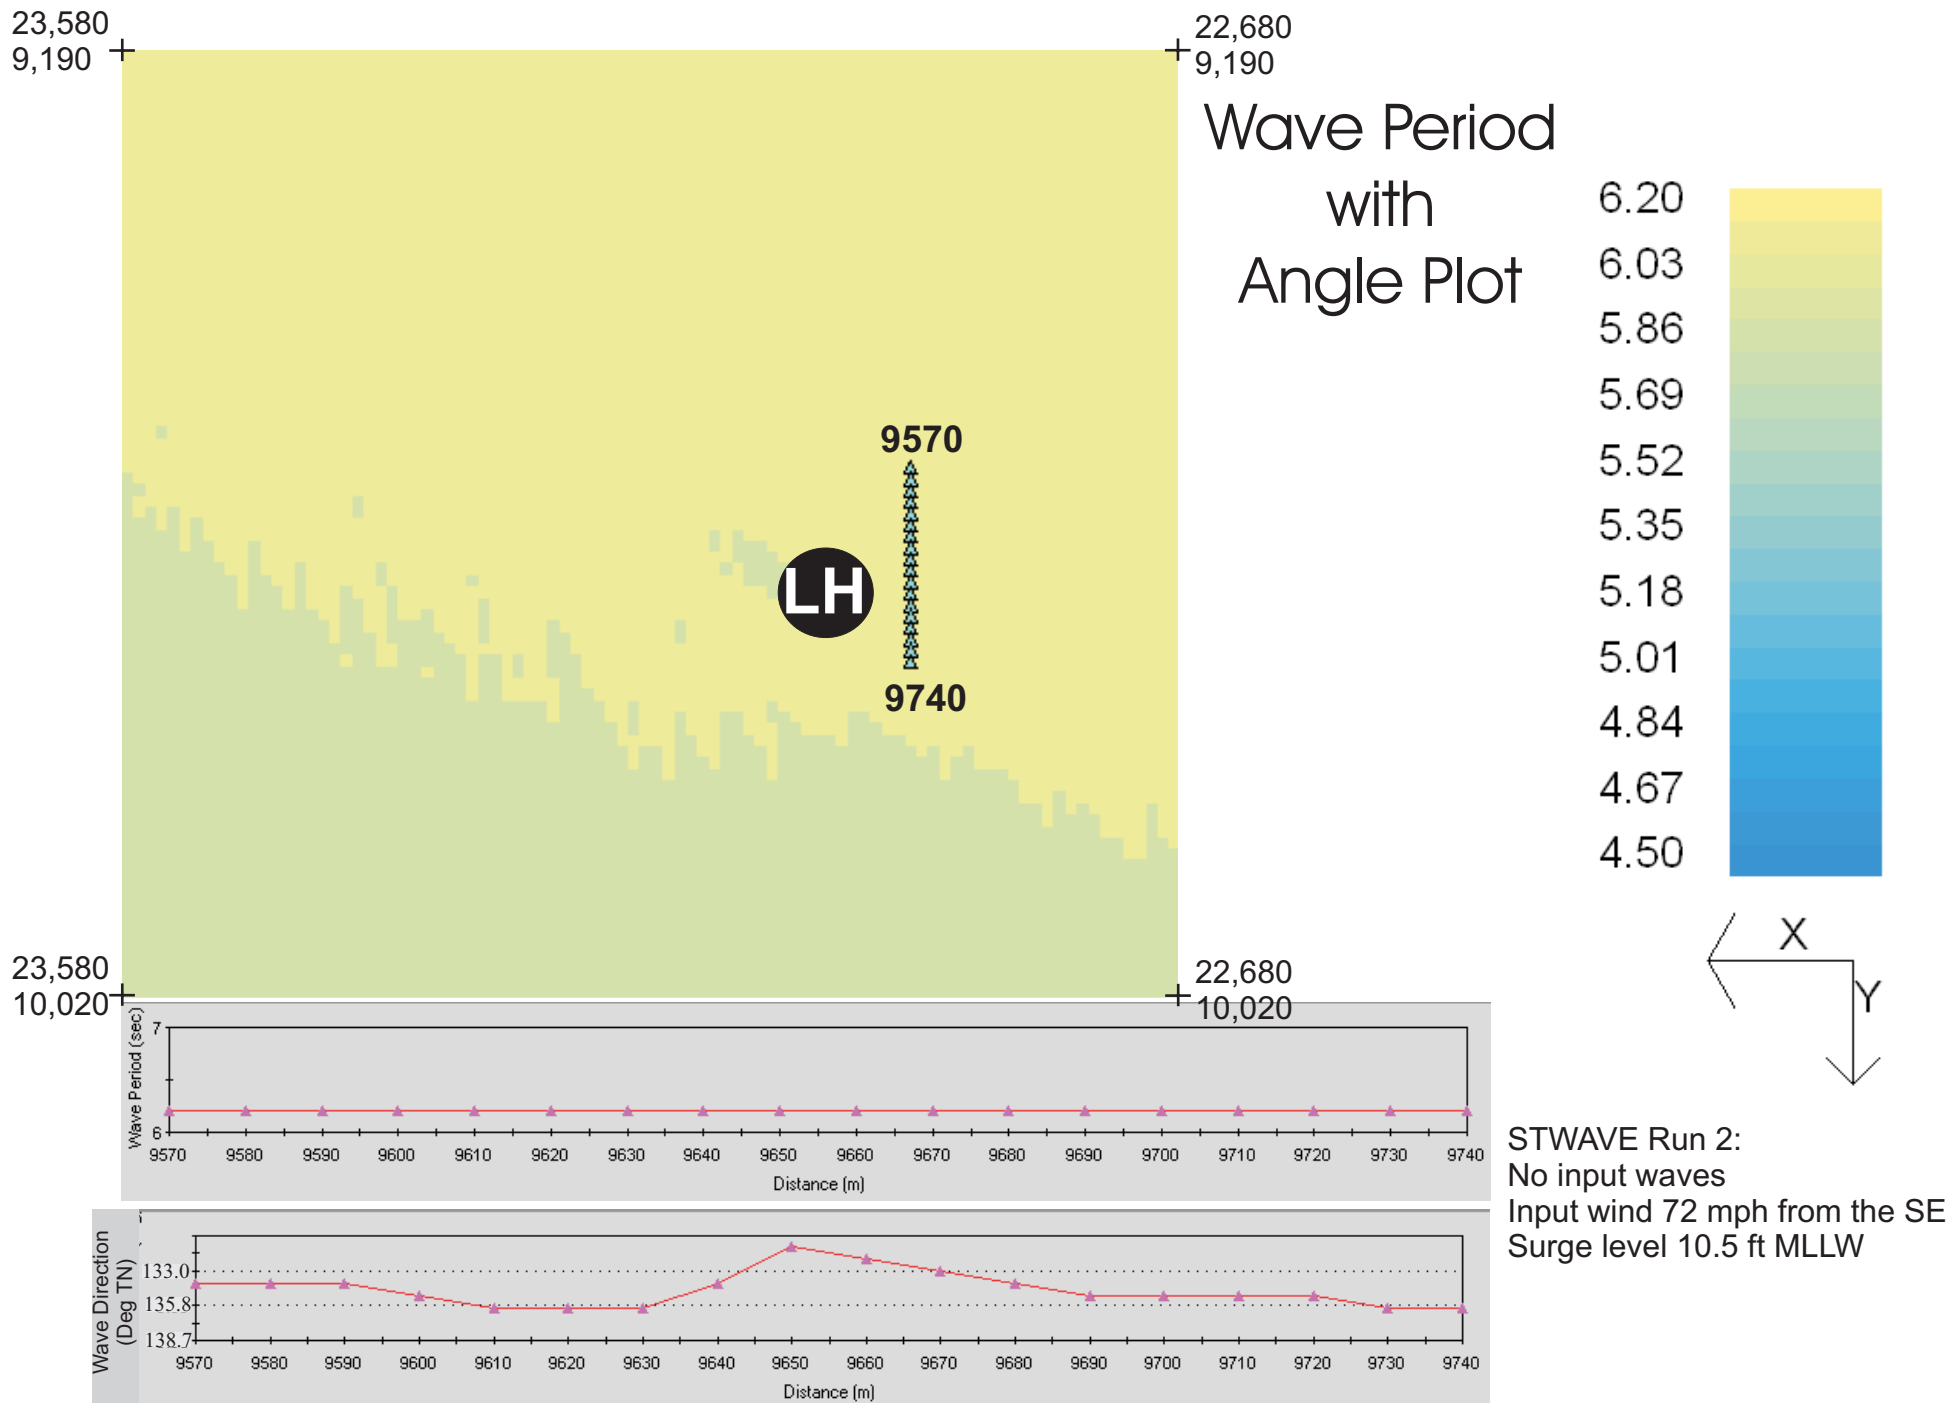
Figure 20. Results from STWAVE model run 2. Lighthouse position is approximate.

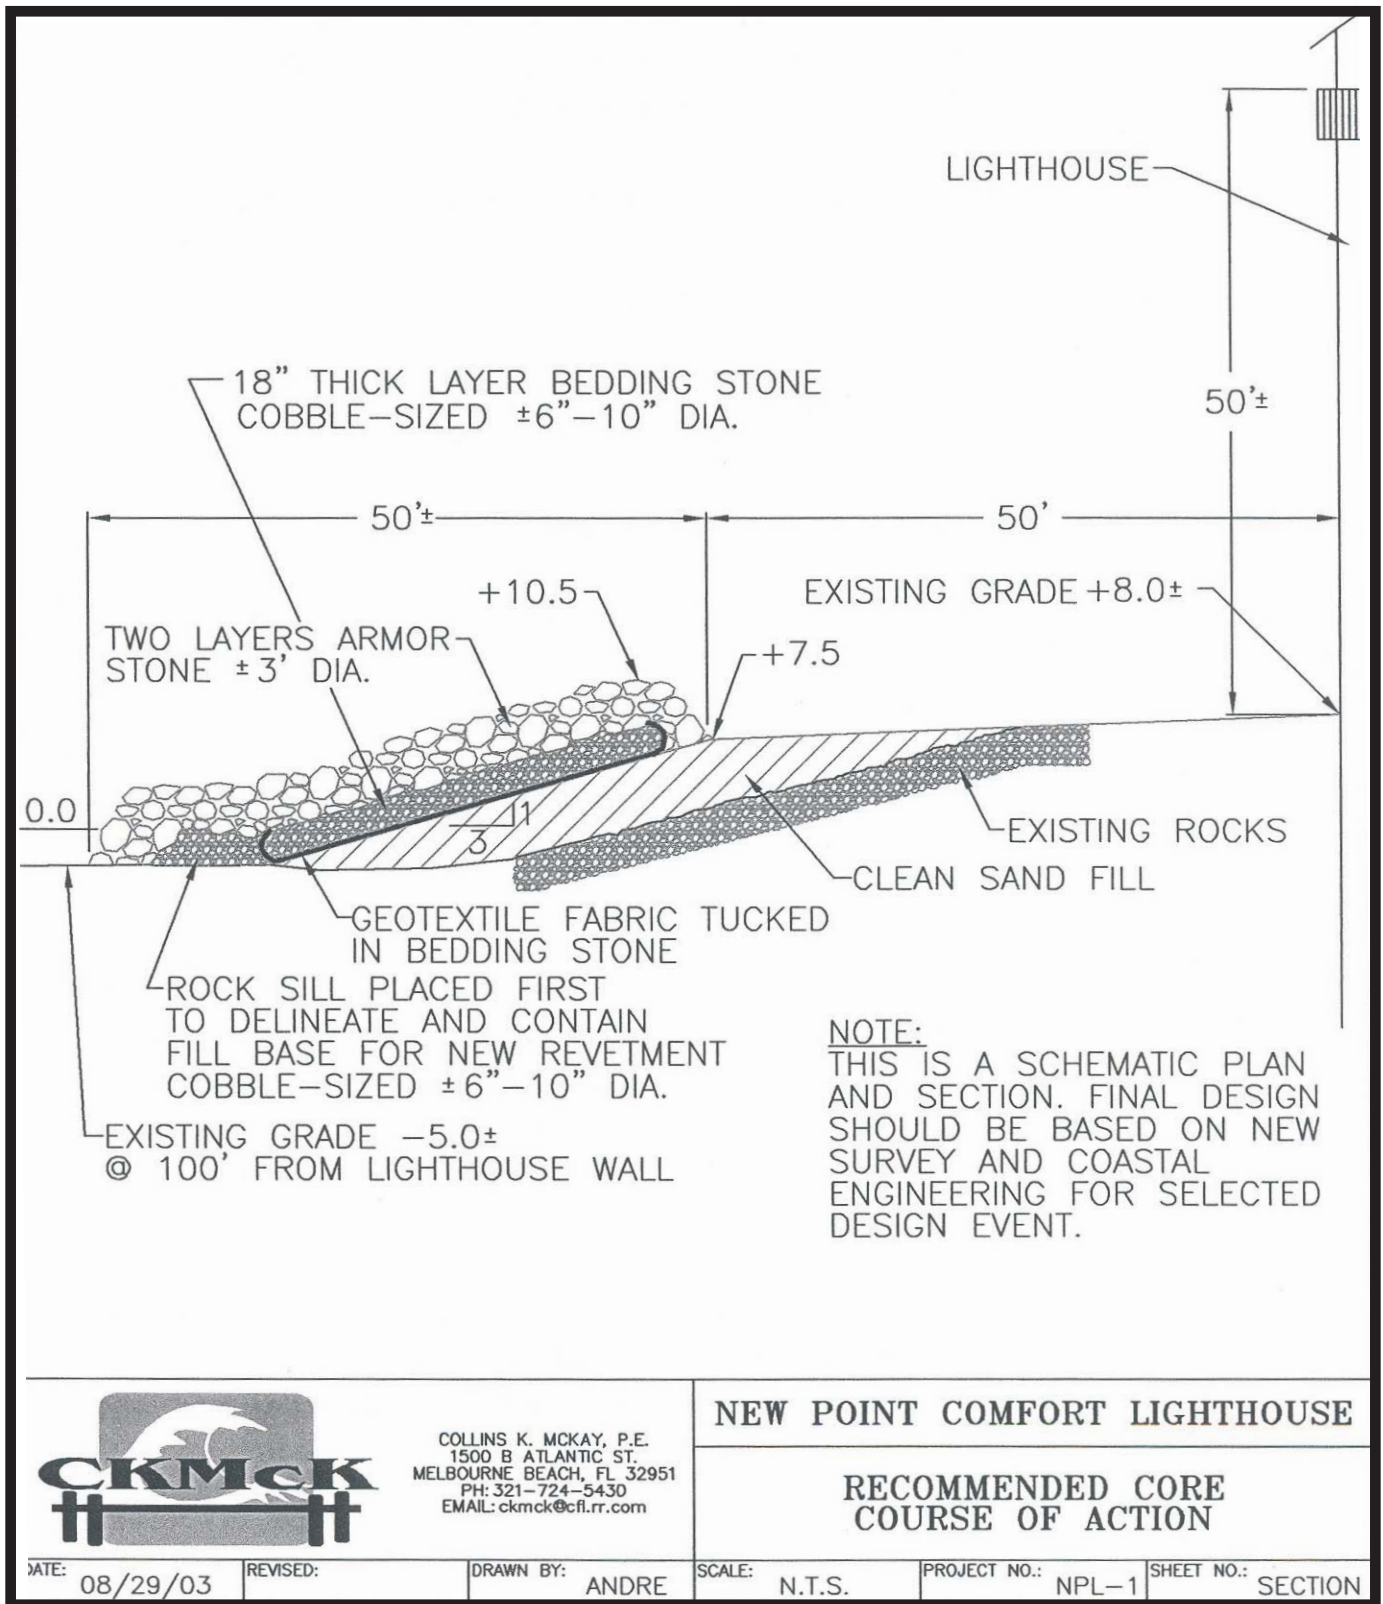
Figure 22. Typical cross-section of the core course of action recommended by McKay (2003).

Previous research has identified the causes of instability of the island on which New Point Comfort Lighthouse sits as well as provided plans for its stabilization. In general, McKay (2003) rated the present rock revetment around the lighthouse as "poor to grave" and susceptible to a large storm event (Figure 21). He predicted that a large storm event would push the undersized rocks at the crest of the revetment into the walls of the lighthouse. This occurred during Hurricane Isabel which impacted the region on September 18, 2003 (Figure 21) as a minimal category 1 storm. As part of his report, McKay (2003) developed several alternative plans but also made a recommended core course of action (Figure 22). His plan consists of a 50 ft level, open surface around the base of the lighthouse, a proper rock revetment 50 ft wide and a crest elevation of +10.5 ft with at least two grades of rock, geotextile fabric, and an embedded toe to guard against undermining, a parapet wall cast into the crest of the revetment, and a new pier. McKay (2003) noted that this core plan, which was estimated to cost just over \$1 million, would stand alone as primary protection for the lighthouse but will also be compatible with future phases, should they occur.

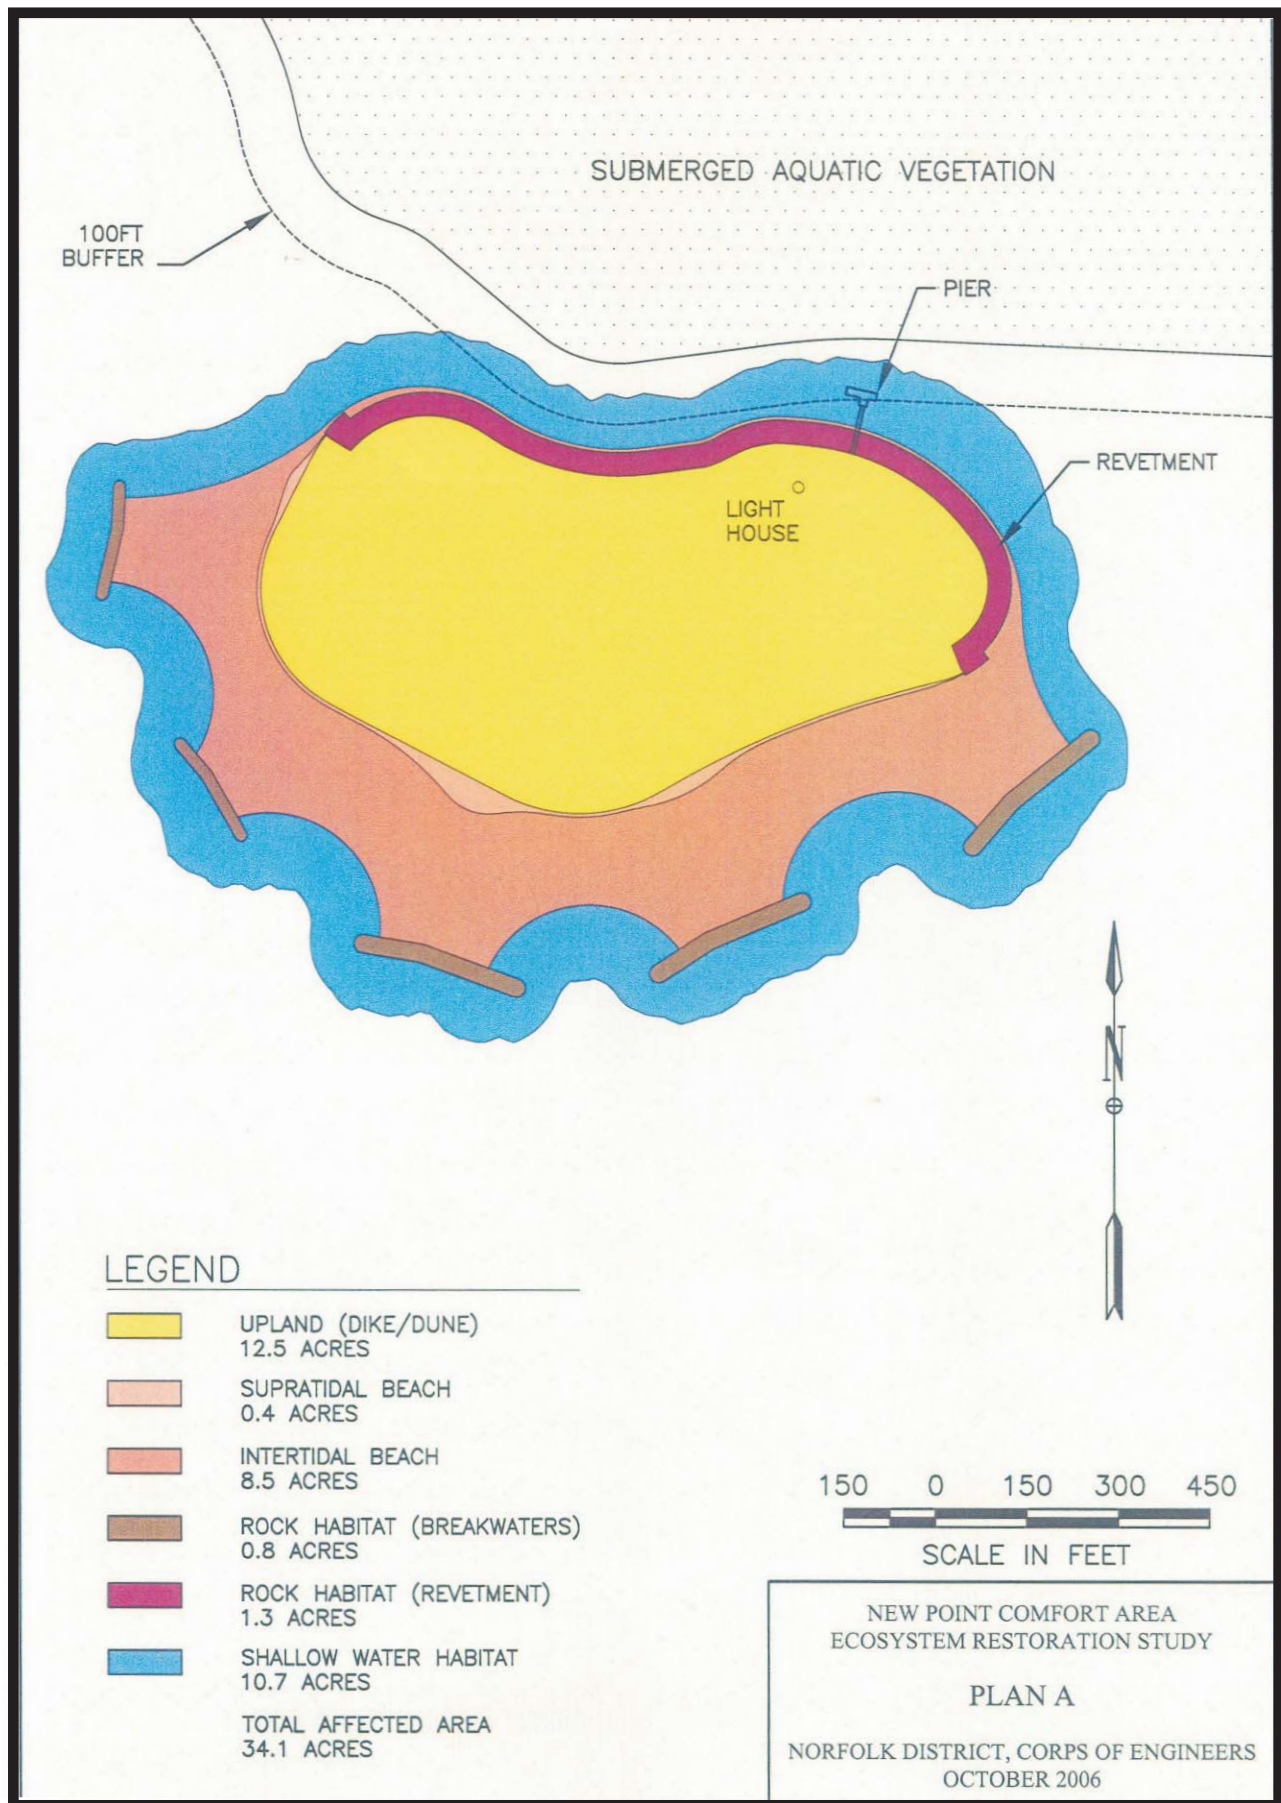
Figure 23. One of the three most cost-effective plans included in the Corps (2007) ecosystem restoration study.
