Report of Trip to Investigate Area Around Heron Island Bar in the Potomac River

REPORT OF TRIP TO INVESTIGATE AREA AROUND
HERON ISLAND BAR IN THE POTOMAC RIVER

Marine Resource Report #81-8

10 July 1981

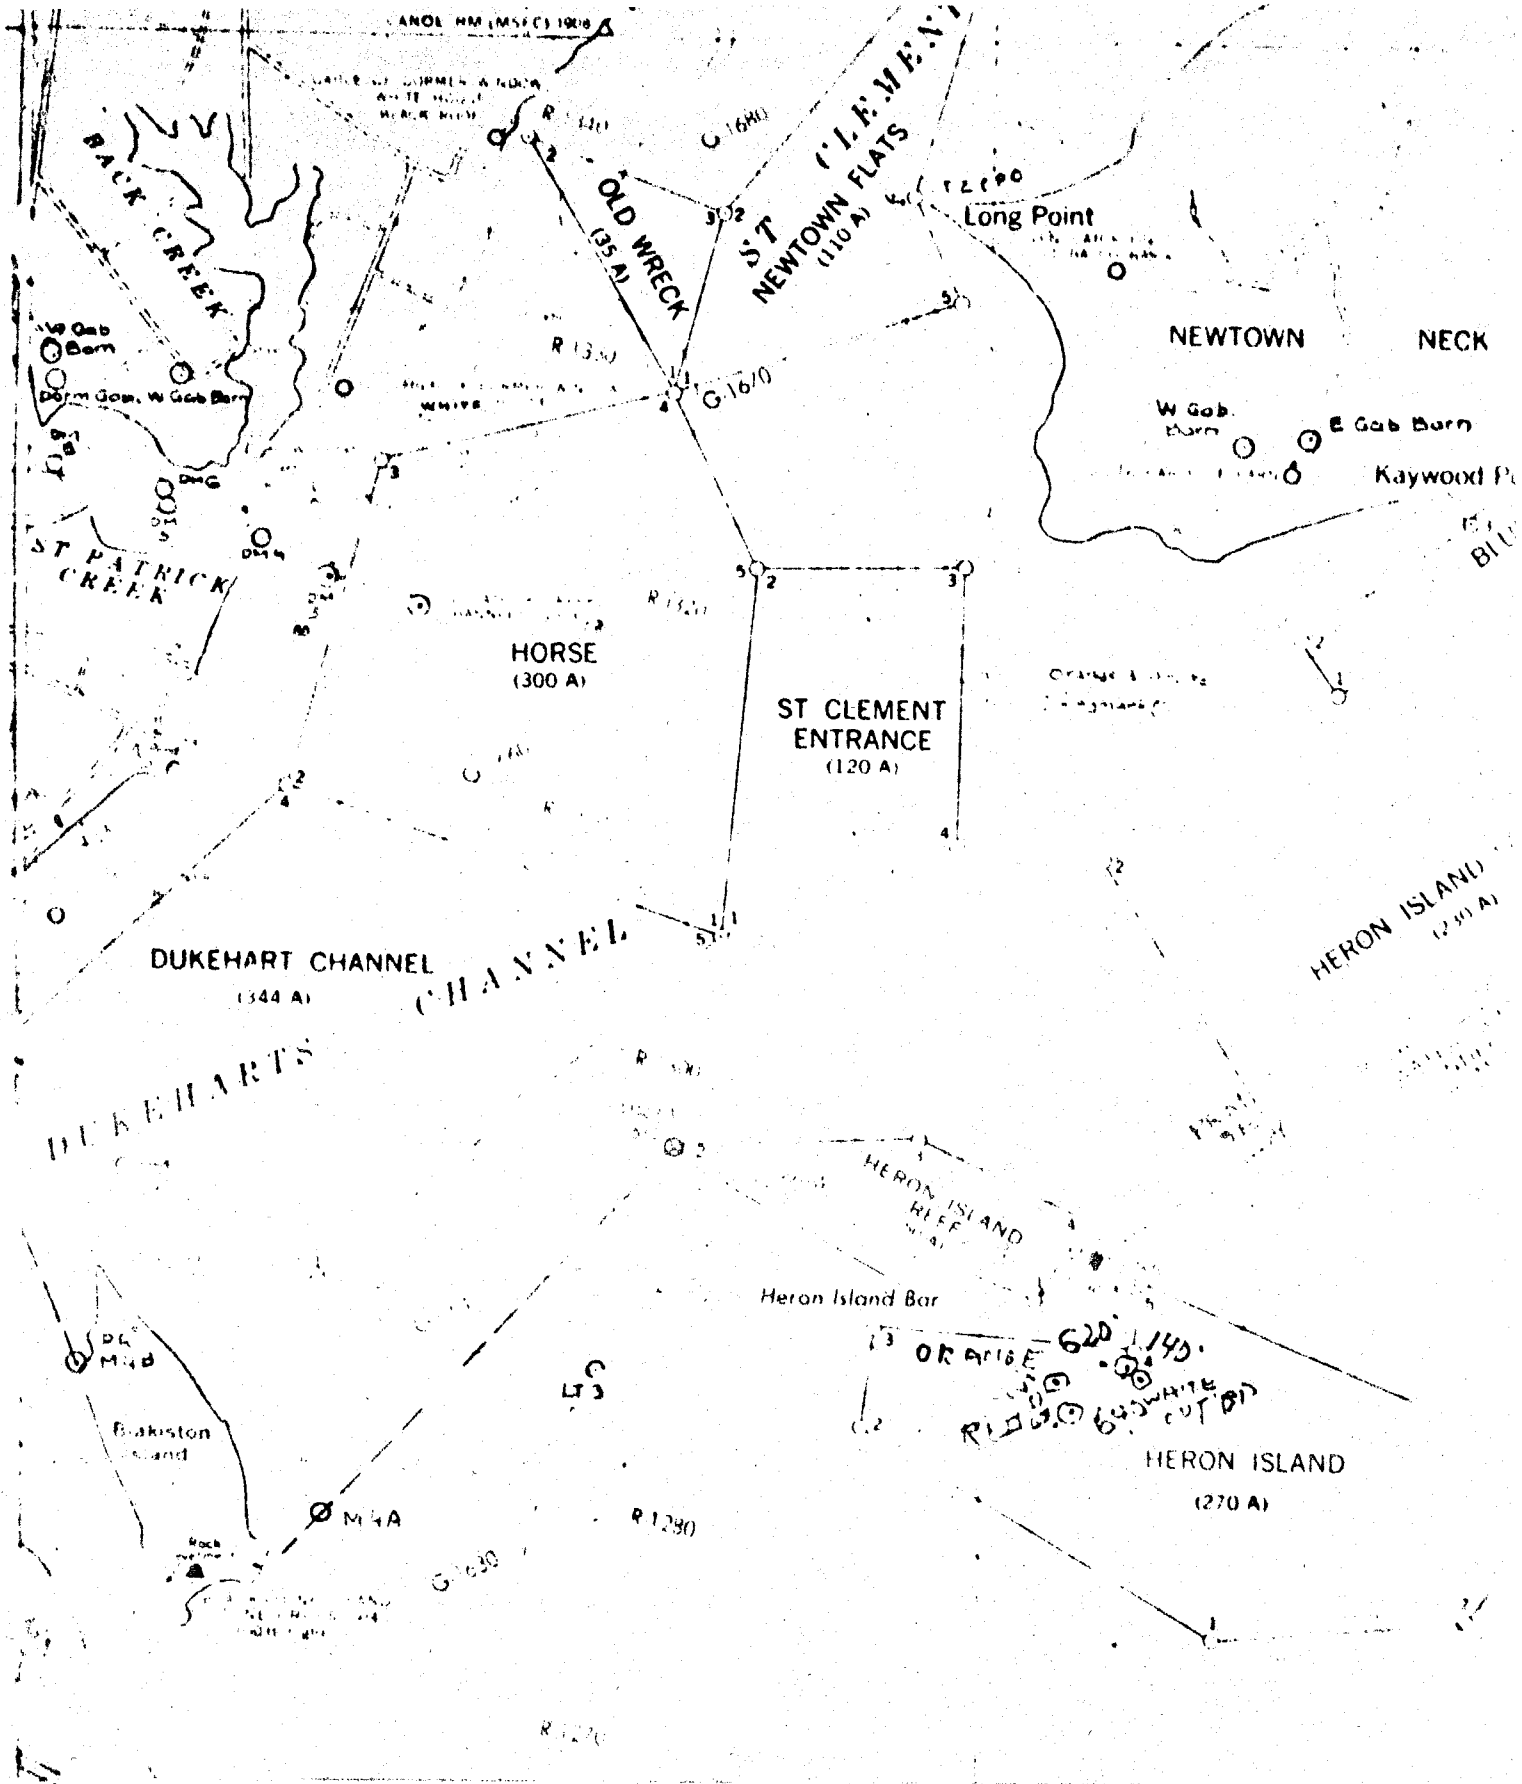
had rested when aground. The locations of these buoys were later fixed by sextant by Mr. Marple and charted by him on a copy of Chart No. 26 (1961) "Natural Oyster Bars of St. Mary's County" (Figure 1). The area enclosed by and surrounding the buoys was crisscrossed and circled while a portable fathometer continuously recorded the profile of the bottom.

Figure 1. MD DNR Chart 26 showing the Heron Island Bar area. Locations of buoys used on 17 June 1981 and the distances between them plotted and measured by Mr. Scott Marple, Chief Surveyor for MD DNR.
