## Piankatank River Shoreline Situation Report

# Piankatank River Shoreline Situation Report

*Special Report in Applied Marine Science and Ocean Engineering*  
*SRAMSOE No. 361*

*April, 2000*

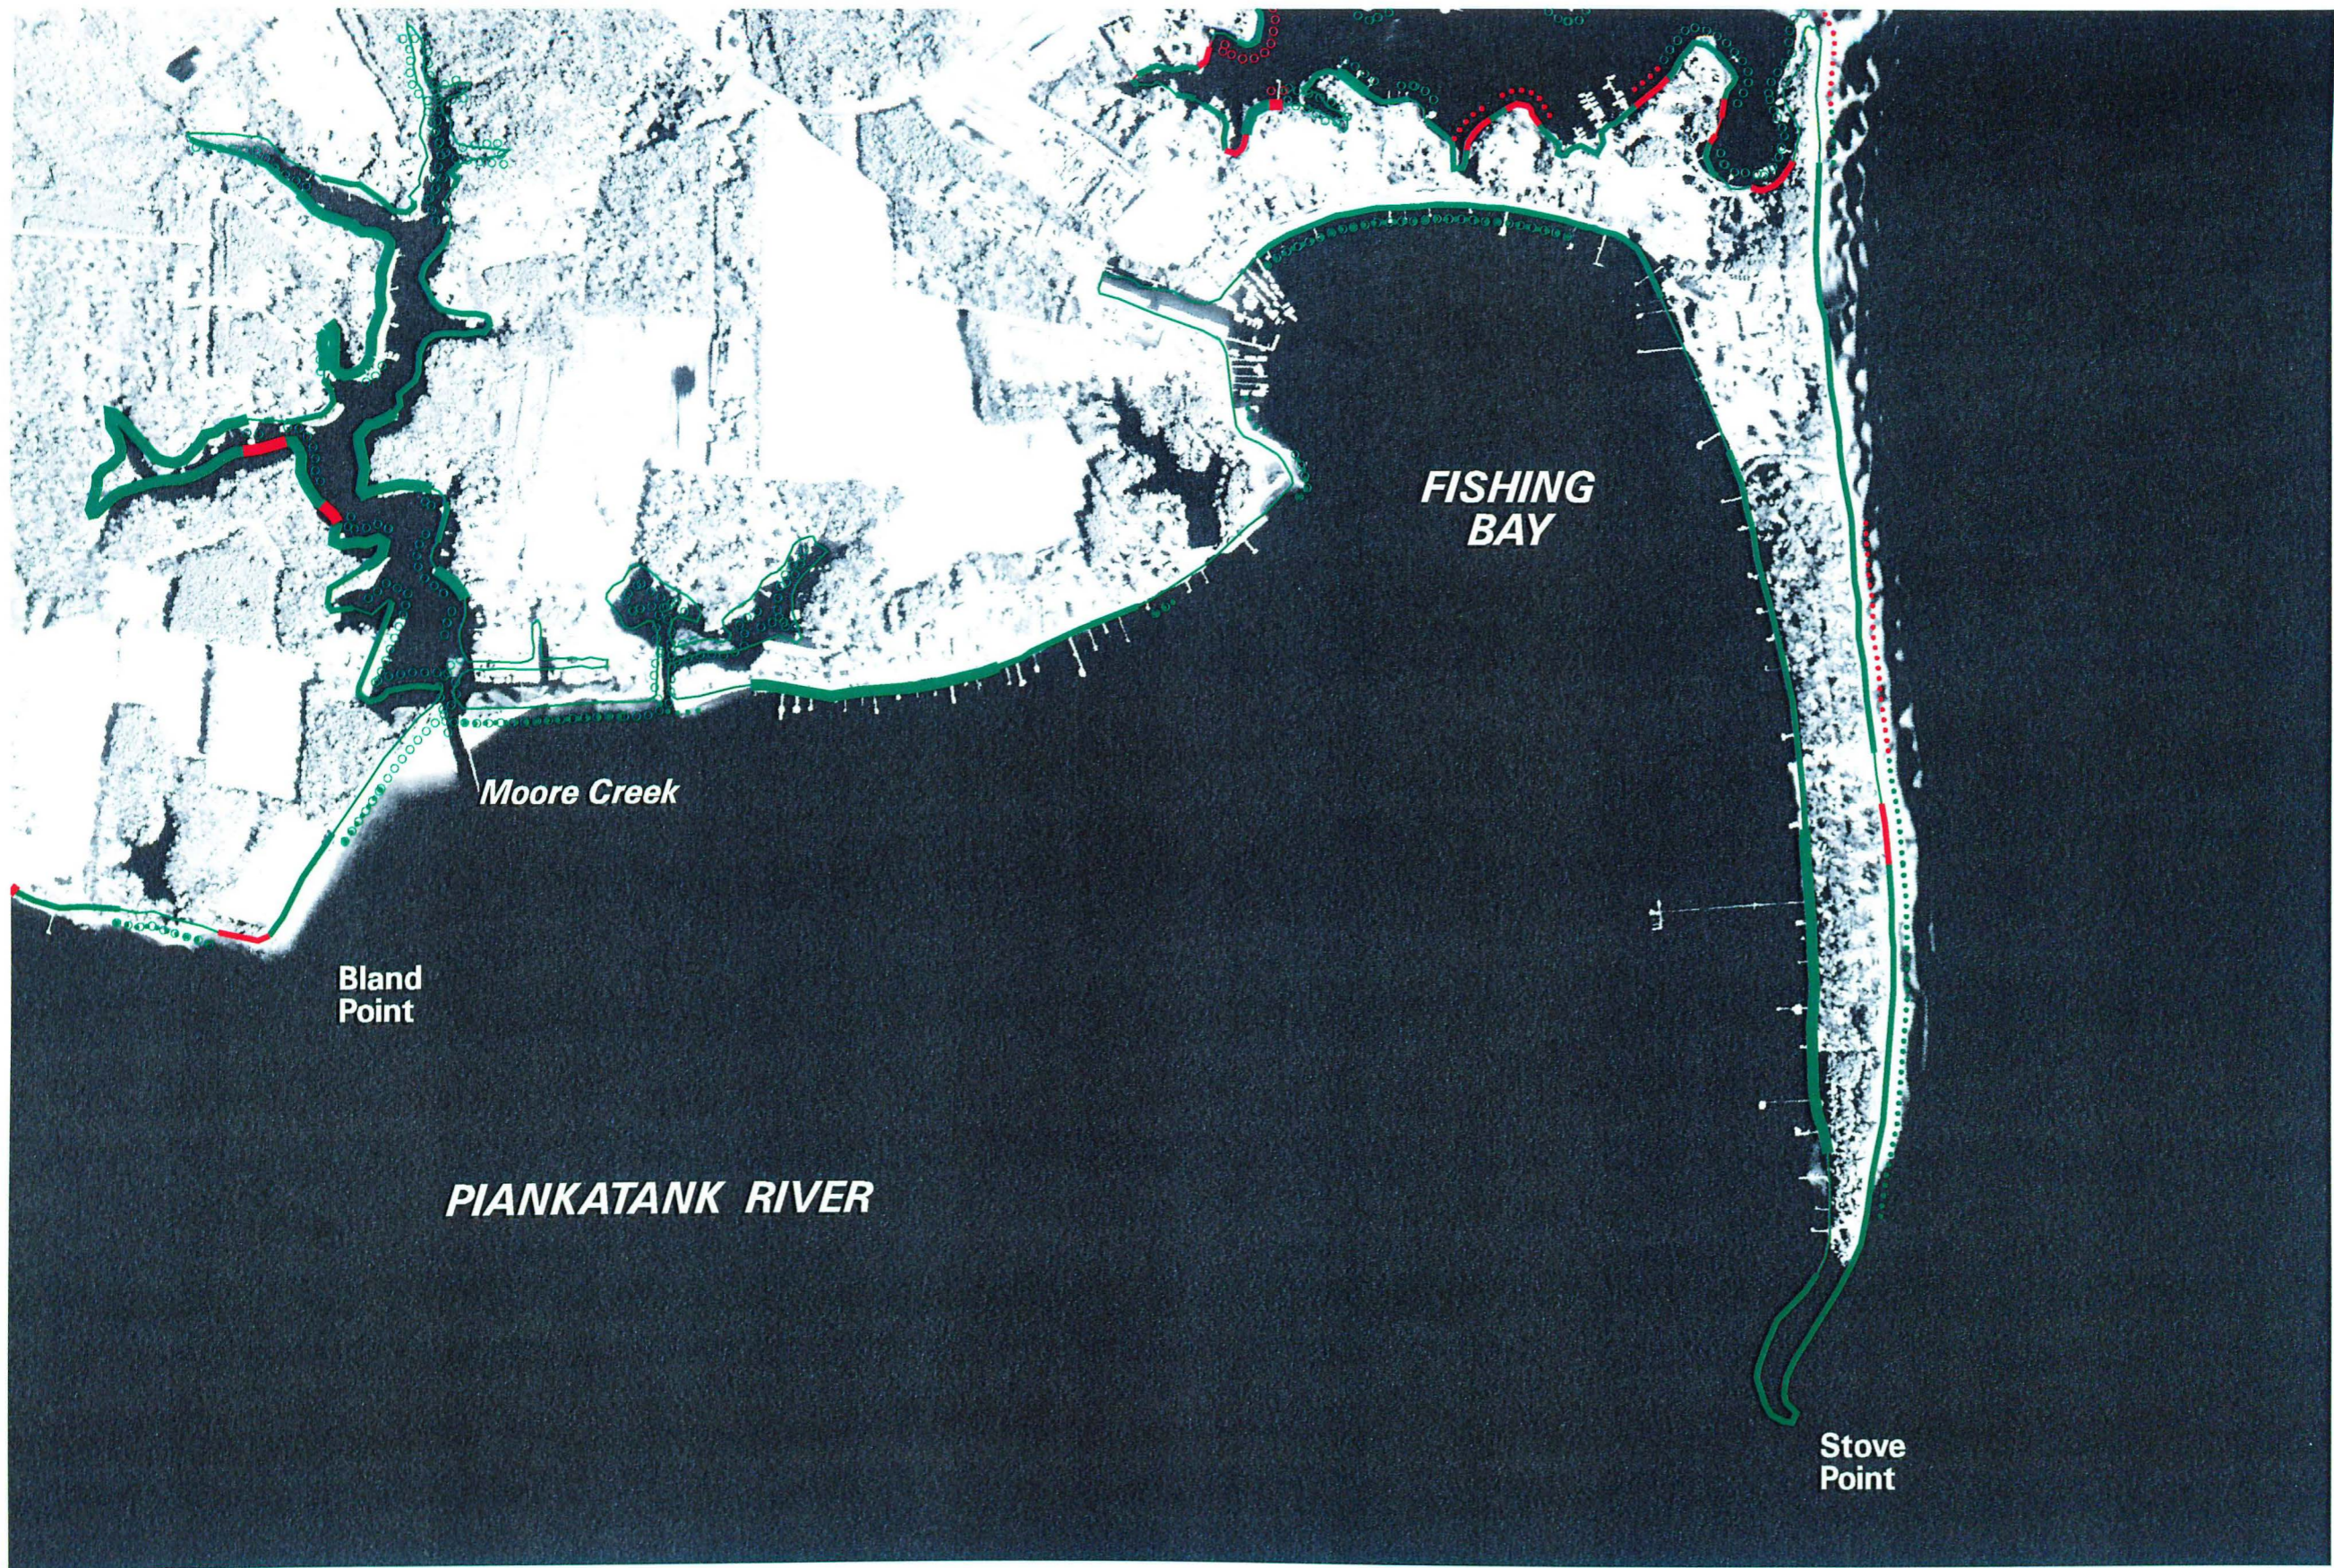
# PIANKATANK RIVER PLATE 7b

**Bank Condition:** Bank height in this area ranges from less than five feet to more than 10 feet. Roughly one third of the banks surveyed were between 5 and 10 feet high. Erosion is low along nearly all reaches, except at select areas of Jackson Creek, and the Bay side of Stove Point. The eastern shore along Stove Point is protected by riprap and bulkheads. A sandy beach here exhibits signs of erosion and accretion at different points. The beach, assisted by a long groinfield (Plate 7c) is wide enough, and persistent enough to offer erosion protection to the bank. Shoals are obvious along the eastern and southern nearshores.

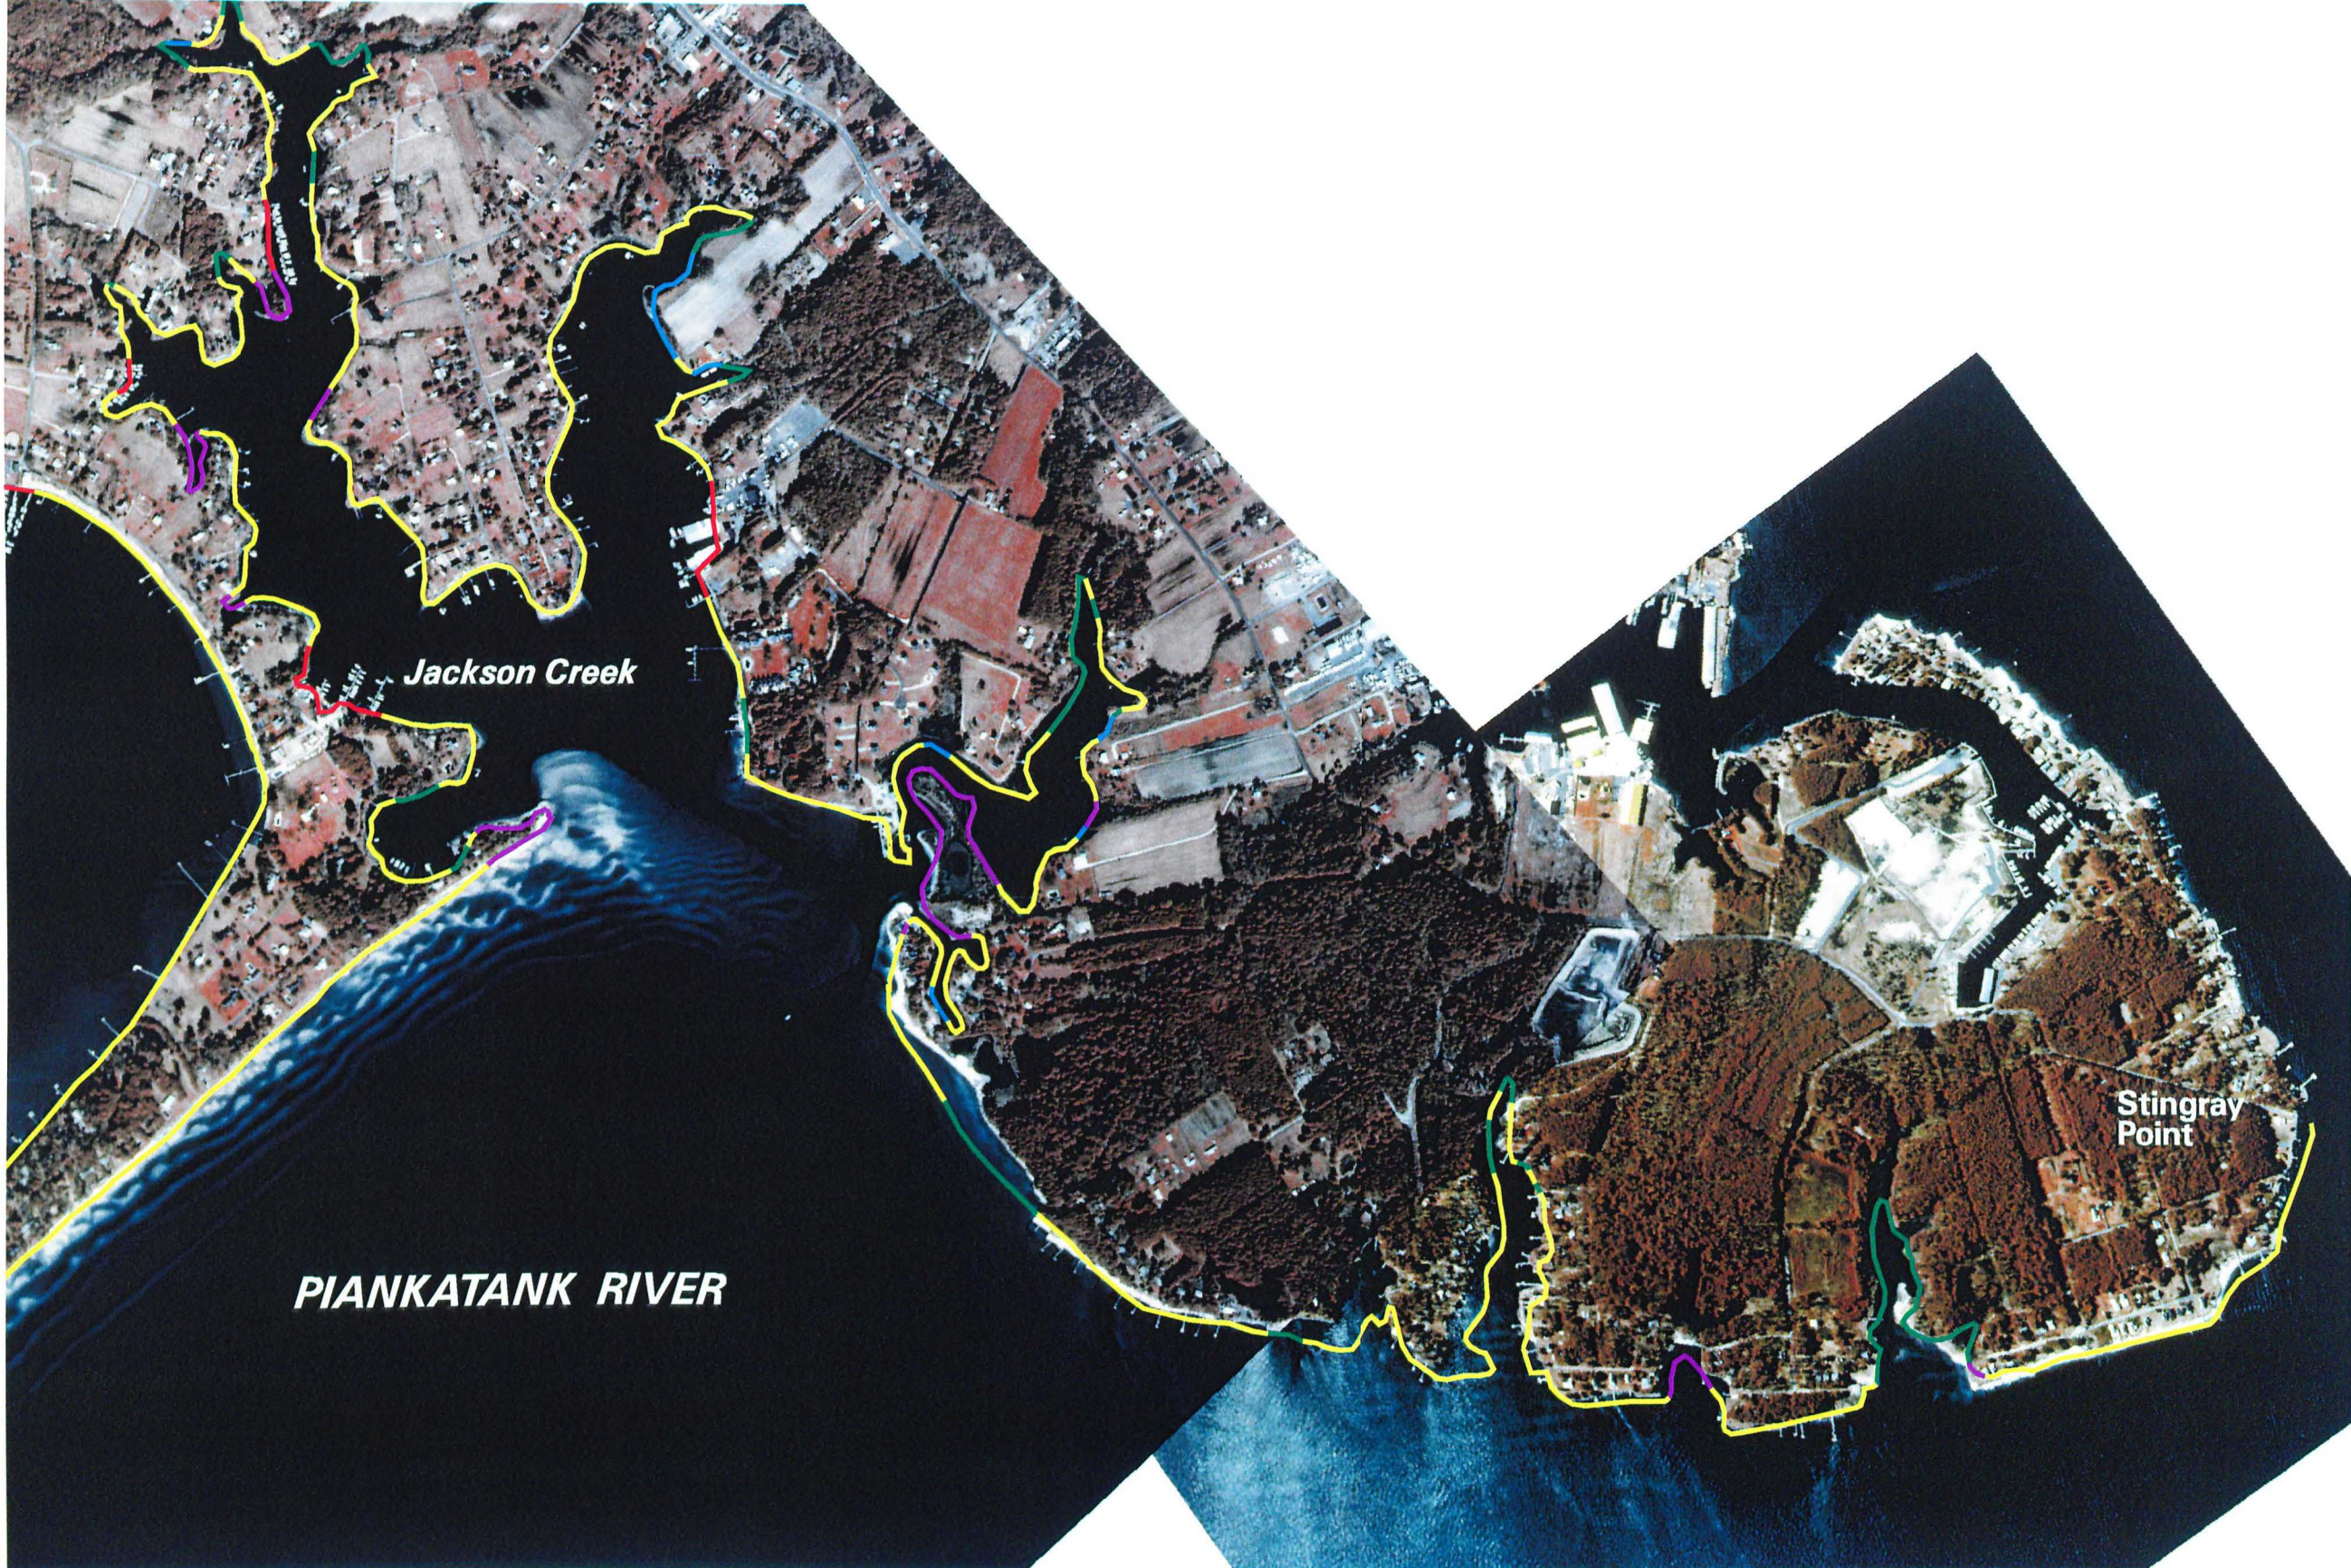
**PIANKATANK RIVER**  
**PLATE 8a**

**Land Use:** Land use within Plate 8 is dominated by residential use with 8.60 miles of the 12.15 miles surveyed designated as residential. Forest cover is present at intermittent sites, and accounts for just over 1.6 miles of the surveyed shoreline. Forest cover is notable in the upland area surrounding the low density residential districts west of Stingray Point. There are five commercial areas. All of these are surveyed as marina/dock facilities of some type.

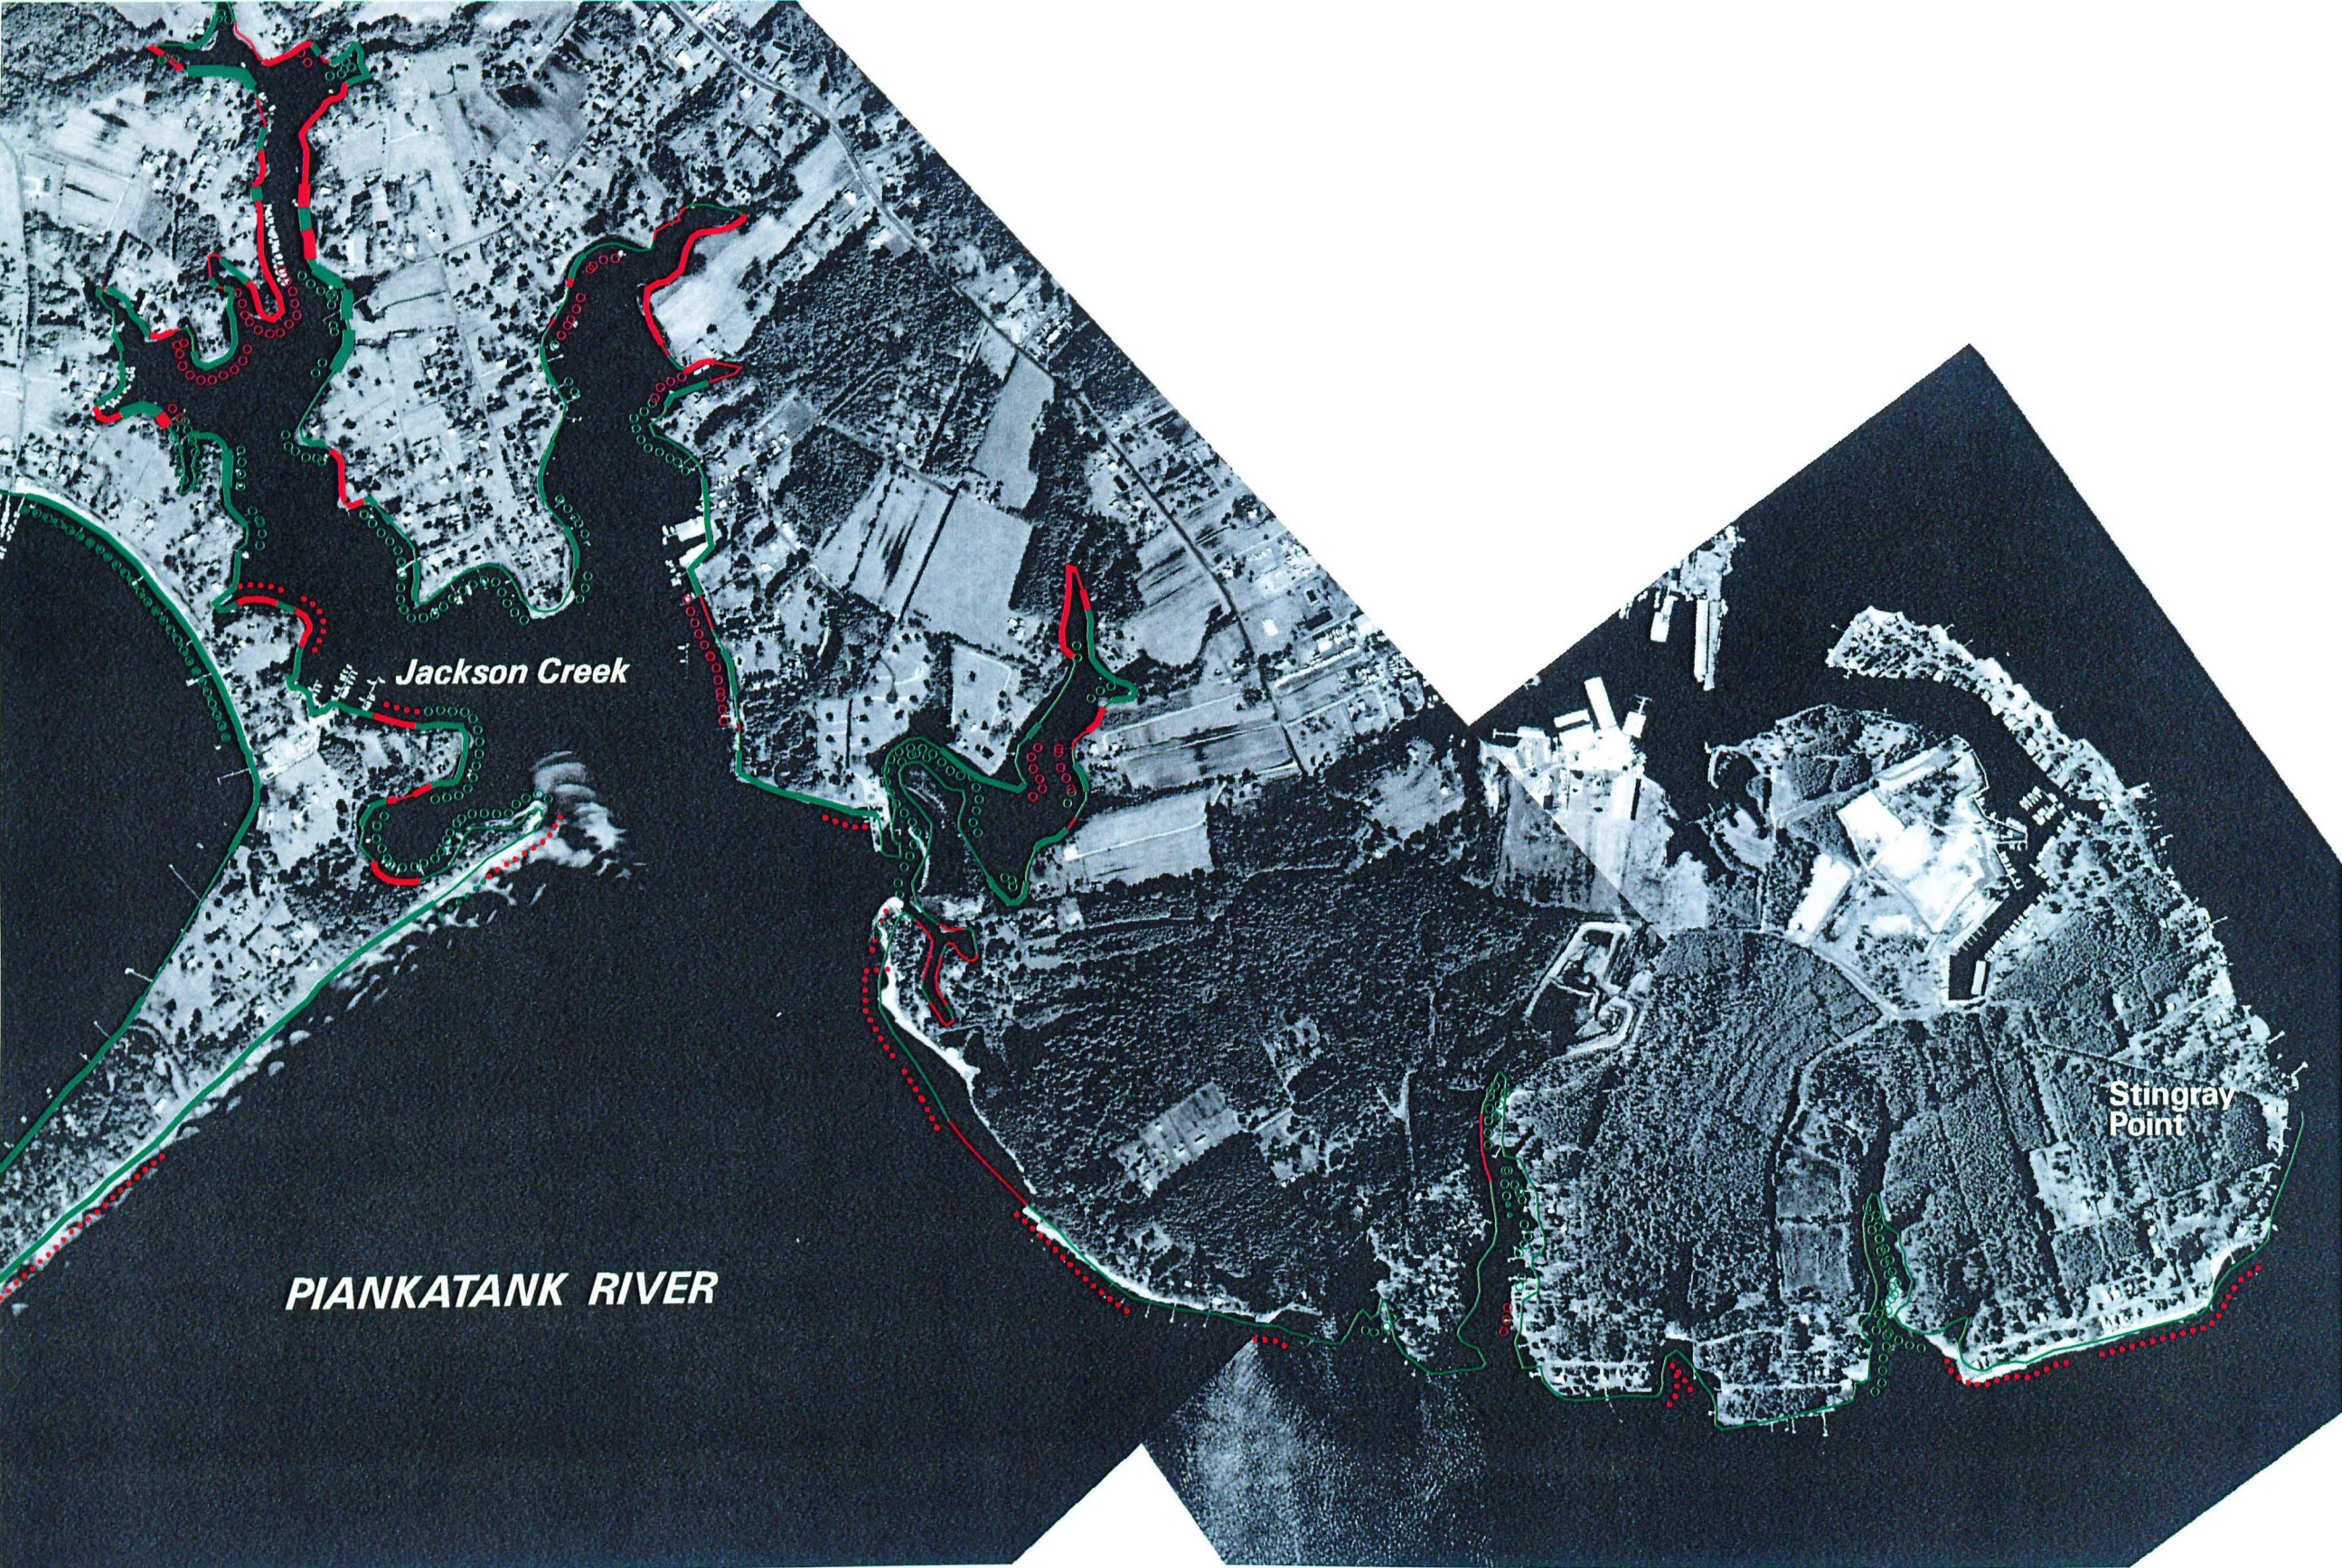
**PIANKATANK RIVER**  
**PLATE 8b**

**Bank Condition:** Nearly six miles of the banks surveyed were classified at less than 5 feet in height, and exhibiting minimum erosion. Approximately 3.6 miles of banks were between 5 and 10 feet in height, and also stable. Banks classified as high erosion accounted for less than 20%. As illustrated in Plate 8b,

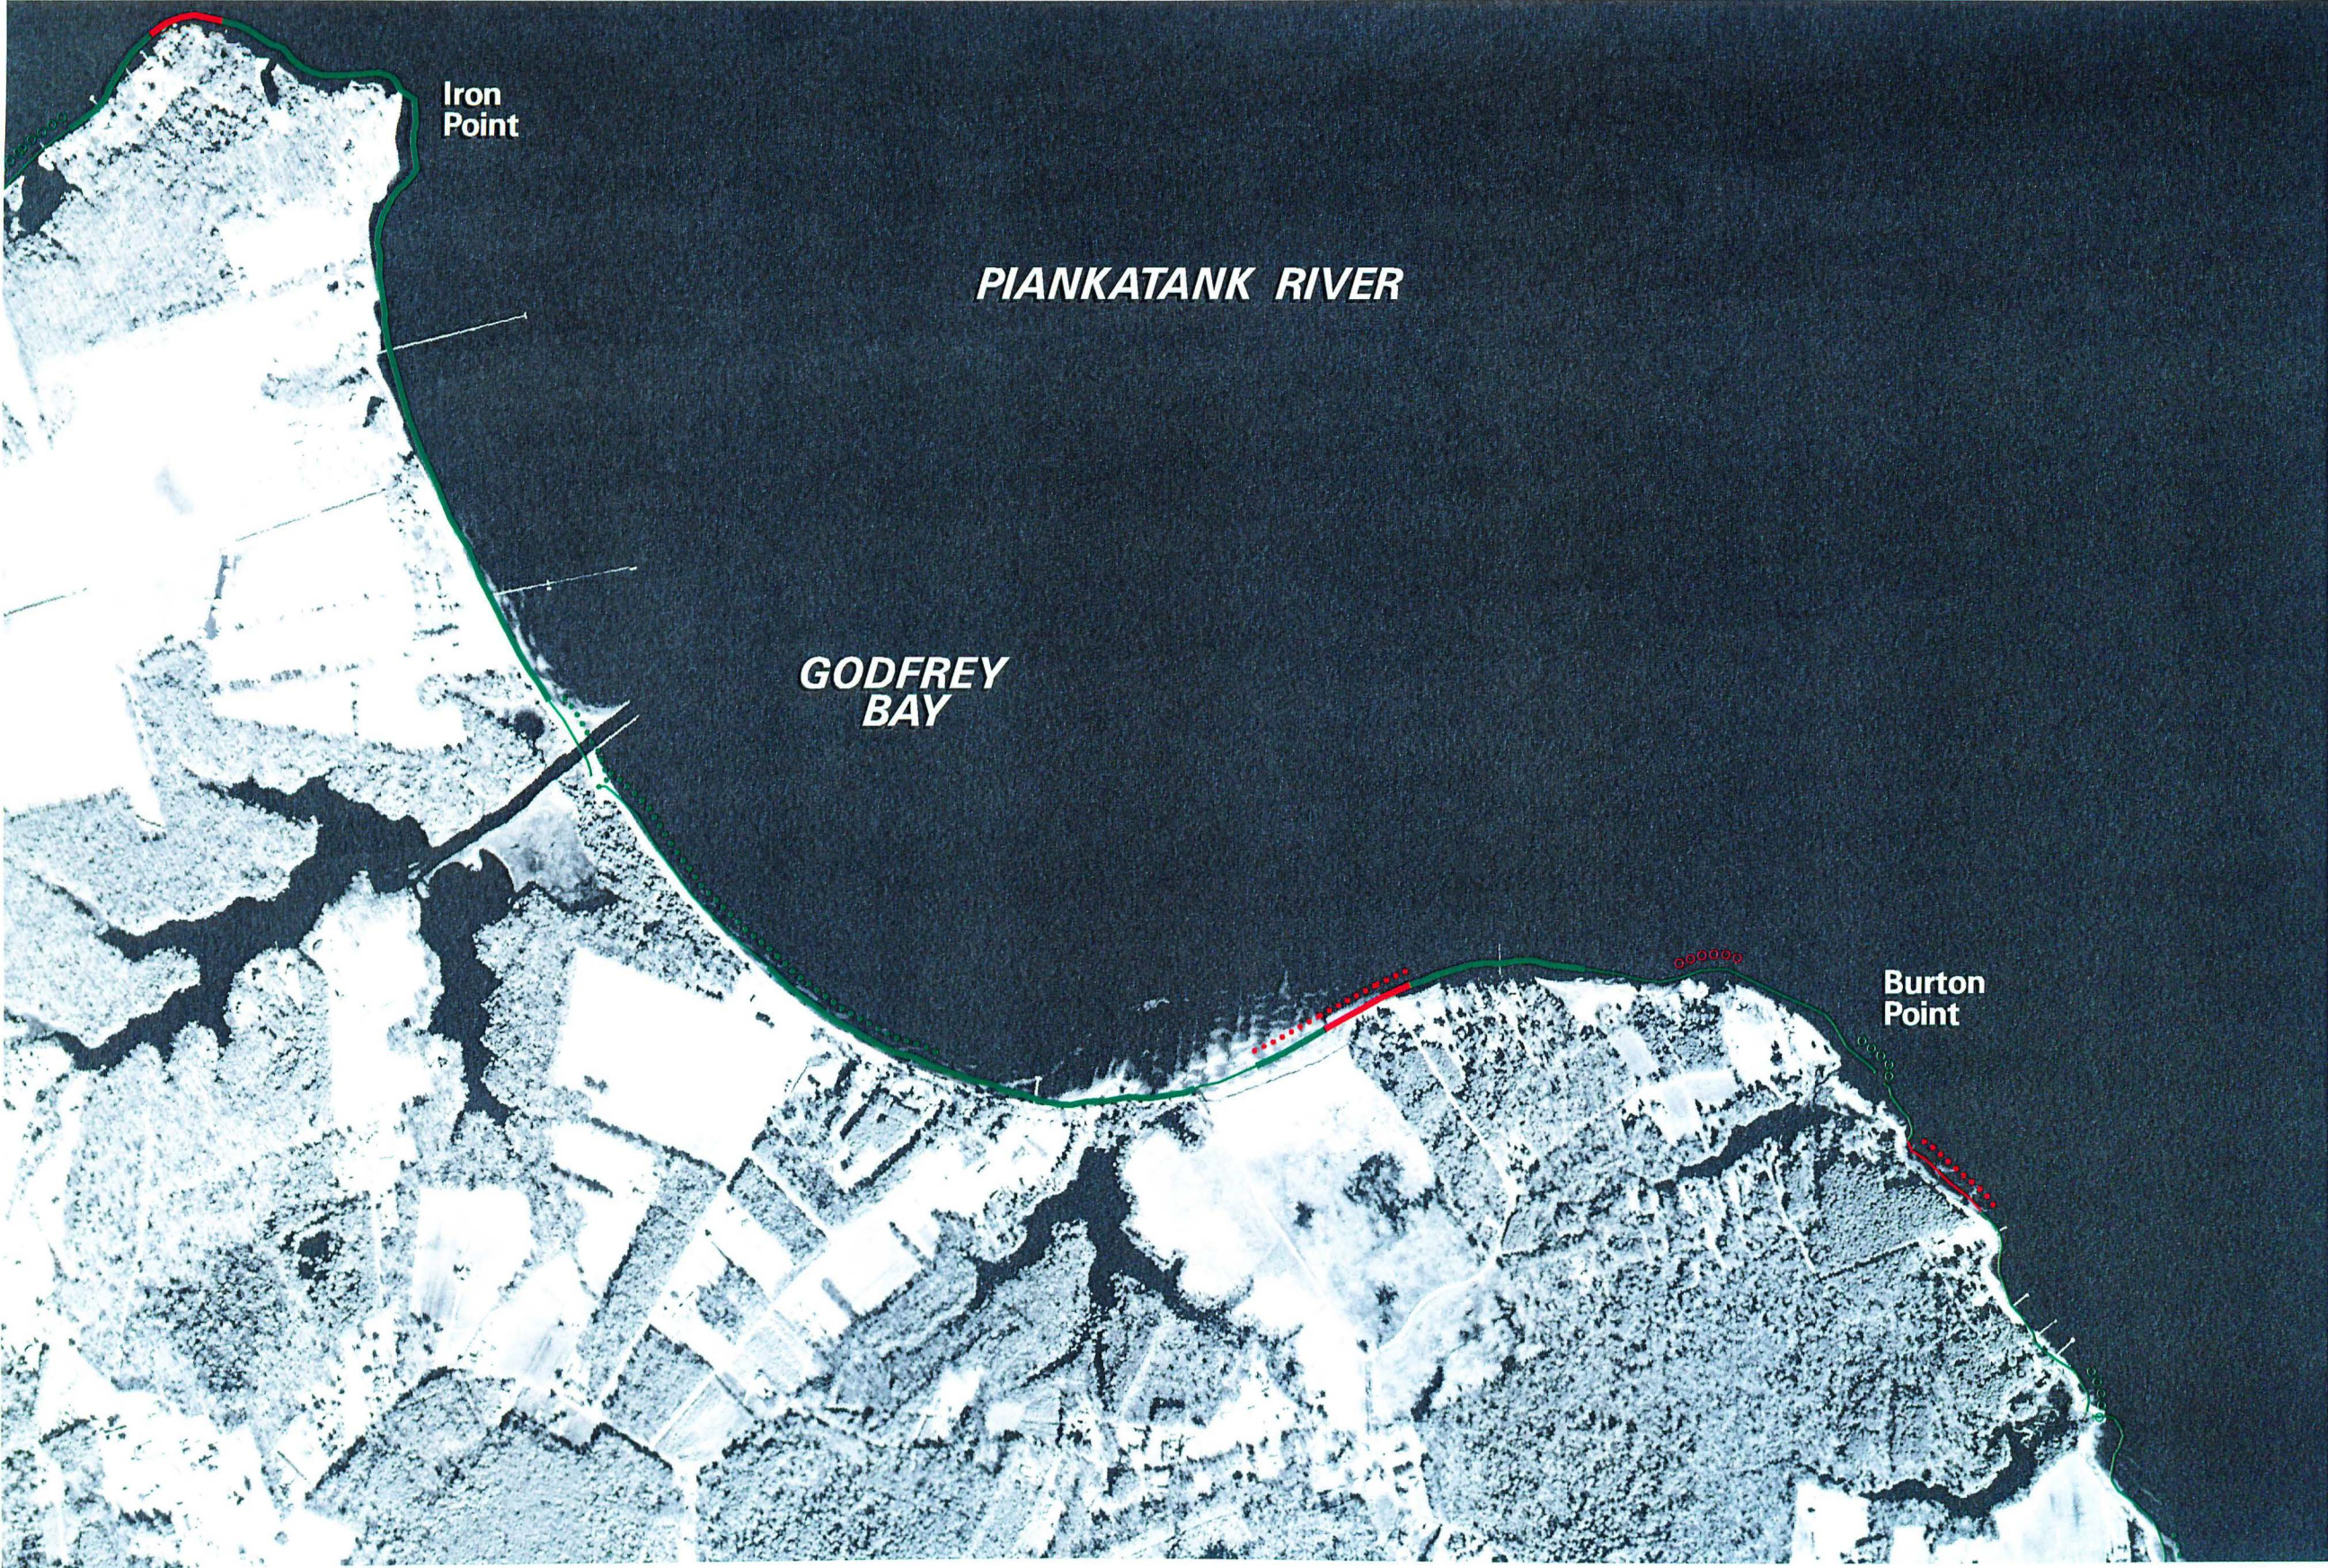
**PIANKATANK RIVER**  
**PLATE 9b**

other points along the shore. Most of the shoreline in Plate 9 is within Reach 33 (Figure 2). From Byrne and Anderson (1978), historic erosion rates along this reach equal 2.2 ft/yr. A comparison between Plates 9b and 9c indicate that beaches are absent in most areas where riprap and bulkheads have been installed. The longest stretch of beach is associated with a section where no shore protection structures have been constructed. There are relatively few piers in the area. Only 17 were surveyed. One boat ramp, south of Burton Point was observed. This appears to be a private access.

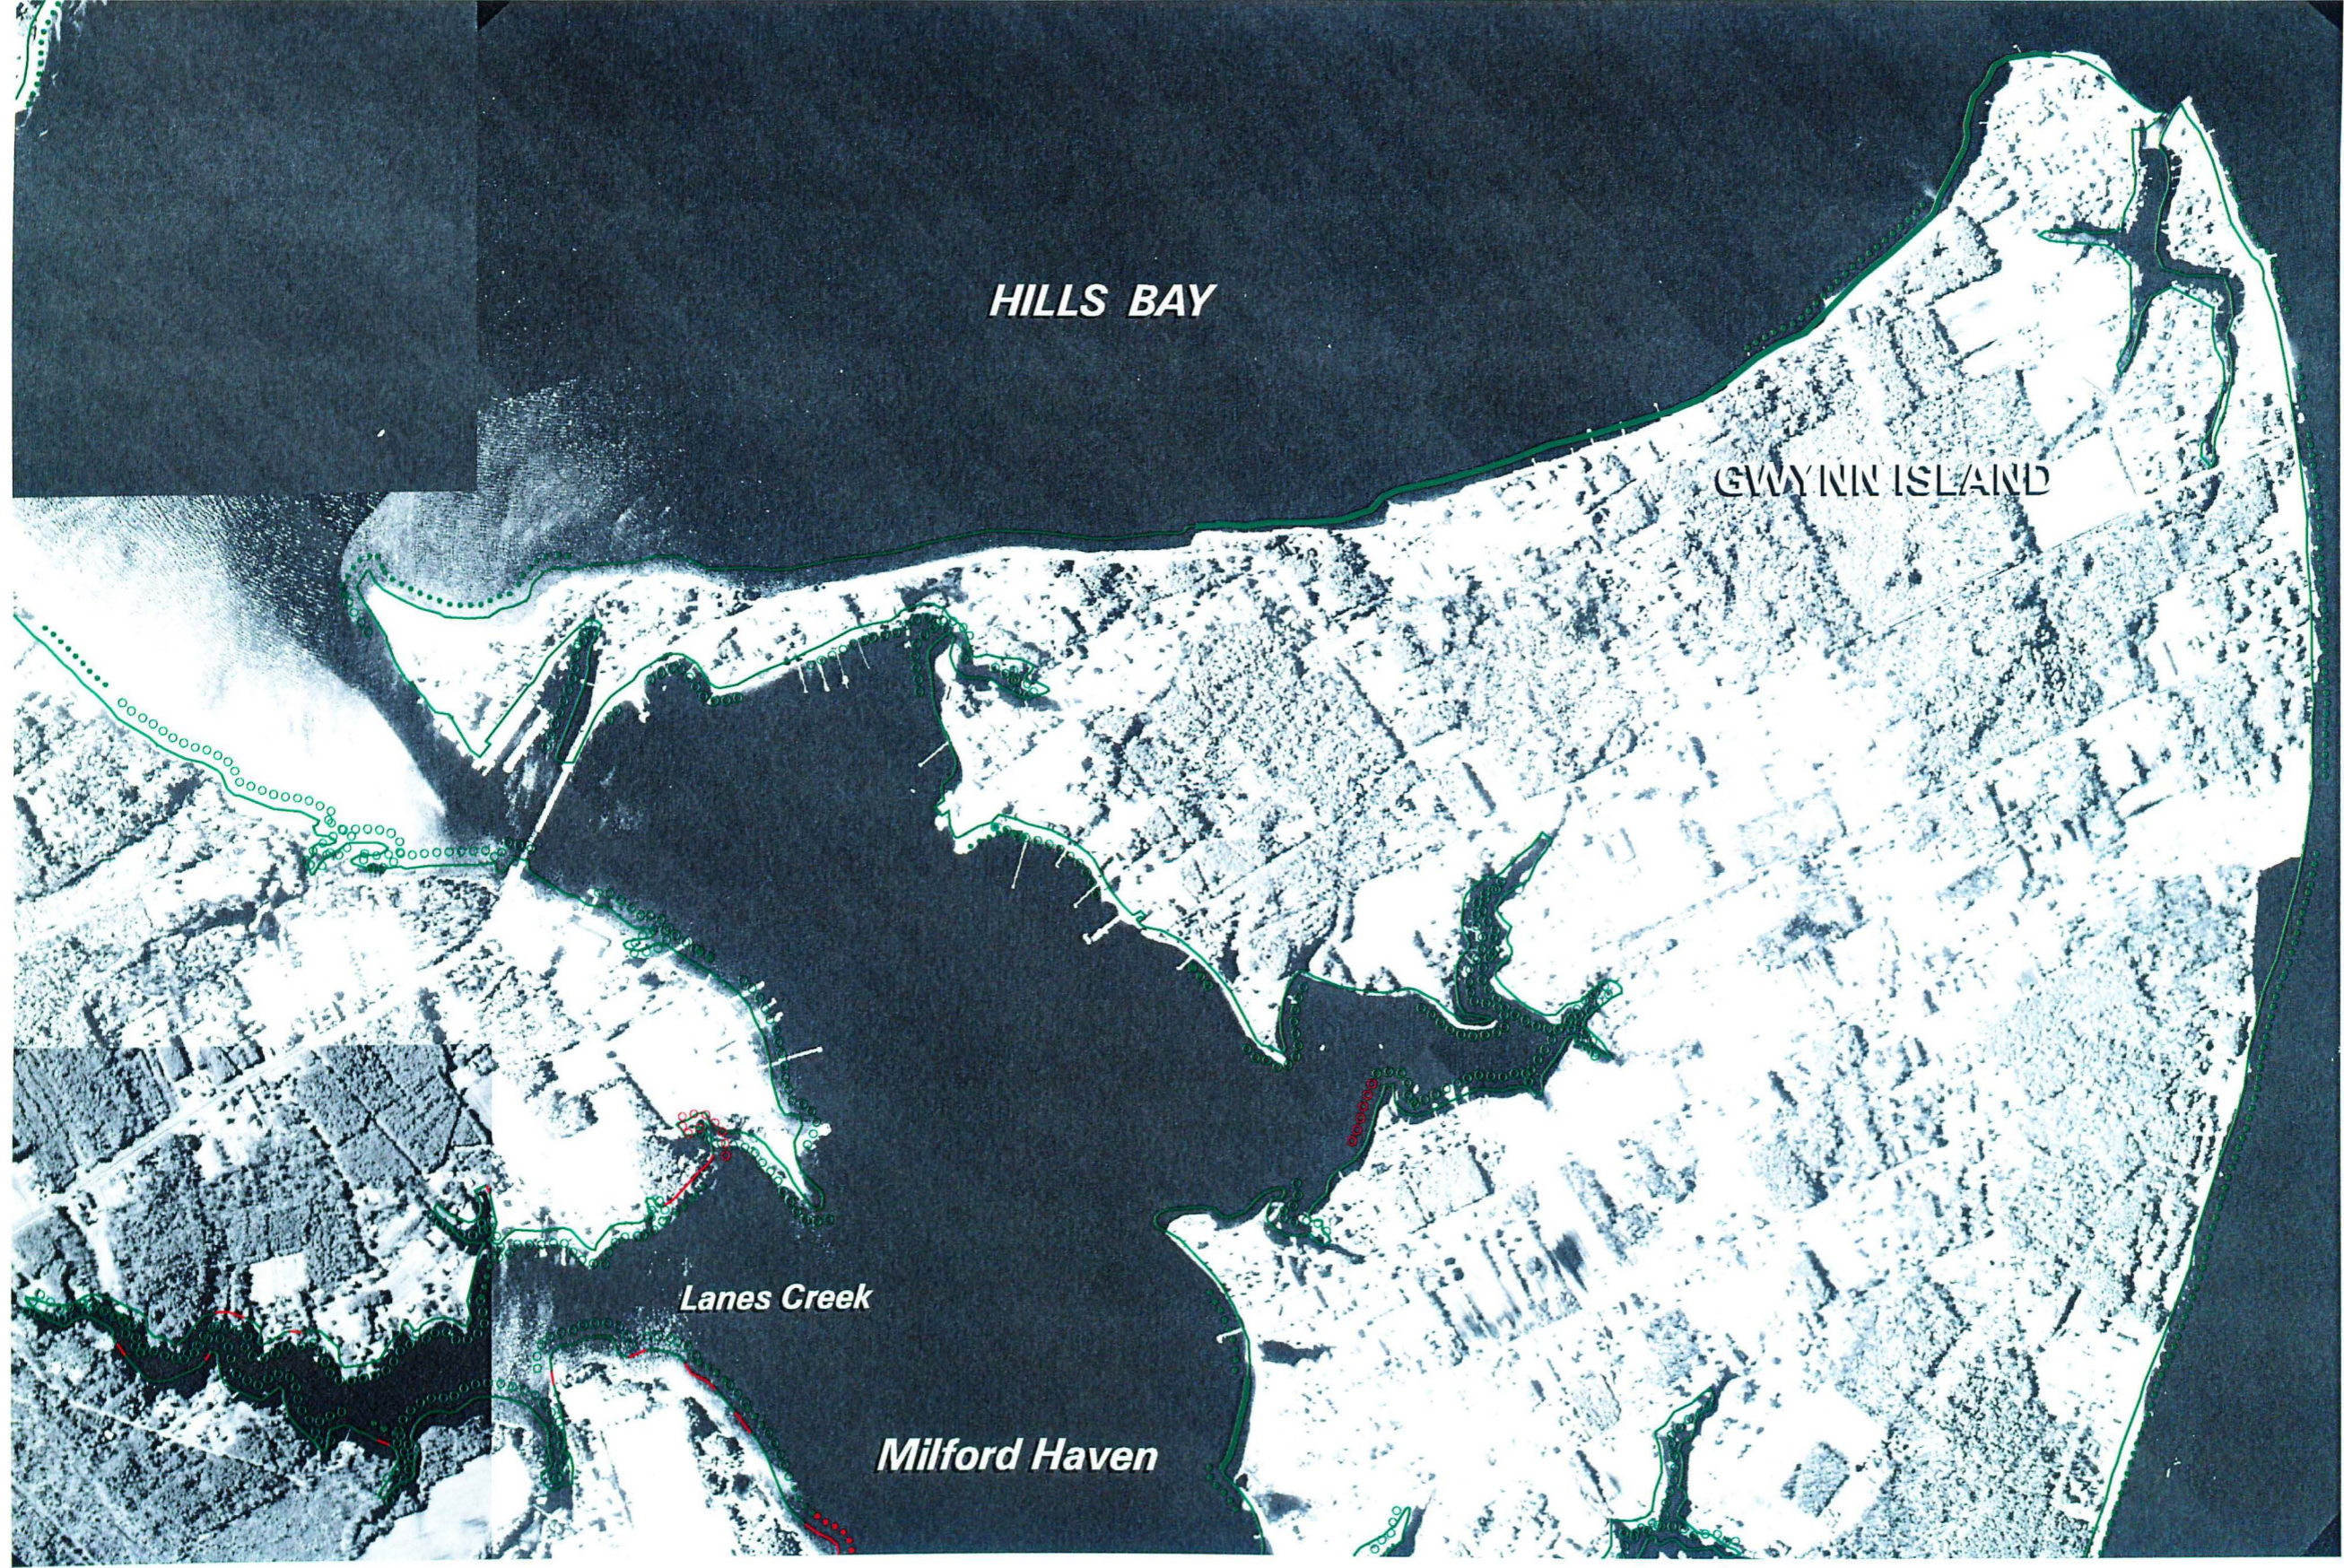
**PIANKATANK RIVER**  
**PLATE 11b**

**Shore Condition:** High historic erosion rates of 7.1 ft/yr are reported for Reach 326 along the Bay shoreline of Gwynn Island. These rates measure recession of the shoreline over 90 years of change. Cherry Point (Reach 327) at the north tip of the island is accreting at a rate of 1.3 ft/yr. The western shore of Gwynn Island has erosion rates up to 2.1 ft/yr recorded. Erosion within Lanes Creek was estimated to be 1.4 ft/yr. Shore protection is in place along the western shore of the island. Several groin fields have been constructed in combination with existing riprap and bulkheads. Nearly one third of the shoreline in Plate 11 has been defended. One hundred and forty-three docks are in place, along with eight boathouses. There are seven boat ramps. A public launch is located on the southeast side of the bridge on Gwynn Island.
