Oyster Bag Sill Construction and Monitoring at Two Sites in Chesapeake Bay

Donna A. Milligan
Virginia Institute of Marine Science

October 2018

Shoreline Studies Program

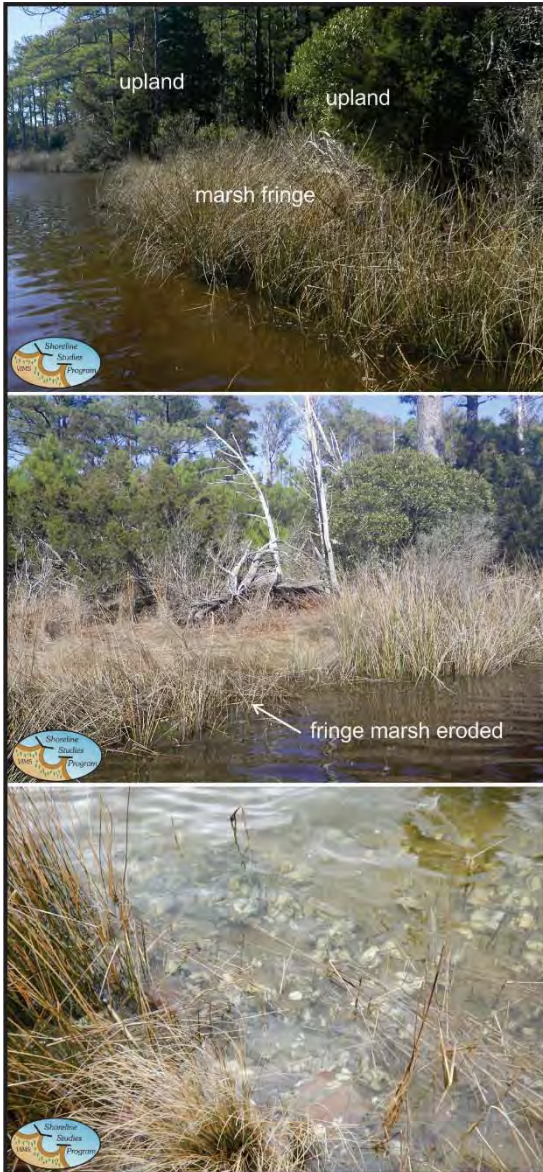
The coast is mostly eroding tidal marsh with three low exposed upland bank segments that are 45 feet, 75 feet and 45 feet, respectively (Figure 2-2). Larger pocket marshes exist between the uplands. The uplands are very low, only about 4-5 feet MLW with a narrow marsh fringe in front (Figure 2-3, top). In some areas, the fringe has been lost completely, and the upland bank is now being impacted (Figure 2-3, mid). The site has a derelict pier.

Estuarine tidal marsh is important habitat for numerous species of fish and crabs; fiddler crabs and oysters are prevalent on the site (Figure 2-3, bottom). The marsh shoreline consists primarily of black needlerush and smooth

Figure 2-3. Existing conditions at Heritage Park. Top: A low upland bank is protected in some areas by a narrow fringe marsh. Middle: In other areas, the marsh fringe has completely eroded. Bottom: Oysters are prevalent in the nearshore at the site.

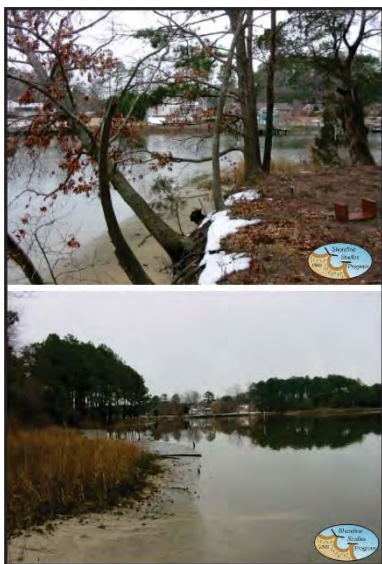
The Site 1 project is located on Northeast Branch of Sarah's Creek ([Figure 4-2](#)). Before the project, the site shoreline consisted of an exposed and eroding upland bank and eroding marsh fringe ([Figure 4-3](#)). The oyster bag sill was installed in the spring of 2011 along approximately 190 linear feet of shoreline that was protected using 175 linear feet of oyster bag sill ([Figure 4-4](#)). The gapped oyster bag sill was constructed with 15 bags per foot and is 2.5 feet high, and about 266 cy of sand fill was placed in an area of about 3,610 ft². Marsh grass plantings of *S. alterniflora* and *S. patens* were placed landward of the sill on about 2 ft centers ([Figure 4-5](#)). About 100 ft² of existing *S. alterniflora* was impacted by the project. Filter cloth was installed under and landward of the oyster bags. A revetment along portions of the eroding, upland bank was added later.

Figure 4-3. Site 1 before project installation. The marsh is eroding and an upland bank is exposed and eroding. Photo credit: VMRC permit application uploaded 28 Oct 2010.

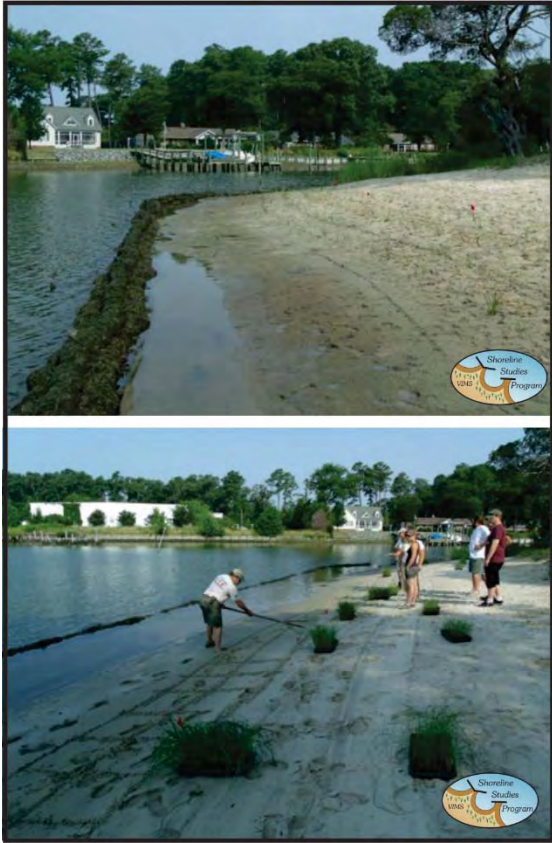
Figure 4-5. Post bag and sand installation at Site 1. The sand fill is visible landward of the sill, and volunteers planted grasses on the fill. Photo credit: Walter Priest, 29 June 2011.

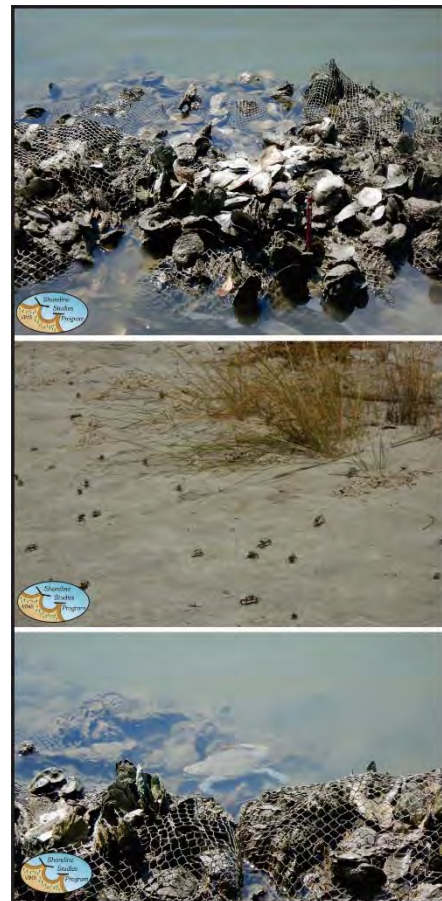
(Figure 4-6). Additional sand may have been placed along the shoreline. A site visit in 2016 showed that the sand came up to the back of the sill and was not planted in grass (Figure 4-8). The grass also may be controlled with herbicides as indicated by the brown grasses (Figure 4-7); however, that cannot be confirmed.

Figure 4-7. Fauna visible at Site 1 oyster bag sill. Juvenile fish also were visible.

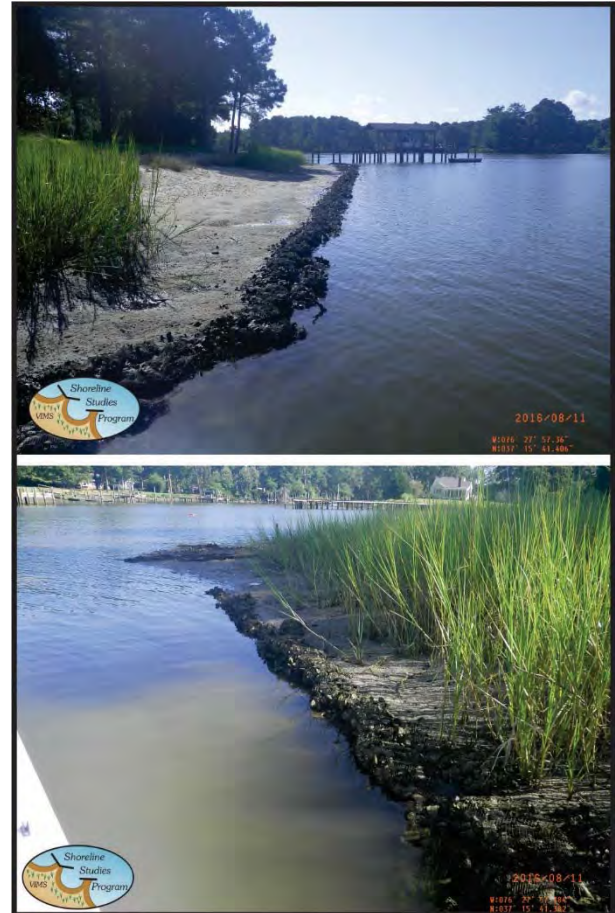
Figure 4-8. Site 1 shown in 2016 approximately four years after installation.

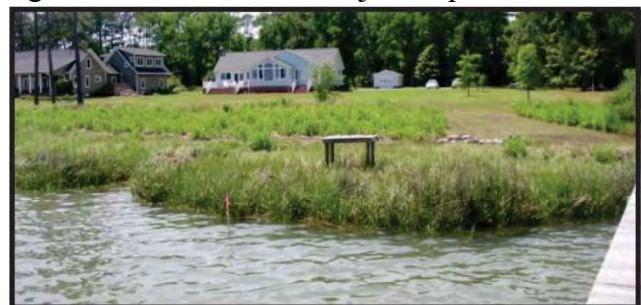
The Site 2 project is located on the York River behind Allens Island (Figure 4-9). Before the project, the site shoreline consisted of an exposed marsh (Figure 4-10). Though the site is on the York River, it is protected by the Allens Island marsh and generally has a low erosion rate (0 to -1 ft/yr) and average fetch of less than 1 mile. Approximately 201 linear feet of marsh toe oyster bag sill was installed in 2012. Bags were placed by hand in stacks of three (Figure 4-11). An oyster castle also was incorporated into the site. The project impacted approximately 657 ft² of nonvegetated wetlands.

Figure 4-10. Site 2 before project installation. Because tide level is up, the eroding marsh cannot be seen. Photo credit: VMRC permit application uploaded 6 June 2012.

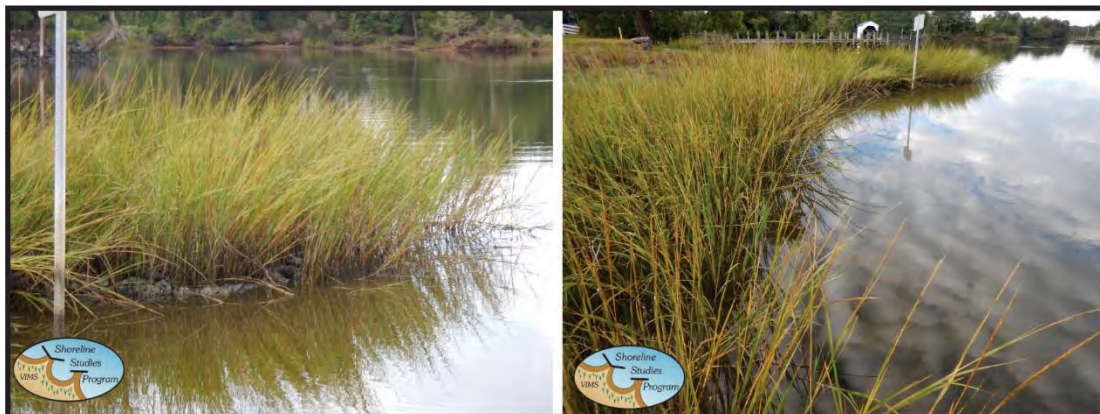
After three years, the marsh was growing in front of the bags in one section of the sill. After four years, the area behind the bags has filled in with marsh, creating a nice marsh fringe at the site that has grown in front of the bags in some areas of the project (Figure 4-15).

Figure 4-15. Oyster bag sill at Site 3, St. Johns Point in September 2018 approximately 4 years after placement.

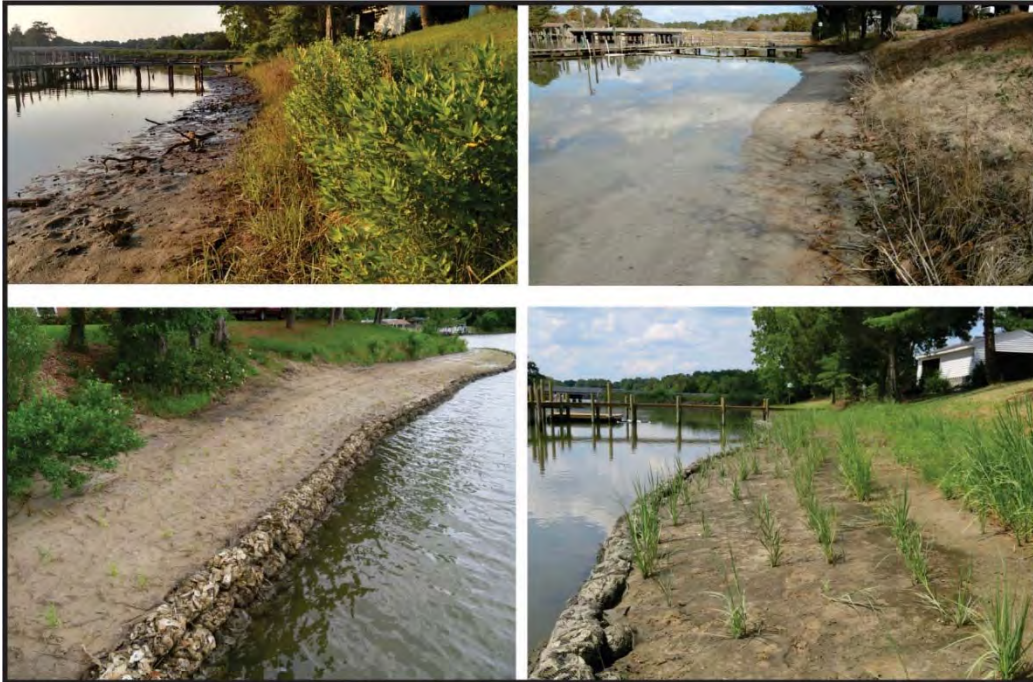
Site 4 on the northwest branch of Sarah Creek (Figure 4-16). Prior to the project installation, the shoreline was a small marsh fringe and an eroding, scarped upland bank (Figure 4-17). The project was installed in the spring/summer of 2017. The sill system extends about 264 linear feet along the shoreline as it curves around the upland bank from pier to pier with a 3 ft wide and 2 ft tall structure, sand fill, and 2,640 ft² marsh grass planting (Figure 4-18). The nearshore bottom is firm allowing for minimal structure settlement, and a filter cloth was placed under the structure. Both *Spartina alterniflora* and *Spartina patens* were planted. The oyster bag sill along the west facing segment has a 10 bag sill, 4 bags high, about 10 feet from the base of the bank with a top elevation of the sand and sill about +1.5 ft MLW (Figure 4-18). The bags were placed by hand, backfilled with sand, then the marsh grasses planted (Figure 4-17). Over the past year, the plants have coalesced into a vibrant marsh fringe (Figure 4-19, top right). The *S. patens* has begun stabilizing the upland base of bank. There is sparse oyster growth due in part to this past winter's heavy ice (Figure 4-19, top left).

Figure 4-17. Site 4, Top left: Shoreline prior to the project on 26 May 2016; Top right: May 2017 prior to the bags being placed; Bottom left: after bags were placed in May 2017; and lower right: after the grass was planted in July 2017. Photo credit: Walter Priest.

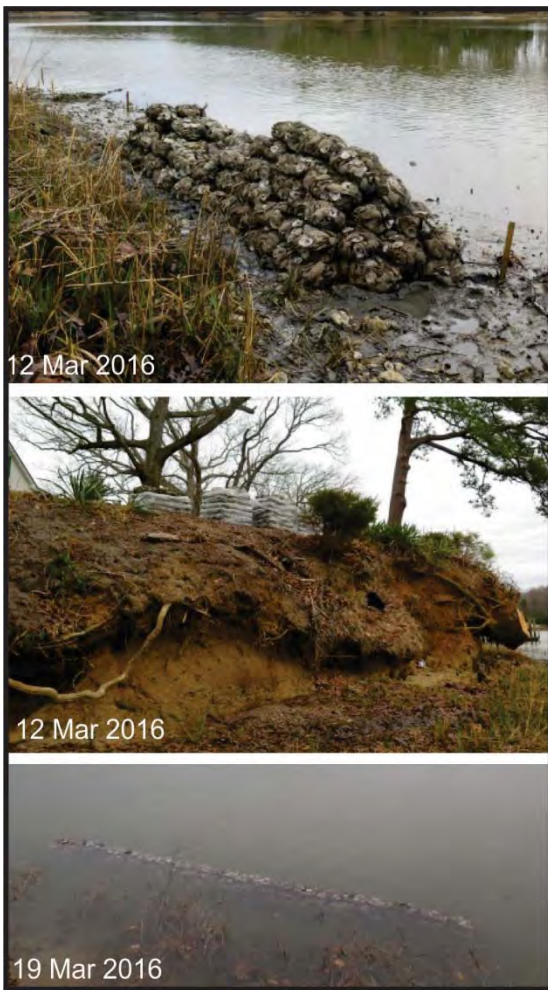
Site 5 is located on Cedar Bush Creek in Gloucester County (Figure 4-20). Cedar Bush is a small tributary to the York River. It is very shallow in the area of Site 5 with depths being less than 3 feet mean low water. Facing southeast, the site has a very low fetch. However, prior to the project, the site had an eroding upland bank and narrow fringing marsh in some areas (Figure 4-21). The site was constructed in summer 2016 and

Figure 4-21. Site 5 during construction. Top: the bags are stacked in a 15 bag triangle at low water. Middle: the eroding upland bank was not graded. Bottom: the sill under high water. Photo credit: VMRC permit application.

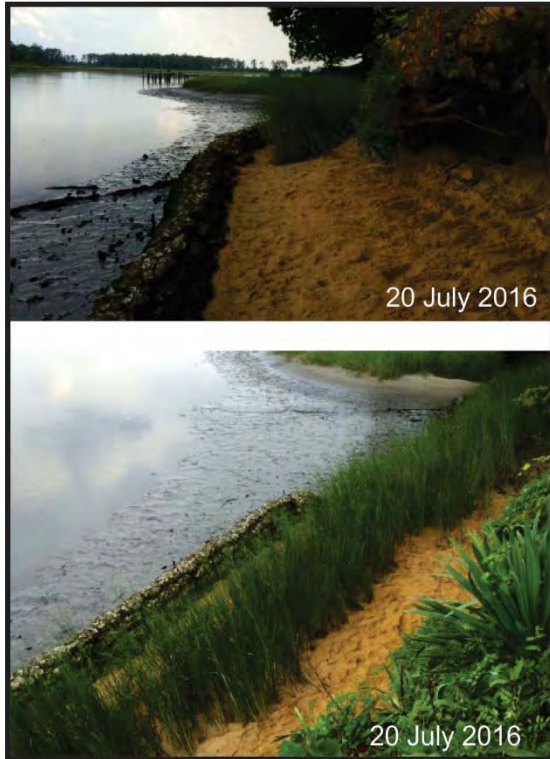
consisted of a 15 bag triangle configuration (five bags at the base) from mean low water shoreward along 170 linear feet (Figure 4-22). Approximately 128 cy of sand was pushed over the bank by bobcat, and *Spartina alterniflora* planted (Figure 4-23). No bank grading occurred, and the bank is being allowed to slough naturally. Overall encroachment was 24 ft from mean high water.

Figure 4-23. Site 5 during construction. Top: Sand was placed along the shoreline. Bottom: Marsh grass was planted. Photo credit: VMRC permit application.

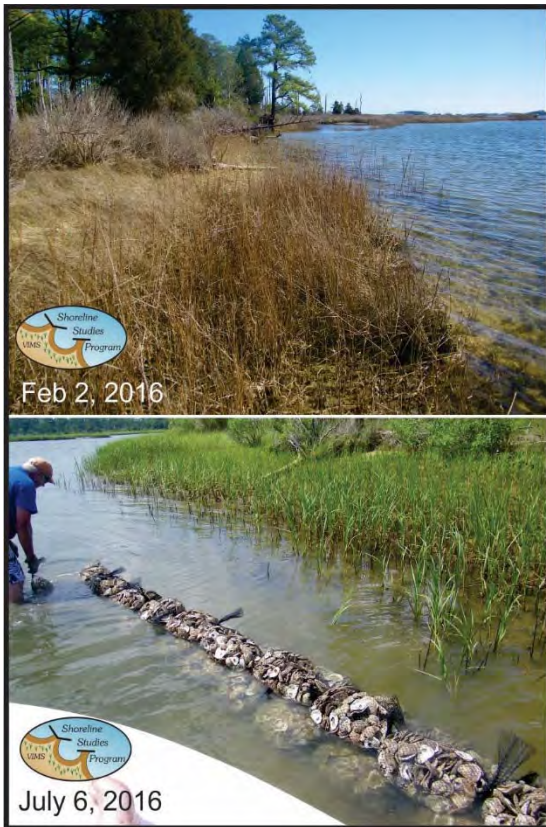
As part of a National Fish and Wildlife Foundation grant, VIMS Shoreline Studies Program installed a small oyster bag sill along Whittaker Creek as a test site (Figure 2-4). The site was an eroding marsh scarp that had a very low erosion rate (Figure 4-25). The average fetch was low, but the longest fetch is over a mile. The site was stabilized with a 3-bag oyster sill approximately 60 feet long (Figure 4-26). No additional marsh grass was planted. The bottom was very soft and the lower layer of bags had to be installed to walk on to place the rest of the bags (Figure 4-25).

Figure 4-25. Site 6 Top: prior to installation, the site had an eroding marsh. Bottom: a 3-bag oyster bag sill was installed in July 2016.

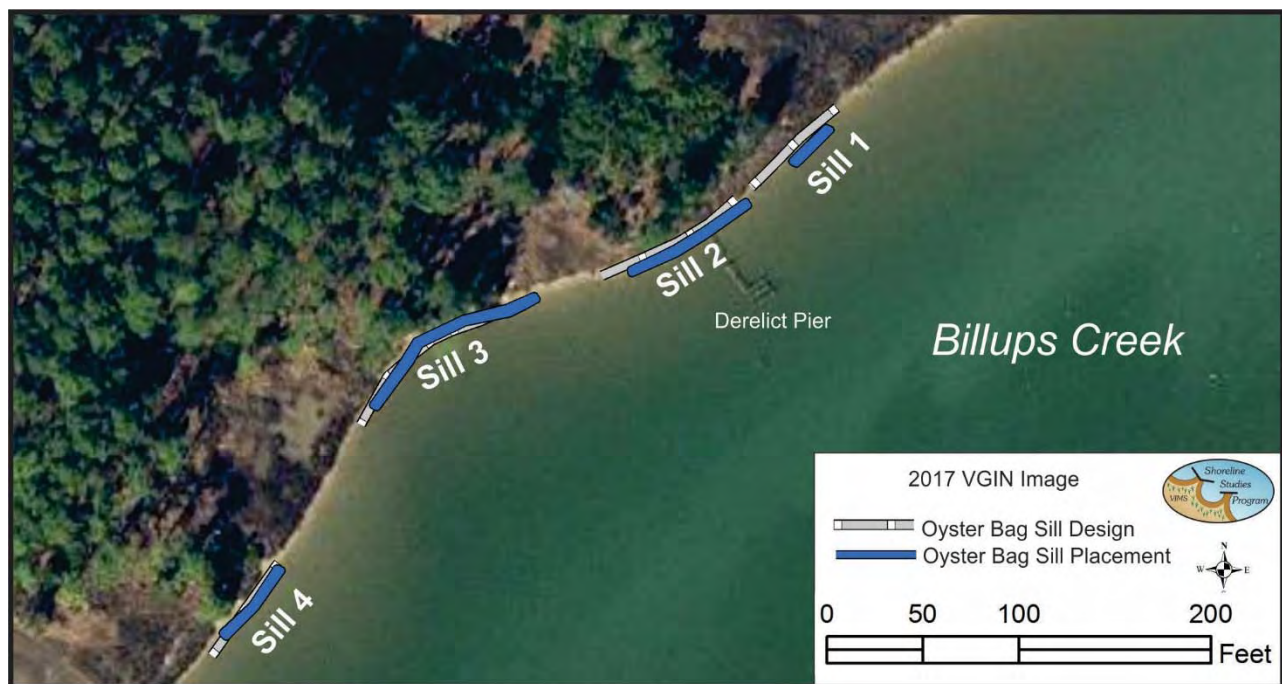
During construction, the sill design was modified somewhat based on site conditions (Figure 5-3). Sills 2, 3, and 4 were constructed as designed; however, Sill 1 was shortened slightly to create a wider gap for a kayak launch. The extra bags were placed on Sill 3. The center section of Sill 3, where it is adjacent to the upland section of shore, was built as a 5 bag sill, 3 bags on the bottom and two on the top. This widened the sill to provide more protection to the eroding upland bank.

Figure 5-3. Location of the oyster bag sills as designed (gray) and actual placement (blue).

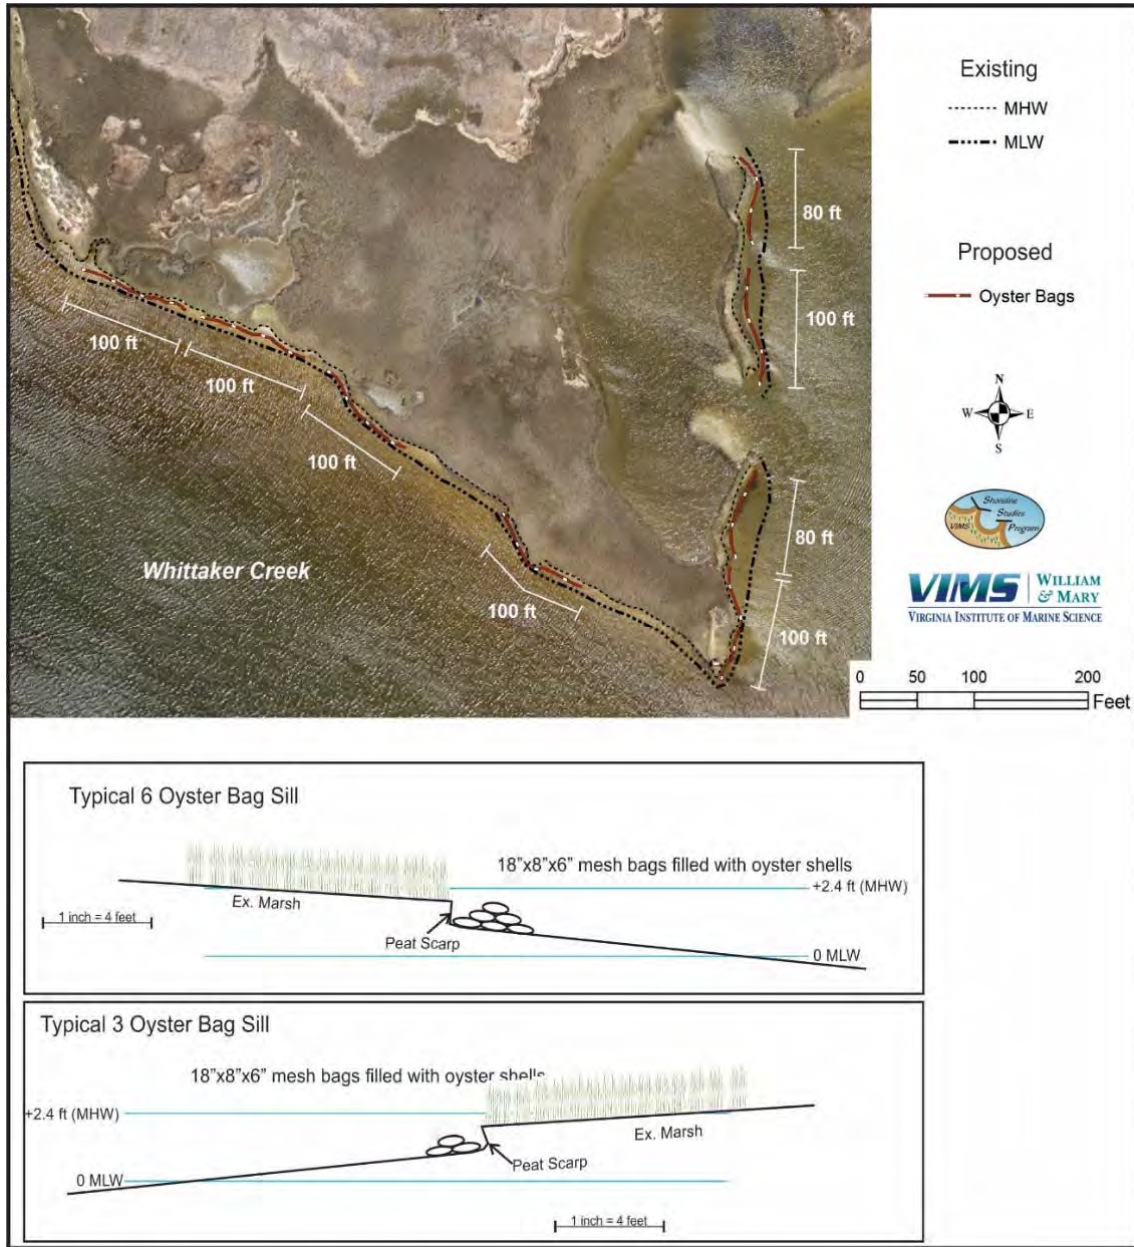
Figure 5-6. Permit application drawing for the oyster bag sill at CSRA. The southwest facing shoreline has the 3 bag sill and the southeast facing shoreline has the 6 bag sill.

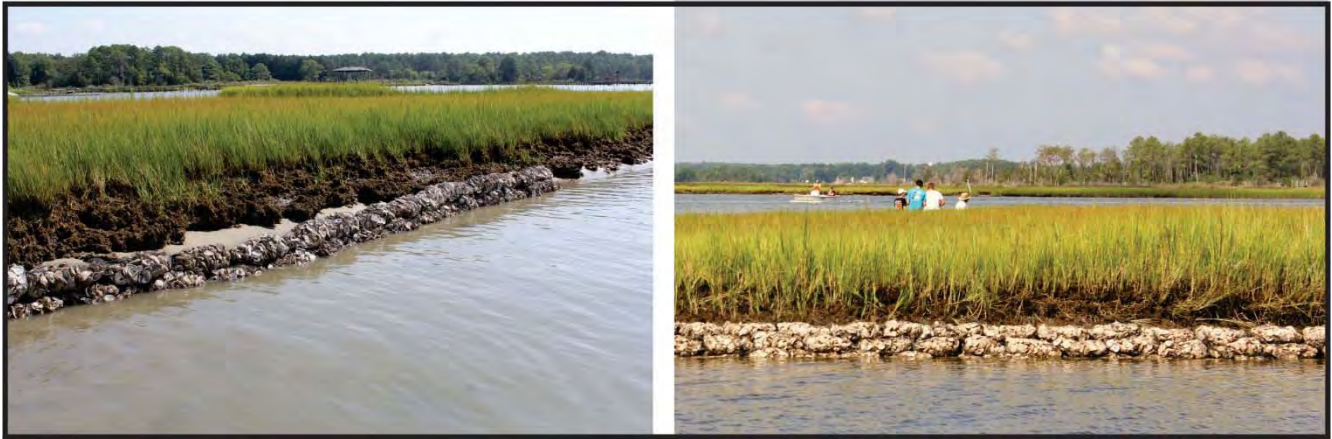
Figure 5-7. Construction of the 3-bag sill (left) and 6-bag sill (right). Photo credit: Linda Tjossem.

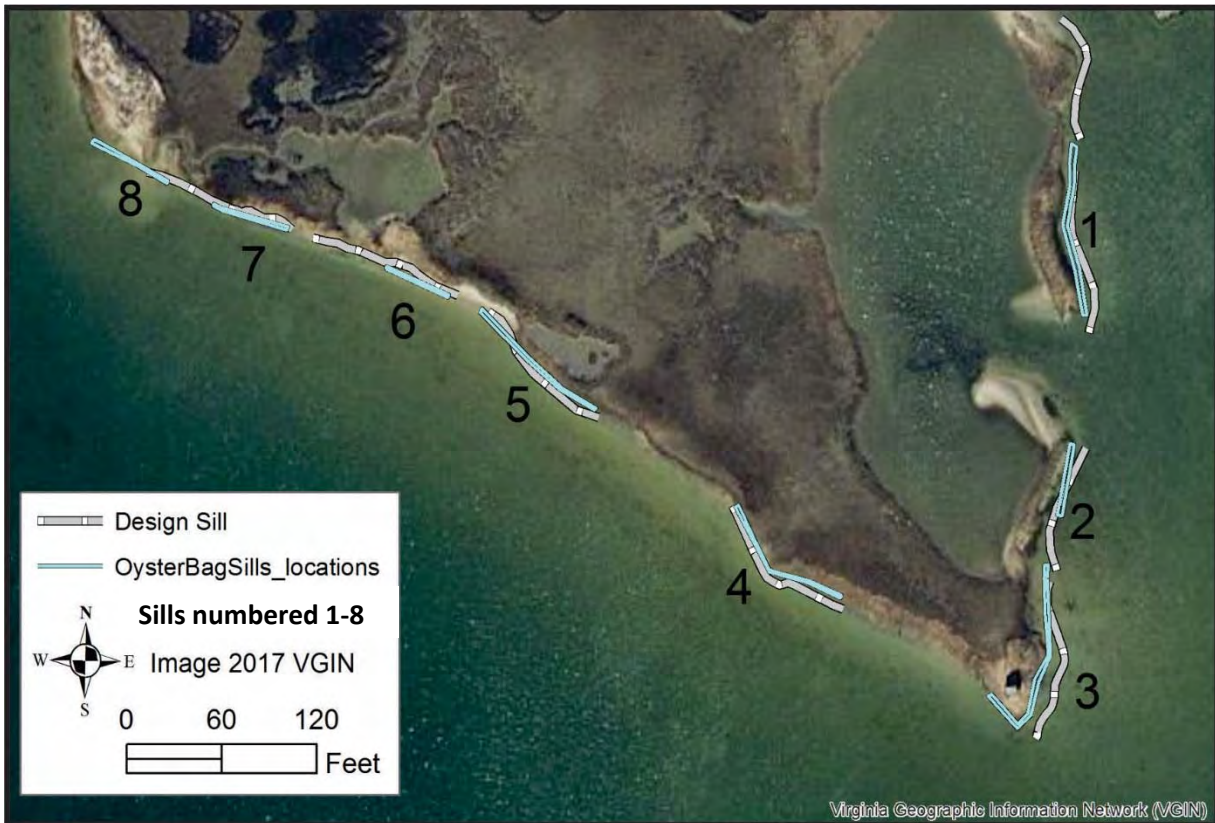
The site was surveyed by real time kinematic global positioning system on September 8, 2017 and April 3, 2018 ([Appendix C](#)). The survey shows that the oyster bags were placed similar to what was designed ([Figure 5-8](#)). However, only three sections of sill were built on the southeast facing shoreline while 5 sections were built on the southwest facing shoreline because shore conditions were different at the time of installation. The 6-bag sill was wrapped around the southernmost point very close to the marsh to provide additional protection to the area with the largest erosion rate. A duck blind is located close to the shore in this area.

Figure 5-8. Comparison between the location of the oyster bags sills (numbered 1-8) in the design (white) and what was installed (blue).

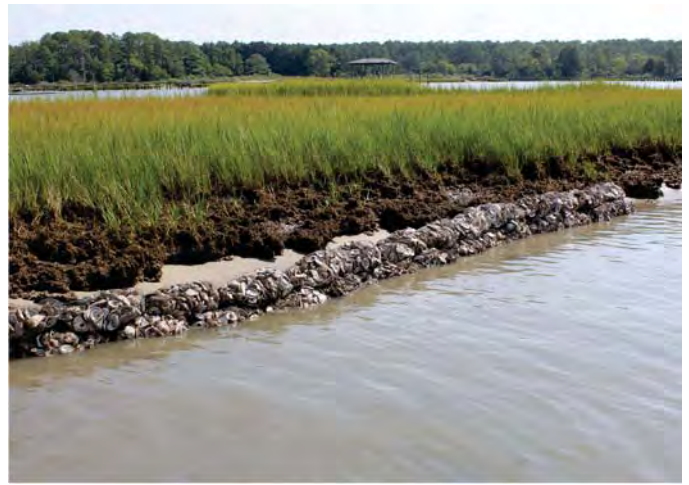
The finished sill along one section of shoreline and eroding marsh. Photo credit Linda Tjossem.

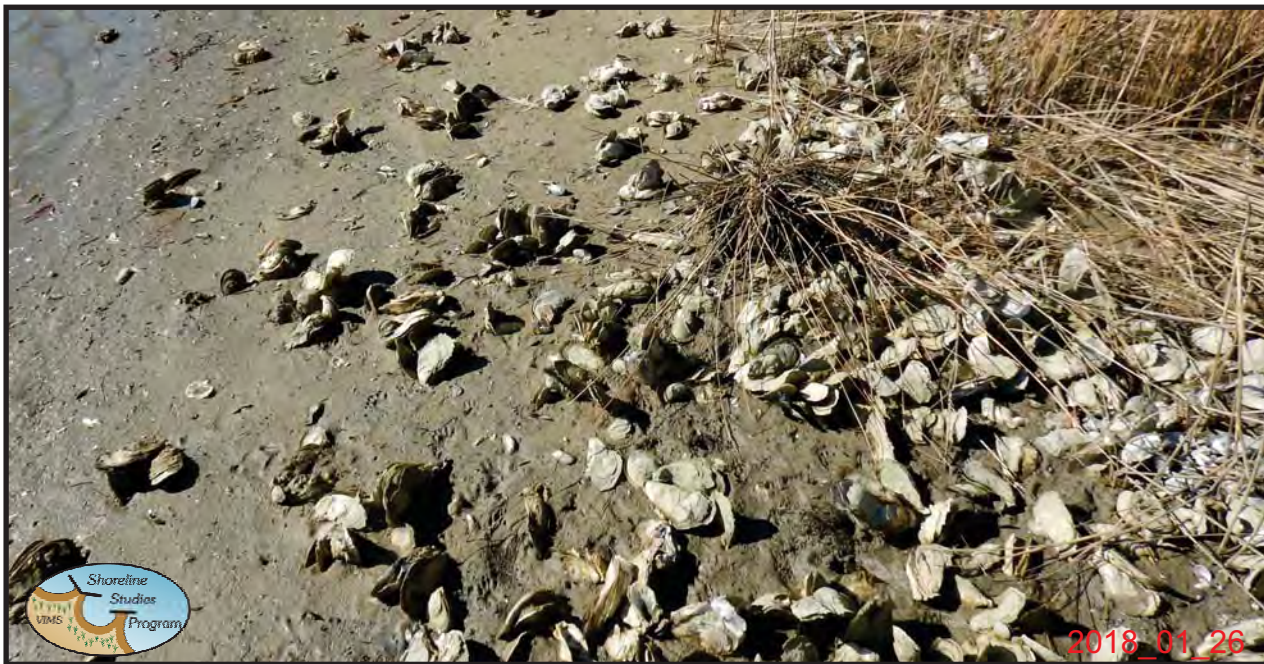
Oysters occur naturally in large numbers along this shoreline.

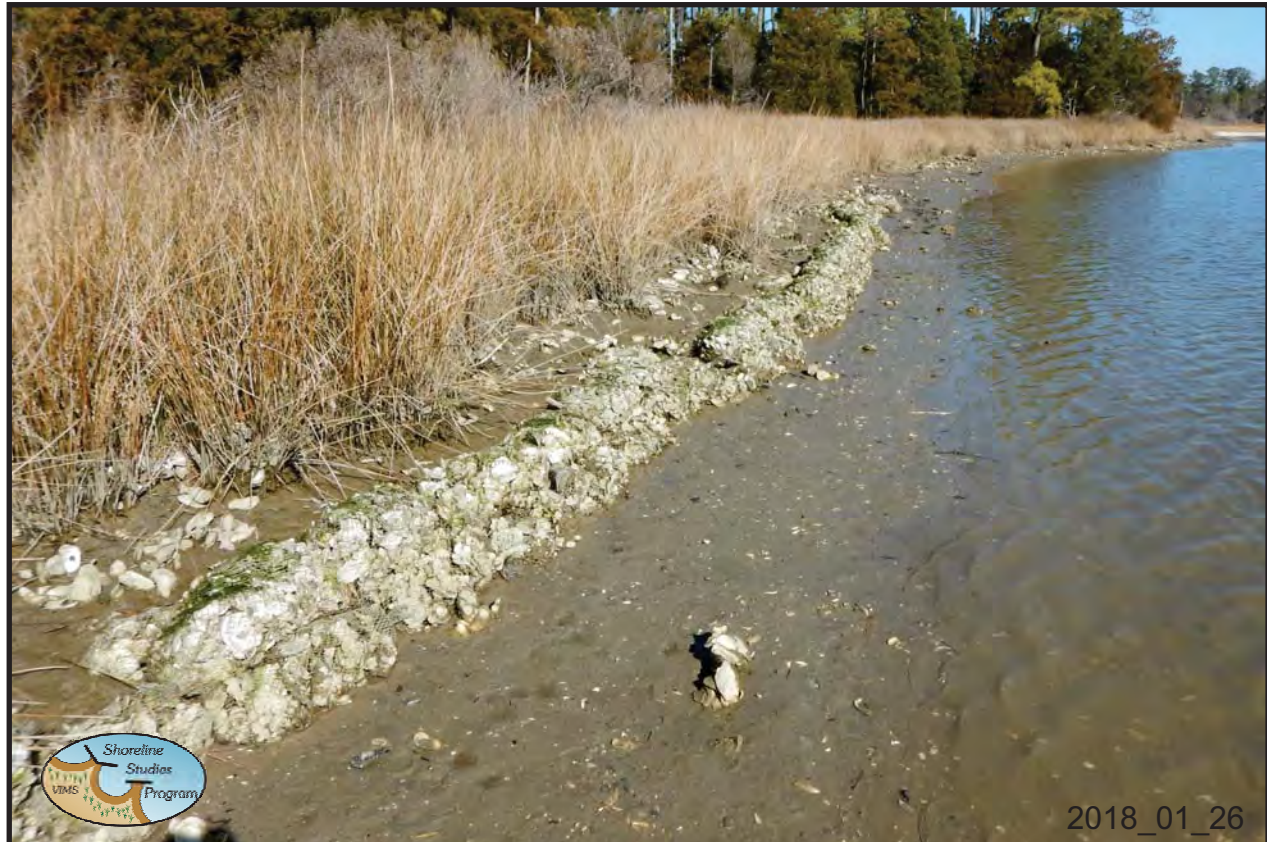
The 3-bag Sill 1.

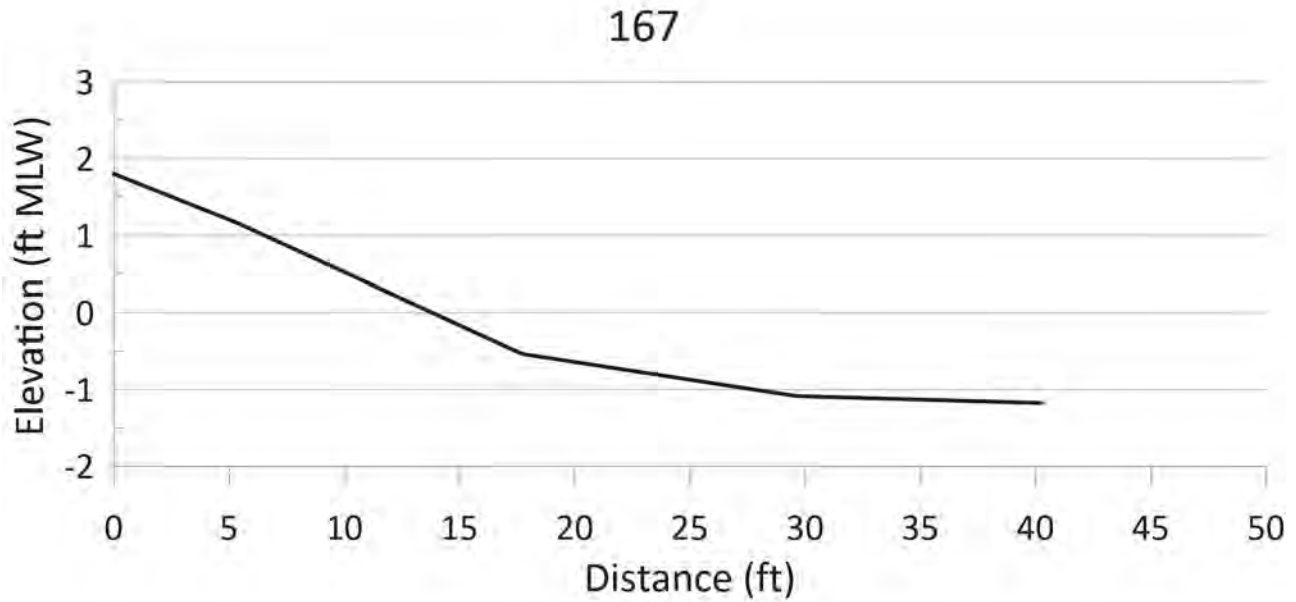
Cross-sectional profile 167 of the shoreline between Sill 2 and 3 in the marsh. Survey taken 26 Jan 2018, ten months after installation.

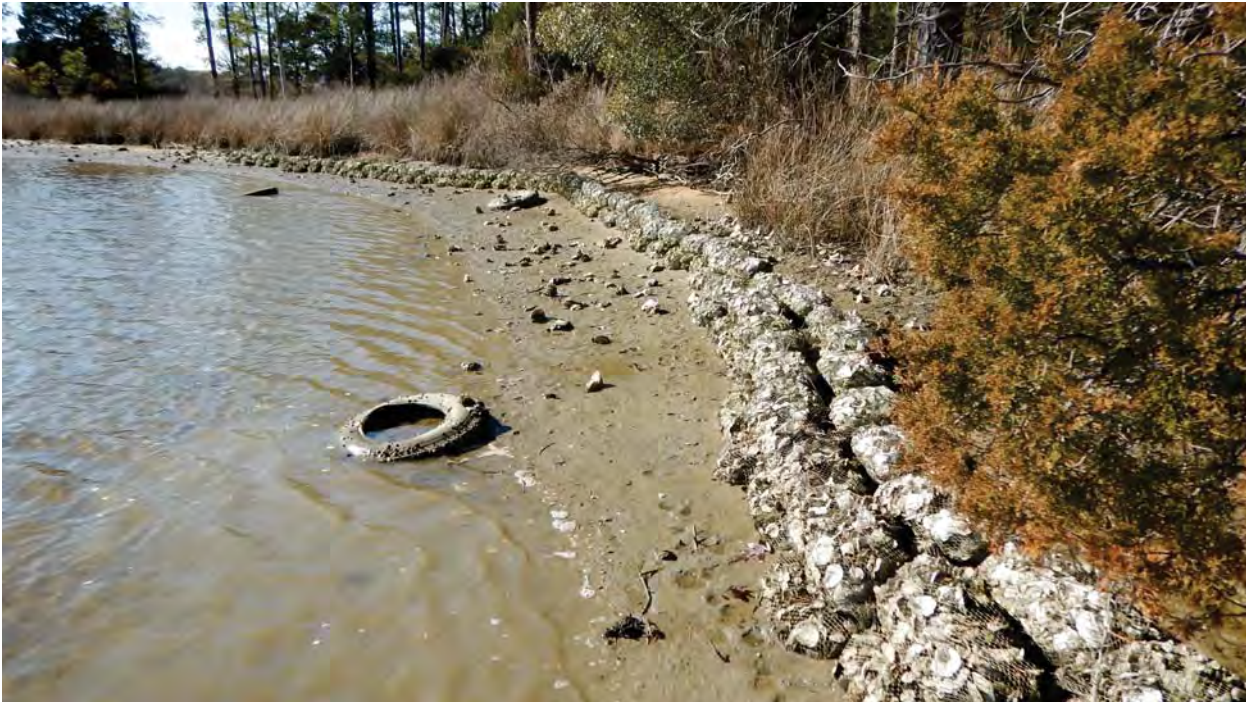
The middle section of Sill 3 was built as a 5 bag sill, 3 bags on the bottom and two on top, because it fronted a section of eroding upland. The ends of Sill 3 are 3 bag sills.

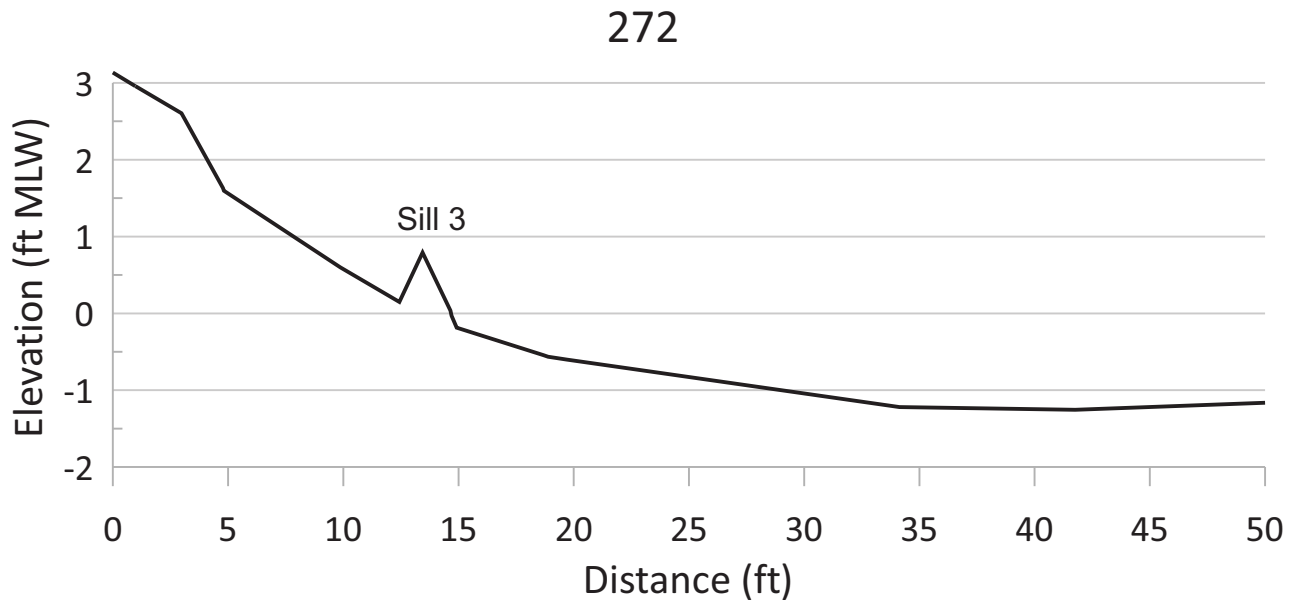
Cross-sectional profile 272 of the 5 bag section of Sill 3. Survey taken 26 Jan 2018, ten months after installation.

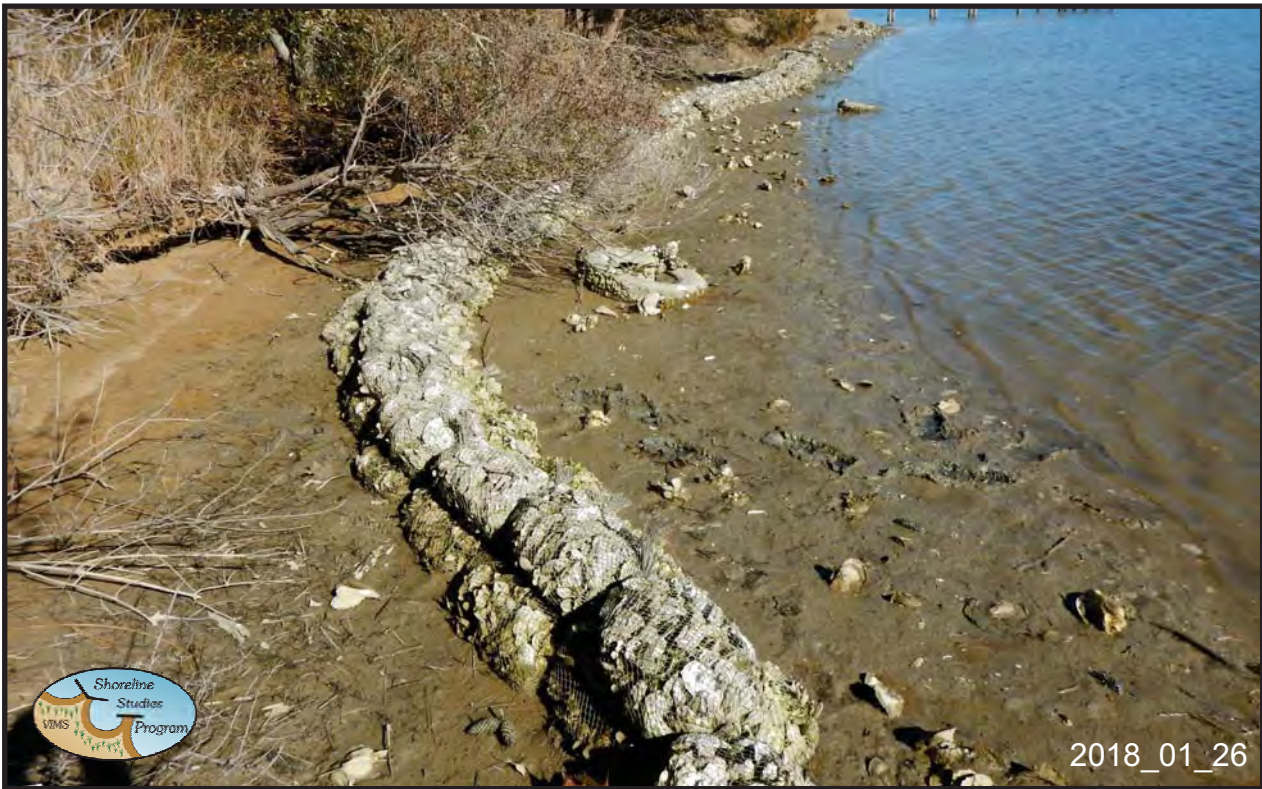
The southern end of Sill 3 flares out to follow low water.

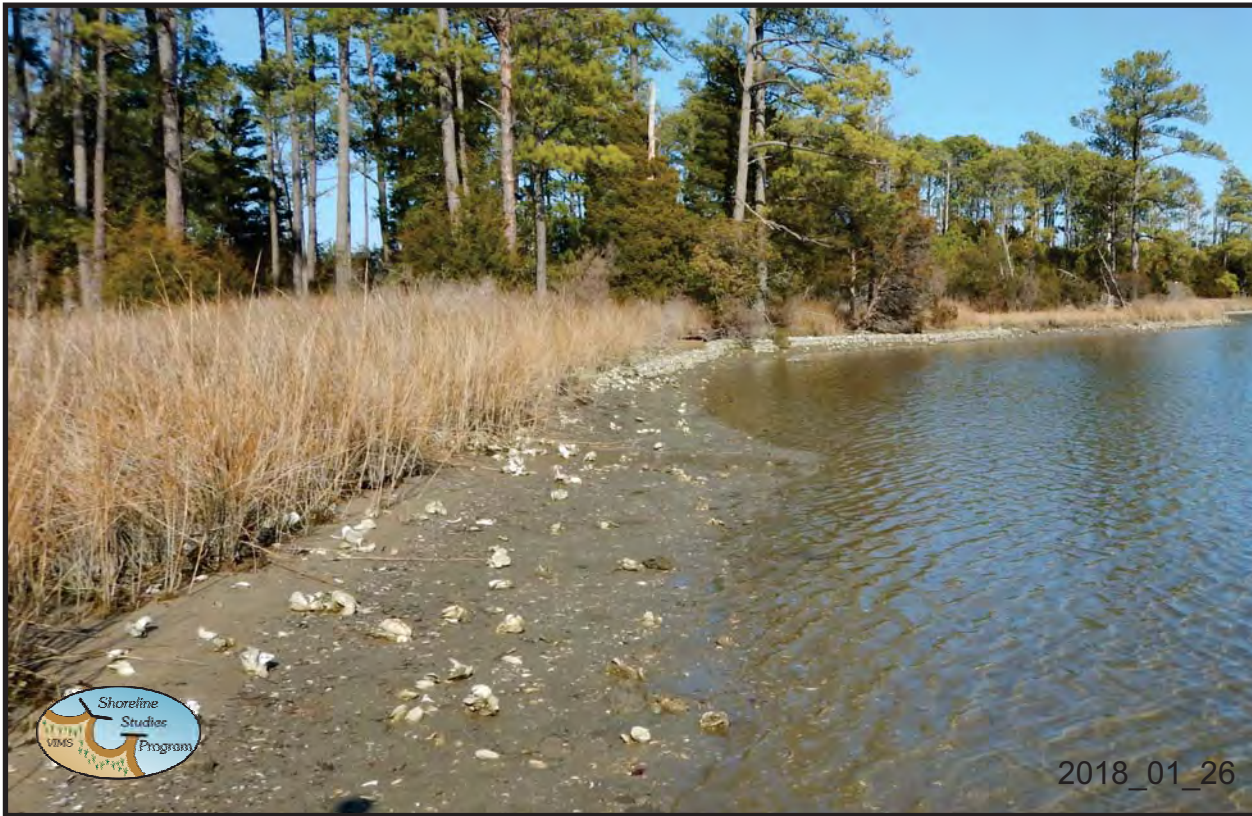
The marsh shoreline between Sills 3 and 4.

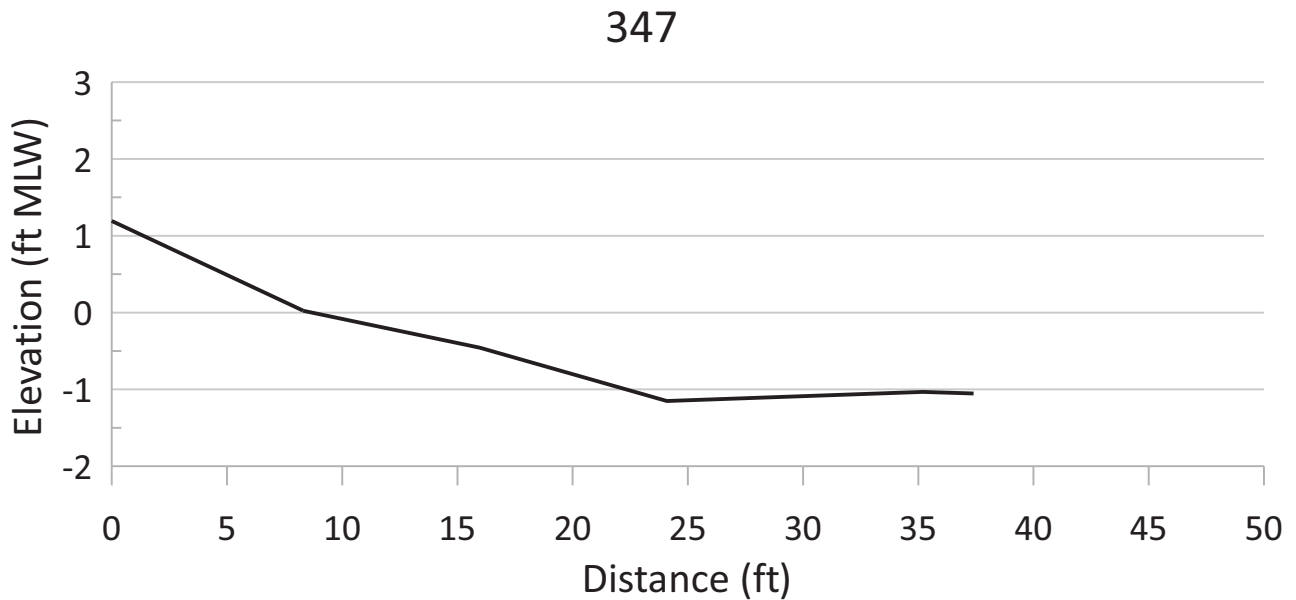
The cross-sectional profile for the shoreline between Sills 3 and 4. Survey taken 26 Jan 2018, ten months after installation.

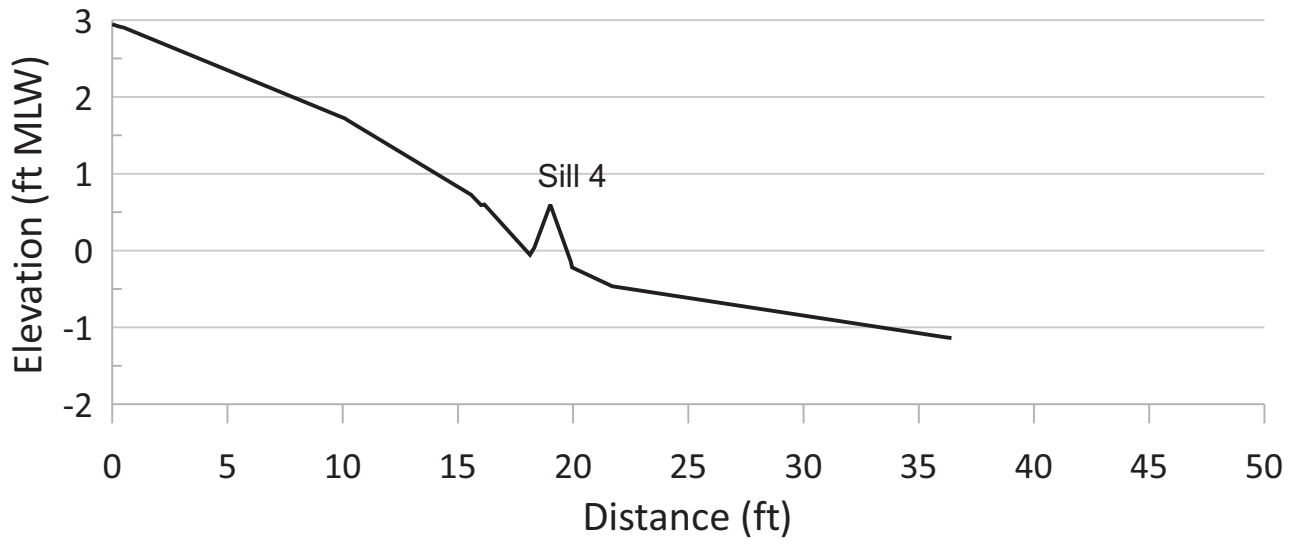
Cross-sectional survey 424 at Sill 4. Survey taken 26 Jan 2018, ten months after installation.

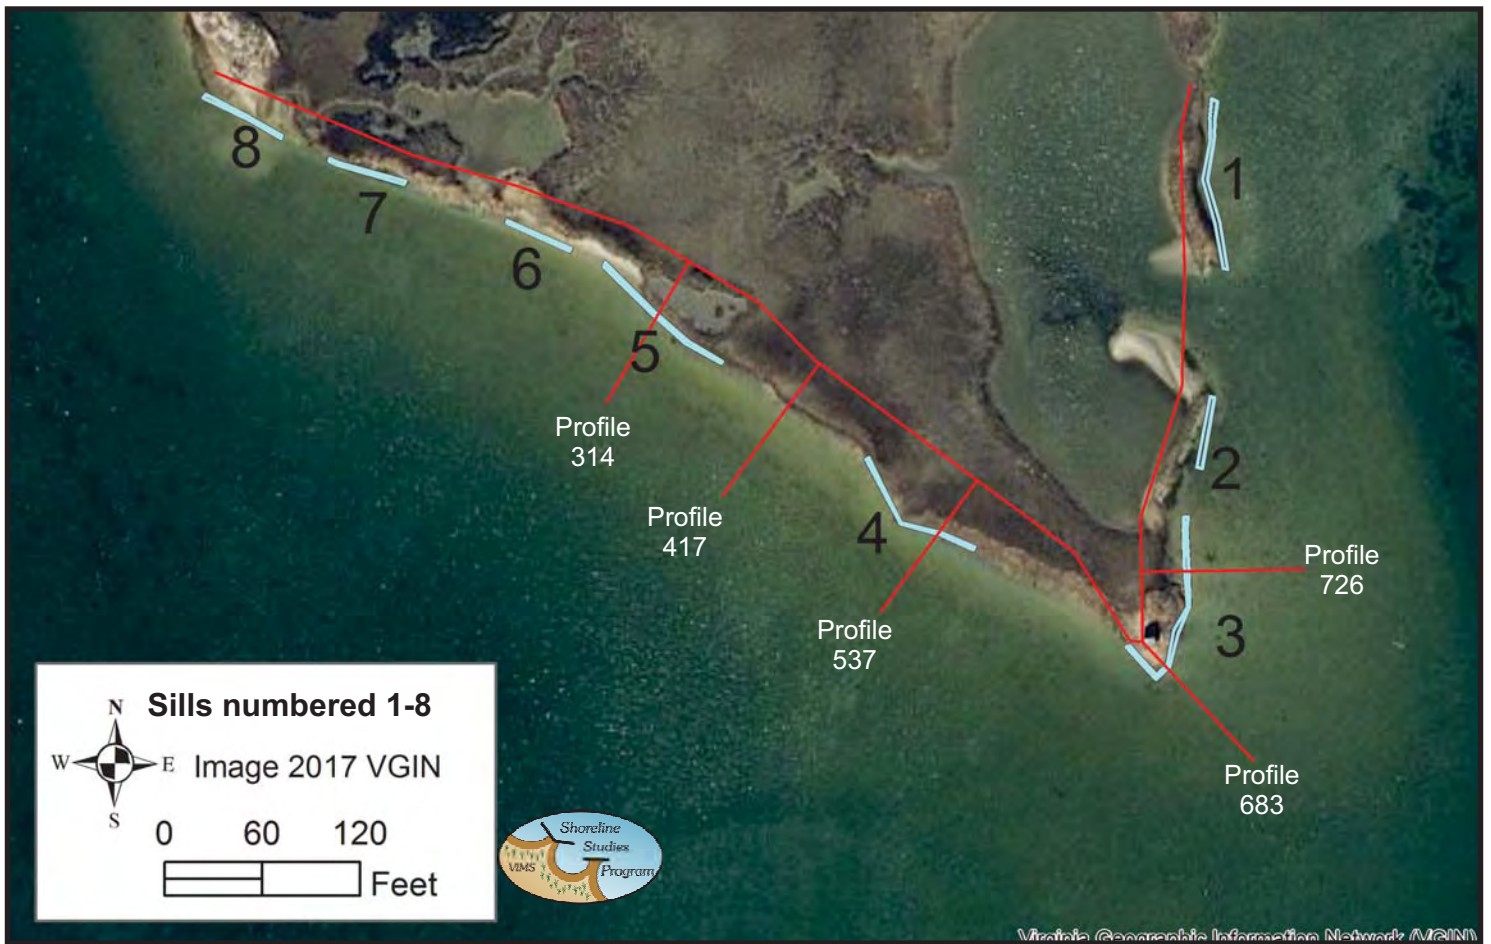
Location of cross-sectional profiles that were surveyed in September 2017 and April 2018. The profiles are shown on succeeding pages.

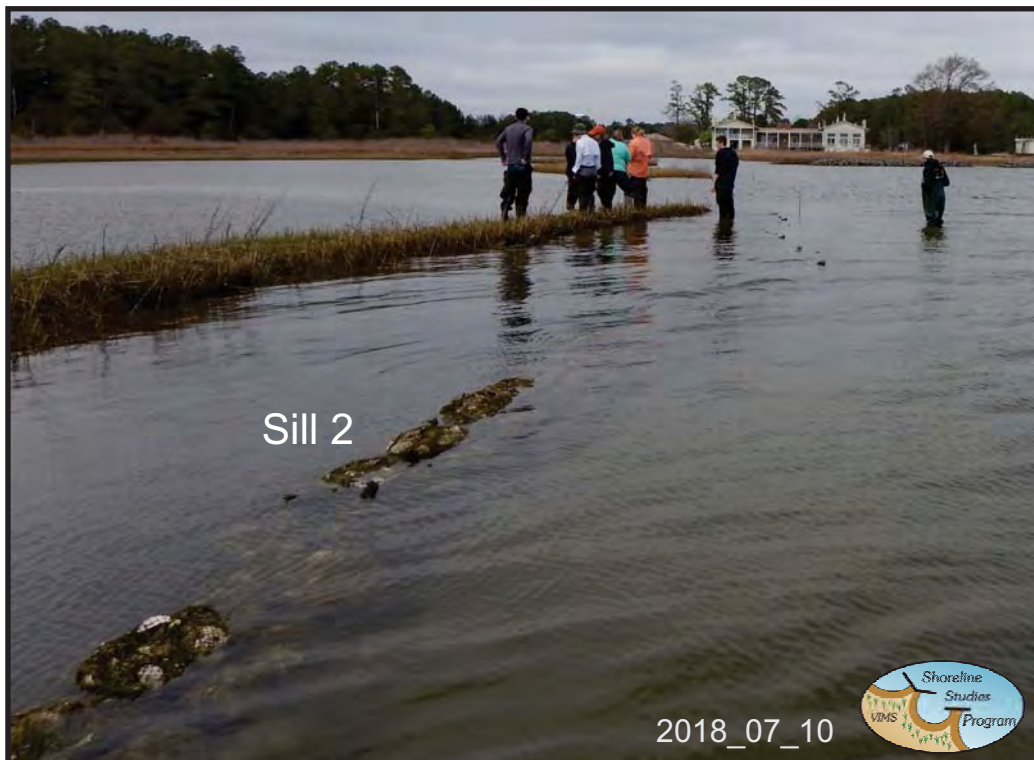
Sills 1 and 2 are 6 bag sills on the east-facing shoreline that fronts narrow, low marsh barriers that are covered at high water.
