Oyster Bag Sill Construction and Monitoring at Two Sites in Chesapeake Bay

Donna A. Milligan
Virginia Institute of Marine Science

October 2018

Shoreline Studies Program

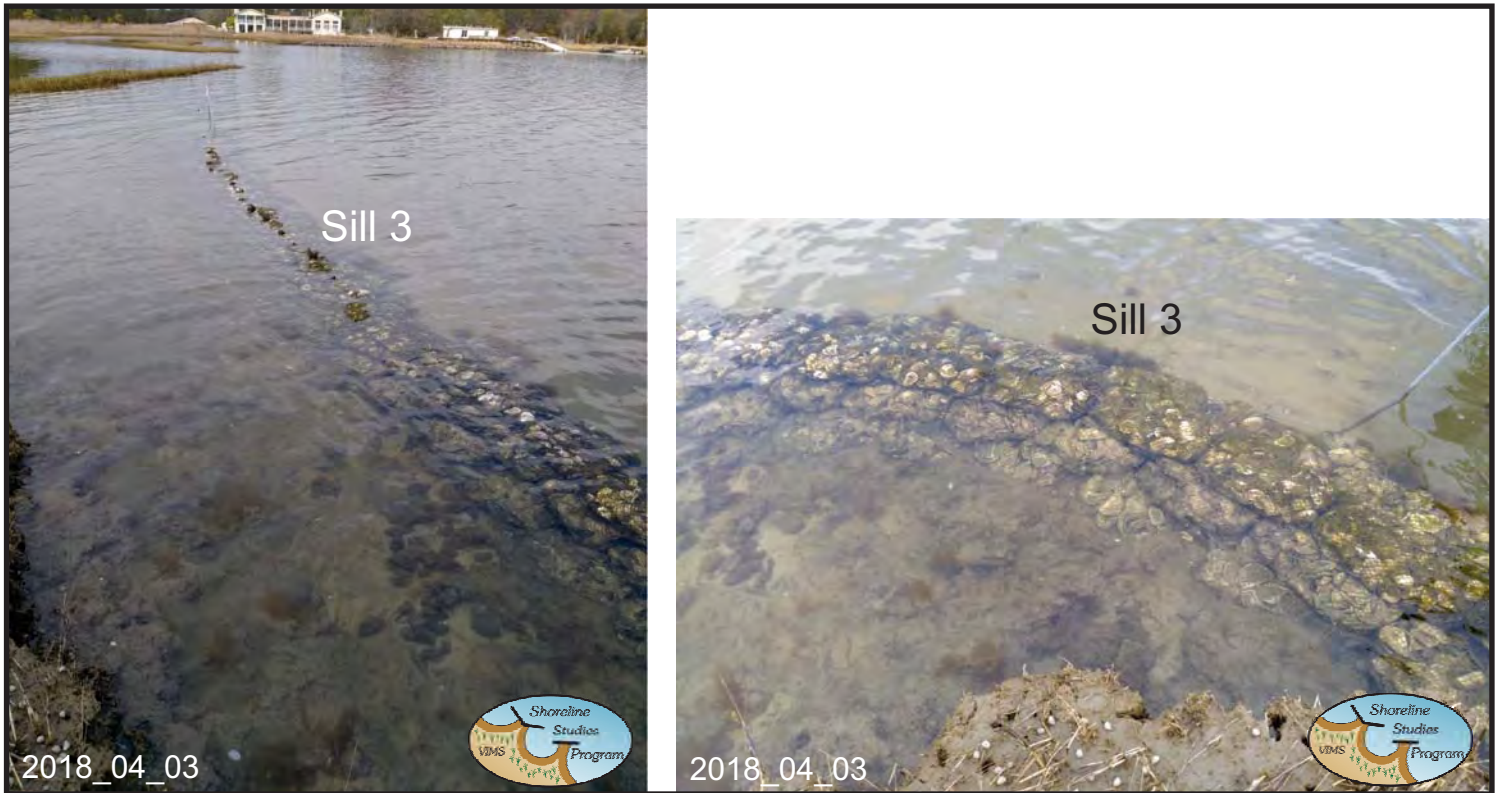
Sill 3 is a 6 bag sill on the east-facing shoreline. The bags were placed directly up against the marsh scarp at the point (Profile 683), but farther north along the shoreline, the sill moves away from the shoreline to follow because mean low water is farther offshore.

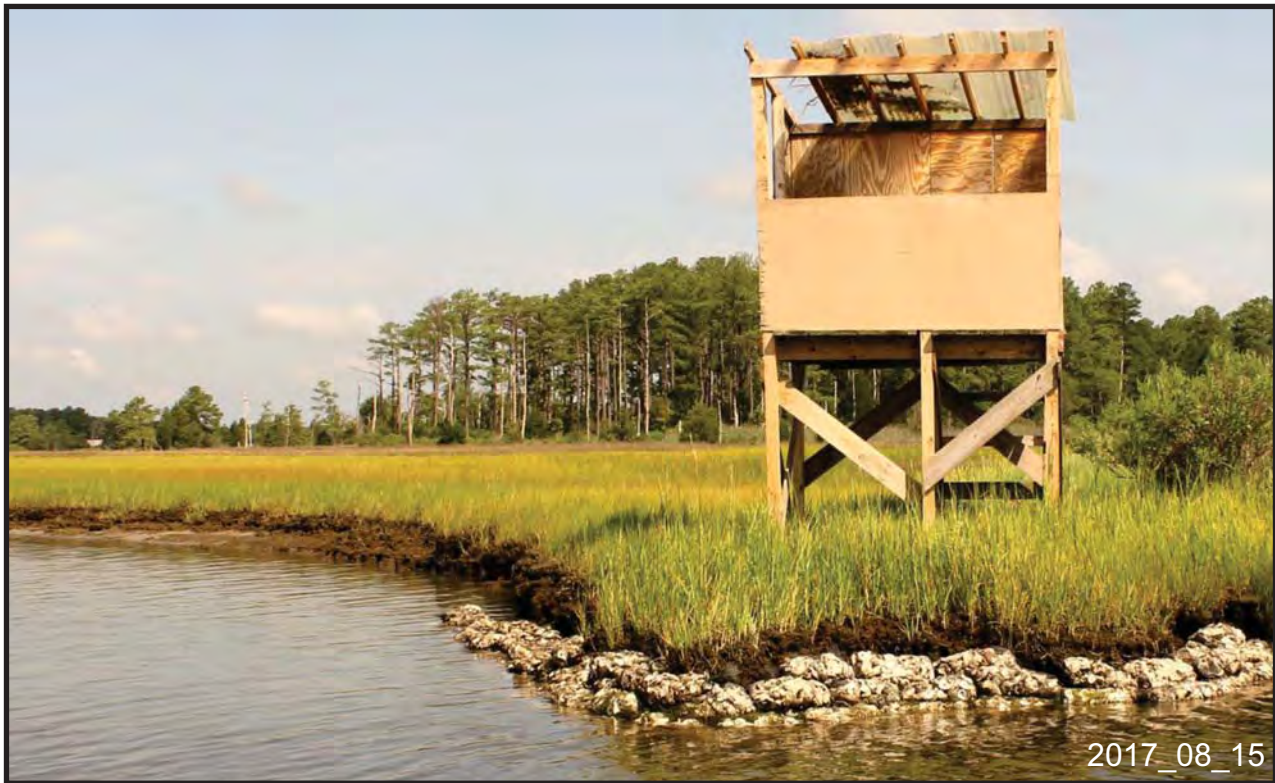
Sill 3 wraps around the point and comes in close to the marsh scarp to provide the maximum amount of protection to the shoreline. Photo credit Linda Tjossem.
