# A CASE STUDY OF ENGINEERING ETHICS: LESSON LEARNED FROM BUILDING COLLAPSE DISASTER TOWARD MALAYSIAN ENGINEERS

*This paper presents the case study on the Hotel New World tragedy. The building collapsed on 15th March 1986 and an investigation was conducted to determine the main cause of this tragedy. There were several speculations made on the cause of the collapse such as internal explosion, bad concrete mixture and swampy land affecting the building's foundations. However, after thorough investigations, these speculations were proved to be inappropriate and the main cause was found to be due to the engineer's miscalculation during the designing stage which leads to this catastrophic failure of the building. Rescue operation was initiated immediately after the collapse to rescue the victims and the aftermath of this tragedy had led to multiple reclamations. These reclamations include the endorsement of Building Control Act 1989 along Building Control (Accredited Checkers) Regulations 1989 as a stricter quality control measure. The analysis shows that this case may be due to unwanted mistakes or negligence of the engineers in carrying out their duties. Several actions were taken a

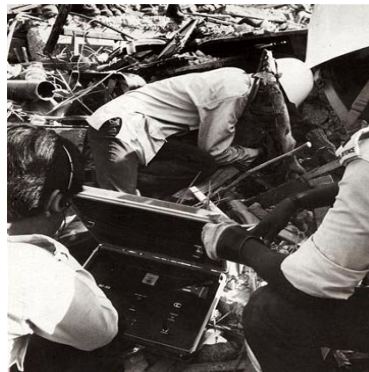
Fig. 4: Rescue operation [7].

After five day rescue operation, 17 people were rescued but 33 people were killed. Fig. 4 shows the rescue operation conducted at the day of collapse.
