Geomorphological Accidents caused by the Tokachioki Earthquake

Kasuke NISHIMURA, Shuryo SEGAWA, Hiroshi MIZUNO,
Hosei HOTTA, Osamu MIURA, Toshikazu TAMURA
and Takekazu AKAGIRI

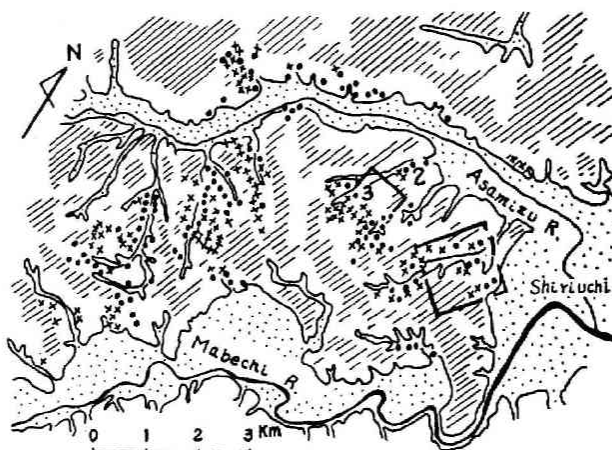
Fig. 3 Failed zones in the region to the west of Hachinohe
spot: failed zone with Scauper-type erosion area, cross: failed zone with Plane-type erosion area, hatch: upland surface, blank: valley wall, stipple: valley floor and the lowest terrace
Encircled areas with heavy lines are shown in Fig. 4.

Many slope failures by the Tokachi-oki earthquake in Hachinohe and around (Fig. 3) are not the rejuvenation of the former landslide areas subject to geological

structure such as the landslides observed at the Niigata earthquake (Nishimura *et al.* 1965) and as the landslides at this earthquake in Yamagata prefecture (Yonechi 1968). The sites of failures are not steep hillslopes but rather gentler slopes (5° at minimum). Collapsed materials of these failures are neither waste mantle nor bedrocks but younger pyroclastic fall deposits. The volume of the detritus is small (about $15,000 \text{ m}^3$ at maximum) but the distance of transport is relatively long (310 m at maximum).

Most of slope failures are concentrated in the valleys of small tributaries of the Asamizu river (west of Hachinohe) where there had been the heaviest rainfall amounting to 210 mm (observed at Gonohe) in preceding three days (Figs. 2 and 3). Each failed zone on the slope between the undulating upland surface and the narrow valley floor is composed of erosion area, runway through which detritus passed and deposition area (Figs. 4 and 5). The form of erosion area is apparently classified into Scauper and Plane types (Fig. 5, Photos. 1, 2).

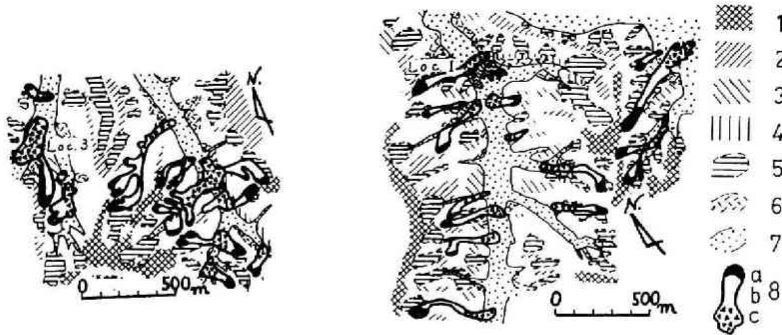
Fig. 4 Landform classification maps near Locs. 1 and 3.

The erosion area of scauper type is situated in small shallow depression excavated in upper convex slope. The lower end of the erosion area looks like a Karboden and is at the boundary between upper convex slope and middle straight slope (Photo. 3).

The erosion area of plane type is generally on a little steeper slope than the slope on which that of scauper type is, and lacks Karboden-like terracette. But the fact that small scaupers are often at the head of the plane-type erosion area may suggest the similarity of the mechanism of the failures of both types.

Runway, regardless to the type of erosion area, is very long in proportion to the whole size of the failed zone (Figs. 4 and 5). This area was free from any erosion but was subject to a little deposition. Surface materials of a few decimeter

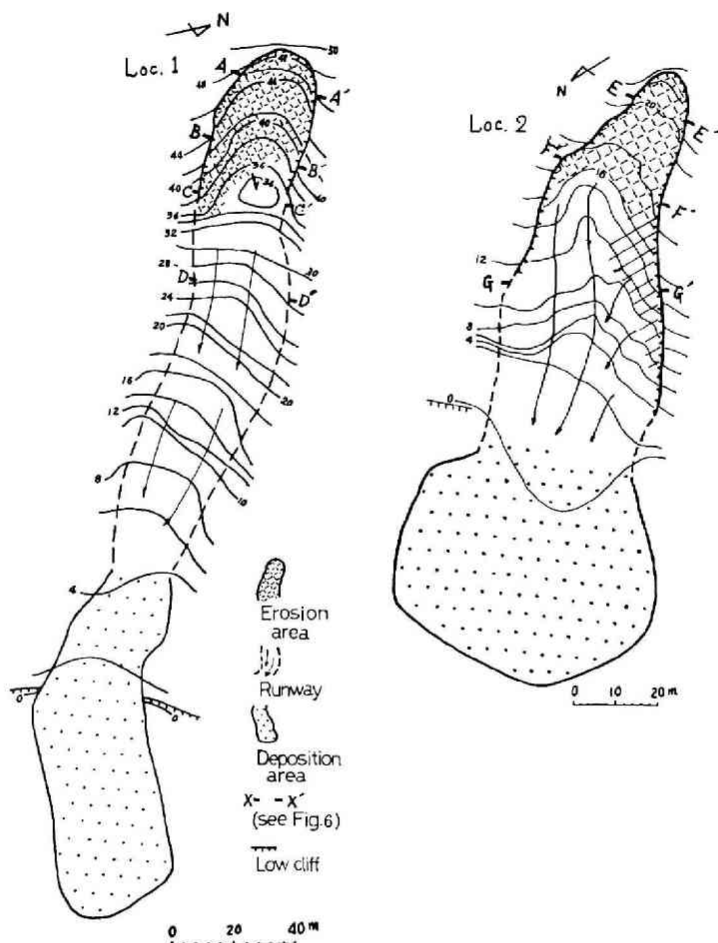
Fig. 5 Detail map of the failed zones surveyed by the authors
 Loc. 1 and Loc. 2 are shown in Fig. 3.

There are some compound types of scauper and plane types in erosion area (Fig. 5b). The slope failures observed at Nyûguchi-zawa (Photo 5), to the north of the area shown in Fig. 3, are varieties of plane-type failures fit for the local topographic setting which has small river terraces in front of upper convex slopes. The case seen in the campus of Kitazato College, Towada city, is a scauper-type failure lacking runway because of the gentle (5°) and low (10 m) valley wall (Photo. 6). Collapsed materials of these cases are stratigraphically same as the region to the west of Hachinohe.

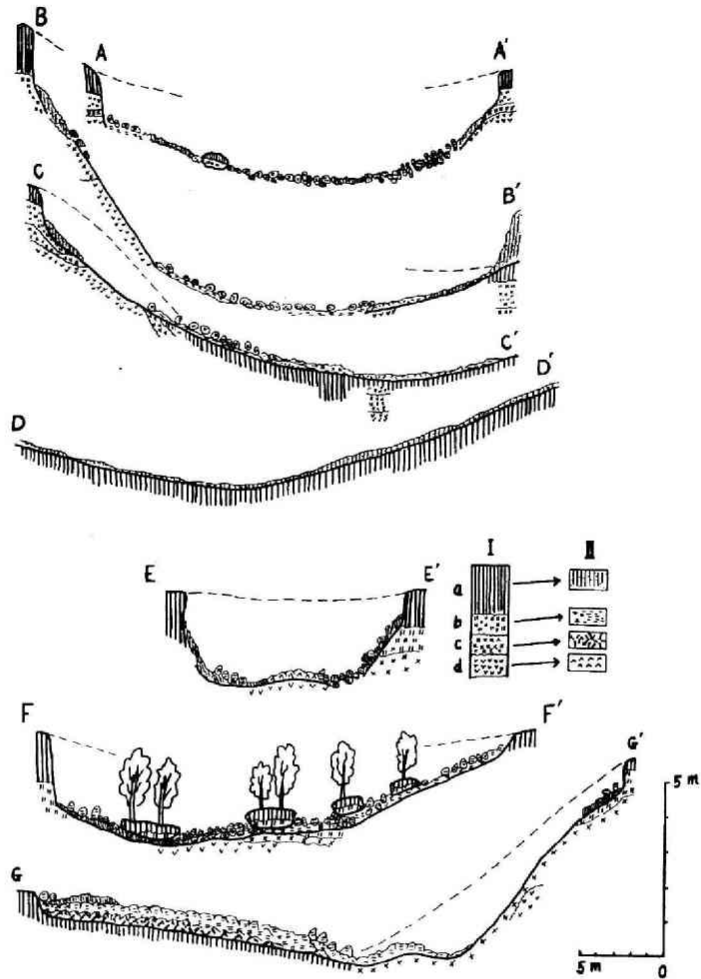
Fig. 6 Cross sections of the failed zones (Locs. 1 and 2)
 from A-A' to D-D': Loc. 1 from E-E' to G-G': Loc. 2 (see Fig. 5)

Stratigraphic sequence of surface materials less than 2 m in thickness are, upper to lower, black surface soil intercalating sandy pumice of Holocene, dark brown subsoil, yellowish brown clayey volcanic ash with yellow pumice grains of the latest Pleistocene, greyish white fine pumice of the latest Pleistocene and whitish coarse pumice of the latest Pleistocene (Fig. 6). Those materials except the coarse pumice were removed.

on the ground surface before the failure were mainly smashed materials of black surface soil and subsoil with blocks of yellowish brown volcanic ash removed from the erosion area (Fig. 6). Greyish white milky pumice was deposited directly on the original surface soil at some places of runway. Then it is suggested that this pumice removed at first from the erosion area. Deposits on runway were occasionally left at flow of materials from the erosion area to deposition area. The flow was very fast, seemingly 20 m/sec., an estimation based on several witnesses' observation.

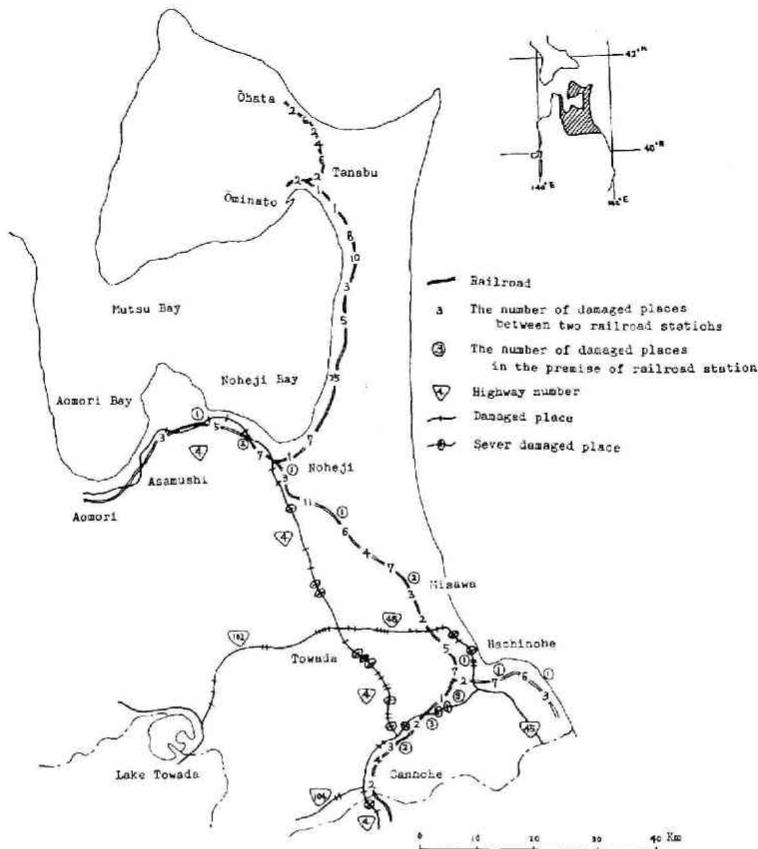
Fig. 7 Damaged places of railroad and highway in the eastern part of Aomori prefecture

The Tokachi-oki earthquake brought severe damages to railroads and highways in the eastern part of Aomori prefecture (Fig. 7).

The destruction of railroads and highways at more than two hundred places in Aomori prefecture were caused by the collapses of artificial embankments such as railroad basements or highway roadbeds across the dissected valleys. They were generally filled with dark-brown loamy volcanic ash (Photo. 7).

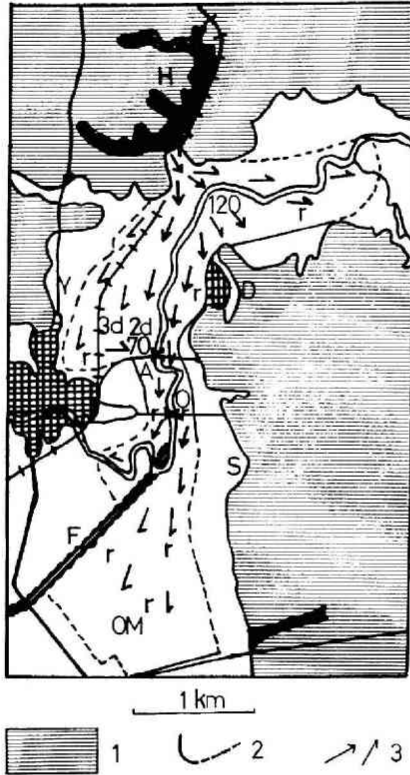
Fig. 8

At Hayakake-numa the earthquake caused several cracks parallel to the length of the dam and broke it at two places. Total width of the breaks reached about 150 m (Photo. 8). Consequently a flood happened and it flowed with full strength eastward to the Tanabu river, and it washed away the roadbed of the Ohata line railroad (Photos. 9, 10). Then the flood flowed down southward along the Tanabu river, when the flood-flow was weakened and controlled by micro-landforms, and formed a temporary lake at the upper side of Akasaka bridge east of Mutsu city.

The water flowed down again and drained mostly through the flood control bypass channel to Mutsu bay, and some flood water was drained through the lower Tanabu river and the rest of flood water flowed southward into the Kanamagari lowland and augmented the stagnant water level due to the rainfall (Fig. 8).

Causes of breaks of the dams in Shimokita district are as follows: 1) dams were made of earth and constructed over 20 years before, 2) capacity of reservoirs were large and every reservoir was filled fully with the rain water of the preceding heavy rainfall, 3) the shock of the earthquake was too strong.

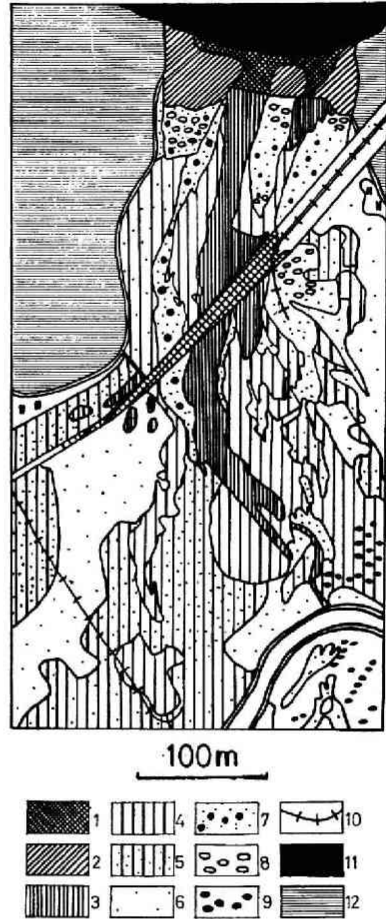
Fig. 9

Landforms changed apparently at the section between the dam and the Tanabu river. Two holes like the waterfall basin were dug just downstream of the two breaks. An erosion trough (width 5–15 m, length 350 m, max depth, 2 m) was scooped out downstream of the bigger hole. Then the area of deposition and erosion belts follows from the roadbed to the Tanabu river. Three deposition belts are clearly distinguished, west (width 5–20 m, length about 300 m, thickness 1 m), central (30 m, 90 m, 2 m) and west of remained part of roadbed (30 m, 110 m, 1.9 m). Deposited materials are coarse sands and gravels near the dam, fine sands increase gradually to the lower part of the roadbed and brown clay near the Tanabu river. Many plant-root blocks originated from the floating islands on Hayakake-numa were transported to paddy fields 500 to 800 m distant from the dam (Fig. 9).

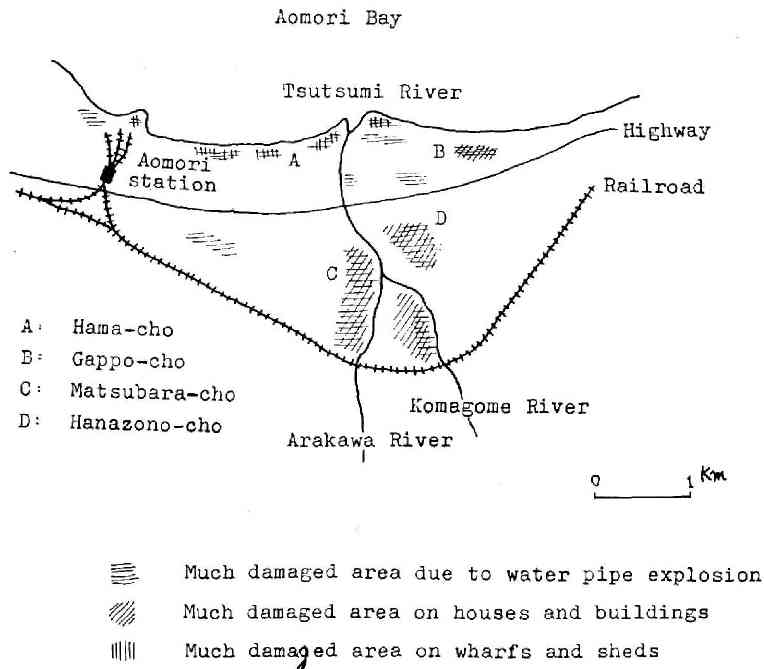
Fig. 10 Distribution of damaged area in Aomori city

prefecture, which is situated on the coastal lowland along the Aomori bay. Many houses and buildings were completely or partially destroyed in the urban area of Aomori city, moreover water pipes exploded everywhere and wharves and sheds in coastal zone collapsed (Fig. 10).

The distribution of damages is concentrated in two areas, one is the coastal area along the Aomori bay including Hama-cho and Gappo-cho, and the other is on both sides of the Tsutsumi river including Matsubara-cho and Hanazono-cho.

In the coastal area the land had been graded for the purpose of constructing factories, wharves and sheds. Unconsolidated lands which once had been back-marshes among beach-ridges were depressed unequally and jetted out water, and then many factories, wharves and sheds were damaged there (Photo. 14).

In the Tsutsumi river area the damages occurred on the reclaimed land from the former river courses and former back-marshes of the Tsutsumi river, as many cracks, depressions and water-jettings. As the result, many houses and buildings were slanted in various degrees.

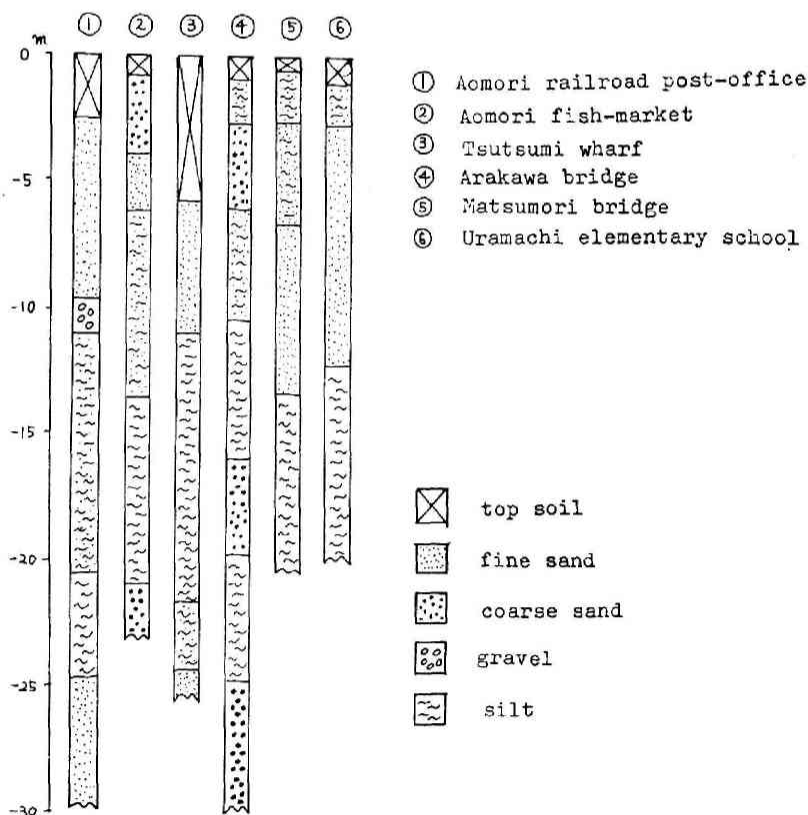
Fig. 11 Boring data near the damaged area in Aomori city

According to the boring data (Fig. 11) in and around those damaged areas, it is proved that weak-kneed dark-blue silt layer (-10 m. to -25 m. in depth) is buried there. The damages in Aomori city were mainly caused by the quicksand phenomena as in Hakodate city shocked by the earthquake in the weak-

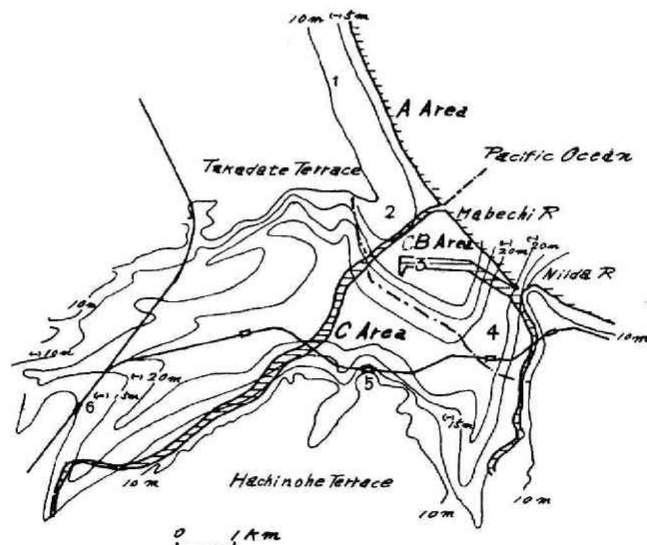
Fig. 12 The lowland of Hachinohe city

Alluvial lowlands are divided into 3 areas, northern coastal lowland (A), alluvial delta (B) along the Pacific Ocean and the valley plains along the Mabechi river and the Niida river (C) (Fig. 12).

On the lowlands, generally speaking, the degree of the damages was determined with the character of the alluvium 5 m under the land surface. The most heavily damaged area was the recently reclaimed back-marsh or lagoon area. Next to was the deltaic area, and little damaged area was the floodplain area.

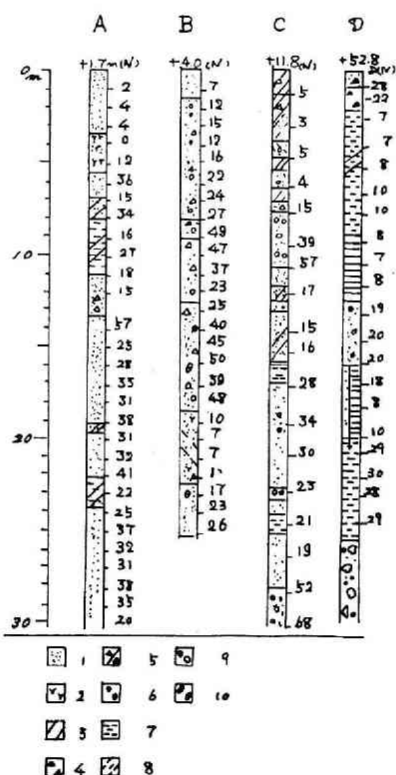
Fig. 13. Boring Columns around Hachinohe city

acceleration of the earthquake was recorded in N-S direction 235 Gal, E-W 188 Gal, Up-Down 80 Gal with the seismometer (SMAC-B2 Type) at the center on the area, and there occurred many cracks, unequal depressions, and sand-jettings. The damages in (A) area were many tilts and depressions of the factory sites and cuts, ruptures, or bendings of the pipes for processing and water supply buried under the ground 2-3 meter in depth. High ground water table, unconsolidated alluvium about 5 m in thickness, and newly graded land, made the damages more severe (Fig. 13).

thick volcanic ash and volcanic loamy ash (3–4 m in thickness), and underlying deposits are sand and gravel (2–3 m in thickness). The terrace surface is cut by open, shallow valleys which are also buried with the above mentioned volcanic ashes (Fig. 13), and the most damages occurred in these valleys. One runs from Kashiwazaki to Chojasan hill, and another runs just under the civic center where are located newly buildings and houses. Here, steel-concrete buildings, many houses, water pipes, and gas pipes suffered severe damages, because of the alluvial character in the buried valley areas and the insufficient condition of drainage. Out of these buried valley areas, at the smaller valleys and at the margin of the terrace, heavy damages occurred.

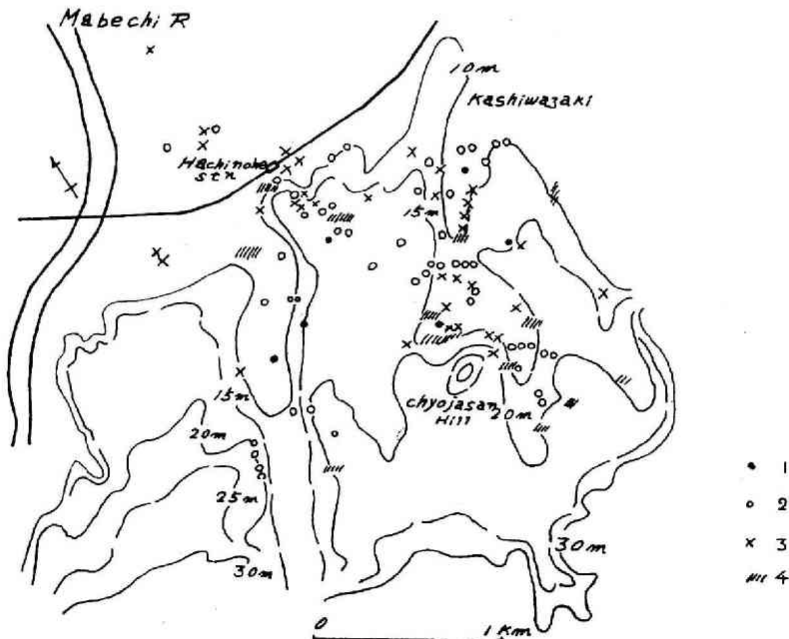
Fig. 14 Damages on the Hachinohe terrace

On the Hachinohe terrace (Fig. 14), where there is the urban center of Hachinohe city, the damage occurred selectively. Hachinohe terrace is covered with

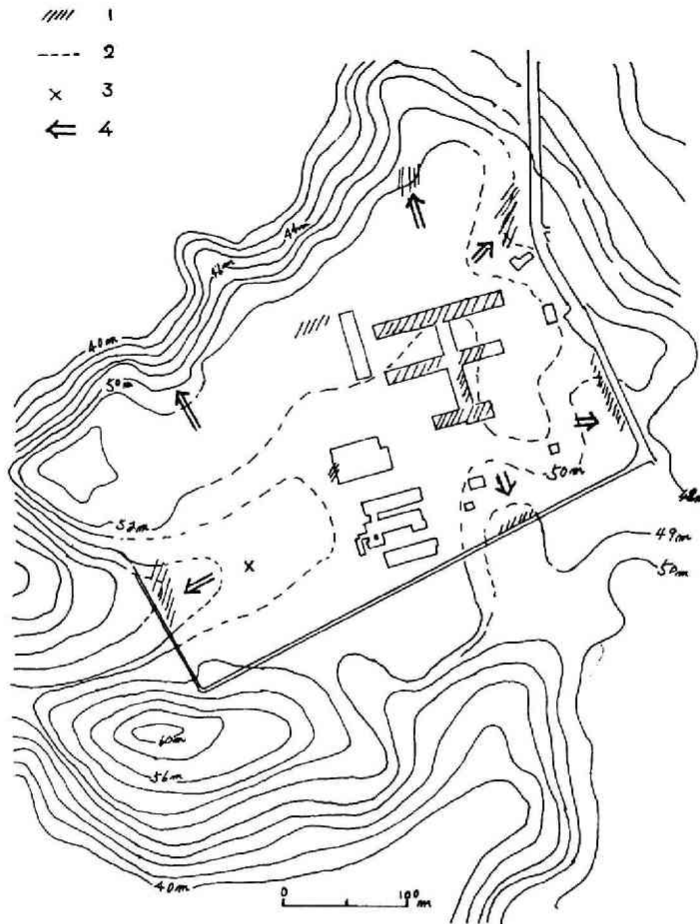
Fig. 15 Damages in Hachinohe Technical College

The three-storied steel-concrete building of Hachinohe Technical College on another terrace 50–53 m above sea level suffered severe destruction by the earthquake (Photo. 17). The subsurface geology of the ground of the building is almost the same as the Hachinohe terrace. Before the College was built, there had been a few open, shallow valleys cutting the terrace surface as on the Hachinohe terrace (Fig. 15). In the college campus there occurred cracks on paved road, and depressions and mud-jetting on the ground. Especially, in the first floor of the college building many parts of wall cracked, many pillars and windows broke. It is dangerous to build steel-concrete building on the very position of the above mentioned valleys buried with thick volcanic ashes which absorb water easily.
