Journal of University of Babylon, Engineering Sciences, Vol. (26), No. (5): 2018.

Geometrical Design Errors in Duhok Intersections by Driver Behavior

Abstract

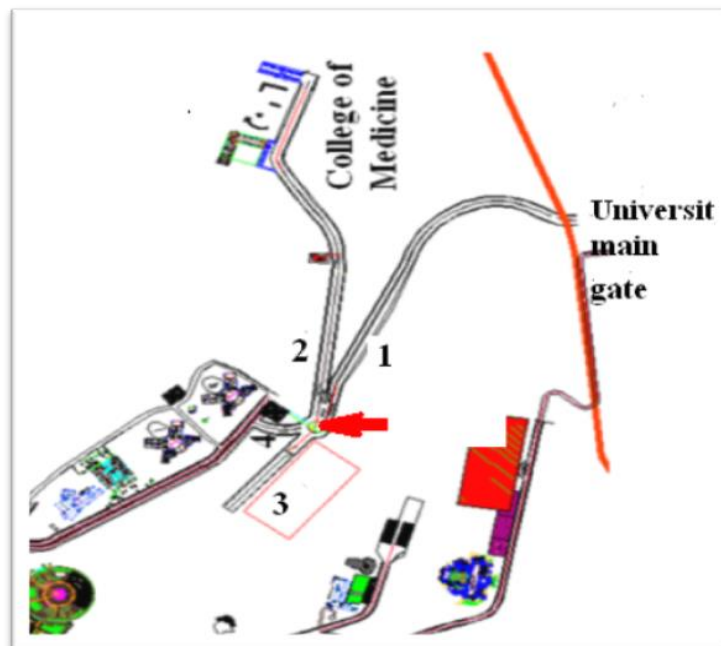
Figure (2) shows the location of the first site, the roundabout near the department of psychology. The roundabout have four approaches. Approaches 1 and 4 are the major roads connecting the university gate to the whole campus. Approaches 2 and 3 are the minor with the lowest in flow and density as they end at the college of medicine and the department of psychology respectively.

Figure (2) the location of the roundabout

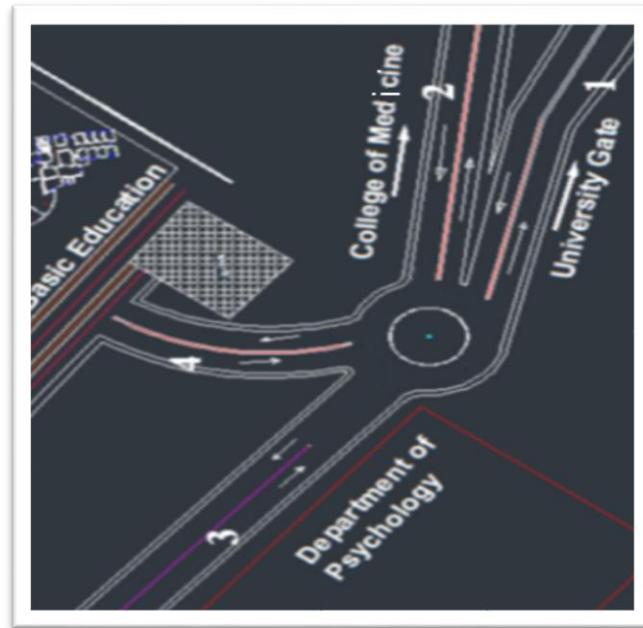
Figure (3) shows the detail plan of the roundabout. The inscribed circle diameter = 46m and central island diameter = 24m. Making a clear circulatory roadway = 11.1m or three lanes of 3.7m.

Figure (3) a close look on the roundabout

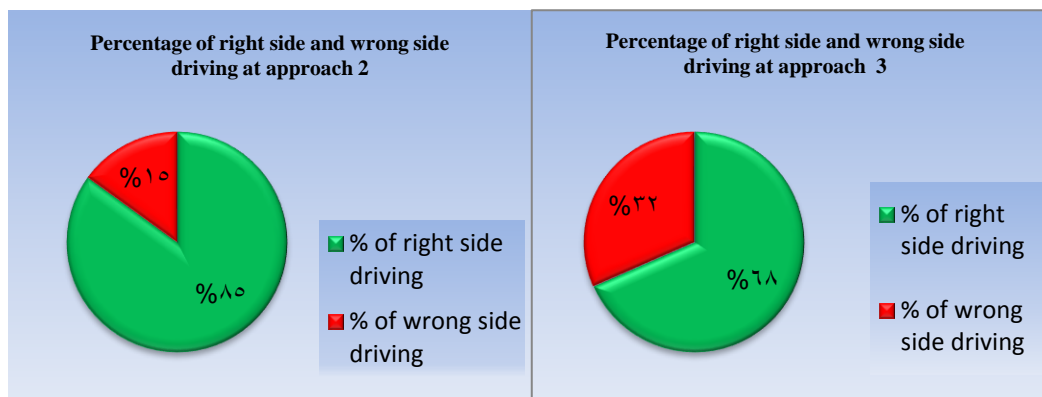
Table (1) list the count during the peak hour at the roundabout a total of 226 vehicles were observed on approach 2 and 171 on approach 3. As shown from table (1) and Figure (11), there is 15% and 32% wrong side driving on approaches 2 and 3 respectively.

Figure (11) Percentages of right side and wrong side driving on approaches 2 and 3

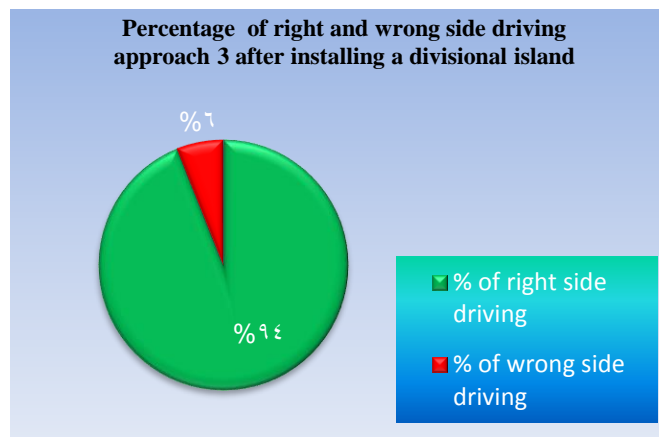
A large reduction in wrong side driving from 32% to 6% was observed. Figure (15) shows the small share of wrong side driving in approach 3

Figure (15) the obvious reduction in wrong side driving in approach 3 after erecting the divisional island

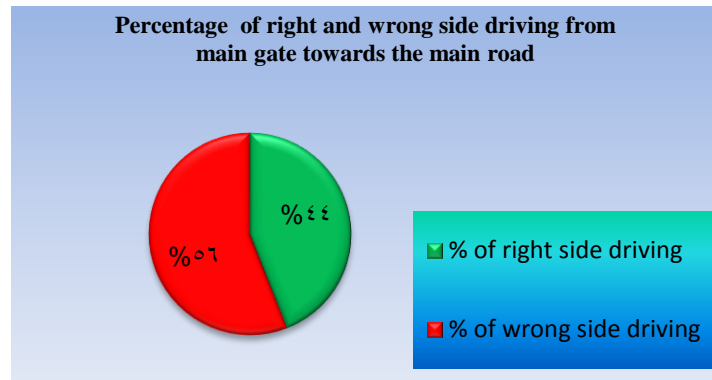
Figure (16) Percentage of right and wrong side traffic from the main gate

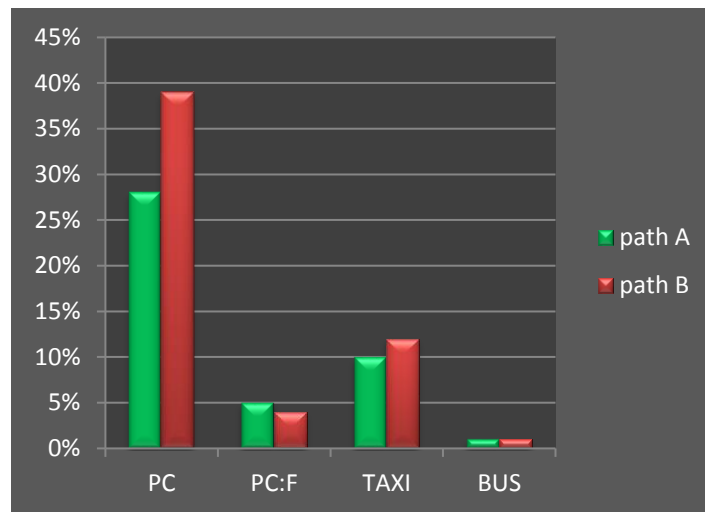
Figure (17) Vehicle categories in right and wrong paths

Figure (17) shows that there is no significant difference in road user's categories in the right and wrong paths except for the passenger cars. 28% of the total vehicles emerging from the main gate go in direction A, whereas 39% go in the wrong direction.

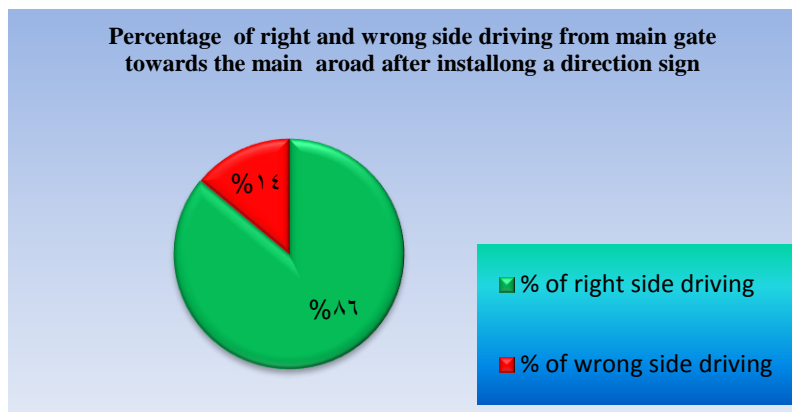
Figure (19) Percentage of right and wrong side driving after installing the direction sign

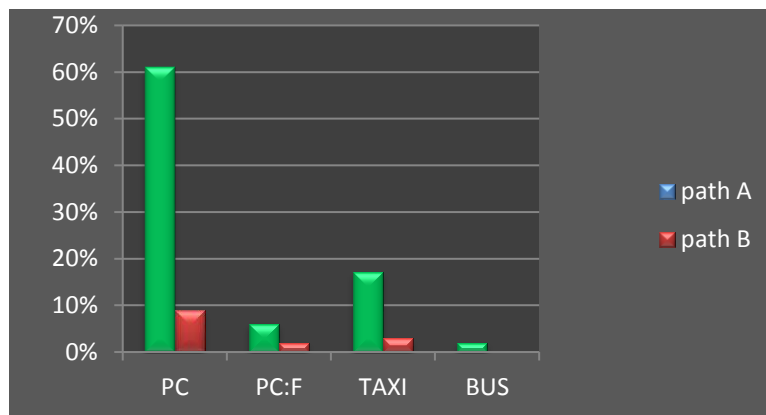
Figure (20) Vehicle categories in right and wrong paths after installing the direction sign

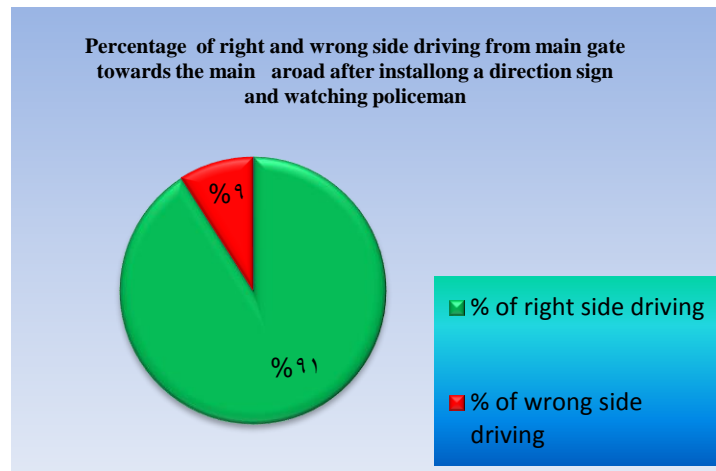
Figure (22) a large reduction in wrong side driving was achieved as a result of having direction sign and standing policeman

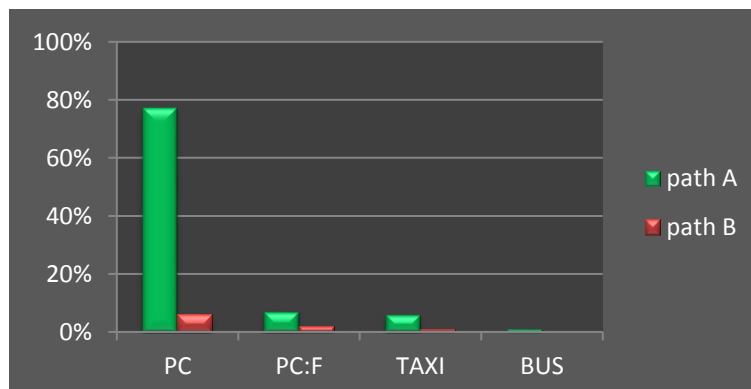
Figure (23) shows the greater reduction in wrong side driving among all categories with the presence of control sign and standing policeman.

Figure (23) the great reduction in wrong side driving after installing a direction sign and standing policeman

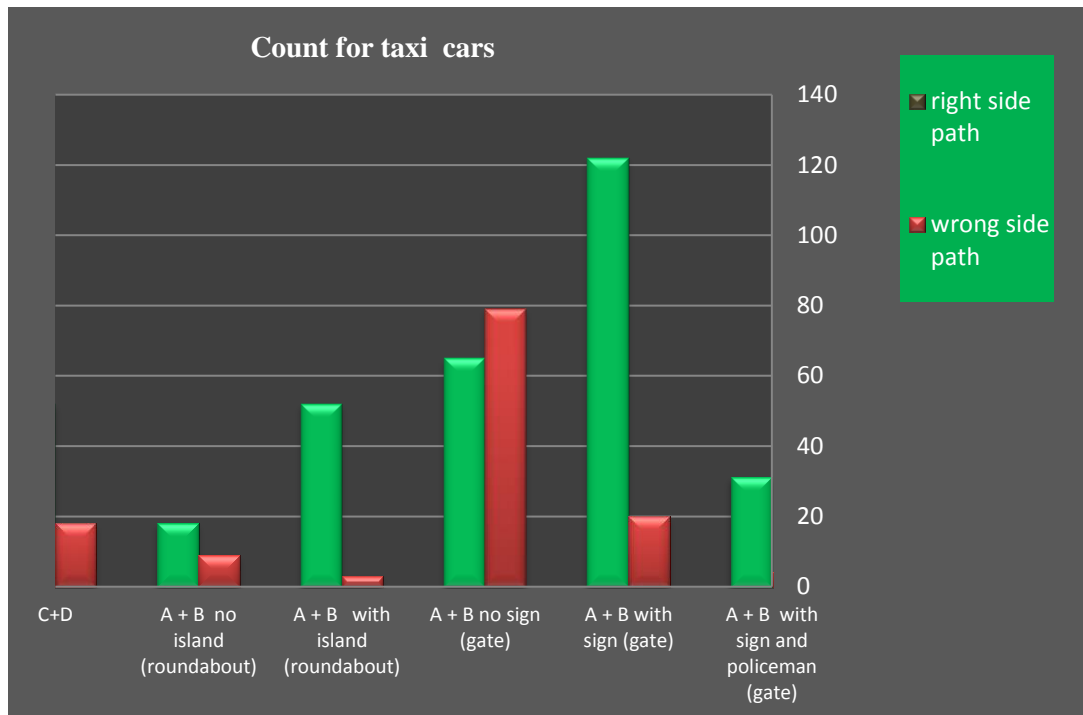
Figure (24) shows car number in different cases. Among all the cases we can notice the obedience of taxi drivers in the eastern gate to the direction sign. After installing the direction sign only, among 142 taxi car only 20 made wrong side movement.

Figure (24) Count for right and wrong side taxi vehicles in different cases
