Field Experimental Study on Corrosion Mechanism of Well Lai 14-9

Abstract

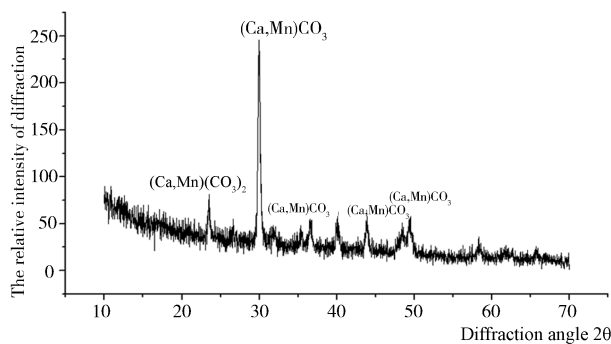
Figure 11
XRD Analysis Spectrum of the Corrosion Fouling Picture of 1,500 m Depth

The corrosion fouling of 1,600 m depth from the ectoecium of oil tube of well Lai 14-9 is collected and analyzed with SEM observation and Energy spectrum analysis and the results are shown in Figure 10 and Table 4. From Table 4 we can see that the main elements in the corrosion fouling are still C, O and Fe. The result of XRD analysis spectrum shows that the corrosion product is mainly (Ca, Mn) CO₃ (Figure 11), it also indicates serious scale deposit in this injecting well. The existence of CO₃²⁻ indicates that CO₂ corrosion is the main reason for the casing corrosion in this layer.
