Proceedings of International Conference : Issues, Management And Engineering In The Sustainable Development On Delta Areas Semarang, Indonesia – February 20th, 2015 Paper No. XXX (The number assigned by the OpenConf System)

The Impact of Alluvial Land Subsidence Towards Extension of Inundation and Infrastructure Damage At Settlements Around Harbor Area of Tanjung Mas – Semarang

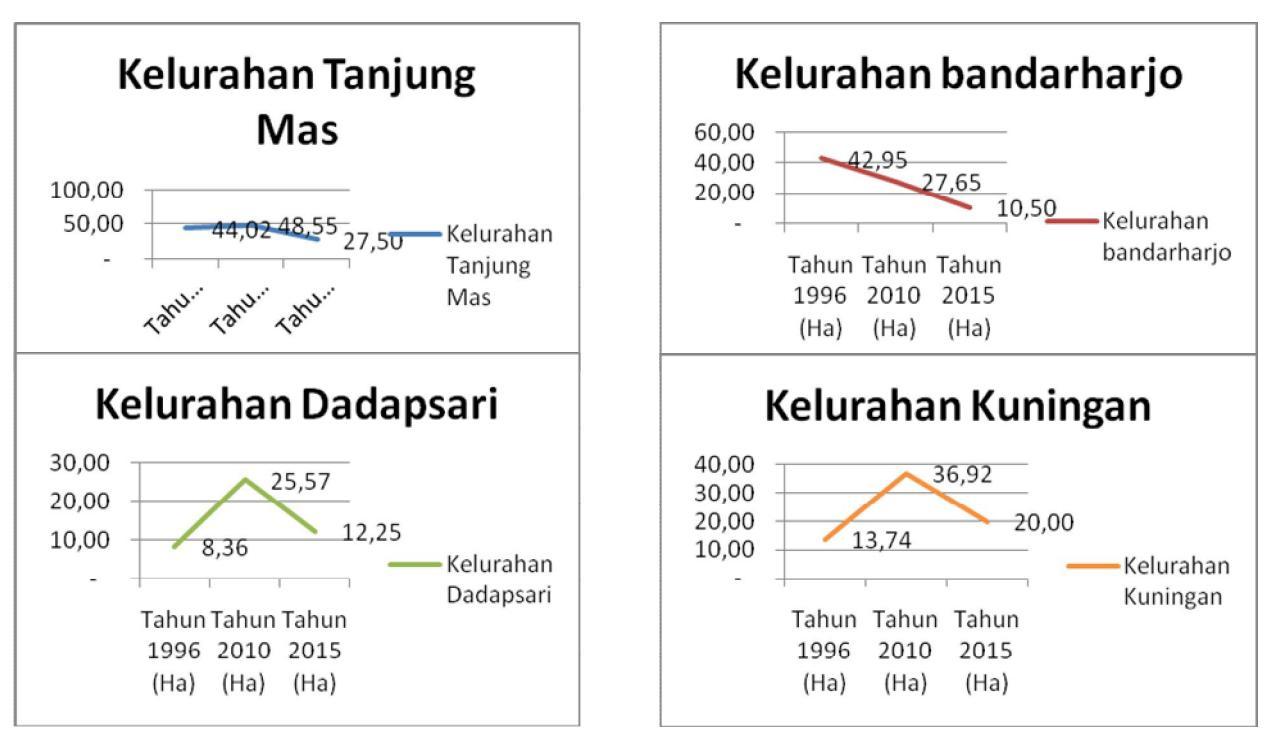
Figure 4. Graphic of Area and Inundation in 1996, in 2010, and in 2015

In 2014, Normalization and sediment dredging in Semarang River and Asin River were completely done and retensive pool of Semarang River firstly began to function, the result of which, the change of inundation width and infrastructure damage in 2015 as seen in the figure 04 and table 03.
