**Structural Evaluation and Testing of Damaged  
Reinforced Concrete Bent Caps**

**Thesis**

The University of Texas at Austin

May 2019

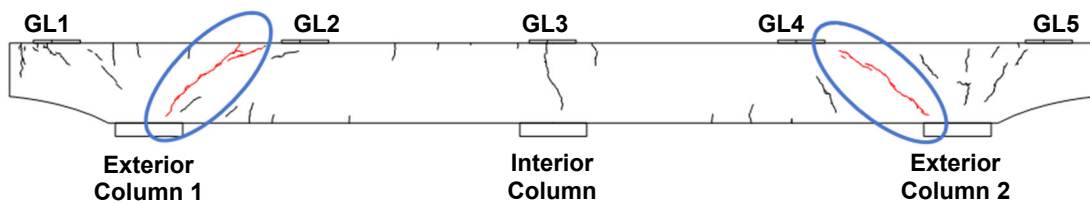
Figure 2.6. Larger-width, “primary,” shear diagonal cracks

Note that the identified larger-width, “primary,” shear diagonal cracks (see Figure 2.6), extend from the outside columns to the loads stemming from the first interior girder line on both sides of the bridge (i.e., GL2 and GL4 for the 5-girder bridges).

were found to extend from the outside columns to the application of forces stemming from the first interior girder lines on both sides of the bridge (i.e., GL2 and GL4 for the 5-girder bridges). These eight cracks had maximum measured crack widths that ranged from 0.028 to 0.059 in. (0.70 to 1.50 mm) and an average crack width of approximately 0.024 in. (0.60 mm). Note that this maximum crack width is nearly three times the average measured crack width obtained from the rest of the cracks on the bent caps (~0.008 in. [0.22 mm]).

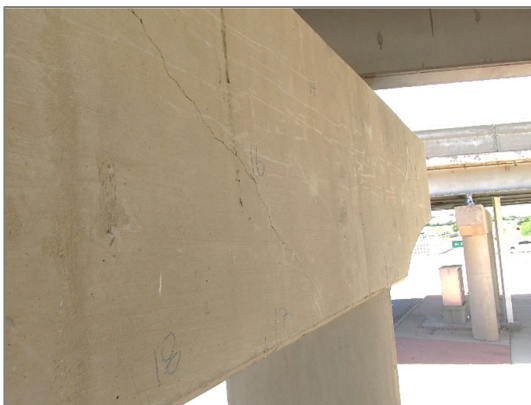
(a) dominant shear crack (southwest face of BC1)

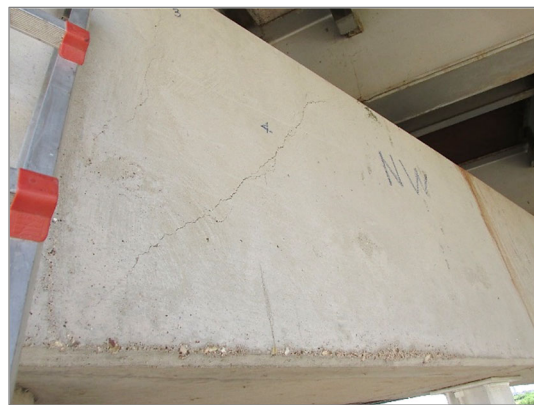
(b) dominant shear crack (northwest face of BC1)

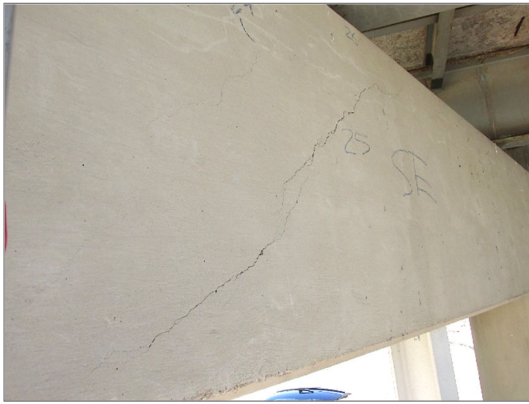
(c) dominant shear crack (southeast face of BC1)

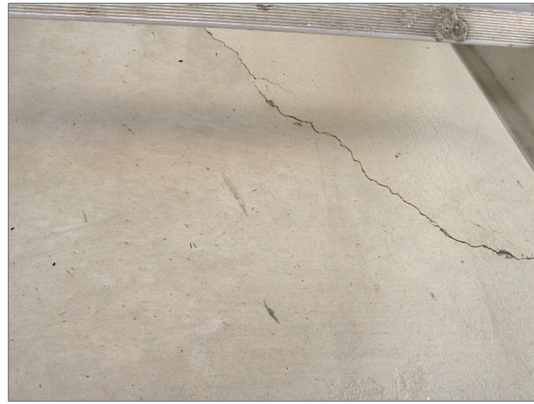
(d) close-up of dominant shear crack (northeast face of BC1)

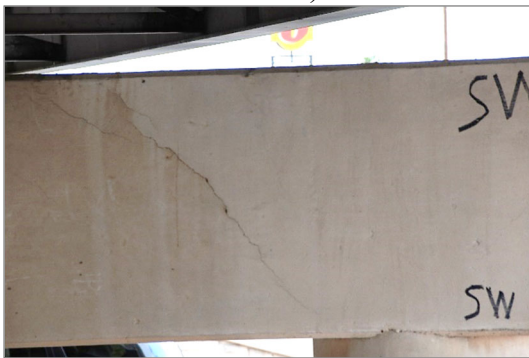
(e) dominant shear crack (southwest face of BC2)

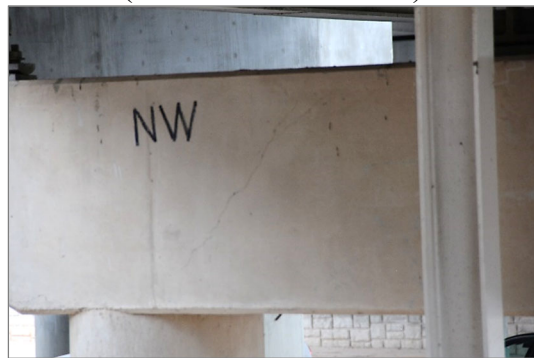
(f) dominant shear crack (northwest face of BC2)

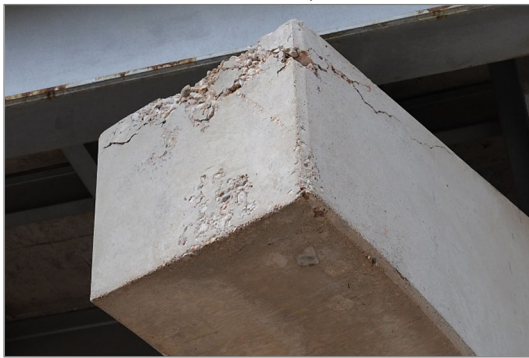
(g) end region cracking, chipping, and spalling (north end of BC2)

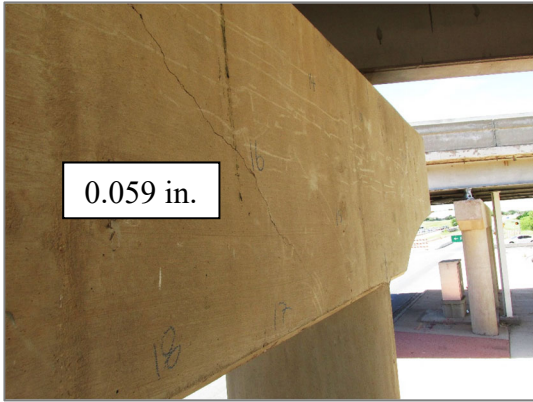
(a) In-field largest width primary crack on SW face of BC1

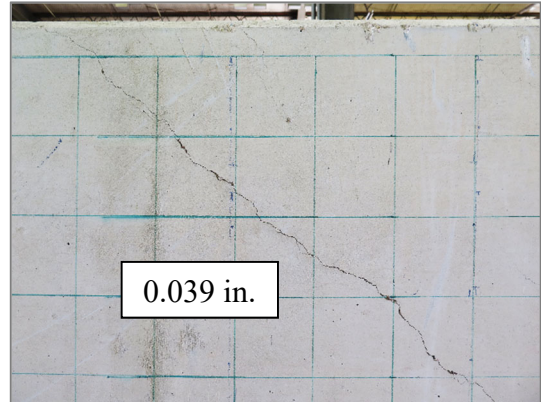
(b) In-lab largest width primary crack on SW face of BC1

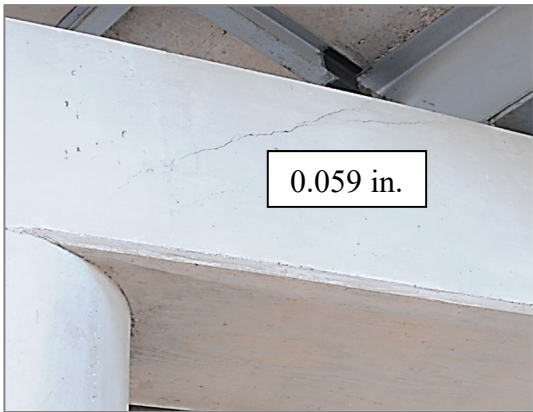
(c) In-field largest width primary crack on SE face of BC2

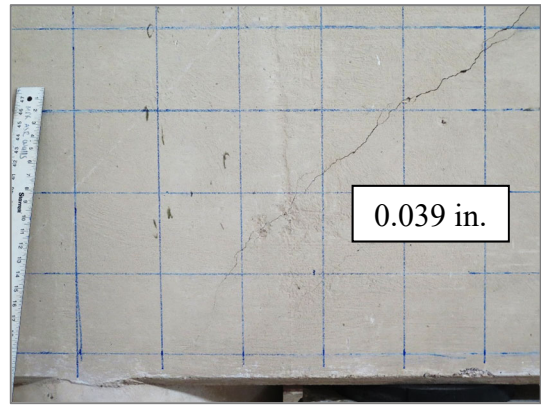
(d) In-lab largest width primary crack on SE face of BC2

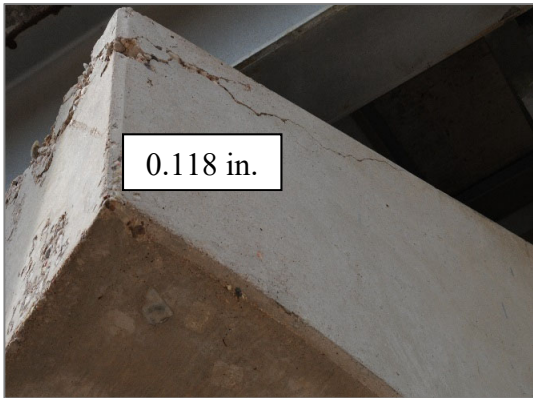
(e) In-field largest width crack on NW face of BC2

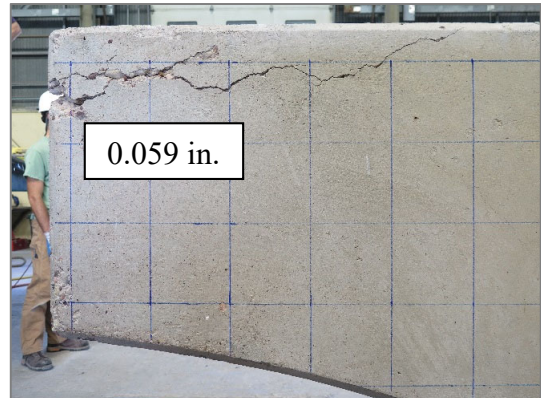
(f) In-lab largest width crack on NW of BC2

Note that, in the case of BC2, the maximum crack width was found to be located on the northwest face of the bent cap, beneath the outermost girder line bearing plate where some localized concrete damage was observed (refer to Figure 2.9a and 2.9f). The

maximum width primary shear crack measured for BC2 was 0.059 in. (1.50 mm) in the field and 0.039 in. (1.00 mm) in the laboratory. Recall that Figure 2.9 presents photographs showing the primary crack locations and widths. Figure 2.11 shows the location of the largest width cracks for each bent cap and the stirrups GPR locations.

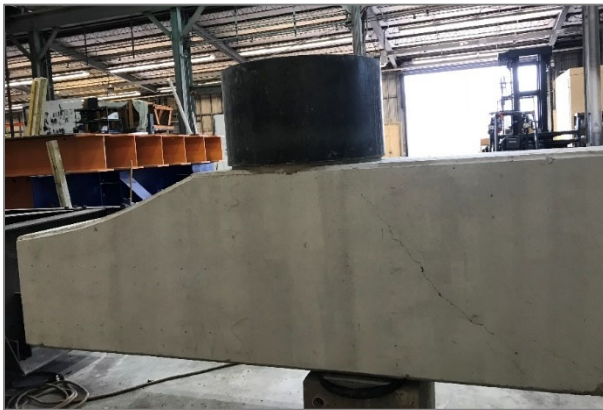
(b) Interior span 1 prior to retrofit

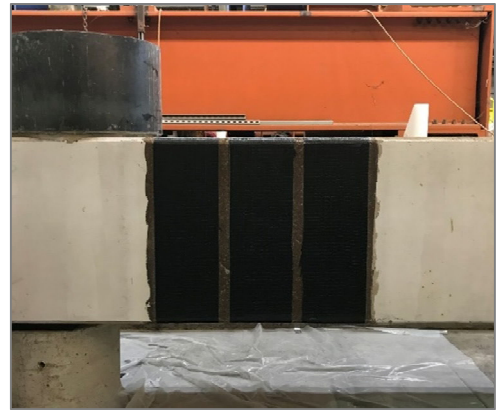
(c) Interior span 1 with CFRP retrofit

The shear-cracked interior spans of Bent Cap 2 were retrofitted using a unidirectional carbon fiber-reinforced polymer (CFRP) wrap to investigate its effectiveness in increasing the strength and stiffness of the shear-cracked bent cap. The location of the completed interior span retrofit, and a photograph of one of the completed

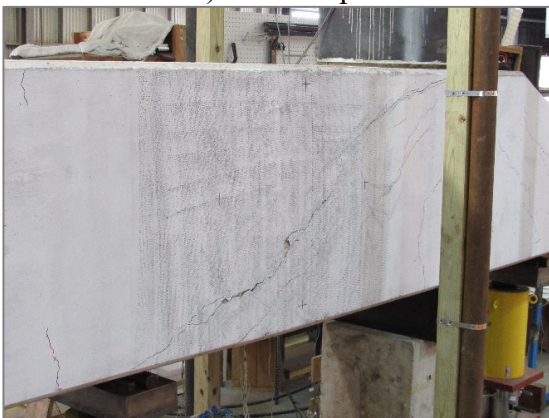
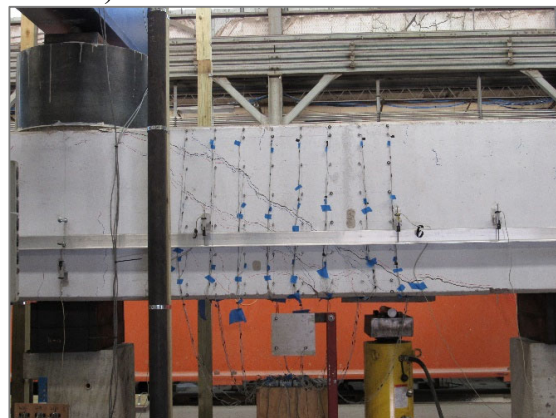
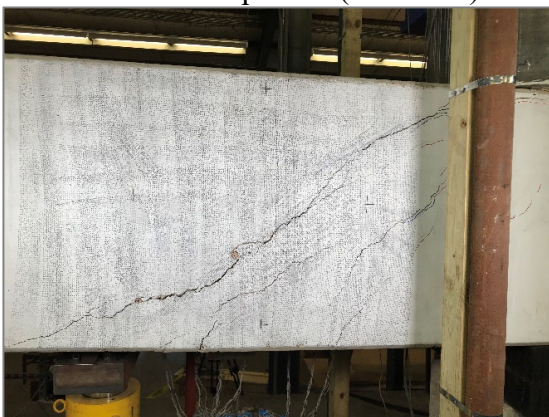
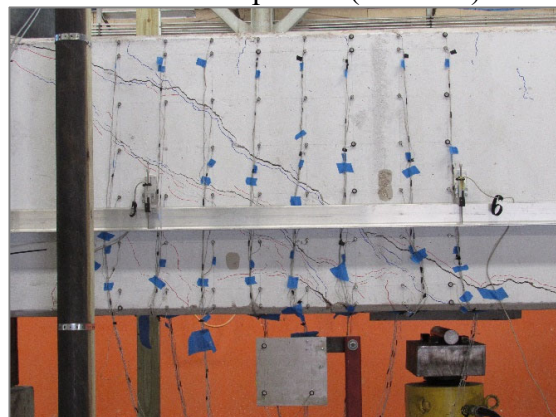
Figure 3.9. BC1-1 photos

The failure of test BC1-1 was controlled by a tension-controlled shear failure. Shear cracking damage was observed on the interior span throughout the duration of the test, specifically within the concrete comprising the main strut (i.e., stemming from the location of the column stub to GL2). The development of new, but small-width, shear cracks were formed at the overhang. The failure occurred after the shear cracks of the interior span widened excessively. Concrete crushing was also observed within the concrete comprising the main interior span strut. Note that, after reaching ultimate shear, the resistance of the cap rapidly decreased and no sign of ductile behavior was observed. At 90 % of ultimate load, the major shear crack was x 1.3 the width of that measured during the field inspection. The shear cracks can be visualized in Figure 3.9c, 3.9d, 3.9e, and 3.9f.

c) Major shear crack on the interior span after test completion (west face)

d) Major shear crack on the interior span after test completion (east face)

e) Major shear crack on the interior span after test completion (west face)

f) Major shear crack on the interior span after test completion (east face)

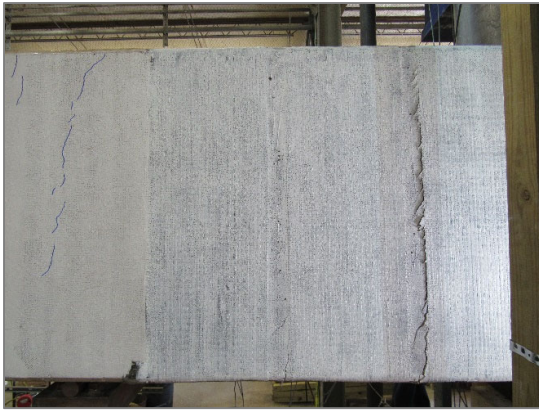
The failure of test BC2-1 was controlled by flexure. The formation of shear cracks was evident in the small gaps between the CFRP strips and in bent cap regions adjacent to the reaction points that were not covered with CFRP. However, the bent cap presented severe loss of stiffness when major flexural cracks formed at the face of the column stub, and at a section approximately 14 in. away from the column stub face (which may have caused the delamination and rupture of the inner edge of CFRP strip closest to the column

stub, shown in Figure 3.11a). After the formation of the first major flexural cracks, load continued to be applied to verify yielding of the longitudinal reinforcement. The bent cap was then unloaded to the constant dead load case (i.e., the pressure in each hydraulic ram was reduced to a pressure representing the 80 kip dead load) and reloaded to confirm the same unloading and reloading stiffnesses, as is shown in Figure 3.12d. During the reloading stage, the CFRP was reengaged at approximately 0.6 in. of average deflection (Figure 3.12d). As a result of continued displacement of the retrofitted span and after extensive yielding of the longitudinal reinforcement had taken place, the concrete comprising the main strut began to show some evidence of crushing.

a) Major flexural cracks after unload showing flexural crack along the inner edge of CFRP strip (west face)

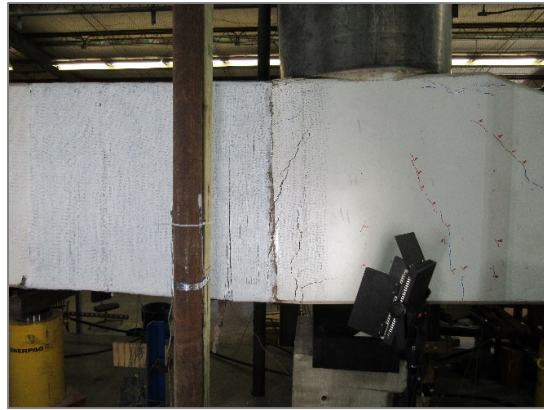
b) Major flexural cracks at the face of the column after reloading (west face)

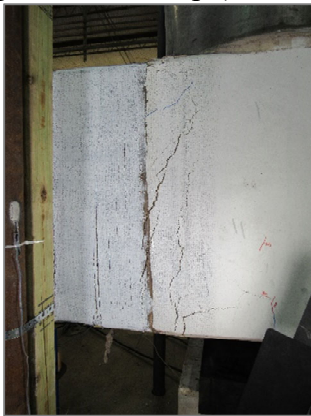
c) Major flexural cracks at the face of the column after reloading (west face)

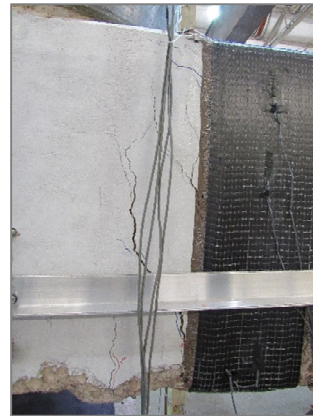
d) Shear and flexural cracks at the face of the column after test completion (east face)

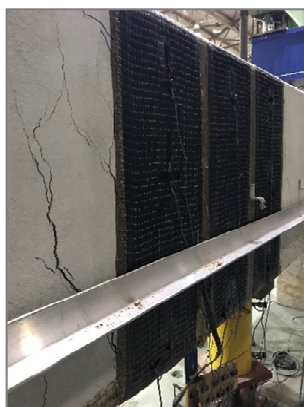
e) Shear and flexural cracks at the face of the column after test completion, and ruptured CFRP shown (east face)

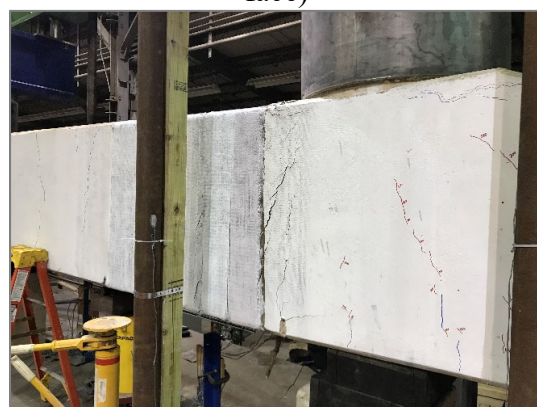
f) Major flexural crack at the face of the column after test completion (west face)

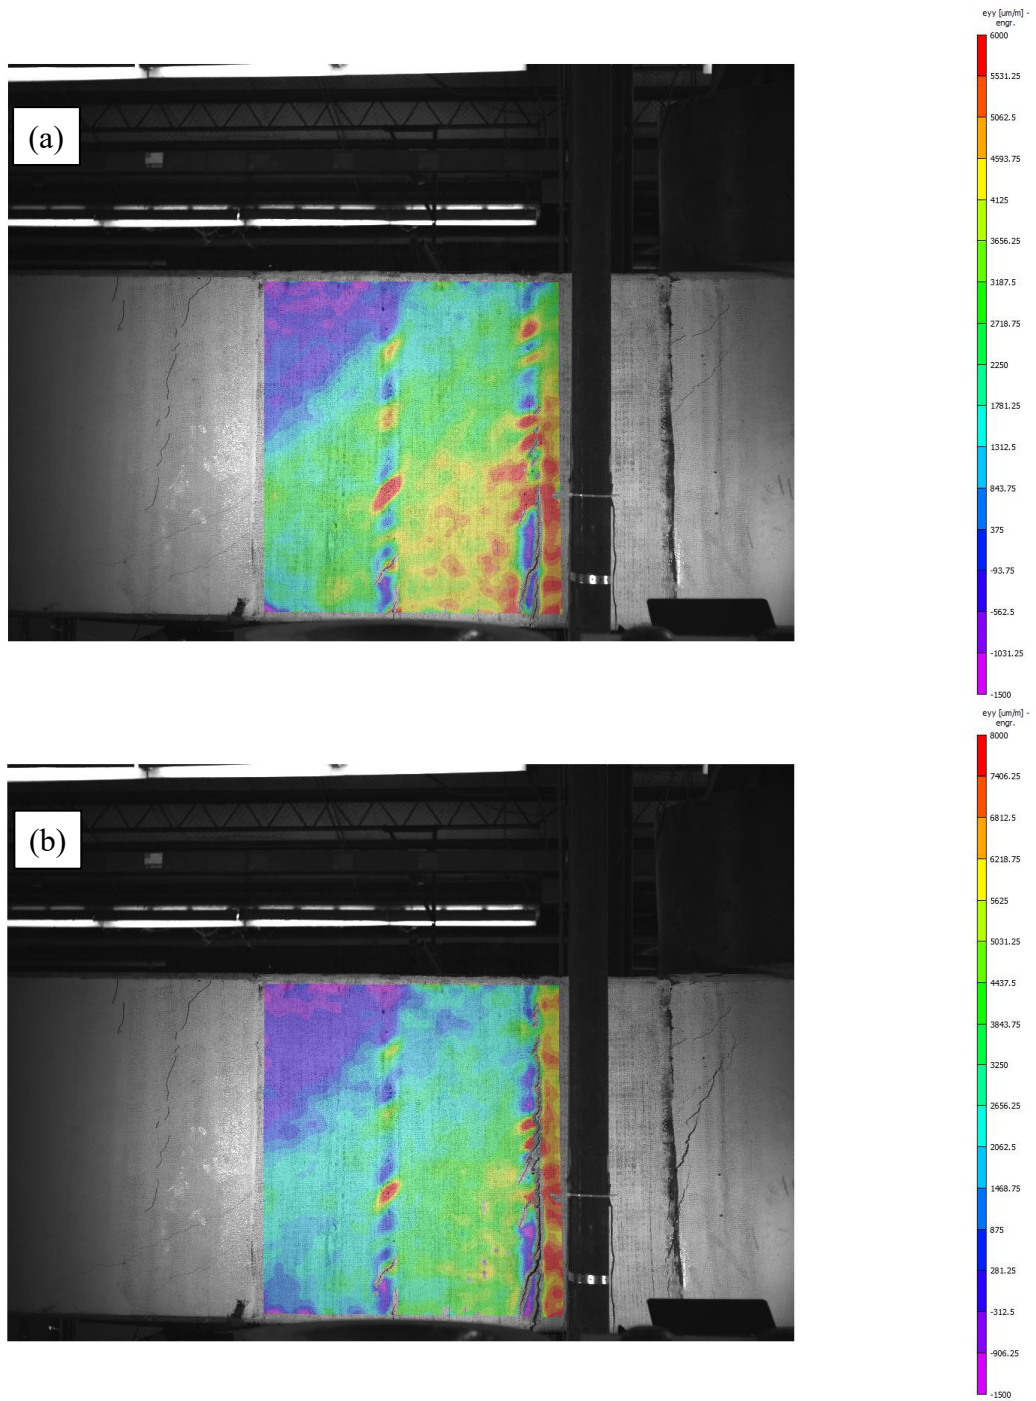
Figure 3.13. BC2-1: DIC strain contours; a) First loading stage peak load, b) Reloading stage peak load

Results from the digital image correlation (DIC) system data show that the largest strain in the CFRP-wrap was concentrated at a section located approximately 14-in. away from the column stub face, which coincides with the region where major flexural cracks formed. The strain profiles for the first loading stage peak load and the reloading stage peak load are shown in Figure 3.13a and 3.13b, respectively. The strain profiles show a

maximum CFRP strain on the order of  $6 \times 10^{-3}$  in./in. for the first loading stage and of  $8 \times 10^{-3}$  in./in for the reloading stage. Note that the strain differences between both load stages are a result of the large deflections and crack widening during the reloading stage. Figure 3.13b (i.e., reloading stage peak load strain profile) show wider and larger flexural and shear cracks than Figure 3.13a (i.e., first loading stage peak load strain profile), specifically at the region closest to the face of the column stub.

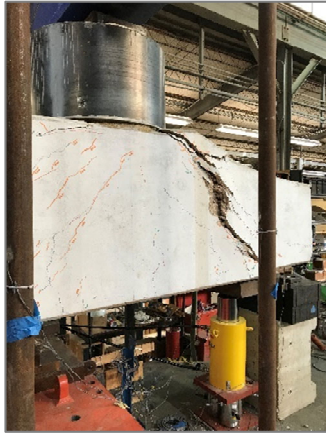
The failure of test BC1-3 was governed by a compression-controlled shear failure. Over the course of the test, new shear cracks formed within the overhang region (i.e., from GL1 to the column stub centerline) and at the interior span (i.e., from the column stub centerline to the added support), as shown in Figure 3.17b, 3.17c, and 3.17d. Evidence of concrete crushing was observed within the concrete comprising the main strut as shown in Figure 3.17b and Figure 3.17f. Concrete crushing also occurred at the column stub centerline, as shown in Figure 3.17b. Ultimately, the cap failed after significant widening of the shear cracks and accompanied concrete crushing comprising the overhang strut. The resultant of this damage led to appreciable stiffness degradation.

e) Shear cracks at overhang after test completion (west face)

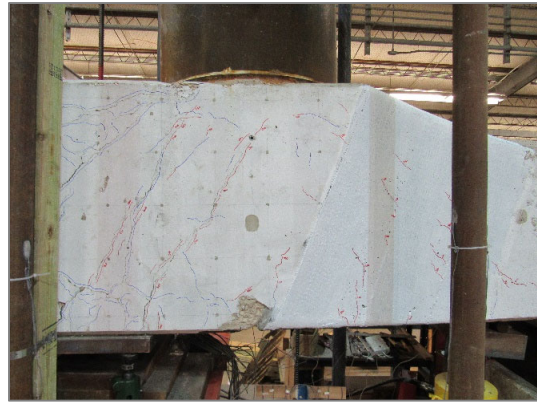
The failure of test BC1-3 was governed by the pullout of the longitudinal reinforcing bars and concrete crushing at the location of the added support bearing. Over the course of the test, new shear cracks formed at both the interior span and the retrofitted overhang, as visible in Figure A.4b. The failure of the overhang corresponded with the observation of extensive steel reinforcement pullout (refer to Figures A.4e and A.4f). While the primary initiator of the overhang failure was not identified in this case, the location of saw-cut made in the bent cap (which limited the development of the longitudinal steel reinforcement), the existing damage stemming from prior interior span shear testing (i.e., damage incurred previously under test BC1-2), and the concrete crushing at the added support bearing (Figure A.4d) are all likely contributors to the pullout of the longitudinal reinforcing bars.

b) Shear cracks formed at 300 kip load case (west face)

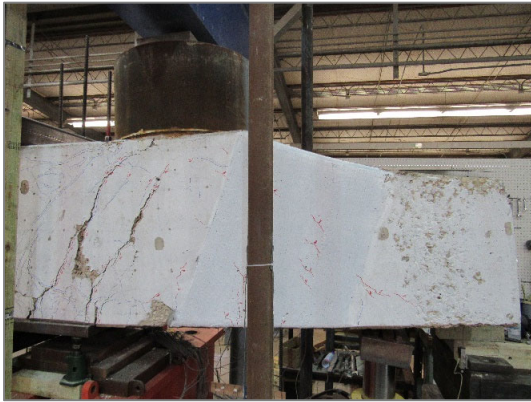
c) Shear cracks after cap failure (west face)

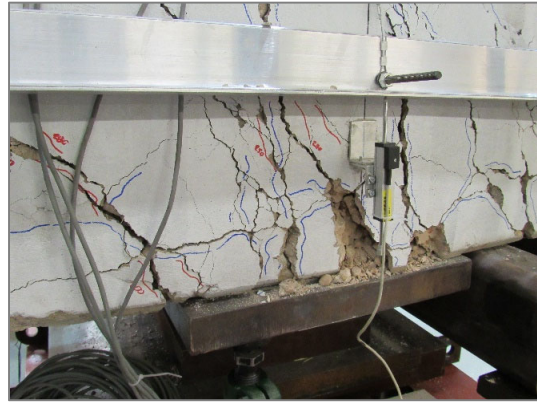
d) Concrete crushing at the added support bearing (west face) after cap failure

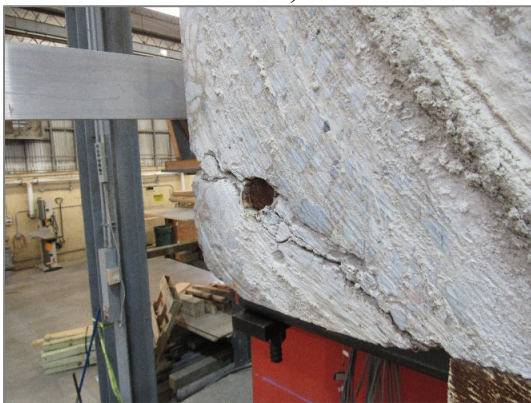
e) Pullout of bottom longitudinal bar after test completion

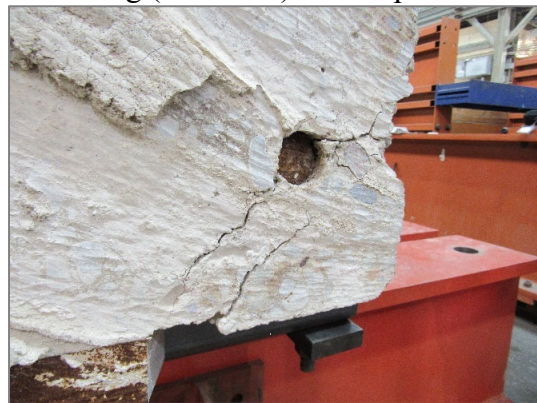
f) Pullout of bottom longitudinal bar after test completion

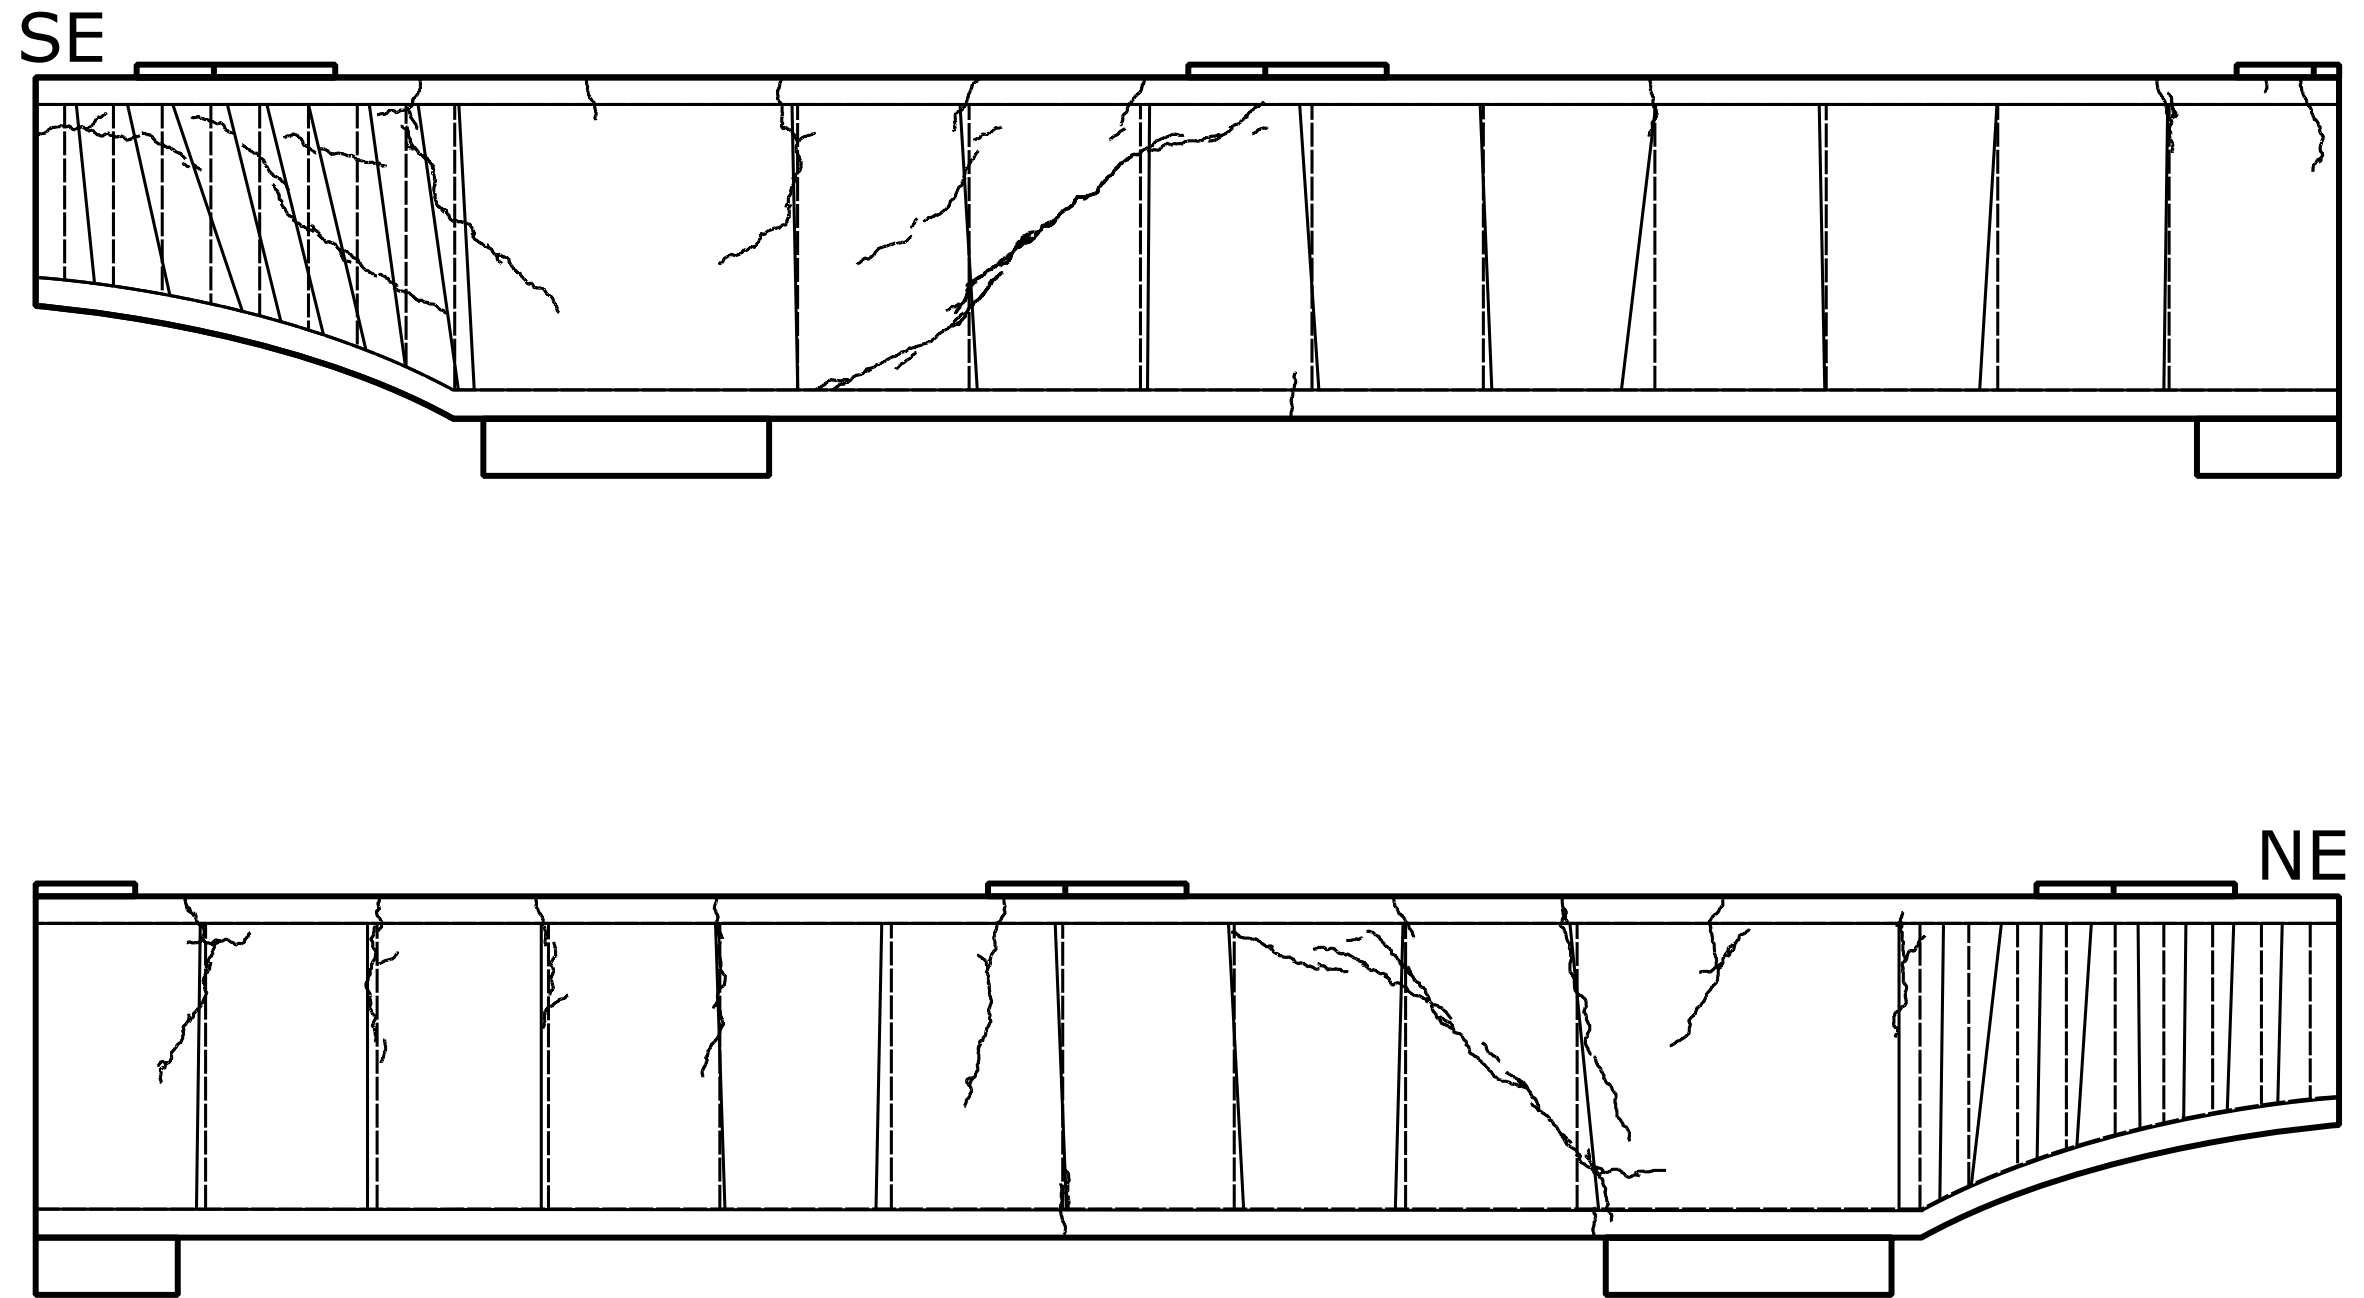
Figure A.7. East face of BC1 as-built steel reinf. (solid lines) and design drawings steel reinf. (dashed lines)

The following digital drawings summarize the crack locations and widths measured in the field and while in service. Additionally, the GPR-located steel reinforcement is also shown with respect the crack patterns.

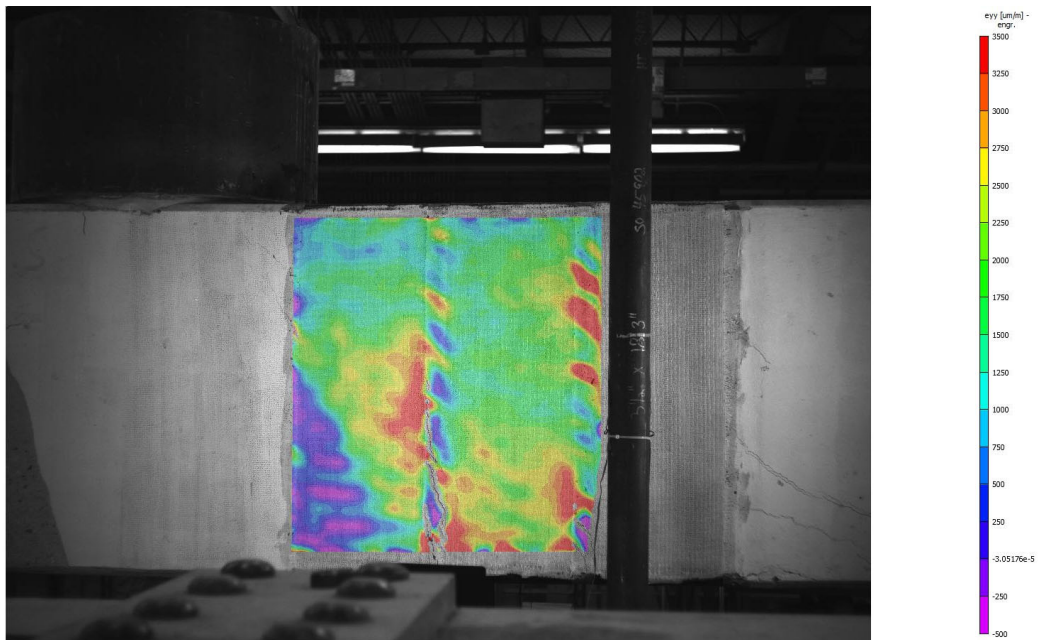
Figure B.1. BC2-2A: DIC strain contour at ultimate load

Results from the DIC data show that the largest strain in the CFRP-wrap was concentrated a section approximately 14-in. away from the column stub face, which coincides with the region where major flexural cracks formed. The strain profile for the

ultimate load is shown in Figure B.1 The strain contour shows a maximum CFRP strain of  $3.5 \times 10^{-3}$  in./in. Thus, in comparison to the manufacturer's reported ultimate strain capacity of  $10 \times 10^{-3}$  in./in. for the CFRP system, it is evident that only limited CFRP strain development had occurred. Note that rupture of the CFRP was observed as a function of the formation of flexural and shear cracks underneath the wrapping system and was likely mostly attributed to the widening of the flexural cracks.

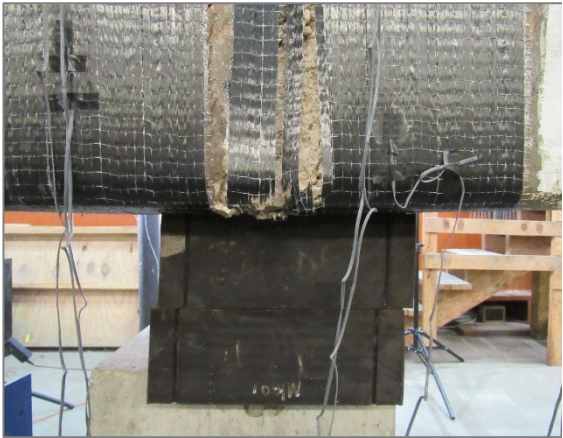
c) Temporary support in contact with bent cap bottom surface (west face)

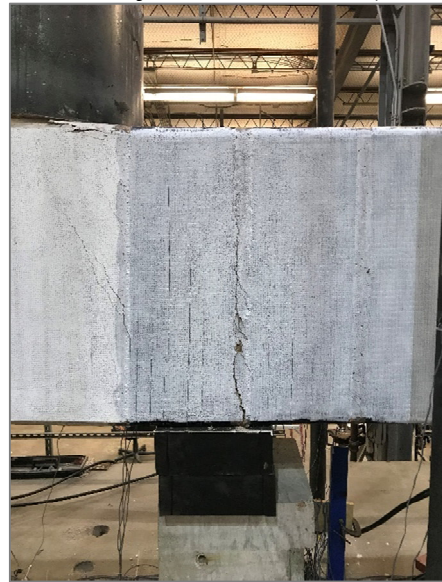
d) CFRP retrofitted span after test completion (west face)

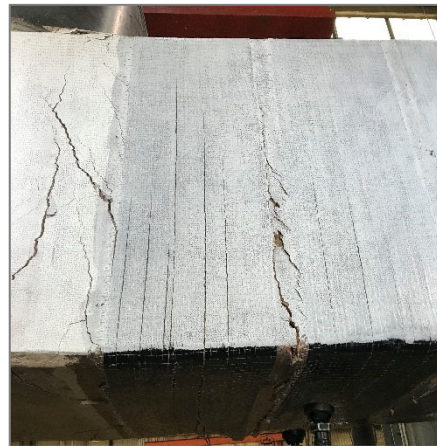
b) Major shear and flexural cracks after test completion (west face)

and the section already contained severe flexural and shear cracks (see Figure B.2). After reloading the previously tested bent cap, the flexural cracks at the face of the column widened significantly as can be seen from Figure B.4.

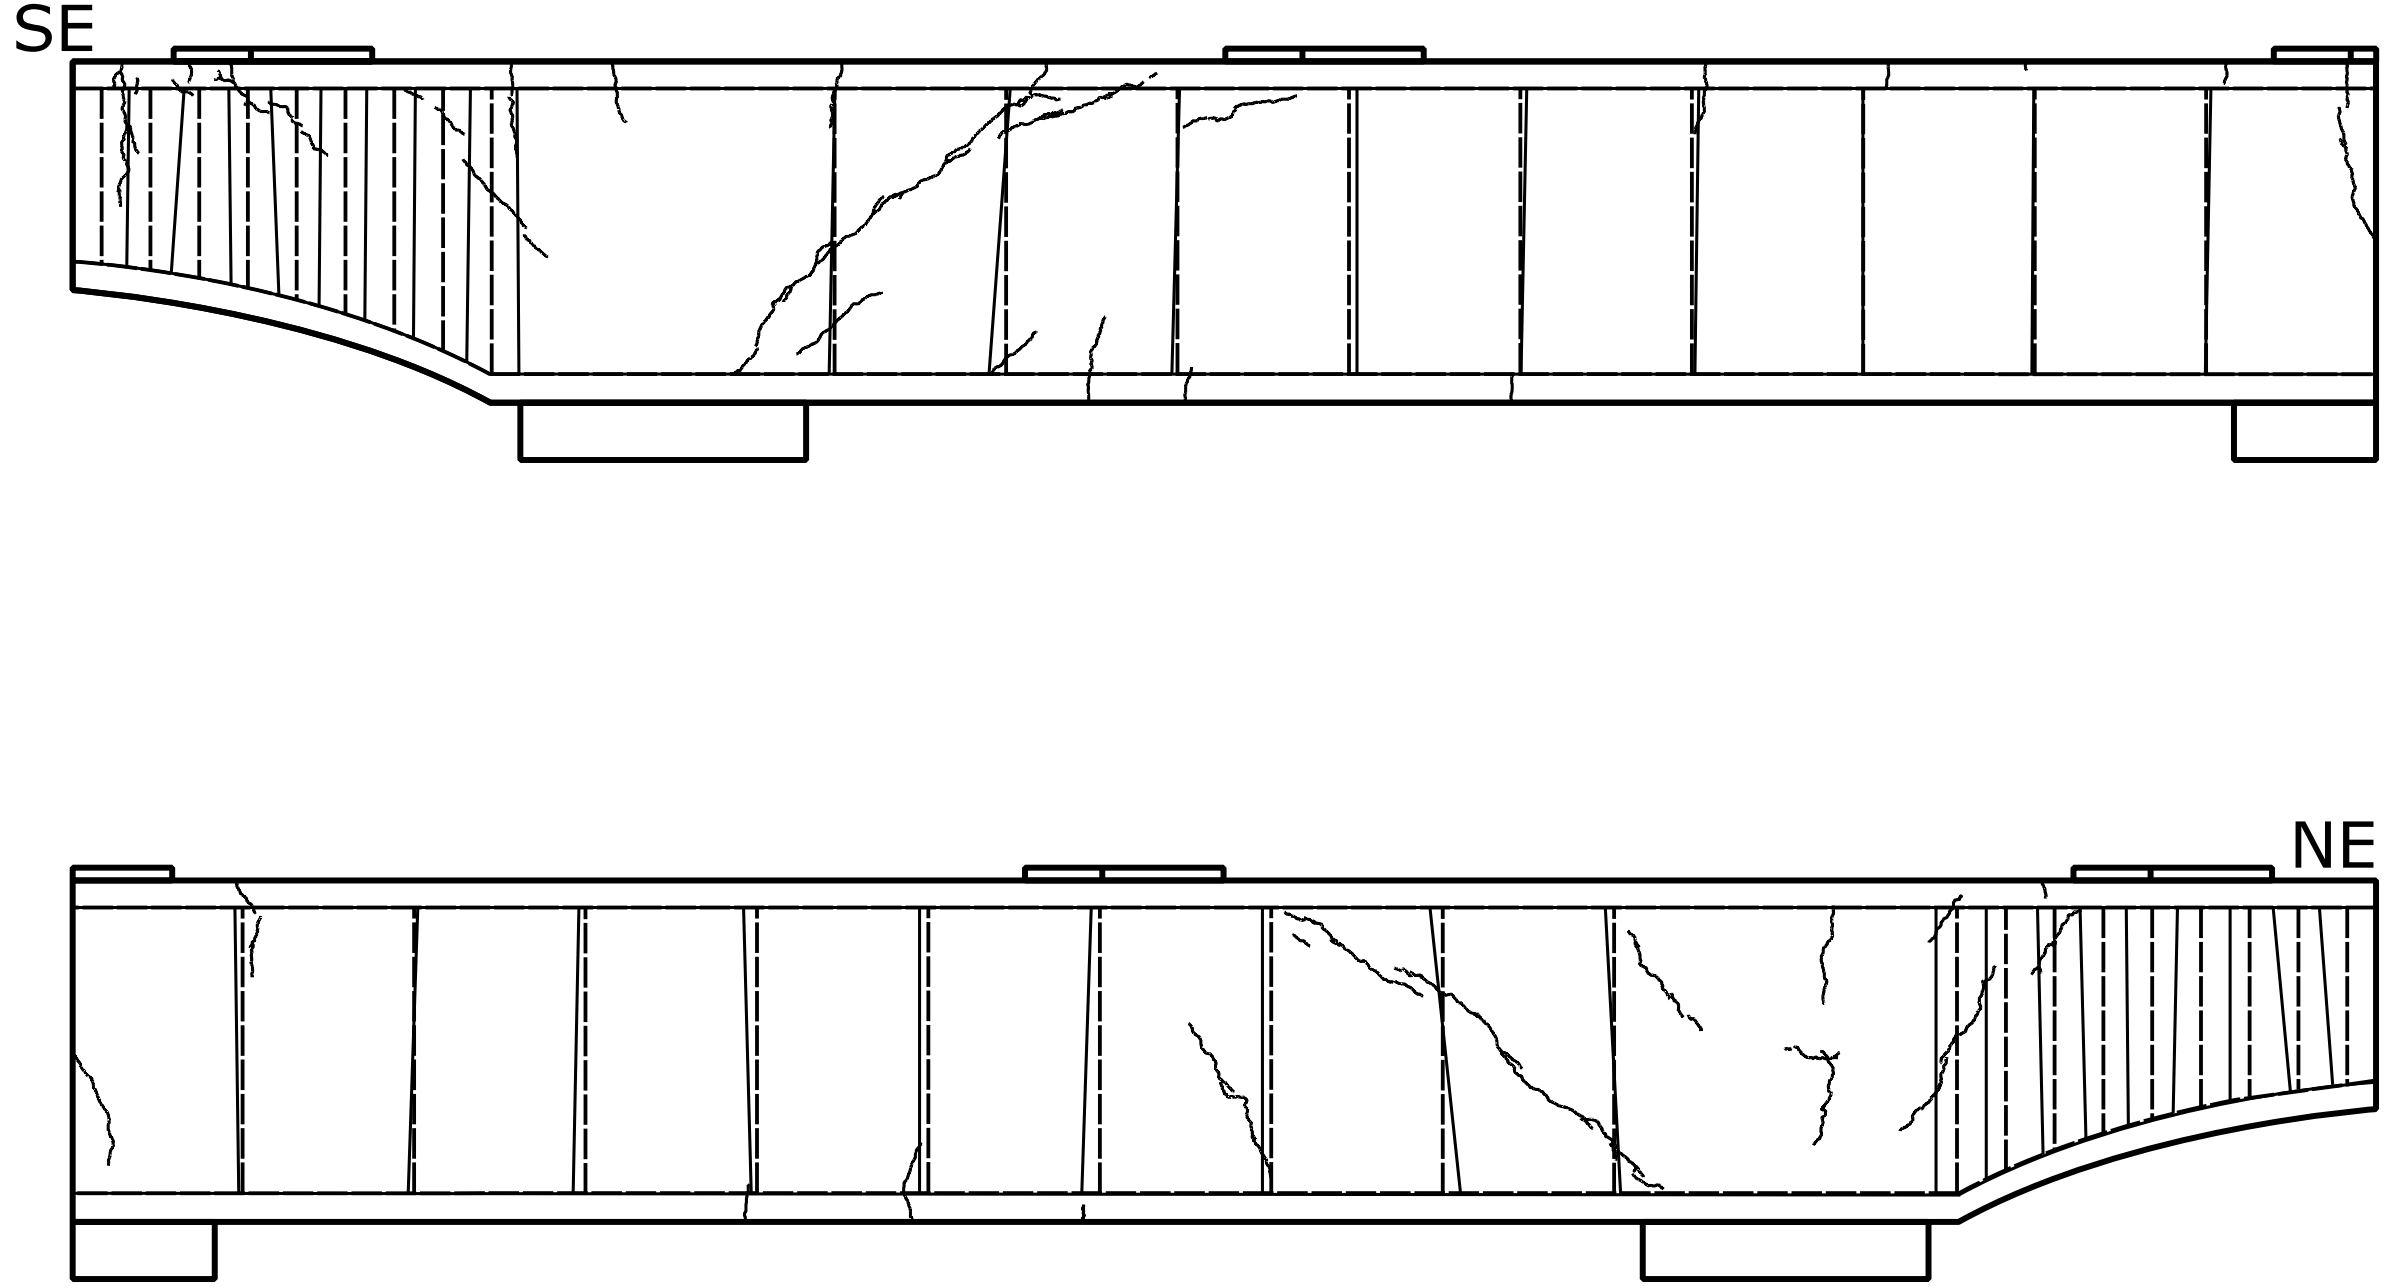
Figure B.7. East face of BC2 as-built steel reinf. (solid lines) and design drawings steel reinf. (dashed lines)

The following digital drawings summarize the crack locations and widths measured in the field and while in service. Additionally, the GPR-located steel reinforcement is also shown with respect the crack patterns.

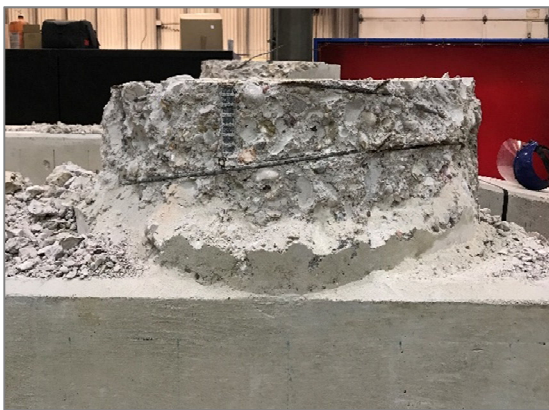
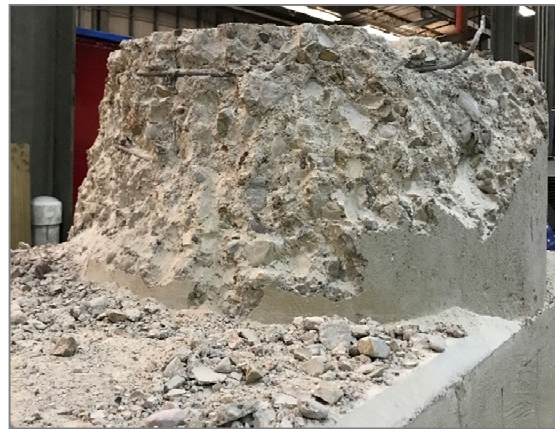
Figure D.6. Concrete cover removal

1. Column stub concrete cover removal: Concrete was chipped off from the side surfaces of the column stubs until the column spiral reinforcement was exposed along the perimeter, over the height of the stub. An approximate 2 to 3-in. height of concrete cover was left in-tact at the base of the column stub to ensure that the column stub-bent cap connection geometries of the specimens remained unaltered from that provided in service. Loose concrete and debris were removed from the exposed cores of the column stubs and the resulting roughened surface was maintained to ensure maximum adhesion of the grout to the column stub core concrete. Figure D.6 shows the column stub concrete cover removal process and the exposed column spiral reinforcement.

(a) concrete cover removal from BC1 middle column stub

(b) concrete cover removal from BC1 south column stub

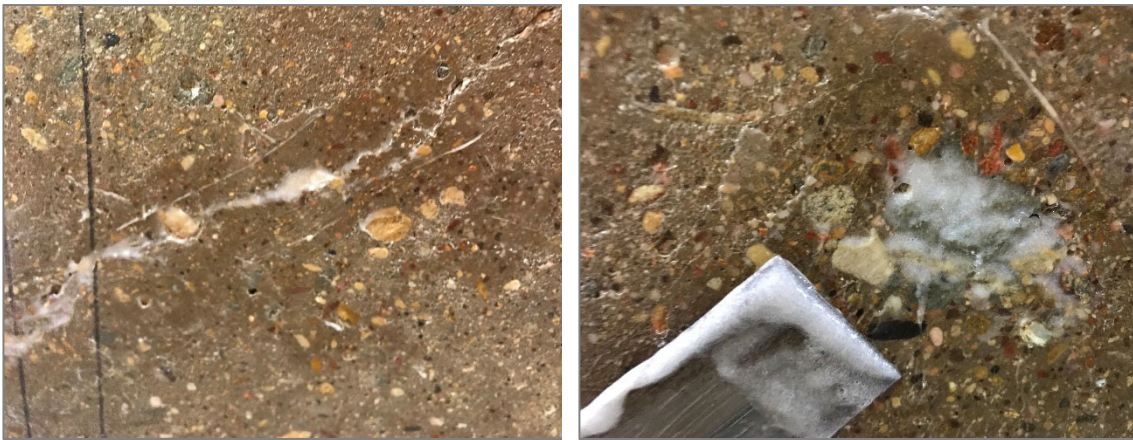
Figure D.10. Resin application on cracked and uneven surfaces

(a) thickened epoxy on crack

(b) thickened epoxy on uneven surface

4. CFRP location marking: The target installation locations of the CFRP were initially marked on the surface of the bent cap. Surface priming: After mixing the Tyfo S Epoxy, a thin layer was applied with a roller on the target zones for the CFRP application. On uneven surfaces (i.e., at locations of existing cracks, cured concrete voids, damaged areas, etc.) a thicker epoxy was used to level the surface using a trowel (refer to Figure D.10).

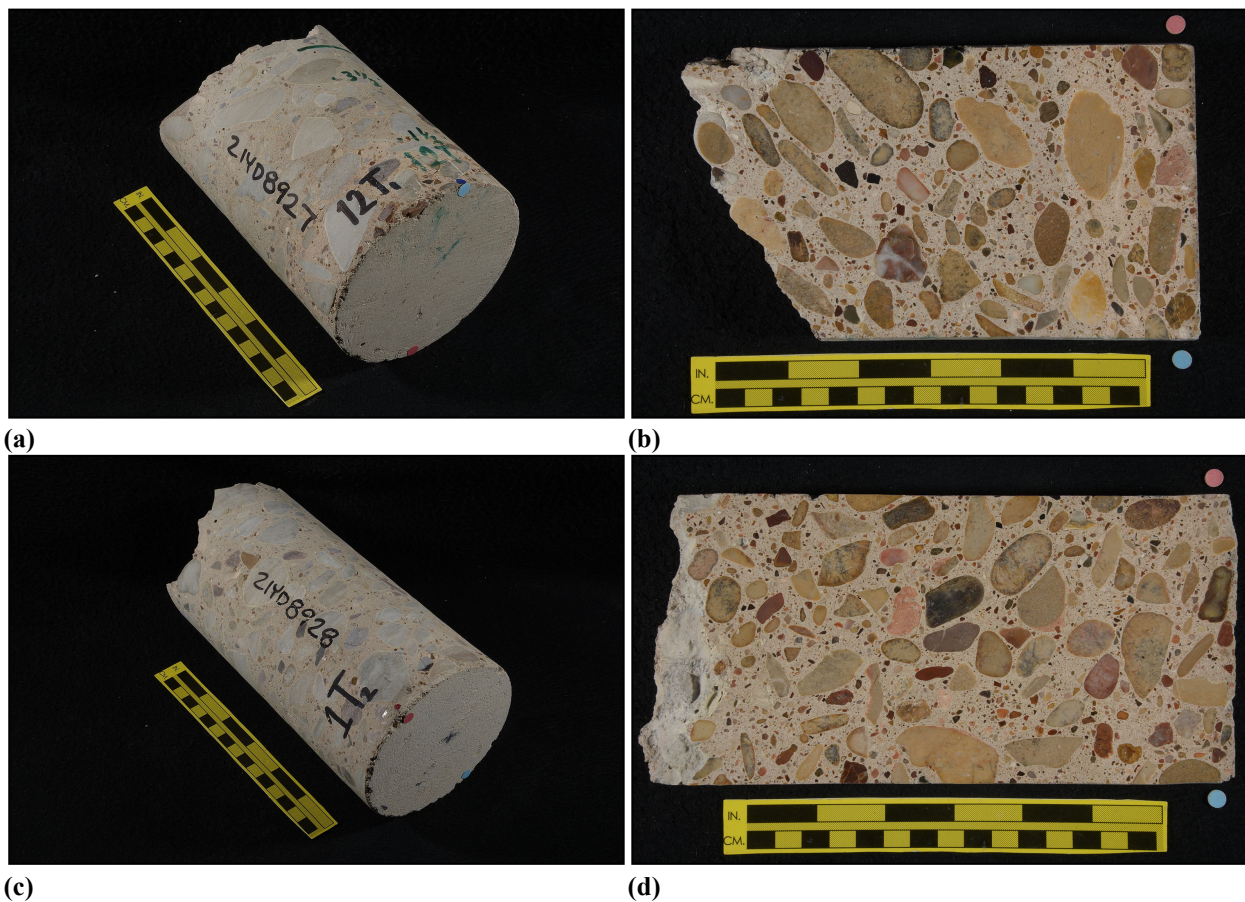
**3.1 Orientation, Dimensions & As-Received Condition** Both cores are horizontal in orientation and measure 100 mm (4 in.) in diameter. Both cores span from intact formed surfaces to fracture surfaces such that they represent partial thicknesses of the bent caps. Core 12T1 is 125-175 mm (5-7 in.) long and Core 1T2 is 190-210 mm (7 ½-8 ⅜ in.) long. Neither core contains reinforcing steel or other embedded objects. **Figure 1** contains photographs of the cores in their as-received condition and the polished surfaces from the cores.

**Figure 1.** (a) Photograph of Core 12T1 showing oblique view of the top and side of the core. (b) Photograph of polished surface of Core 12T1. (c) Photograph of Core 1T2 showing oblique view of the top and side of the core. (d) Photograph of the polished surface of Core 1T2. The yellow scale is ~ 150 mm (6 in.) long in all of the photos. The red and blue dots in (a) and (c) indicate the orientation of the saw cuts used to prepare the sample.

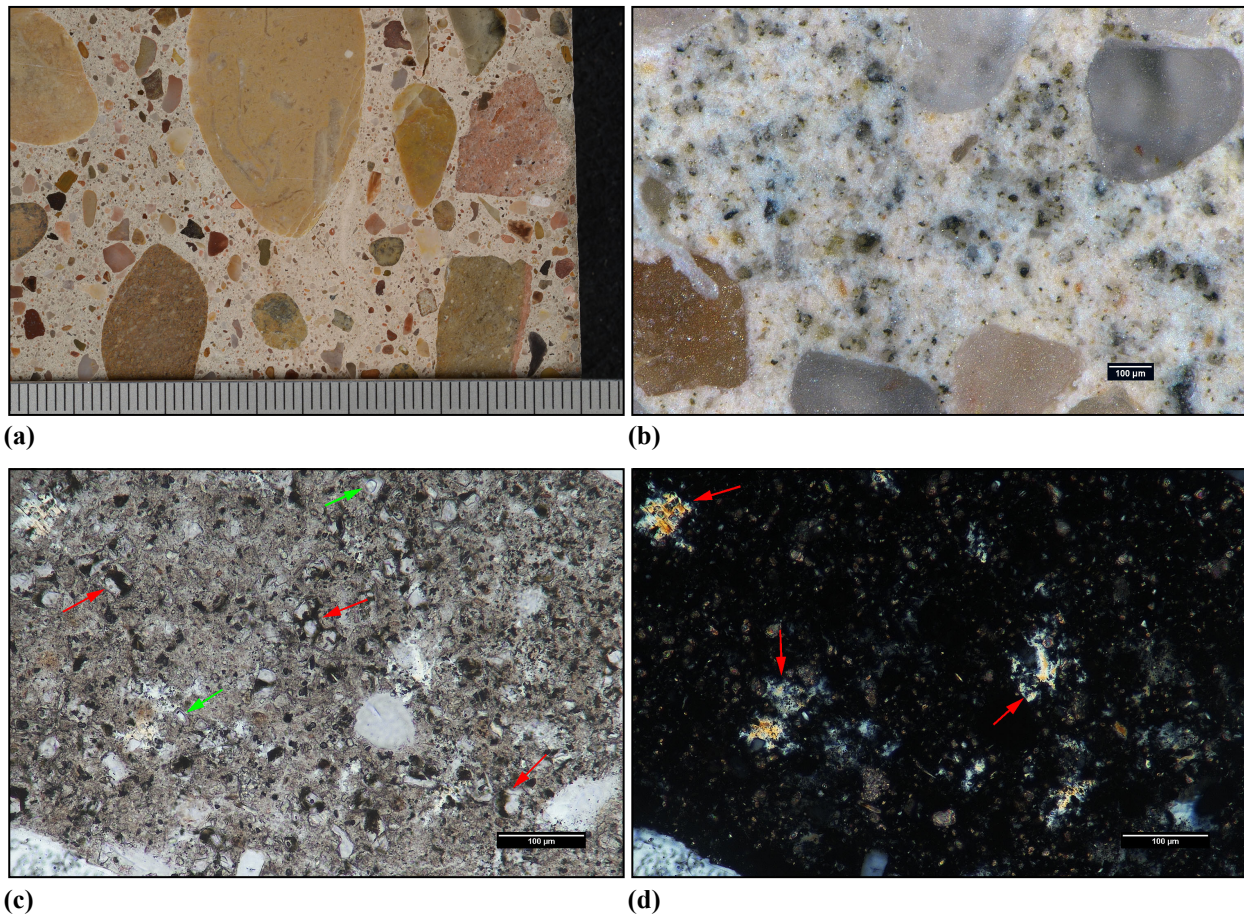
**3.2 Components: Paste** The paste fraction of both samples is similar in terms of composition. The paste consists of hydrated portland cement with no fly ash; no slag cement or other supplemental cementitious materials were observed. The hydration is normal to somewhat less advanced than anticipated for concrete that is ~ 60 years old. Calcium hydroxide is medium to coarse-grained and distributed evenly. The paste is light gray to pale yellow with a granular texture and dull luster. The paste is moderately soft (Mohs 2.5-3). **Figure 2** shows photographs and photomicrographs of the paste from Core 12T1 as an example of the paste properties. Both cores showed slightly darker paste at the outer end of the core.

**Figure 2.** Examples of paste properties in Core 12T1. (a) Photograph of the polished surface showing overview of paste at the top of the core. (b) Reflected light photomicrograph of polished surface showing detail of paste in the middle of the core. Transmitted light photomicrographs of thin section showing detail of the paste in (c) plane-polarized and (d) cross-polarized light. The red and green arrows in (c) indicate relict and residual cement grains and fly ash, respectively.
