**Structural Evaluation and Testing of Damaged  
Reinforced Concrete Bent Caps**

**Thesis**

The University of Texas at Austin

May 2019

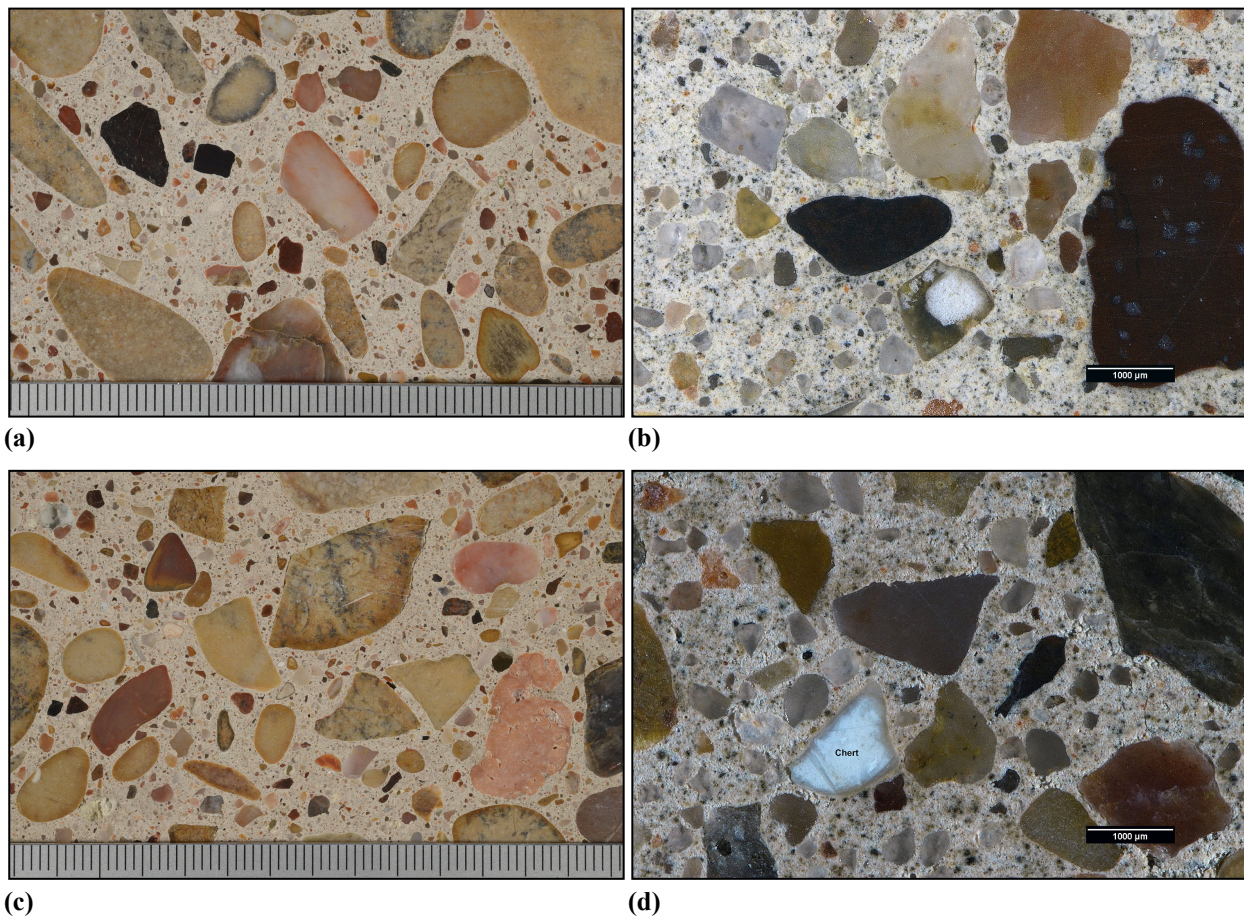
**3.4 Components: Aggregates** The cores contain similar aggregates (**Figure 5**). The coarse aggregate is a natural gravel with a nominal top size of 25 mm (1 in.). The grading and distribution are relatively even. The aggregate consists of a mixture of carbonate and siliceous sedimentary rocks that consist mostly of limestone (~ 85%) with minor amounts of chert (~ 10%) and quartzite (~ 5%). The fine aggregate is a natural sand that consists mostly of quartzite and chert with minor limestones similar to those observed in the coarse aggregate. Chert and quartzite are potentially susceptible to alkali-silica reaction (ASR) but no evidence of such reactions were observed in either core apart from some internal microcracks and reaction rims on chert particles. No deposits of gel were observed.

**Figure 5.** (a) Photograph and (b) reflected light photomicrograph of polished surface of Core 12T1 showing coarse and fine aggregate, respectively. The scale is in millimeters in (a). (c) Photograph and (d) reflected light photomicrograph of polished surface of Core 1T2 showing coarse and fine aggregate, respectively. The scale is in millimeters in (c).

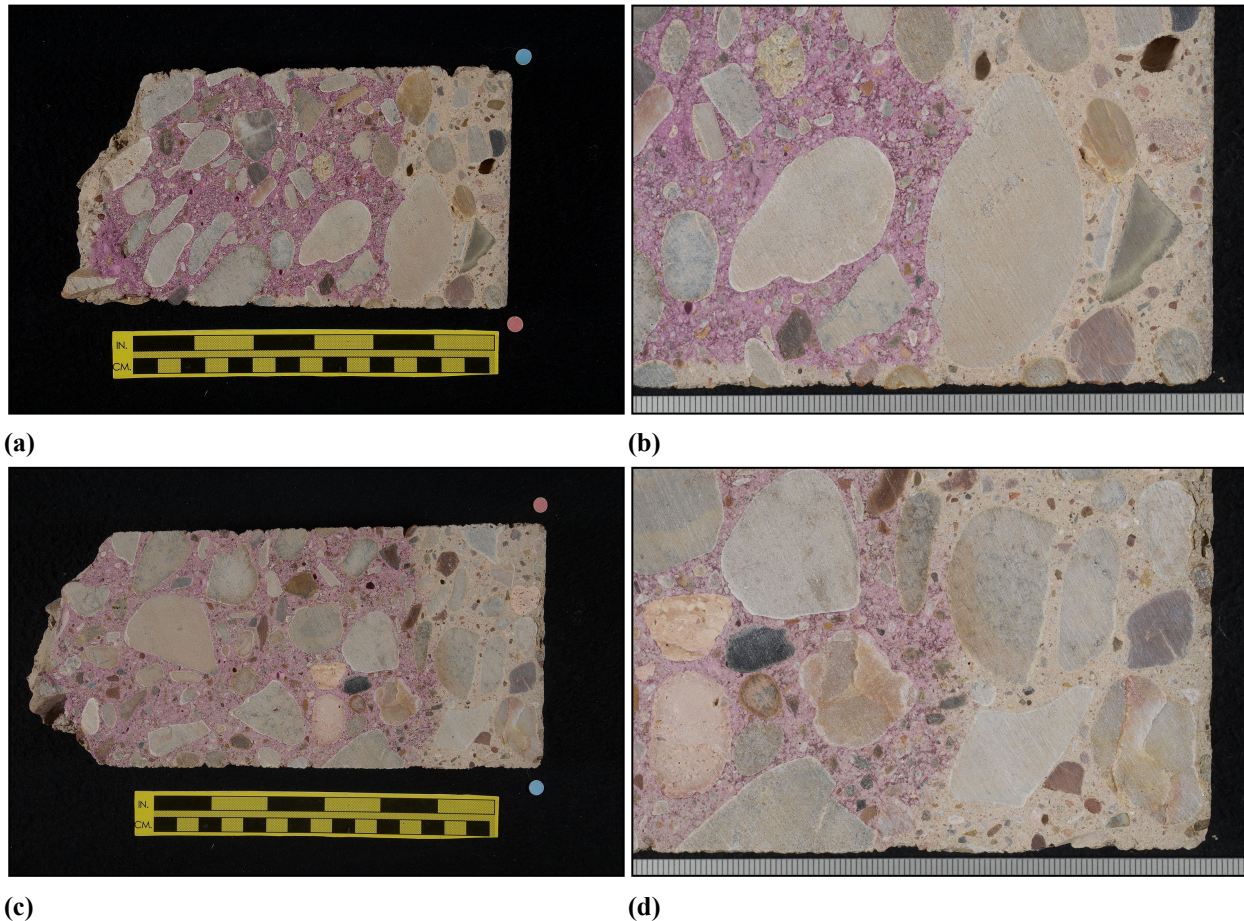
**3.6 Secondary Deposits** Both cores show deep carbonation as detected by phenolphthalein staining and thin section microscopy that reaches a depth of ~ 50 mm (2 in.). **Figure 7** contains photographs showing the phenolphthalein-stained surfaces. No other secondary deposits were observed.

**Figure 7.** Photographs showing (a) overview of phenolphthalein-stained surface from Core 12T1 and (b) detail of the surface near the outer surface of the Core 12T1. The yellow scale in (a) is ~ 150 mm (6 in.) long and the scale in (b) is in millimeters. Photographs showing (c) overview of phenolphthalein-stained surface from Core 1T2 and (d) detail of the surface near the outer surface of the Core 1T2. The yellow scale in (c) is ~ 150 mm (6 in.) long and the scale in (d) is in millimeters.

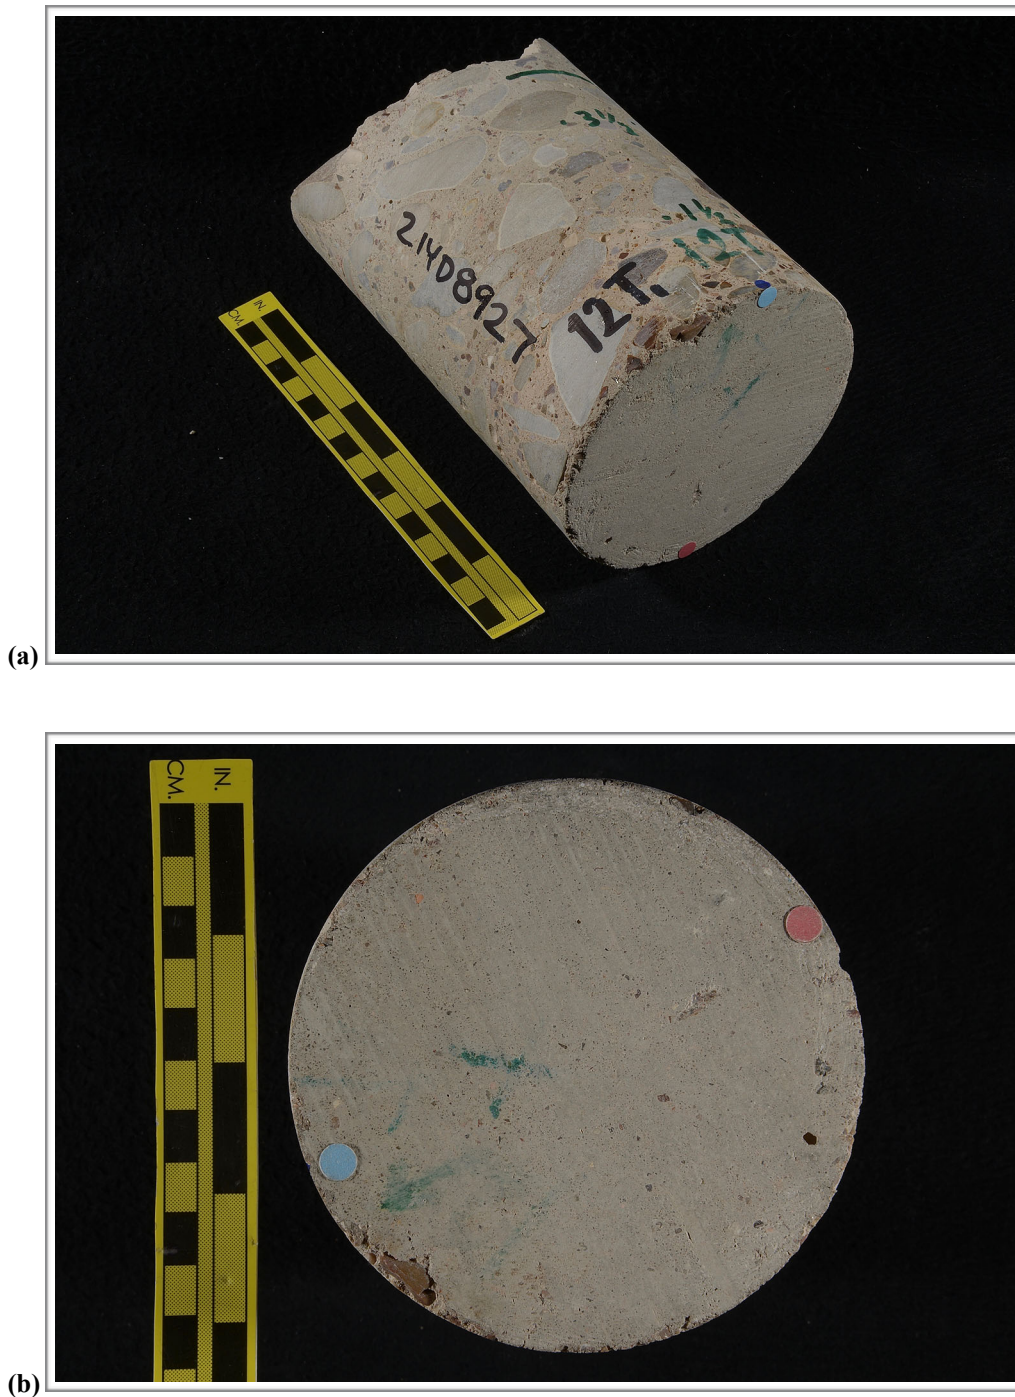
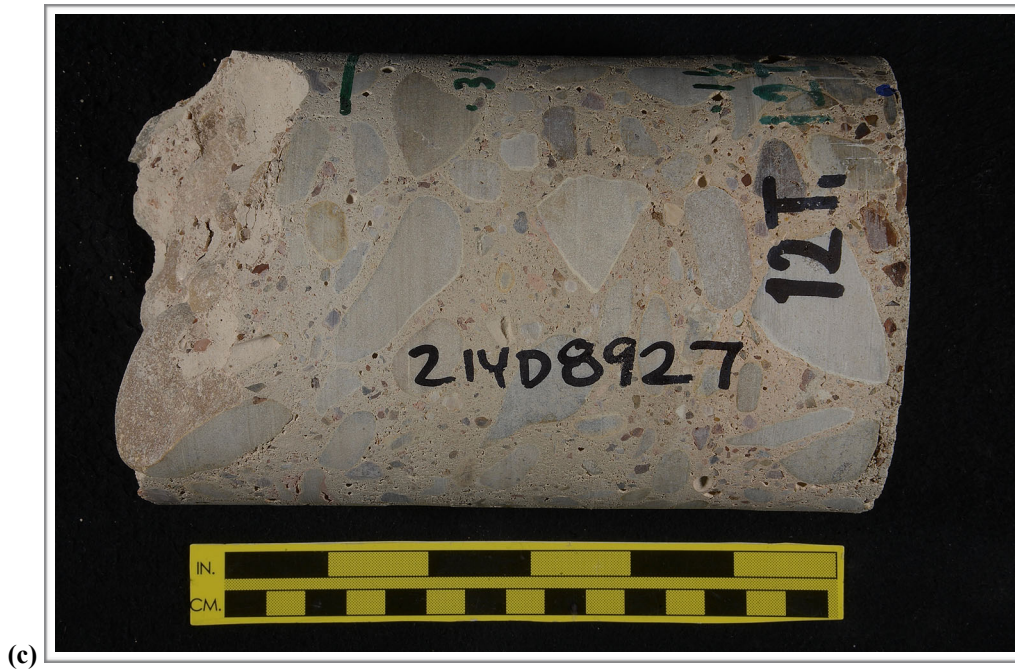
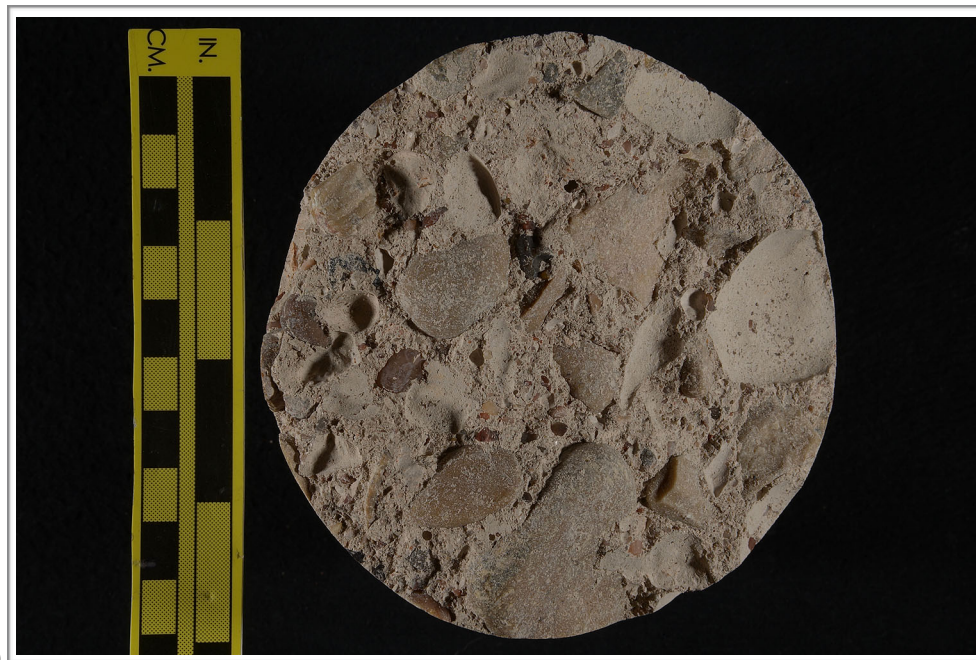
1. RECEIVED CONDITION	
ORIENTATION & DIMENSIONS	Horizontal core through bent cap panel measures 100 mm (4 in.) in diameter and 125-175 mm (5-7 in.) long ( <b>Figure A1, Figure A2</b> ).
SURFACES	The outer surface is formed and the inner surface is a fracture such that the core represents a partial thickness of the bent cap. The outer surface is smooth and intact ( <b>Figure A3</b> ).
GENERAL CONDITION	The concrete is hard and compact and rings lightly when sounded with a hammer.

Figure A1. Photographs showing (a) oblique view of the outer surface and side of the core with identification labels and (b) the outer surface of the core. The red and blue dots show the orientation of the saw cuts used to prepare the sample. The yellow bar in (a) is ~ 150 mm (6 in.) long; the large and small divisions on the yellow scale in both photos are in inches and centimeters, respectively.

Figure A1 (cont'd). Photographs of the core in as-received condition showing the (c) side of the core and (d) the inner surface of the core. The yellow scale in (c) is ~ 150 mm (6 in.) long; the large and small divisions on the yellow scale in both photos are in inches and centimeters, respectively.

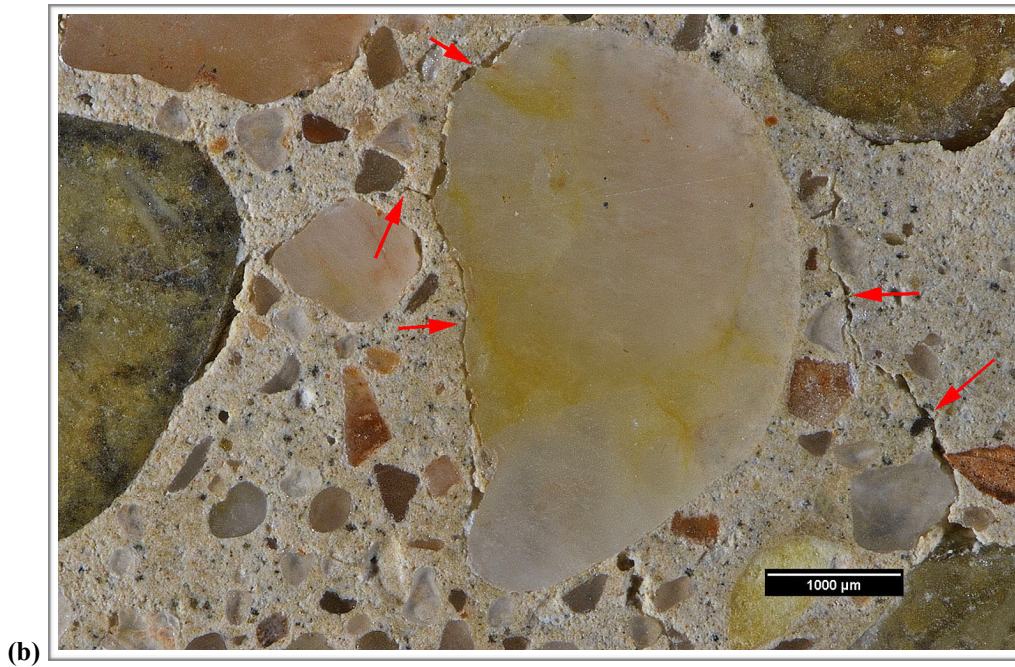
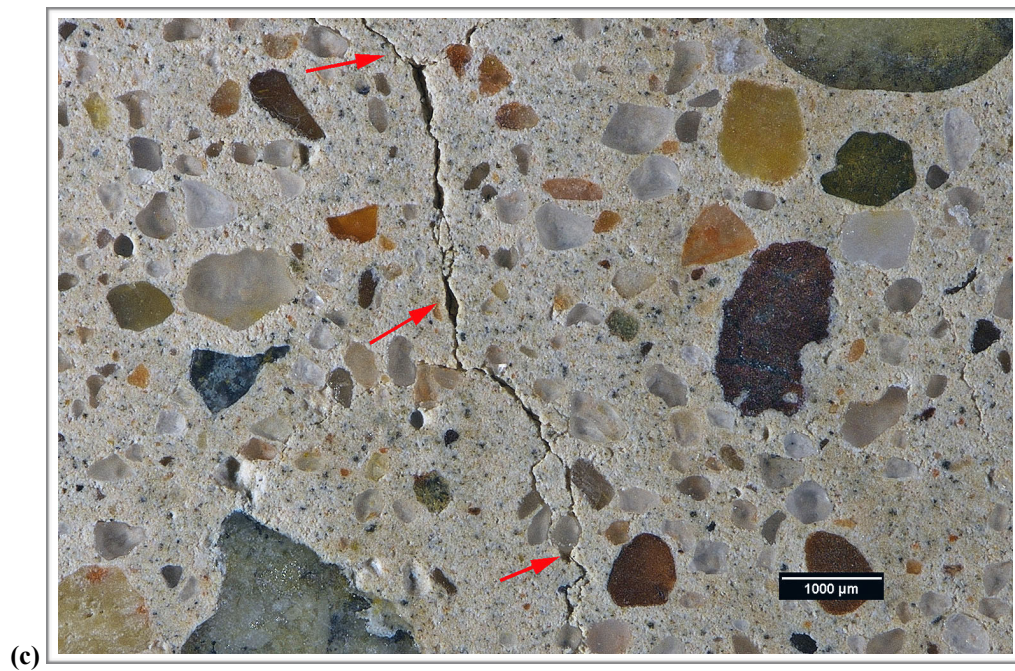
3. CRACKING	
MACROSCOPIC	Numerous hairline cracks were observed in the outer ~ 19 mm (¾ in.) of the core ( <b>Figure A4</b> ). Most of these cracks are sub-vertical to oblique in orientation, range up to 500 µm (20 mil) wide and 6 mm (¼ in.) long. Occasional cracks of similar dimensions were observed throughout the core. These cracks pass around aggregate particles and are free of secondary deposits.
MICROSCOPIC	Microcracks are also abundant in the outer ~ 19 mm (¾ in.) of the core; these range up to 100 µm (4 mil) wide and 3 mm (½ in.) long ( <b>Figure A5</b> ). Occasional microcracks of similar dimensions cut sub-horizontally from the formed surface. A sub-vertical microcrack ranging from 50-100 µm wide cuts sub-vertically through the paste over a 15 mm (⅝ in.) strike length about 25 mm (1 in.) from the formed surface. All microcracks cut around aggregate particles and lack secondary deposits.

Figure A5 (cont'd). Reflected light photomicrographs of the polished surface showing microcracks (red arrows) cutting through the paste (b) ~ 19 mm ( $\frac{3}{4}$  in.) and (c) ~ 25 mm (1 in.) from the outer surface of the core.

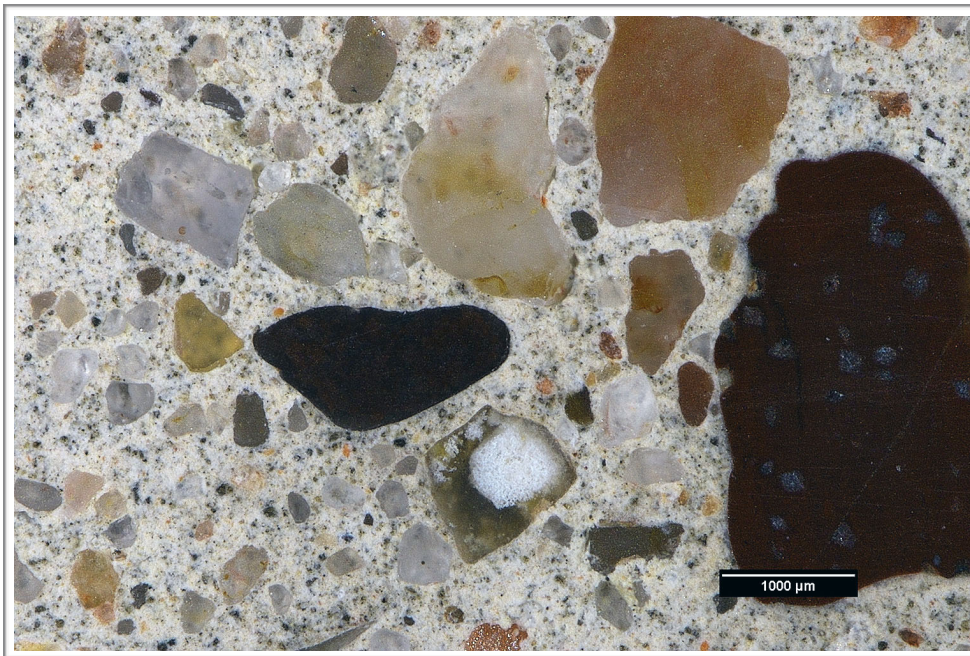
6. FINE AGGREGATE	
PHYSICAL PROPERTIES	The fine aggregate is a natural sand that consists of rocks that are hard and competent ( <b>Figure A7</b> ). The particles are sub-equant to slightly elongated in shape with sub-rounded to angular edges. The grading and distribution are relatively even.
ROCK TYPES	The sand consists primarily of siliceous rocks that include quartzite, chert and fragments of quartz with minor amounts of limestone similar to those observed in the coarse aggregate. Chert and quartzite are potentially susceptible to ASR.
OTHER FEATURES	No deleterious coatings or incrustations observed. No low w/c mortar coatings observed. No evidence of ASR was observed involving the fine aggregate.

Figure A7. Reflected light photomicrograph of the polished surface showing the fine aggregate.

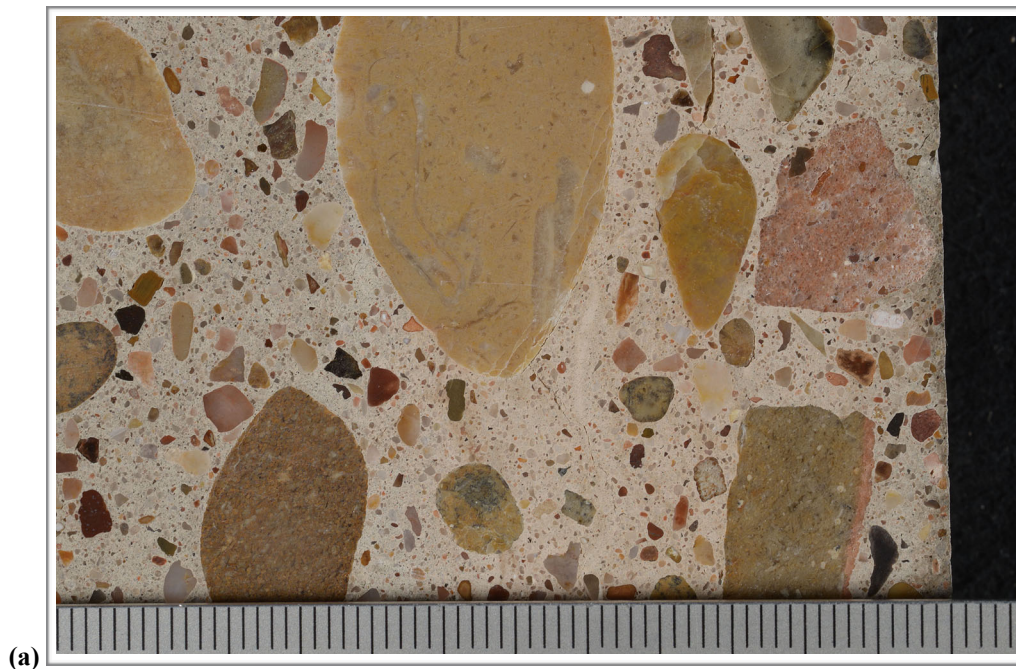
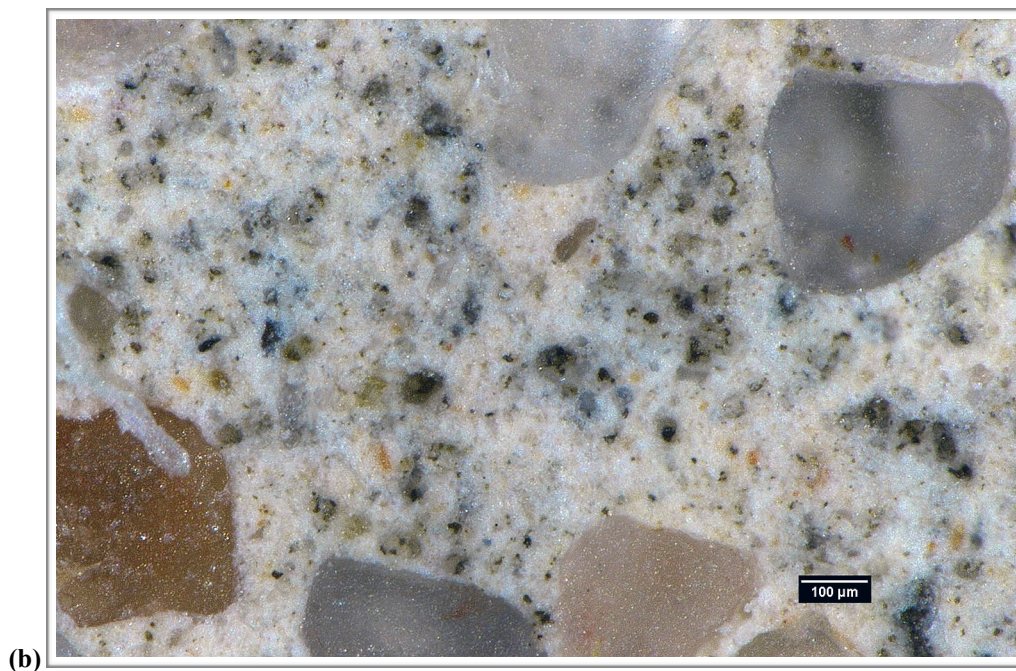
7. PASTE OBSERVATIONS	
POLISHED SURFACE	Paste is light gray (Munsell 2.5Y/7/1) to pale yellow (2.5Y/8/4), has a granular texture and a dull luster ( <b>Figure A8</b> ). The paste is moderately soft (Mohs 2.5-3). The paste is gray for up to 2 mm (80 mil) from the formed surface.
FRESH FRACTURE	Fracture surface is light gray, has a punky texture and a dull luster ( <b>Figure A9</b> ). The fracture cuts mostly around coarse aggregate particles.
THIN SECTION*	The paste contains hydrated portland cement with no fly ash, slag cement or other SCM observed. The hydration is normal with relict and residual cement grains that consist mostly of belite making up 3-7% of the paste ( <b>Figure A10</b> ). CH is medium to coarse grained and evenly distributed.

Figure A8. (a) Photograph of the polished surface showing overview of the paste at the outer end of the core. Scale in millimeters. (b) Reflected light photomicrograph of the polished surface showing detail of paste in the middle of the core.

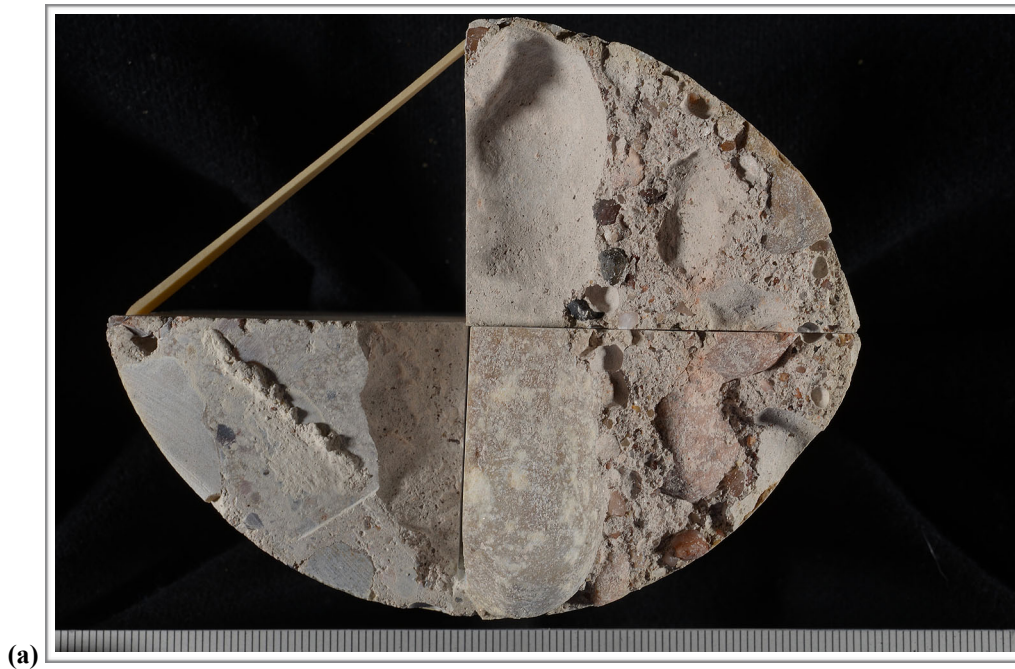
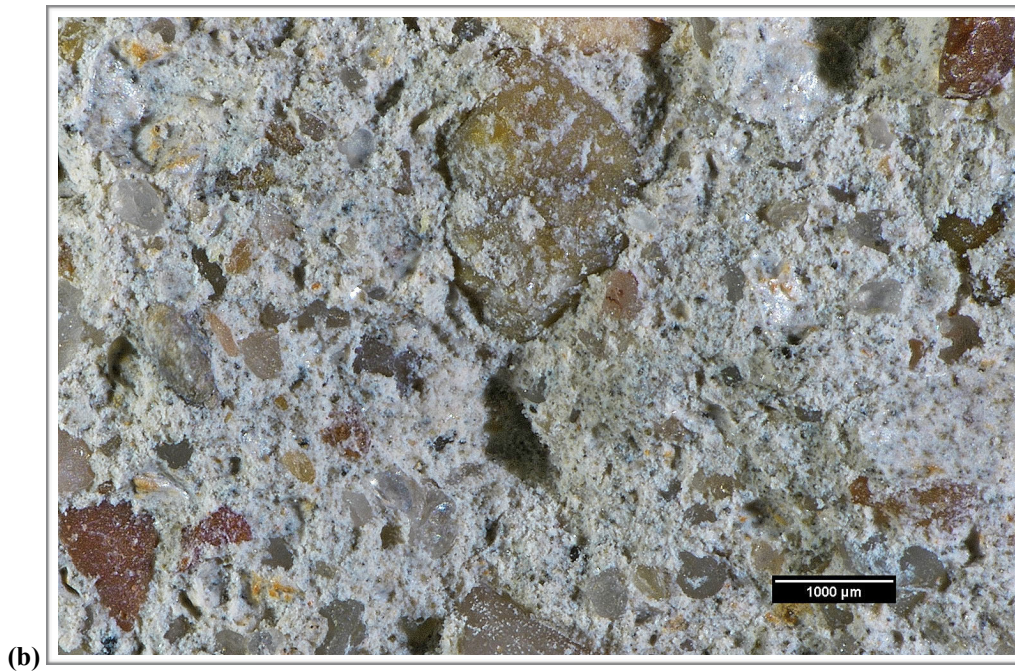
Figure A9. (a) Photograph and (b) reflected light photomicrograph of fresh fracture surface. The scale is in millimeters in (a).

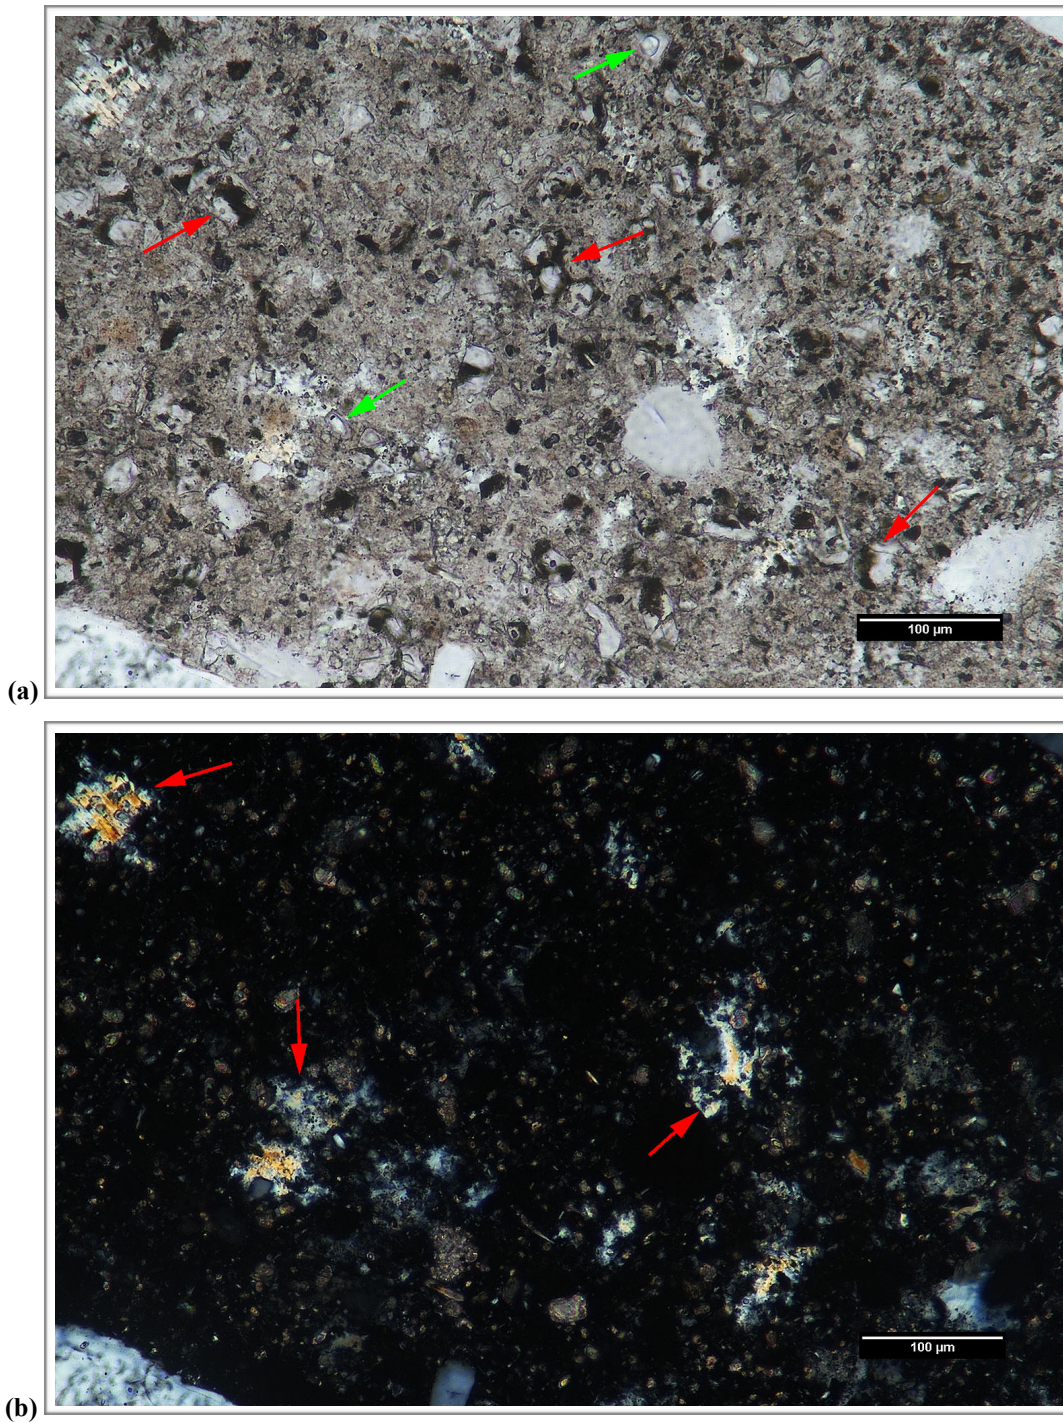
Figure A10. Transmitted light photomicrographs of thin section showing detail of paste in (a) plane-polarized and (b) cross-polarized light. The red arrows in (a) indicate RRCG; in (b) they indicate CH. The green arrows in (a) indicate particles of fly ash.

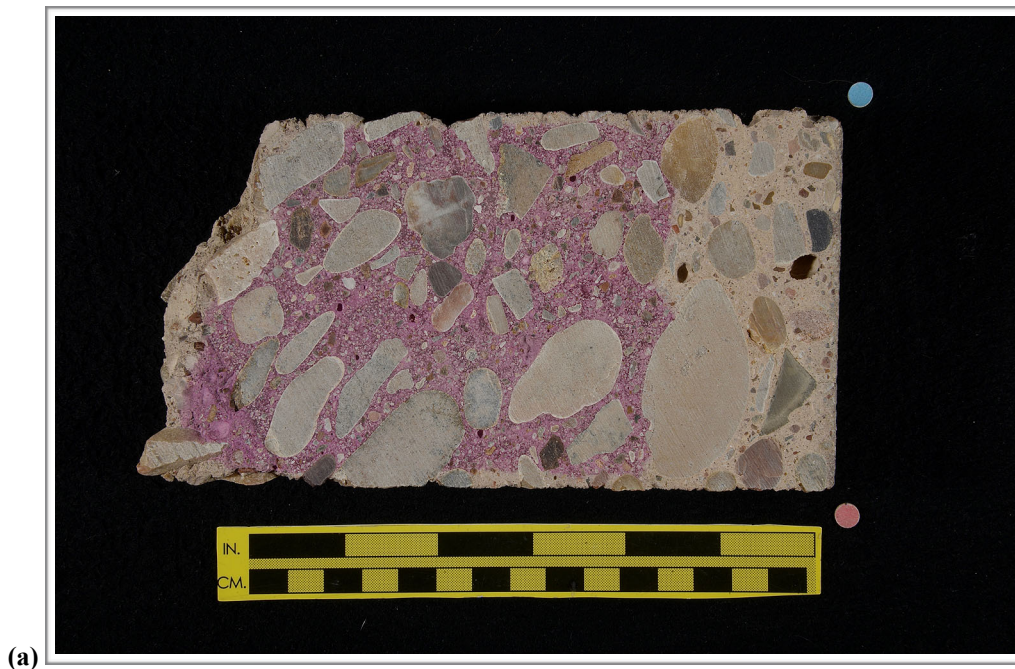
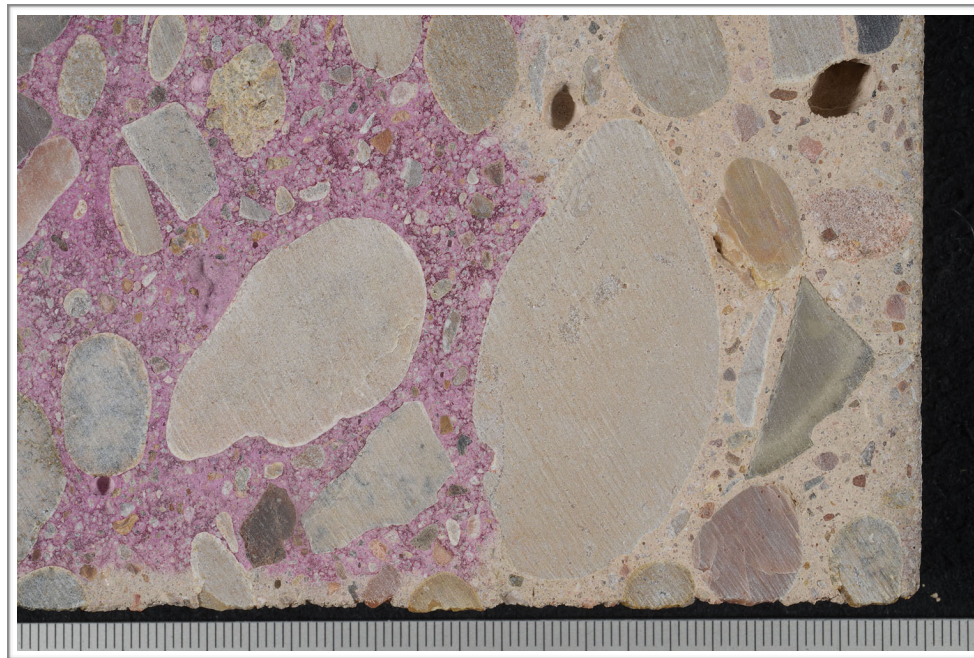
8. SECONDARY DEPOSITS	
PHENOLPHTHALEIN	No staining for up to 50 mm (2 in.) from the outer surface and up to 5 mm (200 mil) from the sides of the core ( <b>Figure A11</b> ).
DEPOSITS	No significant secondary deposits were observed apart from carbonation.

Figure A11. Photographs showing (a) overview of phenolphthalein-stained surface and (b) detail of surface near the outer end of the core. The large and small divisions on the yellow scale in (a) are in inches and centimeters, respectively. The scale in (b) is in millimeters.

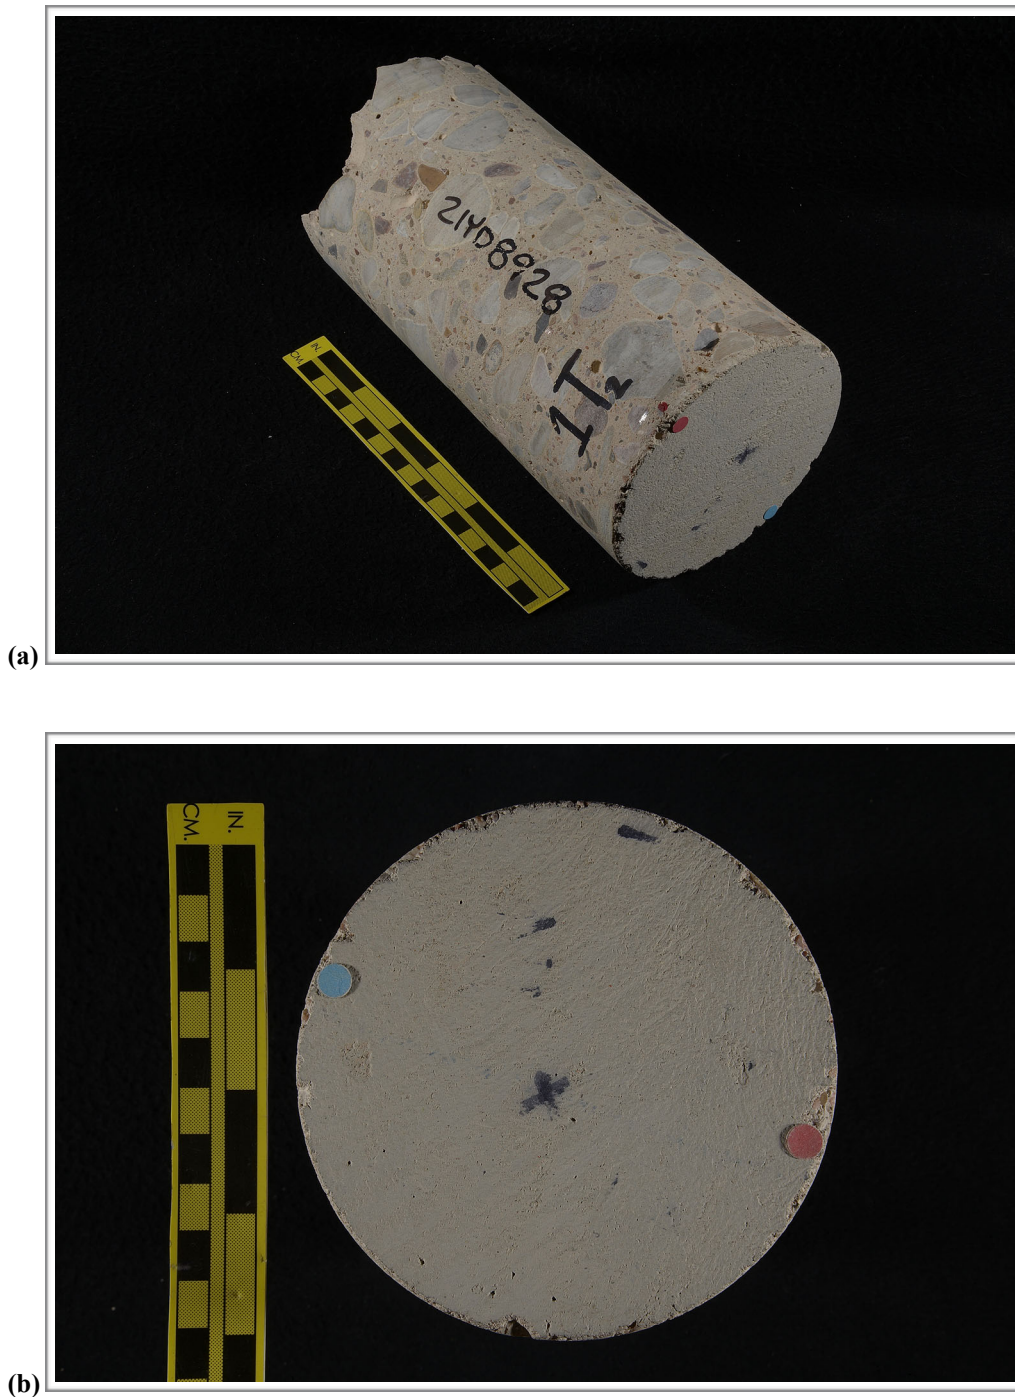
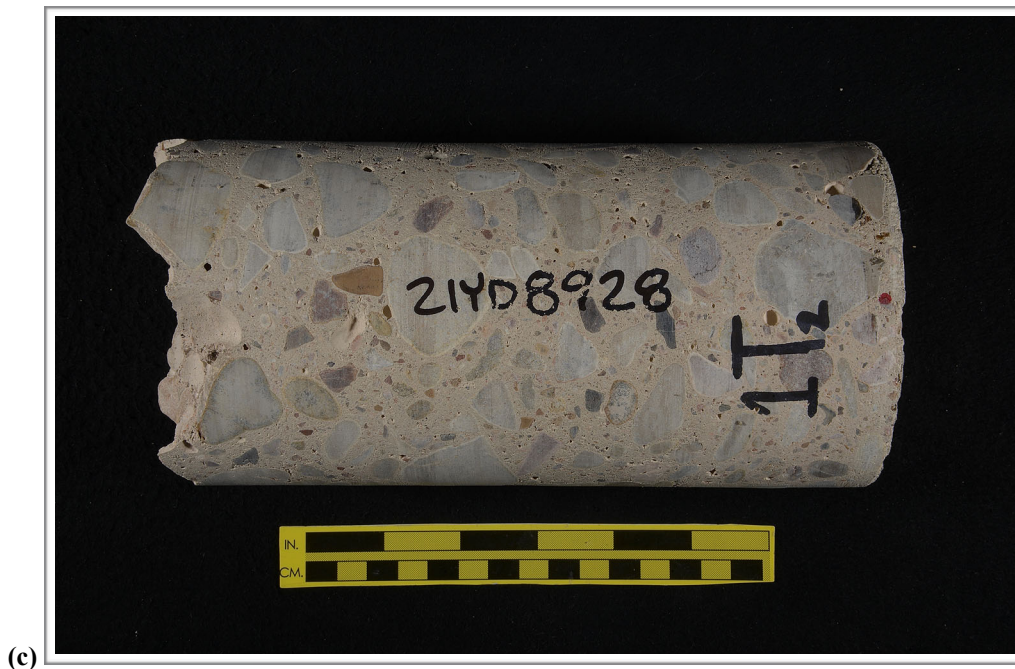
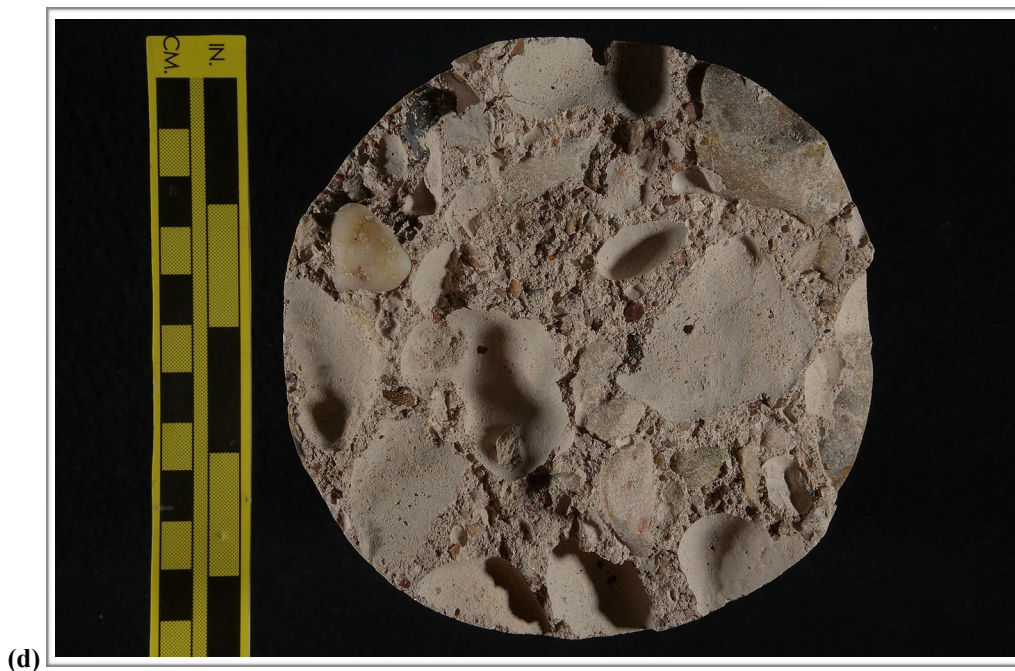
1. RECEIVED CONDITION	
ORIENTATION & DIMENSIONS	Horizontal core through bent cap panel measures 100 mm (4 in.) in diameter and 190-210 mm (7 ½ - 8 ⅜ in.) long ( <b>Figure B1, Figure B2</b> ).
SURFACES	The outer surface is formed and the inner surface is a fracture such that the core represents a partial thickness of the bent cap. The outer surface is smooth and intact ( <b>Figure B3</b> ).
GENERAL CONDITION	The concrete is hard and compact and rings lightly when sounded with a hammer.

Figure B1. Photographs showing (a) oblique view of the outer surface and side of the core with identification labels and (b) the outer surface of the core. The red and blue dots show the orientation of the saw cuts used to prepare the sample. The yellow bar in (a) is ~ 150 mm (6 in.) long; the large and small divisions on the yellow scale in both photos are in inches and centimeters, respectively.

Figure B1 (cont'd). Photographs of the core in as-received condition showing the (c) side of the core and (d) the inner surface of the core. The yellow scale in (c) is ~ 150 mm (6 in.) long; the large and small divisions on the yellow scale in both photos are in inches and centimeters, respectively.

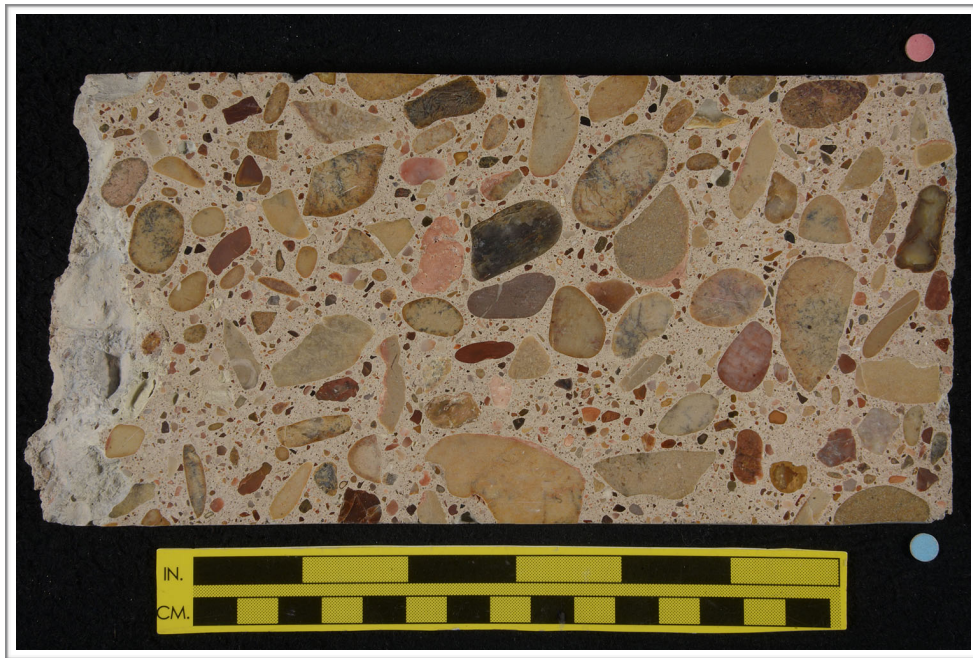
Figure B2. Photograph showing the polished surface of the core. The large and small divisions on the yellow scale are in inches and centimeters, respectively.

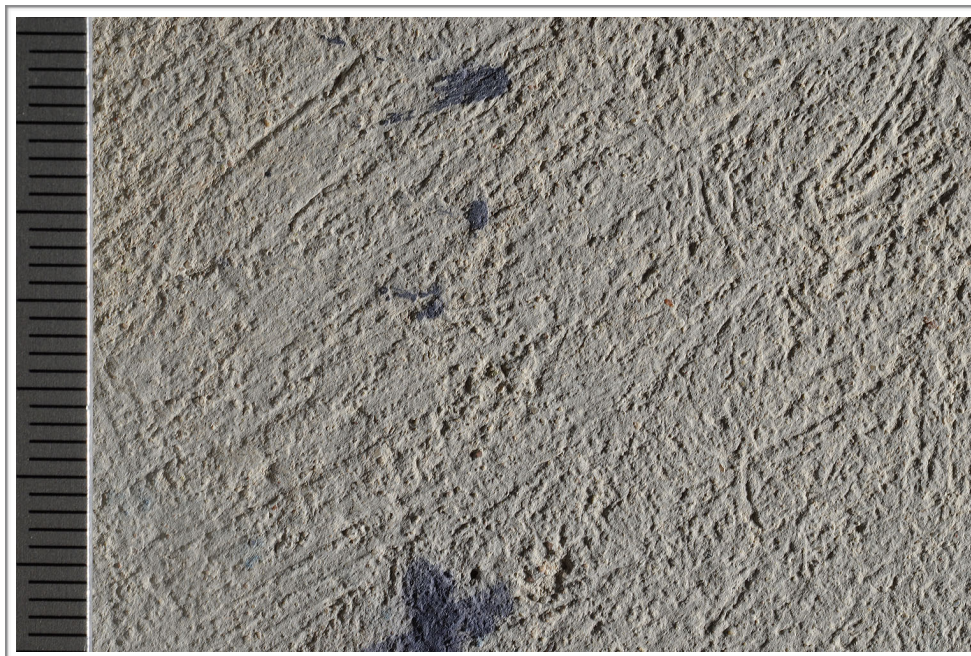
Figure B3. Photograph showing detail of the outer surface; scale in millimeters.

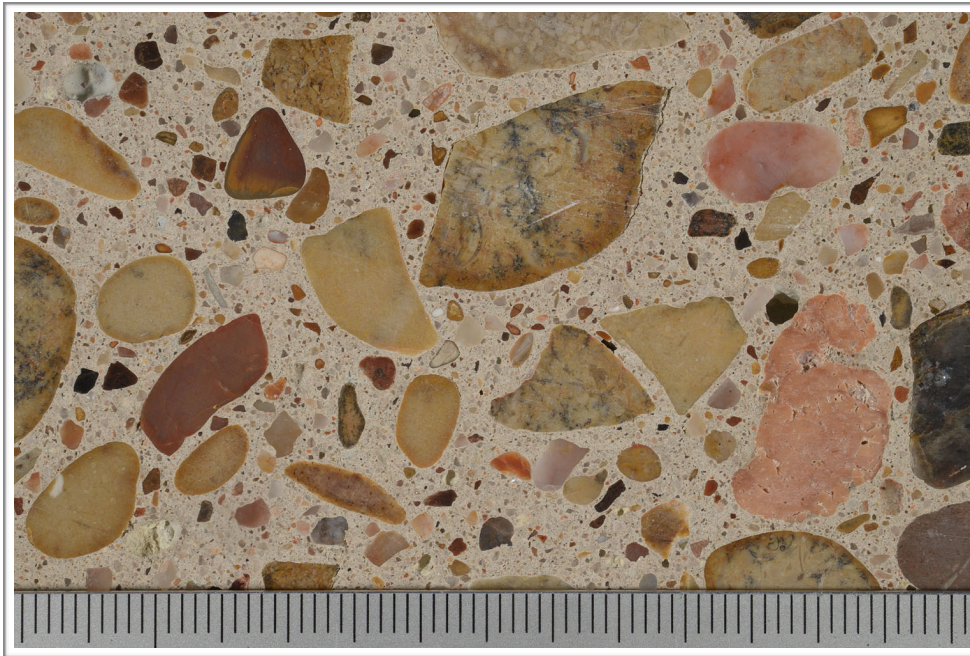
Figure B6. Photograph of the polished surface showing overview of coarse aggregate; scale in millimeters.

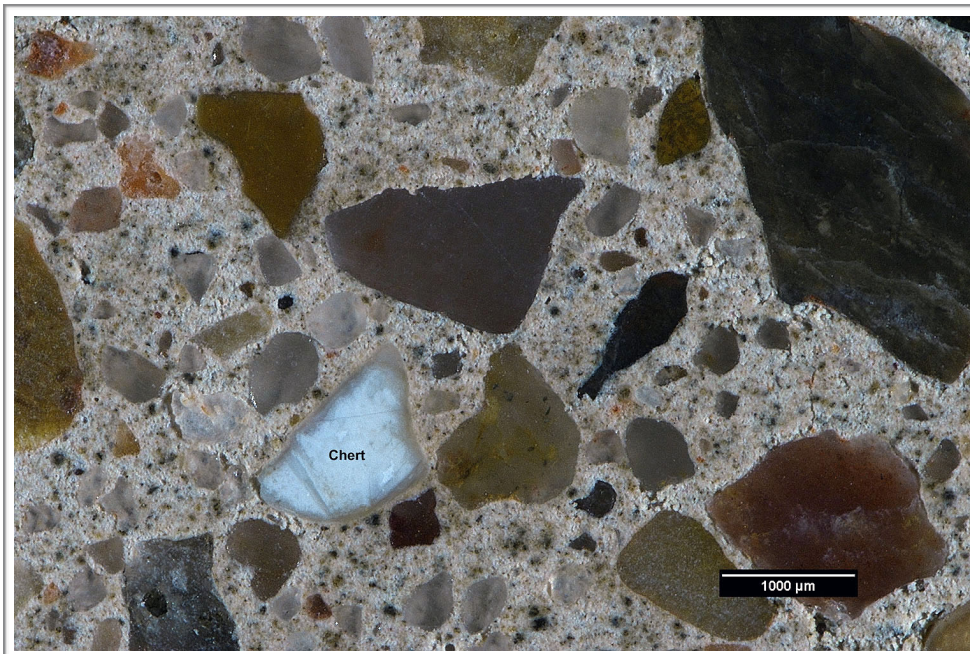
6. FINE AGGREGATE	
PHYSICAL PROPERTIES	The fine aggregate is a natural sand that consists of rocks that are hard and competent ( <b>Figure B7</b> ). The particles are sub-equant to slightly elongated in shape with sub-rounded to angular edges. The grading and distribution are relatively even.
ROCK TYPES	The sand consists primarily of siliceous rocks that include quartzite, chert and fragments of quartz with minor amounts of limestone similar to those observed in the coarse aggregate. Chert and quartzite are potentially susceptible to ASR.
OTHER FEATURES	No deleterious coatings or incrustations observed. No low w/c mortar coatings observed. No evidence of ASR was observed involving the fine aggregate.

Figure B7. Reflected light photomicrograph of the polished surface showing the fine aggregate.

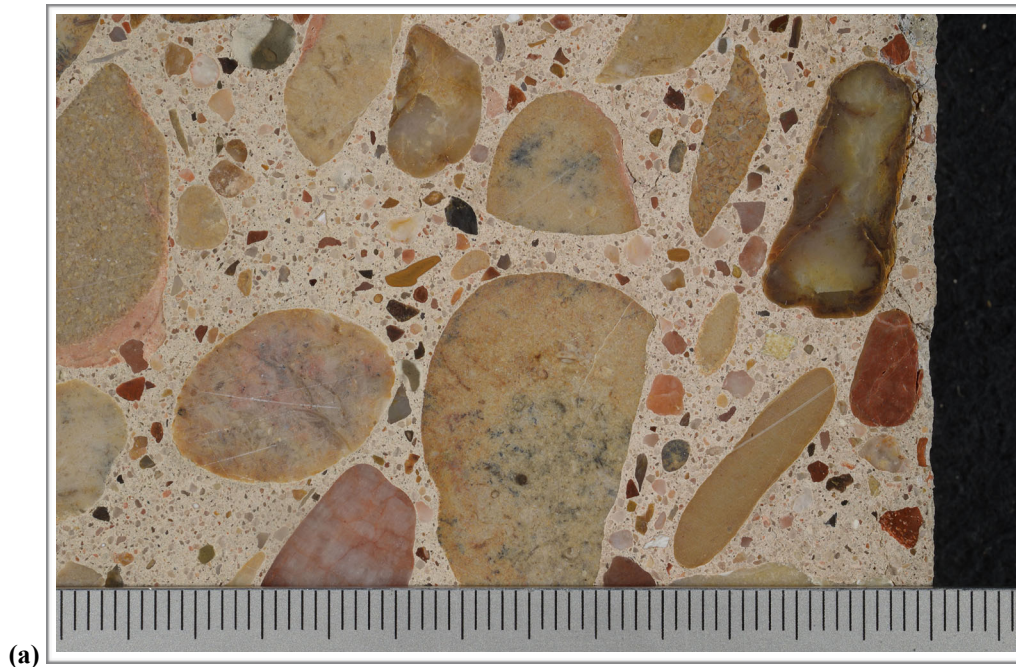
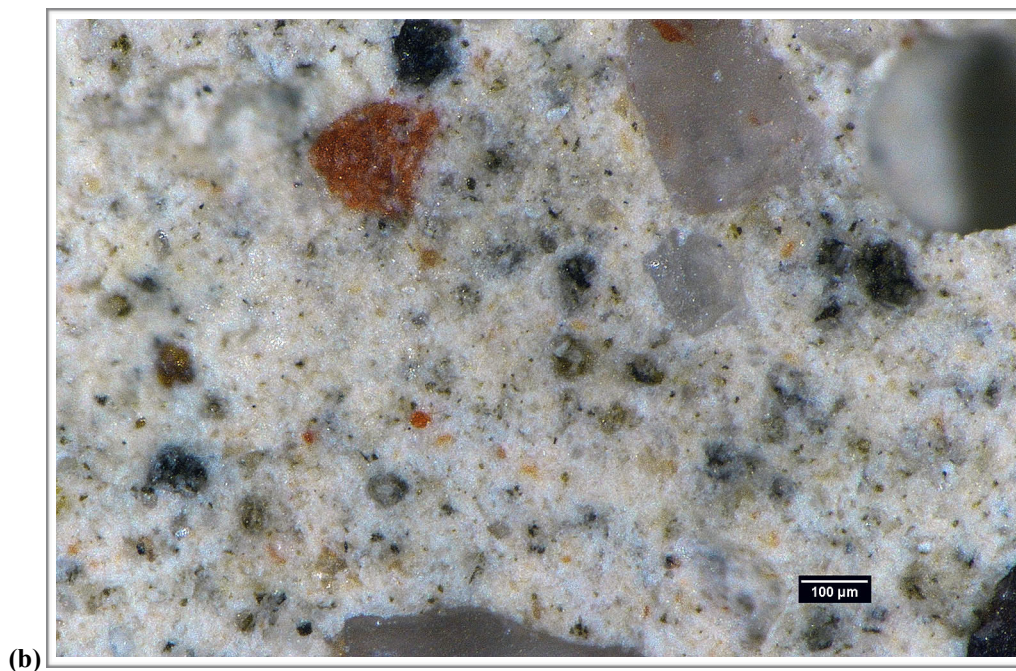
7. PASTE OBSERVATIONS	
POLISHED SURFACE	Paste is light gray (Munsell 2.5Y/7/1) to pale yellow (2.5Y/8/4), has a granular texture and a dull luster ( <b>Figure B8</b> ). The paste is soft (Mohs ~ 2.5).
FRESH FRACTURE	Fracture surface is light gray, has a punky texture and a dull luster ( <b>Figure B9</b> ). The fracture cuts mostly around coarse aggregate particles.
THIN SECTION*	The paste contains hydrated portland cement with no fly ash, slag cement or other SCM observed. The hydration is normal with relict and residual cement grains that consist mostly of belite making up 3-7% of the paste ( <b>Figure B10</b> ). CH is medium to coarse grained and evenly distributed.
* Abbreviations as follows: RRCG = relict and residual cement grains; SCM = supplemental cementitious materials; CH = calcium hydroxide; ITZ = interfacial transition zone. Modal abundances are based on visual estimations.

Figure B8. (a) Photograph of the polished surface showing overview of the paste at the outer end of the core. Scale in millimeters. (b) Reflected light photomicrograph of the polished surface showing detail of paste in the middle of the core.
