**Structural Evaluation and Testing of Damaged  
Reinforced Concrete Bent Caps**

**Thesis**

The University of Texas at Austin

May 2019

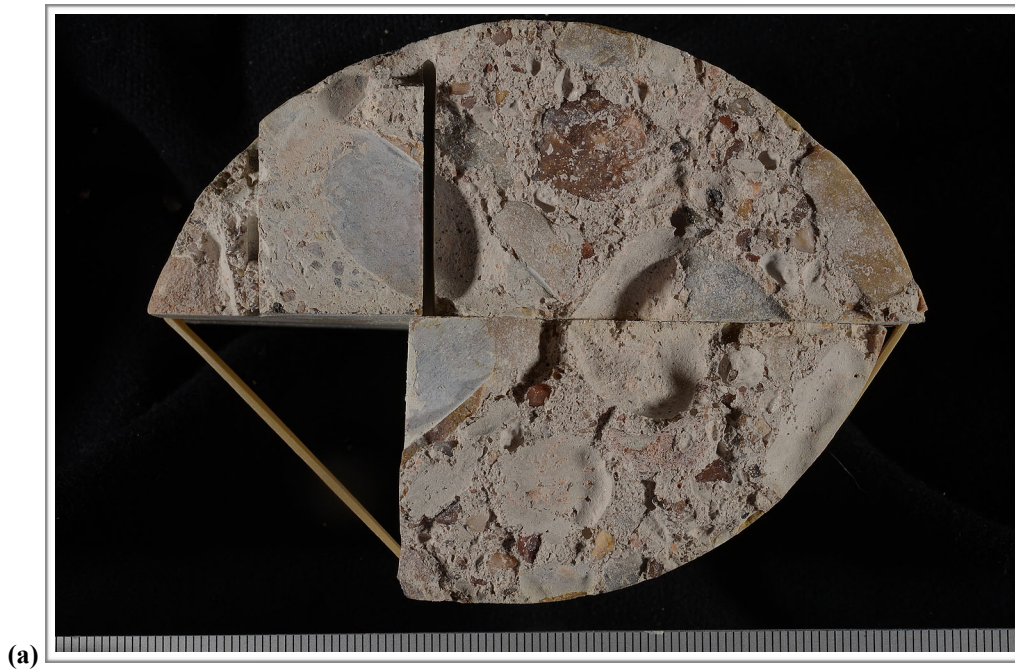
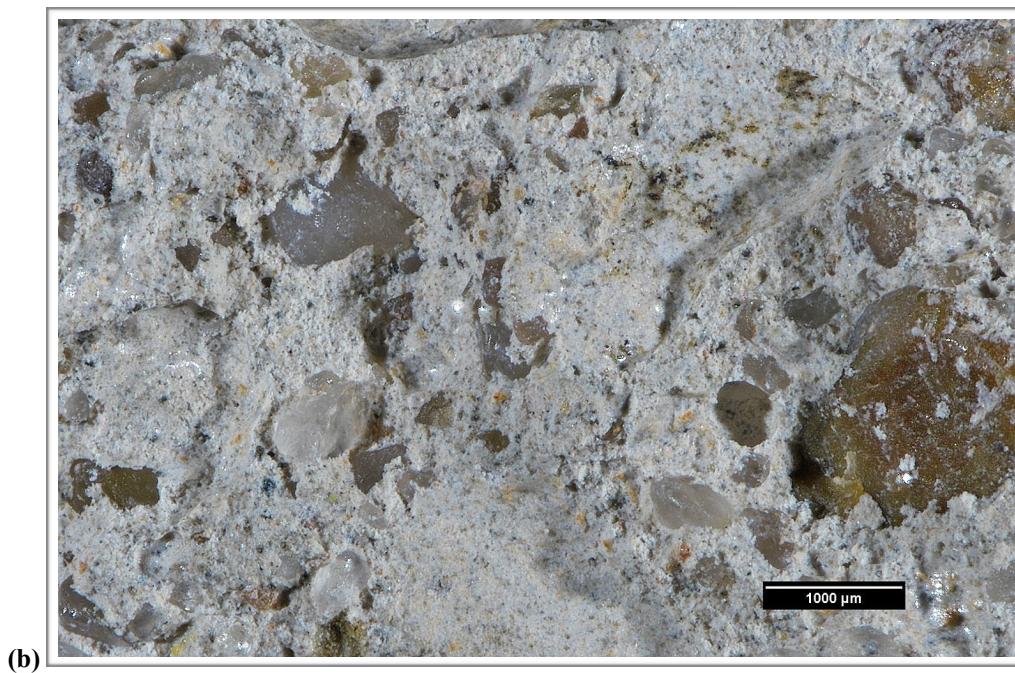
Figure B9. (a) Photograph and (b) reflected light photomicrograph of fresh fracture surface. The scale is in millimeters in (a).

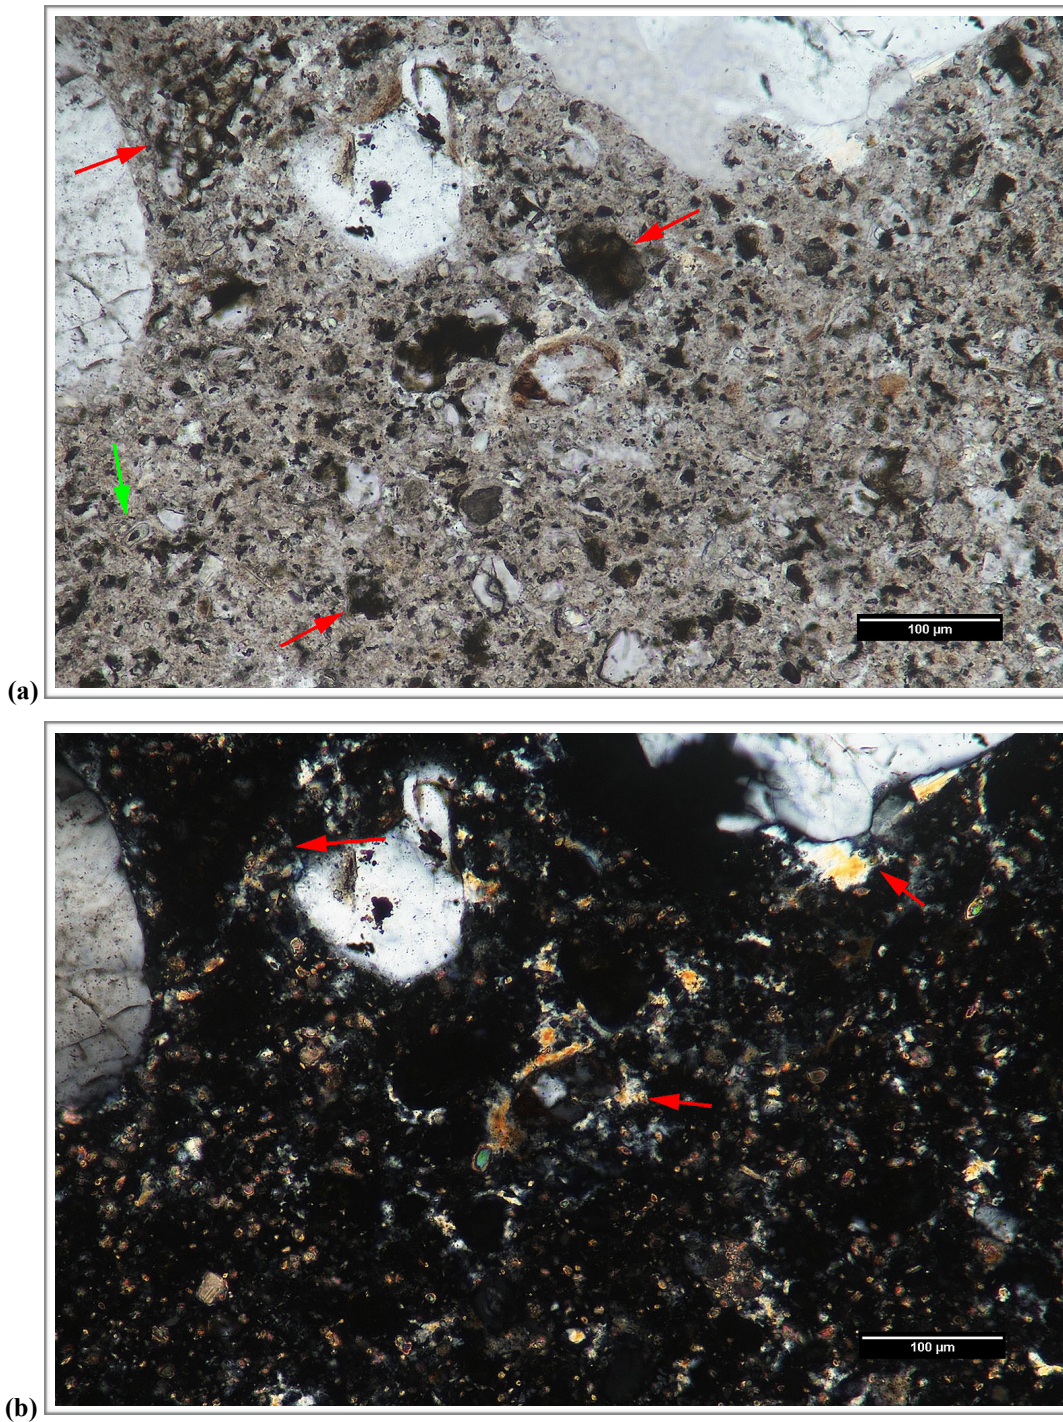
Figure B10. Transmitted light photomicrographs of thin section showing detail of paste in (a) plane-polarized and (b) cross-polarized light. The red arrows in (a) indicate RRCG; in (b) they indicate CH. The green arrow in (a) indicates a fly ash particle.

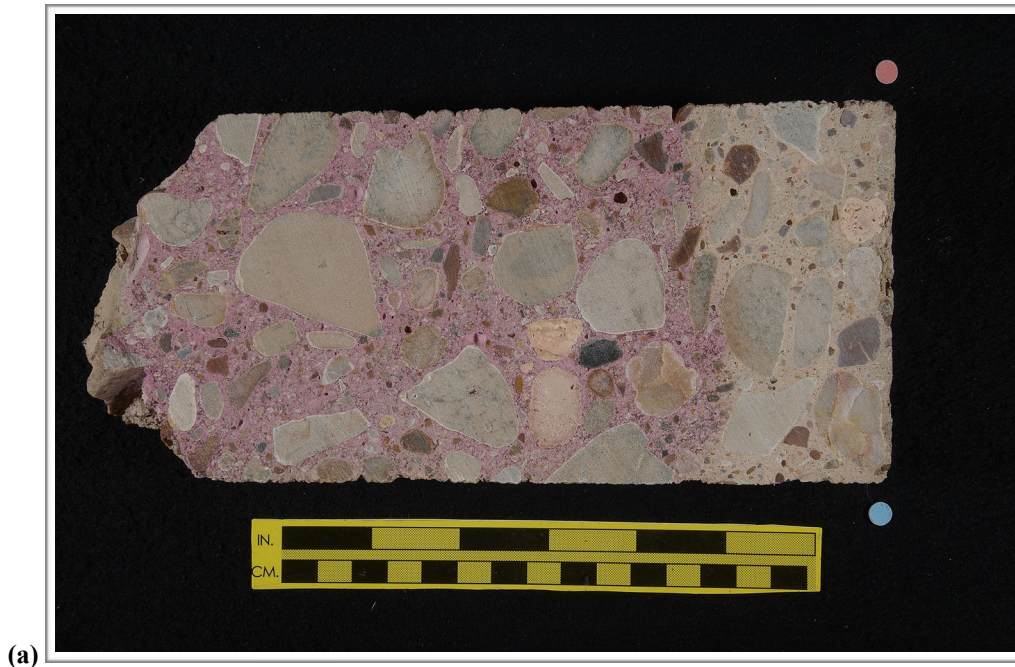
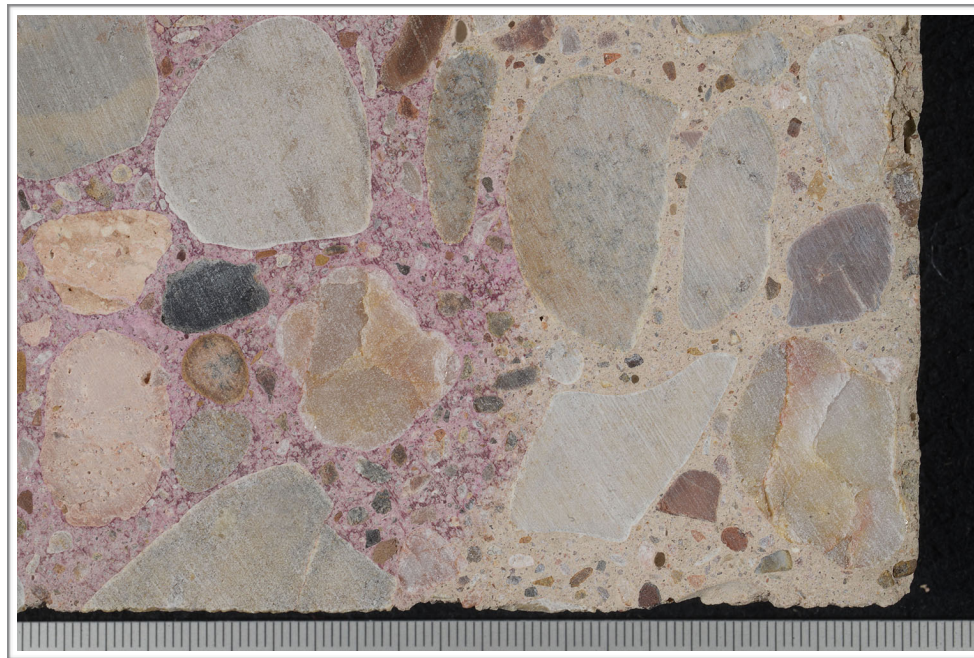
8. SECONDARY DEPOSITS	
PHENOLPHTHALEIN	No staining for up to 50 mm (2 in.) from the outer surface ( <b>Figure B11</b> ).
DEPOSITS	No significant secondary deposits were observed apart from carbonation.

Figure B11. Photographs showing (a) overview of phenolphthalein-stained surface and (b) detail of surface near the outer end of the core. The large and small divisions on the yellow scale in (a) are in inches and centimeters, respectively. The scale in (b) is in millimeters.
