Site Assessment Report

**Douglas Shoal Remediation Project
Great Barrier Reef Marine Park Authority**

8 November 2019

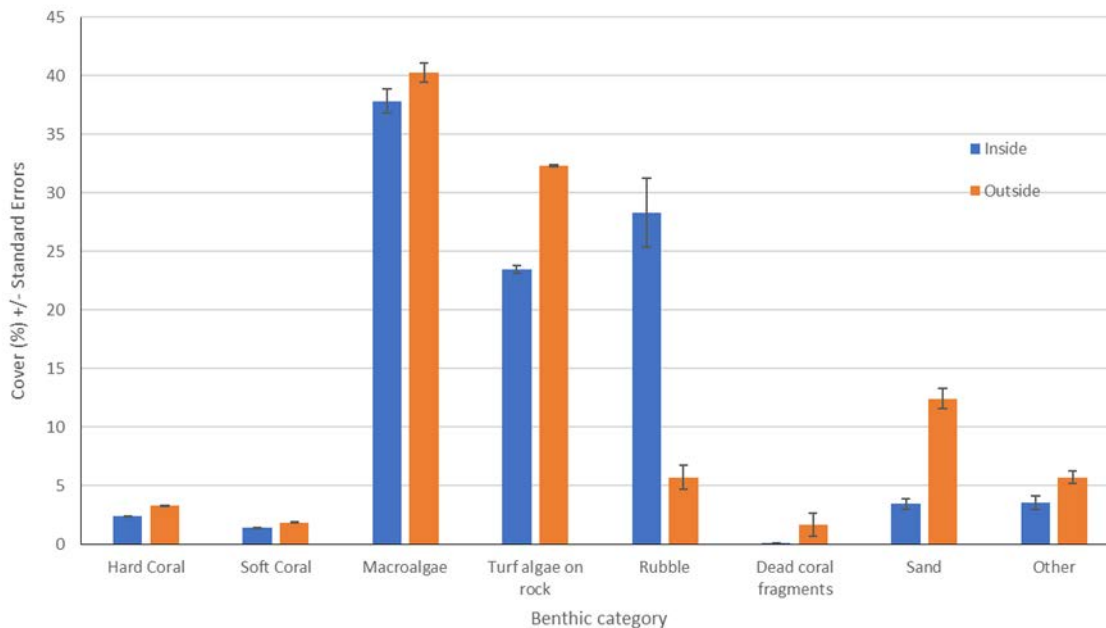
Figure 1-6 Percentage covers (+/- standard error) of benthic groups inside and outside the assumed impacted areas

Comparison of 2019 survey benthic habitat and benthos data from inside and outside the area assumed to be impacted by the grounding is shown in Figure 1-6. Outside the impacted areas, hard and soft coral, macroalgae, turf algae on rock, sand and other benthos were more abundant. The impacted areas were characterised by having very high cover of rubble. Closer examination of the benthic groups shows the cover of rubble is highest inside the impacted area in Priority Area F (47.9%), followed by Priority Area C (23.5%), Area E (31.4%) then Area A (10.4%). It is considered likely that the grounding caused habitat changes on the shoal including the replacement of areas of 'turf algae on rock' and areas of 'sand' with 'rubble'.

The appearance of the rubble does not appear to have changed significantly since the grounding and remains obviously different to the natural sediments found in the reference or unaffected areas; however, some areas of rubble do support benthic organisms and have consolidated over time. It appears that some areas of substrate smothered by rubble following the grounding have been exposed with westward movement of rubble over time. Undulating substrate was found in these areas to be devoid of algal growth; however, now exposed these areas may support the settlement and growth of coral recruits and other benthos.

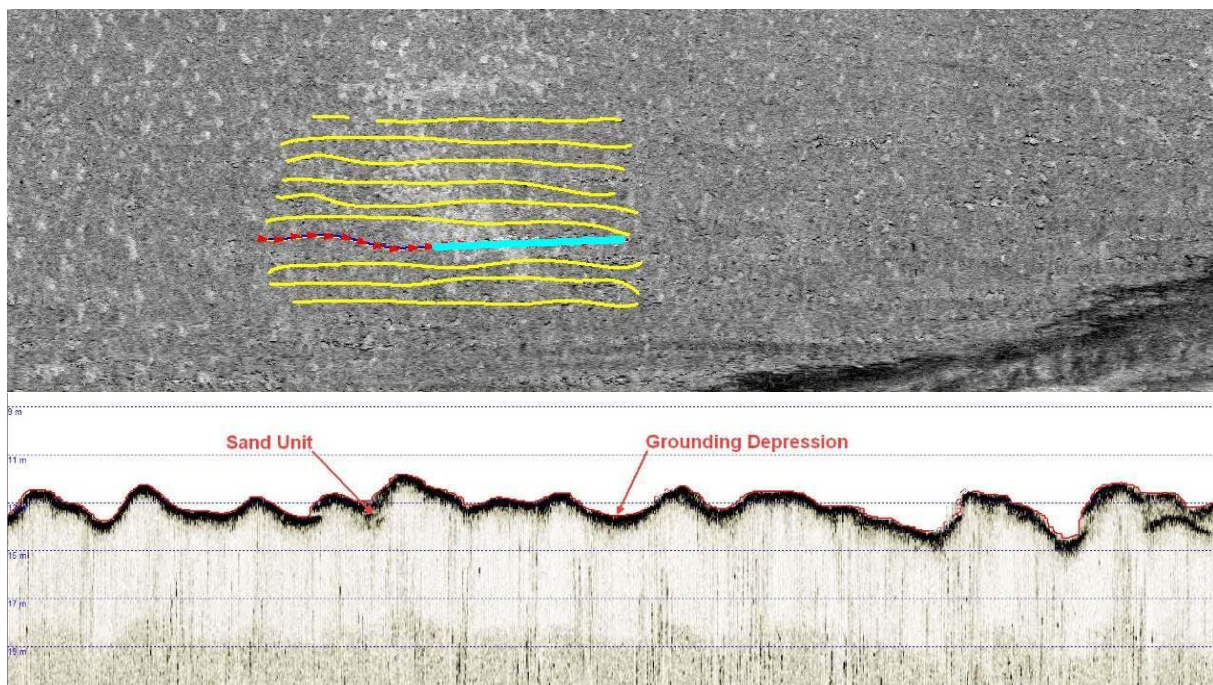
Figure 4-9 SBP transects in Priority Area F with cross-section of the blue line transect section in the lower image

Results of the SBP survey and depth measurements taken during sampling provide further information to understand the area and volume of sediments on the shoal. The SBP survey provided limited information regarding the location and depth of sediments across survey transects. An example of the SBP output from surveys in Priority Area F is provided in Figure 4-9. In this example, the grounding footprint is evident as a depression and the depth of penetration of the acoustic signal is very limited indicating there is very little overlaying sediment on a hard surface at this location. This was typical of the results of the SBP survey, indicating few areas of sediment and generally limited sediment depth.

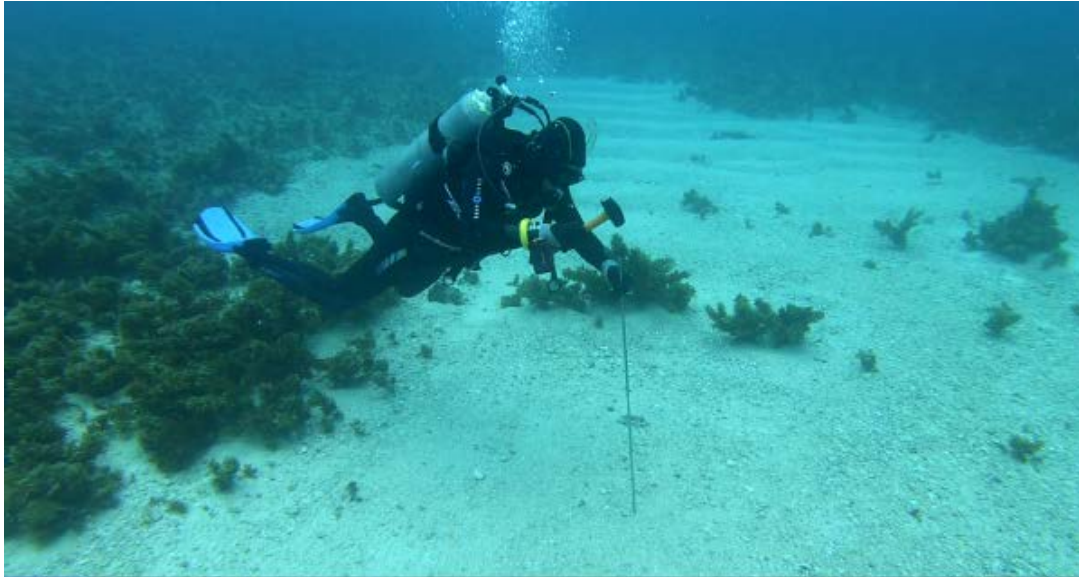
Figure 4-10 Diver hammering scaled stainless steel rod in Priority Area F to measure sediment depths

A sound indication of sediment depth across the survey area is provided by diver measurements (Figure 4-10). Depth of sediment at each of the sampling sites ranged from 5mm to 400mm, averaging 73mm across all sites (Table 4-2 and Figure 4-11). Areas AX and FX contained the deepest sediments on average, with 99.5mm and 114.8mm depth respectively. These sampling sites were located outside of a priority area, and in some cases in deeper water. Sediment depths may be greater at these sites due to the lower energy environment of the deeper water which may allow for more settlement.

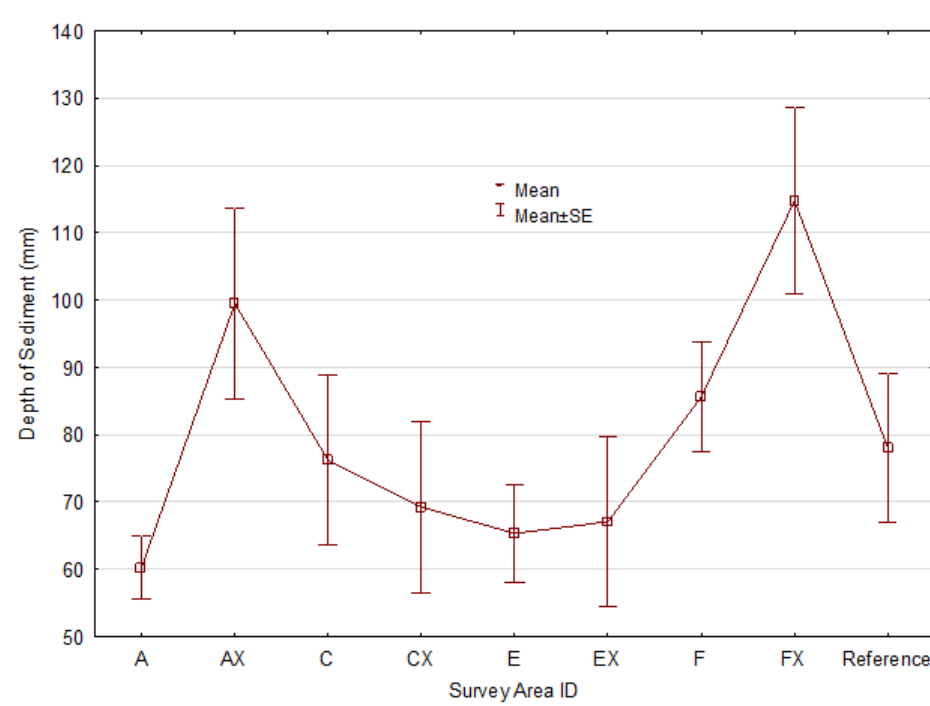
Figure 4-11 Graphical representation of the mean depths of sediments (mm) in each sampling area

Of the areas sampled, Priority Area A had the shallowest sediment on average. This may reflect the structure and location of the area. This is the most uniform of the priority areas in terms of sea floor

structure and is the most exposed of the priority areas to prevailing winds and swell. This may cause resuspension rather than accumulation of sediments in this area.

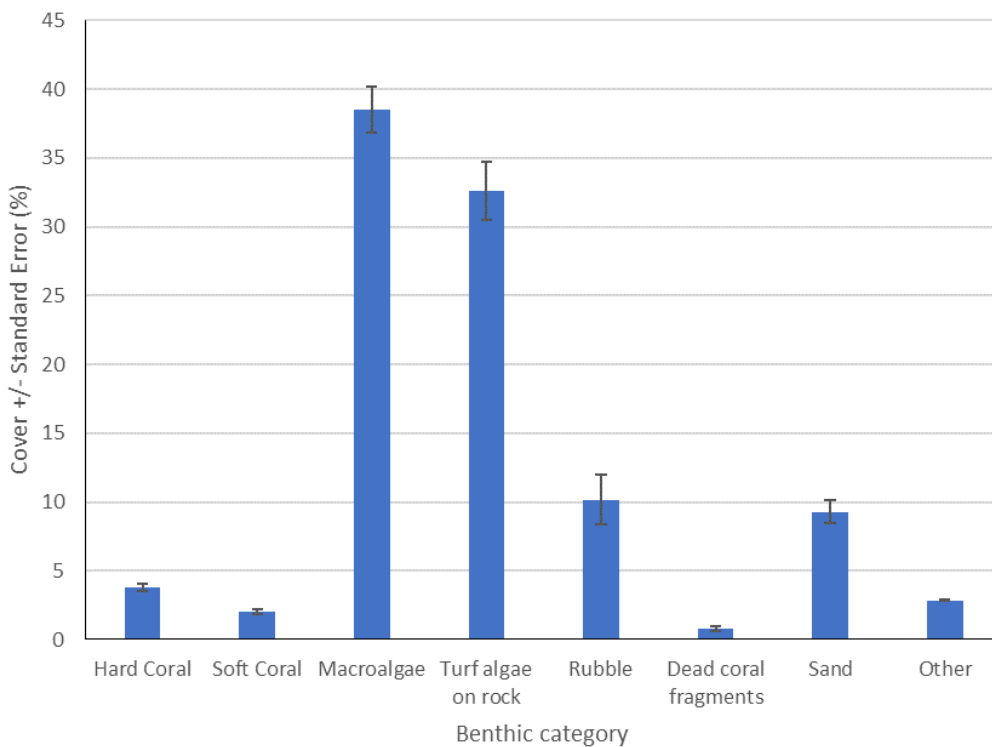
Figure 4-12 Percentage covers (+/- standard error) of broad benthic groups at Douglas Shoal

The benthic habitat within and surrounding the priority areas at Douglas Shoal in 2019 are dominated by macroalgae (38.5%) and turf algae growing on hard substrate (32.6%) (Table 4-3 and Figure 4-12). Hard coral (3.8%) and soft coral (2.0%) are sparse and low in abundance. Rubble and sandy areas devoid of benthos cover 10.2% and 9.3% of the area respectively. Dead coral fragments cover <1% of the shoal while coralline algae, sponge, and other organisms represent the remaining 3% cover. Examples of the benthos found on Douglas Shoal are provided in Figure 4-13. A full list of hard and soft coral families and genera observed during the analysis is provided at Table 4-6.

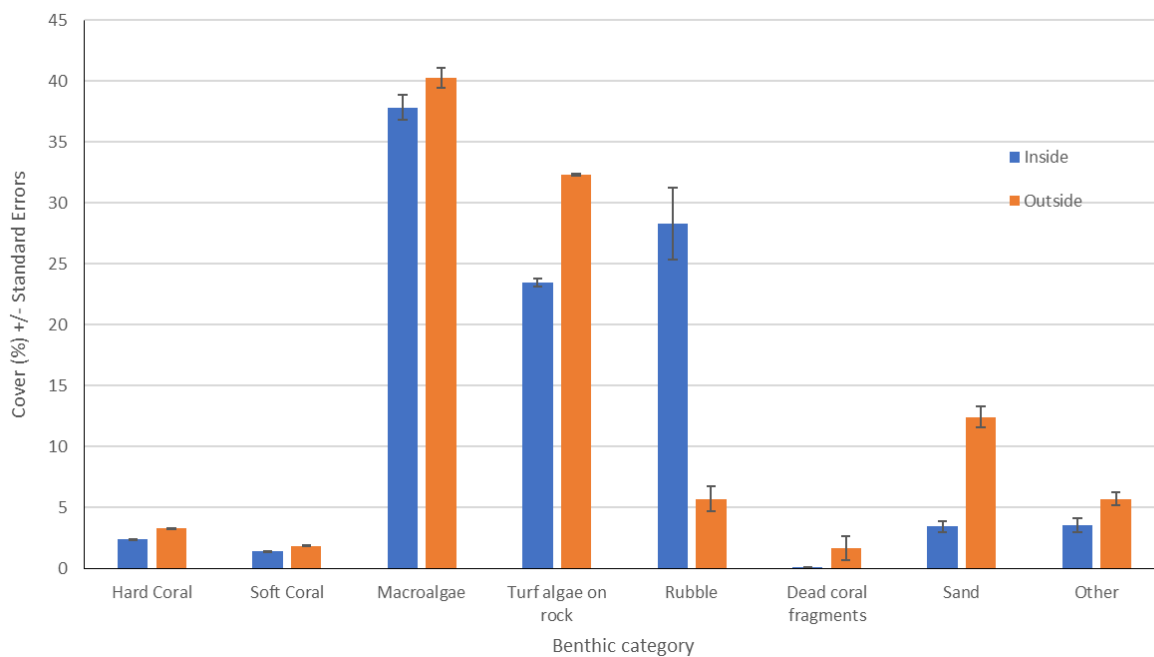
Figure 4-14 Percentage covers (+/- standard error) of benthic groups inside and outside the impacted areas

Comparisons between the broad categories of benthic habitat and benthos inside and outside the impacted areas are shown in Figure 4-14 and Table 4-4. Outside the impacted areas, hard and soft coral, macroalgae, turf algae on rock, sand and other benthos were more abundant. The impacted areas were characterised by a very high cover of rubble. Closer examination of the rubble / sand / dead coral fragments categories (Note: (I)= Inside impacted areas, (O) = Outside impacted areas, (DS)= Deep Shelf outside impacted areas, (S)= Shallow Shelf outside impacted areas)

Comparison of 2019 survey benthic habitat and benthos data from inside and outside the area assumed to be impacted by the grounding shows that outside the impacted areas, hard and soft coral, macroalgae, turf algae on rock, sand and other benthos were more abundant. The impacted areas were characterised by having very high cover of rubble. The cover of rubble is highest inside the impacted area in Priority Area F (47.9%), followed by Priority Area C (23.5%), Area E (31.4%) then Area A (10.4%). It is considered likely that the grounding caused habitat changes on the shoal including replacement of areas of 'turf algae on rock' and areas of 'sand' with 'rubble'.

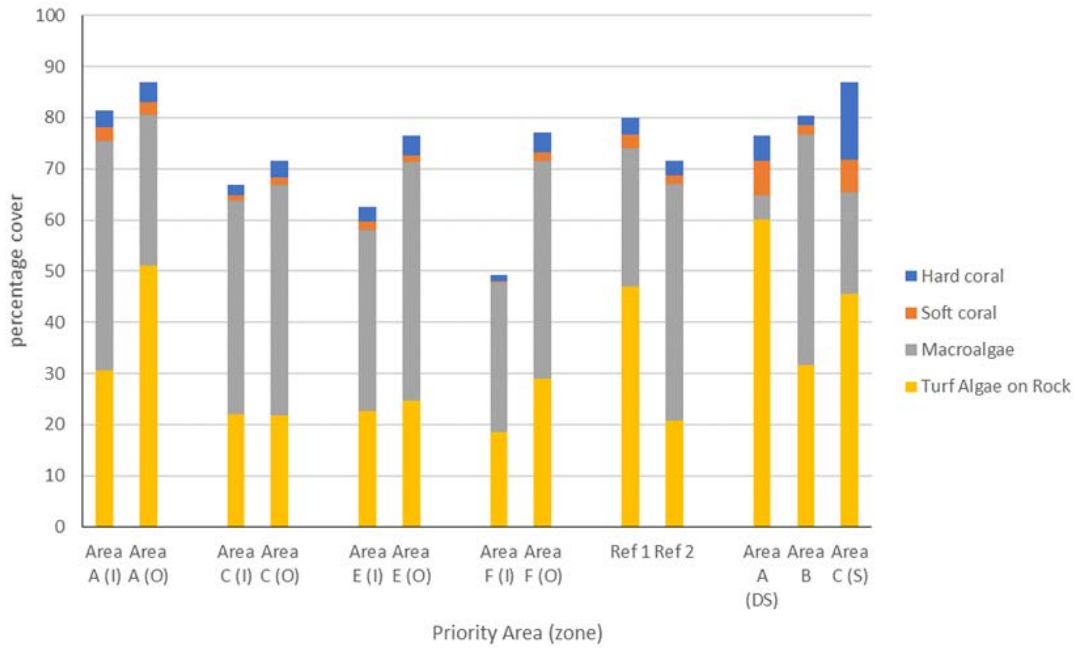
Figure 4-15 Selected live benthic habitat percentage covers across all priority areas and impacted areas

Hard coral cover was highest on the High Relief Terrace (15.2%) and lowest inside the grounding footprint at Area F (1.9%). Hard coral cover was below 5% at all sites including the reference areas but slightly higher in areas outside the grounding footprint compared to those inside the footprint across all priority areas. Hard corals, where found, were dominated by corals from the genus *Acropora* and *Stylophora*, with very sparse (<1%) cover of *Seriatopora*, *Pocillopora* and *Montipora*.

Turf algae growing on the reefal structure (rock) represented the highest category of benthos, ranging from 60.2% cover in the deeper sections outside of Priority Area E to 18.6% inside the grounding footprint of Priority Area F. The cover of turf algae on rock was generally higher outside of the grounding footprint.

Macroalgae is most abundant outside Priority Area E (46.7%), but similarly abundant at several locations. The lowest abundance of macroalgae occurred in the deeper areas outside of Priority Area A (4.7%). Macroalgae cover was generally higher outside of the grounding footprint except in Priority Area A. Macroalgal communities were dominated by the genus *Sargassum*, *Dictyota* and *Halimeda spp.*

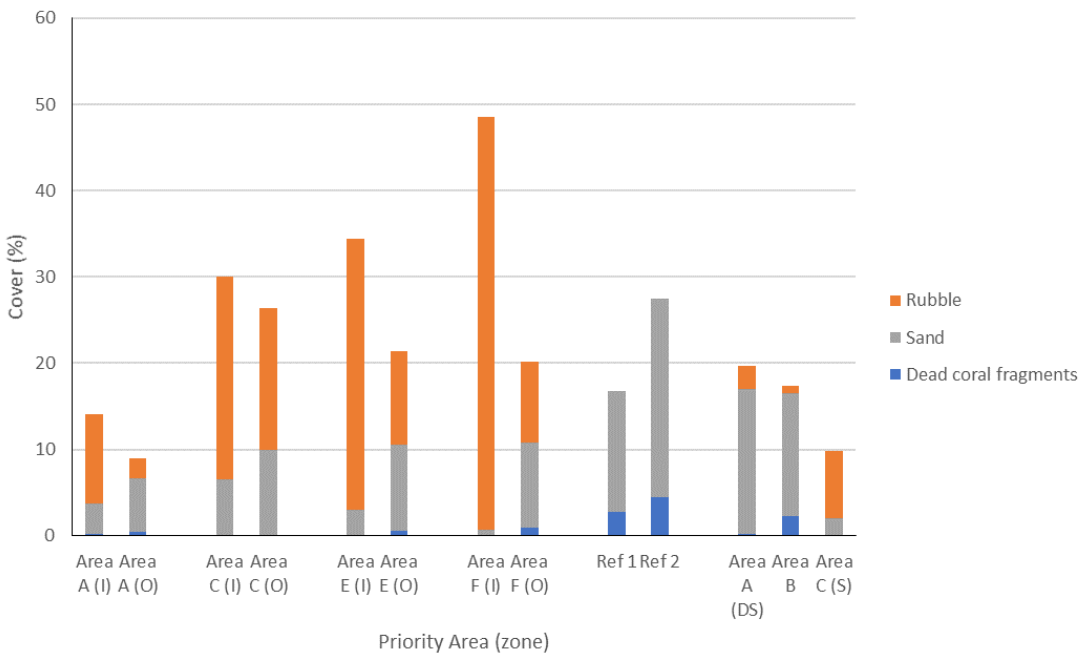
Figure 4-16 Selected dead (abiotic) benthic habitat percentage covers across all priority areas and impacted areas

Figure 4-15) show the cover of rubble is highest inside the impacted areas in Priority Area F (47.9%), followed by Priority Area C (23.5%), Area E (31.4%) then Area A (10.4%). Dead coral fragments are predominately found outside the impacted areas and in reference areas (Note: (I)= Inside impacted areas, (O) = Outside impacted areas, (DS)= Deep Shelf outside impacted areas, (S)= Shallow Shelf outside impacted areas)

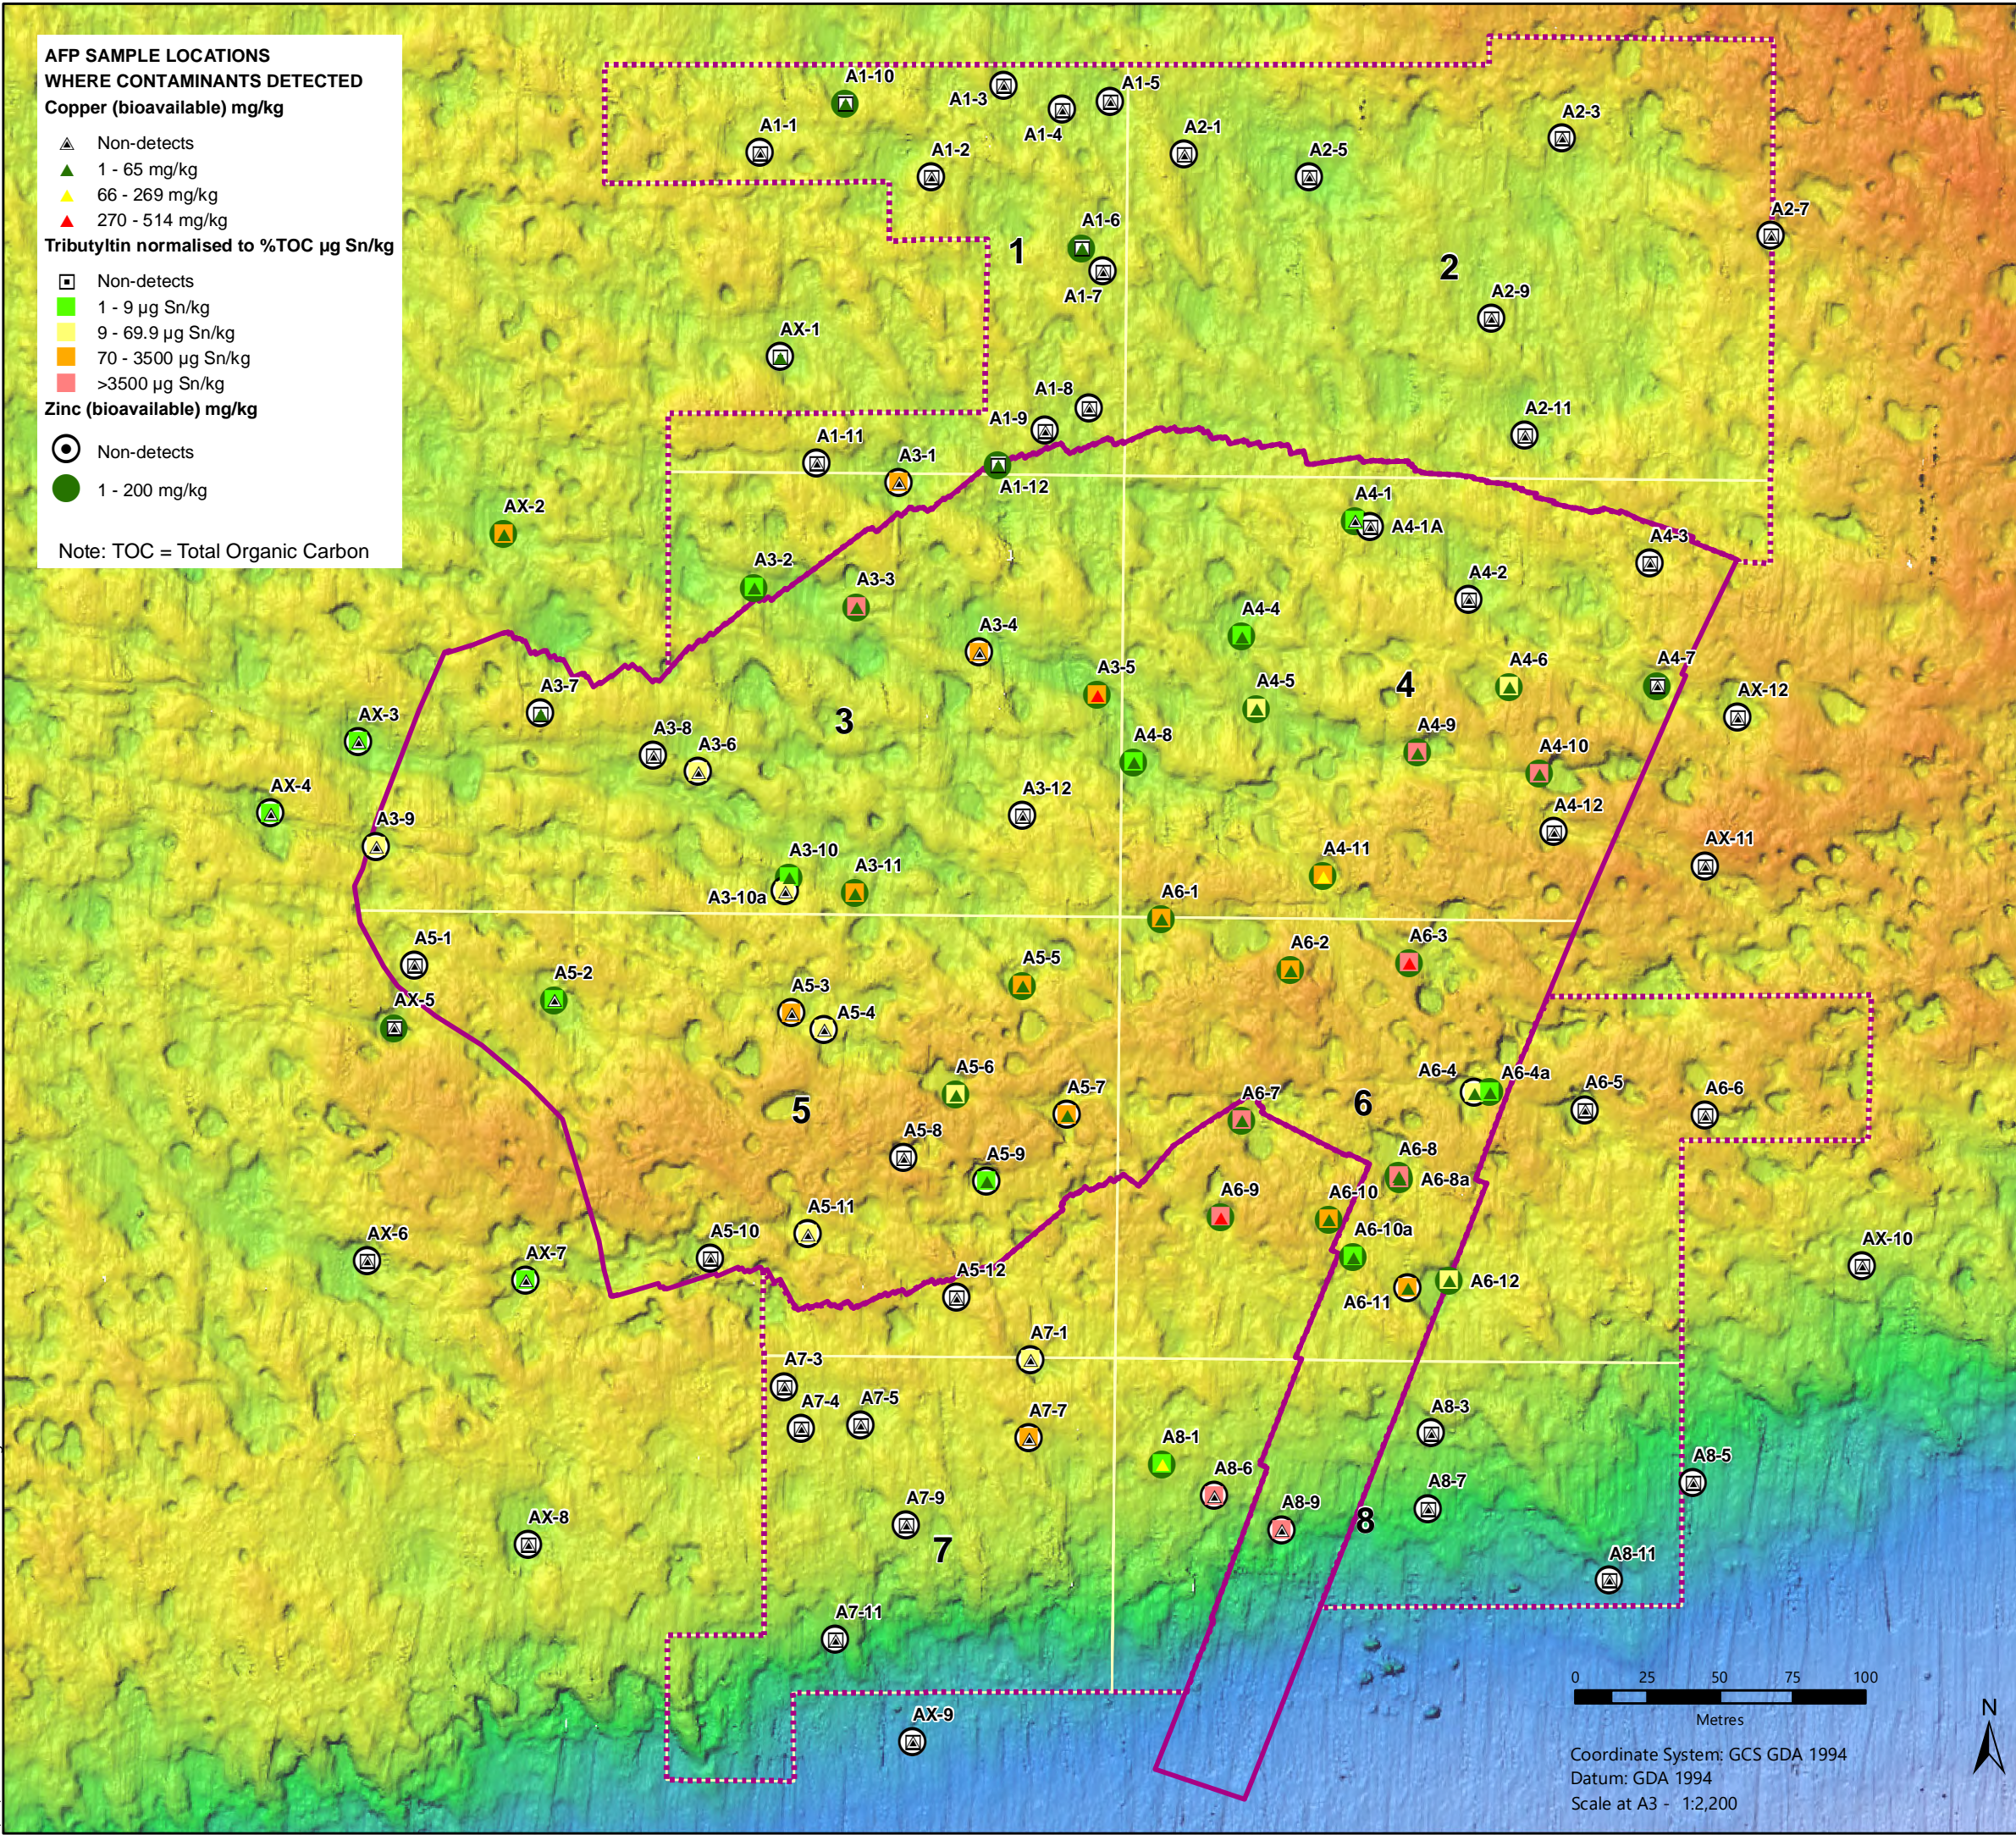
Figure 5-1 AFP* Constituent Concentrations at Sediment Sampling Sites in Priority Area A

In **Priority Area A** (Figure 5-1) sediment was collected from 97 sites and sent to the laboratory for analysis. TBT was detected at 48 sites; 35 sites were above the ANZG (2018) guideline of 9µgSn/kg. Copper was detected at 55 sites; five sites were above the ANZG (2018) guideline of 65mg/kg. Zinc was detected at 48 sites; no sites were above the ANZG (2018) guideline of 200mg/kg. Elutriate testing of samples from Priority Area A which exceeded the ANZG (2018) guidelines found 15 samples (of the 48 tested) with TBT concentrations (ng Sn/L) above the ANZG 99% Species Protection Guideline. Three (of the five elutriate tested for elevated copper) samples had copper (µg/L) above the ANZG 99% Species Protection Guidelines. No zineb was detected in samples tested.

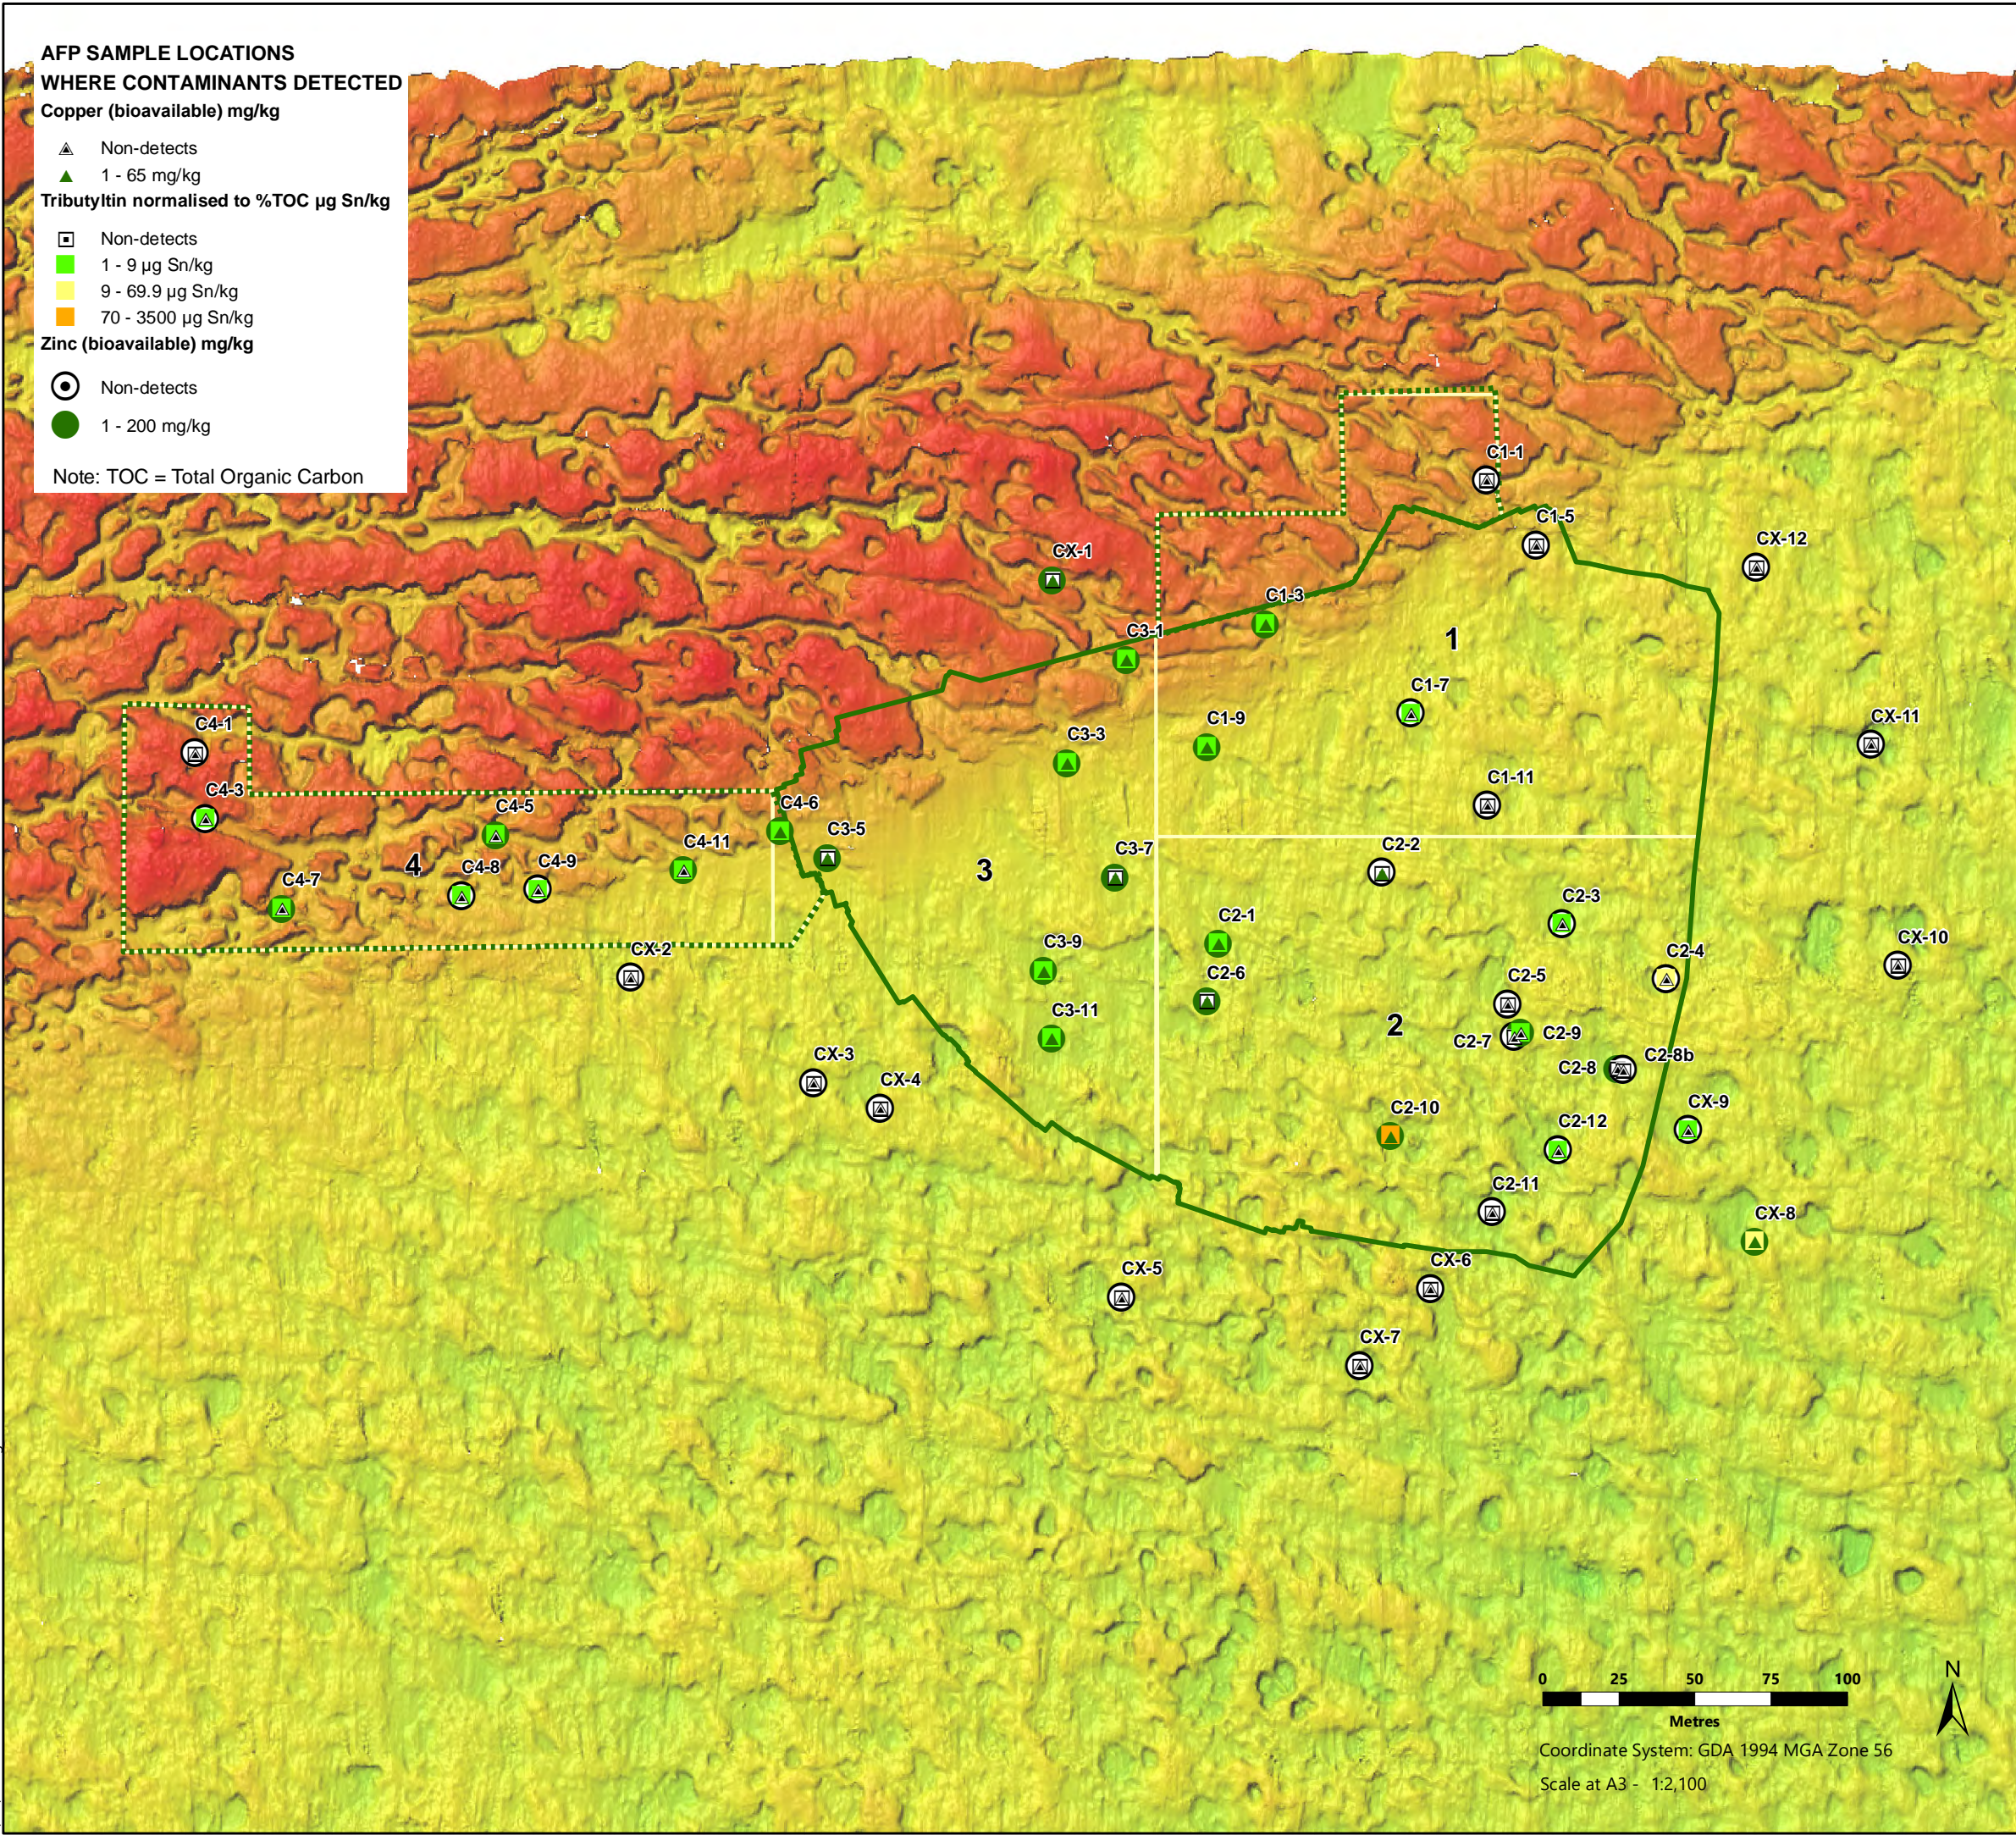
Figure 5-2
AFP* Constituent Concentrations at Sediment Sampling Sites in Priority Area C

In **Priority Area C** (Figure 5-2) sediment was collected from 45 sites. TBT was detected at 22 sites; three sites were above the ANZG (2018) guideline of 9µgSn/kg. Copper was detected at 15 sites; no sites were above the ANZG (2018) guideline of 65mg/kg. Zinc was detected at 19 sites; no sites were above the ANZG (2018) guideline of 200mg/kg. Elutriate testing of the 22 samples from priority Area C where TBT was detected found one sample (site CX-8) had a TBT concentration (ng Sn/L) above the ANZG 99% Species Protection Guideline. No zineb was detected in samples tested.

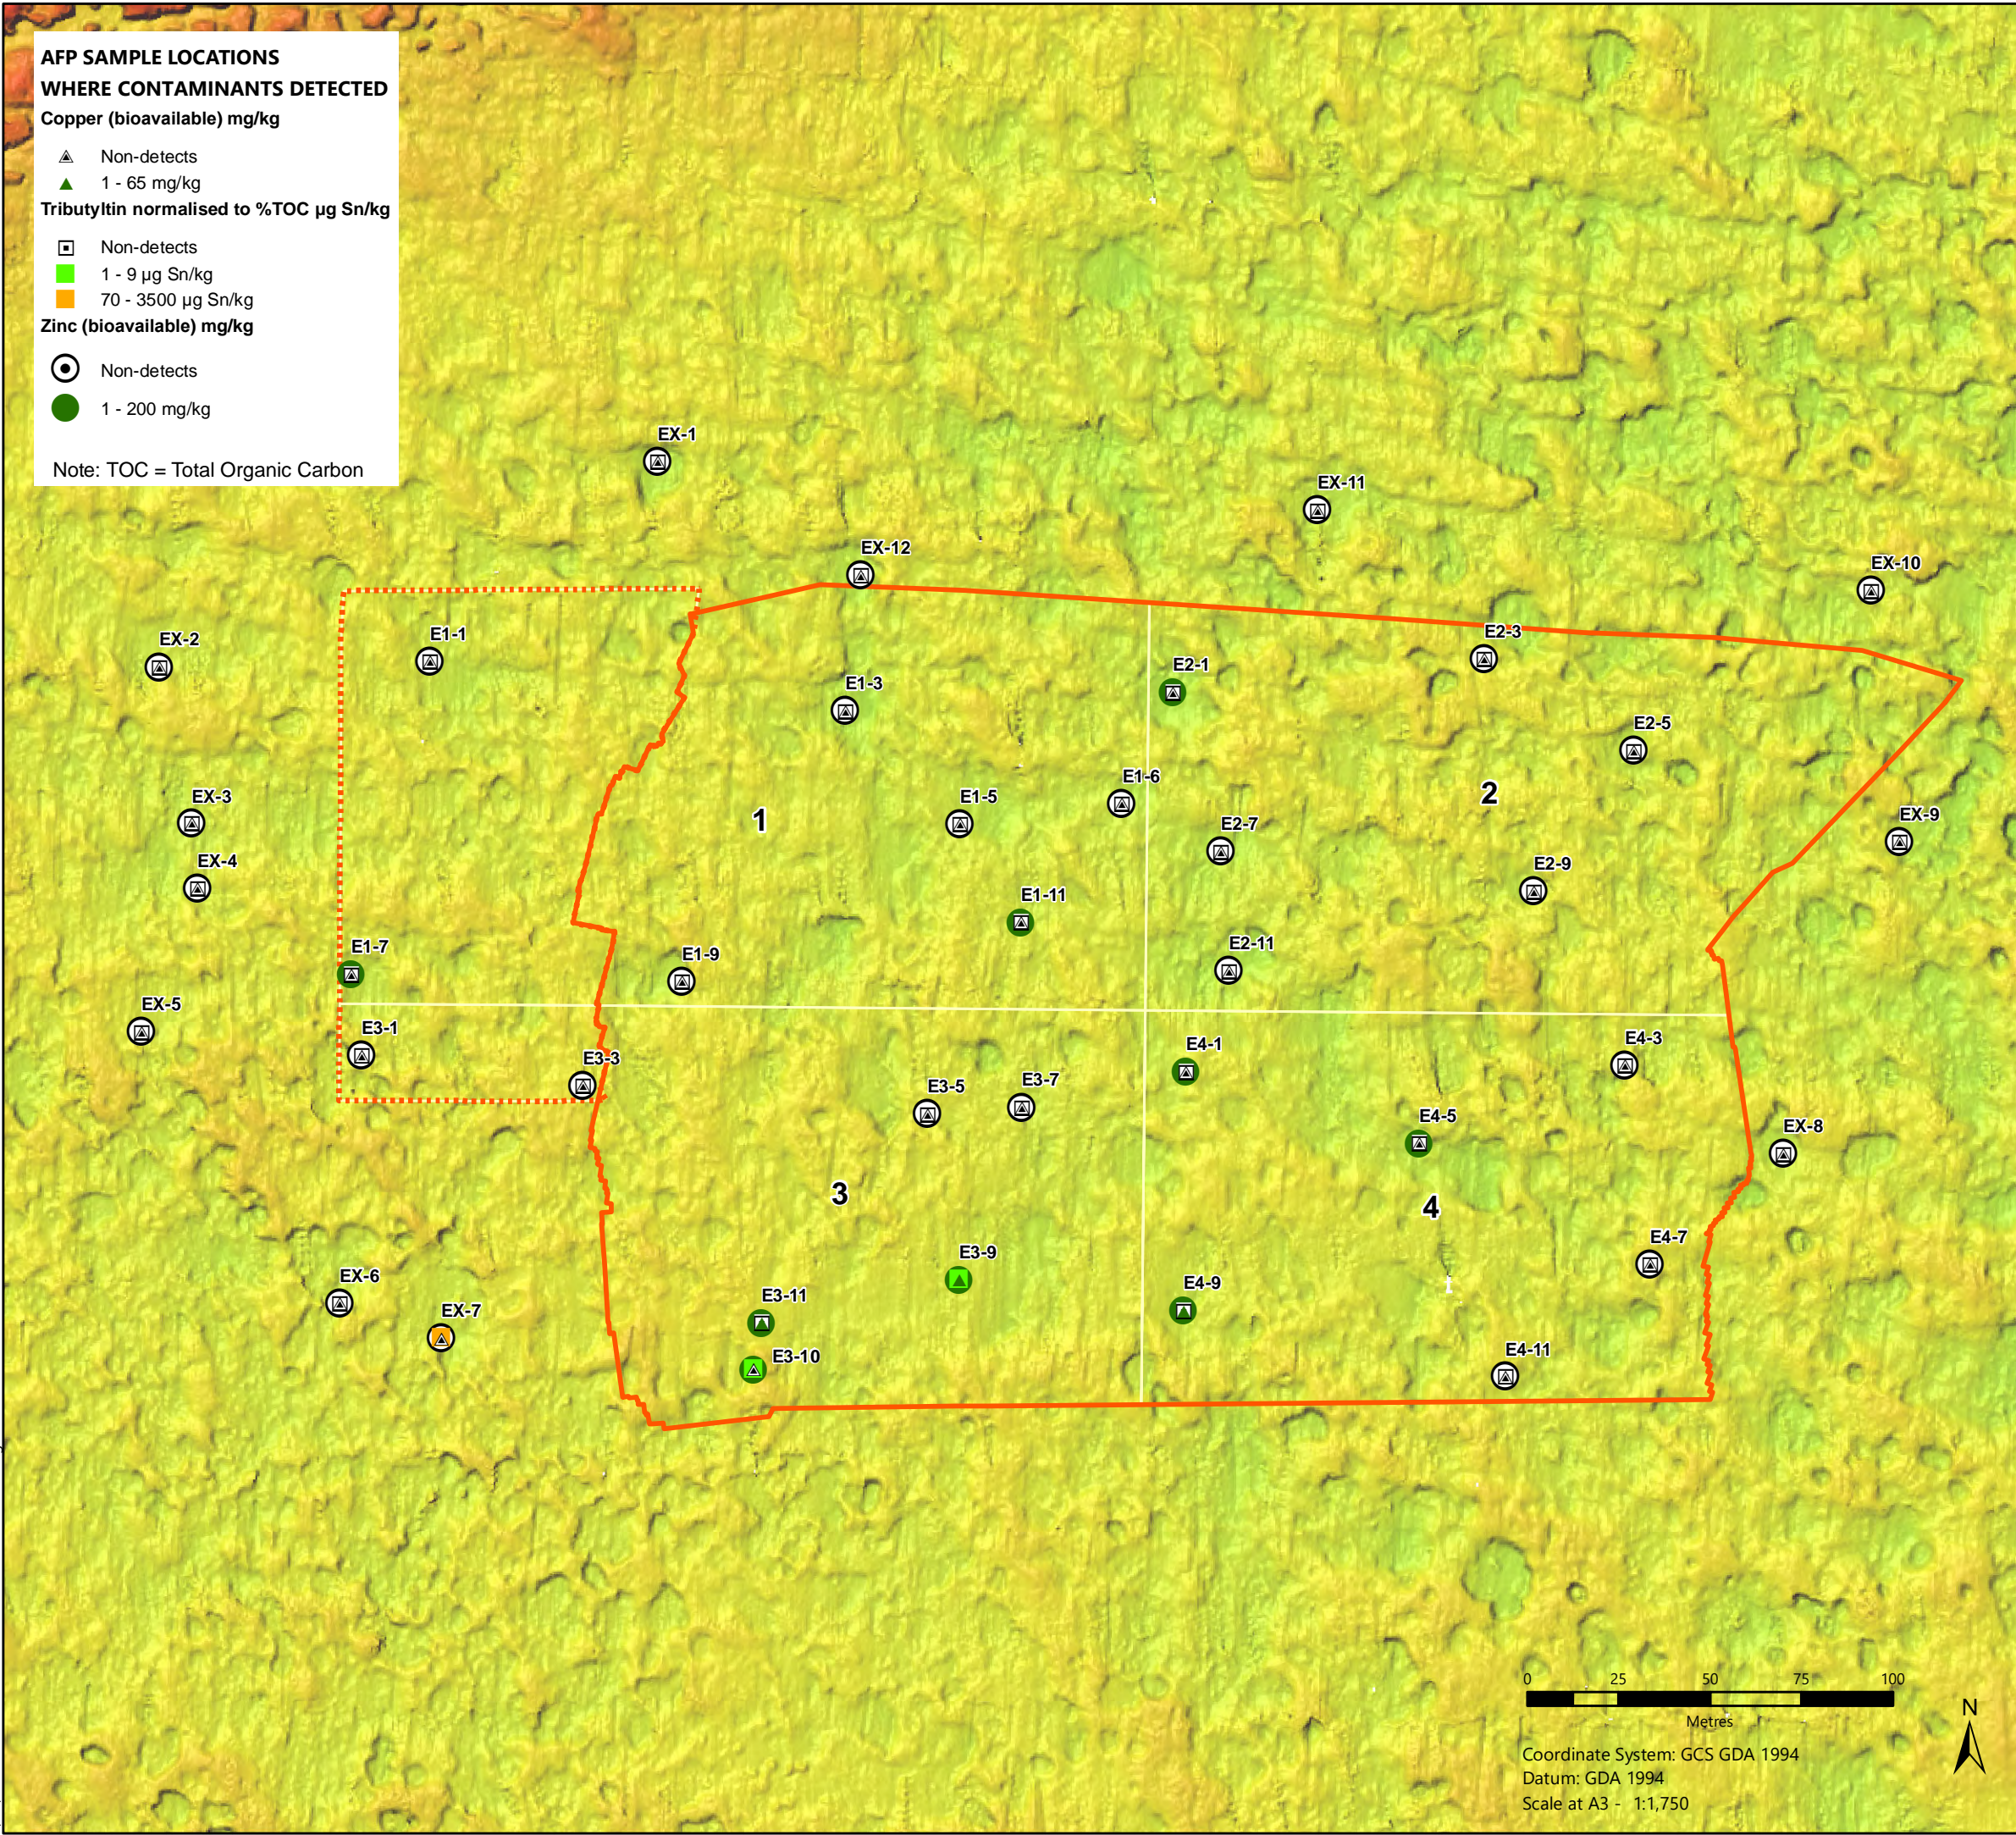
Figure 5-3
AFP* Constituent Concentrations at Sediment Sampling Sites in Priority Area E

In **Priority Area E** (Figure 5-3) sediment was collected from 38 sites. TBT was detected at three sites; one site was above the ANZG (2018) guideline of 9µgSn/kg. Copper was detected at three sites, no sites were above the ANZG (2018) guideline of 65mg/kg. Zinc was detected at nine sites, no sites were above the ANZG (2018) guideline of 200mg/kg. Elutriate testing of the three samples where TBT was detected found no sites had a TBT concentration (ng Sn/L) above the ANZG 99% Species Protection Guideline. No zineb was detected in samples tested.
