Site Assessment Report

**Douglas Shoal Remediation Project
Great Barrier Reef Marine Park Authority**

8 November 2019

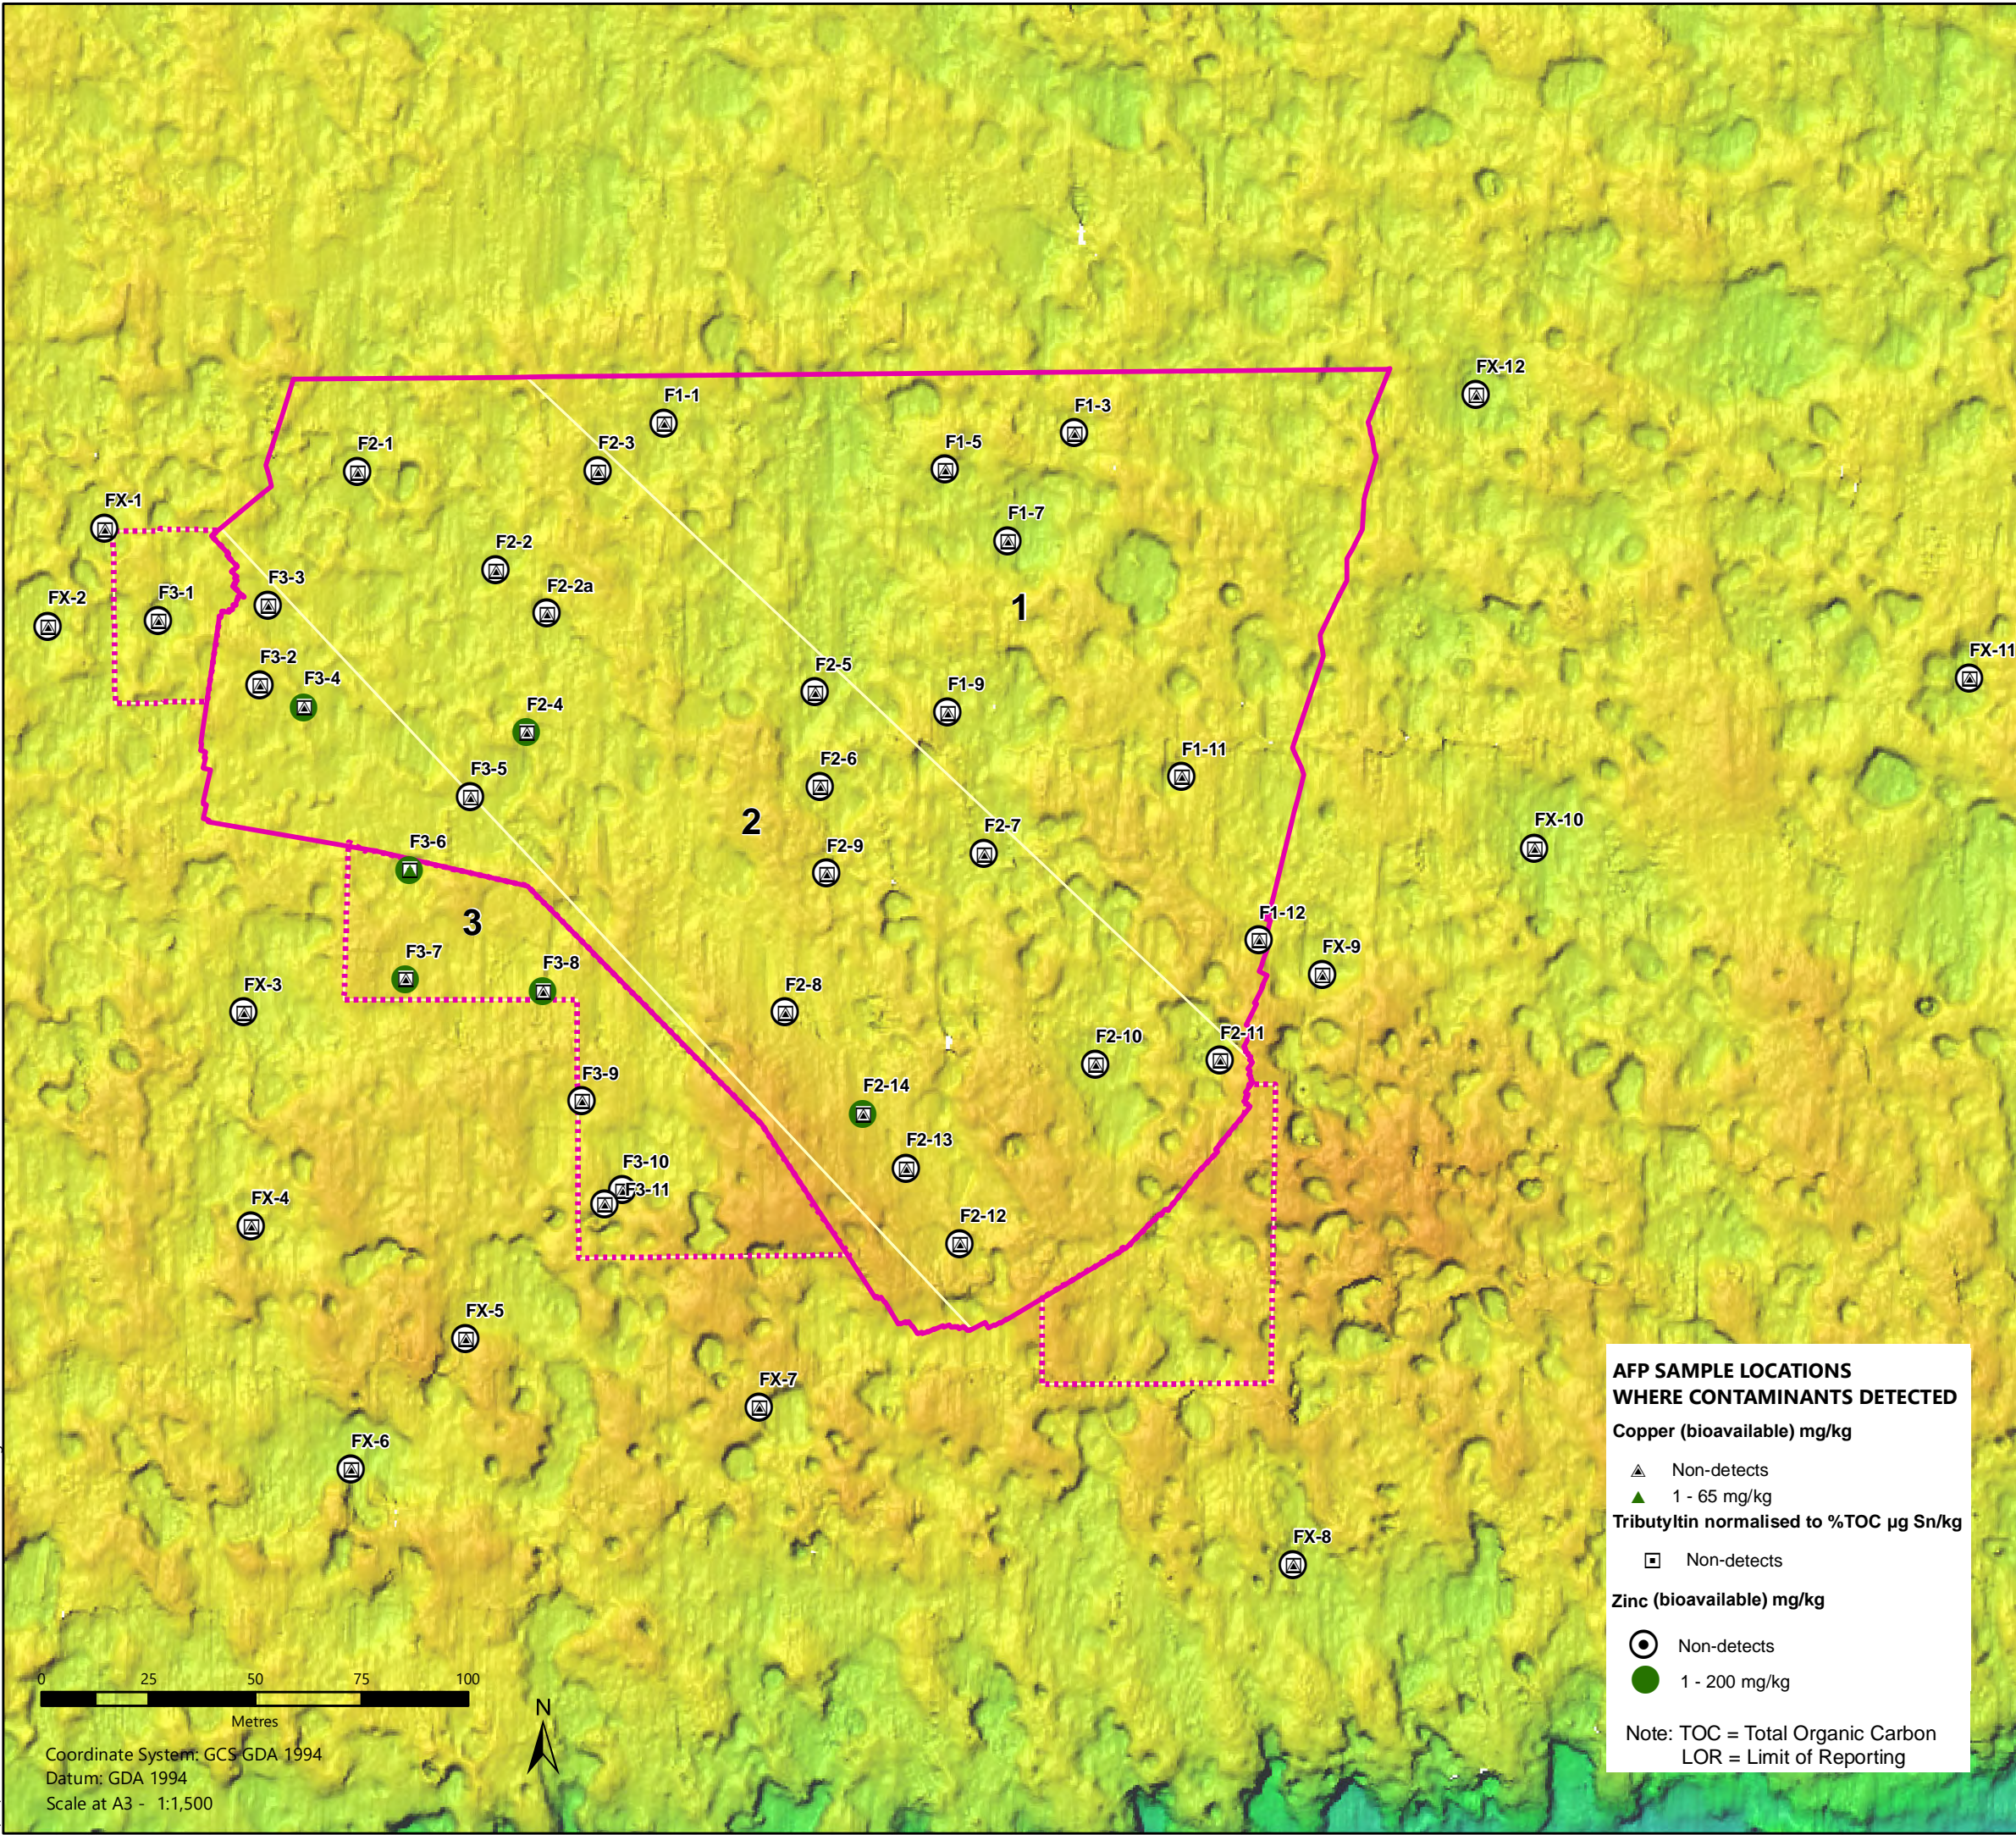
**Figure 5-4
AFP* Constituent Concentrations
at Sediment Sampling Sites in
Priority Area F**

In **Priority Area F** (Figure 5-4) sediment was collected from 45 sites. TBT was not detected. Copper was detected at one site, below the ANZG (2018) guideline of 65mg/kg. Zinc was detected at six sites; no sites were above the ANZG (2018) guideline of 200mg/kg. Elutriate testing was not undertaken and therefore no analysis for zineb was undertaken in this priority area.

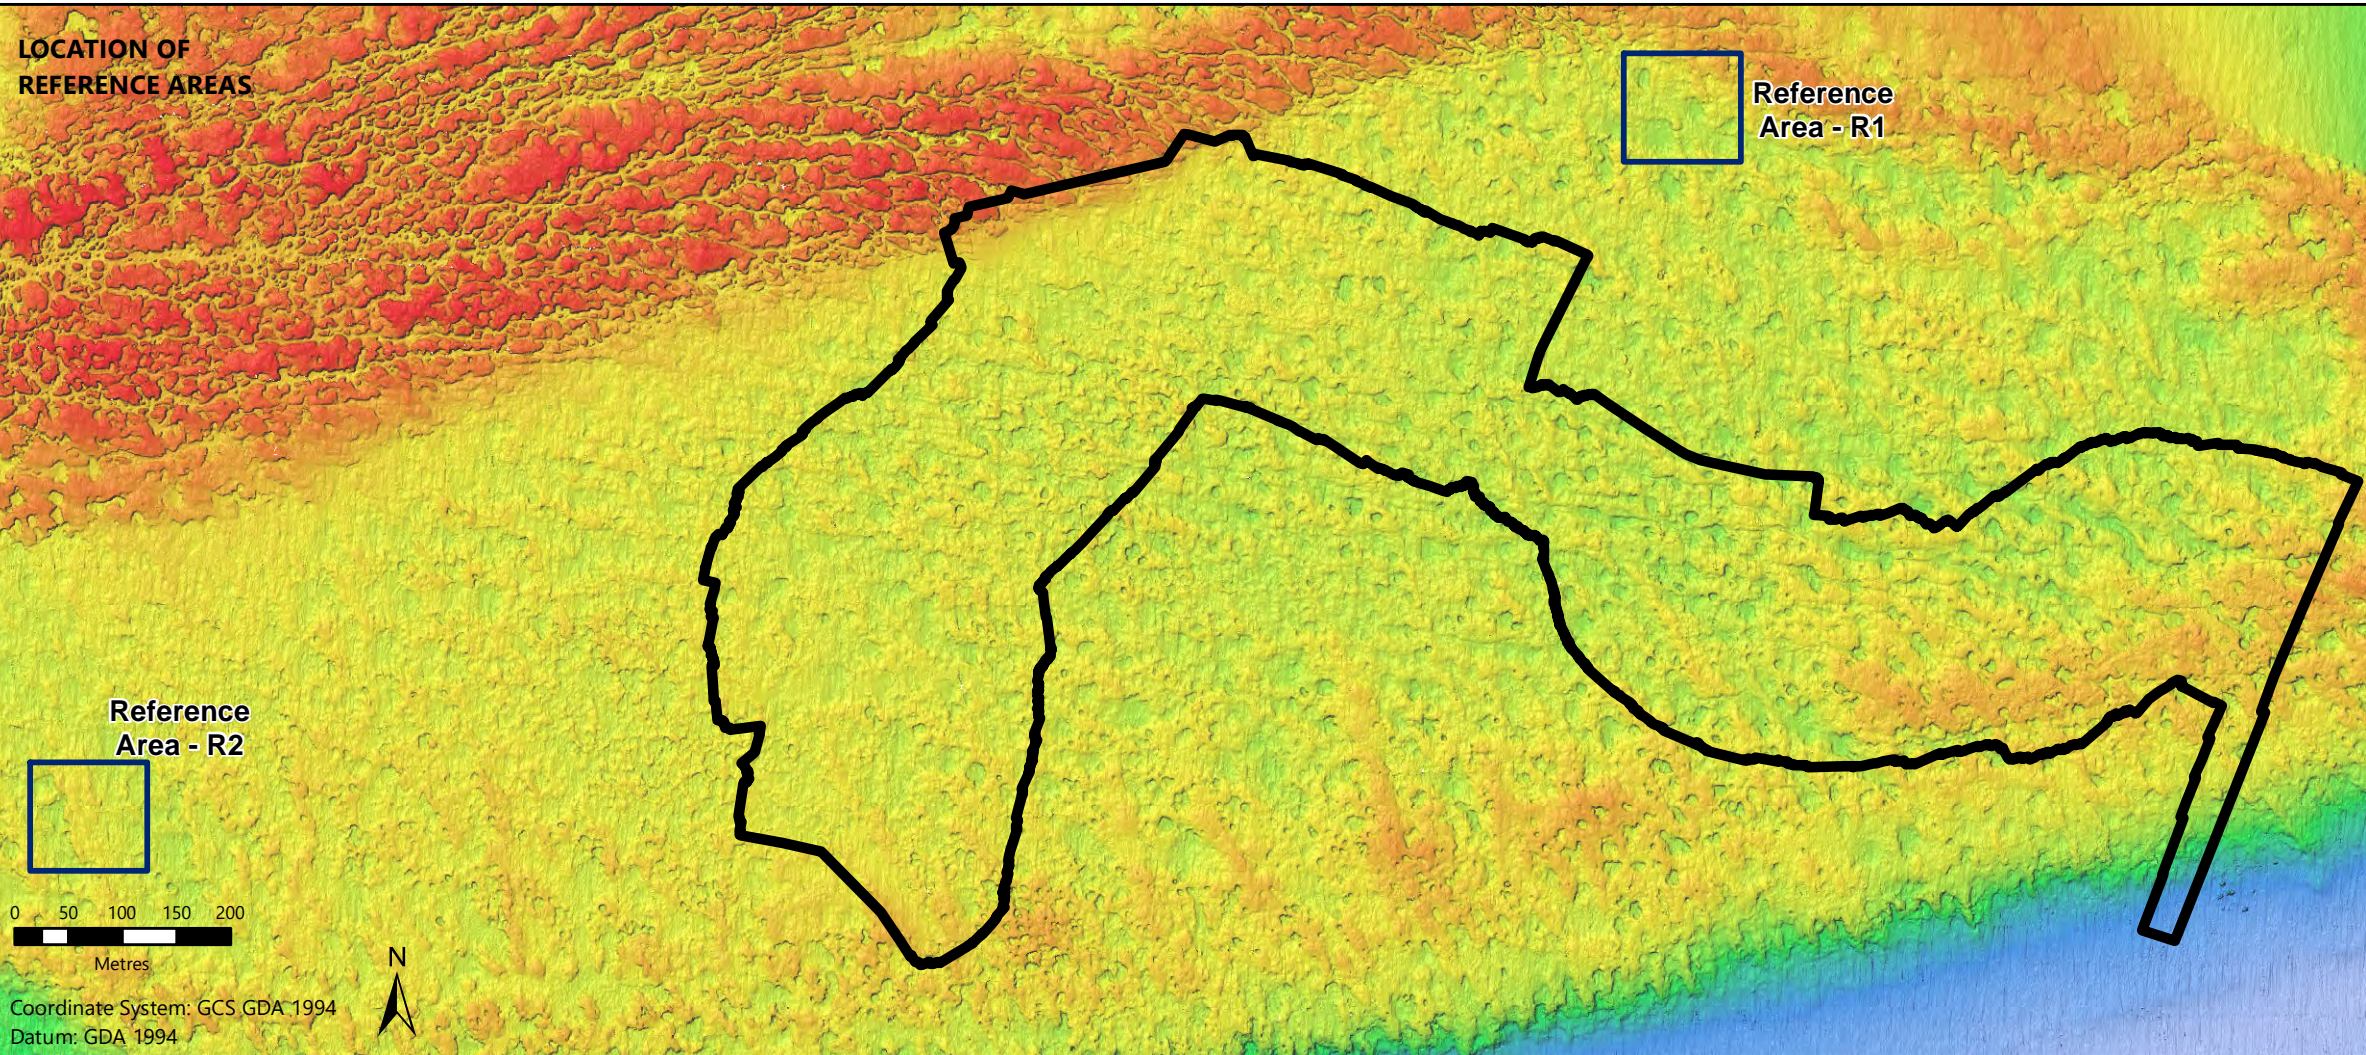
**Figure 5-5
AFP* Constituent Concentrations at Sediment Sampling Sites in the Reference Areas**

In **reference areas** (Figure 5-5) sediment was collected from 12 sites. TBT, copper and zinc was not detected in any of the samples. Elutriate testing was not undertaken and therefore no analysis for zineb was undertaken in these areas.

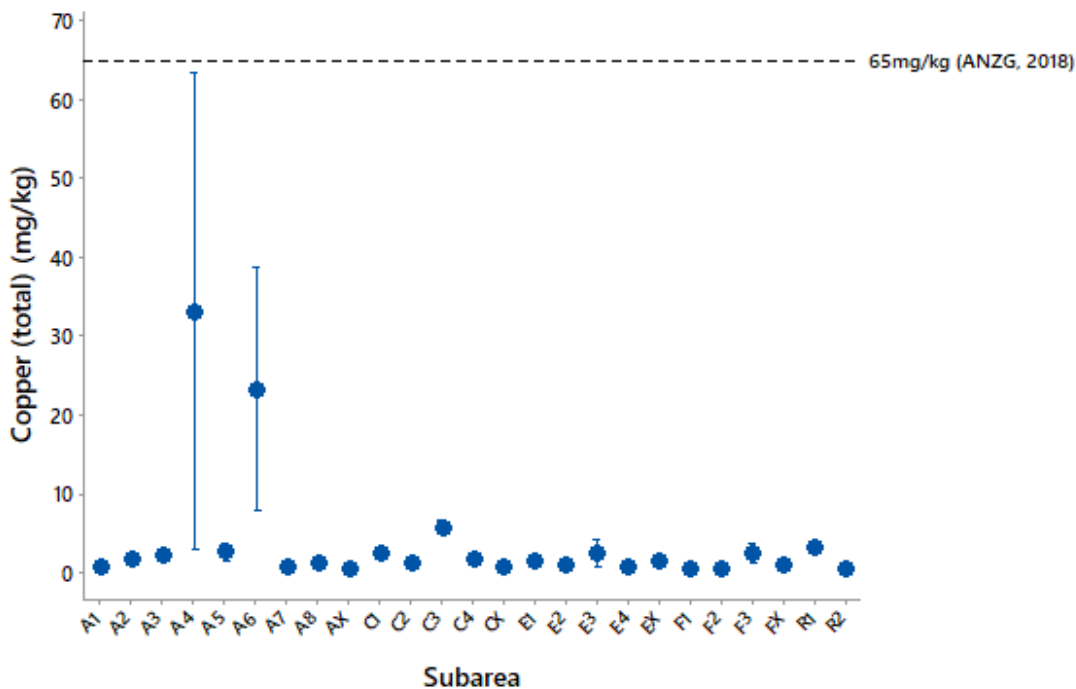
Figure 5-6: Mean concentrations of total copper (mg/kg) (+/- standard error) by sub-area with the ANZG (2018) default guideline value of 65mg/kg

- The mean concentration of total copper (mg/kg) was higher at sub-areas A4 and A6 in comparison to the reference areas (R1 and R2) and all other sub-areas (Figure 5-6). The elevated mean concentrations at A4 and A6 were due to high values in one of 13 sampling sites in sub-area A4 and one of 15 sampling sites in sub-area A6.
- The mean concentration of total zinc (mg/kg) was highest at sub-area A6 in comparison to reference areas R1 and R2 and all other sub-areas (Figure 5-7). The elevated mean concentration was due to a high value in one of 15 sampling sites in sub-area A6.

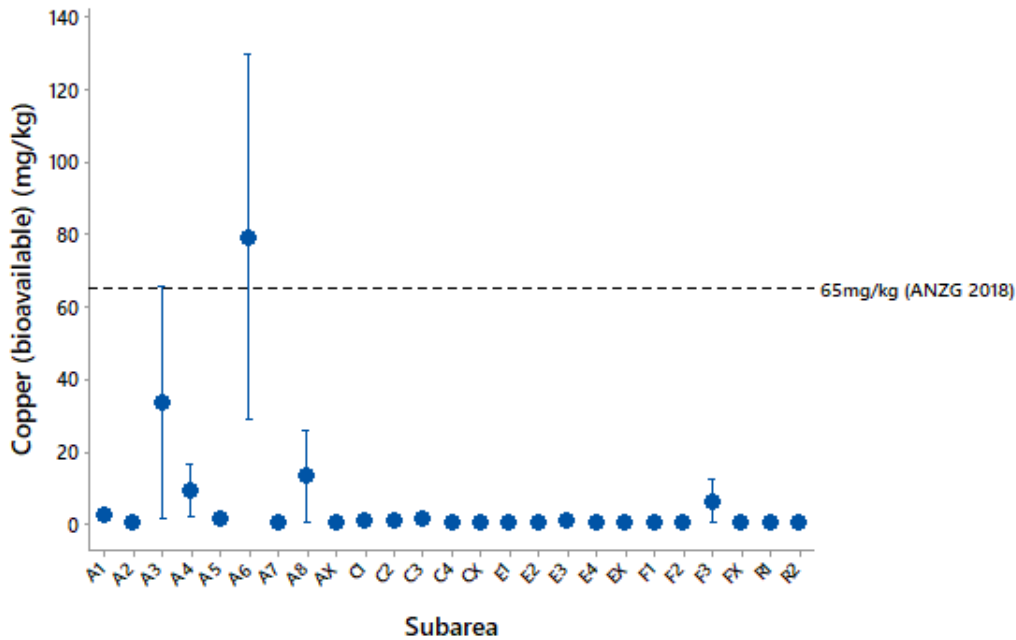
Figure 5-8 Mean concentrations (+/- standard error) of bioavailable copper (mg/kg) by sub-area with the ANZG (2018) default guideline value of 65mg/kg

Mean concentration of bioavailable copper (Figure 5-8) was higher at sub-areas A3 and A6 in comparison to reference areas R1 and R2 in which all sample concentrations were below the LOR. The elevated mean concentration in sub-areas A3 and A6 was due to one or two samples from sub-areas A3 and A6 which had concentrations above the ANZG (2018) guideline of 65 mg/kg. Mean concentration of bioavailable zinc (Figure 5-9) was higher at sub-areas A1, A3, A4, A6 and A8 in comparison to reference areas R1 and R2. The elevated mean concentration was due to high values in one or two sampling sites in each sub-area.

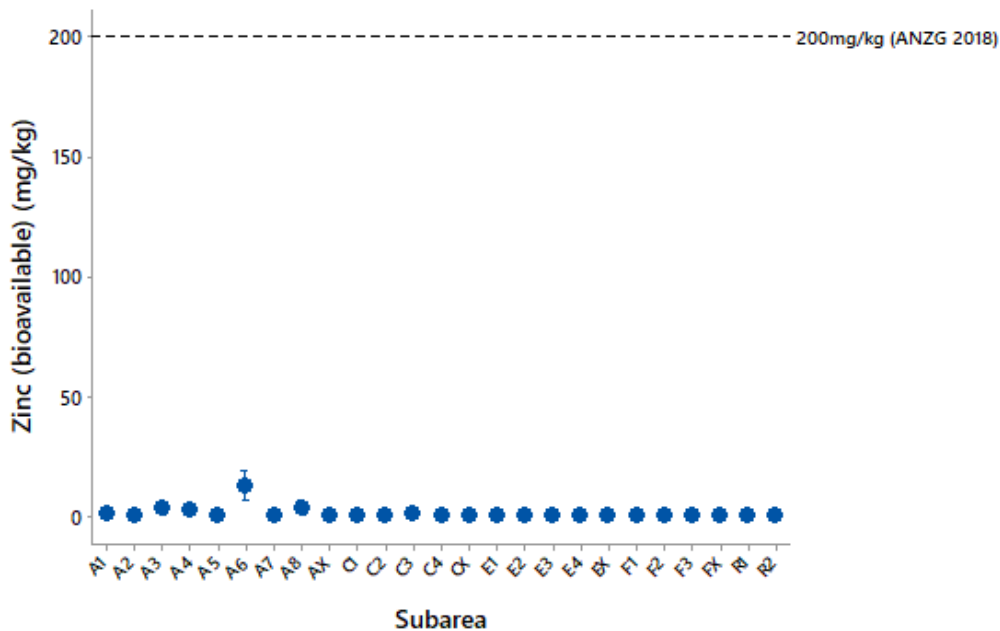
Figure 5-9 Mean concentrations (+/- standard error) of bioavailable zinc (mg/kg) by sub-area with the ANZG (2018) default guideline value of 200mg/kg

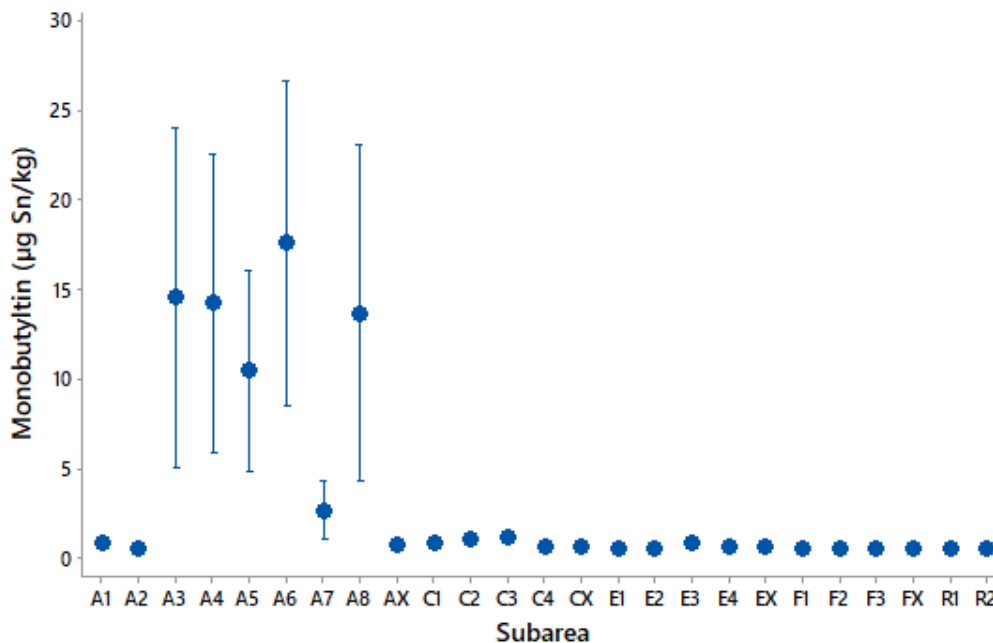
There was high 'within sub-area variability' of organotin concentration as shown by the high standard errors in Figure 5-10, Figure 5-11 and Figure 5-12. This is likely due to the nature of the sediments at Douglas Shoal having high heterogeneity i.e. a large range of different sediment fractions from large to small in each sample with TBT potentially present in the form of minute paint flakes. It is possible that laboratory sample mixing and subsampling may lead to smaller sized fractions being over represented and analysed. Concentrations of the breakdown organotins MBT ($\mu\text{g Sn/kg}$) (Figure 5-10) and DBT ($\mu\text{g Sn/kg}$) (Figure 5-11) along with TBT ($\mu\text{g Sn/kg}$) (Figure 5-12) are higher in sub-areas A3, A4, A5, A6 and A8, and to a lesser degree A7, in comparison to all other sub-areas, including reference areas R1 and R2. Note the variation in the y axis scale for each organotin graph.

Figure 5-10 Mean concentrations (+/- standard error) of monobutyltin ($\mu\text{gSn/kg}$) by sub-area

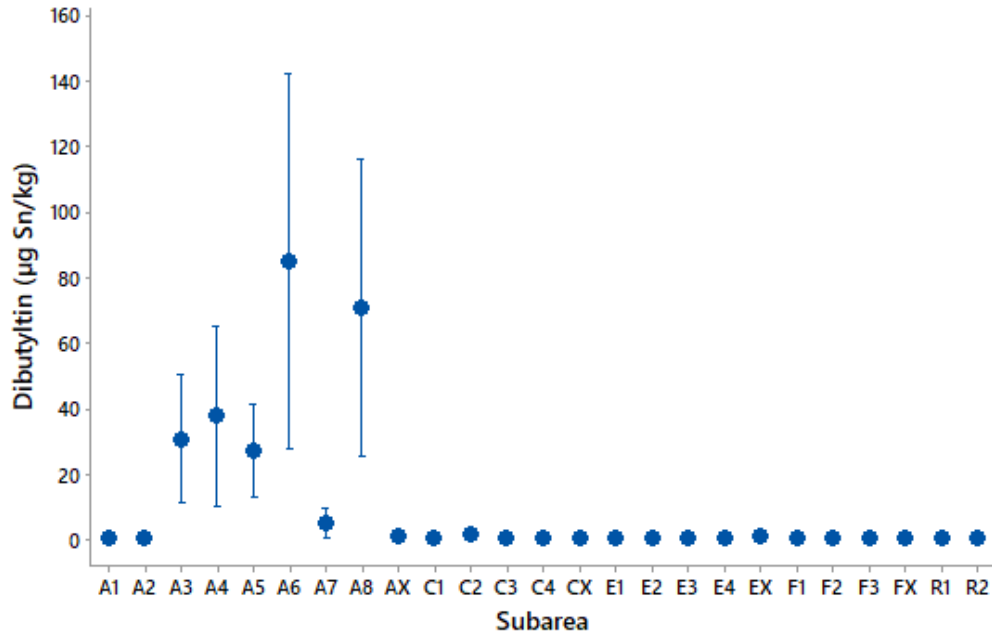
Figure 5-11 Mean concentrations (+/- standard error) of dibutyltin (µgSn/kg) by sub-area

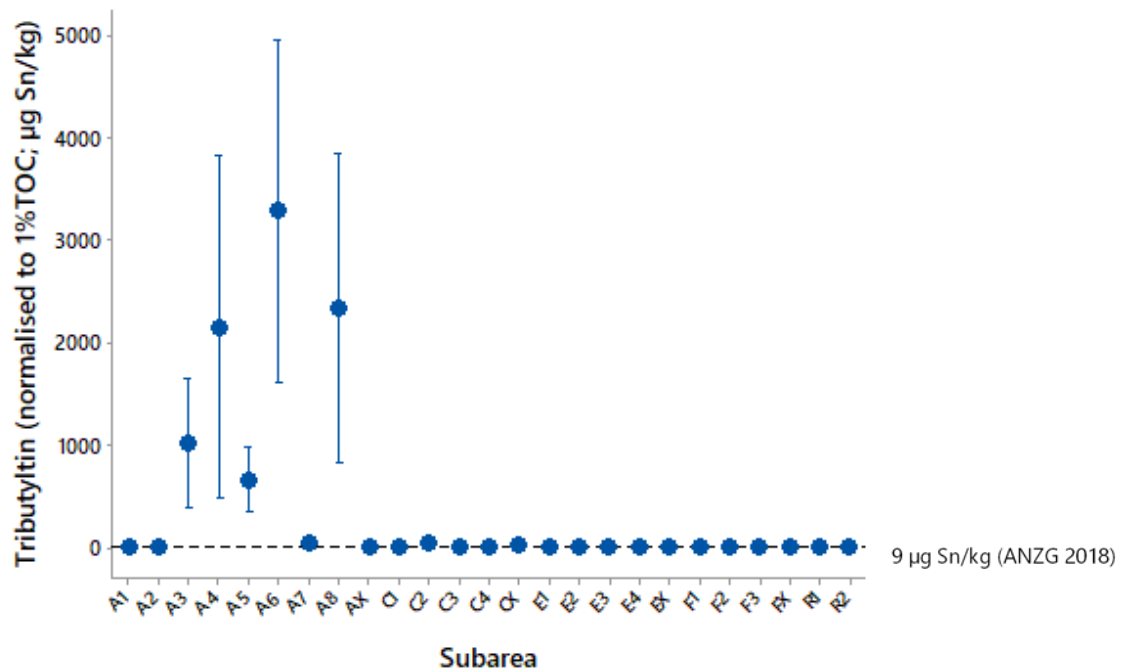
Figure 5-12 Mean concentrations (+/- standard error) of tributyltin (normalised to 1% TOC) (µgSn/kg) by sub-area with the ANZG (2018) default guideline value of 9µgSn/kg

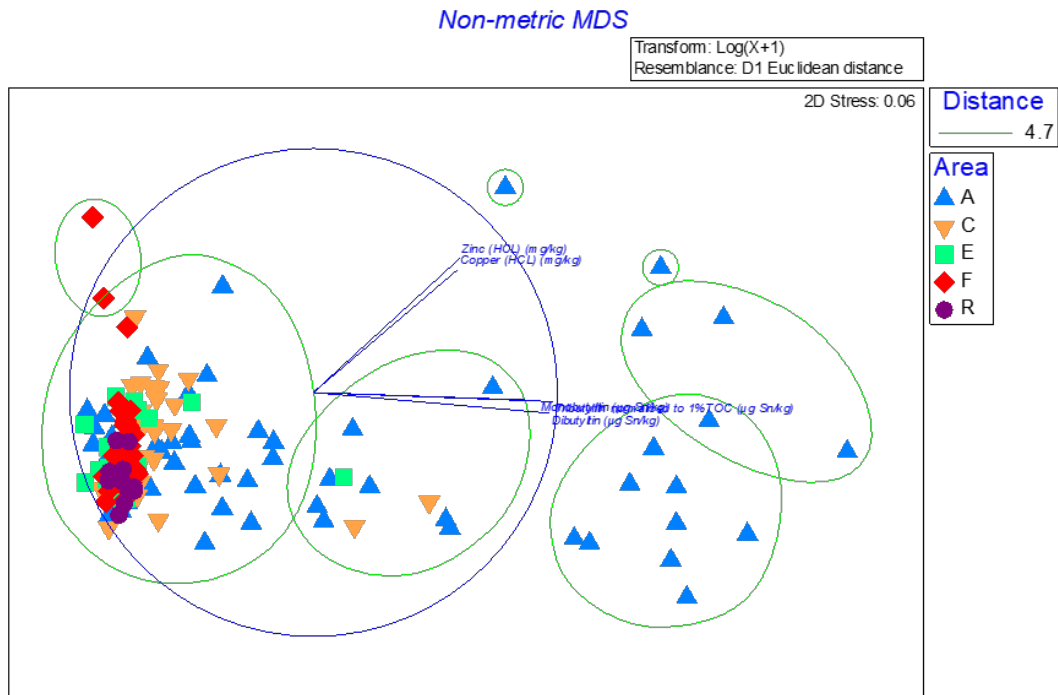
The nMDS plots were completed to identify the priority areas and sub-areas that are different in terms of their contamination profile and the specific contaminants driving these differences. There are three main groups / clusters of priority areas showing contamination due to organotins (Figure 5-13). These groups or clusters are comprised predominantly of sub-areas from Priority Area A. The results suggest:

- Priority Area A is most different from the other priority areas due to the elevated concentrations of organotins as well as (to a lesser extent) bioavailable copper and zinc (Figure 5-13).
- Sub-areas A3, A4, A5 and A6 are the most different from other sub-areas, again due to elevated concentrations of organotins as well as (to a lesser extent) bioavailable copper and zinc (Figure 5-14).
- There was one sampling site within each of sub-areas C2, CX and EX that were different from other Priority Area C and E sub-areas due to bioavailable aluminium and iron (Figure 5-14).
- There were two sampling sites within sub-area F3 that were different due to higher concentrations of total arsenic, cadmium, cobalt, lead and nickel (Figure 5-14).

The nMDS analysis showed that differences for sub-areas in Priority Areas C, E and F were driven by elevated concentrations of metals in one or two samples within the priority area. For sub-areas within Priority Area A, the nMDS analysis indicated that differences are due to elevated organotin, copper and zinc concentrations, all of which are a component of AFP associated with the grounding.

Figure 5-13 nMDS plot of the contaminant data matrix overlaid with the factor of area (sub-areas that are clustered together and most similar are circled)

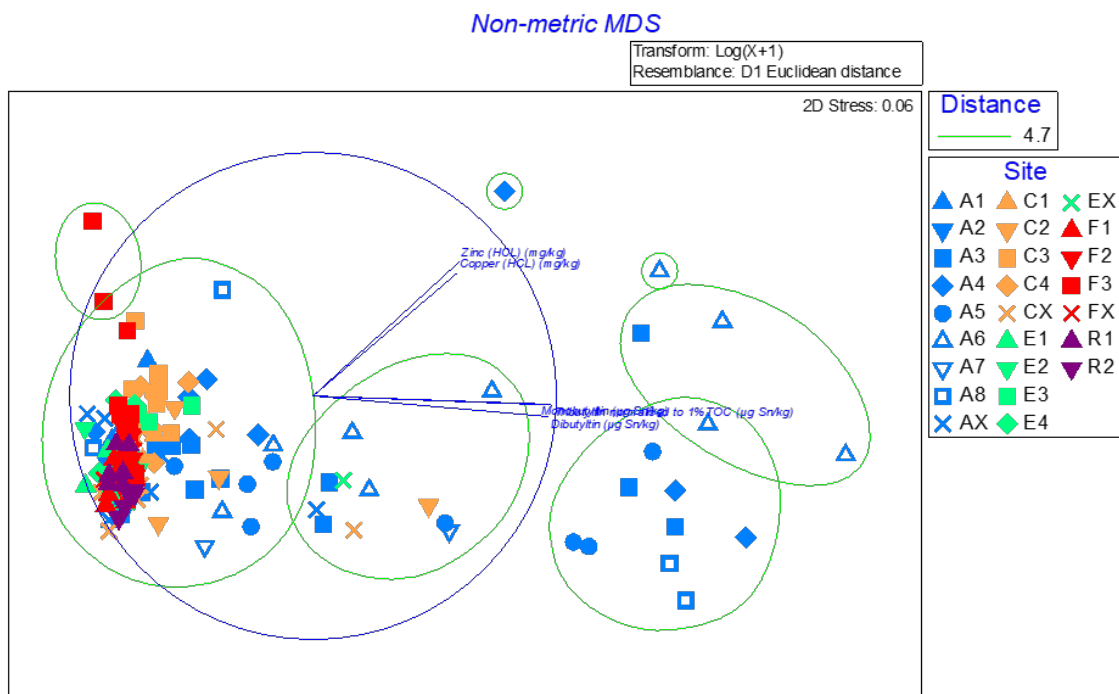
Figure 5-14 nMDS plot of the contaminant data matrix overlaid with the factor of sampling site (sampling sites that are clustered together and most similar are circled)

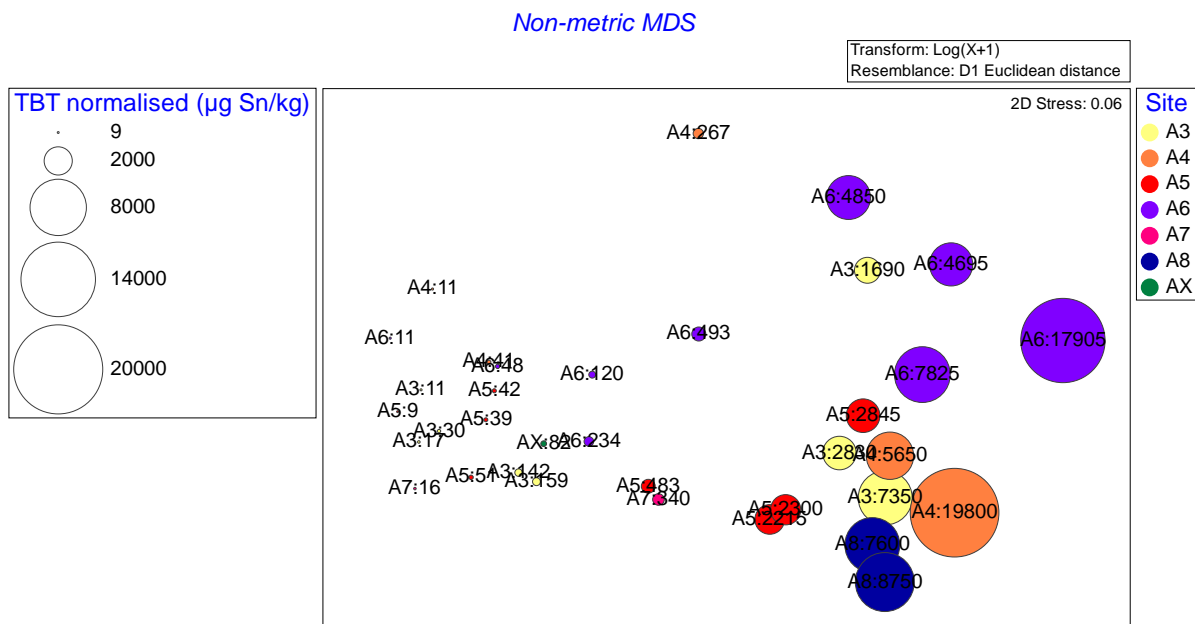
- There were many exceedances of the ANZG (2018) guideline for TBT (Figure 5-15). The highest concentrations (normalised to 1% TOC) were seen in sub-areas A4 (19,800 $\mu\text{g Sn/kg}$), followed by A6 (17,905 $\mu\text{g Sn/kg}$), A8 (8,750 $\mu\text{g Sn/kg}$), A3 (7,350 $\mu\text{g Sn/kg}$) and A5 (2,845 $\mu\text{g Sn/kg}$).

Figure 5-15 Concentrations of TBT (normalised to 1% TOC) which exceeded the ANZG (2018) guideline of $9\mu\text{gSn/kg}$ within Priority Area A.

Based on the analysis described above part of Priority Area A is the only remediation priority area for contamination. Contamination in other priority areas occurs at isolated sites or in some cases a single site and further analysis (Phase III) of those samples via elutriation found no residual concentrations above the relevant guidelines. Elevated concentrations of TBT are evident at many sites in Priority Area A and it is considered that TBT is likely to remain a contaminant of concern in this area for another decade. Consideration should be given to the address of TBT contaminated sediments in this area.

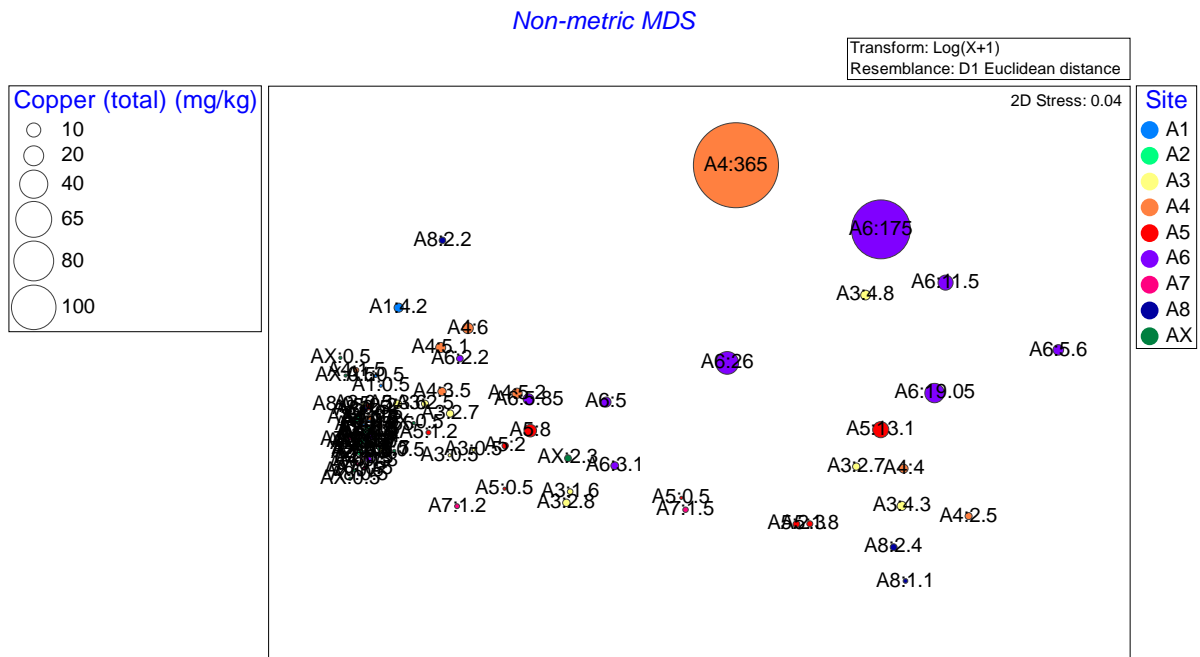
- Similar patterns to that of TBT were observed for concentrations of DBT and MBT.
- Concentrations of total copper (mg/kg) were most elevated in two sub-areas (A4 and A6) due to only one sample in each site exceeding the ANZG (2018) guideline of 65 mg/kg (Figure 5-16). These samples were 365 mg/kg in A4 and 175 mg/kg in A6.

Figure 5-16: Concentrations of total copper within Priority Area A (only one sample in sub-area A4 and one in sub-area A6 were above the ANZG (2018) sediment guideline of 65mg/kg).

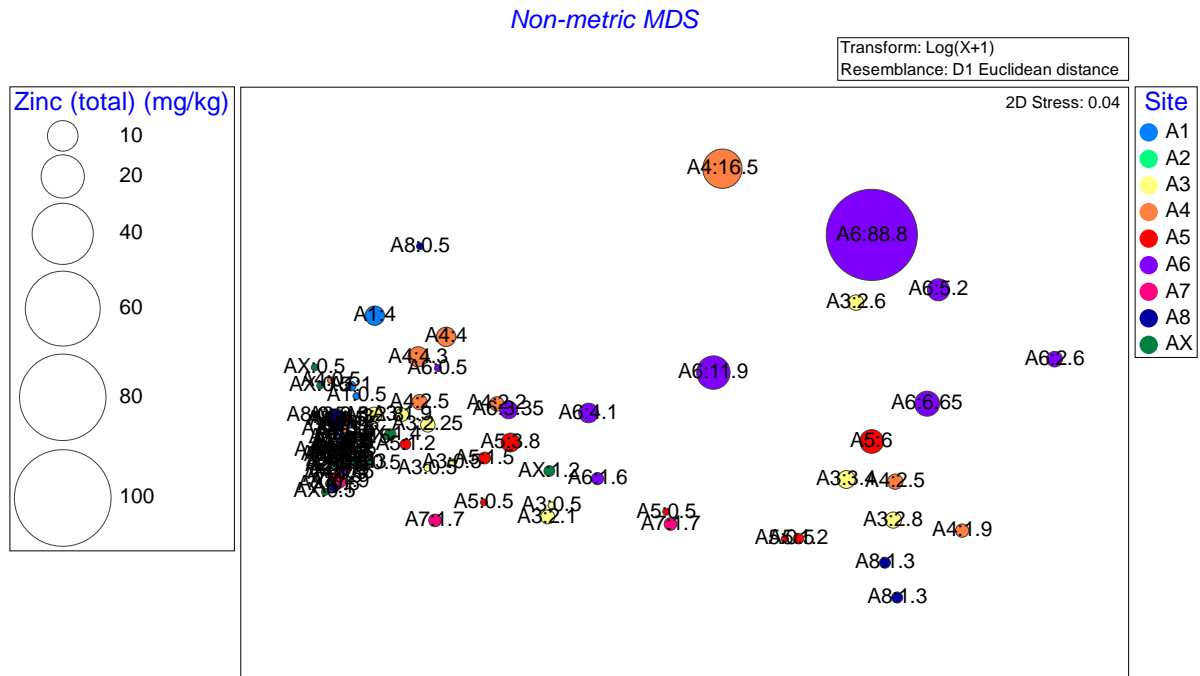
- Similar patterns to that of copper were observed for total zinc (mg/kg) concentrations which were elevated in two sub-areas (A4 and A6) due to one sample in each sub-area (Figure 5-17). No values exceed the ANZG (2018) sediment guideline of 200 mg/kg for zinc.

Figure 5-17: Concentrations of total zinc within Priority Area A (no samples exceeded the ANZG (2018) sediment guideline of 200mg/kg)

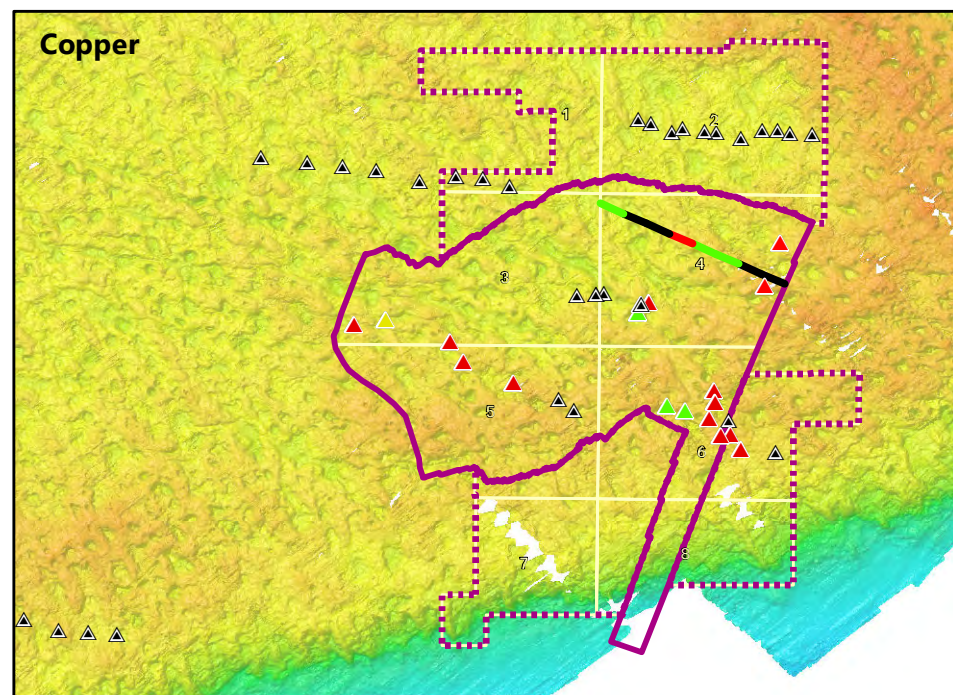
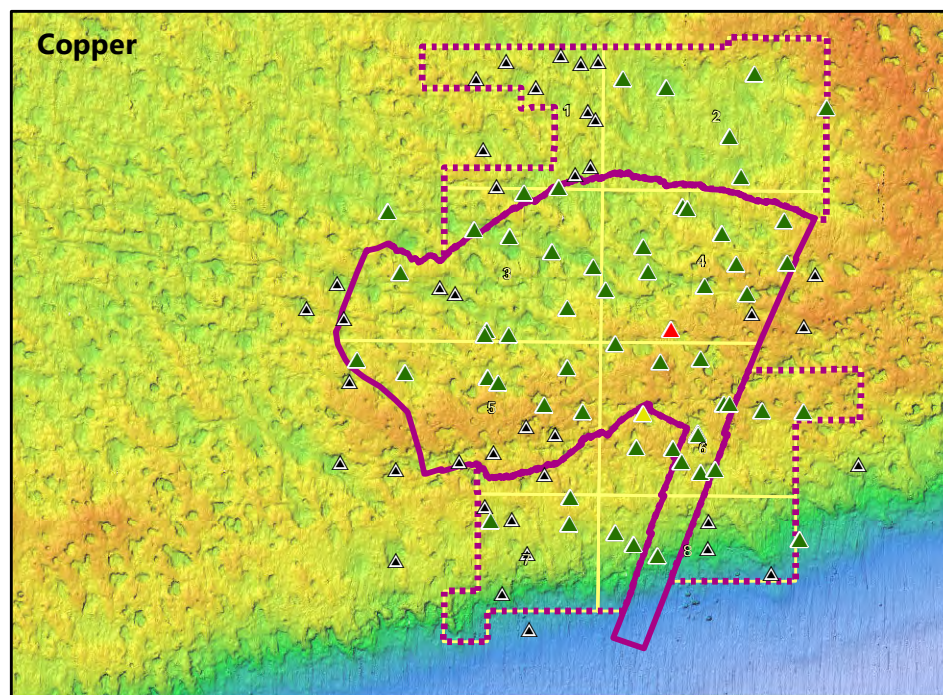
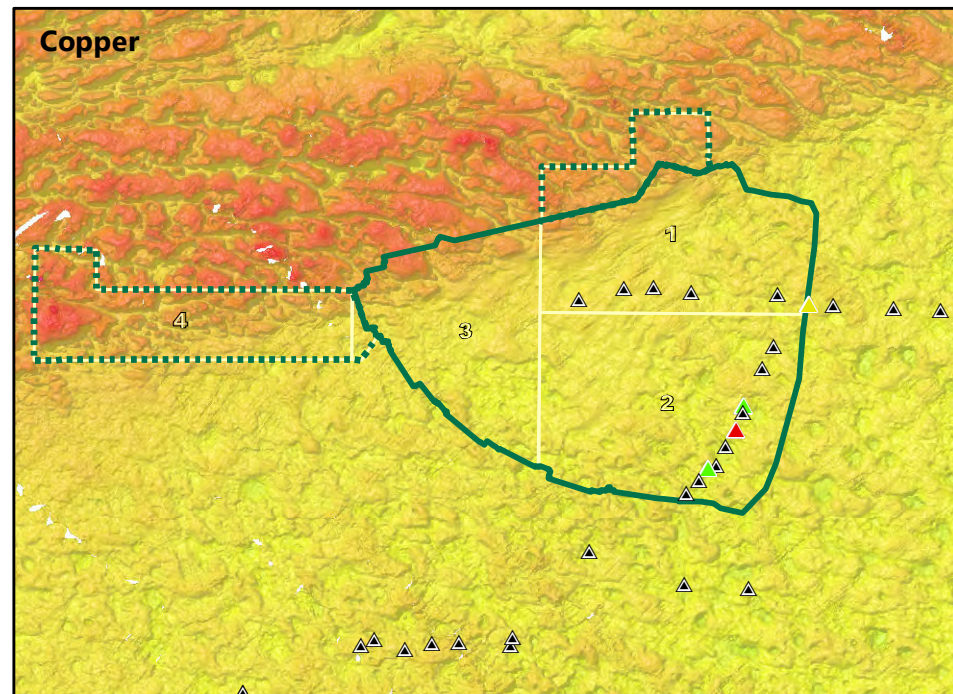
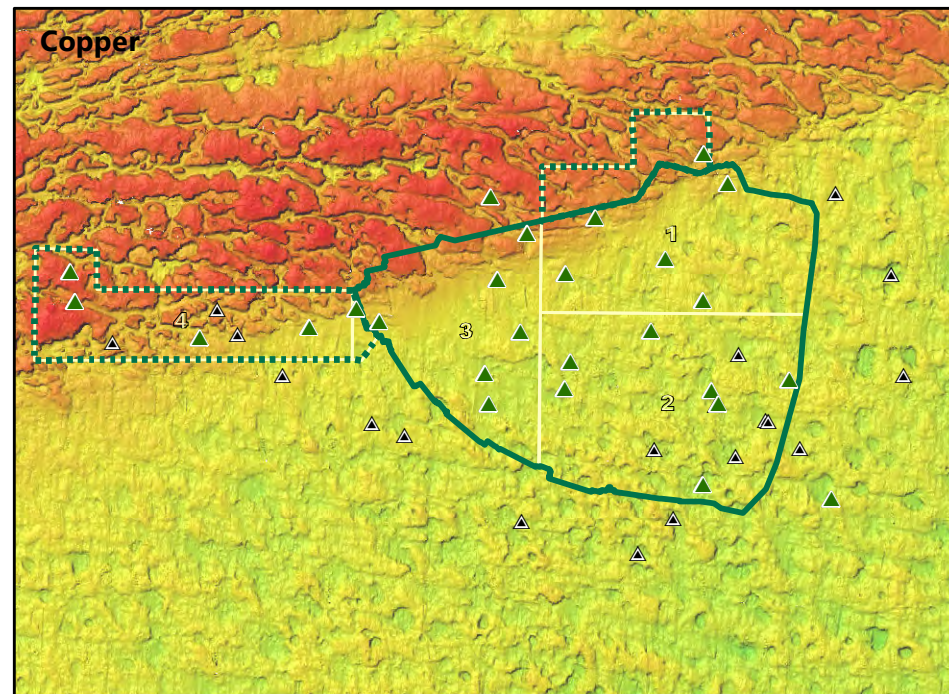
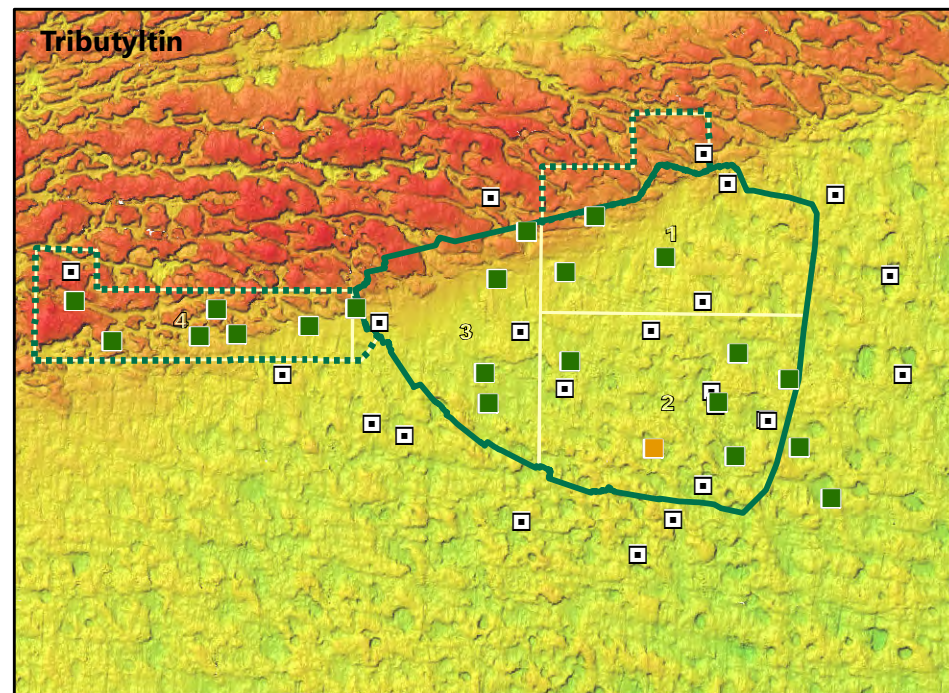
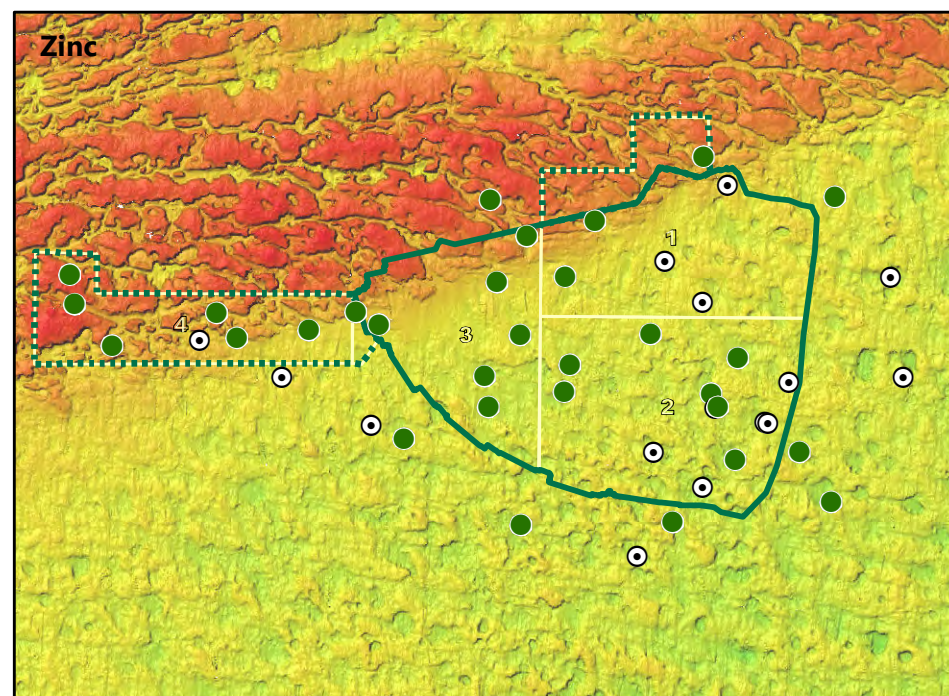
Figure 5-18
Comparison of AFP* Constituent Concentrations at Sediment Sampling Sites in Priority Area A

A semi-quantitative comparison is discussed below to provide a broad indication of change over time in terms of the contamination profile. Summary statistics for the primary constituents of AFP for the 2010 data are compared to the 2019 dataset in Table 5-1. Maps comparing the spatial distribution and concentrations of AFP contaminants between samples collected in 2010 versus those collected in 2019 are provided for Priority Area A (Figure 5-18), Priority Area C (Figure 5-19), Priority Area E (Figure 5-20) and Priority Area F (Figure 5-21). The TBT data presented in these figures (for 2010 and 2019) is not normalised to 1% TOC and care should be taken when comparing these values to the guidelines which are for normalised data. These comparisons suggest that generally the concentrations of the AFP contaminants present on the shoal have decreased over time, especially in Priority Area C, E and F.

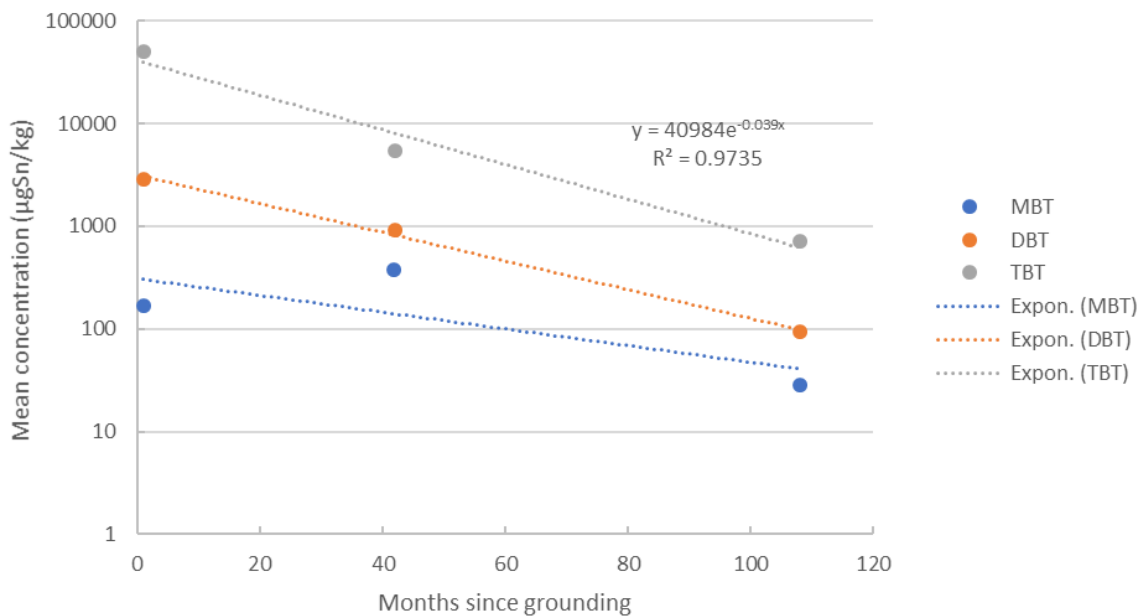
Figure 5-22 Mean concentration of MBT, DBT and TBT over time with line of best fit (equation and R^2 for TBT)

The estimated time (x-value) until TBT concentrations (non-normalised to 1% TOC) in sediments are below the ANZG guideline value of 9µgSn/kg (y-value) is provided in Table 5-4. The mean and maximum concentrations of TBT may be reduced below the guideline value within approximately 18 years and 20 years of the grounding respectively. No threshold or trigger values are available for MBT and DBT. As such an estimate for when they may cease to be of potential concern is not made. Notwithstanding this, it is likely that once concentrations of TBT are below the guideline value, remaining MBT and DBT will not pose a significant environmental risk.

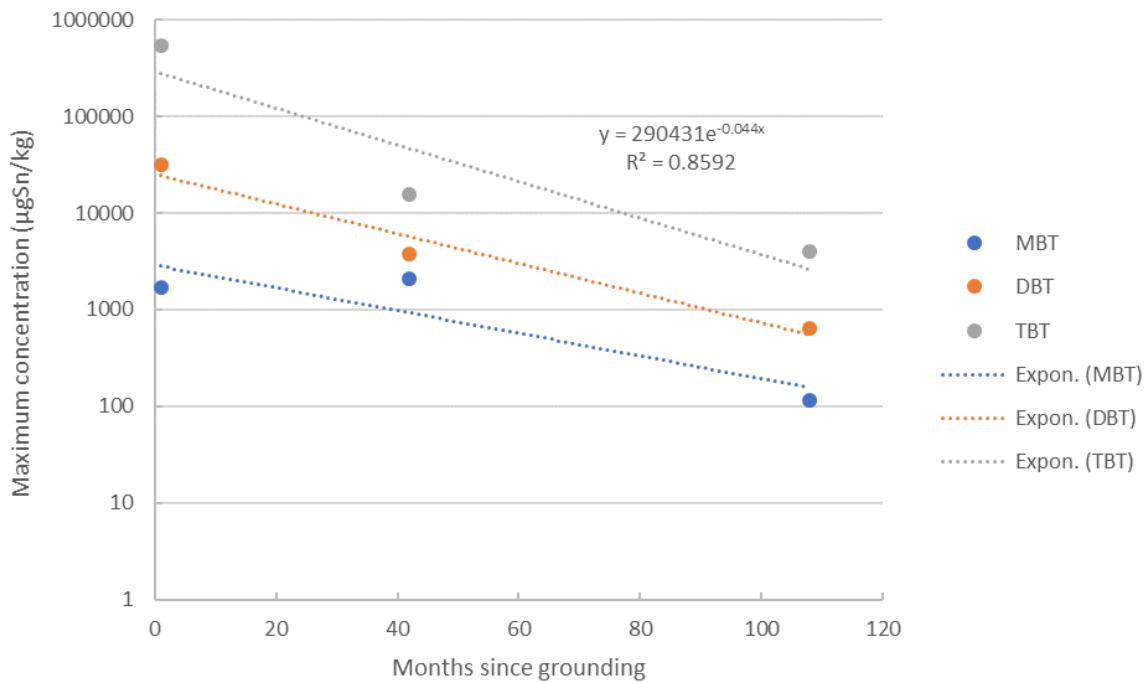
The line of best fit for the change in maximum concentration of TBT over time is:

$$y = 290431e^{-0.044x} \quad \text{or when rearranged} \quad x = \frac{1}{-0.044} * \ln\left(\frac{y}{290431}\right)$$

Figure 5-23 Maximum concentration of MBT, DBT and TBT over time with line of best fit (equation and R² for TBT)
