Site Assessment Report

**Douglas Shoal Remediation Project
Great Barrier Reef Marine Park Authority**

8 November 2019

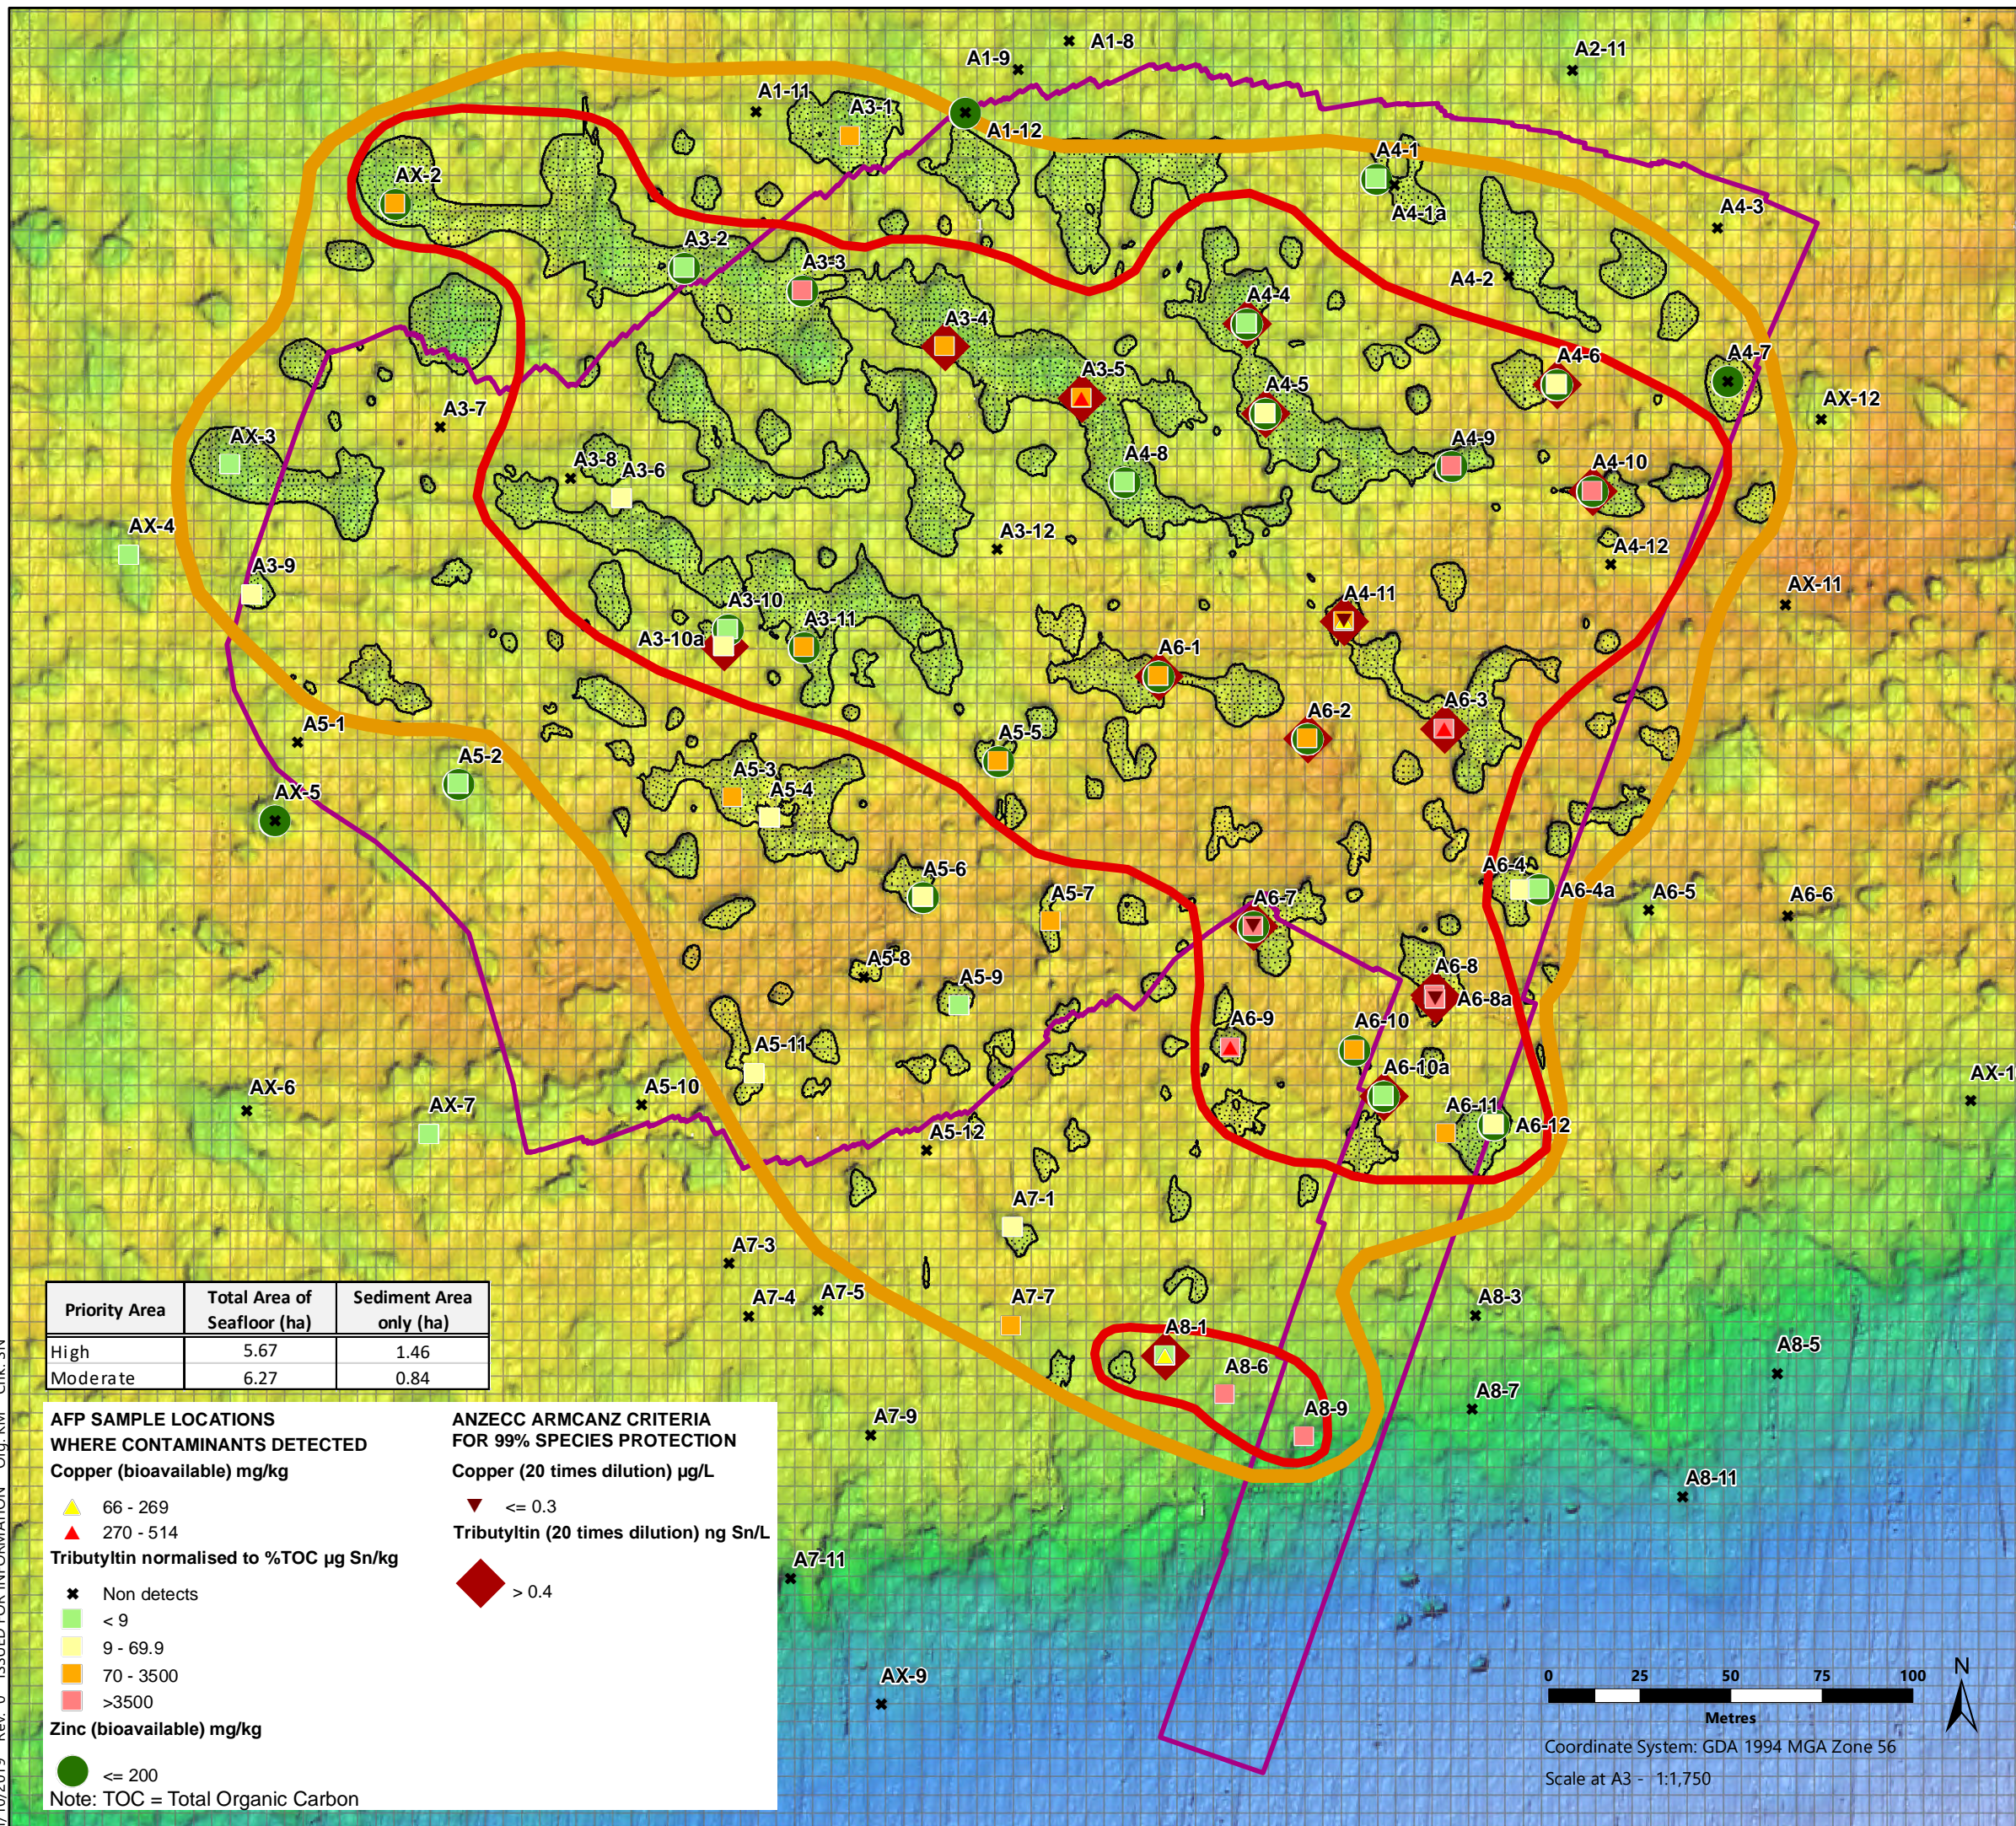
Figure 5-25
Priority remediation areas
for contamination
Priority Area A

Based on the analysis described above part of Priority Area A is the only remediation priority area for contamination. Contamination in other priority areas occurs at isolated sites or in some cases a single site and further analysis (Phase III) of those samples via elutriation found no residual concentrations above the relevant guidelines. Elevated concentrations of TBT are evident at many sites in Priority Area A and it is considered that TBT is likely to remain a contaminant of concern in this area for another decade. Consideration should be given to the address of TBT contaminated sediments in this area.

The results of the priority remediation area delineation are presented in Figure 5-25.

Priority Area	Total Area of Seafloor (ha)	Sediment Area only (ha)
High	5.67	1.46
Moderate	6.27	0.84

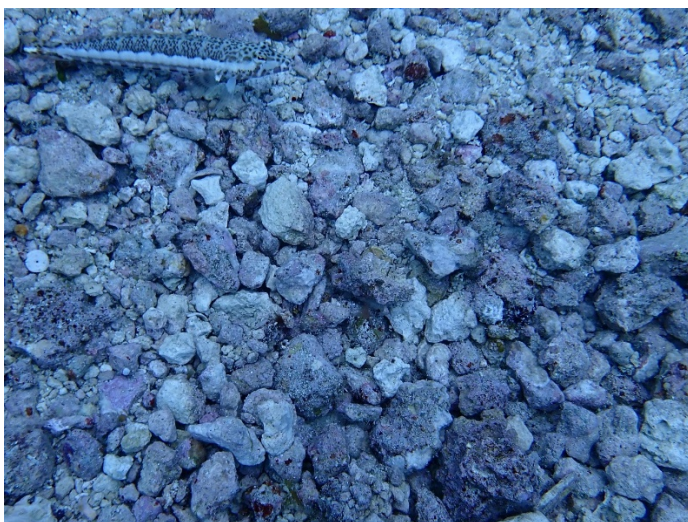
The rubble (Figure 6-3) typically appears to be bereft of encrusting organisms (coralline algae or turf algae, encrusting sponges or coral), indicating the rubble is mobile in some areas.

Figure 6-3 Close-up of rubble in 2019 from Priority Area F

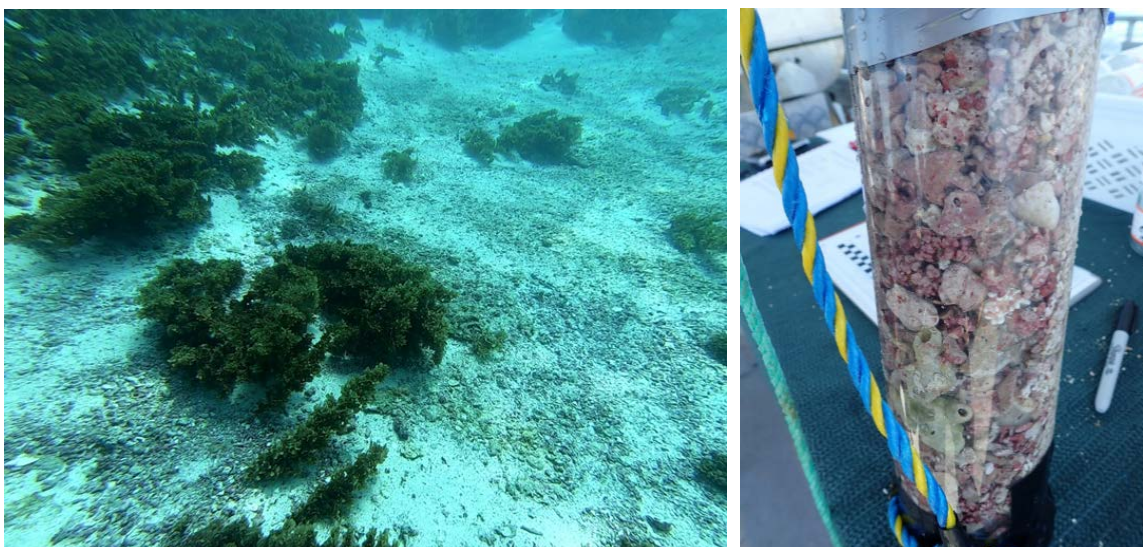
Figure 6-5 Natural sediments (in situ and collected) from outside Area E (Site EX-2)

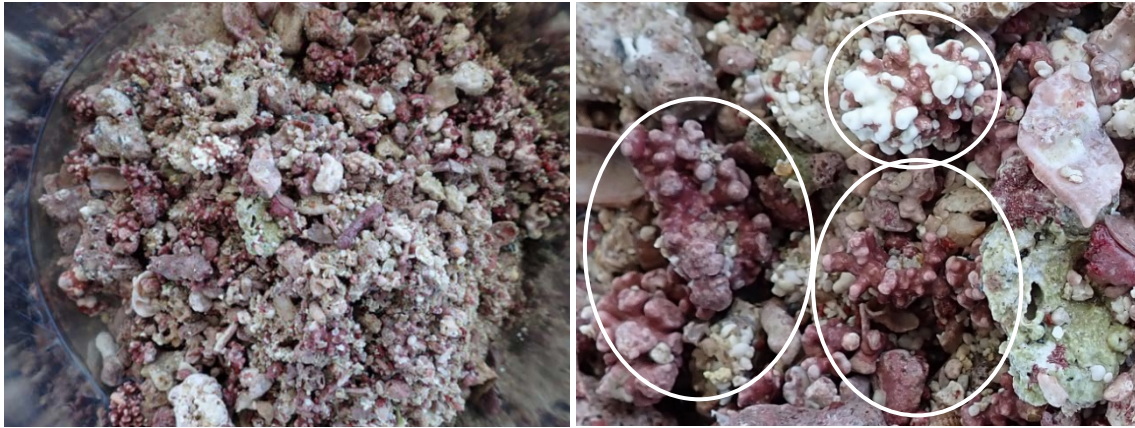
Figure 6-6 Natural sediments (collected) with a close-up of rhodoliths (circled) from outside Area E (Site EX-2)

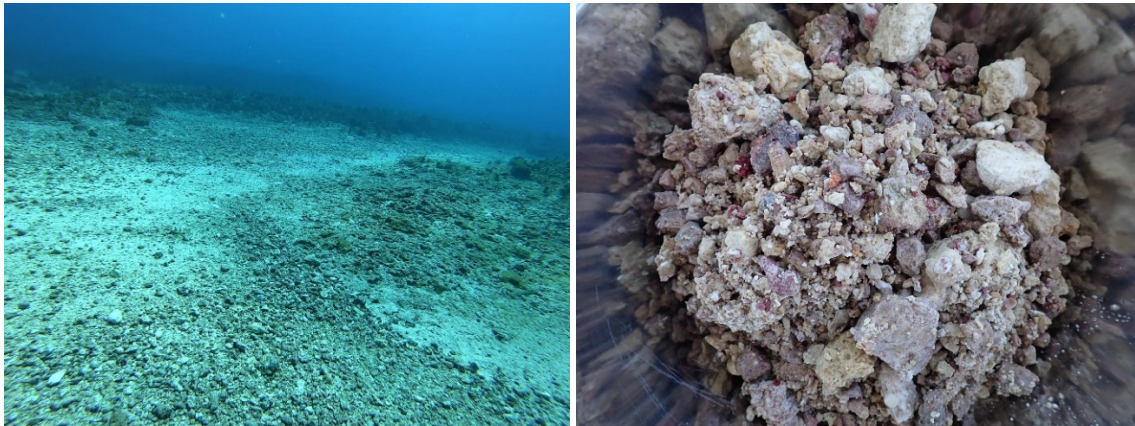
The appearance of the rubble has not changed significantly since the grounding and remains obviously different to the natural sediments found in the reference or unaffected areas. Some areas of rubble do support benthic organisms and have consolidated over time (Figure 6-9).

Figure 6-7 In-situ rubble areas and collected sediments from Area C (Site C3-3)

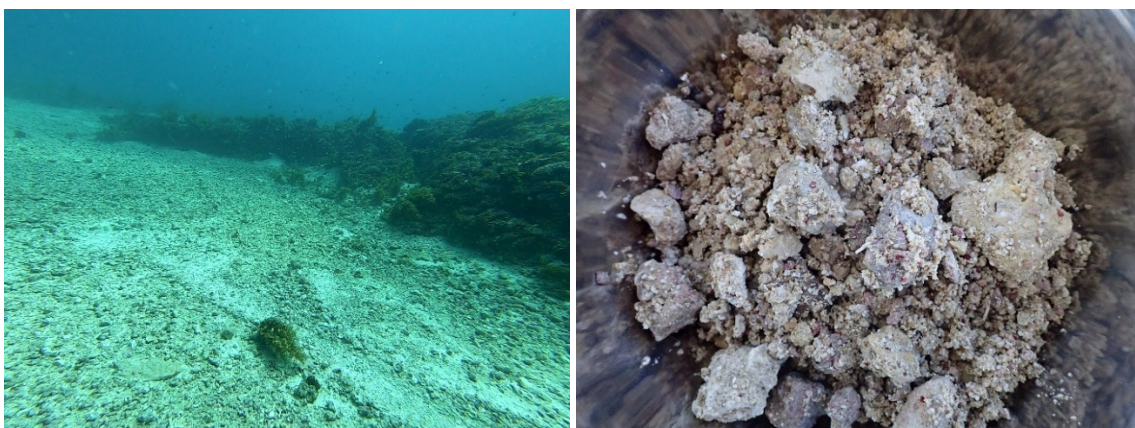
Figure 6-8 In-situ rubble areas and collected sediments from Area E (Site E3-10)

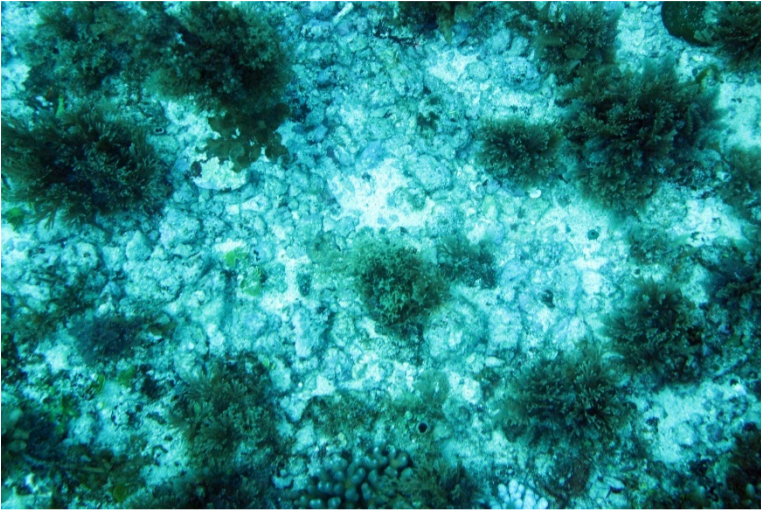
Consolidated rubble and macroalgae growth.

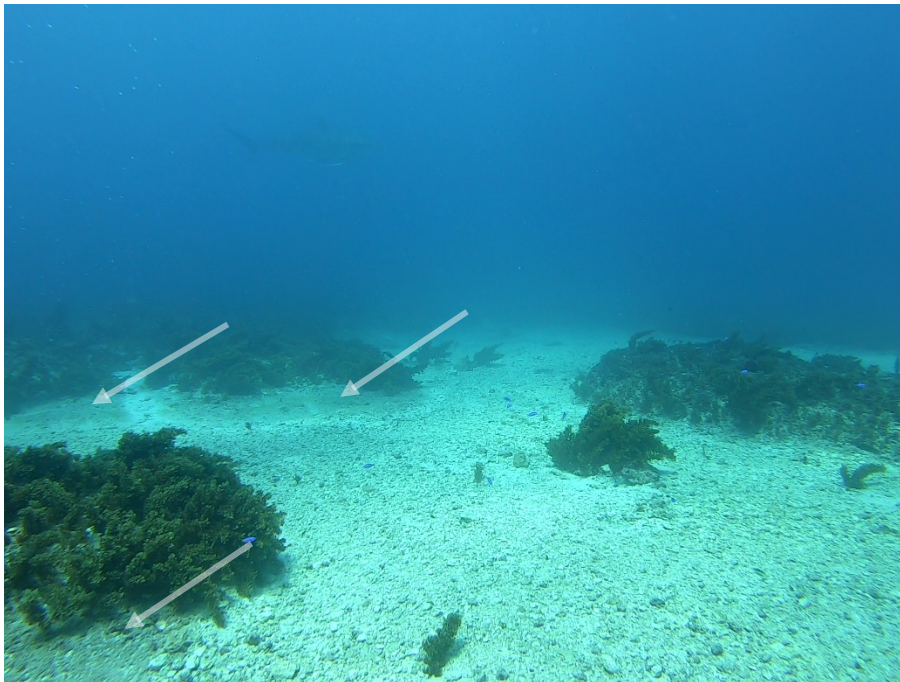
Evidence of the movement of rubble in a generally westerly direction is supported by slope analysis data (Section 6.2). Further evidence in the form of imagery from key locations in the eastern and middle section within the footprint of Priority Area C (Figure 5-19) appear to support this analysis. Images captured from site C1-3 (Figure 6-10), C1-9 (Figure 6-11, Figure 6-12) and C3-3 (Figure 6-13) show areas of rubble and areas of undulating depauperate substrate devoid of algae growth (indicated by arrows and circles) which may have been smothered by mobile rubble banks originating from the grounding, and subsequently exposed over time. These exposed areas devoid of rubble may now be able to support the settlement and growth of coral recruits and other benthos.

Figure 6-10 Images of rubble and exposed substrate from Priority Area C (site C1-3)

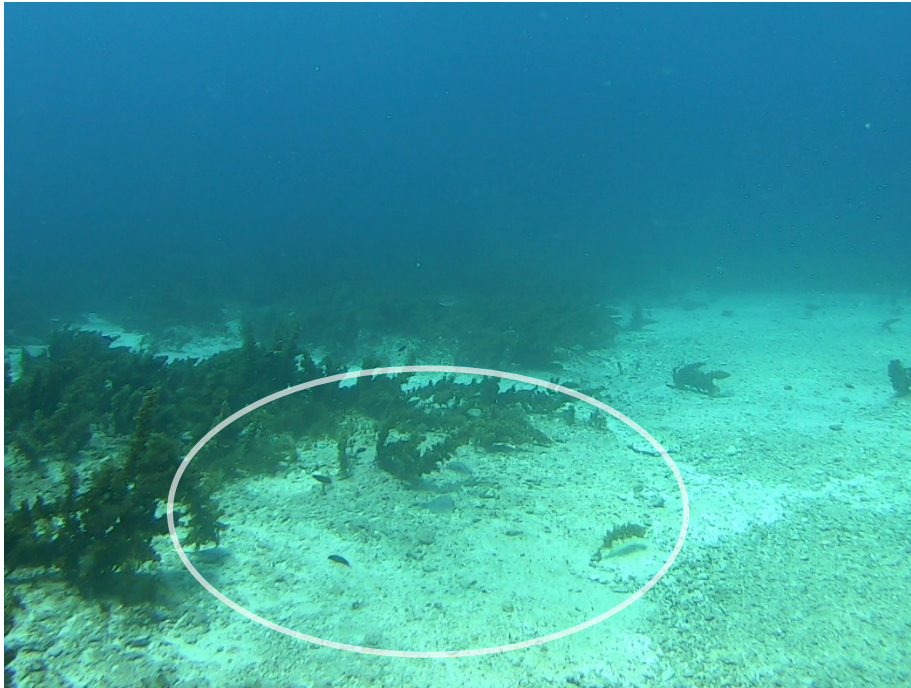
Figure 6-11 Images of rubble and exposed substrate from Priority Area C (site C1-9)

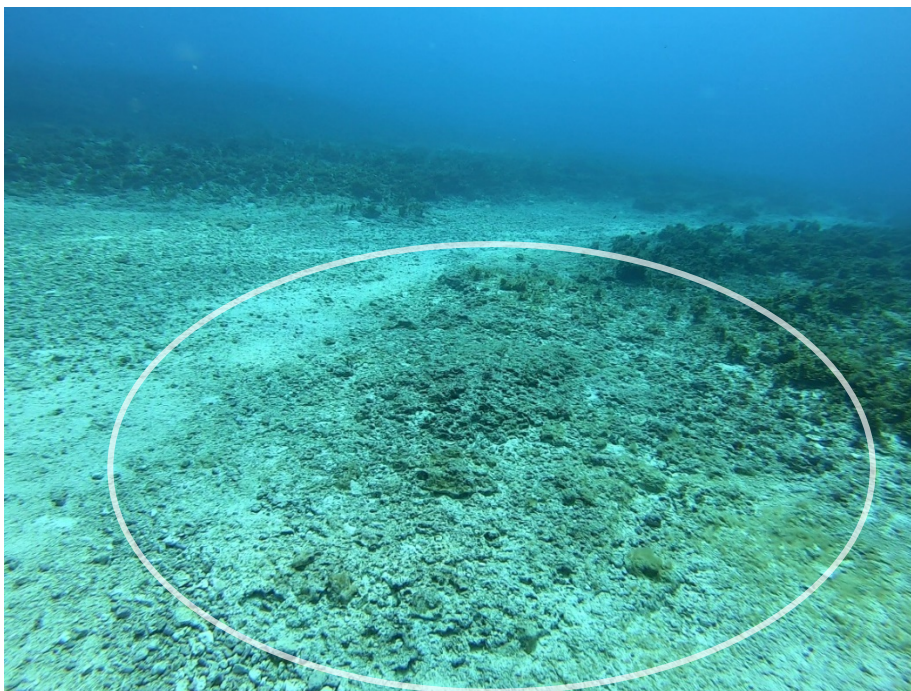
Figure 6-12 Image of rubble and exposed substrate from Priority Area C (site C3-3)

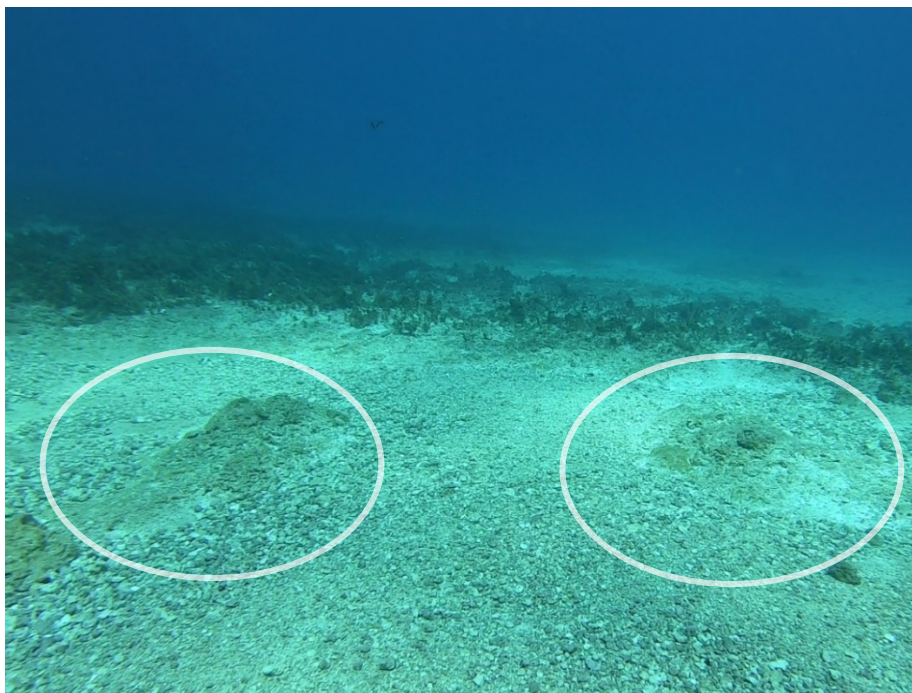
Figure 6-13 Images of rubble and exposed substrate from Priority Area C (site C3-3)

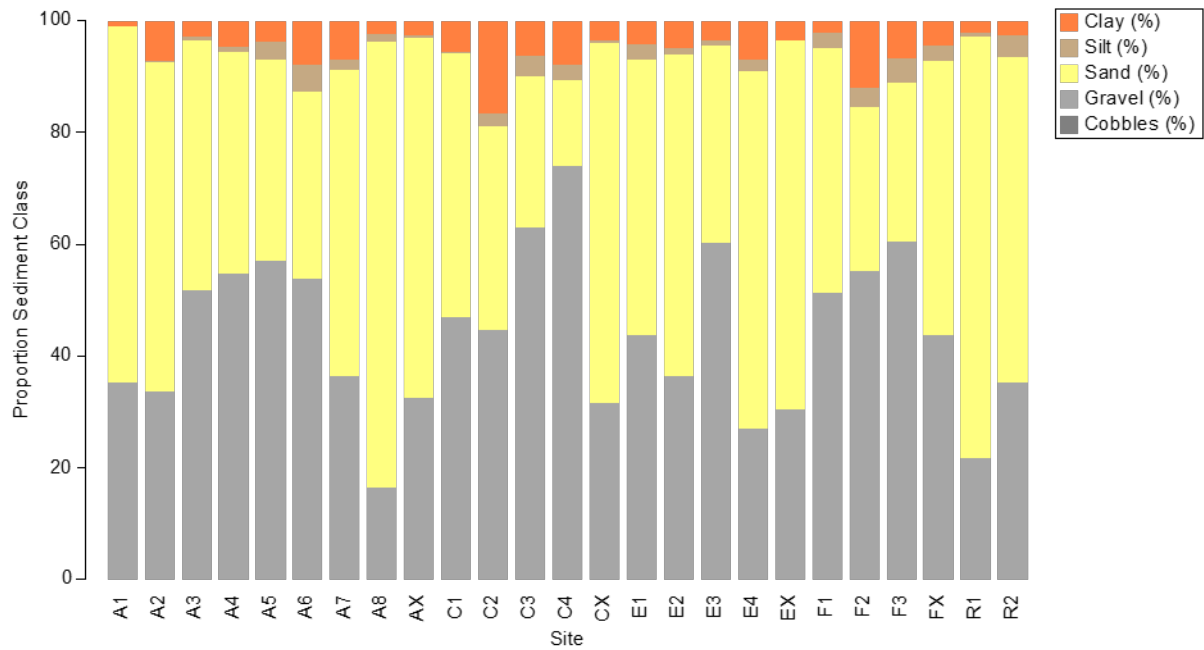
PSD varied considerably between priority areas and between sub-areas within priority areas for percent (%) clay, silt, sand and gravel (Figure 6-14).

- The mean proportion of clay was highest in sub-area C2 (16.7%), and across all sub-areas the mean proportions ranged from 1%-16.7%
- The mean proportion of silt was highest at sub-areas A6 (4.7%), F3 (4.3%) and R2 (4%) and across all sub-areas the mean proportions ranged from 0%-4.7%
- The mean proportion of sand was highest in sub-area A8 (80%) and across all sub-areas the mean proportion ranged from 2-95%
- The mean proportion of gravel was highest at sub-area C4 (74.1%), and across all sub-areas the mean proportions ranged from 61-83%.

Figure 6-14 PSD (%) shown by sub-area

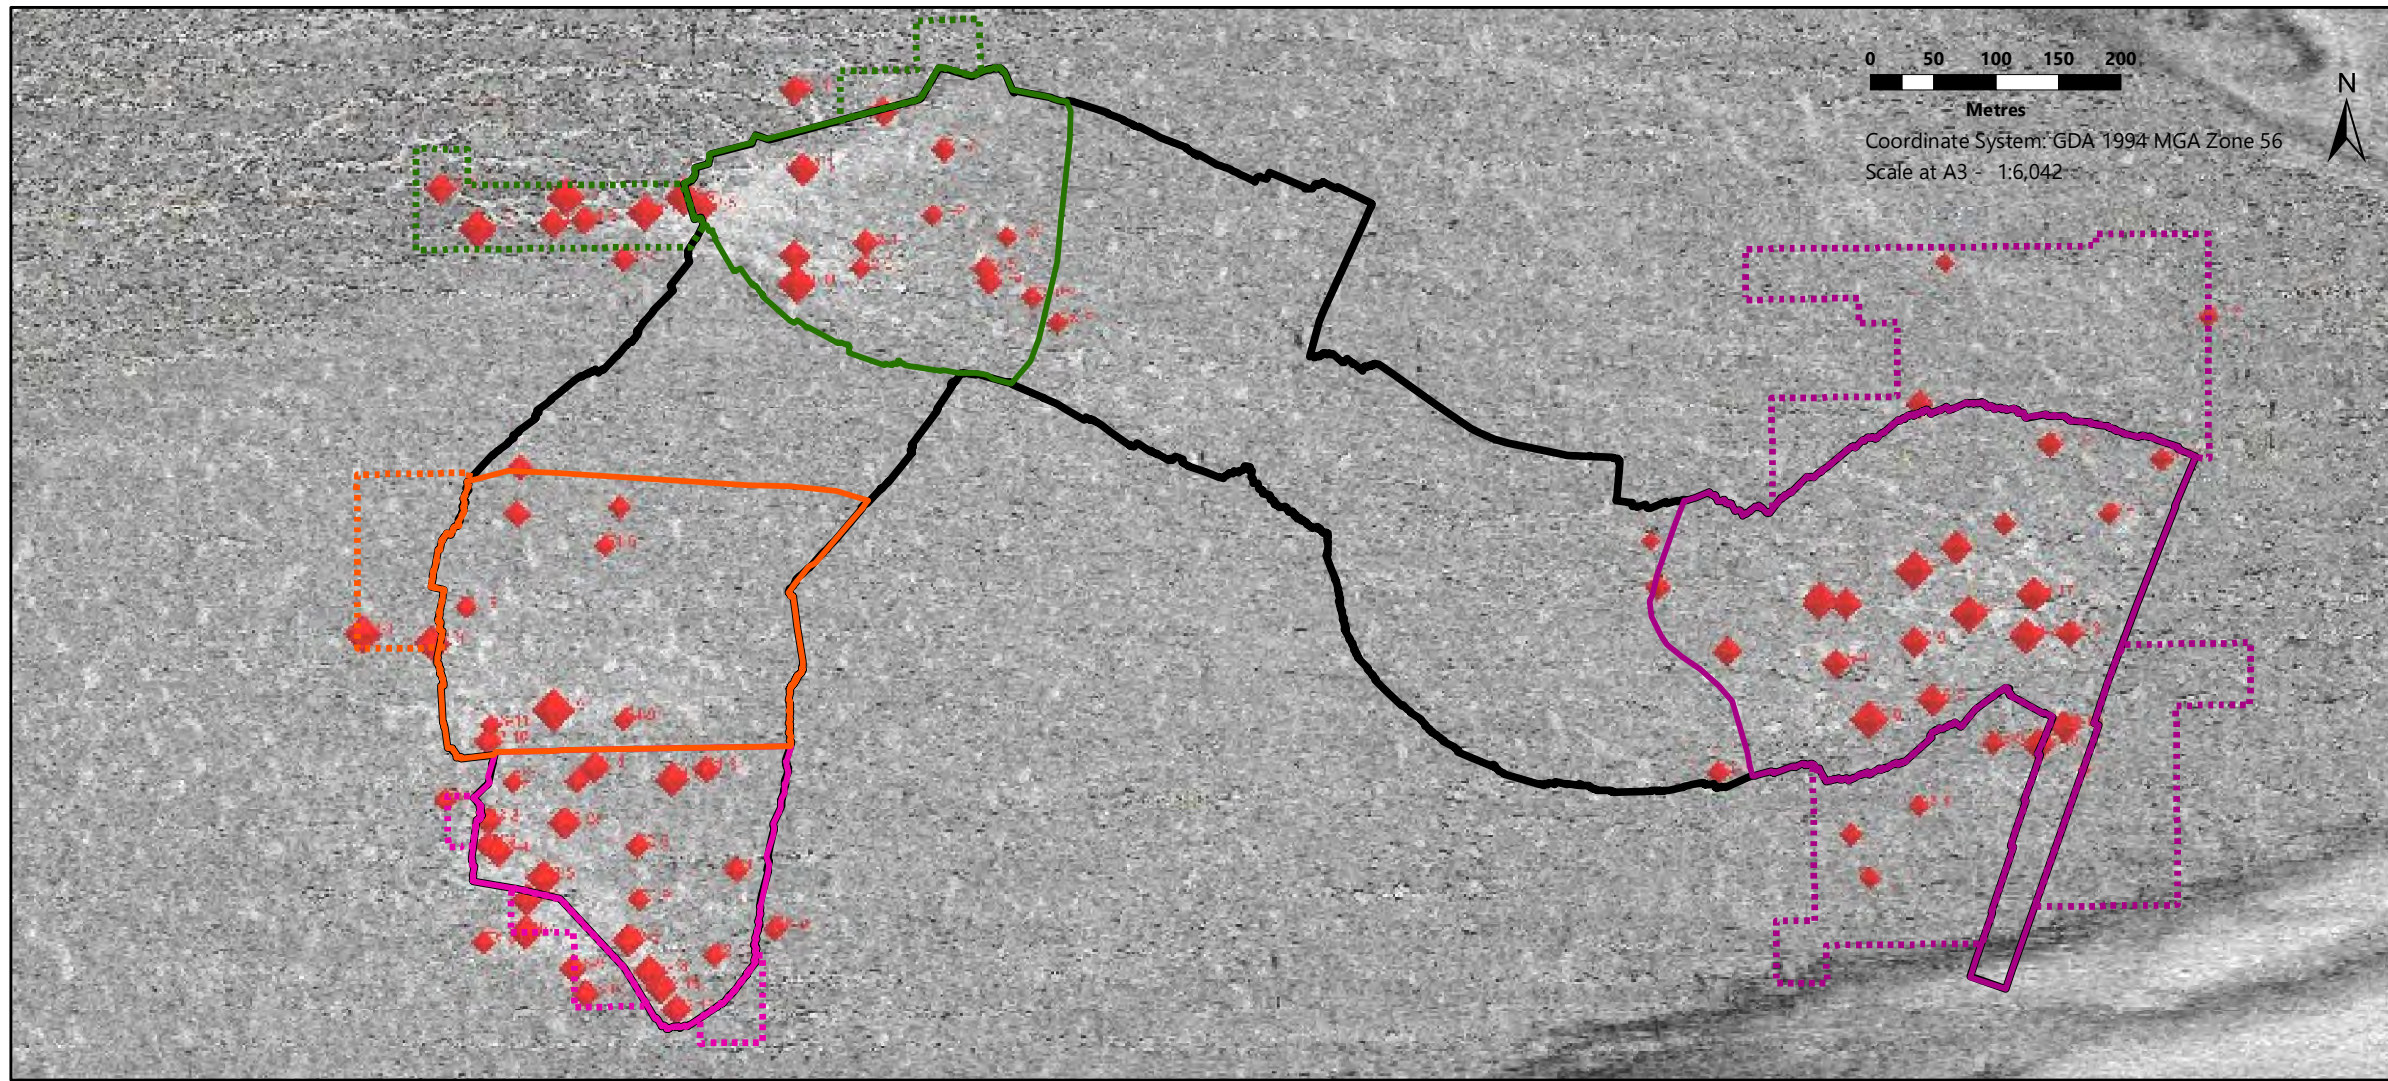
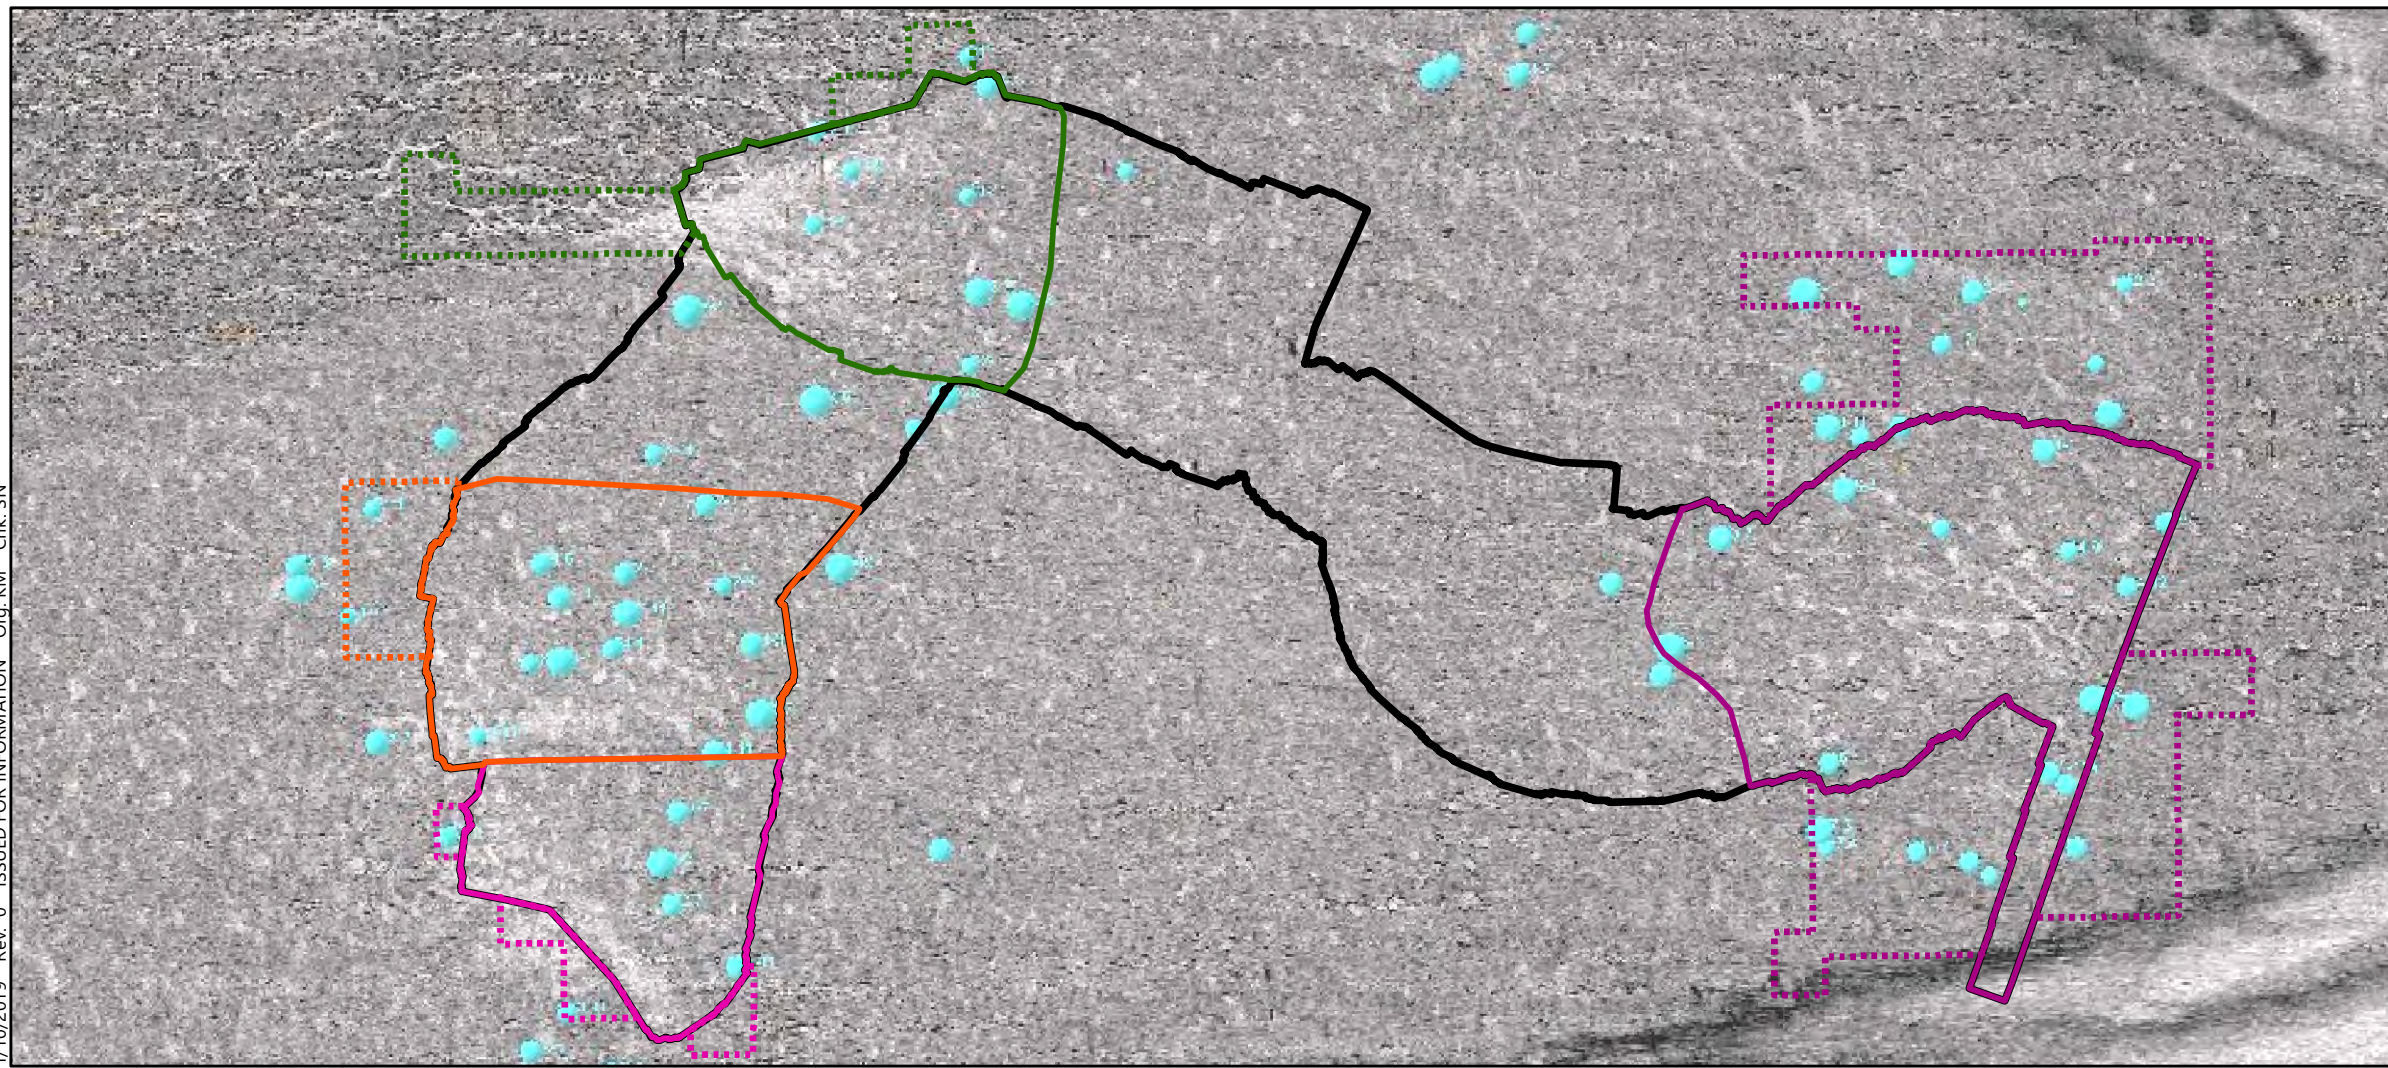
Figure 6-15
Backscatter mosaic (300Hz)
overlaid with sites containing
gravel and sand fractions

The backscatter from the multibeam surveys provides an excellent correlation with the results from the PSD analysis. The backscatter images are overlaid with results from all sites where PSD information was collected for gravel fractions (upper image) and sand fractions (lower image) in Figure 6-15. The lighter areas in the backscatter images represent flattened areas. For each figure the larger the symbols the higher is the percentage of each fraction found at each site when compared to all other fractions (cobbles, silt and clay). Figure 6-15 shows the larger rubble class were confined to the areas where the grounding occurred, and the more 'natural' sand fractions occurred outside the grounding footprint.

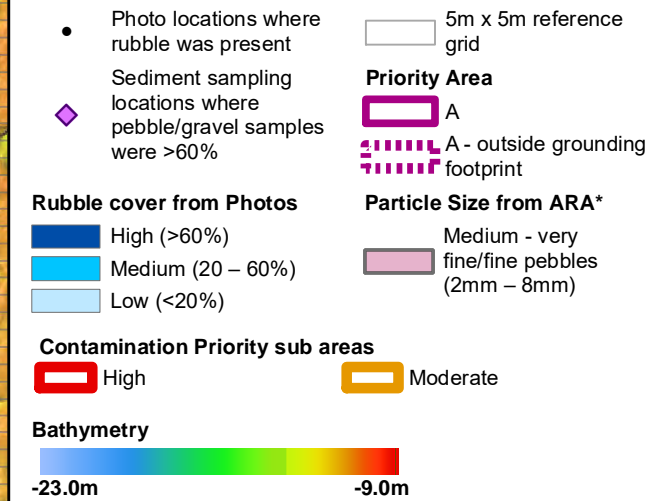
Figure 6-17 Distribution of Rubble in Priority Area A

Mapping of the rubble areas using all sources of information from Priority Area A found small patches of rubble spread throughout the grounding footprint in isolated patches within holes and gutters (Figure 6-16 and Figure 6-17). When the contamination-related high and moderate priority remediation areas are superimposed onto Figure 6-17, all areas where the ARA modelling of the MBES data that show rubble (represented by light and dark brown squares on each figure) lie within the high priority remediation area for contamination, as do many of the grids where PSD and towed video data indicate sediment with rubble characteristics. For Priority Area A, the rubble and contamination issues may be dealt with concurrently. The total area of grounding-related rubble is likely to be similar to the area of contamination.

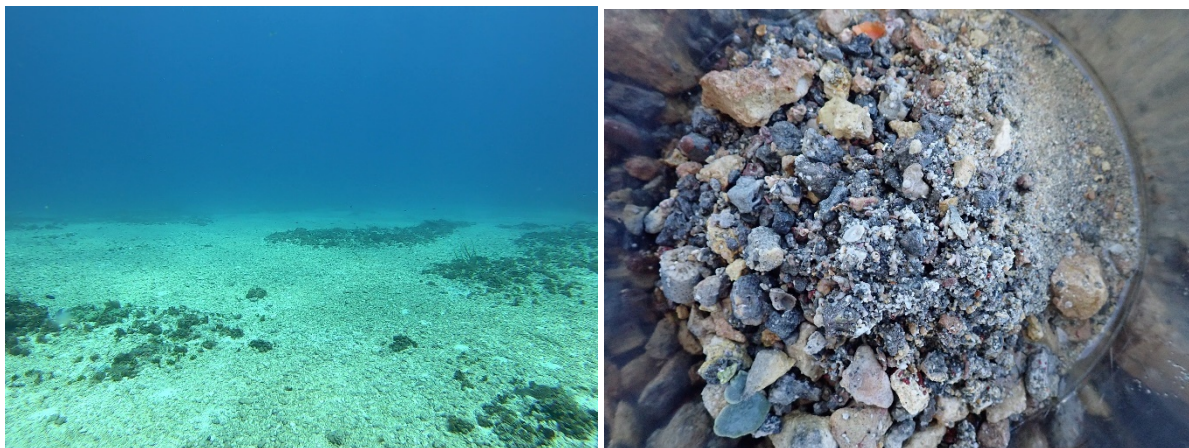
The rubble appears to have shifted westward with the prevailing wave climate along the edge of the upper shelf to outside the grounding footprint. An example of the in-situ area and sediment collected from within the high priority remediation area for rubble (site C3-5) and from an area outside the grounding footprint to the west (Site C4-9) is provided in Figure 6-18 and Figure 6-19, respectively.

Figure 6-18 Rubble areas in-situ and collected from the high priority remediation area within the grounding footprint of Priority Area C (site C3-5)

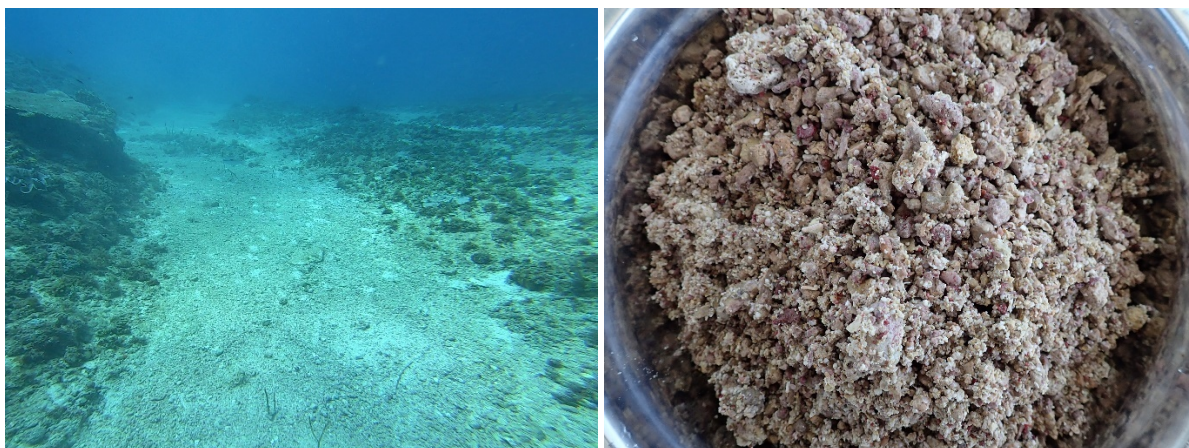
Figure 6-19 Rubble areas in-situ and collected from outside the grounding footprint of Priority Area C (C4-9)

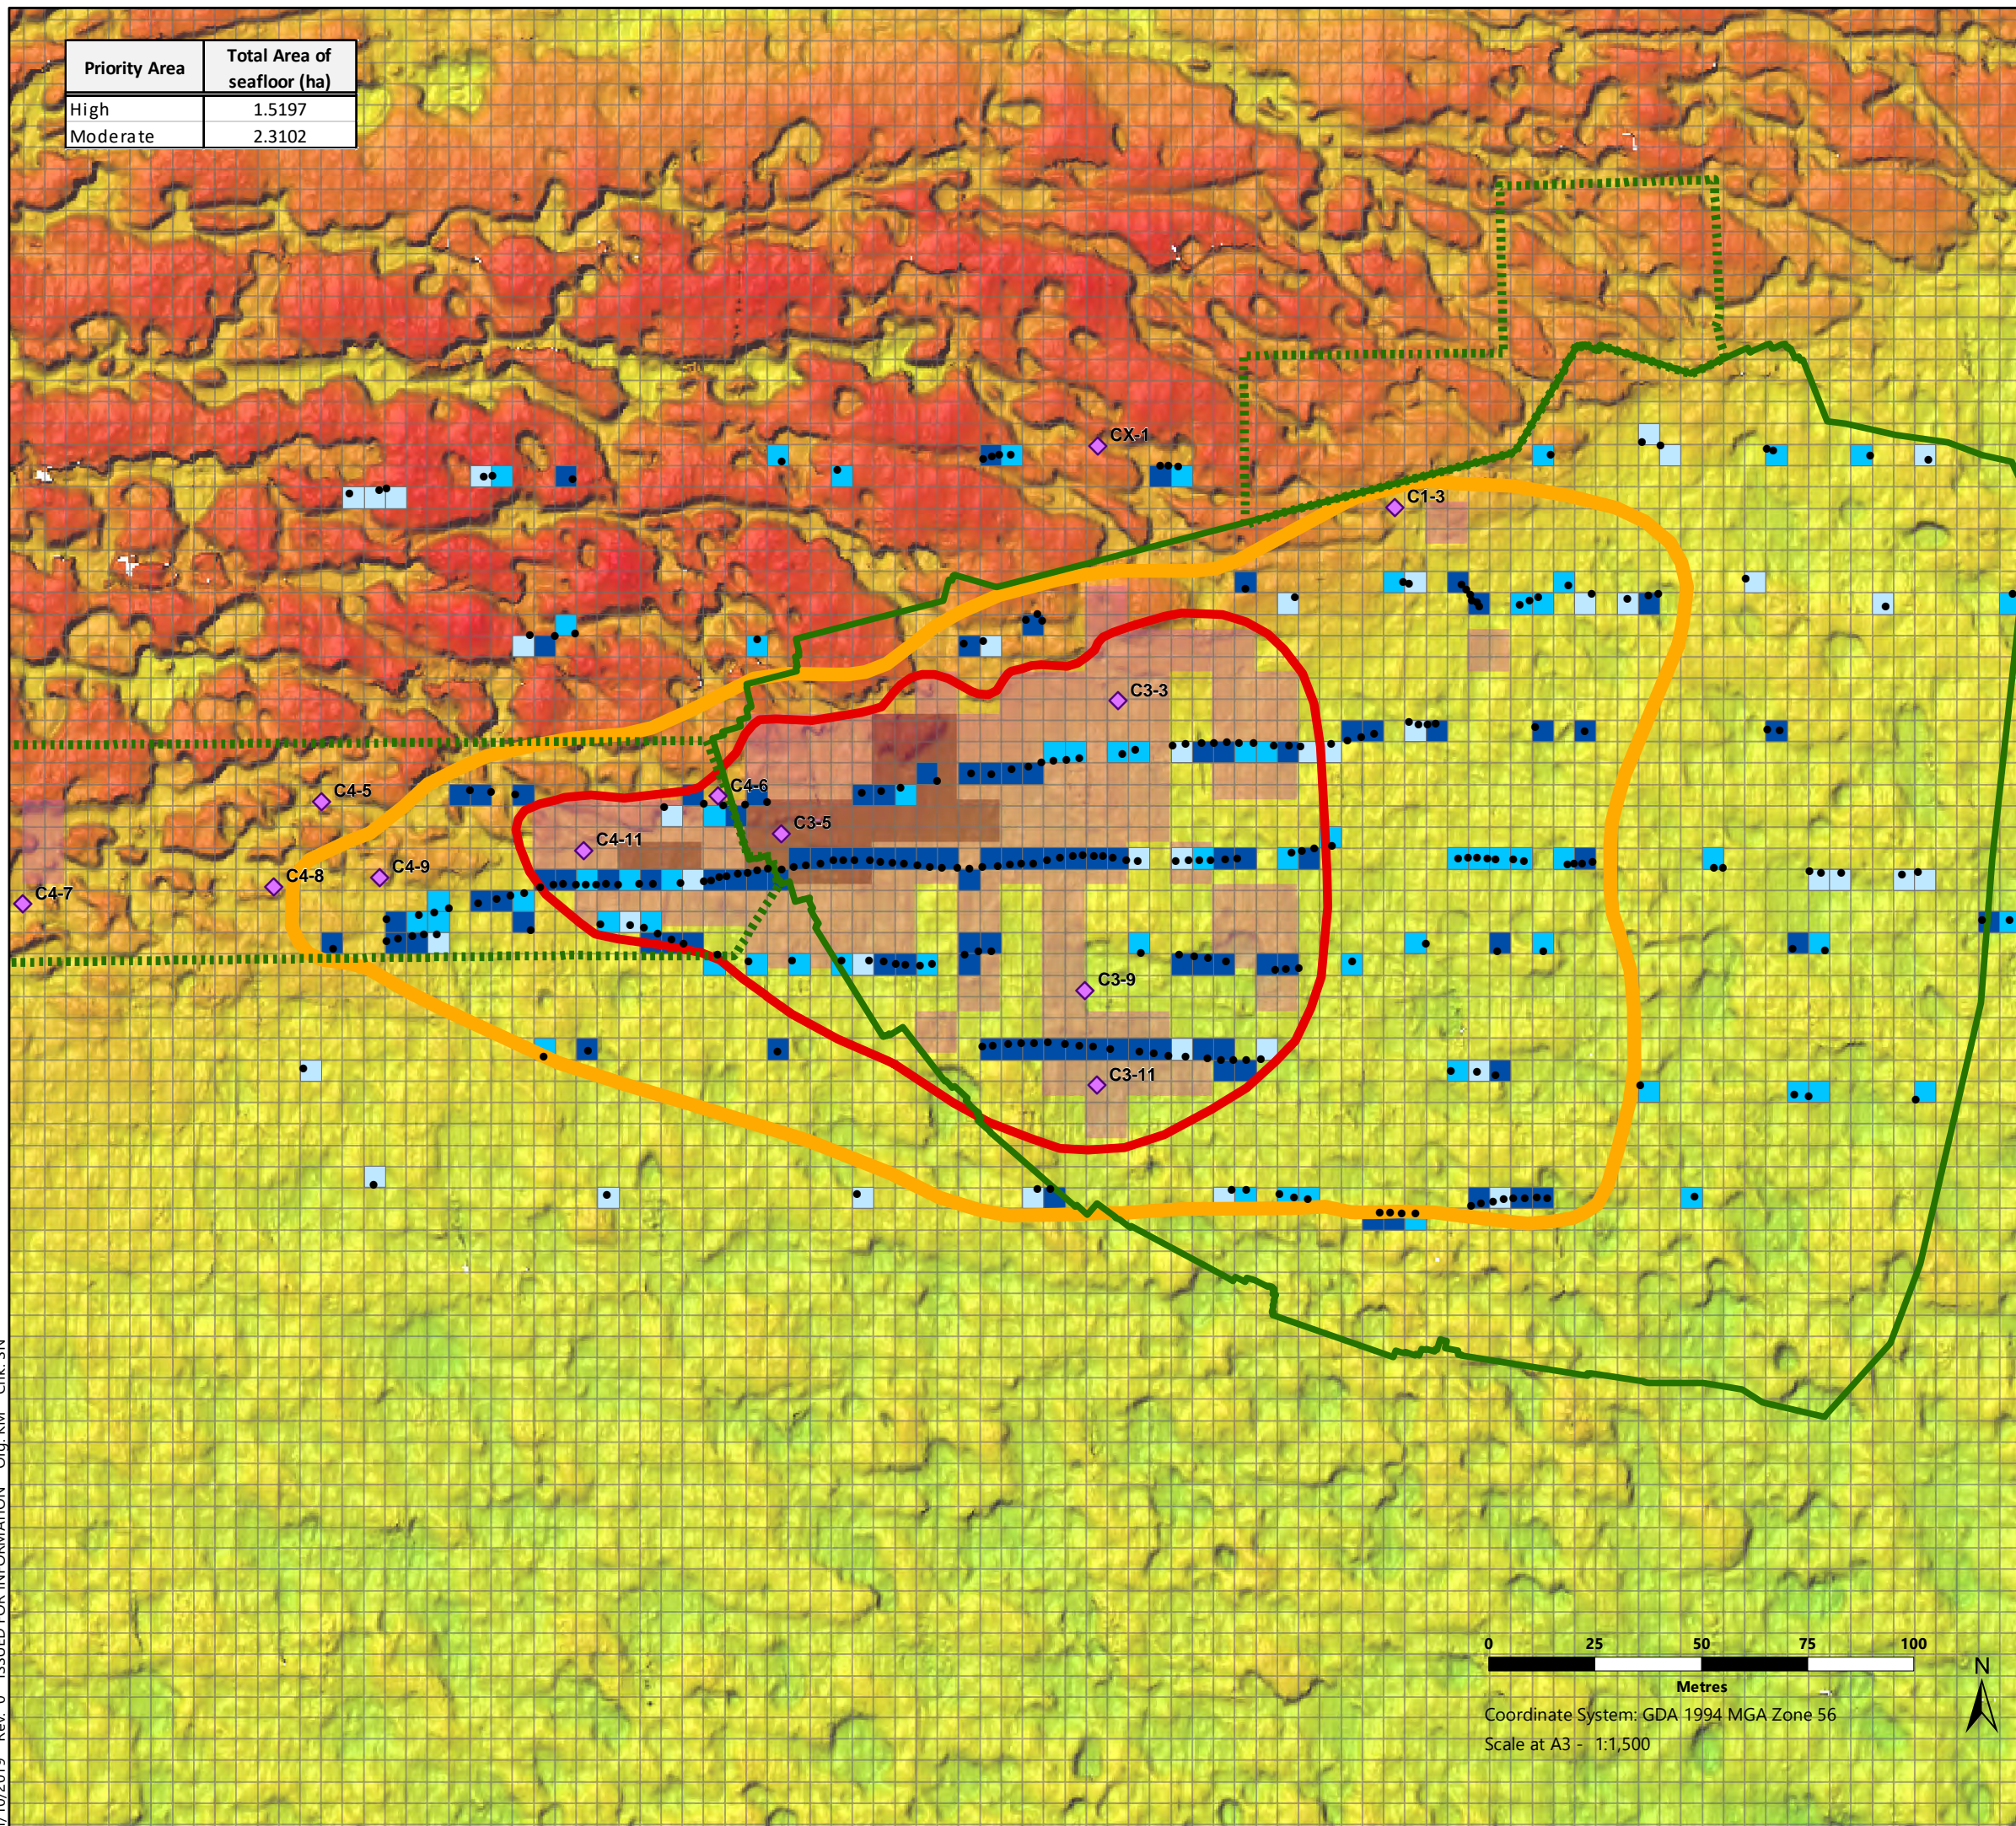
Figure 6-20
Distribution of Rubble in
Priority Area C

Priority Area C contains large expanses of rubble. The vessel sat up against the shallow shelf of the High Relief Terrace and abraded the sea floor in this area for approximately two days. Using the data captured during the site assessment, a map was developed to combine data sources and to delineate the proposed high and moderate priority remediation areas for rubble (Figure 6-20). The area of focus for remediation activities (i.e. the high priority remediation area) is highlighted in red and covers an area of 1.52ha. The moderate priority remediation area (orange polygon) measures approximately 2.31ha and encompasses areas where smaller amounts of rubble were detected using the towed video imagery and PSD analysis of collected sediments.

Priority Area	Total Area of seafloor (ha)
High	1.5197
Moderate	2.3102

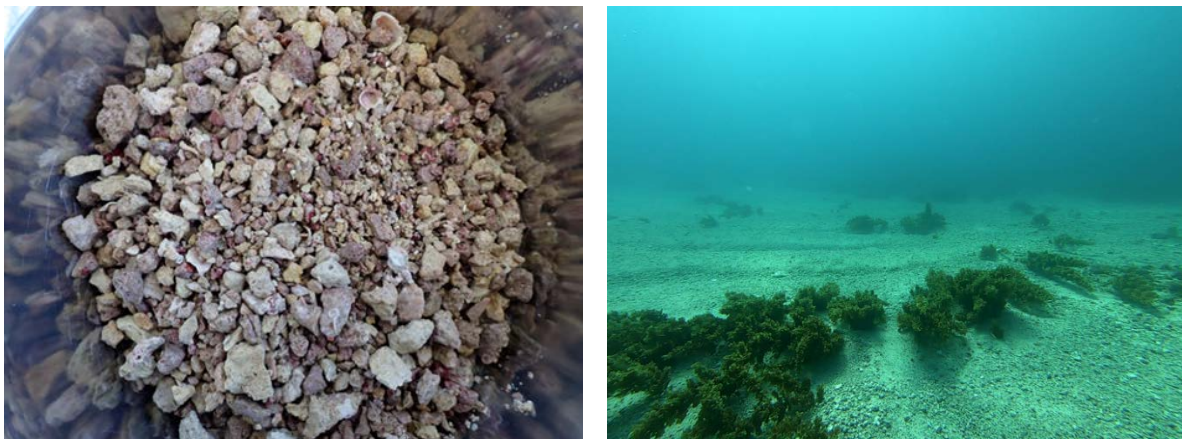
As with Priority Area C, though to a lesser extent, the rubble appears to have shifted westward with the prevailing wave climate to outside the grounding footprint. An example of the in-situ area and sediment collected from within the high priority remediation area site E3-9 and site E3-11 is provided in Figure 6-21 and Figure 6-22, respectively.

Figure 6-21 Rubble areas in-situ and collected from the high priority remediation area within the grounding footprint of Priority Area E (site E3-9)
