Site Assessment Report

**Douglas Shoal Remediation Project
Great Barrier Reef Marine Park Authority**

8 November 2019

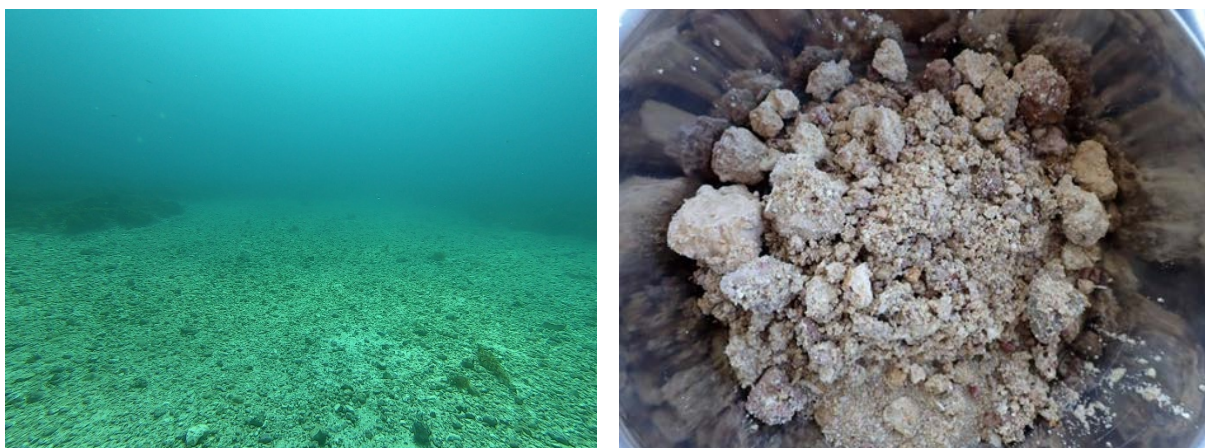
As with Priority Area C, though to a lesser extent, the rubble appears to have shifted westward with the prevailing wave climate to outside the grounding footprint. An example of the in-situ area and sediment collected from within the high priority remediation area site E3-9 and site E3-11 is provided in Figure 6-21 and Figure 6-22, respectively.

Figure 6-22 Rubble areas in-situ and collected from the high priority remediation area within the grounding footprint of Priority Area E (site E3-11)

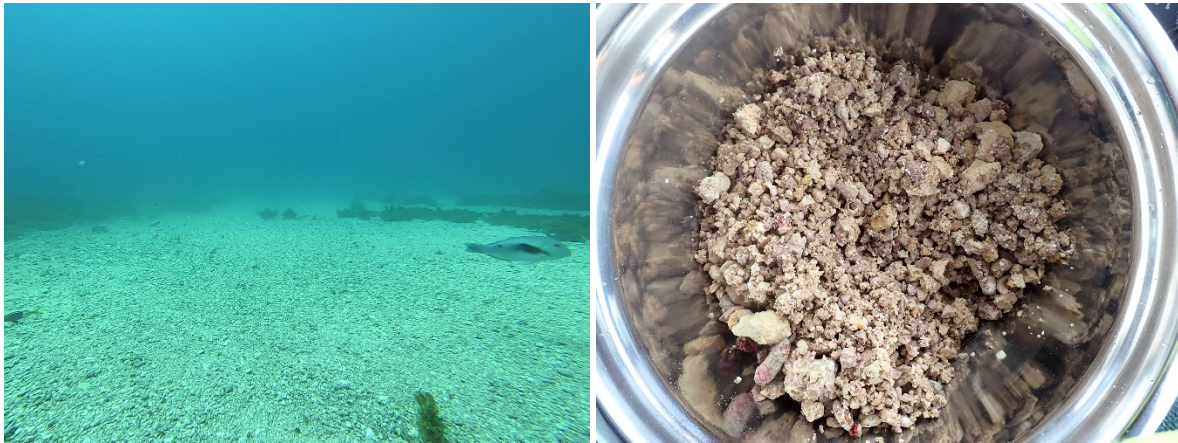
As with Priority Area E, the rubble originating from the grounding footprint appears to have shifted westward with the prevailing wave climate to outside the grounding footprint. An example of the in-situ area and sediment collected from within the high priority remediation area site F2-8 and from site F3-7 outside the grounding footprint is shown in Figure 6-24 and Figure 6-25 respectively.

Figure 6-24 Rubble areas in-situ and collected from the high priority remediation area within the grounding footprint of Priority Area F (site F2-8)

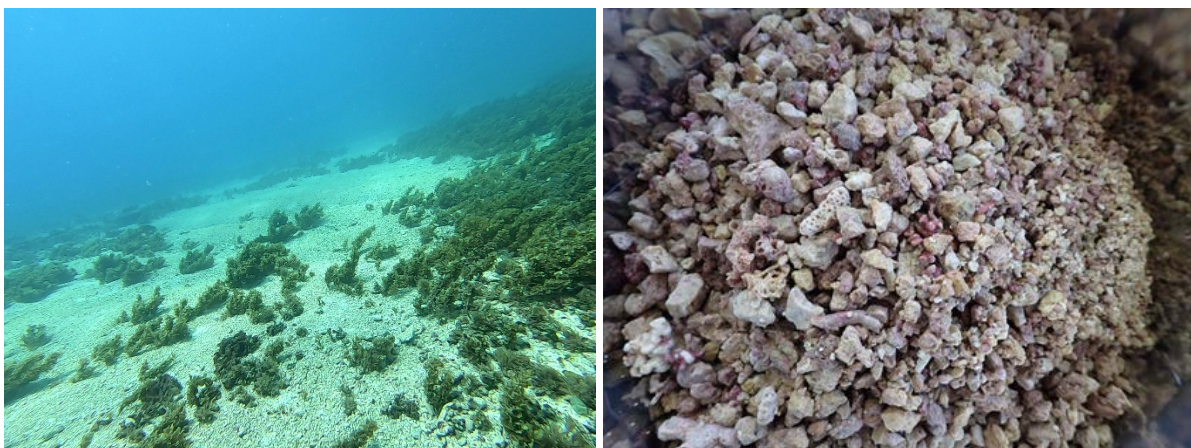
Figure 6-25 Rubble areas in-situ and collected from outside the high priority remediation area (site F3-7)

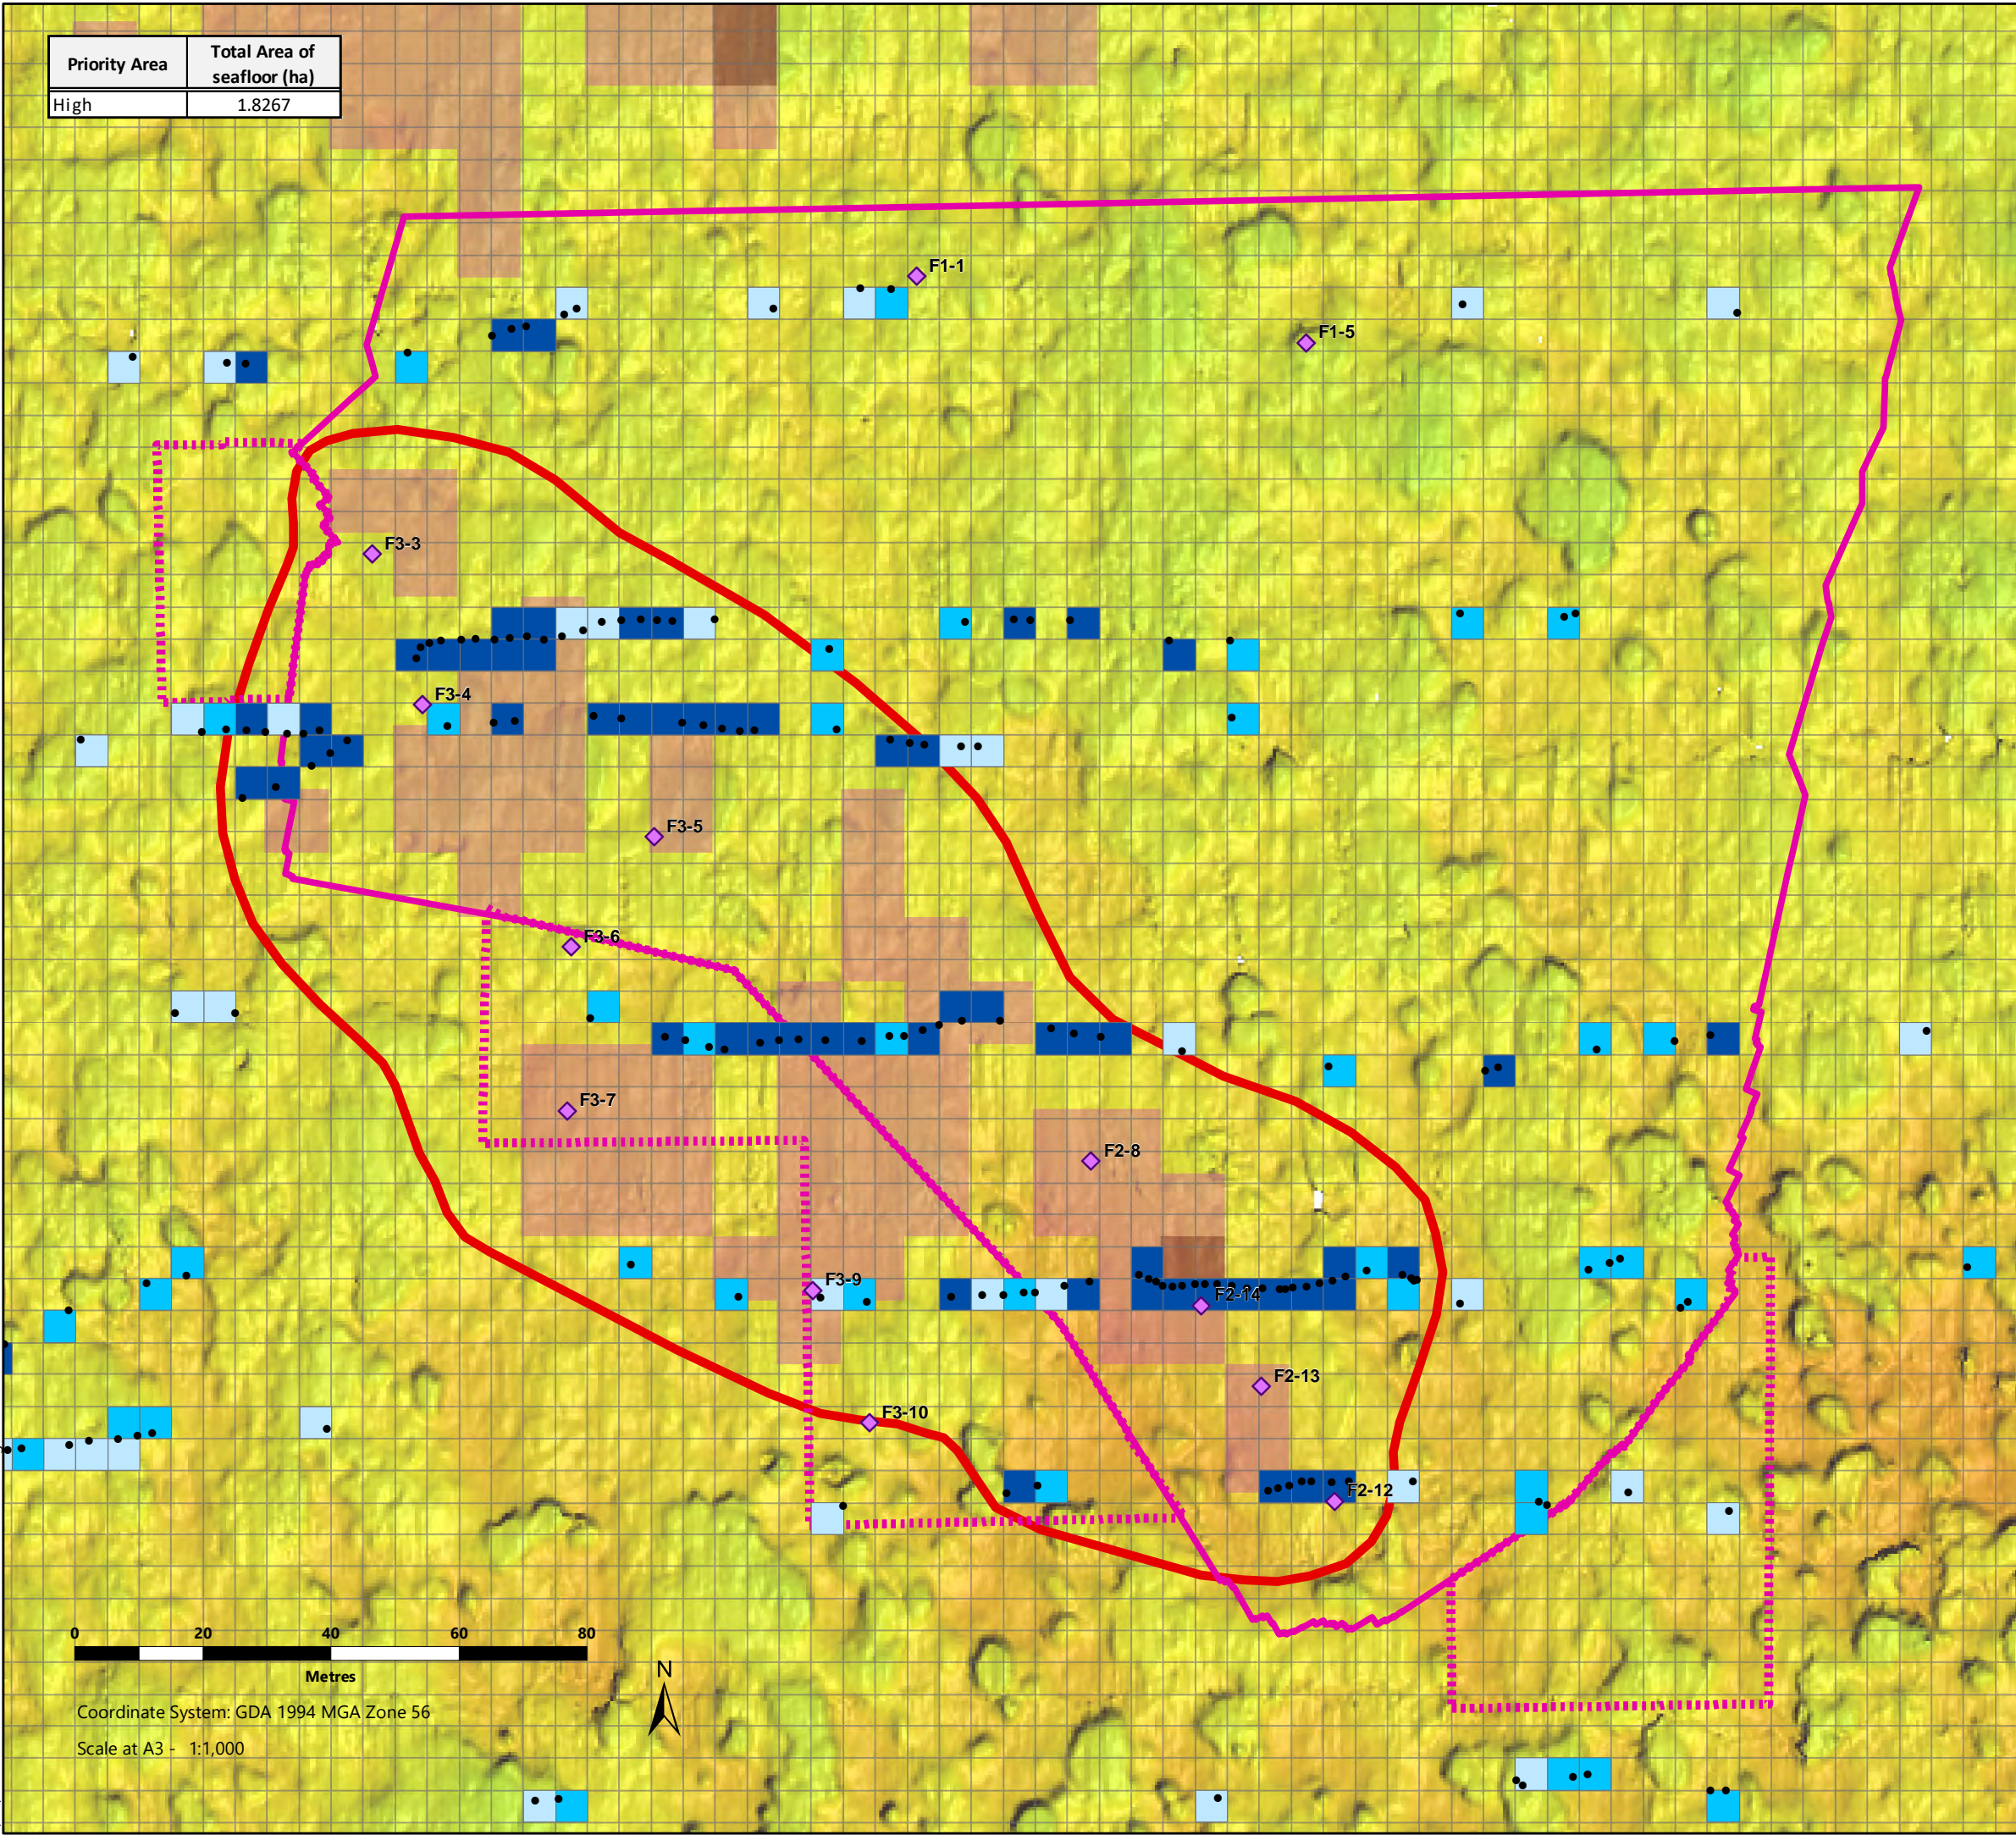
Figure 6-26
Distribution of Rubble in
Priority Area F

The vessel was grounded in Area F for seven days and the abrasion of the reef rock at this site produced large areas of rubble. Using the data captured during the site assessment, a map was developed to combine data sources and to delineate the proposed high priority remediation area for rubble for Priority Area F (Figure 6-26). The area of focus for remediation activities (i.e. the high priority remediation area) is highlighted in red and covers an area of 1.83ha. No moderate priority remediation area is proposed as the high priority area encompasses where significant amounts of rubble was found during surveys.

Priority Area	Total Area of seafloor (ha)
High	1.8267

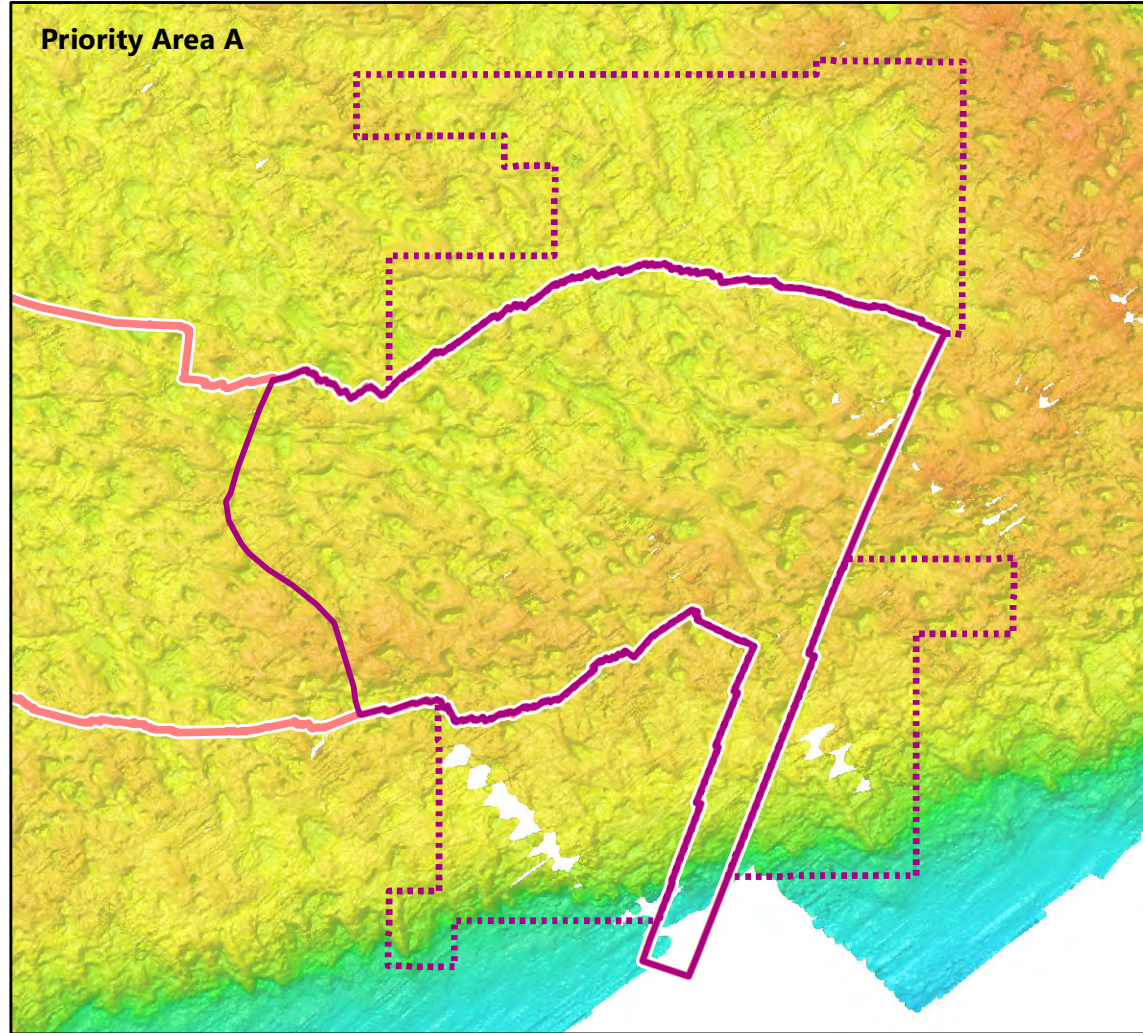
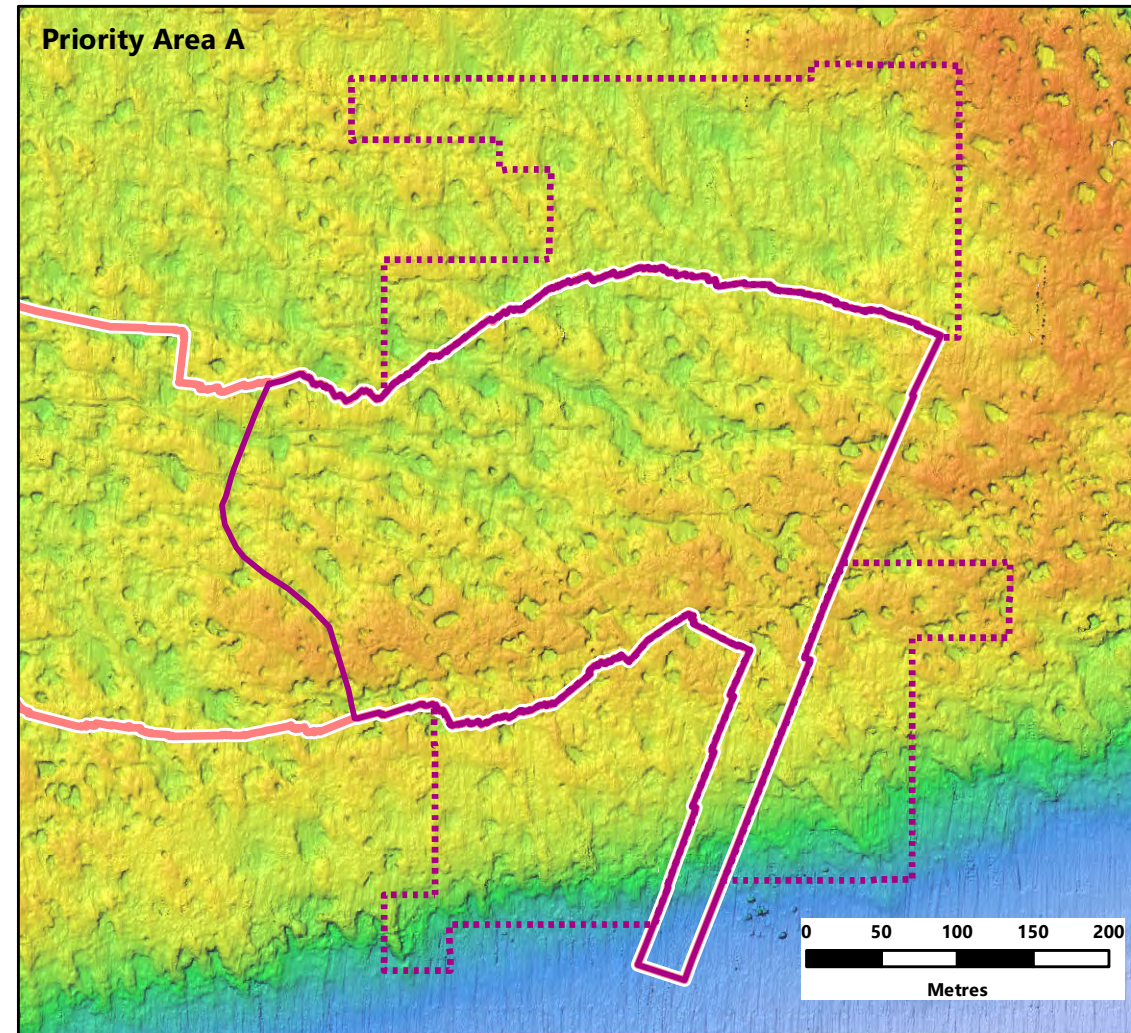
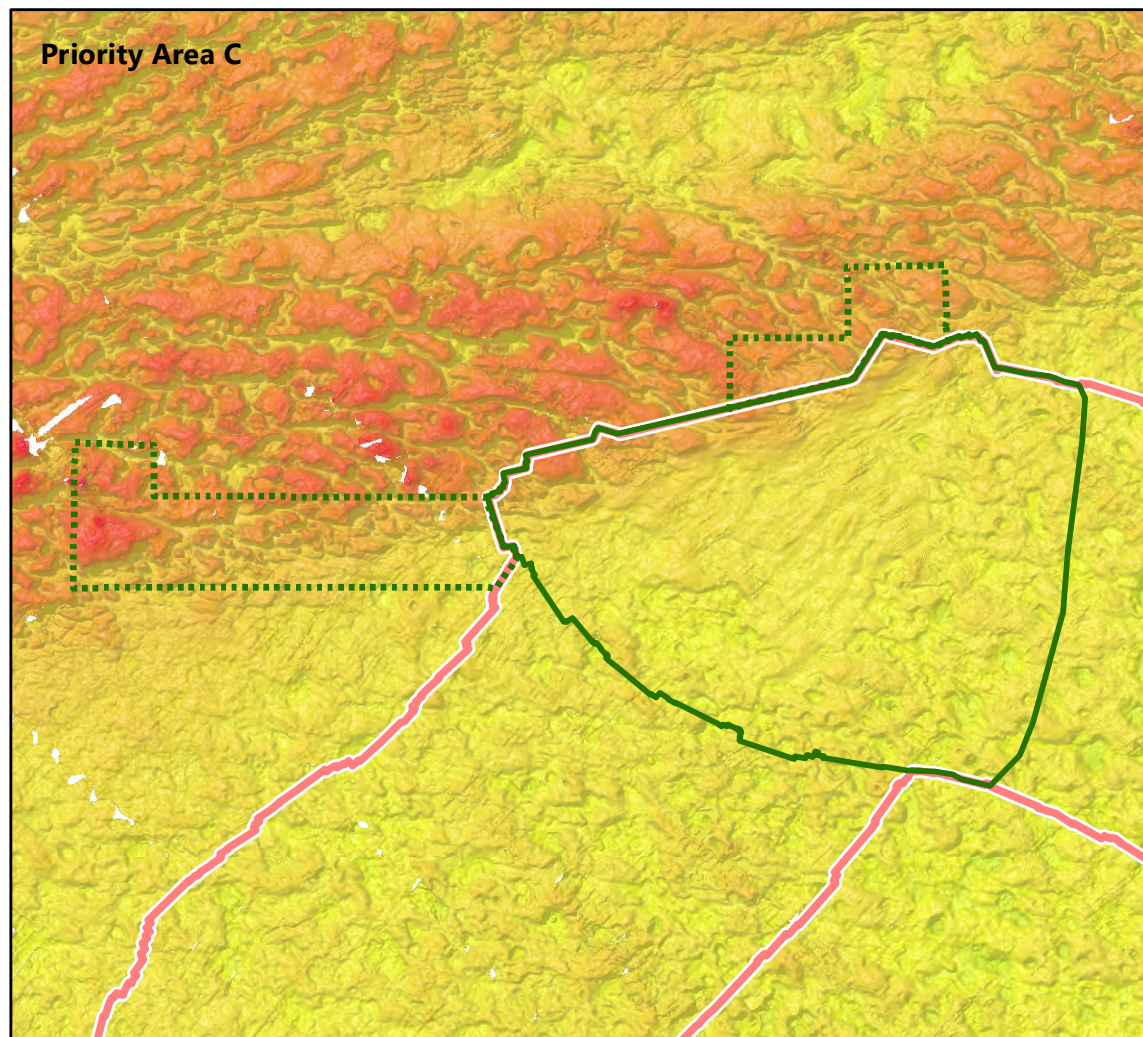
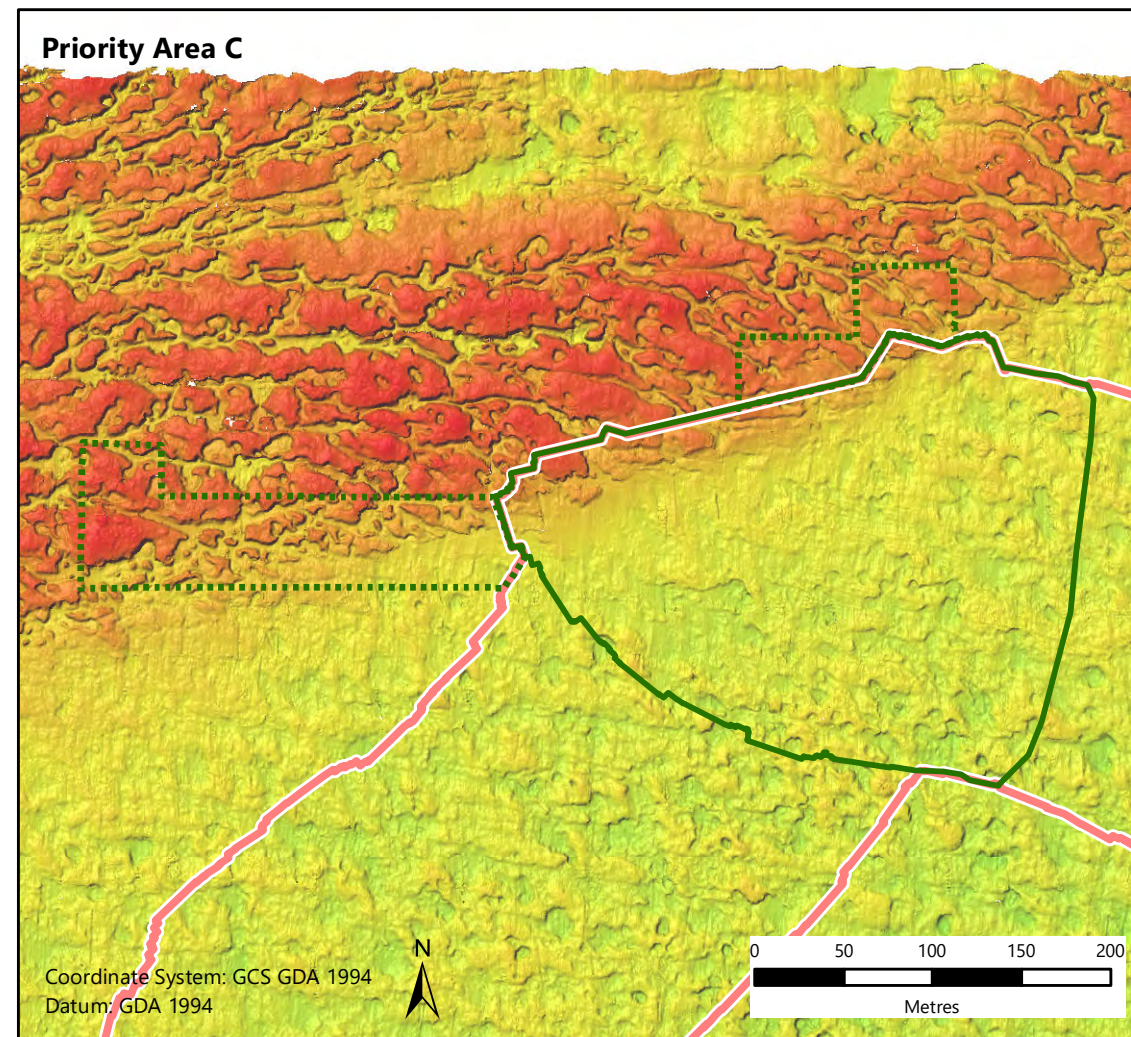
Figure 6-29
Comparisons between 2010
and 2019 bathymetry
in Priority Areas A and C

Comparisons between the high resolution multibeam bathymetry data collected in 2010 (Negri et al, 2010) and that collected for the site assessment for each priority area and reference area are provided in Figure 6-29 (Priority Area A and C), Figure 6-30 (Priority Area E and F) and Figure 6-31 (reference areas). Slope analysis calculations for each of the two datasets identify areas with differing slope angles (0-5, 5-10 and >10 degrees) and are provided in Figure 6-32 (Priority Area A and C) and Figure 6-33 (Priority Area E and F). Changes in the rugosity of the grounding footprint and surrounds is compared over time in these figures. The areas where evidence of flattening remains is in Priority Area C, E and F. Diver investigations of these areas confirm this. Little evidence of significant flattened areas can be found in Priority Area A.

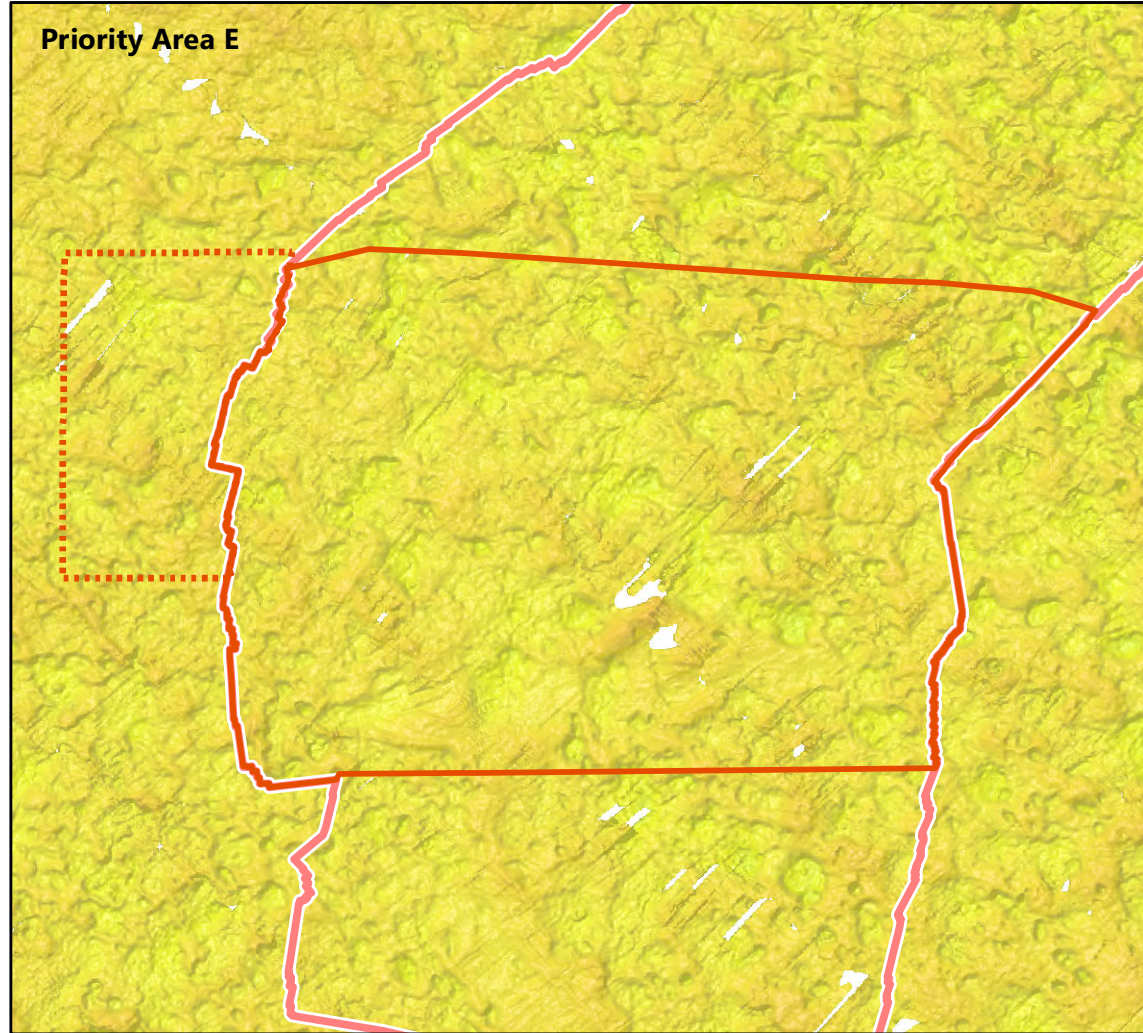
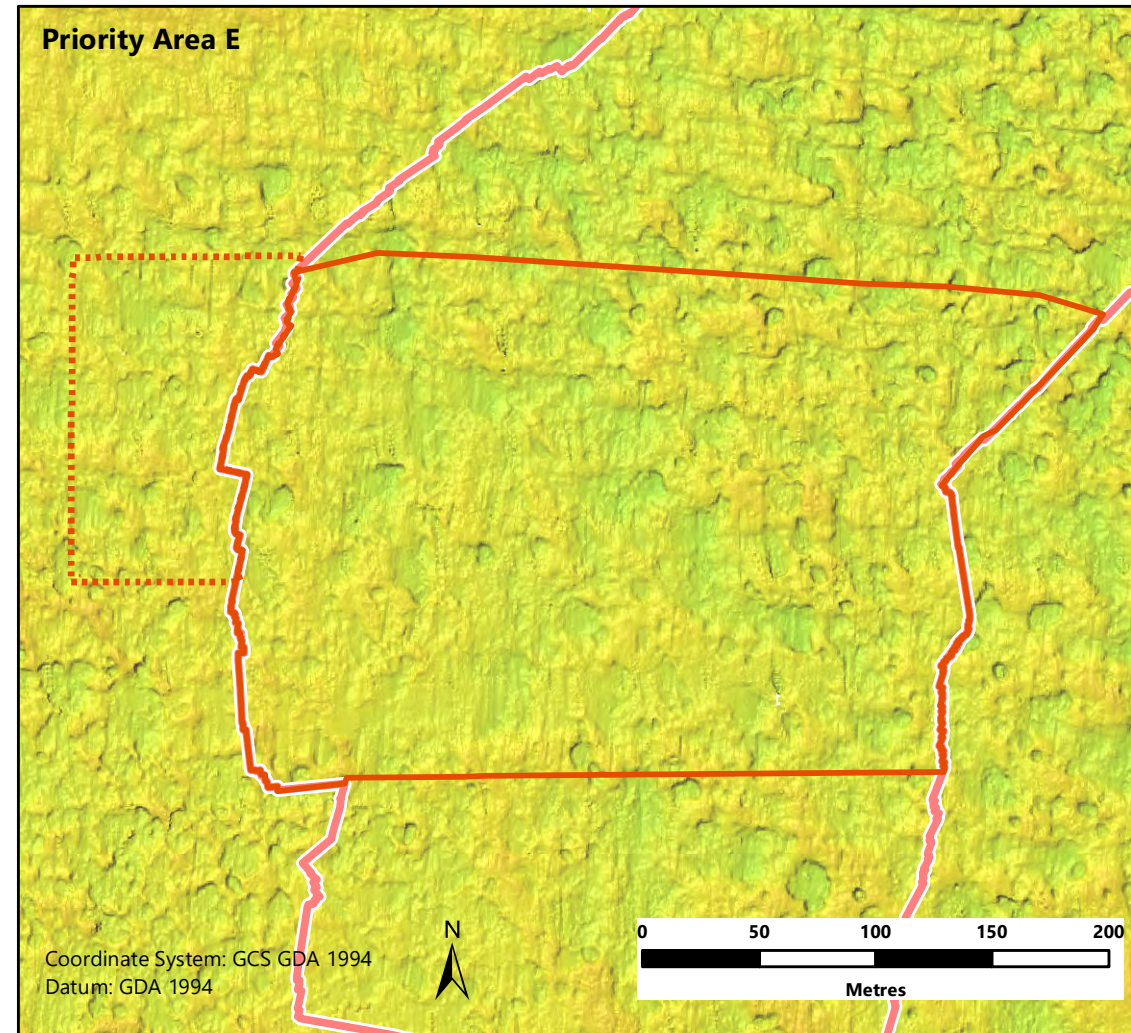
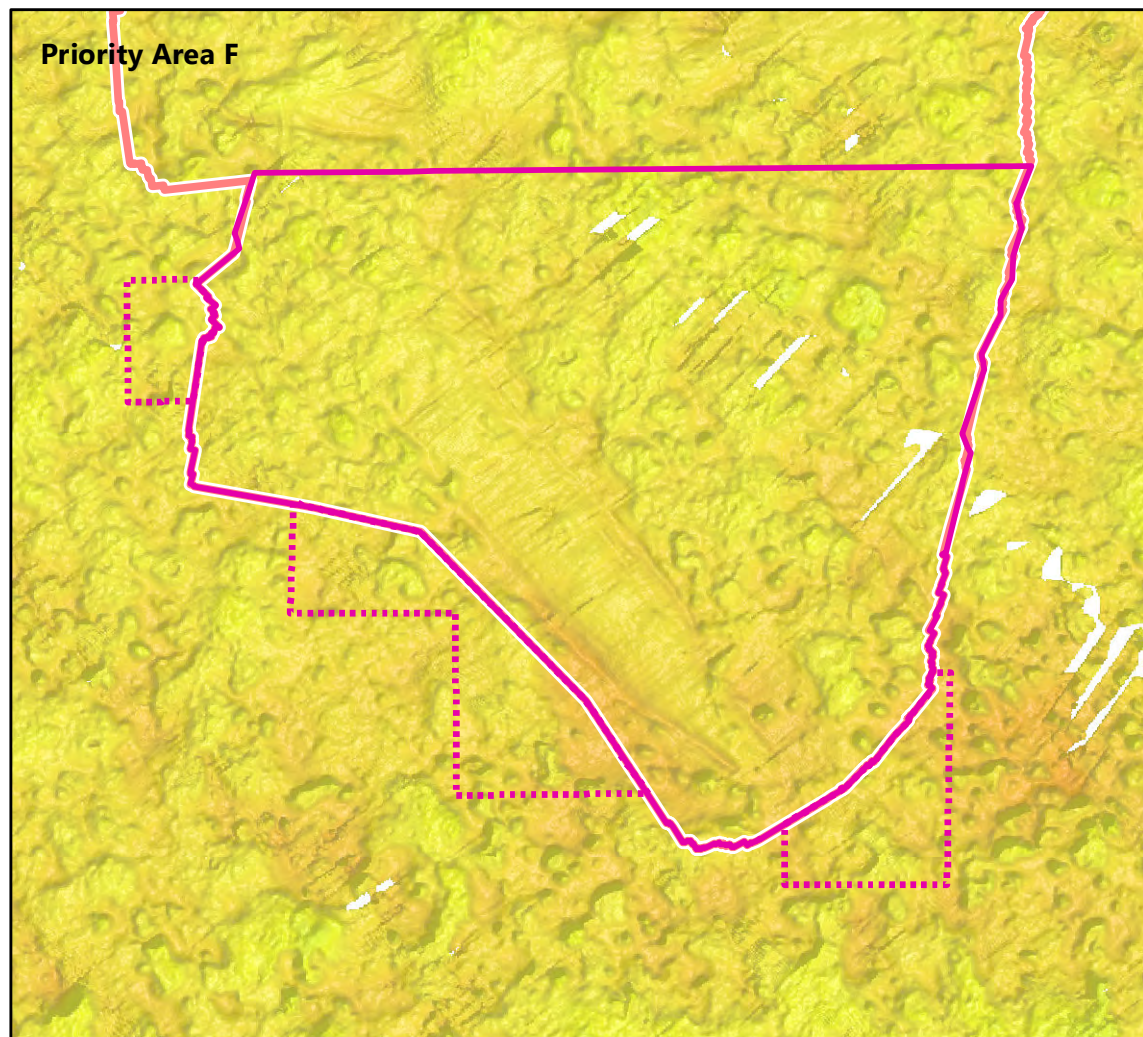
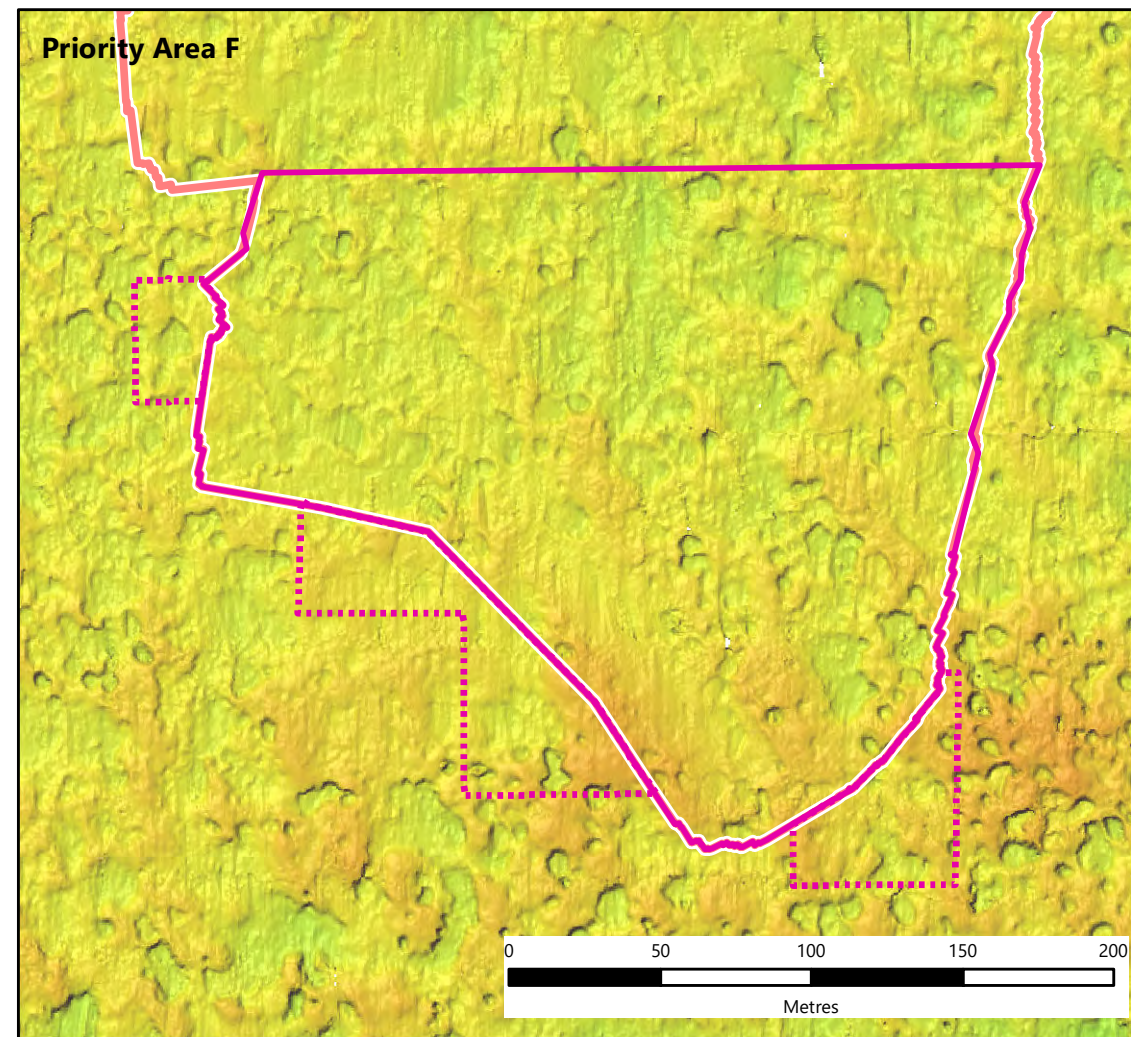
Figure 6-30
Comparisons between
2010 and 2019 bathymetry
in Priority Areas E and F

Evidence of flattening is clearly shown in Area F where the vessel sat for seven days. Investigations by divers in the grounding footprint of Priority Area F found large expanses of rubble covering worn down calcium carbonate reef structure. Within this structure, remnants of the coral matrix formed over time can be seen (Figure 6-27). In nearby areas, potential evidence of rubble created by the grounding being compacted was found (Figure 6-28).

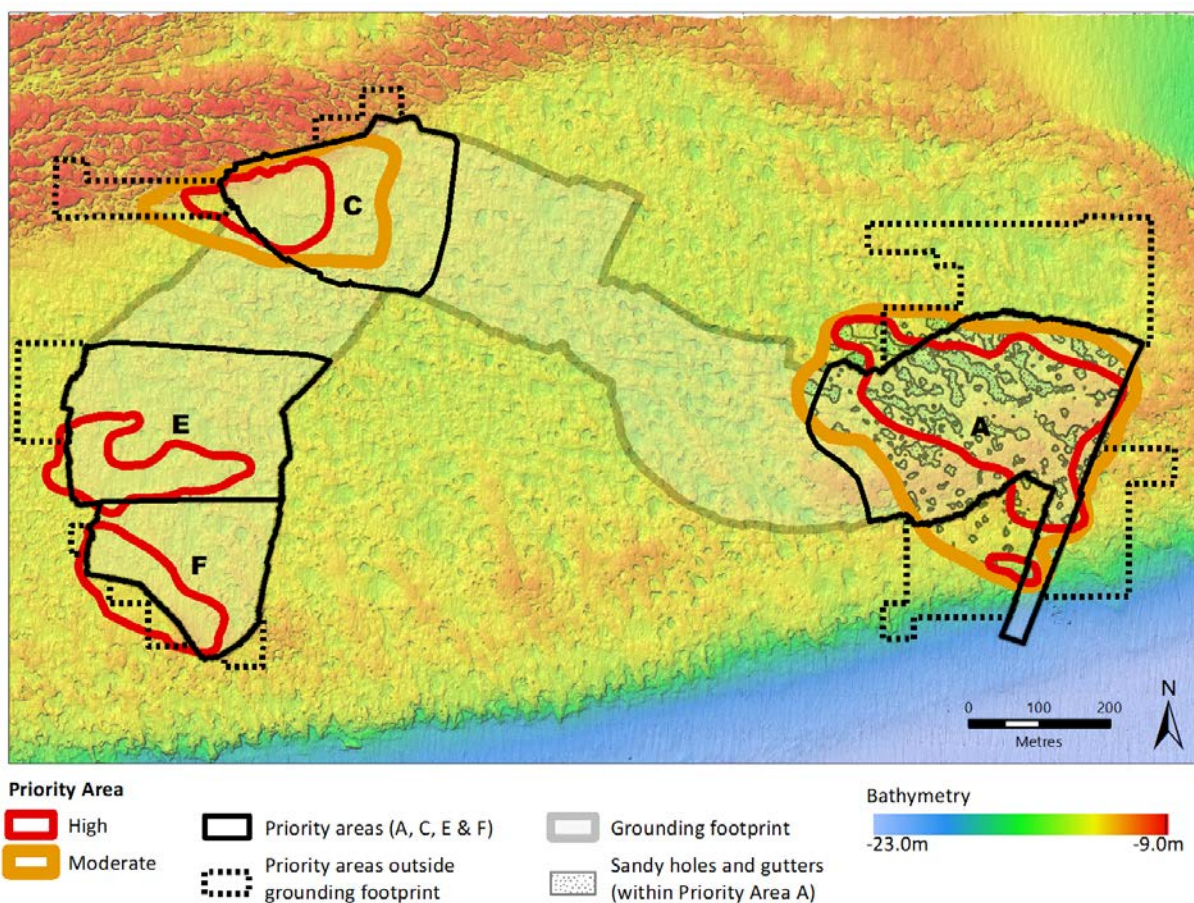
Figure 8-1 Priority remediation areas

- Areas of high and moderate remediation priority with respect to contamination in part of the previously identified Priority Area A
- Areas of high and moderate remediation priority with respect to persistence of grounding-related rubble in part of the previously identified Priority Area C
- An area of high remediation priority with respect to persistence of grounding-related rubble in part of the previously identified Priority Area E
- An area of high remediation priority with respect to persistence of grounding-related rubble in part of the previously identified Priority Area F
- Areas of abrasive flattening and compaction damage in parts of previously identified priority areas C, E and F are not considered to be a priority for remediation.

Priority area	Costen et al (2017) estimates - Contamination and physical damage (ha)	Advisian estimates (ha)			
		Impediment to natural recovery	High	Moderate	Total
A	20.3	Contamination	1.5	0.8	2.3
C	8.2	Physical damage	1.5	2.3	3.8
E	8.1	Physical damage	1.8	-	1.8
F	5.2	Physical damage	1.8	-	1.8
Totals	41.7	Contamination and physical damage	6.6	3.2	9.8
