### Cultural site evaluation of Coloma, Montana, 2000

A CULTURAL SITE EVALUATION OF  
COLOMA, MONTANA  
2000

Prepared for Bureau of Land Management  
By Paige Hoskinson

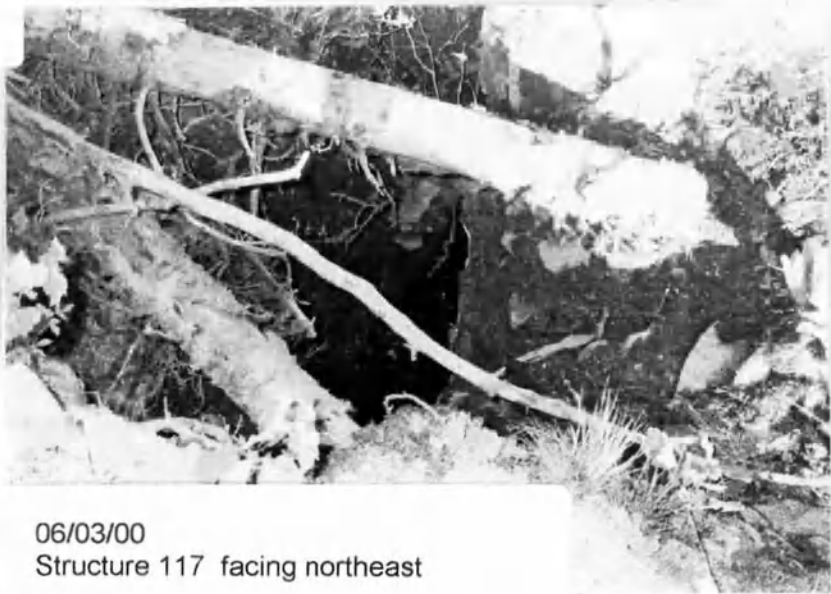
06/03/00  
Structure 117 facing northeast
