# Understanding Architectural Iron Conservation: Corrosion Studies at Fort Sumter National Monument

### UNDERSTANDING ARCHITECTURAL IRON CONSERVATION: CORROSION STUDIES AT FORT SUMTER NATIONAL MONUMENT

A Thesis Presented to the Graduate Schools of Clemson University and College of Charleston

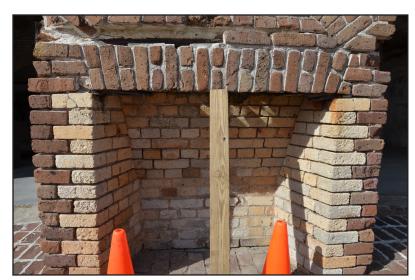
Figure 6.5: Yellow firebrick at Fort Sumter. Likely, this firebrick was brought to the fort at a later date after the Civil War. (photo by author)

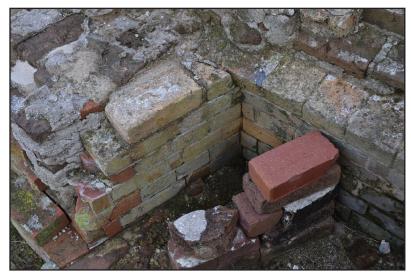
Figure 6.6 Finer quality extruded brick found in the area around the Officer's Quarters. (photo by author)

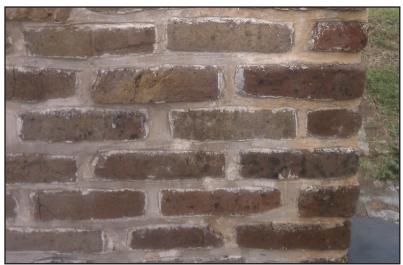
Figure 6.7 Locally-made Charleston grey brick that is common through the fort. (photo by author)

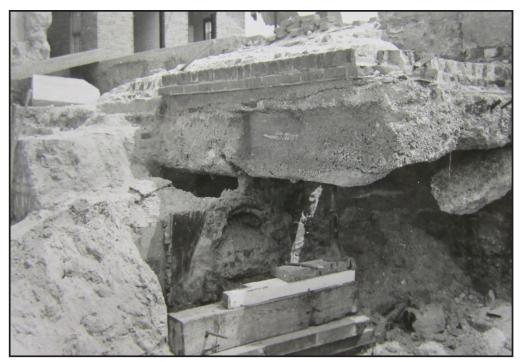
*Figure 7.1 Fireplace basket underneath concrete foundations during the 1950s excavations. (courtesy of Fort Sumter National Monument)*

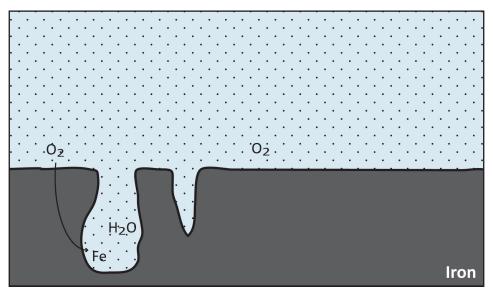
Figure 7.5 Schematic drawing showing pitting corrosion (drawn by author)

As described in figure 7.5, corrosion products can and will transform the iron until a more mineralized form is reached, leaving little or no original iron. Different conditions are believed to influence the formation of different corrosion products and can combine

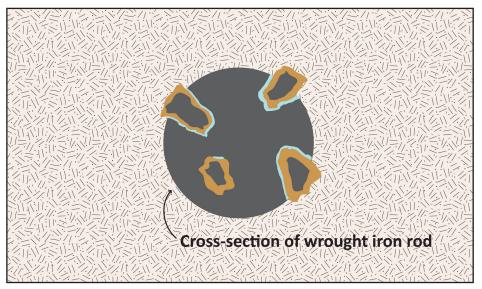
*Figure 7.6 Cross-section of wrought iron rod and crossion forming along slag lines (drawn by author)*

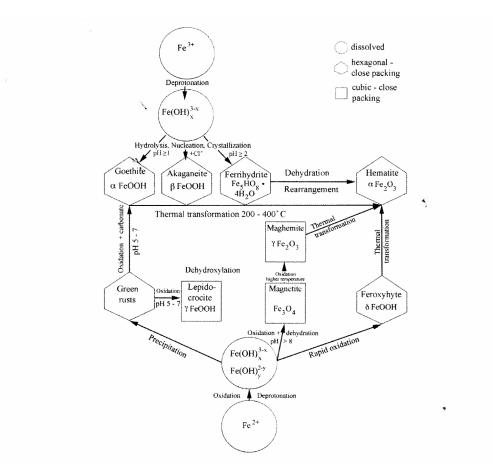
Figure 7.7 Transformation of corrosion products (from Scott, Iron and Steel in Art)

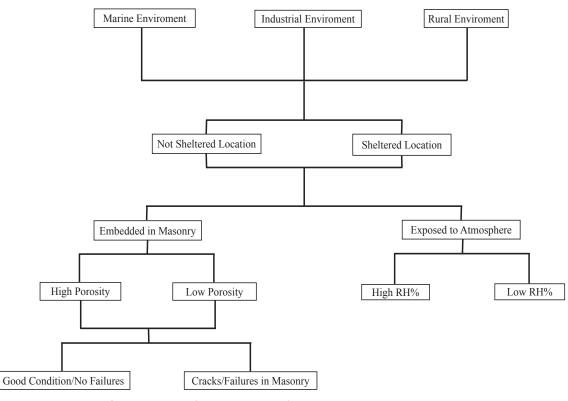
*Figure 10.1 Aspects of iron corrosion (drawn by author)*

The following diagram (Figure 10.1) details and shows only a few influential aspects of atmospheric corrosion and the effect of the surrounding material. By progressing through the options, an enhanced awareness of the varying conditions that affect the corrosivity, or risk level, of historic iron can be formed. These influences are not isolated, and all are dependent on the others. Ideally, this will help shape maintenance plans by ensuring that some of the most influential aspects of iron corrosion are addressed in a timely manner.

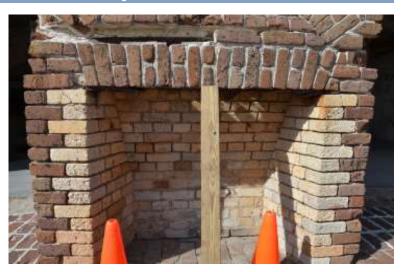
Object Tie-rod

Location Left Flank Casemate n/a Date of Installation 1870-1880

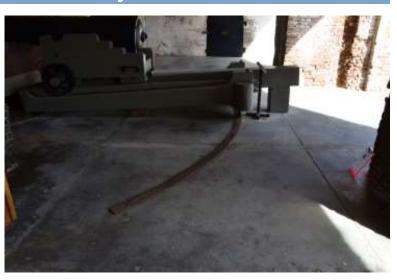
Traverse Rail (2)

Location Left Flank Casemate A-4 Date of Installation 1850

**Previous Treatment** not original

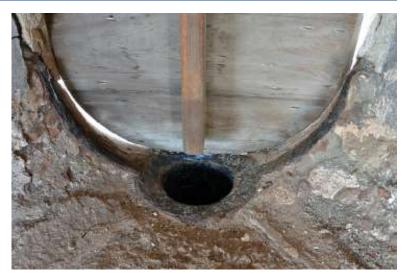
Object Pintle

| Object | Date of<br>Installation | Location | Casemate | Type of Metal | Surrounding Materials | Assumed Porosity | Type of Corrosion |
|---|---|---|---|---|---|---|---|
| Pintle | 1850 | Left Flank | A-5 | cast | concrete (brick rubble), granite | Low | general, pitting, stress cracking |

Location Left Flank Casemate A-5 Date of Installation 1850

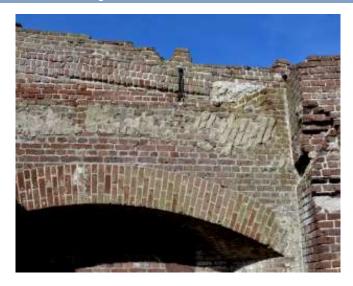
Object Clip

Location Left Face Casemate B-1 Date of Installation unknown

original purpose and date of installation is unknown

**Previous Treatment** none visible

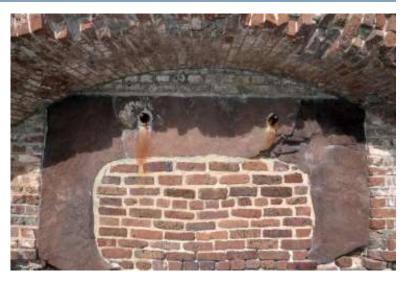
Object Shutter Pins

Location Left Face Casemate A-7 Date of Installation unknown

none visible

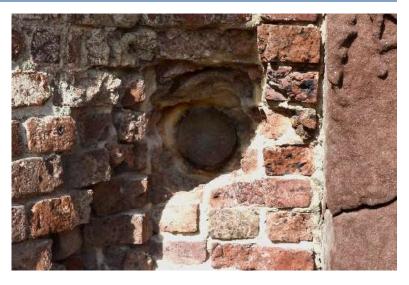
Object Shell

Location Left Face Casemate A-8 Date of Installation 1860

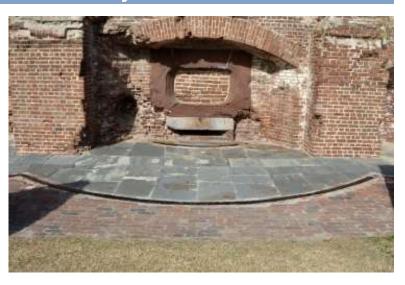
Traverse Rails (2)

Location Left Face Casemate A-9 Date of Installation 1850

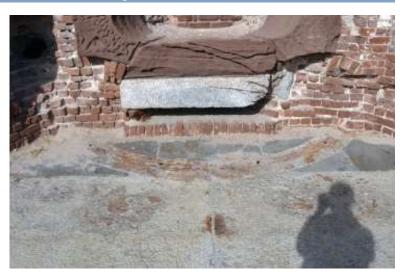
Object
Pintle Tongue

Location Left Face Casemate A-10 Date of Installation 1850

fragment remaining, little original metal remaining

**Previous Treatment** none visible

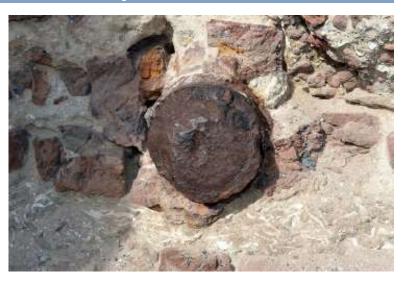
Object Shell

Location Left Face Casemate A-11 Date of Installation 1860

material loss evident

**Previous Treatment** consolidated in December 2012

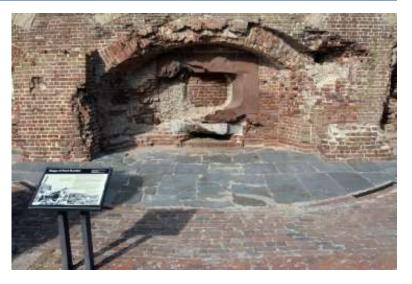
Location Left Face Casemate A-11 Date of Installation 1850

staining visible, middle portion of rails missing

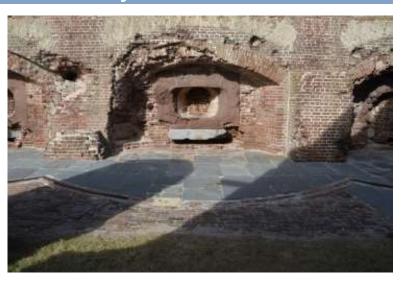
Location Left Face Casemate A-12 Date of Installation 1850

center of rails missing, staining visible around granite base

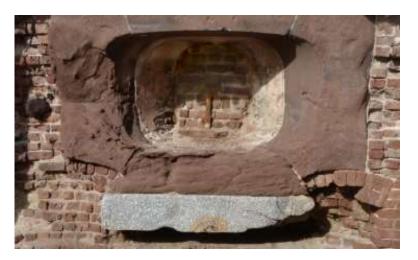
Location Left Face Casemate A-12 Date of Installation unknown

missing iron rails, staining of remaining asphalt mastic visible, unknown purpose and date of installation

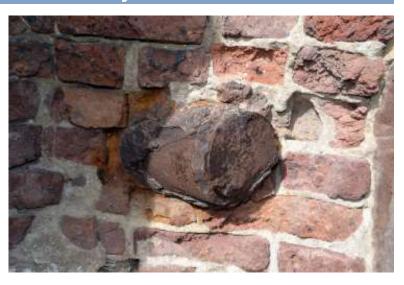
Location Left Face Casemate A-12 Date of Installation 1860

| <b>Type of Metal</b><br>cast | Surrounding Mate<br>brick/mortar | rials |
|---|--|---|
| <b>Current Conditons:</b><br><b>Type of Corrosion</b><br>general, pitting | <b>Priority Level</b><br>high | <b>Risk Level</b><br>high |

**Conditions Comments** material loss evident

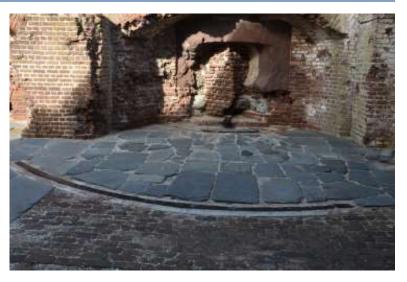
Location Left Face Casemate A-13 Date of Installation 1850

high material loss, staining around granite

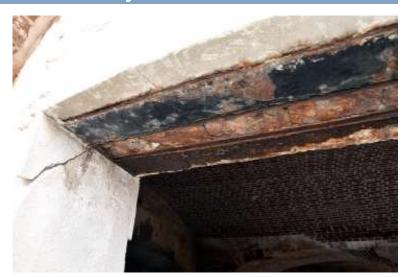
Location Salient Angle Casemate A-13/B-2 Date of Installation 1850

**Conditions Comments** high material loss

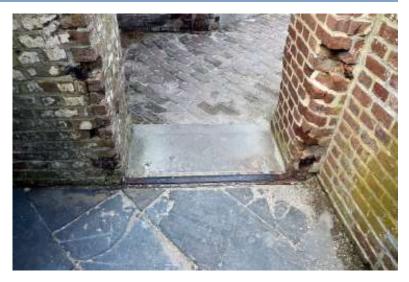
Location Gorge Wall Casemate

| <b>Type of Metal</b><br>cast | <b>Surrounding Materials</b><br>brick/mortar | |
|--|--|---|
| <b>Current Conditons:</b><br><b>Type of Corrosion</b><br>general | <b>Priority Level</b><br>high | <b>Risk Level</b><br>medium |

high material loss

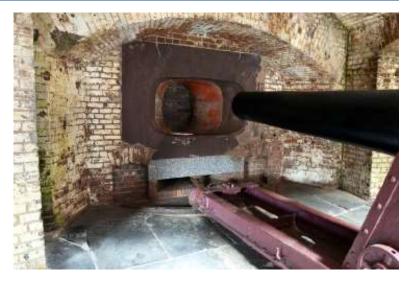
Location Salient Angle Casemate B1-2 Date of Installation 1850

little wear, lots of corrosion

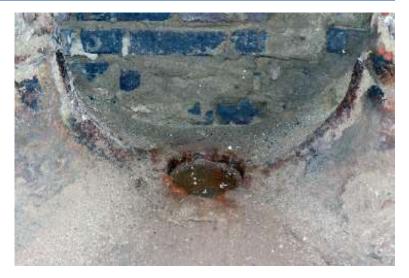
Location Salient Angle Casemate C-4 Date of Installation 1850

**Type of Corrosion** general Priority LevelRisk Levelhighhigh

broken in half, no visible jacking, staining of surrounding rubble concrete

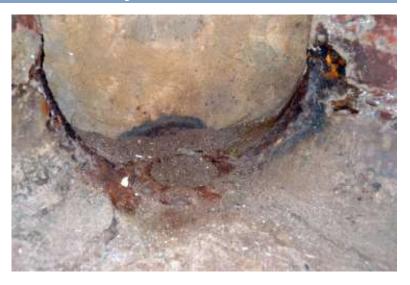
Location Right Face Casemate A-14 Date of Installation 1850

| Type of Metal | Surrounding Mater | rials |
|---|---|---|
| general, stress cracking | high | high |

staining of rubble concrete

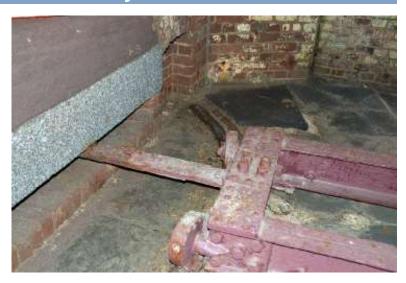
Location Right Face Casemate A-15 Date of Installation 1850

intact, visible pitting

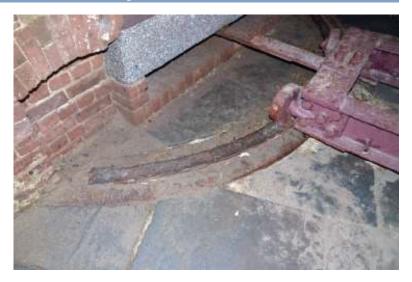
Location Right Face Casemate A-15 Date of Installation 1850

**Conditions Comments** largely intact

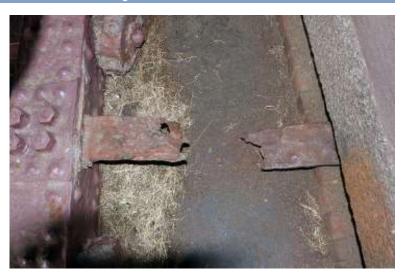
Location Right Face Casemate A-16 Date of Installation 1850

jacking/spalling of concrete occuring around metal interface, staining on top of granite lintel

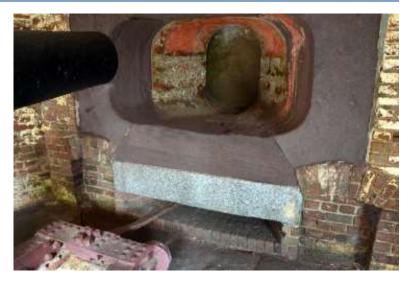
Location Right Face Casemate

| <b>Type of Metal</b><br>cast | <b>Surrounding Materials</b><br>concrete (brick rubble), granite | |
|---|--|---|
| <b>Current Conditons:</b><br><b>Type of Corrosion</b><br>general, pitting | <b>Priority Level</b><br>high | <b>Risk Level</b><br>high |

**Conditions Comments** spalling of stucco

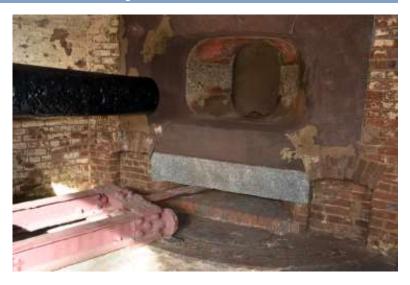
Location Right Face Casemate A-18 Date of Installation 1850

| <b>Type of Metal</b><br>cast | <b>Surrounding Materials</b><br>concrete (brick rubble), granite | |
|---|--|---|
| <b>Current Conditons:</b><br><b>Type of Corrosion</b><br>general, pitting, stress<br>cracking | <b>Priority Level</b><br>high | <b>Risk Level</b><br>high |

# **Conditions Comments** none

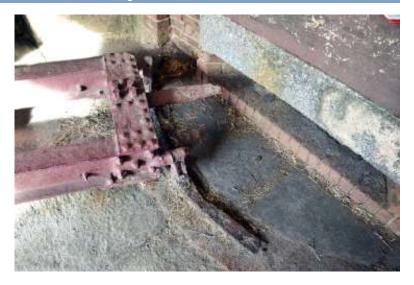
**Traverse Rails**

| <b>Type of Metal</b><br>rolled wrought | Surrounding Mate<br>granite | rials |
|---|--|---|
| <b>Current Conditons:</b><br><b>Type of Corrosion</b><br>general, pitting | <b>Priority Level</b><br>medium | <b>Risk Level</b><br>high |
| <b>Conditions Comments</b><br>portions missing | | |

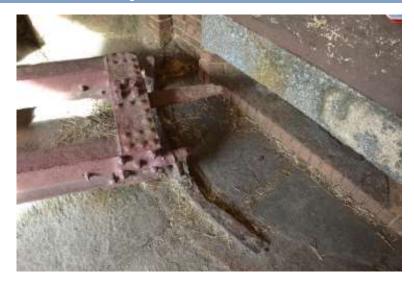
Location Right Face Casemate A-19 Date of Installation 1850

**Type of Corrosion** general **Priority Level** high Risk Level high

broken, corrosion around slag lines visible

previous paint campaigns visible

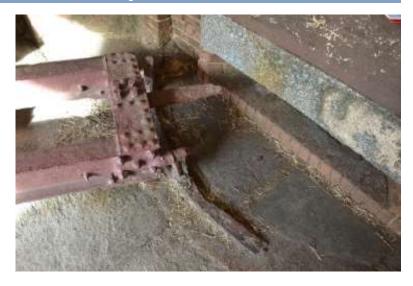
Location Right Face Casemate A-20 Date of Installation 1850

portions missing

none visible

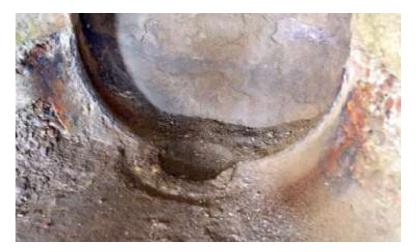
**Pintle & Pintle** Tongue

staining of rubble concrete, pintle tongue largely intact

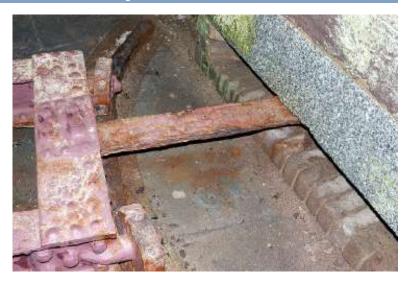
Location Right Face Casemate B1-3 Date of Installation 1850

**Type of Corrosion** general, pitting Priority LevelIhighh

intact, high humidity level, corrosion occuring along slag lines
