29 The research within this paper is based on components postmortem analysis carried out in the
 30 TES-PS10 pilot plant facility built by Abengoa to test the PTC TES systems prior to the design
 31 of commercial projects with this technology [32,33]. The postmortem tests were performed after
 32 more than 30000 hours of operation under representative commercial operation conditions.
 33 Storage fluid analysis is not within the scope of this study, which is focused on the corrosion
 34 performance of storage tanks and pumping systems. Results provide understanding of corrosion
 35 performance of materials typically used for this application and lessons learnt to take into account
 36 for TES systems design to be integrated in PTC facilities at commercial scale.

2 **2. Materials and methods**3 **2.1. TES-PS10 pilot plant**

3 **2.2. Components to be evaluated**

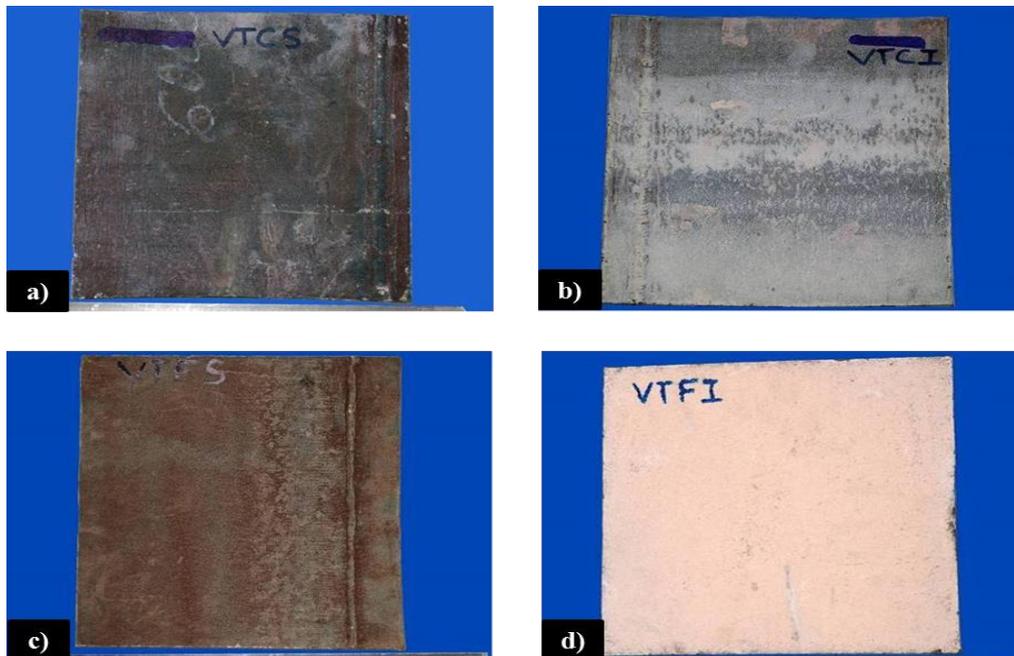
7 **Figure 2. Storage tanks shell sections. (a) upper hot tank (UHT) shell plate section; (b)**
 8 **lower hot tank (LHT) shell plate section; (c) upper cold tank (UCT) shell plate section; (d)**
 9 **lower cold tank (LCT) shell plate section**

7 Generalized corrosion was observed on the UHT plate surface generating an irregular reddish-
8 brown oxide layer (Figure 4a). The plate showed areas in which the oxide layer was detached as
9 well as small areas with somewhat larger corrosion product generation. These areas were
10 examined more in detail in the SEM/EDS analysis. On the other hand, the LHT plate showed
11 abundant nitrate salt deposits which were partially cleaned using distilled water for a detailed
12 examination of the metal surface. Then, a generalized corrosion could be observed with the
13 formation of a reddish-brown oxide layer, slightly less thick than the one observed on the UHT
14 sample. Corrosion products were also partially detached in some areas (Figure 4b). The UCT
15 plate, Figure 4b, showed a generalized corrosion on its surface with a formation of an apparently
16 compact reddish-brown oxide layer. Finally, the LCT shell section showed a general and fairly

17 uniform corrosion with a reddish-brown oxide layer formation.

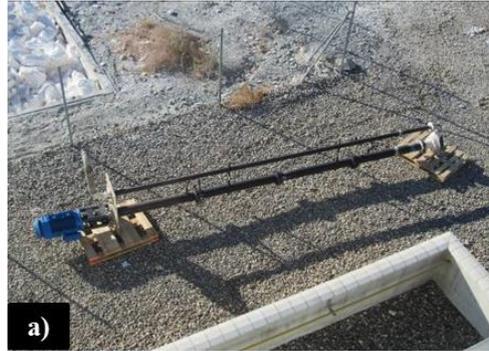
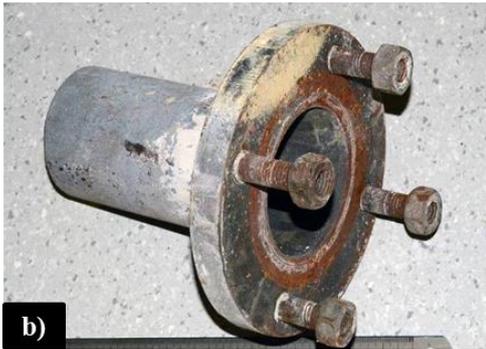
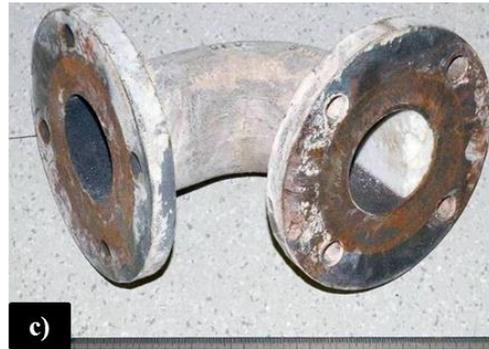
Figure 3. Hot molten salts pump. (a) Molten salts pump removed from the hot storage tank; (b) Discharge pipe section; (c) Discharge elbow section

14 pump was removed from the installation to analyze the corrosion performance of two shaft
 15 sections through which molten salts flow: discharge elbow and discharge pipe (Figure 3).
 16 Therefore, possible corrosion-erosion phenomena produced by molten salts pumping were also
 17 evaluated within these components. While the discharge pipe was manufactured in low carbon
 18 steel, the discharge elbow was fabricated using ASTM A27 cast carbon steel. Summarizing, six
 19 different component sections manufactured in carbon steel were removed for a detailed analysis
 20 of materials compatibility after the facility shut-down.
