SEISMIC REHABILITATION OF COLUMN TO PIER CAP
ACCELERATED BRIDGE CONSTRUCTION
CONNECTIONS AND ACOUSTIC
EMISSION MONITORING
ASSESSMENT

Joel Edgar Parks

A thesis submitted to the faculty of
The University of Utah
in partial fulfillment of the requirements for the degree of

May 2014

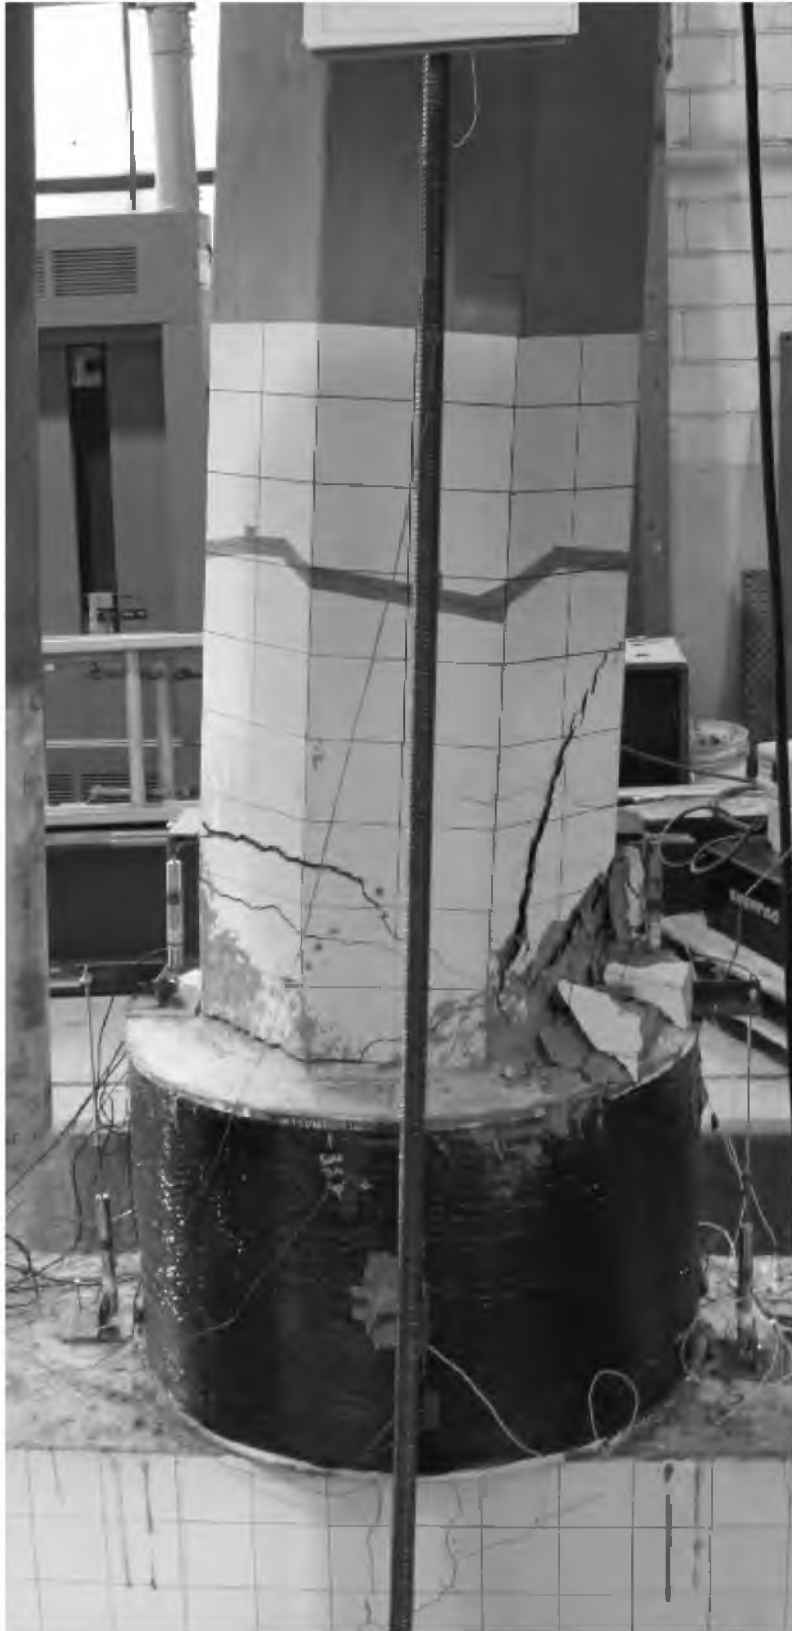
Figure 93. PCLen-2R Monotonic Pushover at Maximum Drift

It was intended to load PCLEN-2R with the loading protocol shown in Figure 56. It was not known, however, that the polarity of the actuator applying the lateral displacements was reversed. Hence, when the test began, the actuator pushed the column to the east to a displacement of 6.65 in. before it could be stopped. The column at the maximum displacement is shown in Figure 93. In this figure, it can be seen that the plastic hinge has been successfully moved above the repair with extensive spalling on the east side of the column that extends up to 20 in. There are, in addition, major flexural cracks that opened on the west side of the column at 2 in., 9 in., and 12 in. above the repair.

After the monotonic pushover, PCLEN-2R was pulled back to zero displacement and the damage was assessed. Figure 94 shows the damage to the column with the loose concrete removed and the column at zero displacement. In the figure, cracks that were observed from the original test are marked in red while the cracks that occurred from the push over are marked in black. With the cracks closed, it can be seen that the cracks that were observed during the monotonic pushover at 2 and 12 in. were existing cracks that opened up, while the crack that was observed at 9 in. is new.

From the test observations of PCLEN-2, the existing cracks at 2 and 12 in. were originally hairline cracks, but after the monotonic pushover, they had grown substantially to a width of 0.05 in. The new crack that opened at 9 in. had a width of 0.016 in.

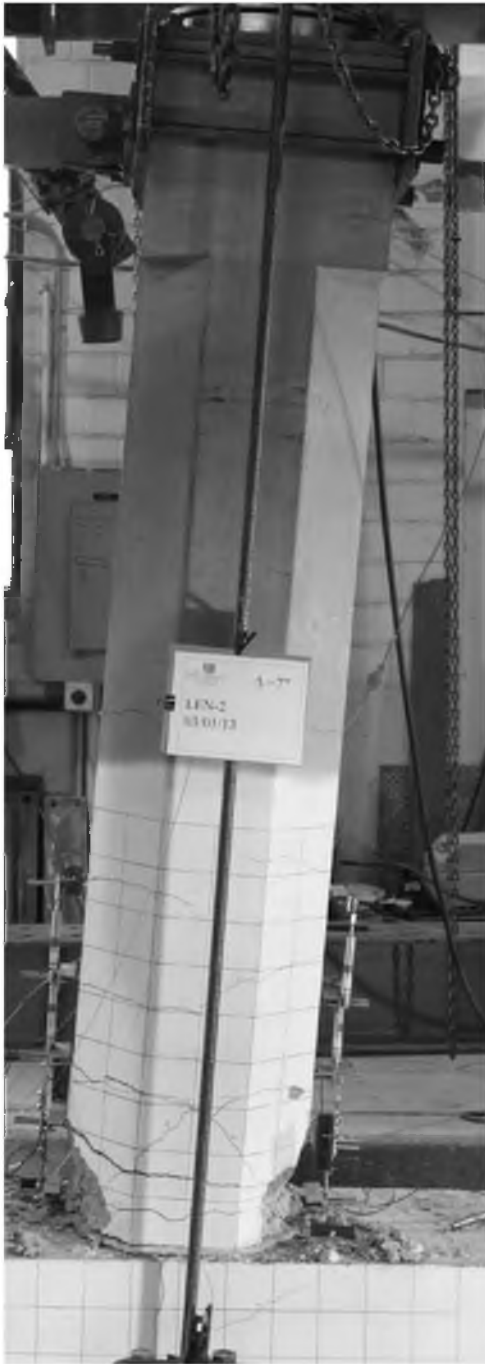
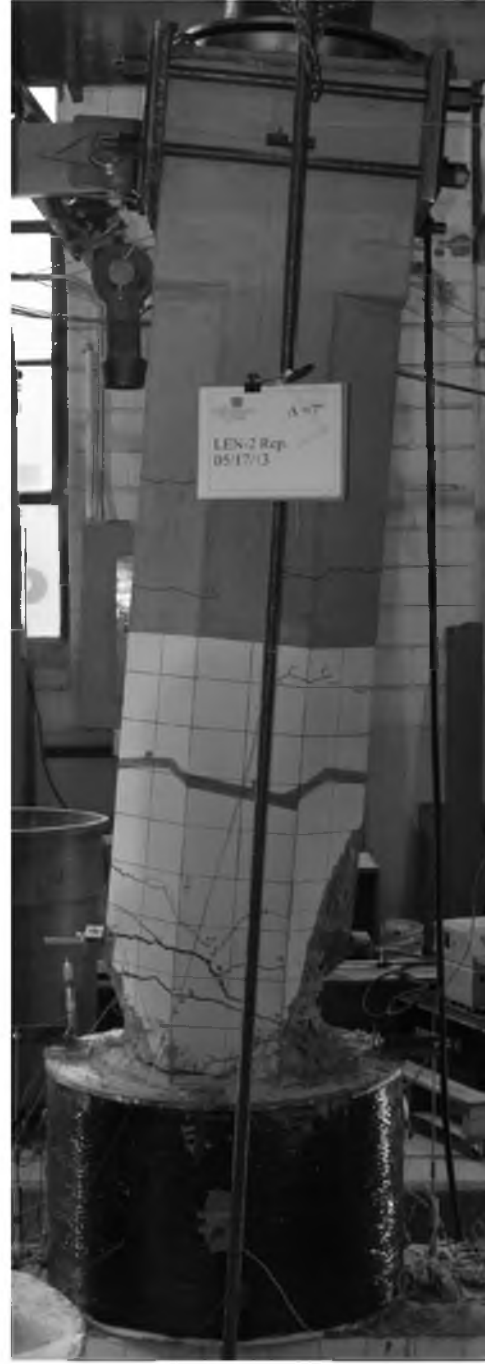
Figure 102. Test Comparison (a) PCLen-2 at Maximum Drift (b) PCLen-2R at Maximum Drift

To clearly see the relocation of the plastic hinge in PCELN-2R, Figure 102 compares PCELN-2 and PCELN-2R at maximum drift. In Figure 102 (a), the plastic hinge formed just above the pier cap while in Figure 102 (b), the plastic hinge was relocated to a position just above the repair. In Figures 103 and 104, the final damage of the east and west side of the column is shown respectively. On the east column face, additional spalling of the concrete occurred, exposing more of the column reinforcement; ultimately the extreme longitudinal bar on this side fractured. The west face of the column had spalling that went 10 in. up the face of the column, exposing transverse reinforcement. No additional flexural cracks developed during the test. The cracks that developed from the monotonic pushover test just continued to widen from 0.05 in. to 0.125 in. by the end of the cyclic test.

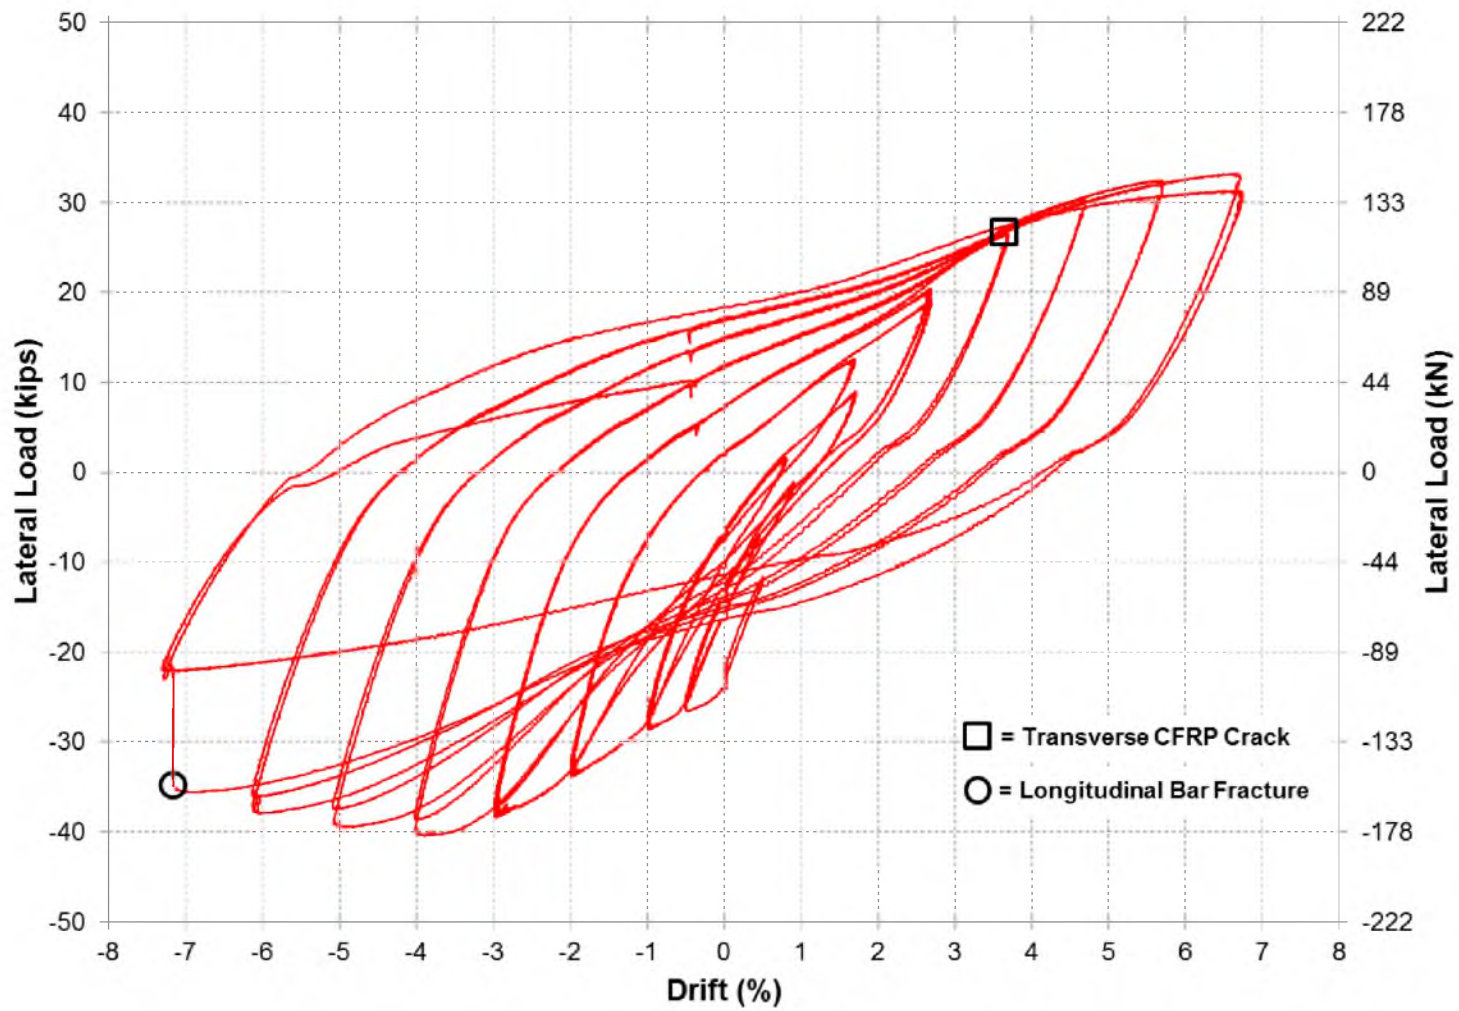
Figure 105. PCLen-2R Hysteresis

Figure 105 shows the hysteresis for PCELN-2R. When the column was pulled back to zero displacement, it required a lateral force of -22 kips to maintain this position due to permanent deformations of the steel reinforcement. Therefore, instead of the hysteresis beginning at zero

force and zero displacement, it begins at a force of -22 kips and zero displacement. Since there was extensive damage to the column from the monotonic pushover test, the right side of the hysteresis has an unusual shape. The left side of the hysteresis, however, was only slightly affected from the monotonic pushover test and has a more normal shape since the column had not yet been displaced in that direction.

Two notable observations during the test are marked on the hysteresis in Figure 105. The square marks the cycle where transverse cracking of the CFRP jacket began to occur and the circle denotes fracture of the column longitudinal reinforcement. Note that there is no apparent change in the hysteresis, due to the transverse CFRP crack. The cracking of the CFRP jacket occurred just above the top of the headed bars and is shown marked by a white line in Figure 106. This crack was not observed during the cyclic test, but was instead identified by the AE event history which will be discussed later. The crack in the CFRP had a final width of 0.125 in., a length of 38.75 in., and only existed on the west side of the jacket. The crack was caused by an increased curvature demand on the repaired section when the column was pushed to the west.

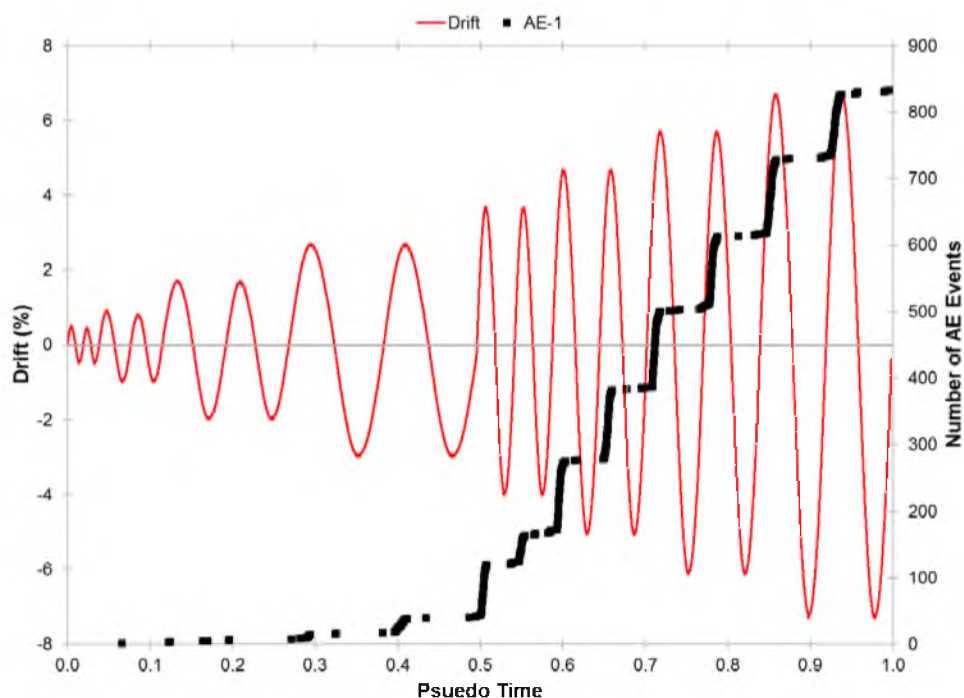
Figure 110. PCLen-2R Cyclic Test AE Events History

of the CFRP jacket had begun. In Figure 110, the AE history for sensor AE-1 is shown. AE-1 was located right above the crack and was able to record all of the events produced by the crack. All the other sensors located on the CFRP jacket recorded very few events and showed no correlation to the damage observed. In Figure 110, it is clear that a dramatic increase of AE events occurs half way through the test and recurs every cycle. To better understand exactly where in the cycle the increase in AE events is happening, Figure 111 shows the AE history of the last half of the test only. In this figure, it can be seen that there is an increase in AE events every time the column is pushed to the east putting tension on the west face of the repair. This increase in AE events occurs right after the column moves through zero displacement, well before it reaches the displacement level previously attained showing no sign of the Kaiser effect.

From the AE history, it is difficult to assess how much damage is being done to the CFRP jacket with each push, but it does give a good indication of the presence and accumulation of the damage. The AE monitoring in this case helped to identify the general location of where damage was occurring in the CFRP jacket and when this occurred by reviewing the AE event history,

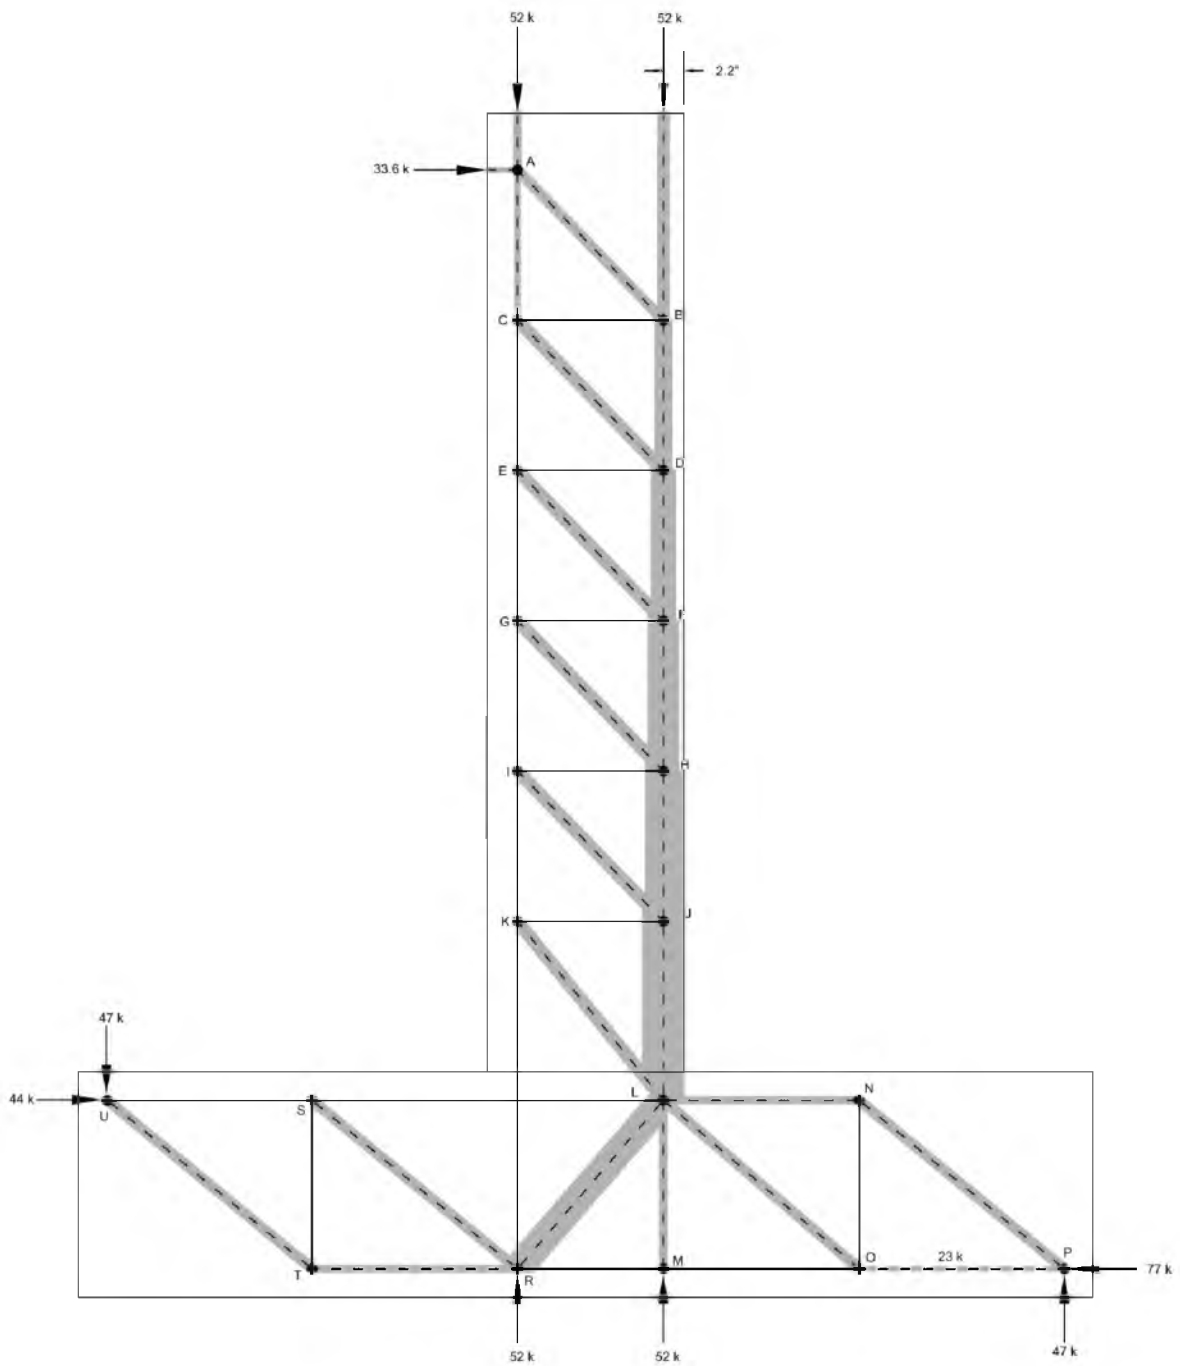
Figure 113. PCLEN-2 STM Strut Width

Figure 113 is a visual representation of Tables 12 and 13 and shows the required strut widths in both the column and pier cap. Note that the width of strut H-J does not reach the face of the column, which from Table 12 has a width of 3.75 in. which is less than the maximum strut width of 4.4 in.

To verify the accuracy of the model, the horizontal load calculated to cause strut J-L to crush in the STM is compared to the maximum horizontal load from the test results of PCLEN-2. The horizontal load at which strut J-L is calculated to crush is 33.6 kips. With a horizontal load of 34.74 kips obtained from the cyclic test results of PCLEN-2, the STM predicts 97 percent of this load. Since the maximum horizontal load from PCLEN-2 is obtained from cyclic testing, it would be expected that the maximum horizontal load from a monotonic pushover test would be higher. Therefore, although the direct comparison of the strut and tie to the PCLEN-2 results are not the best comparison, the strut and tie model shows it is conservative.

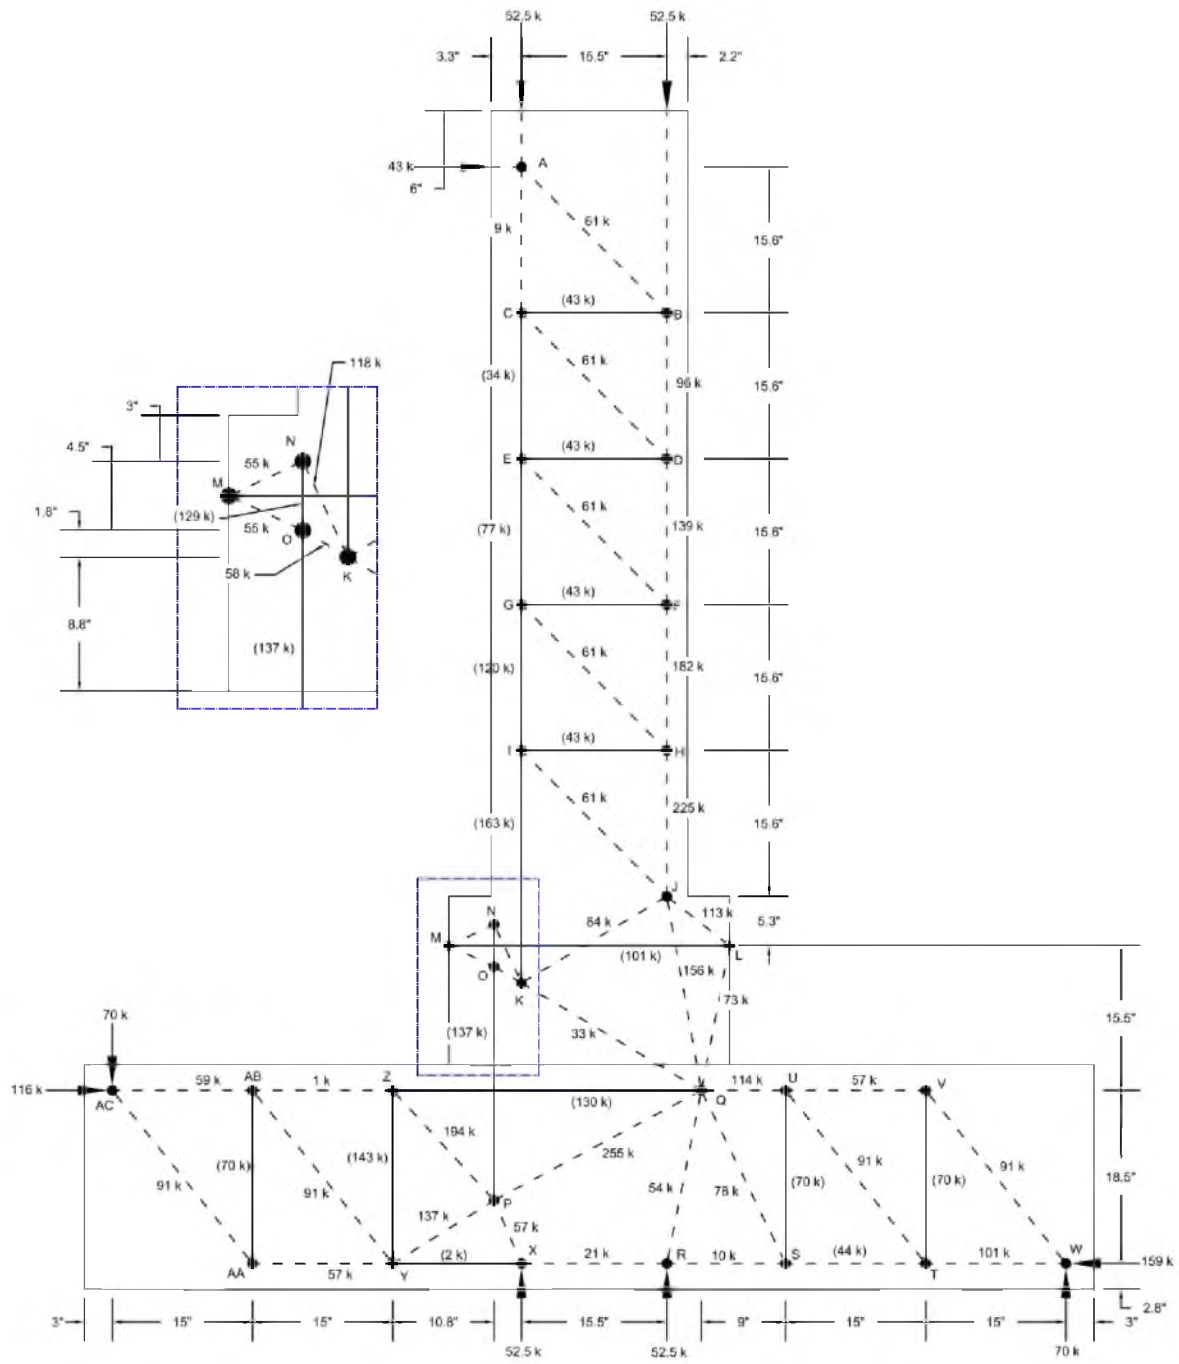
Figure 114. PCLen-2R STM

because the extreme bar in the original specimen PCLEN-2 had fractured just above the pier cap, as shown in Figure 80. Instead, all the tension generated by bending is transferred to the pier cap by ties N-O, and O-P which represents three of the postinstalled headed bars. Since the headed bars were postinstalled, there is not a means to directly transfer the tension in the bars to the pier cap longitudinal reinforcement directly. Therefore, tie O-P is terminated above the bottom longitudinal reinforcement and subsequently anchored with struts P-Q, P-Y, P-Z, and P-X. Also, the CFRP jacket is represented in the STM by tie L-M, which transfers the tension across the repaired region to the headed bars.

From the test results, it is known that the compression strut in the column just above the repair began to crush at the maximum lateral load. In the STM for PCLEN-2R, this failure mode is observed when a horizontal load of 43 kips is applied to the top of the column. The horizontal load calculated by the STM is the same horizontal load that was computed from extrapolating the base moment in section 4.1.3. To verify the accuracy of the STM, the horizontal load calculated by the STM is compared to the horizontal load from the monotonic pushover test results of PCLEN-2R. With an actual horizontal load of 46.88 kips from the monotonic pushover test results of PCLEN-2R the STM conservatively computed 92 percent of the monotonic pushover load.

The same procedure used to develop the STM for PCLEN-2 was used to also develop a STM for PCLEN-2R. Since the column cross-section in the plastic hinge region is the same for both PCLEN-2 and PCLEN-2R, the struts on the compressive face of the column in the STM for PCLEN-2R are considered to be 2.2 in. from the column face just like in the STM for PCLEN-2. Figure 114 shows the STM for PCLEN-2R. In the STM for PCLEN-2R, there is no tie which represents the longitudinal reinforcement in the column that crosses over into the pier cap. This is

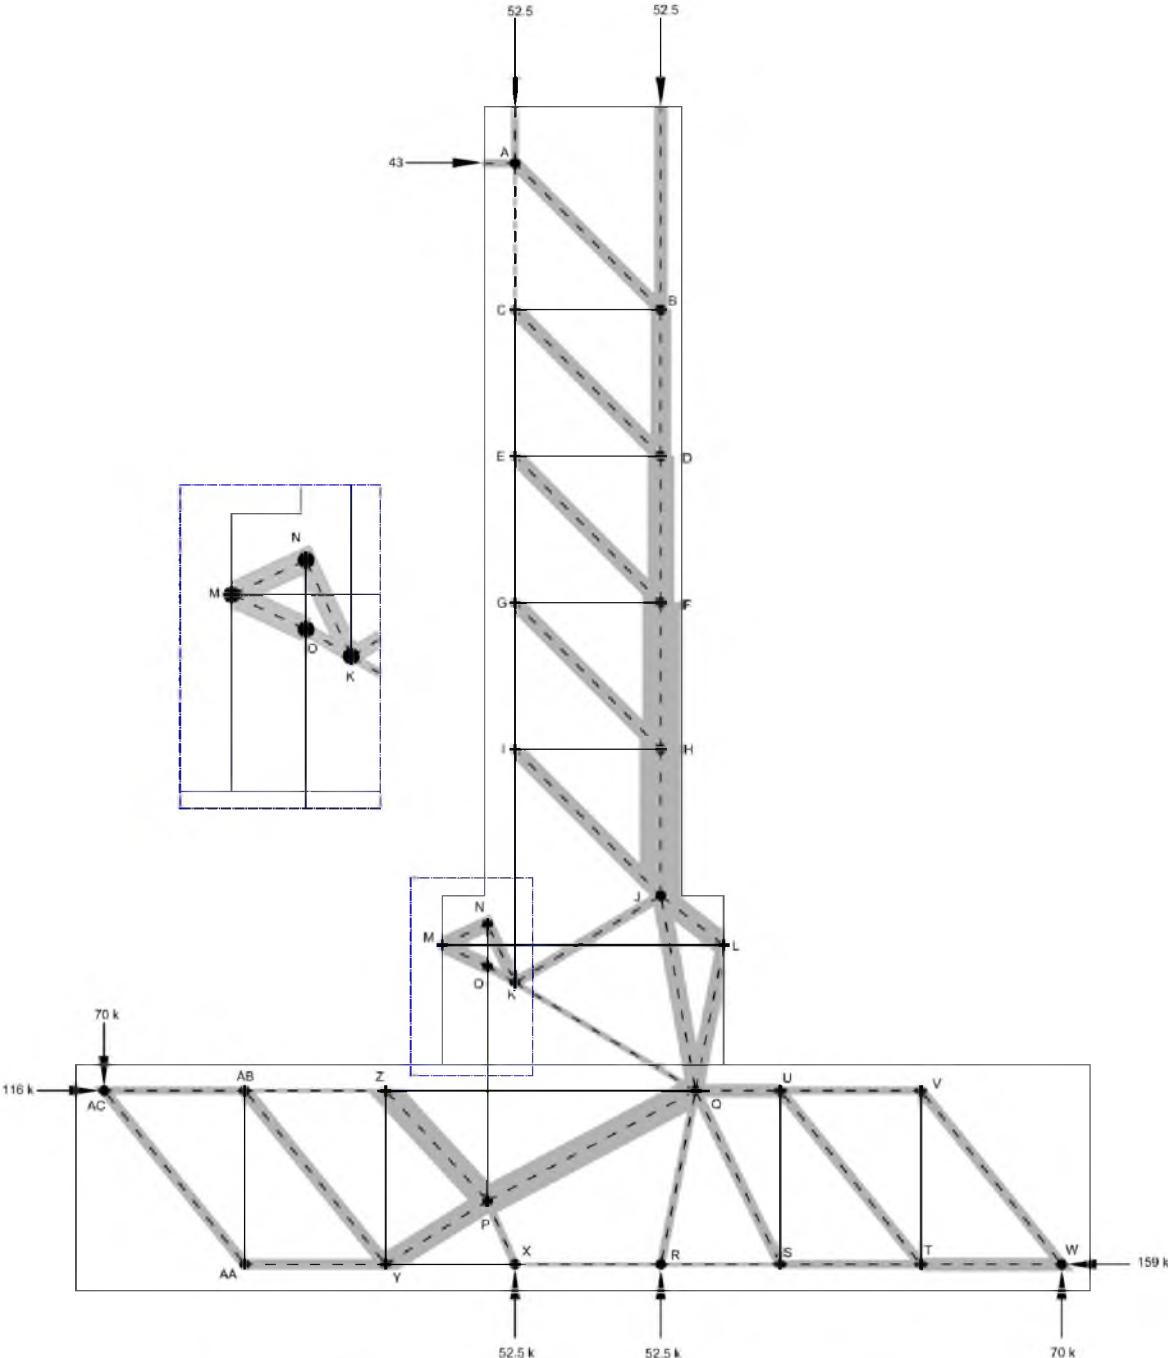
Figure 115. PCLEN-2R STM Strut Widths

The required sizes of the struts in the STM for PCLEN-2R are calculated as before by using equations 9 – 11. The results from these calculations are shown in Table 16 for the struts located in the column, Table 17 for the struts located in the repaired region, and Tables 18 and 19 for the struts located in the pier cap. Note that struts E-F, G-H, and I-J all have the same properties as strut C-D, and for this reason, they were not included. A graphical representation of these calculations is also shown in Figure 115 where the required minimum strut widths are drawn to scale on the STM.

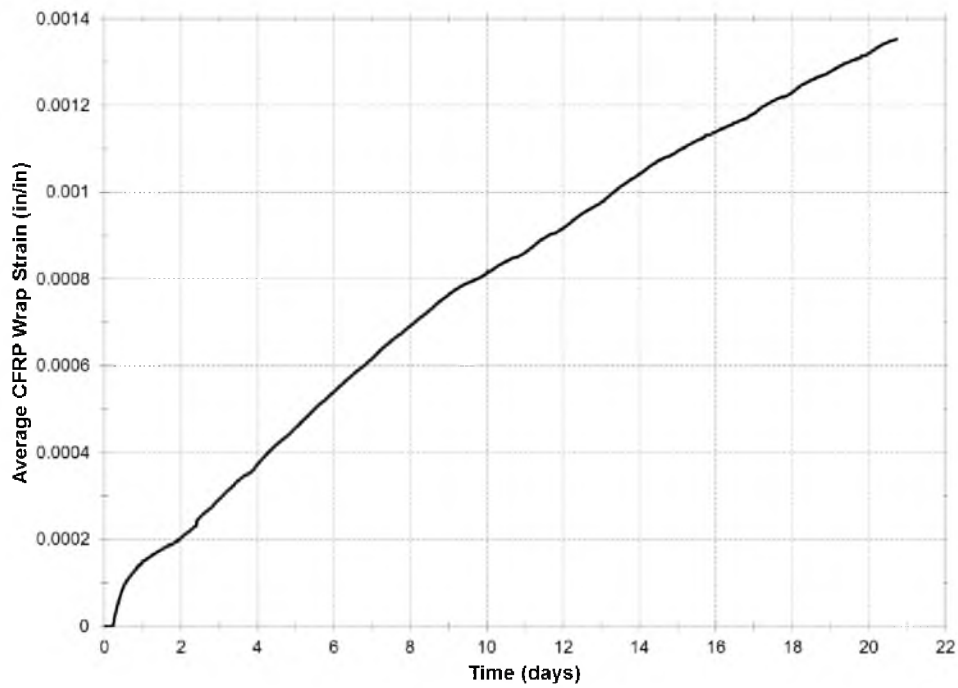
Figure 116. Average CFRP Wrap Strain from Concrete Expansion

Strain gages on the CFRP wrap as shown in Figure 92 were used to measure the posttensioning of the CFRP jacket while the expansive concrete cured. Figure 116 shows the average strain in the CFRP jacket from when the concrete was cast to the day of the test, which was 21 days. The maximum average strain caused by the expansion of the concrete was 0.0013 in./in., which is 12 percent of the ultimate strain capacity of the CFRP composite.

The same postinstalled bar layout and repair procedure used for PCLEN-2R was used for PCLEN-3R. There were, however, two modifications made to the design in an attempt to negate the transverse cracks in the CFRP. The first change was to add an additional 1 in. of length to the postinstalled headed bars in the repaired region in order to lessen the distance from the top of the CFRP jacket to the top of the headed bars. The second change was the use of expansive concrete instead of nonshrink concrete in an attempt to posttension the CFRP jacket and increase the confining pressure. The mix design for the expansive concrete is shown in Table 23.

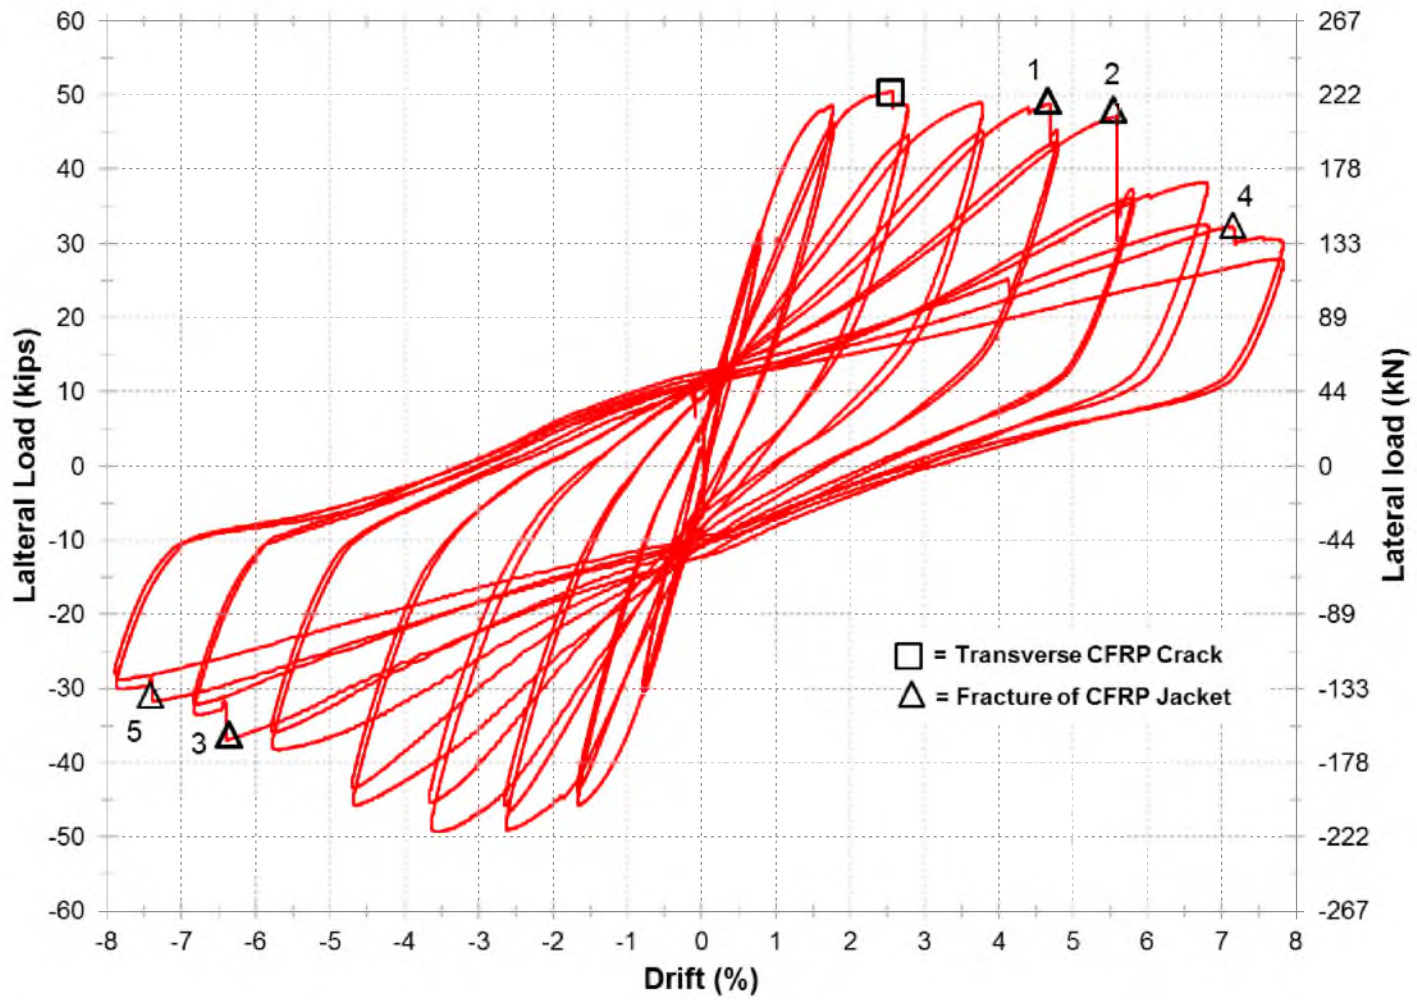
Figure 117. PCLN-3R Hysteresis

PCLEN-3 was loaded to failure using the loading protocol in Figure 56. The results from the cyclic test are shown by the hysteresis in Figure 117. Although measures were taken to try and prevent transverse cracking of the CFRP jacket, it still occurred. The cycle where transverse cracking begins is shown by a box in Figure 117. Similar to PCLEN-2R, the transverse crack developed right at the top of the postinstalled headed bars, but unlike PCLEN-2R there were

multiple layers of transverse cracking with one crack extending around the entire circumference of the CFRP jacket. The cracking of the CFRP jacket is shown in Figure 118. The transverse crack is thought to have occurred on both sides of the column in this test, because both extreme longitudinal bars had pulled out in the original test causing additional demand on both sides of the column.

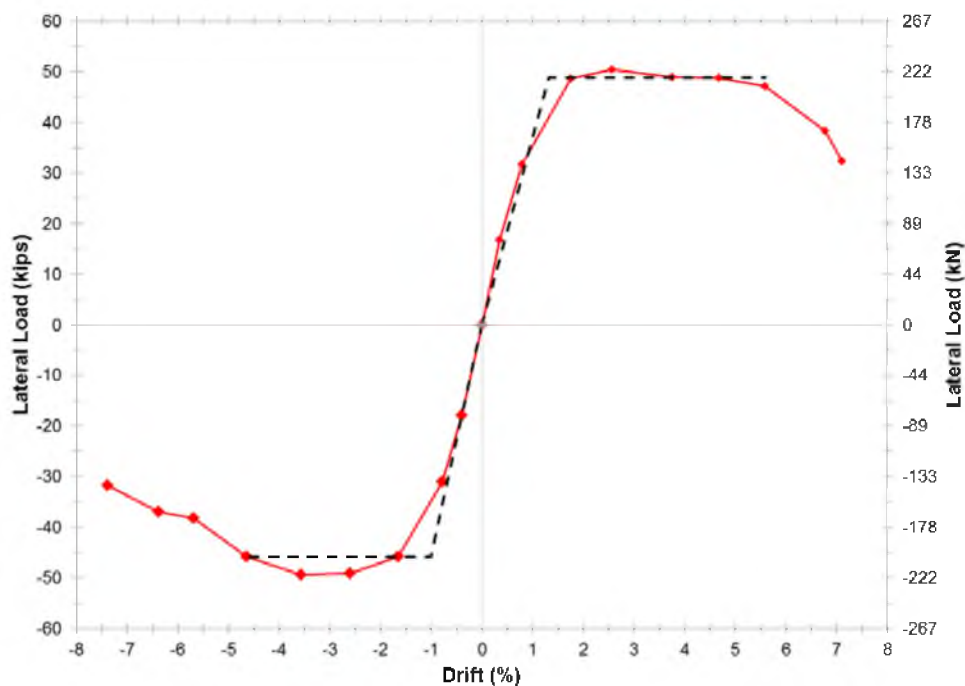
Figure 122. PCLEN-3R Backbone Curve

Although the failure mode of PCLen-3R was not intended and the plastic hinge was not relocated entirely above the repaired region, the specimen still showed a good performance. Figure 122 shows the backbone curve for PCLen-3R with the idealized elastoplastic curves superimposed. Failure of PCLen-3R was considered when the lateral load dropped below 20 percent of the maximum lateral load which occurred at a drift of 5.6 percent in the push direction and a drift of 4.6 percent in the pull direction. Using the equal area method to estimate the idealized elastoplastic curve, the yield drifts were computed as 1.3 percent and 1.0 percent for the push and pull direction, respectively. This results in a displacement ductility of 4.2 in the push direction and 4.6 in the pull direction. Considering that Caltrans limits the displacement ductility of

bridge columns between 4.0 and 5.0, PCLEN-3R still exhibited a satisfactory ductile performance.

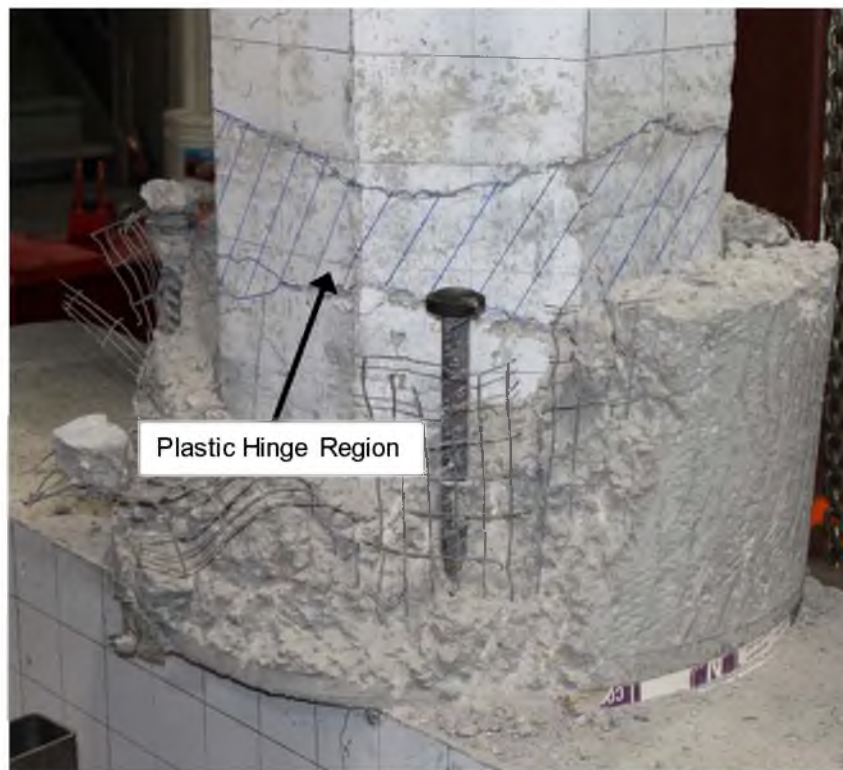
Figure 123. PCLEN-3R Plastic Hinge Relocation

The repair of PCLEN-3R was successful in re-establishing the lateral load capacity of the column and allowing the joint to fail in a ductile fashion. The repair did not move the plastic hinge entirely above the repaired region before failure of the CFRP jacket. However, the plastic hinge was relocated above the originally damaged section of the column even though it was not above the surface of the enlarged cross-section, as shown in Figure 123. There are certain reasons for this: the first is that Lenton splice sleeves in the column were shorter; as such the plastic hinge in PCLEN-3 is much shorter than when the sleeves were located in the pier cap as in PCLEN-2. With a shorter plastic hinge, damage does not spread up the column, meaning the repair could have been shorter thus reducing the required flexural demand in the repaired region. The second reason is that with a stronger concrete in the column than expected, and a column cross-section at the top of the repair with very minor damage, the required moment to move the plastic hinge above the repair was higher than expected, thus causing the failure to occur in the repair. Both of these reasons relate back to the original damage state of the column. Therefore, the importance

of having a good assessment of the damaged column strength is paramount.
