HMS Hampshire 100

Survey Report

Location: Atlantic Ocean, waters west of Orkney, Scotland

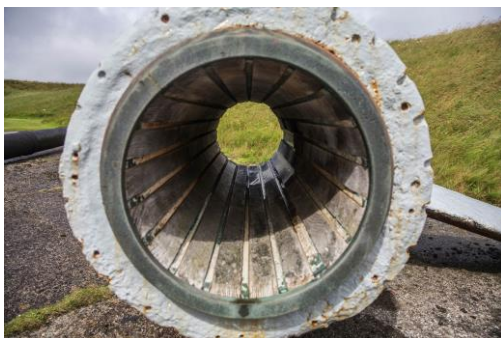
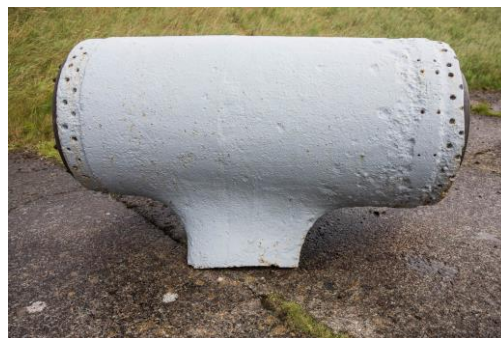
Divers from the 1983 survey reported that the starboard propeller shaft had broken at a flange just outside the shaft casing. The bracket close to the propeller, supporting the shaft, was broken at the hull. The starboard propeller itself was lying on the seabed beside the wreck. The diving licence precluded removing items from the wreck, but the divers believed it did not prevent them from recovering items lying on the seabed around it. The prop, a section of shaft and the bearing support were lifted, and the recovery reported to the Receiver of Wreck in Aberdeen. The prop and shaft were offloaded onto the pier at Peterhead when the vessel arrived there on completion of the works. It lay there for more than a year until it was sent to Orkney, where it remains on display at the Scapa Flow Visitor Centre & Museum at Lyness on the island of Hoy.

Figure 24: Starboard prop shaft bearing on display at Scapa Flow Visitor Centre & Museum, Lyness

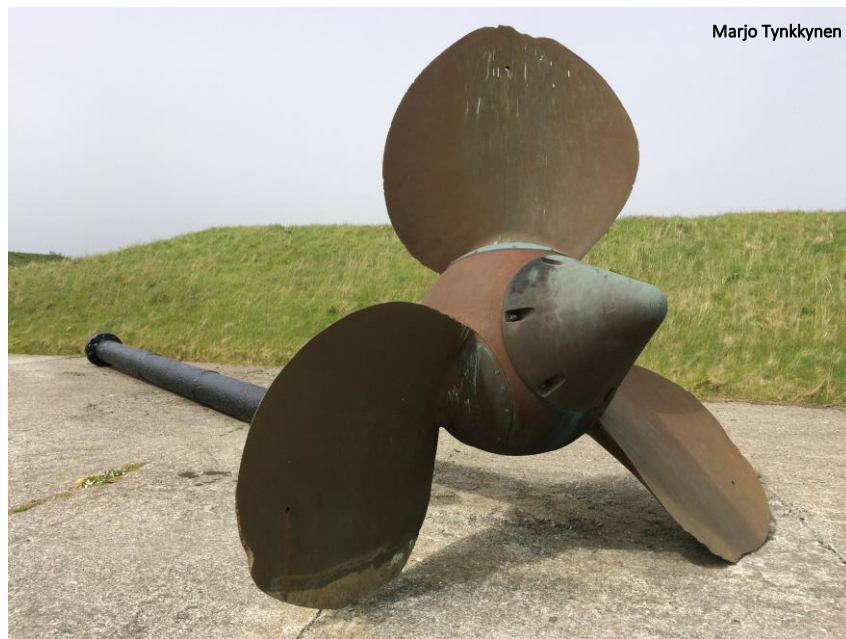
Figure 26: Salvaged starboard propeller at Scapa Flow Visitor Centre & Museum, Lyness

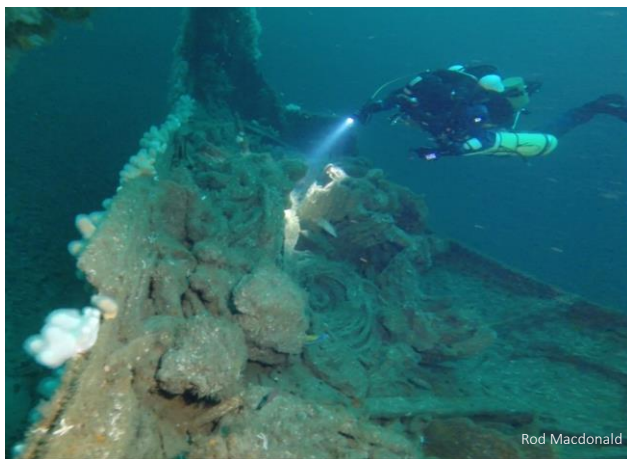
Figure 37: Looking forwards to the upturned stem

Looking forward towards the upturned stem (Figure 37), fragments of hull plating can be seen on the starboard (left) side of the ship, whilst on the port side (right) the remaining shell plating quickly reduces in height to meet the thicker tapered vertical armour belt plates.

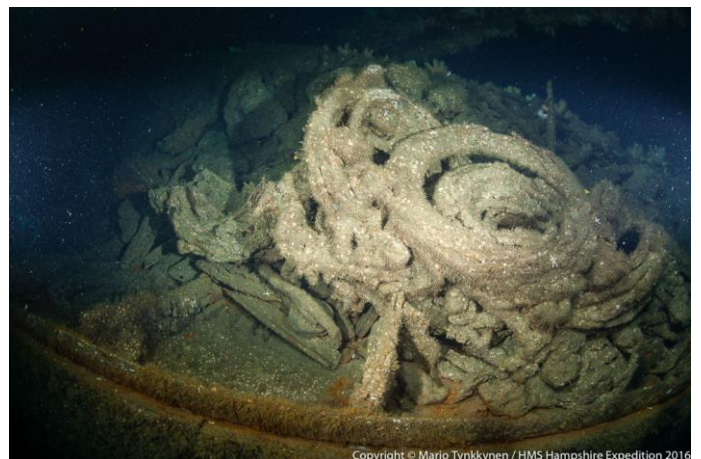
Figure 38: Warps of cable and debris

The internal deck is still present but sags downwards. Warps of cable and associated debris fill the space (Figure 38).

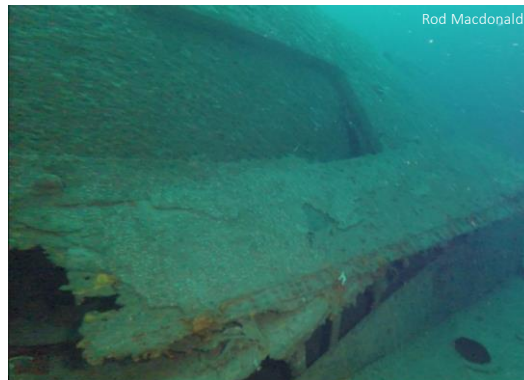
- Further aft on the port side just aft of P-turret, armour belt plates are displaced. Moving further aft, hull plating from the Upper Deck becomes visible as the ship is propped up on her port side by the P-turret and the Bridge structure. This thinner plating has buckled and been pushed out to the side.

Figure 41: Armour belt and Upper Deck plating at P-turret

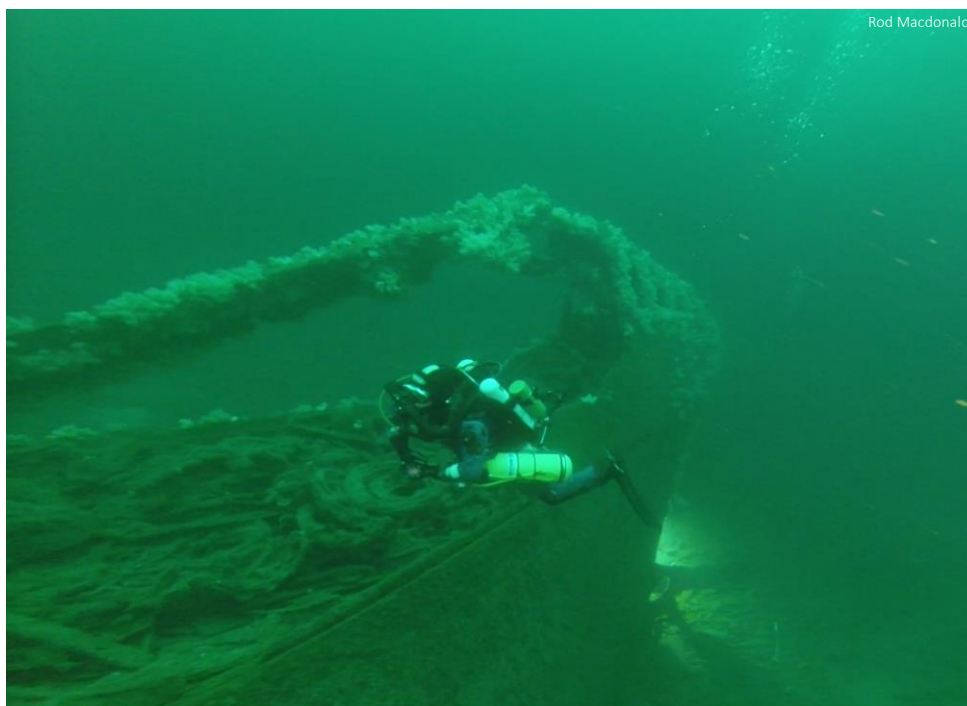
The keel bar has been severed at approximately frame No 28, some 20 metres abaft the stem, and has been smoothly bent over so that it now angles downwards from the stem to where the severed end rests on the seabed to starboard.

Figure 42: Port view of the bow showing keel bent over to starboard

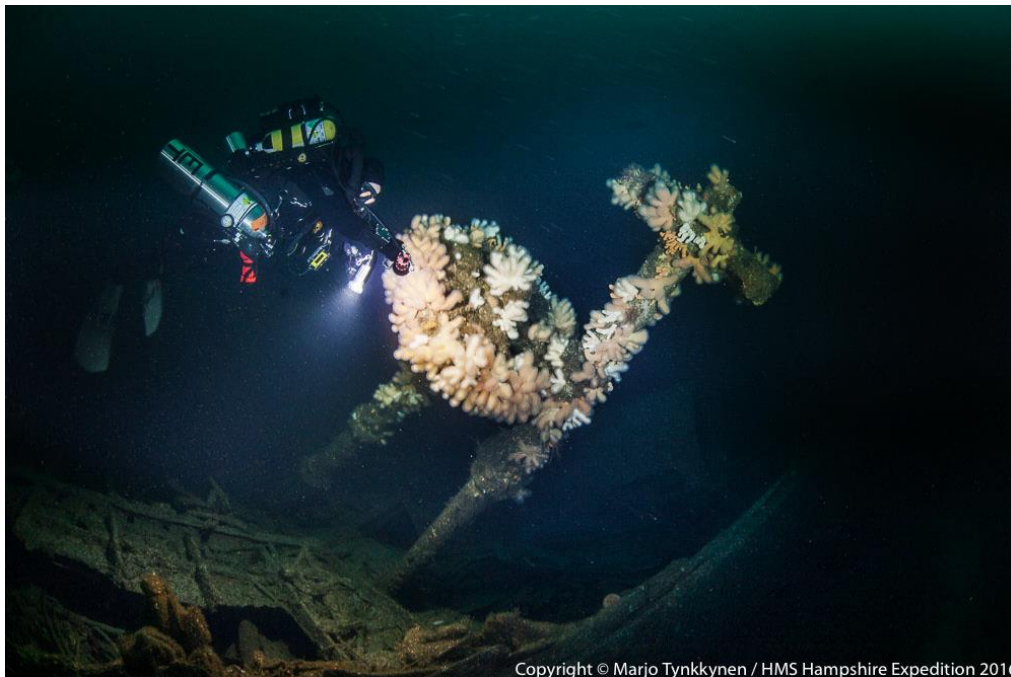
The three anchor capstan drive shafts are undamaged by any blast effect and are canted over to starboard. The deck capstans themselves are under the wreck, with one visible on the port side. The gears seen in the image below would have been driven by a small steam engine, which is also visible in the debris (not pictured).

Figure 45: Capstan drive shafts

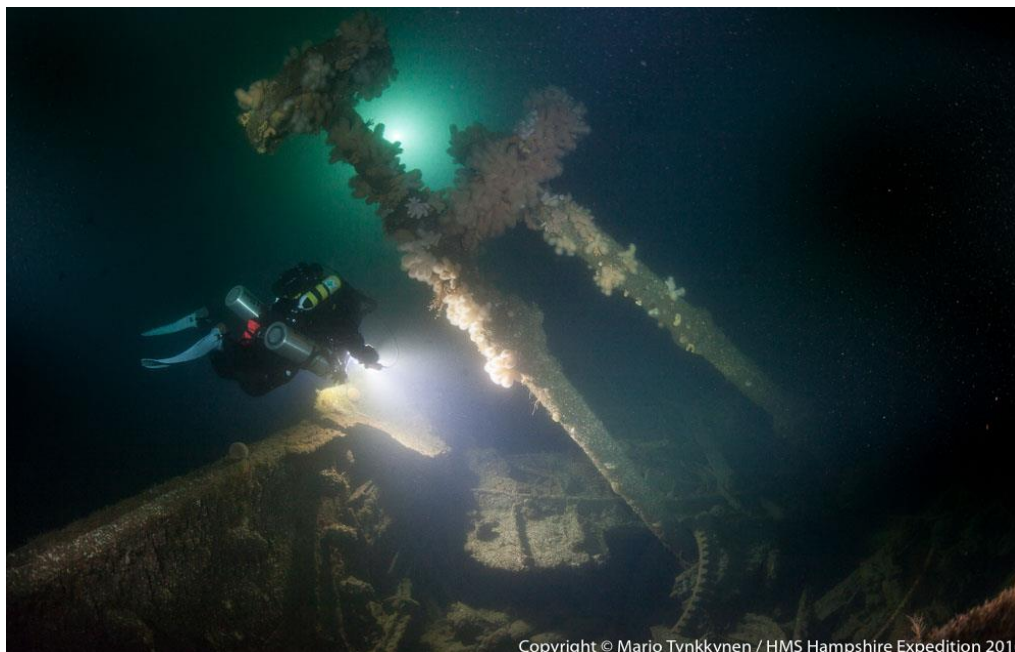
Figure 46: Forward anchor capstan gears and drive shafts protrude up from the bow wreckage

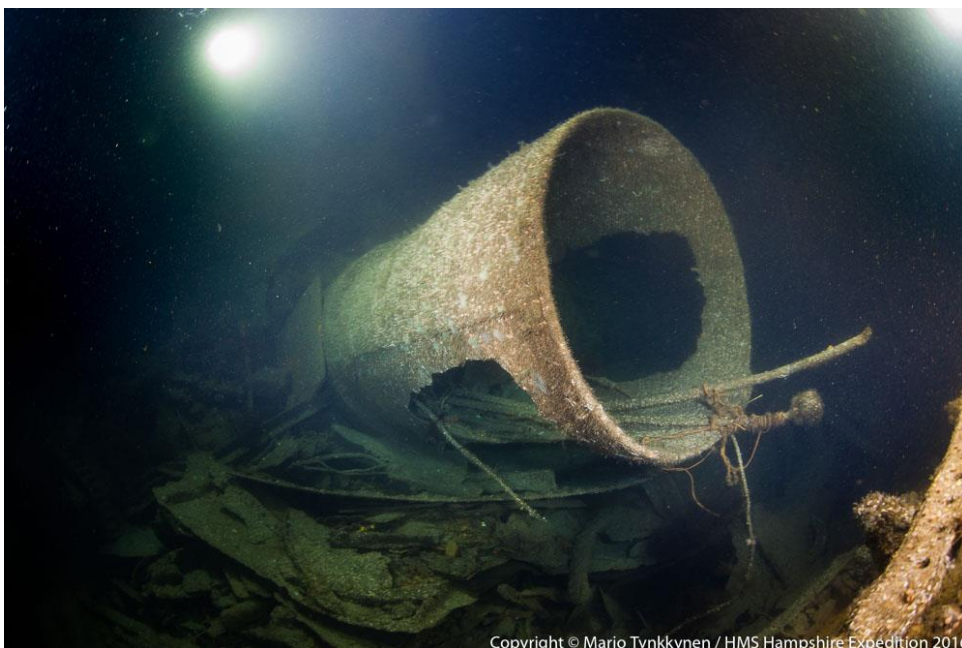
A-turret ammunition hoist trunking lies in the bow debris just aft of the three capstan shafts and leans to starboard. It is still attached to the gun, which is displaced to port and just visible on the seabed. The trunking shows signs of decay consistent with 100 years of submersion in saltwater, but is otherwise undamaged.

Figure 48: Looking aft on the starboard side at the base of A-turret hoist trunking

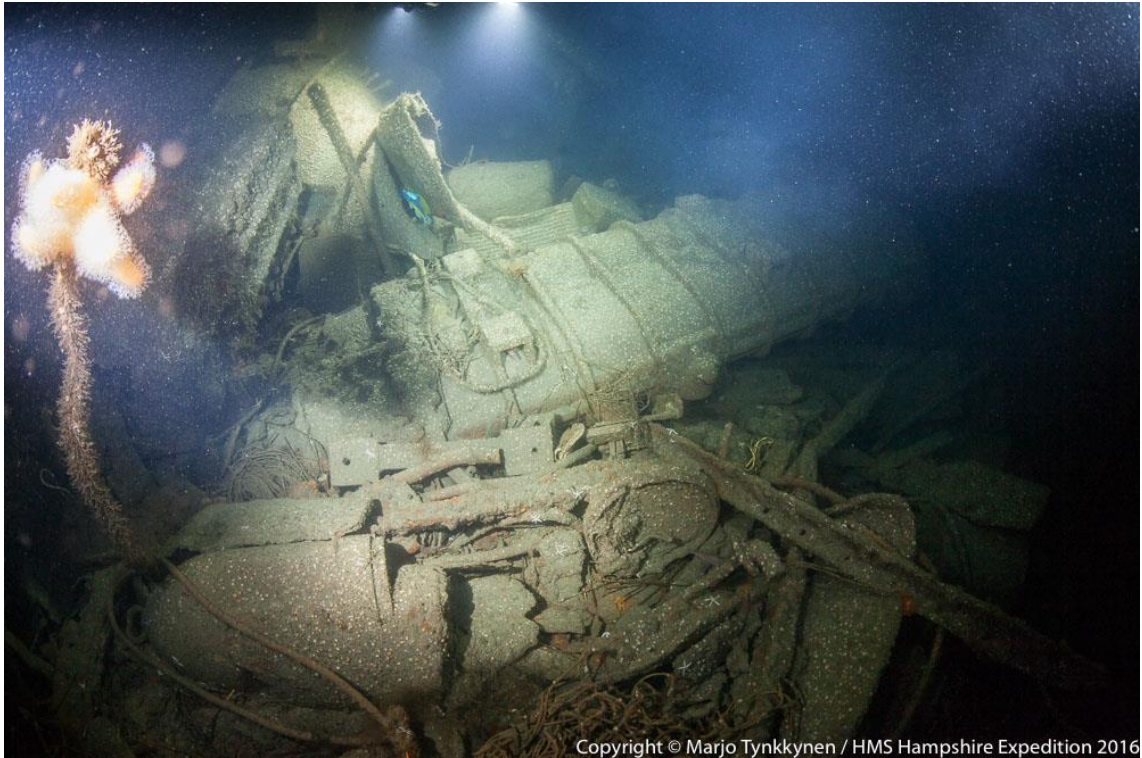
HMS HAMPSHIRE's two lateral submerged torpedo tubes were positioned on the Platform Deck between frame Nos 33 and 37. The starboard torpedo tube lies in the damaged area of the bow in the approximate correct longitudinal position, although it now rests lower in the wreckage. The tube appears complete and undamaged with the inner torpedo door attached. On the seabed the outer door is visible in severed hull plating to starboard. The port side tube was not located during the survey. The port side tube outer door, however, remains in situ in the port hull plating. Intact torpedo warheads lie in the bow wreckage adjacent to the tube and a possible torpedo body lies outside the wreck, flush with the starboard side of the hull.

Figure 50: The starboard torpedo tube seen from forward

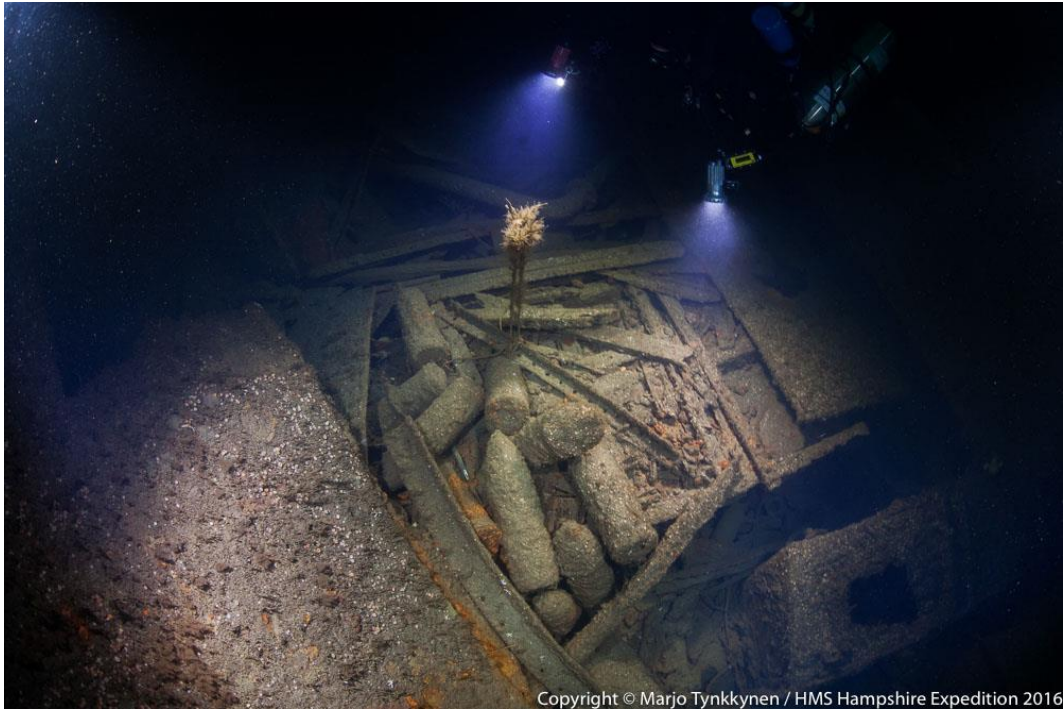
The forward torpedo rooms were surrounded fore and aft by 7.5-inch propellant magazines and shell rooms. The Hold and Platform Decks have collapsed on top of each other down to the armoured Lower Deck, which rest at the bottom of the damaged bow area. Debris from the hull, magazines, shell rooms, torpedo rooms and other compartments now lie amongst the wreckage in this area roughly in their correct relative positions when compared with the plans. Torpedo warheads and sea mines are present along with cordite and cartridge storage boxes and shells. These all appear to be visibly intact, although there is evidence of hydrostatic pressure damage to many of the cordite boxes. The survey found no evidence of explosive damage to the cordite boxes or evidence of mass explosion to any of the other munitions.

Figure 52: 7.5-inch shells from the remains of P-turret shell room

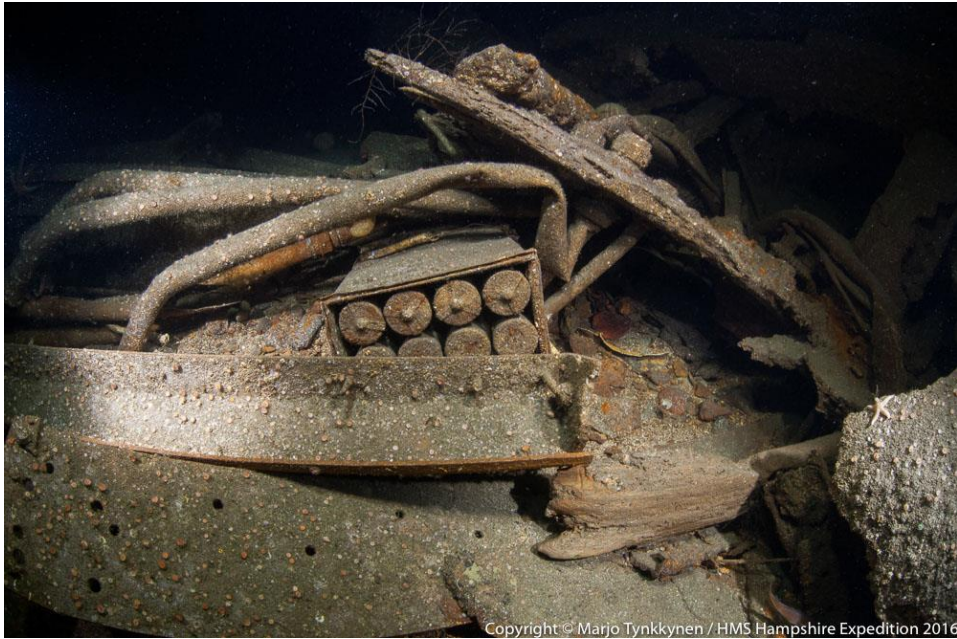
Ribbed brass boxes of cordite propellant in the exposed magazine for P & Q-turrets are being exposed by the collapse of the hull on the starboard side just as the hull reforms its shape at frame No 38 abaft the bow damage.

Figure 55: Box of 12 per QF brass cartridge cases containing cordite

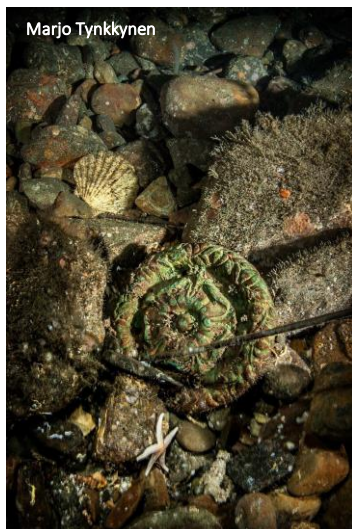
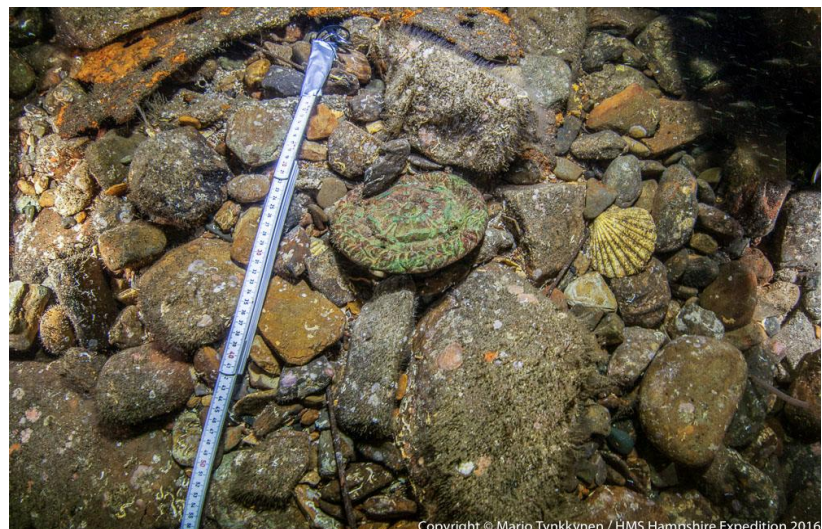
Lying on the seabed a few metres away from her stem is a small nonferrous artefact (likely bronze) some 7 – 7.5 inches across. This is believed to be a decorative tampion cover for one of her main 7.5-inch gun barrels. The artefact's location makes it highly likely that it is from A-turret. The historic emblem of the county of Hampshire, a rose surrounded by a crown of leaves, can still be clearly seen. There are 4 screw holes in the face of the tampion plate where the plate was affixed to a wooden tampion body that fitted in the end of the barrel.

Figure 60: Forward 7.5-inch tampion plate lying on the seabed near the bow.

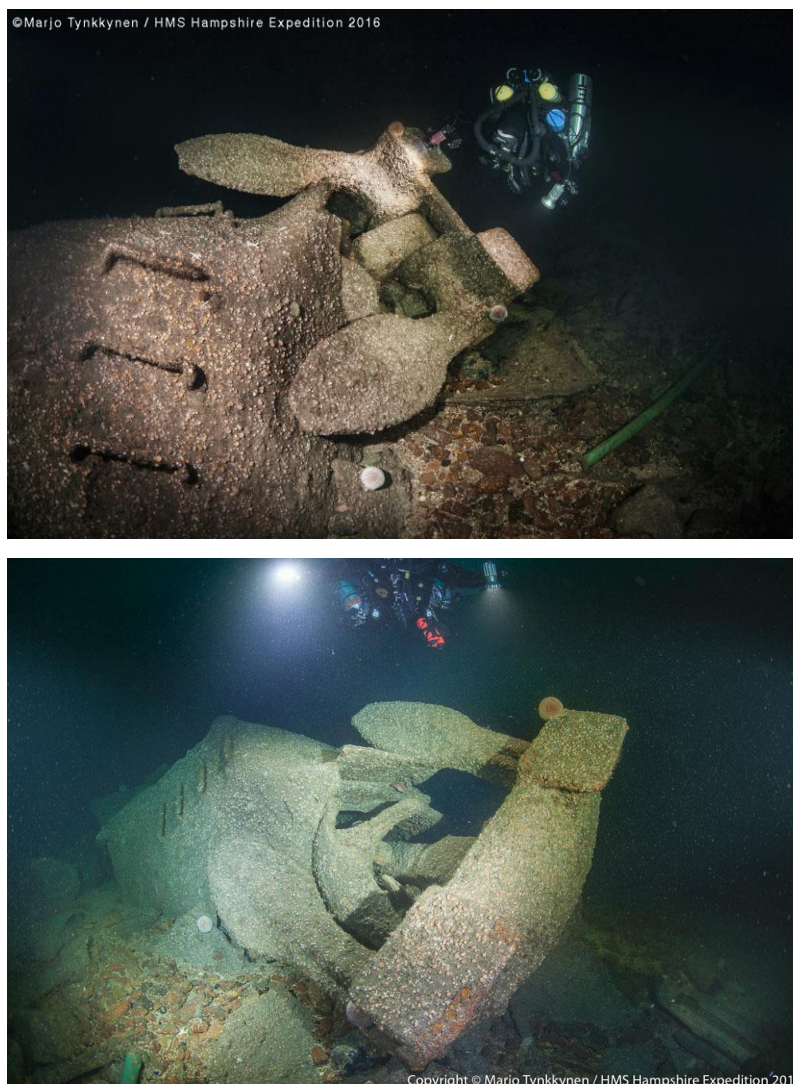
HMS HAMPSHIRE, as with many Royal Navy vessels, was fitted with two bower anchors, one on either side of the bow and a third sheet, or emergency anchor, on the starboard side abaft the bower anchor. The port bower anchor lies on the seabed on the port side of the wreck, still secured in its hawse in a detached section of hull plating. The hull plating has been pushed out to port as the ship came to rest upside down on the seabed. Fixed ladder rungs run up the shell plating alongside. There was no sighting of the two starboard anchors, which are presumed to be buried under the wreck.

Figure 63: Displaced port side anchor in hawser

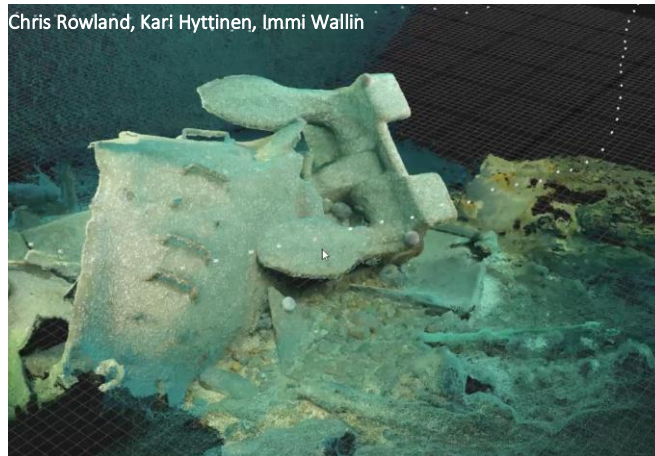
Figure 64: Photogrammetry image of anchor

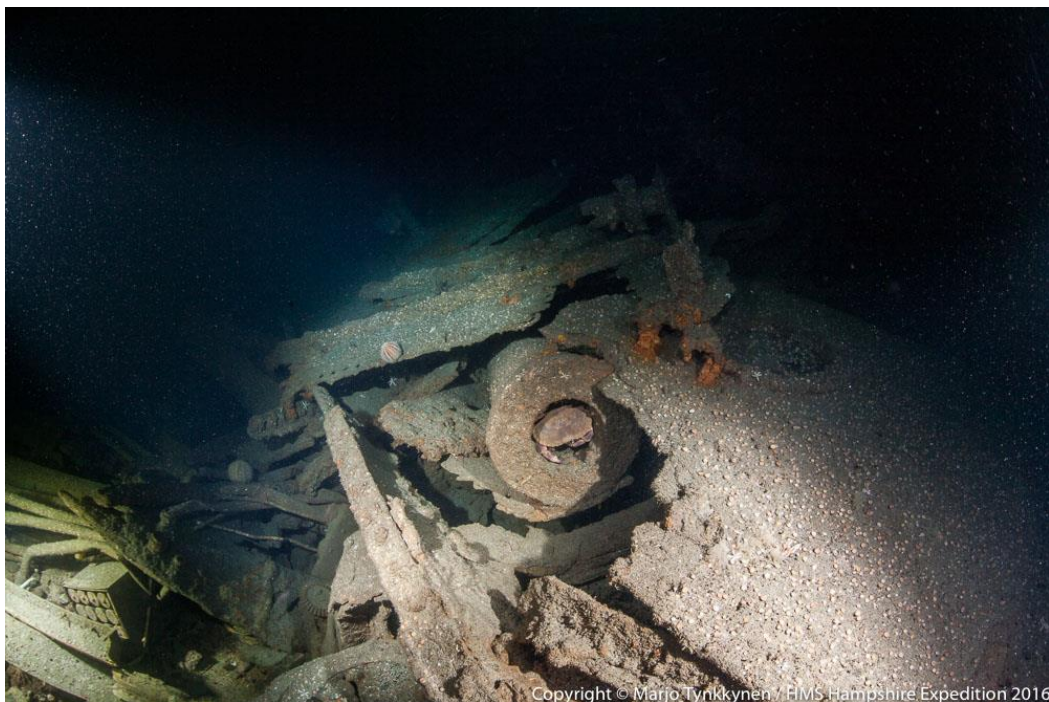
Aft of the anchor on the port side seabed A-turret gun house is visible under the wreckage having been displaced to port during the sinking. P-turret is in situ and clearly visible with the barrel running parallel to the remains of the hull.

Figure 65: The port 7.5-inch P-turret gun barrel abreast the bridge projects from debris

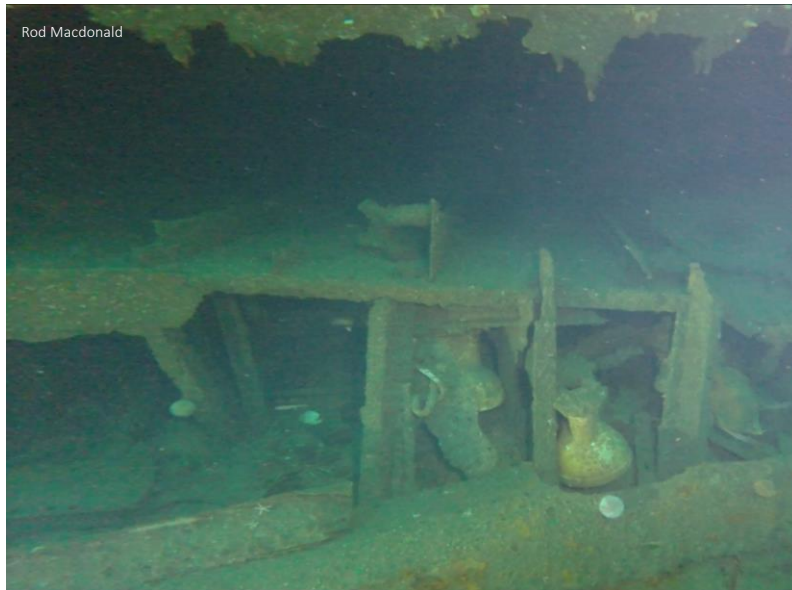
Figure 71: On the port side, abaft P 7.5-inch gun turret, the forward heads are now exposed

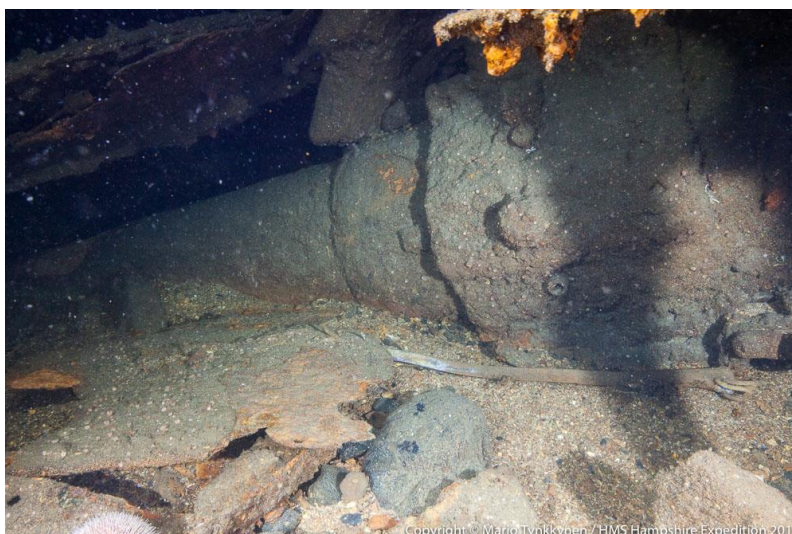
Figure 72: The 4th Mk VII 6-inch gun barrel lies under the wreck

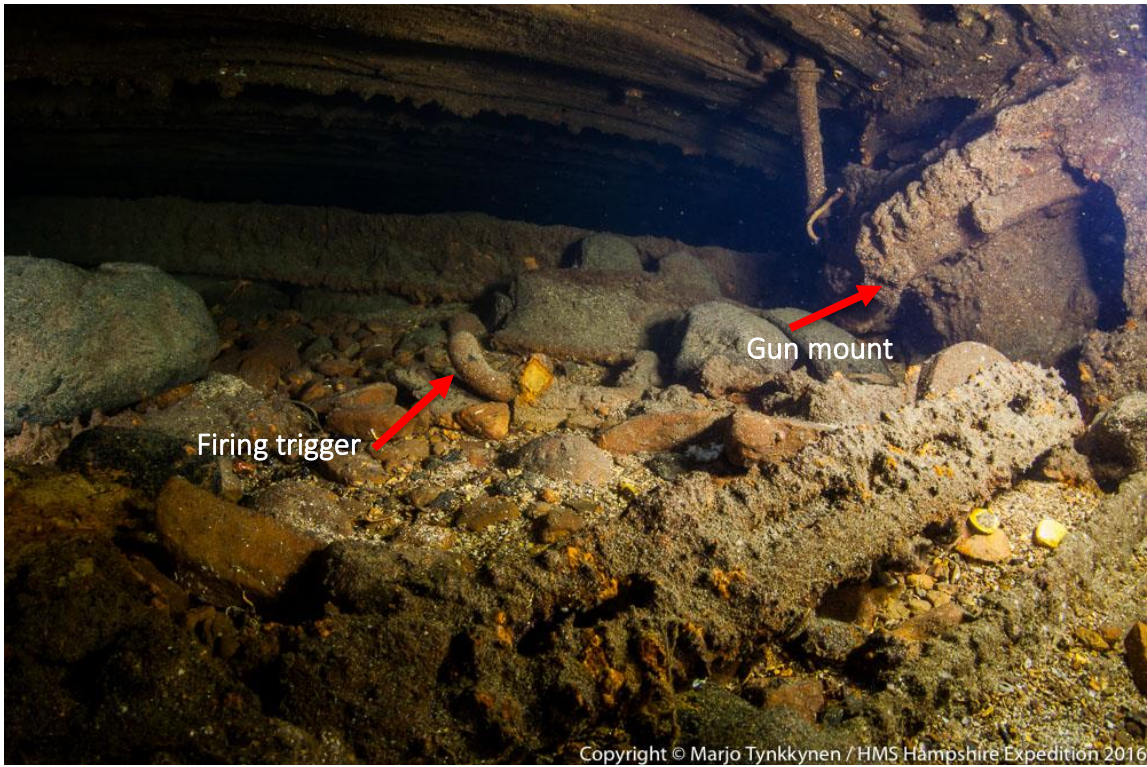
Figure 73: Teak planked deck above. To the right is the gun mount for a Vickers 3-pdr gun

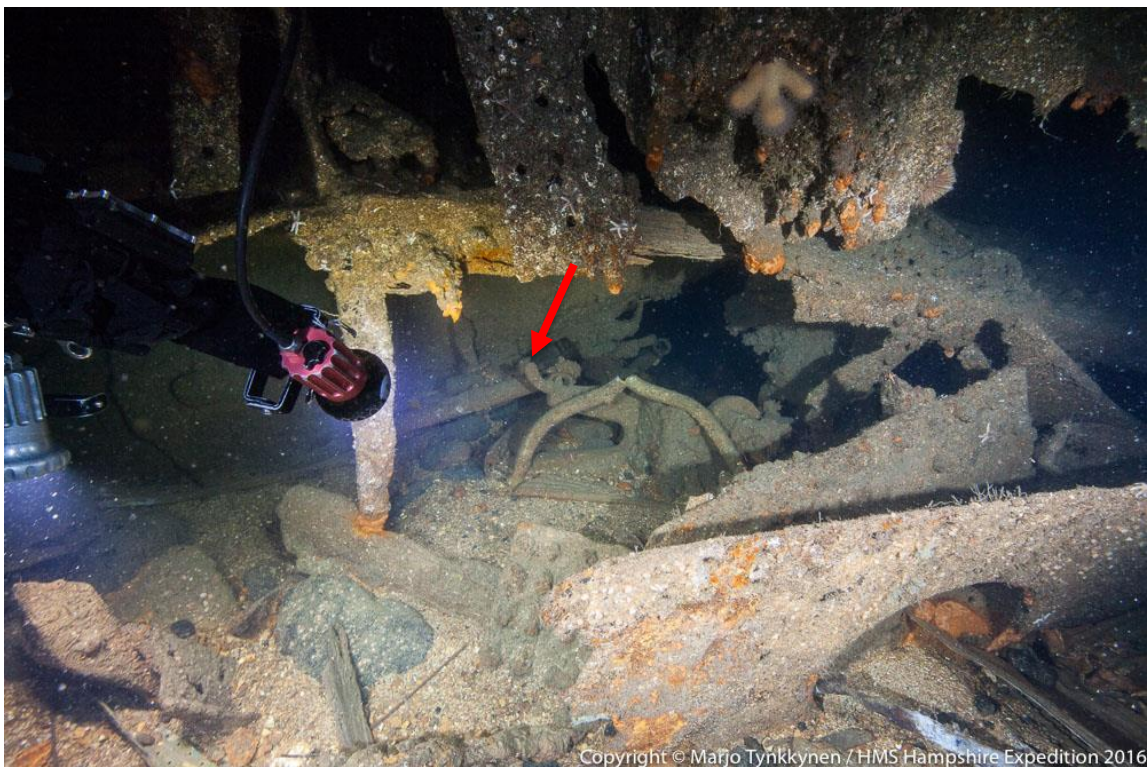
Figure 74: Slightly further forward another upside-down firing trigger can be made out

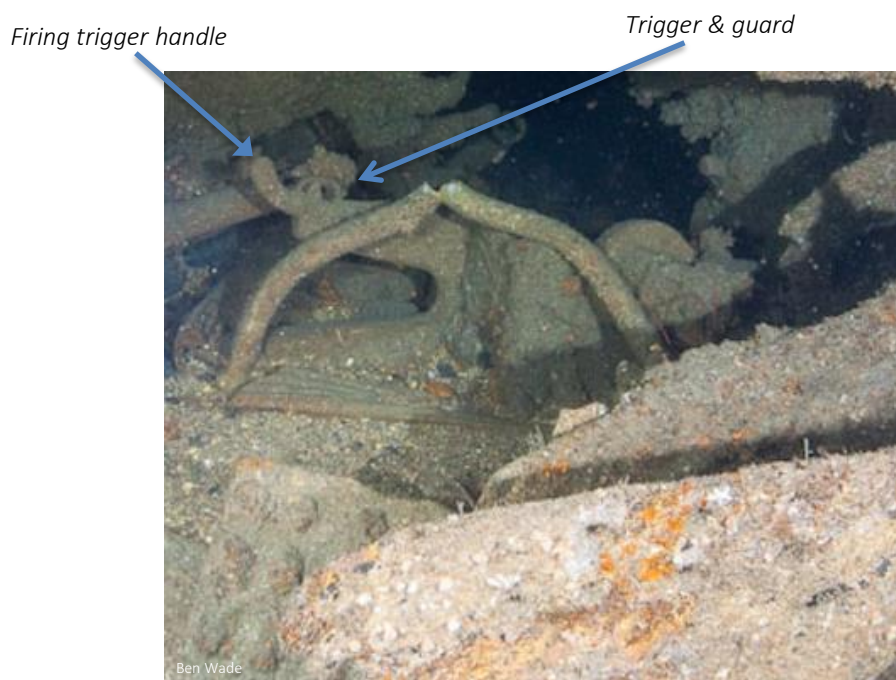
Figure 75: Close up of the firing trigger still on its mount

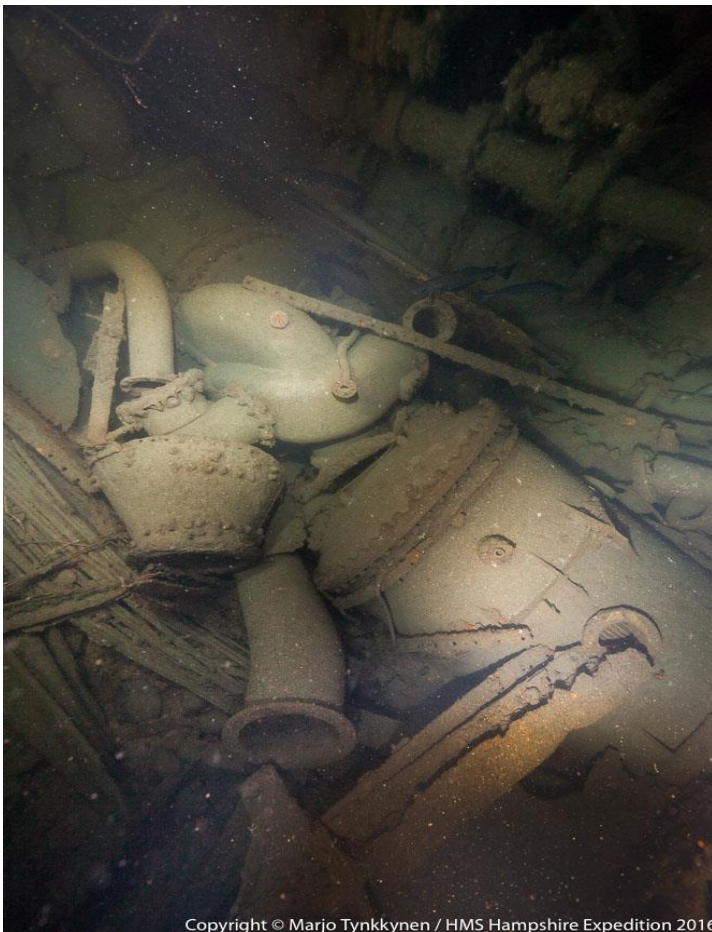
Figure 77: Port side engine room condenser viewed from the top of the port side fissure

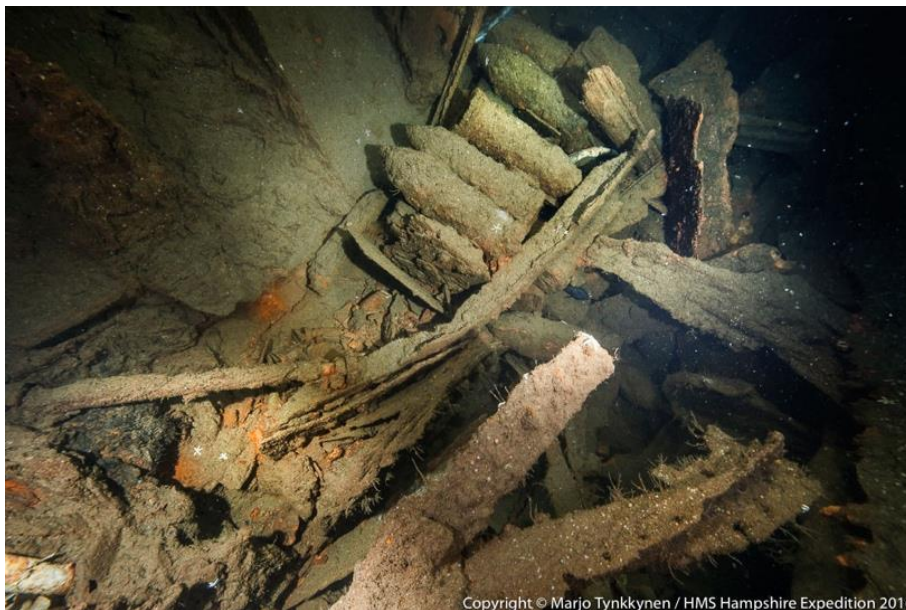
A collection of 6-inch shells were located within the fissure at approximately frame No 92 adjacent to where the ammunition hoist would be located to service the centre casemate. An ammunition passage runs the length of both the port and starboard side of the ship on the Platform Deck from frame No 48 at the front of the first boiler rooms to the aft end of the engine rooms at frame No 150. The fissure along each side of the wreck appears to follow this ammunition passage. Examples of both nose-fuzed and base-fuzed shells are present in this area.

Figure 80: Base fuzed 6" AP shells

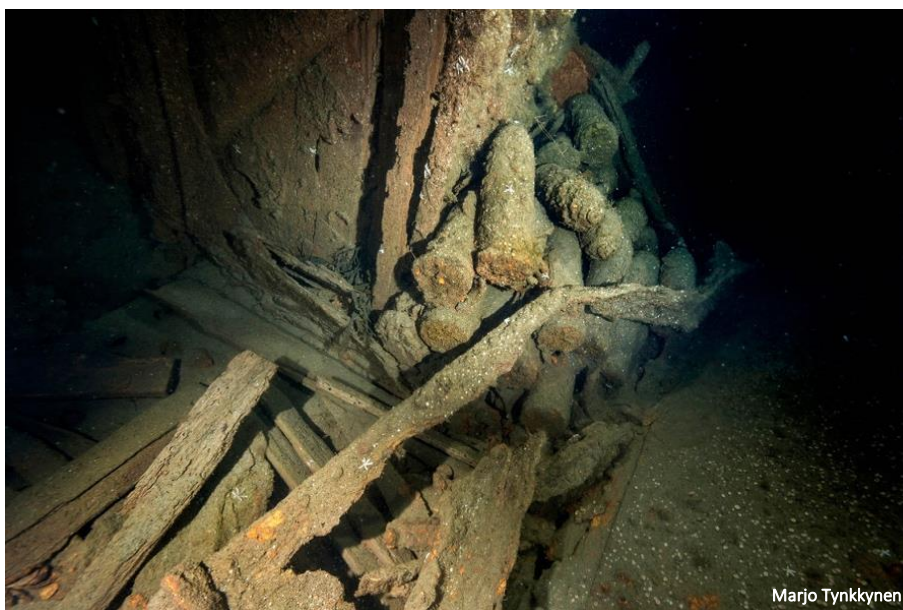
Figure 81: Nose fuzed 6" HE shells

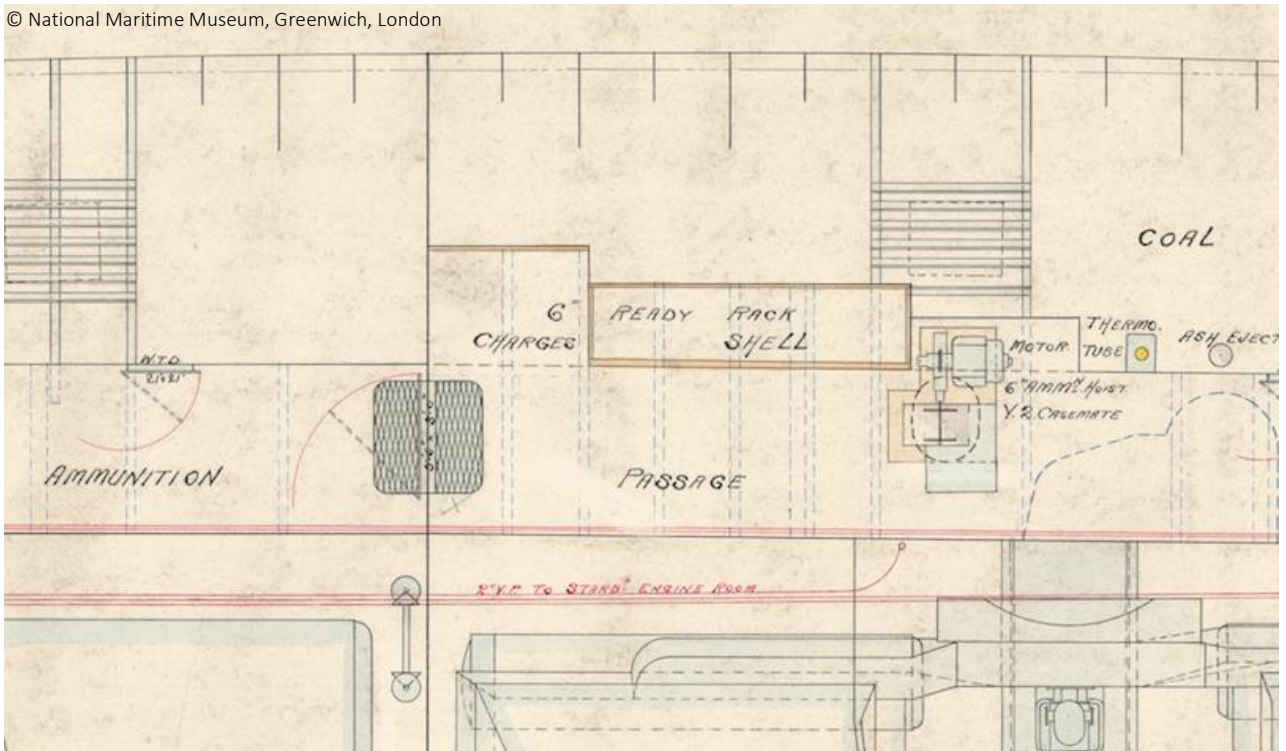
Figure 82: Port side ammunition passage midships showing shell ready rack and ammunition hoist for midships casemate

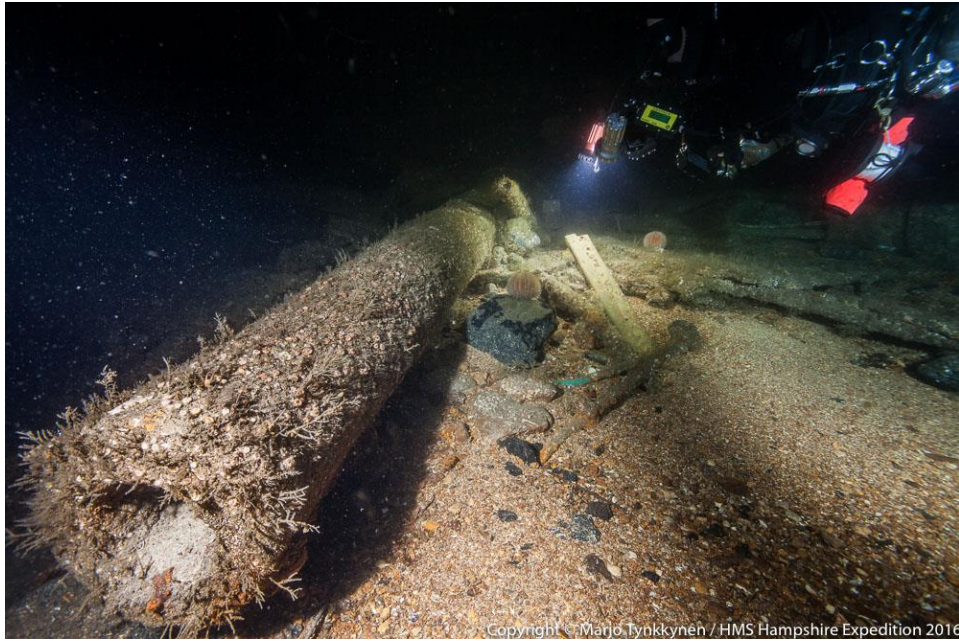
Figure 91: The upper 6-inch Y1 casemate gun barrel lies flat on the seabed pointing aft

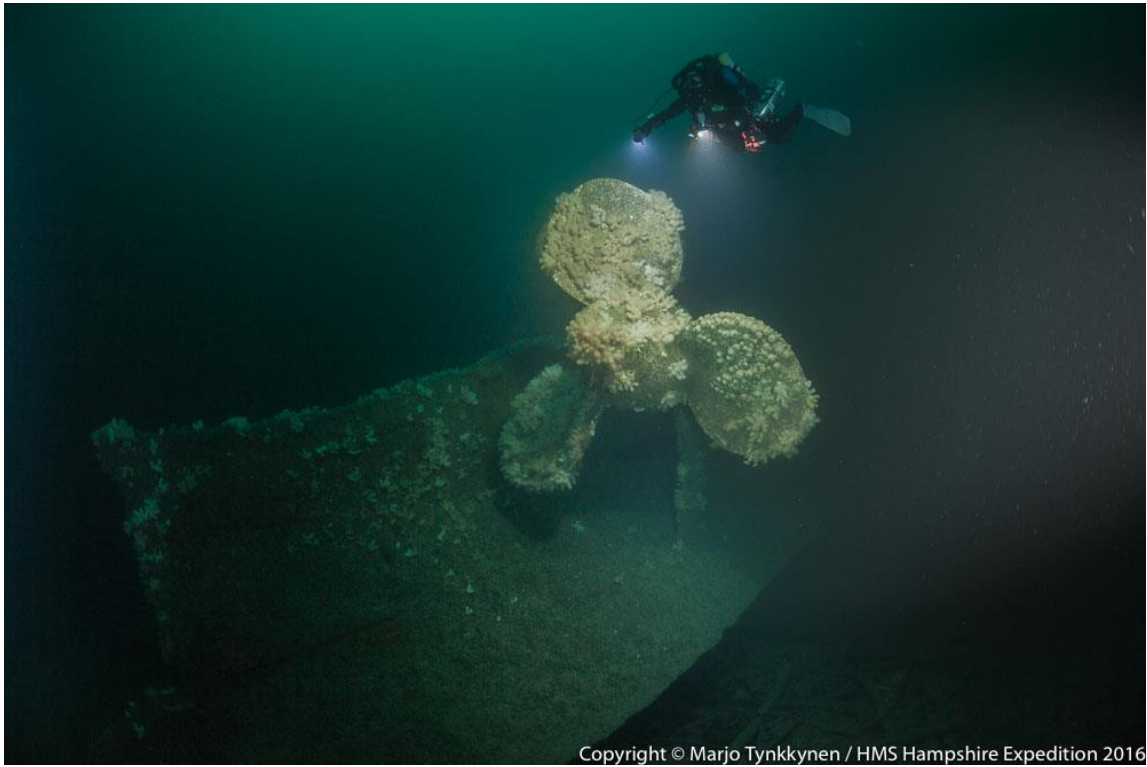
The manganese bronze port propeller, A-frame bracket and shaft are still present on the wreck. The shaft is slightly bent towards the seabed where it exits the ship due to the distortions in the wreck around Y-turret.

Figure 93: Port side propeller

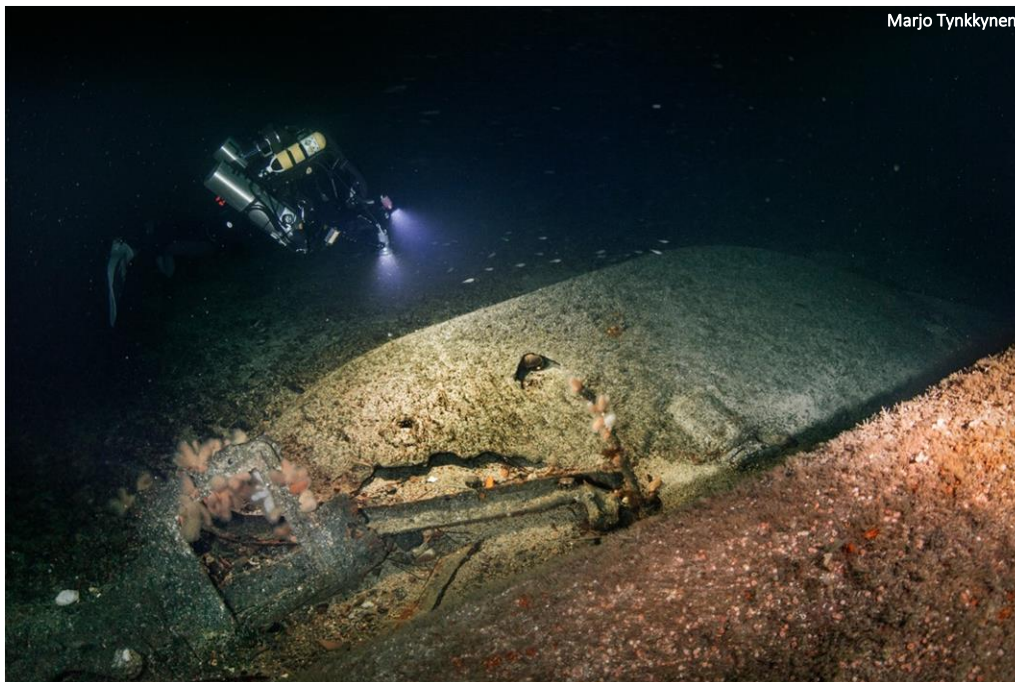
The rudder has fallen from its mount to lie flat on the seabed to starboard (Figure 95, below).

Figure 95: HMS HAMPSHIRE's rudder

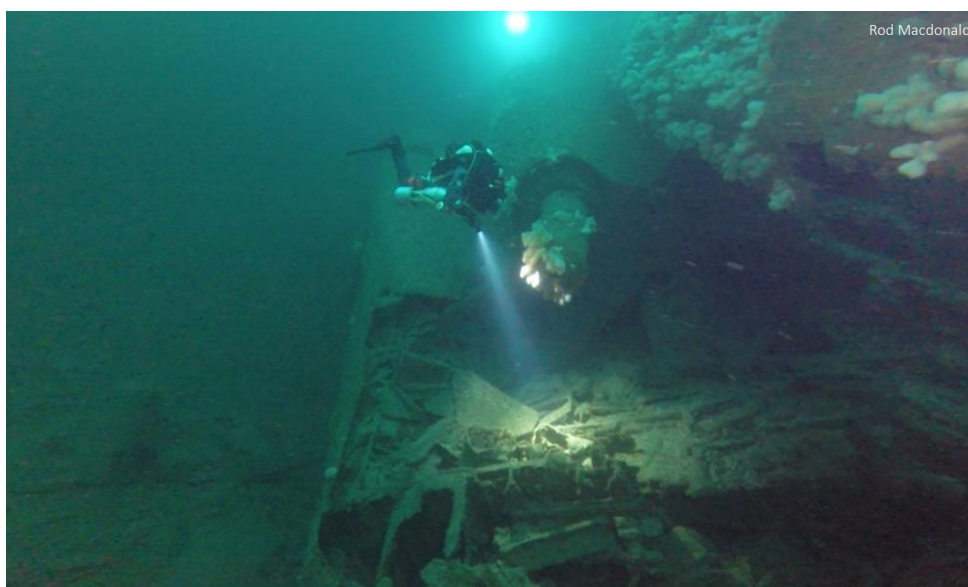
The starboard propeller is not present on the wreck. It was recovered in 1983 during a survey and is now on display at the Scapa Flow Visitor Centre & Museum on the island of Hoy. All that remains of the starboard side stern gear is the severed end of the shaft. The starboard shaft emerges from its stern tube in the photograph below (Figure 96) and appears to have snapped at this point.

Figure 96: Severed starboard side prop shaft
