HMS Hampshire 100

Survey Report

Location: Atlantic Ocean, waters west of Orkney, Scotland

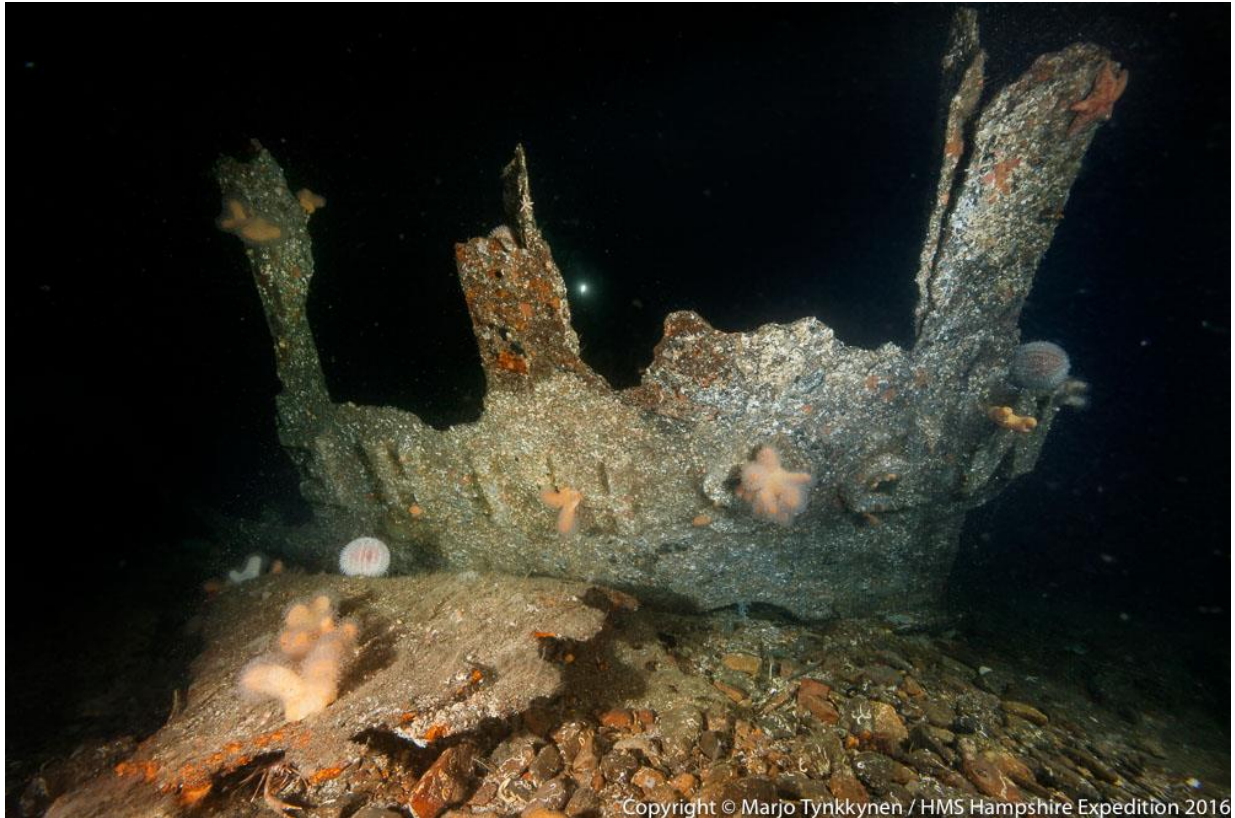
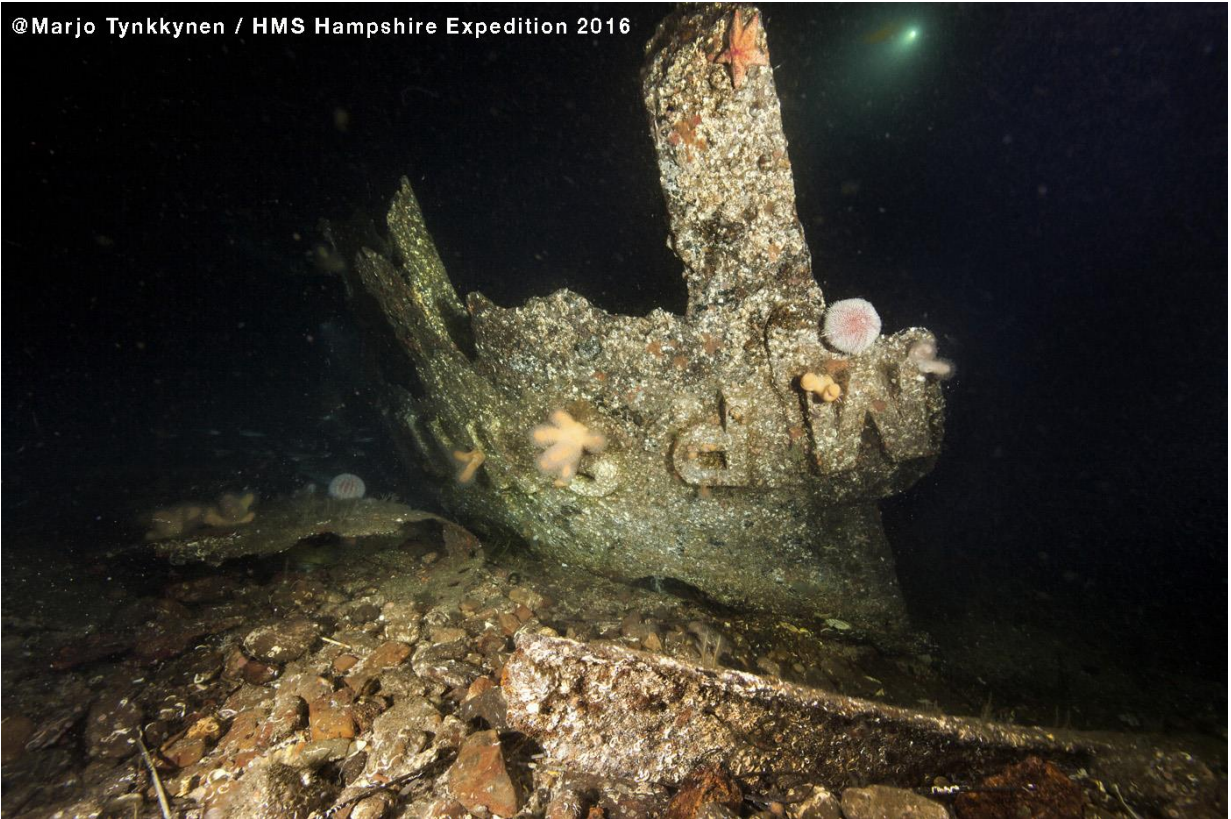
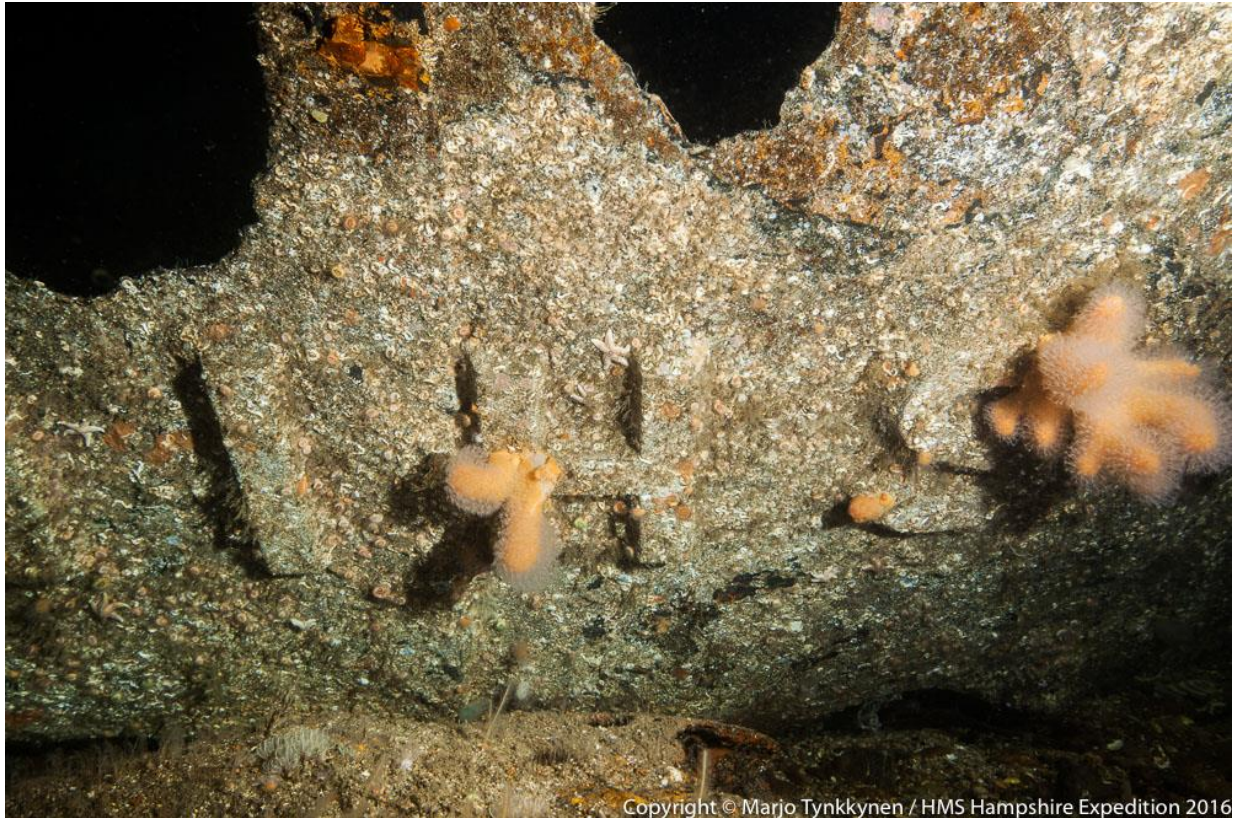
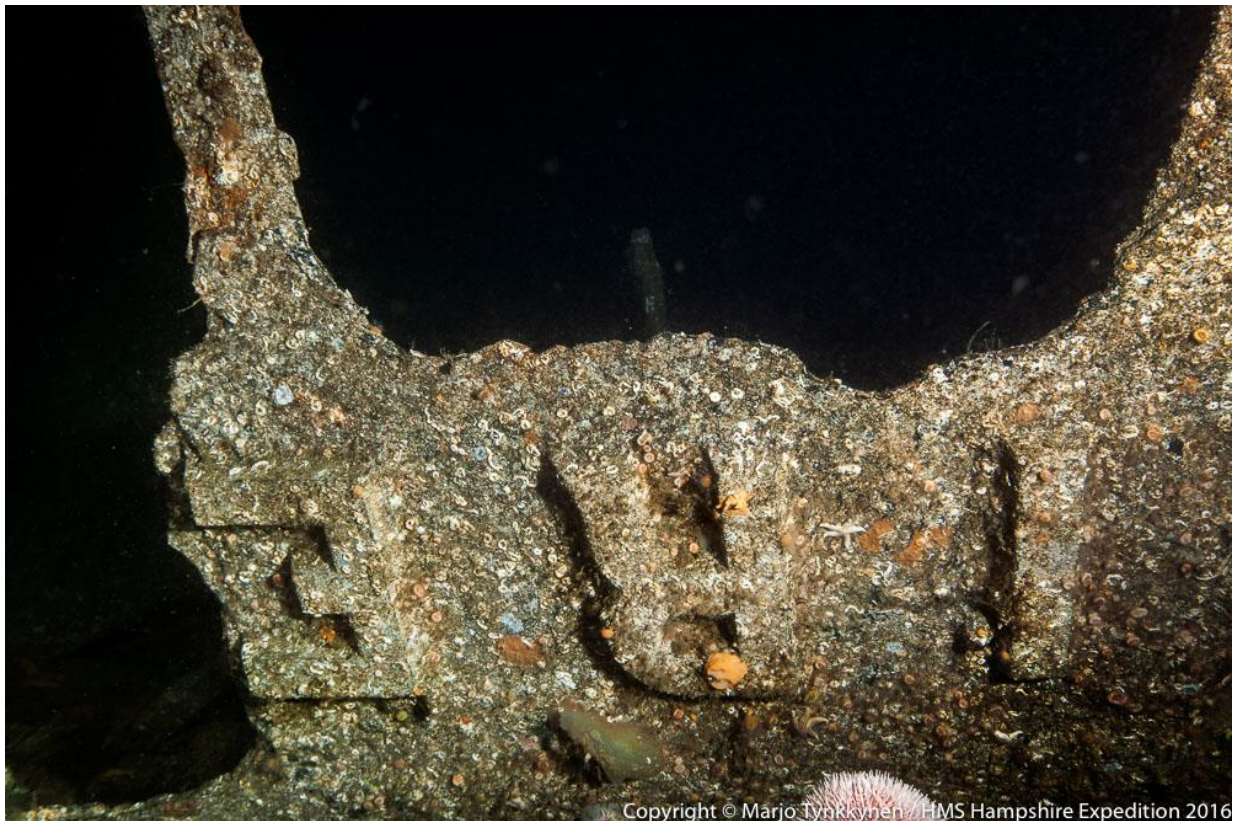
Of the stern of HMS HAMPSHIRE, the keel to the the Platform Deck remains intact. The aft part of the ship now rests on her armoured deck and the Lower and Main Decks are absent, except for a small part of the Main Deck at the very stern which now sits separated from the main stern wreckage by approximately two metres. This wreckage contains the sternmost porthole from the Main Deck and the remains of the ship's name. Hull plating from the Lower and Main Decks now rests on the seabed to port and starboard.

Figure 98: The remains of HMS HAMPSHIRE's name can be clearly seen

Figure 99: The remaining embossed letters of her name 'MPSHIRE can be seen ringing around the remaining section of Main Deck

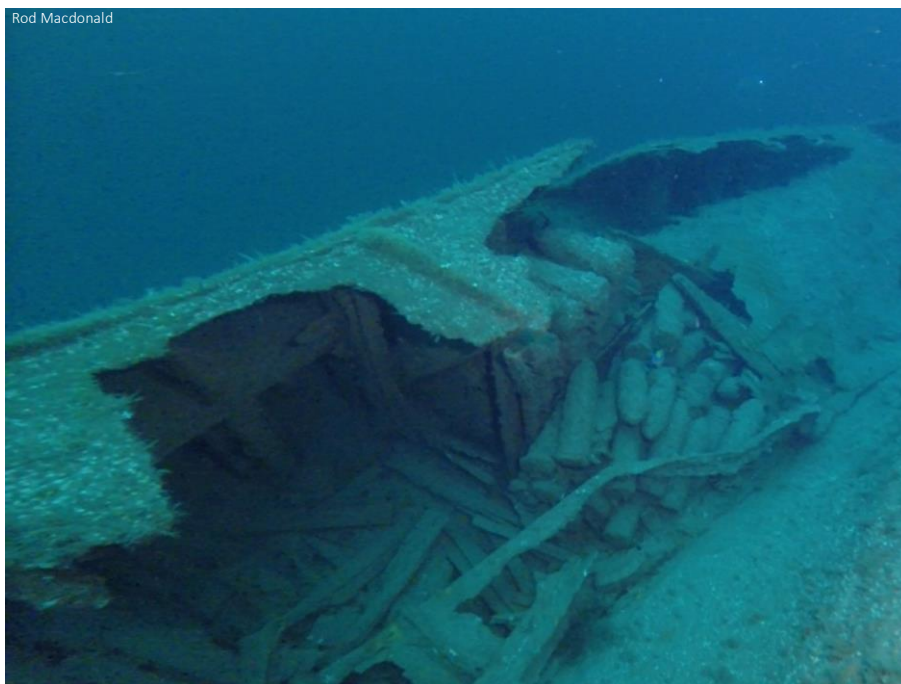
Figure 102: A view from forward, looking aft of the port 6-inch shell room showing separation and collapse of hull bottom (right) from port side of the ship (left)

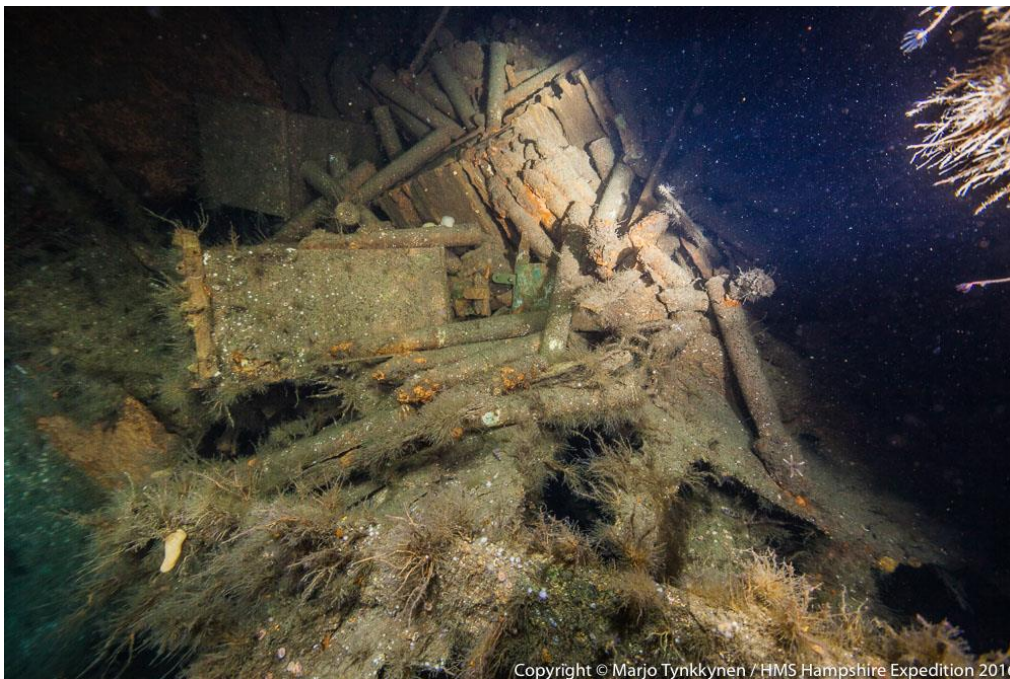
Collapsing of the hull underneath the free section of port prop shaft in the vicinity of Y-turret has exposed the 3-pdr magazines located in the Hold (see Figure 103).

Dozens of rounds of 3-pdr Vickers Mk1 QF fixed ammunition are present, each comprising of a brass cartridge containing cordite, and a corroded steel projectile containing fuze and explosive. Each round of ammunition is approximately 0.5m long and 5cm diameter.

Figure 103: Vickers 3-pdr QF ammunition abaft Y-turret, directly under the port prop shaft

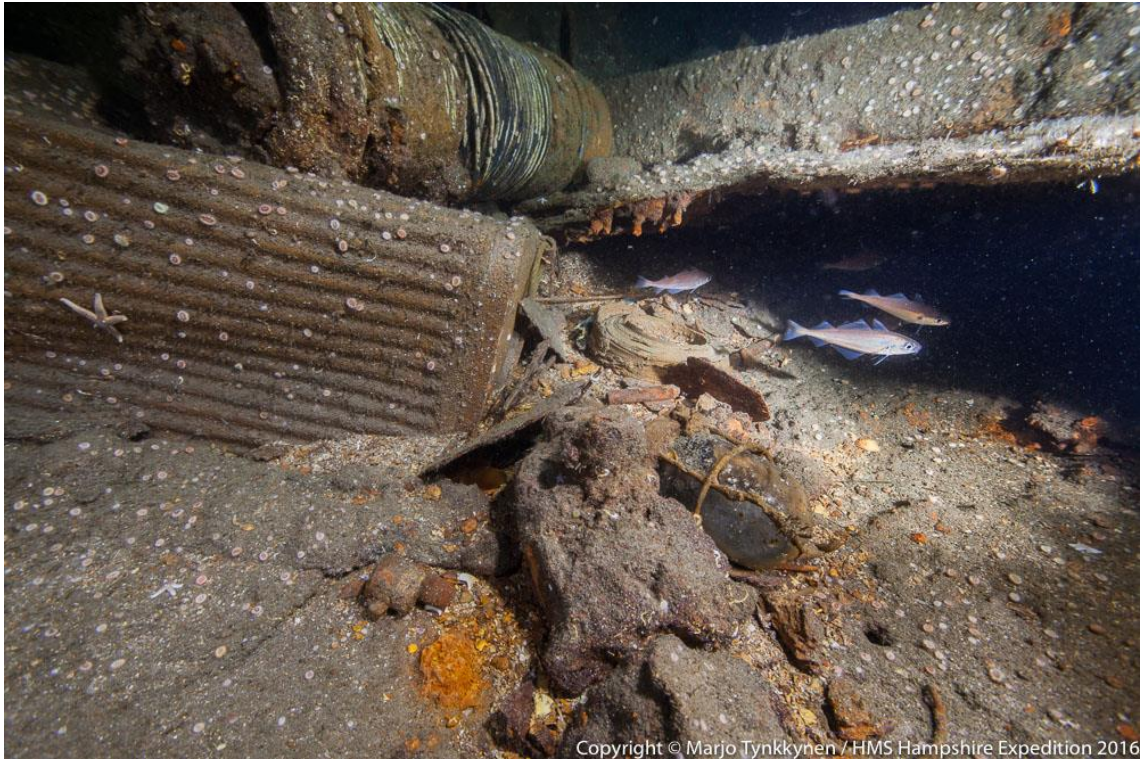
On the seabed in the area are the remains of the 7.5-inch Y-turret magazine. Ribbed flash-proof brass boxes of propellant and scattered cordite are spilled onto the seabed both to port and starboard.

Figure 104: A brass cordite case. A cage lamp with glass intact lies to its right

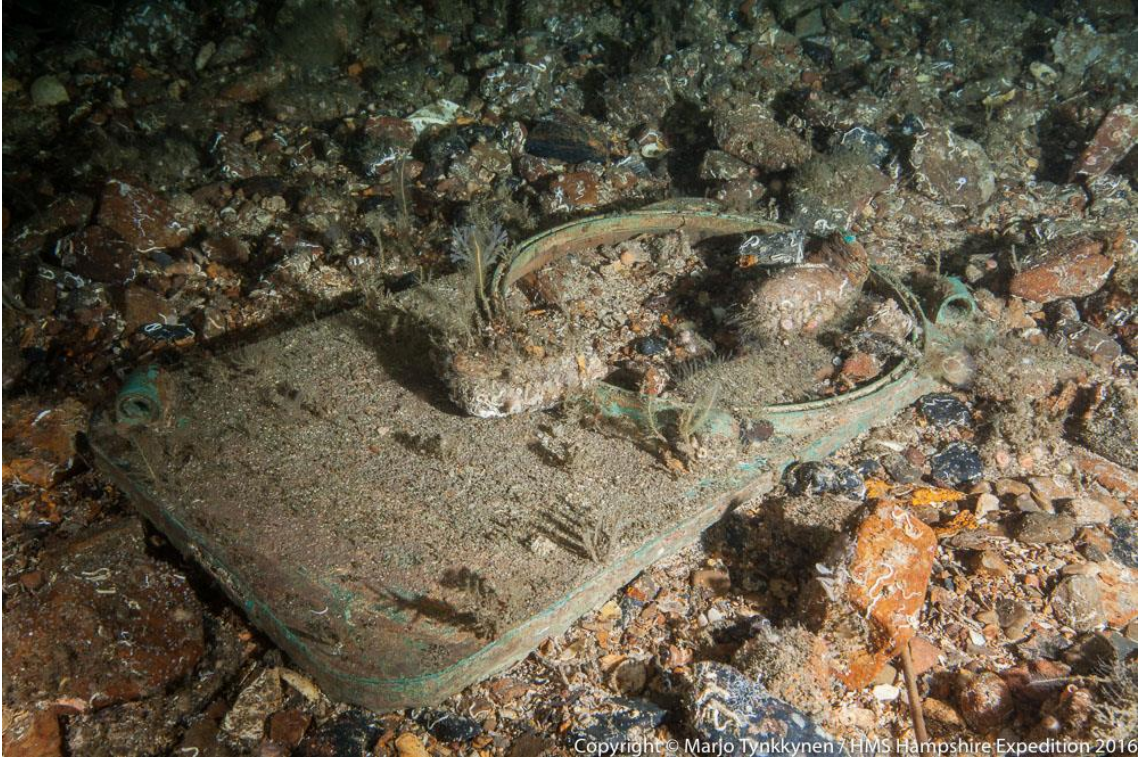
Figure 106: Cordite box lid on seabed

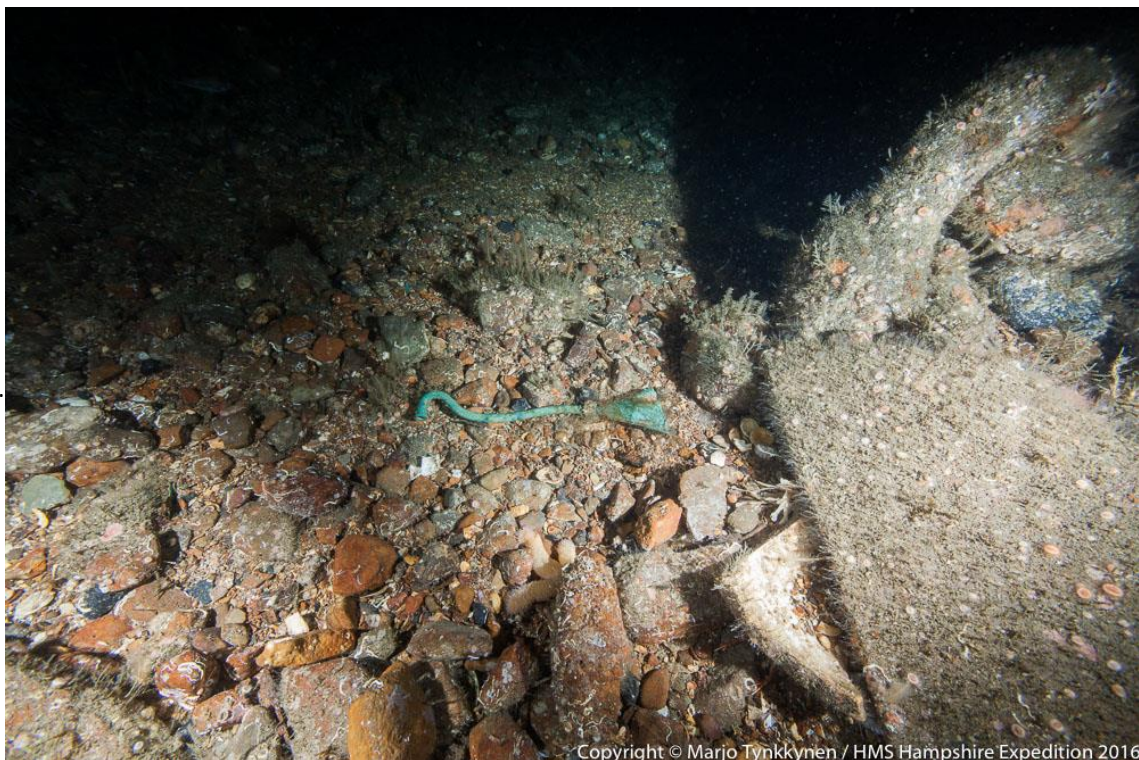
Figure 108: A copper oil filler lies on the seabed next to the main mast. This is similar to those found on small steam engines

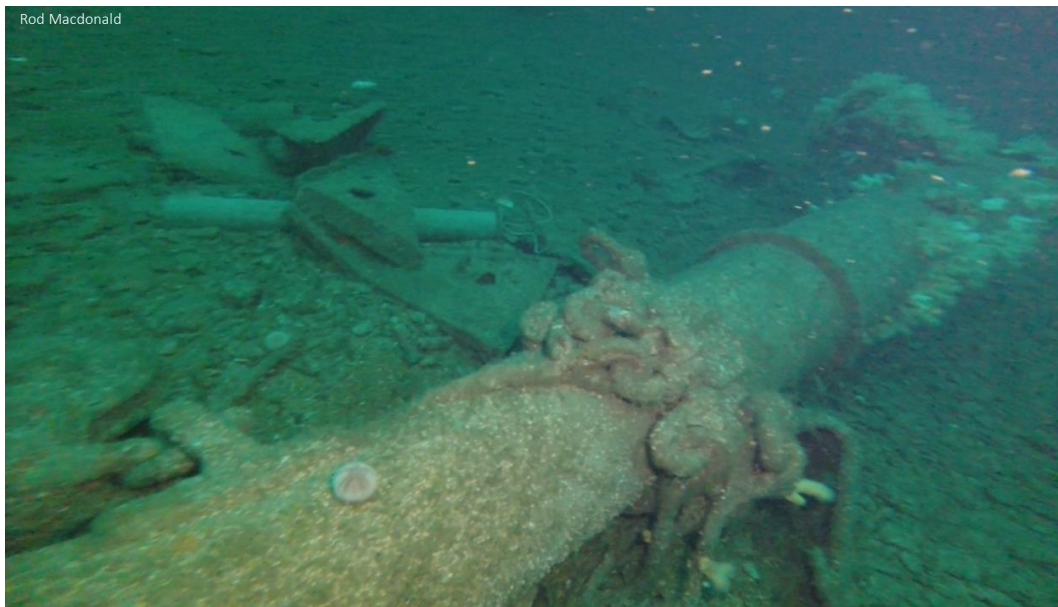
Both fore and aft masts were approximately 150 feet high. Both have been pushed to the port side as the ship sank, and the remains of both now lie on the seabed. Very little structure survives of the forward mast. Adjacent to this structure, however, lies one of the bridge telegraphs and one of the navigation lamps (presumably the port side lamp). No discernible structure remains of the upper spotting top or the upper mast and yardarms. The main mast is more complete at the lower levels. The spotting top and upper mast and yardarms are, for the most part, absent.

Figure 118: Main mast with shackles for standing rigging

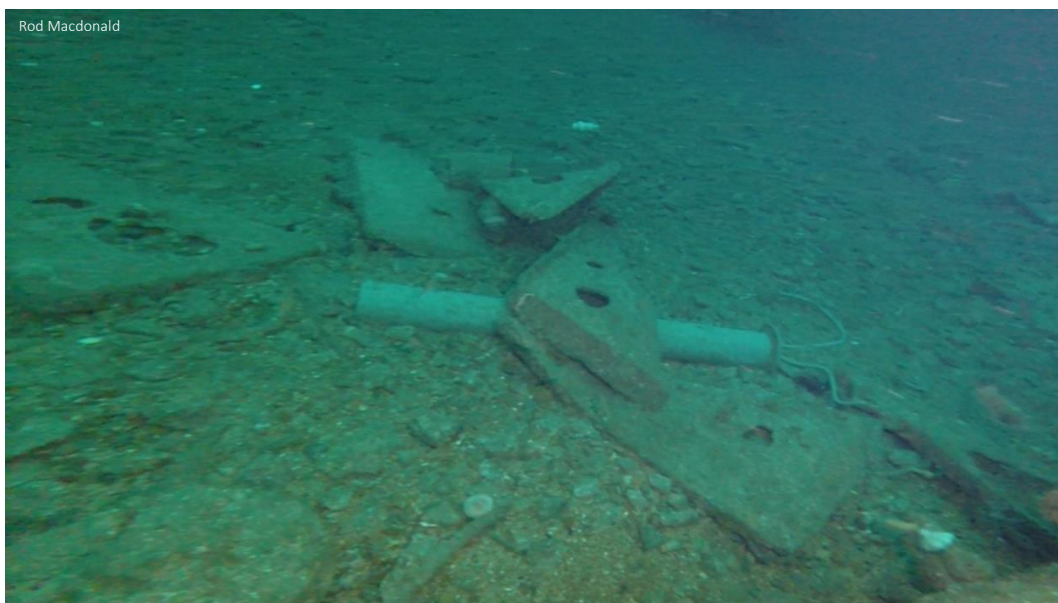
Figure 119: A close-up view of debris next to the main mast. Triangular sections are the lower support for the spotting top platform

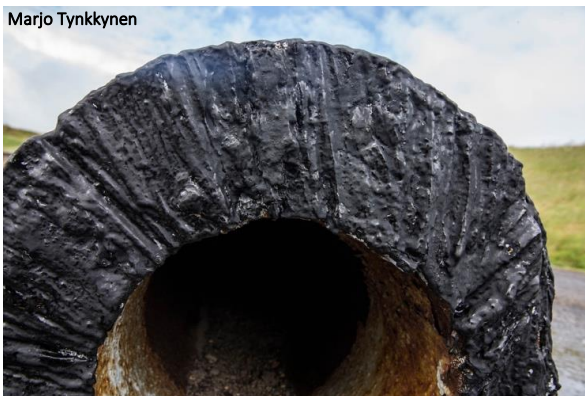
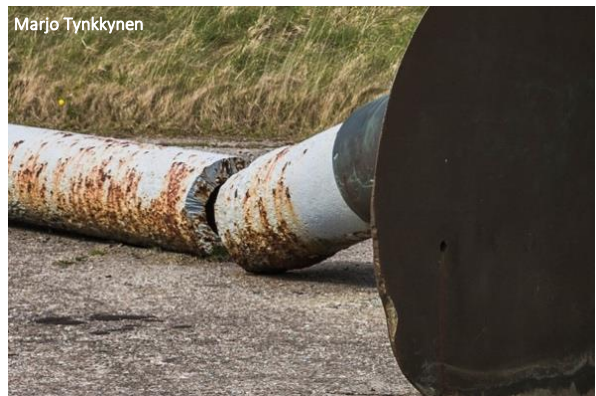
- The starboard shaft has been cut just forward of where the cutlass bearing would have been. This cut has been made post salvage, as archive images of the landed artefact show the shaft and propeller as a composite unit. It is suggested that the cut may have been made in order to ship the items to Lyness.

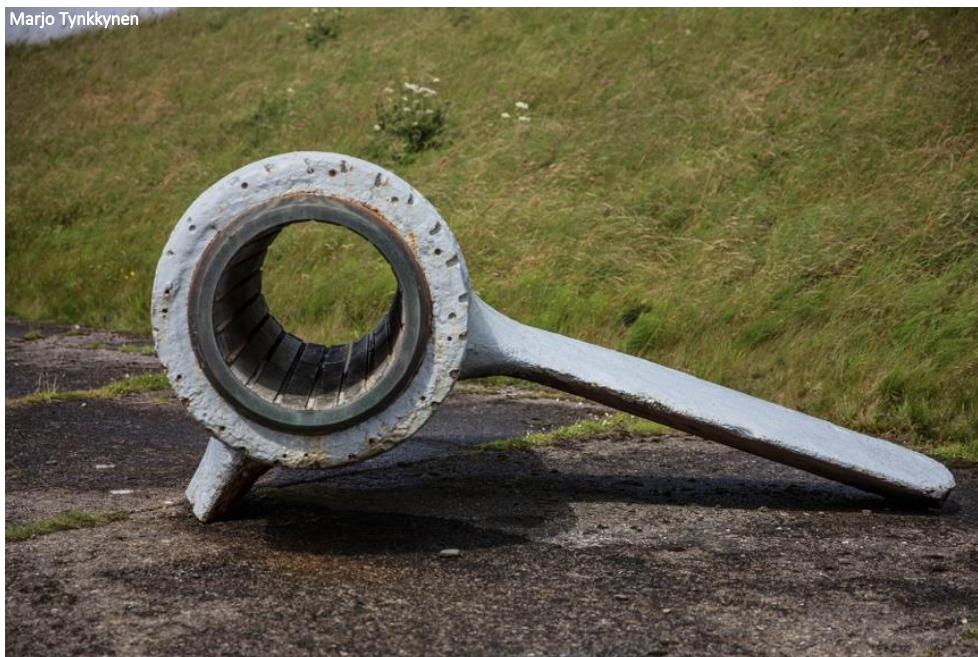
- The starboard side A-frame was also recovered with the propeller and has associated damage consistent with fracturing.

Figure 125: Starboard side A-frame bracket

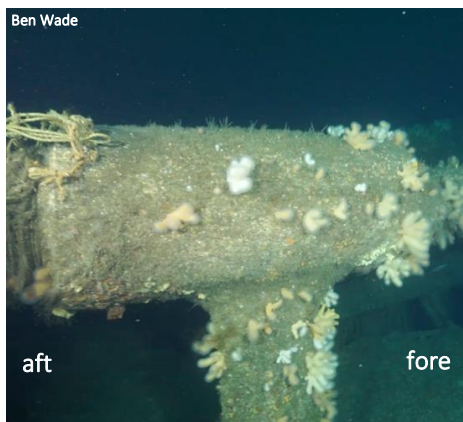
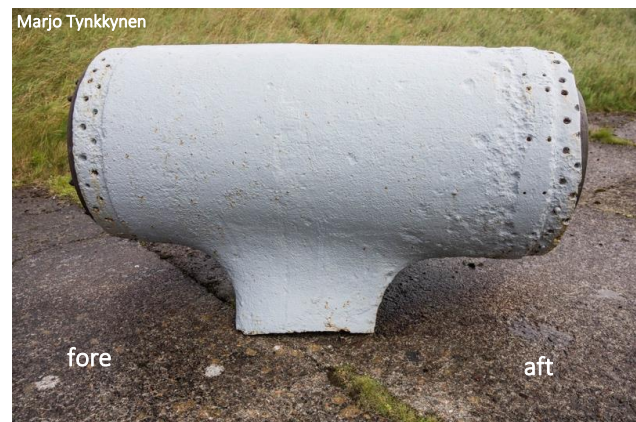
Examination of the footage of the remaining port A-frame clearly shows the cutlass bearing extends further aft than forward of its supports.

Figure 128: Comparison of starboard and port A-frames, detailing fore and aft position

This enabled us to orientate the A-frame and bearing at Lyness, such that the remaining short arm was the upper leg on the ship. The remaining long leg would have been attached to the keel.

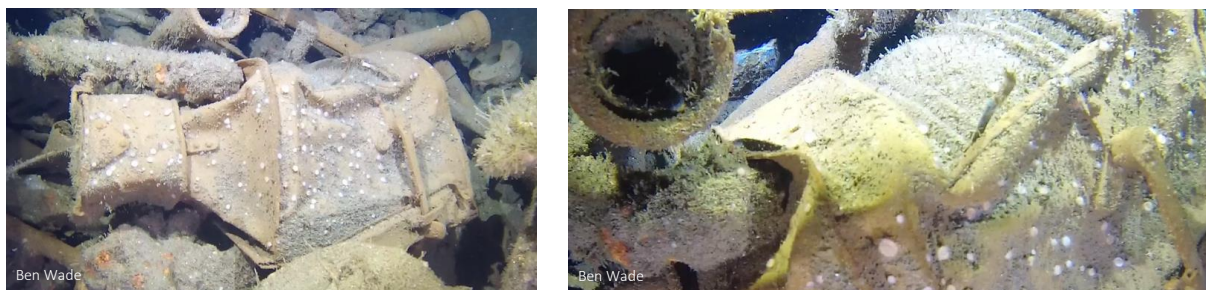
An intact navigation lamp showing possible compression damage from sinking lies in the bow. The glass is intact in the lamp. These were likely held in the boatswain's store which, on the ship's plans, is marked in this part of the bow. In addition to the pressure damage visible on the navigation lamp in the bow, several dozen ribbed brass cordite propellant storage boxes also show evidence of pressure damage consistent with all propellant boxes located on the wreck. Nowhere was there evidence found of explosive damage to the boxes.

Figure 129: Intact navigation lamp

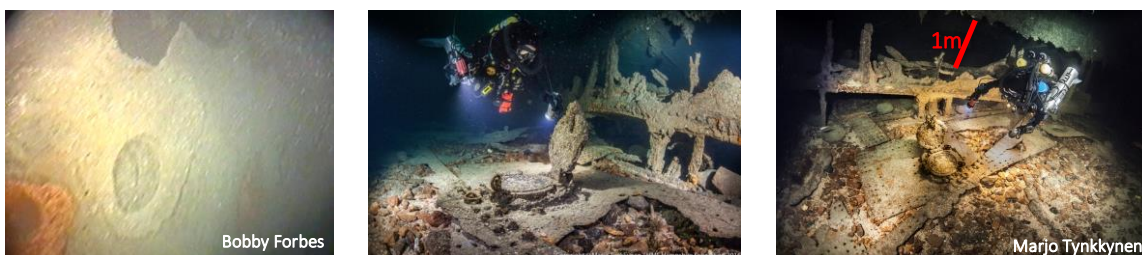
The Main Deck, which is only visible on the port side, has reduced in deck to deckhead height from 2.5 metres at her time of construction to approximately 1 metre at the time of the survey, as shown in Figure 130. It is noteworthy that this has remained stable, and does not seem to have decreased considerably between the 1999 and 2016 images. The associated hull plating along the midships section has fallen away and now lies face down on the seabed.

Figure 130: Hull plating

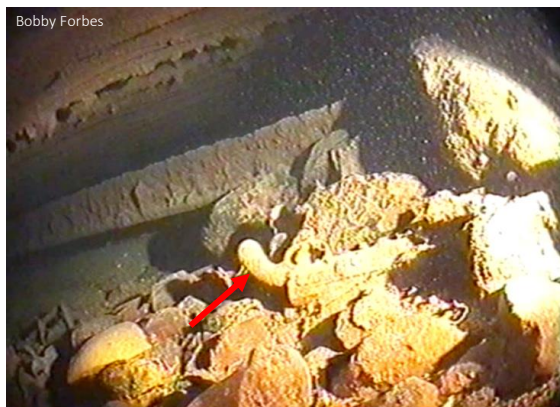
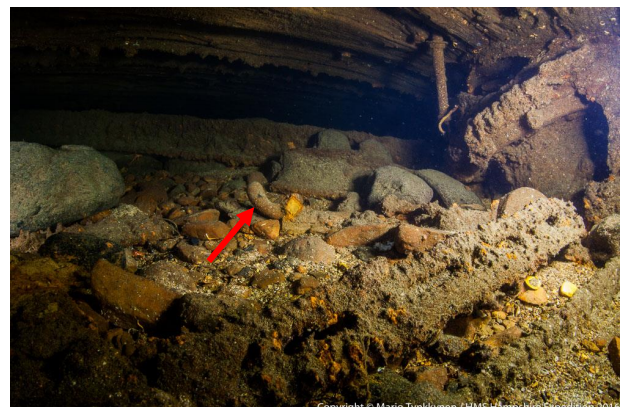
With the decay of the Main Deck, the vertical armour belt was able to settle towards the seabed under its own weight. This process has allowed the port side fissure to form at the weakest part of the hull structure, which is now above the vertical armour belt and armoured deck, in her capsized form. This decay may have been exacerbated by a longitudinal ammunition passageway running the entire length of the midships section.

Figure 131: Images comparing distance between upturned hull and seabed. Note Vickers gun firing trigger

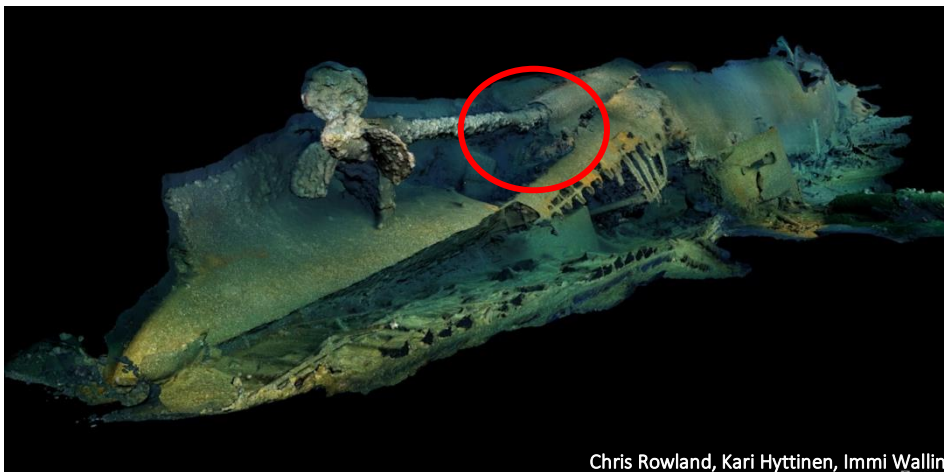
The stern section has suffered severely from saltwater corrosion and decay. The Main Deck and Lower Deck have mostly rotted away, leaving only the Platform Deck and the Hold relatively intact. The Platform Deck is supported by the armoured deck at seabed level while the keel is supported by Y-turret's ammunition hoist. The port side propeller and shaft remain intact, although the shaft is showing signs of stress at the stern tube where circled in red, below. It is anticipated that this will snap over the course of time.

Figure 134: 3 image of port side propeller and shaft
