# IMPACTS OF SURFACE FAULT RUPTURE ON RESIDENTIAL STRUCTURES DURING THE 2016 $M_w$ 7.8 KAIKŌURA EARTHQUAKE, NEW ZEALAND

## ABSTRACT

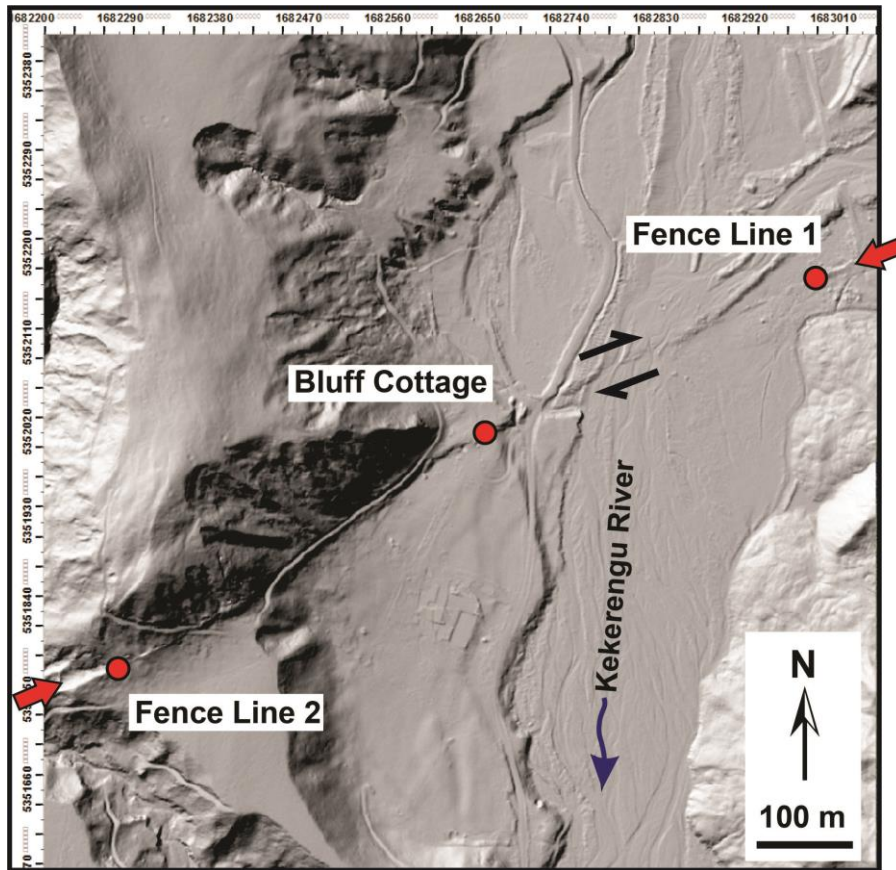
Approximately 10 m of discrete (i.e., concentrated – as opposed to distributed) horizontal and 1-2 m vertical surface fault rupture displacement extended through the foot-print of Bluff Cottage on the Kekerengu Fault (Figure 3) [18]. Offset fence lines within ~450 m either side of the cottage also document lateral displacements of ~10-11 m and narrow fault deformation zone widths (Figures 2 & 4). The foundation of Bluff Cottage was cut in half and displaced by fault rupture. The superstructure of the house was low mass, flexible, regular in shape, timber floored and relatively weakly attached to the foundation. These properties allowed the superstructure to detach from the mainly laterally displacing foundation, and to isolate it from the extreme ground deformation taking place beneath. The house suffered severe structural damage, but it did not collapse. From a life-safety perspective, and considering the large displacement and small fault zone width at this site (i.e., metre-scale strike-slip displacements and shear strains in the order of 10<sup>0</sup>; Table 2), this house performed admirably.

*Figure 2: 2016 post-earthquake LiDAR hill shade DEM illuminated from the NW showing location of surface rupture trace of the Kekerengu Fault (red arrows), Bluff Cottage (Figure 3), the two offset fence lines depicted in Figure 4, and the sense of strike-slip on the Kekerengu Fault (black arrows). Though the size of Bluff Cottage portrayed in this figure is significantly exaggerated, its orientation is accurate. Coordinates are New Zealand Transvers Mercator 2000.*
